Inspection Photos and Issue Report

Operator: CAERUS PICEANCE LLC - 10456

Location #323839

Garfield County, CO

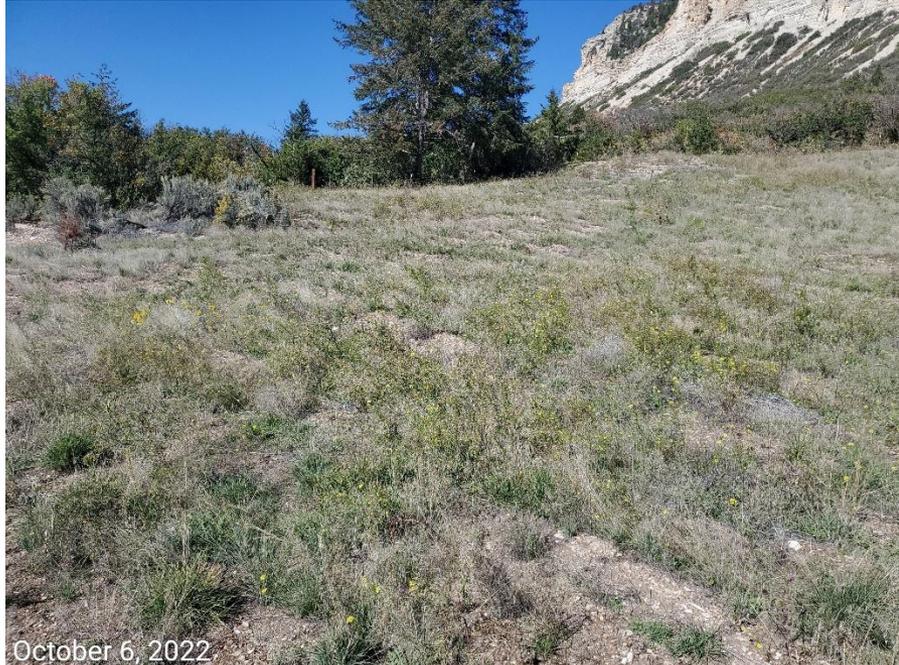
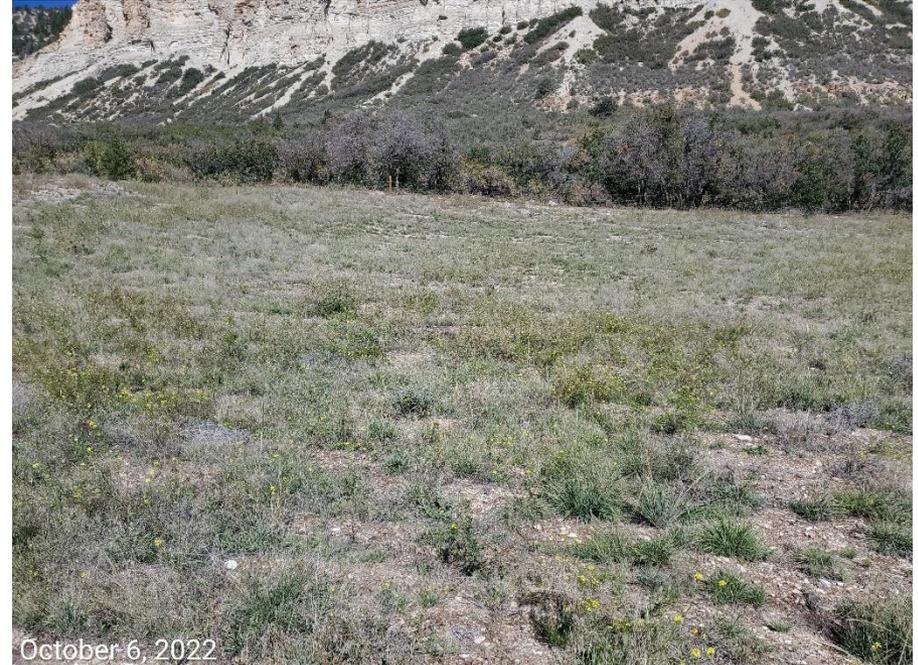
Photo 1: Photos 1-2 taken from the south end of the Location. Photos provide an overview of the reclamation areas from west, northwest, northeast, to east. Revegetation of the Location is predominantly desirable species, and establishment is uniform per 1004 standards.

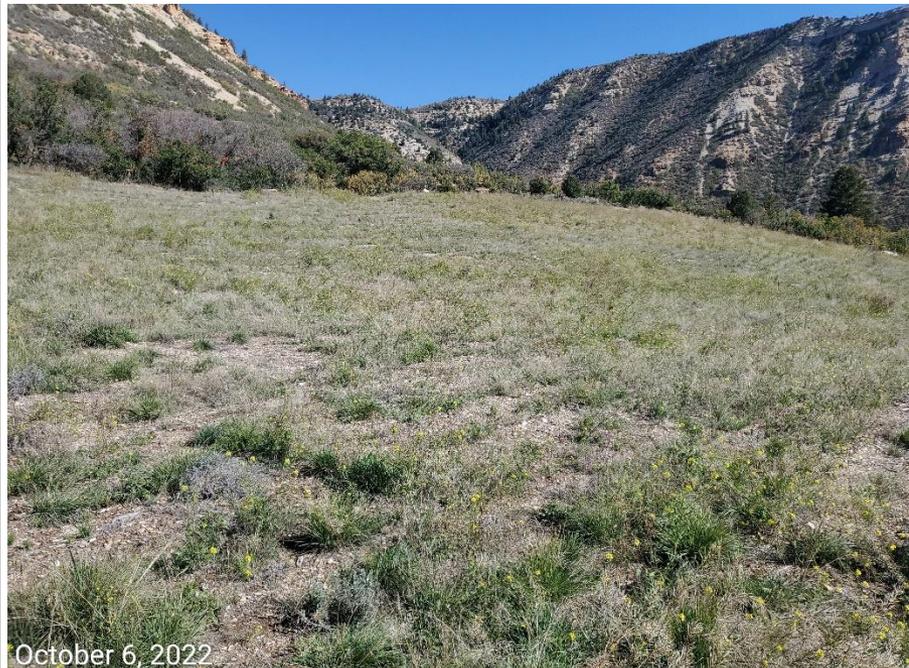
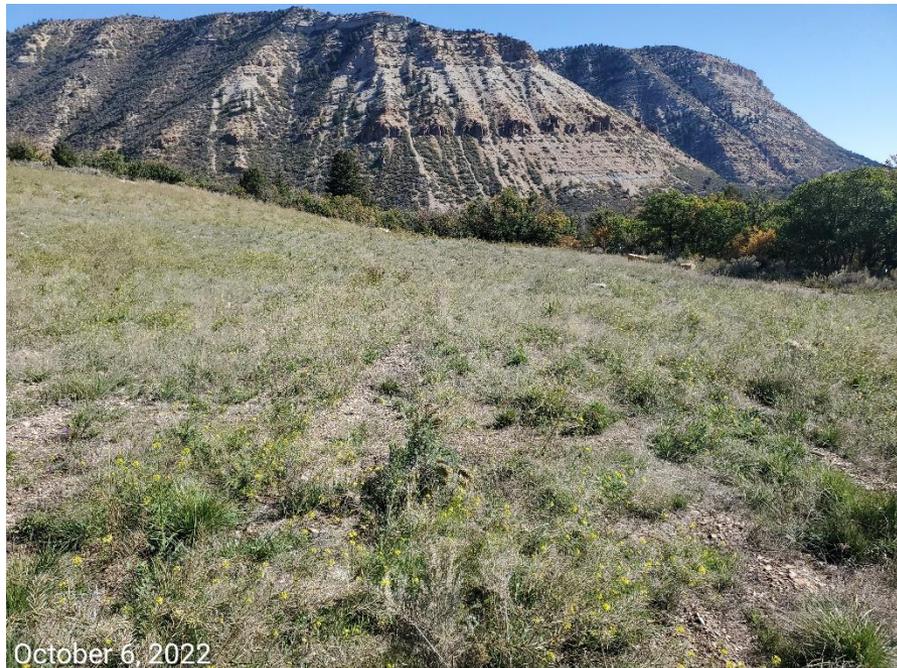
Photo 2: See comments under photo 1.

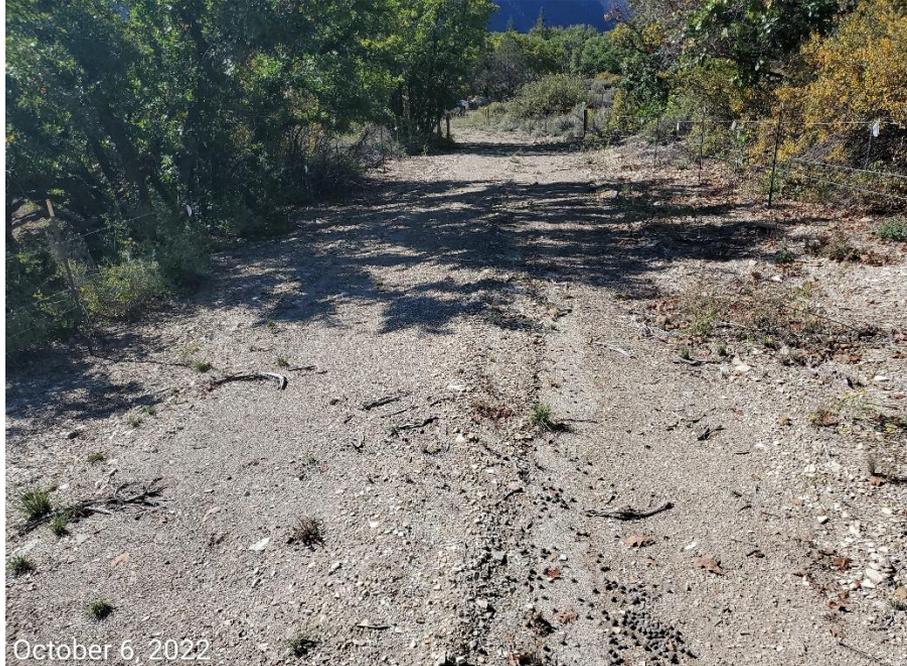
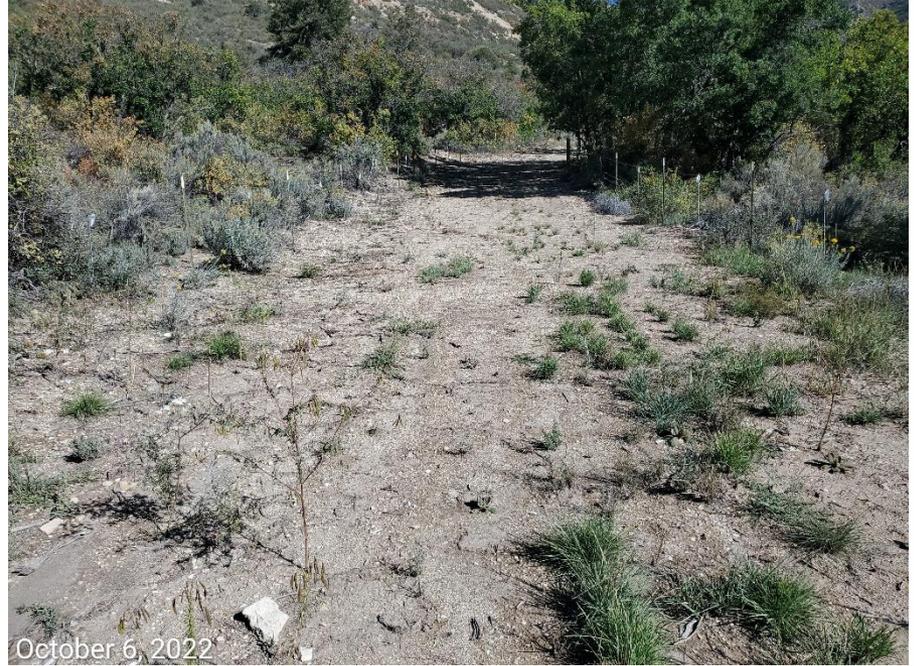
Photo 3: Photos show areas along the access road/location entrance that remains predominantly bare; vegetation within these areas is not progressing towards 1004 uniform standards.
