Inspection Photos

API: 055-06068

Operator: OXY USA INC

Inspection Date: 10/6/2022

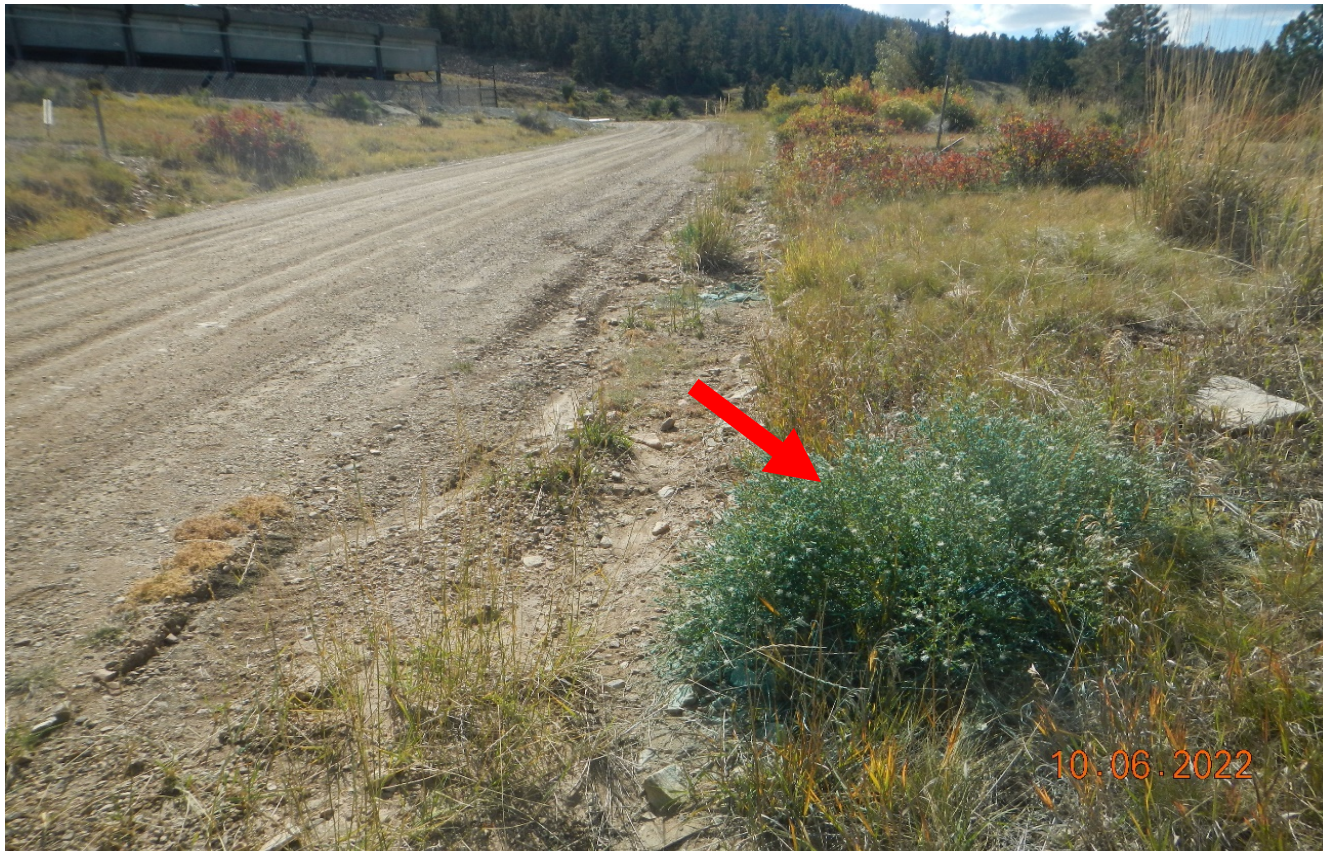
Photo 1. Facing southeast along the road near the location. Red arrow points to Diffuse knapweed which was recently spray. The knapweed has already produced seed. Weed control should be performed sooner before seed dispersal.

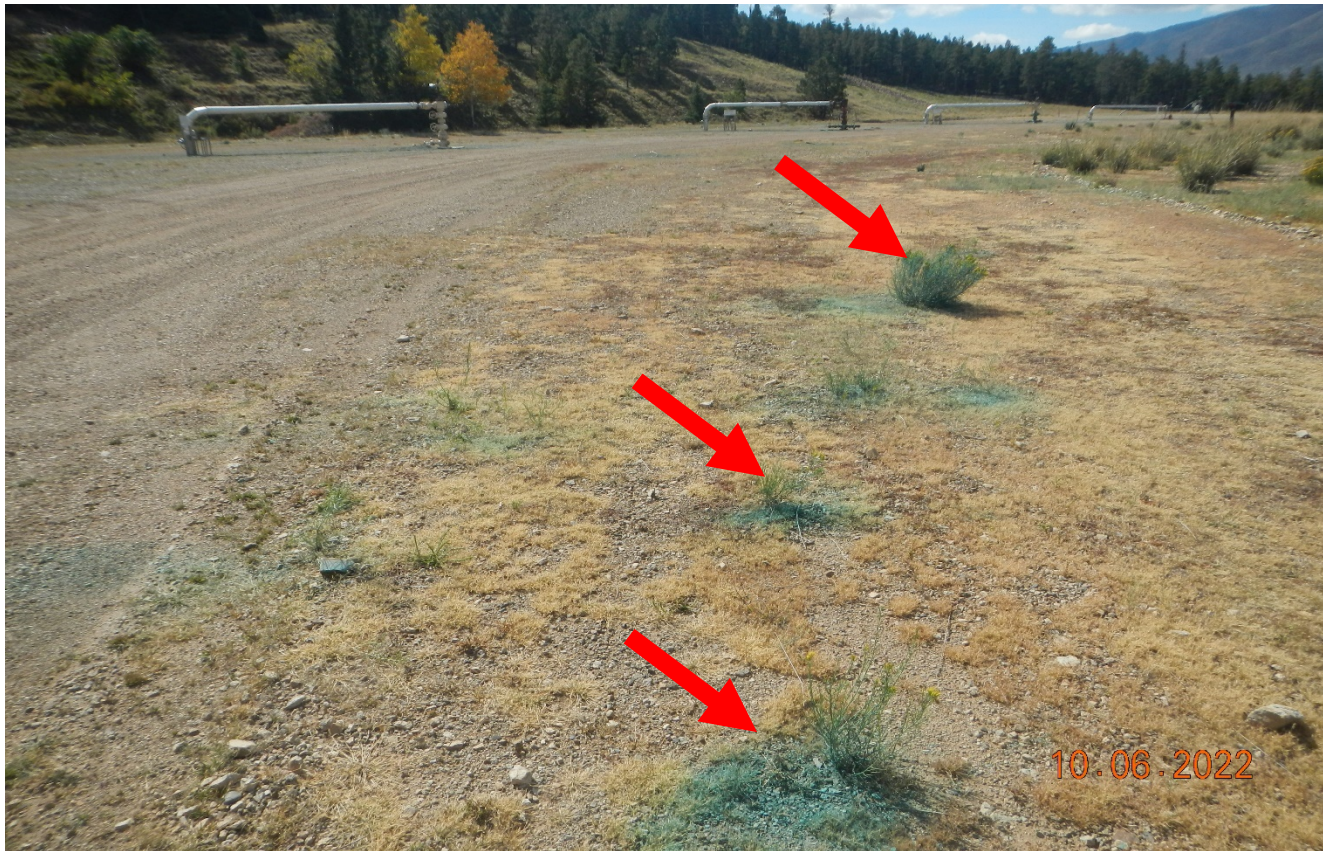
Photo 2. Facing southeast at the location. There is blue dye on plants from weed spraying. The plants shown however are not weeds but native Rubber rabbitbrush. Operator should consult with contractor as to what is being sprayed.

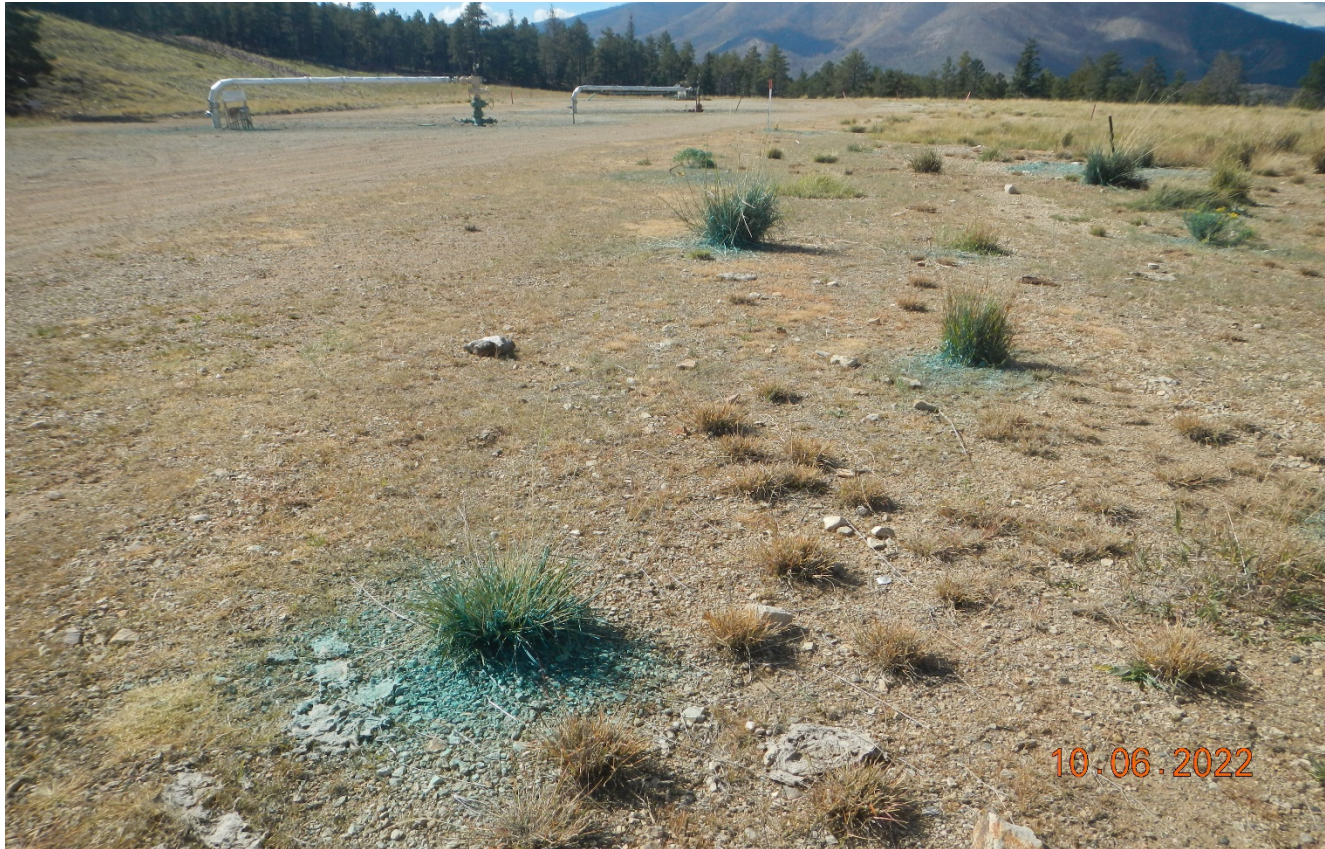
Photo 3. Facing south at the location. There is blue dye on plants from weed spraying. The plants shown however are not weeds but Basin wildrye grass. Operator should consult with contractor as to what is being sprayed.

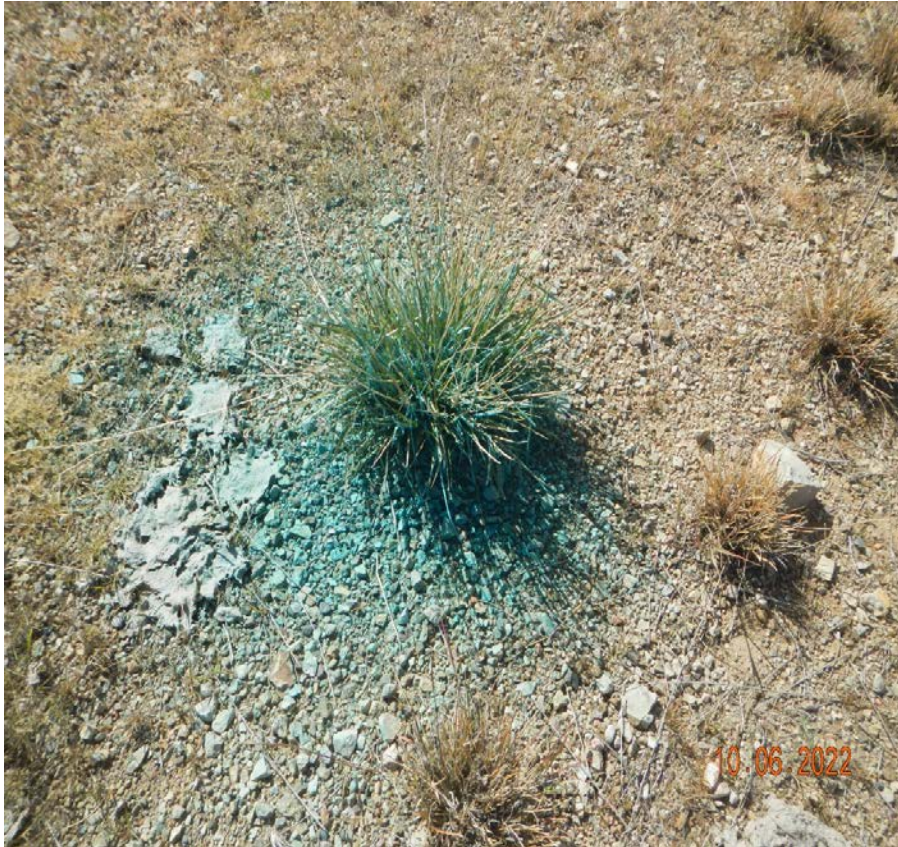
Photo 4. Blue dye observed on native grass.

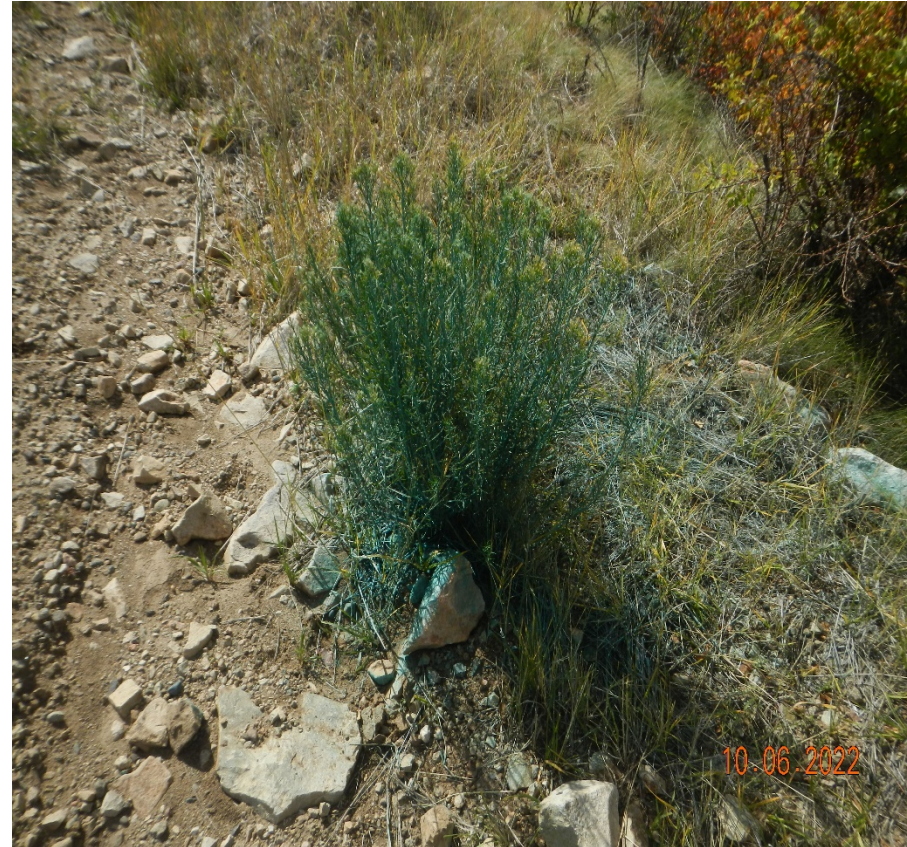
Photo 5. Blue dye observed on Rubber rabbit brush.

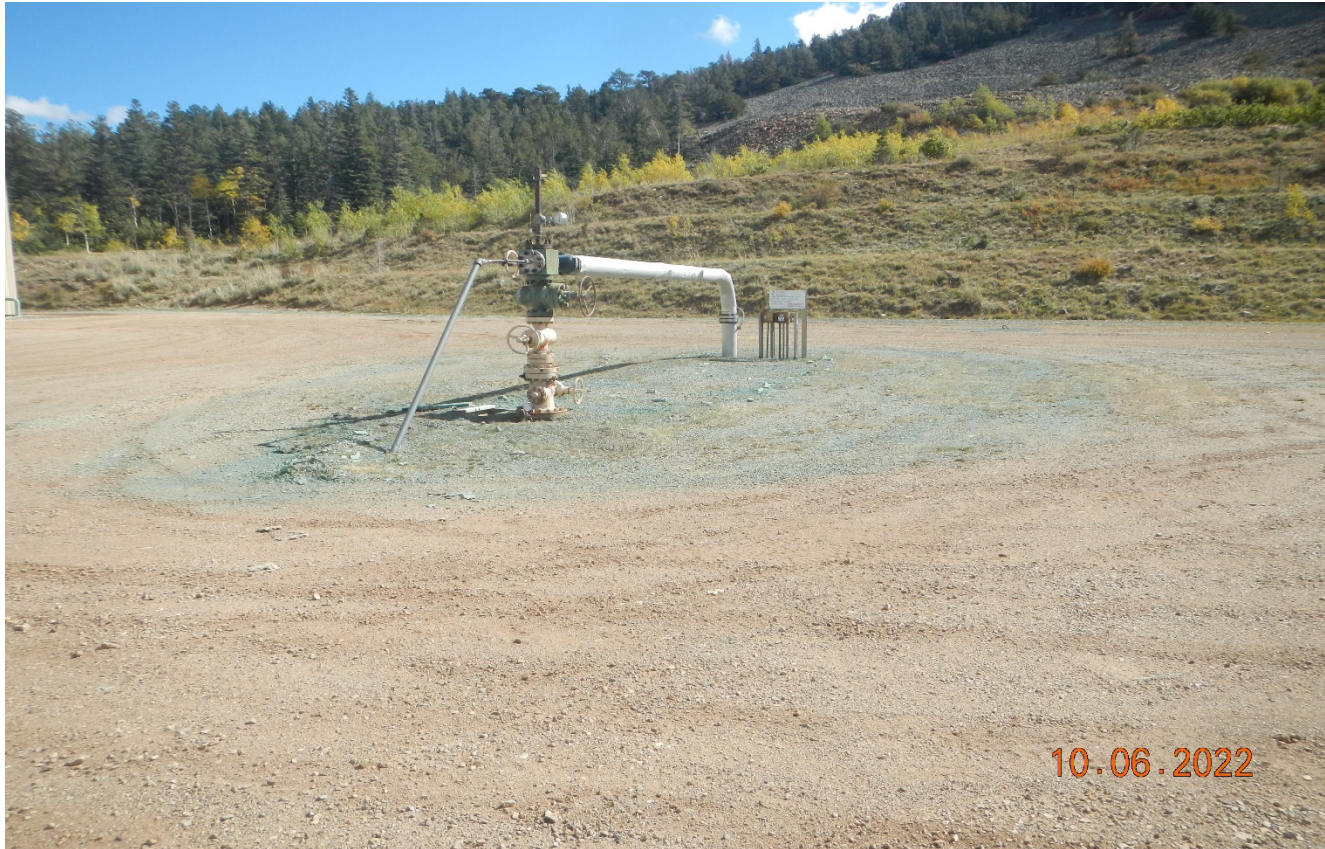
Photo 6. Facing toward the wellsite.

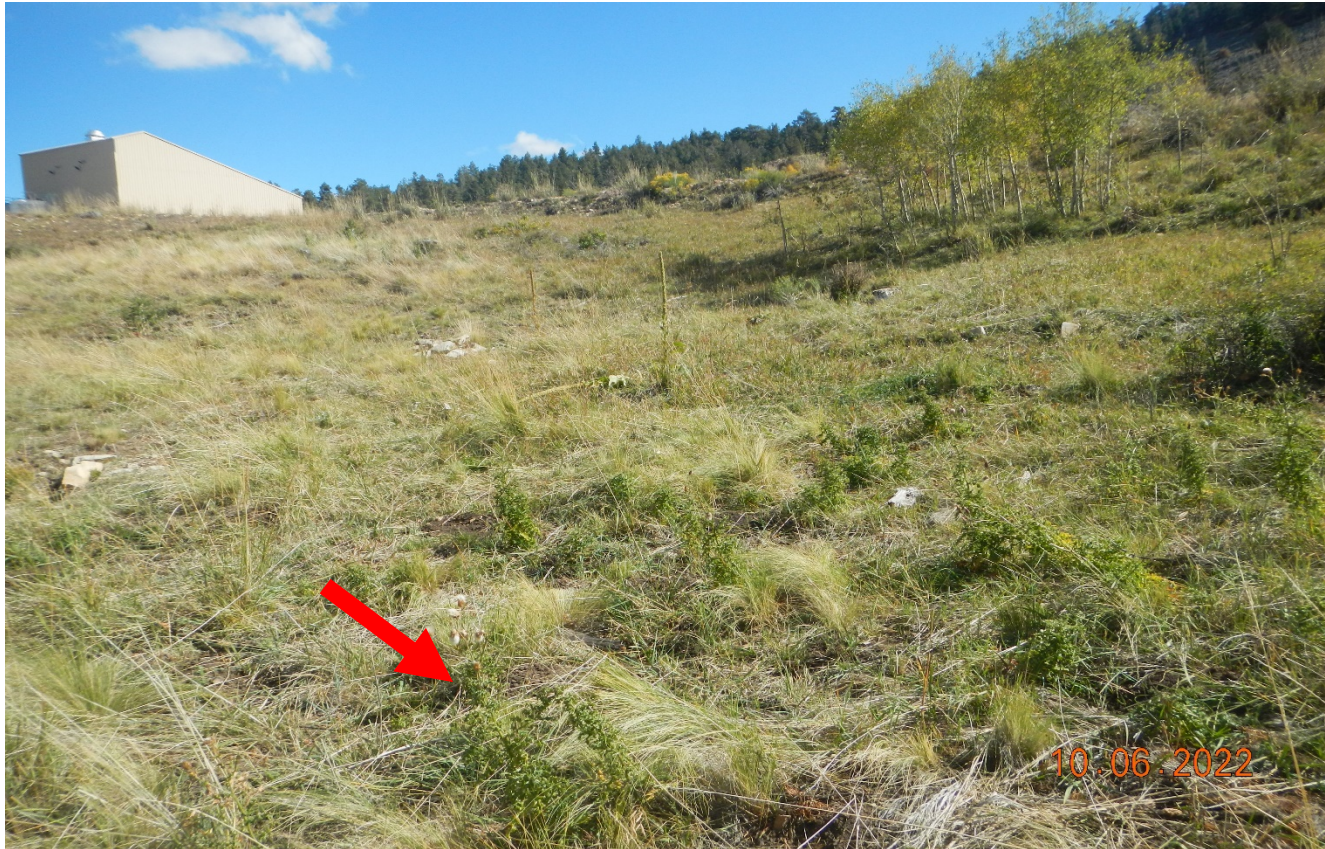
Photo 7. Facing east toward the fill slope of the location. There are noxious weeds in this area that need to be controlled. There was no blue dye observed indicating no weed control was performed. Red arrow → Canada thistle

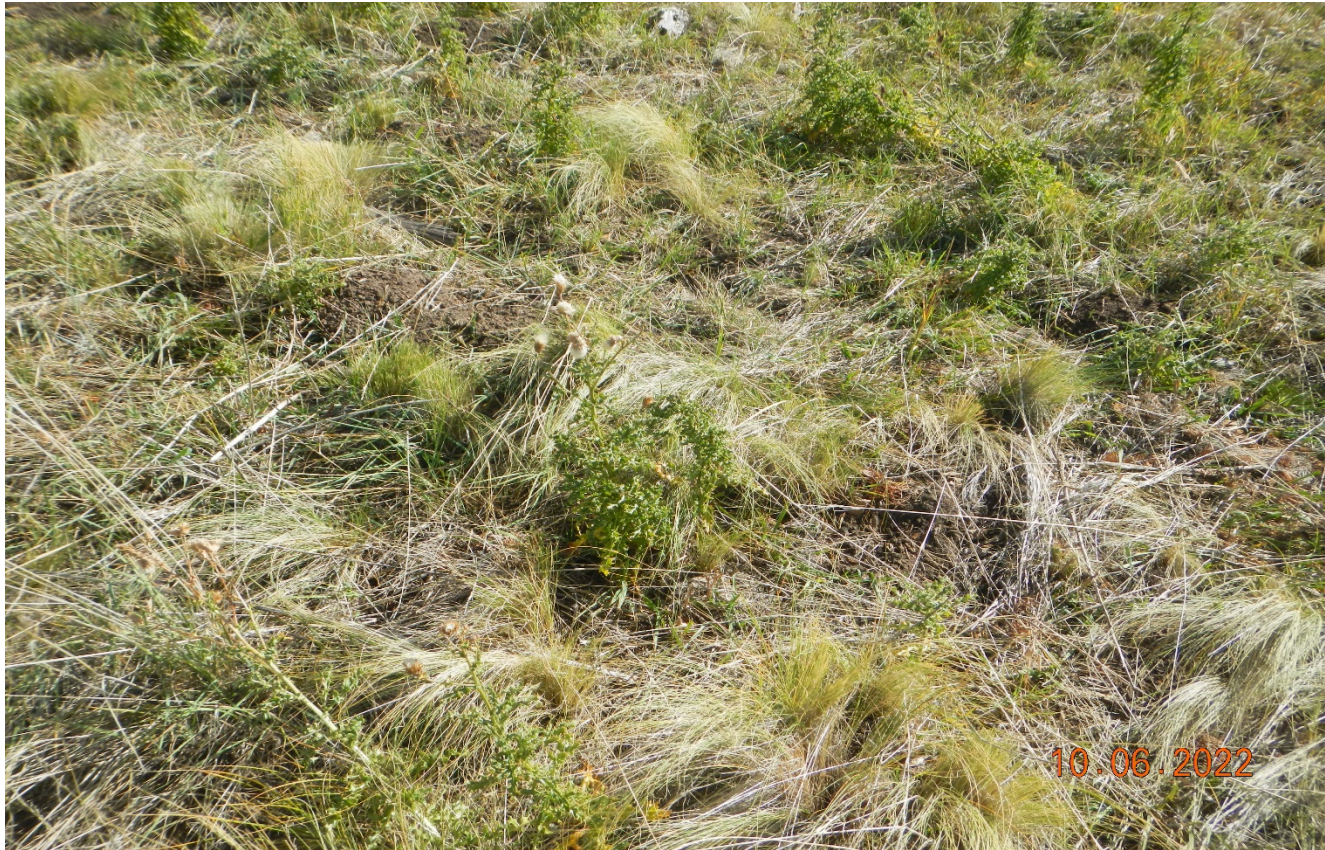
Photo 8. Canada thistle observed in previous photos has already dispersed seed.
