# Inspection Photos and Issue Report

Operator: LARAMIE ENERGY LLC - 10433

Location #312741

Mesa County, CO

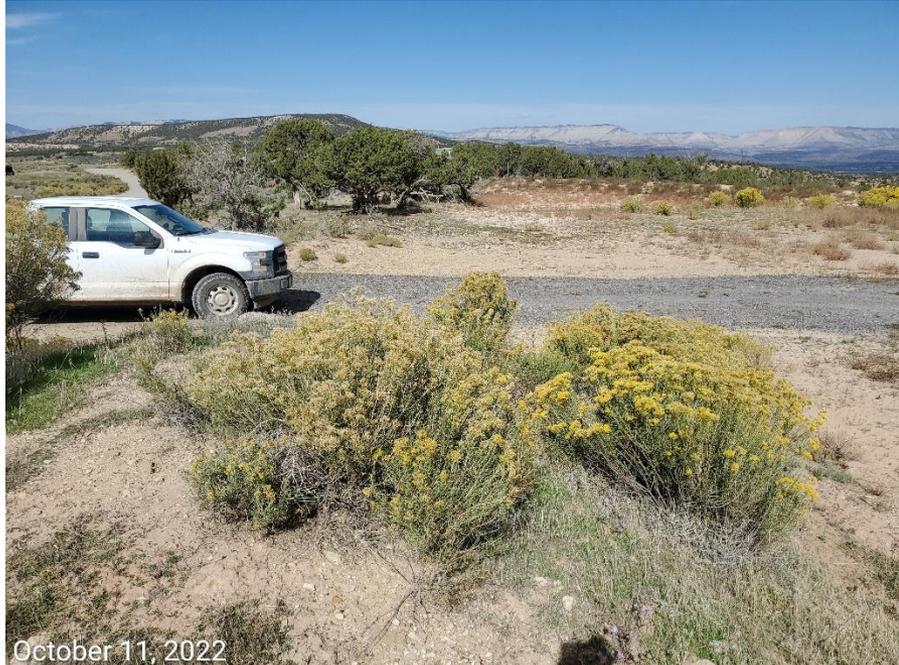
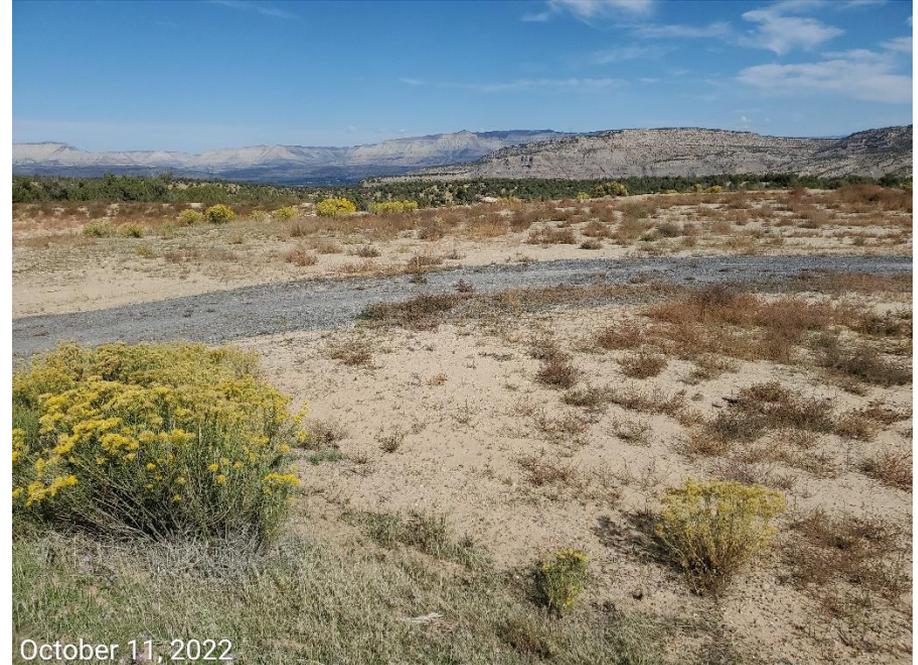
**Photo 1:** Photos taken from the southwest end of the Location. Photos provide an overview of the Location from northwest, north, northeast to southeast. Photos show Location has not been reclaimed per 1004 Rules including, but not limited to, removal of gravel, compaction alleviation (cross ripping to a minimum depth of 18 inches), contouring/regrading, replacement of soils and revegetation activities. Brown vegetation observed in photo is predominantly Undesirable Weedy Plant Species such as Russian Thistle.

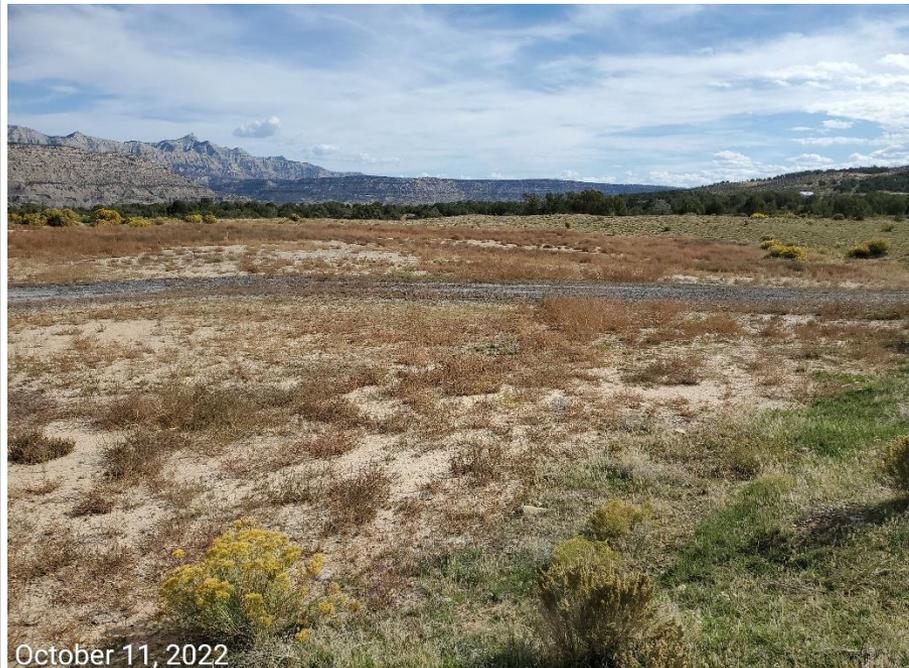
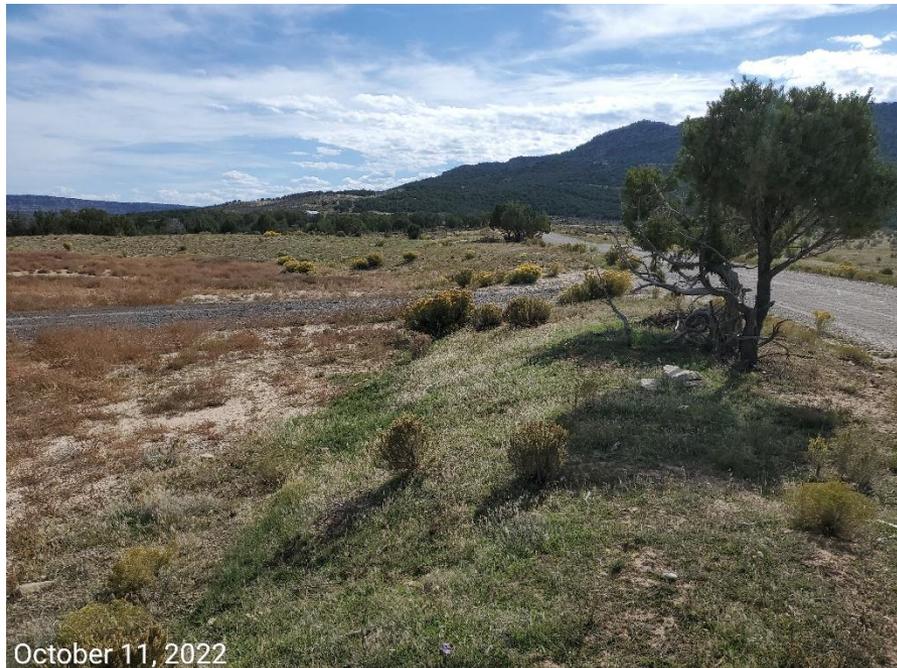
**Photo 2:** See comments under photo 1.

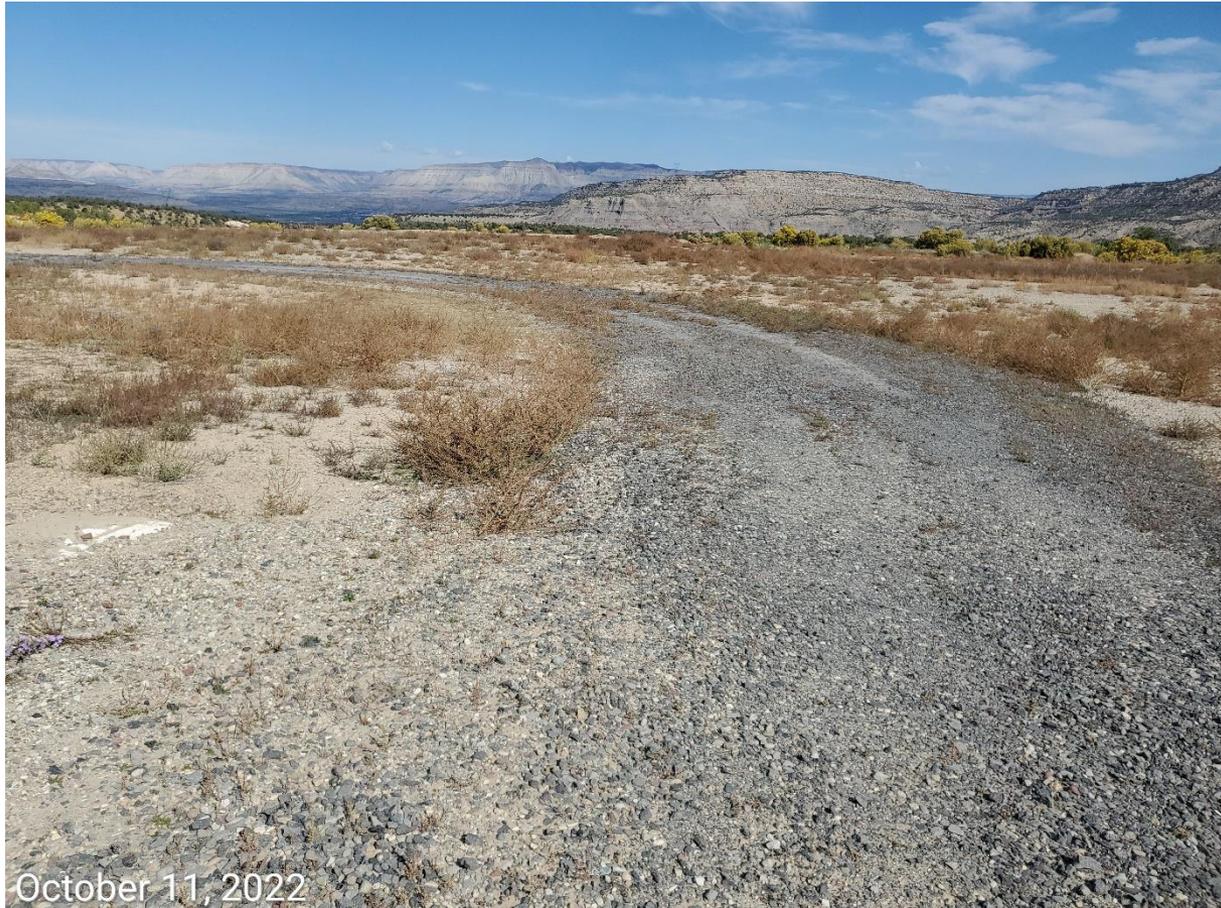
**Photo 3:** Gravel/road base remaining on Location.

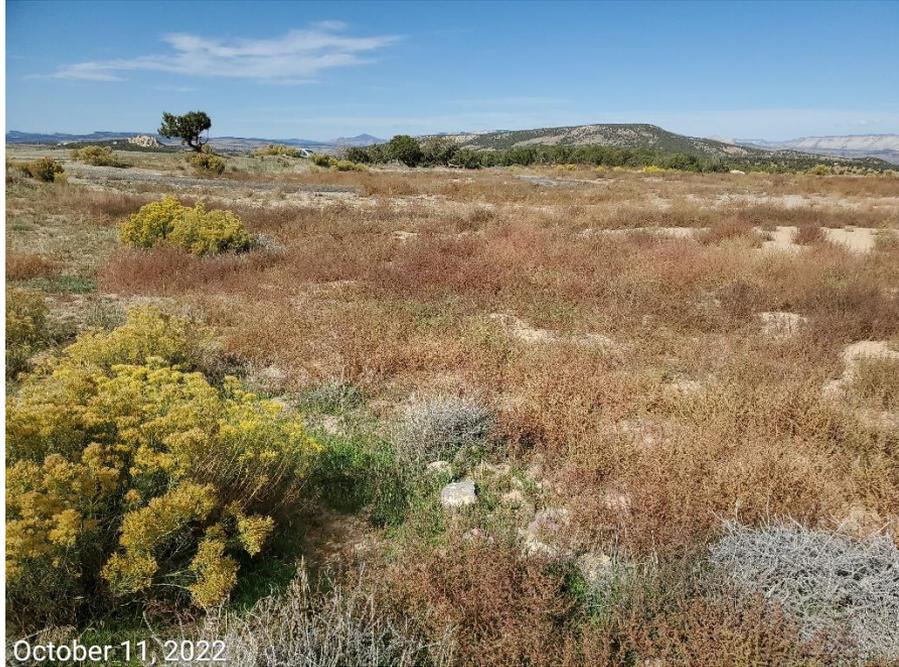
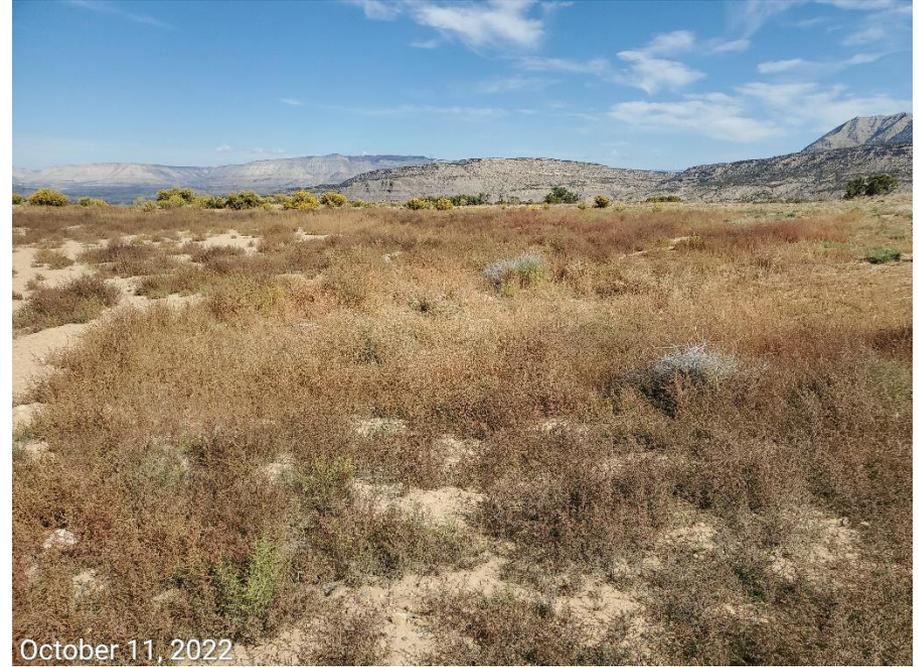
**Photo 4:** Photos taken from the southeast end of the Location, facing northwest and north. Photo shows Undesirable Plant Species established throughout the Location. Weed management efforts inadequate on the Location. Vegetation mostly dead, is considered debris and requires removal.

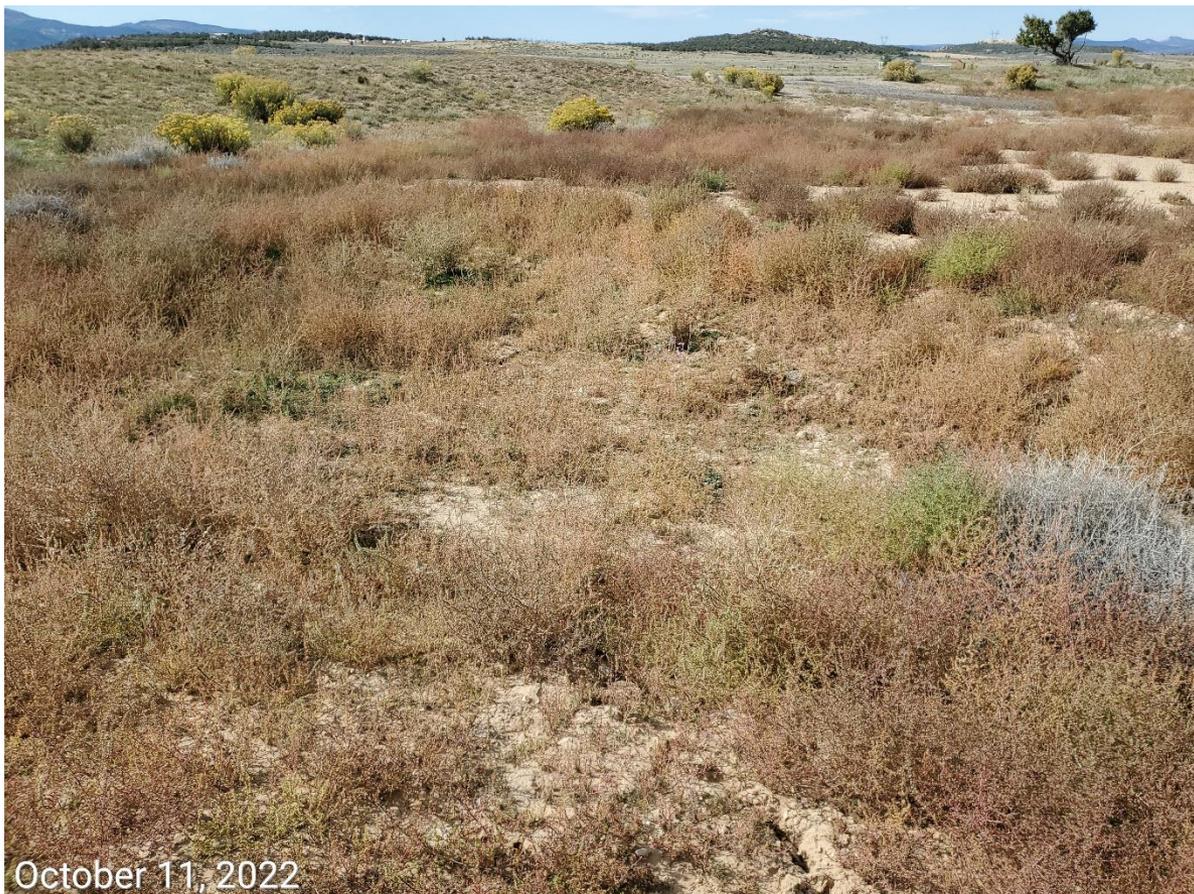
**Photo 5:** Photo shows a pit remaining on the southeast end of the Location.

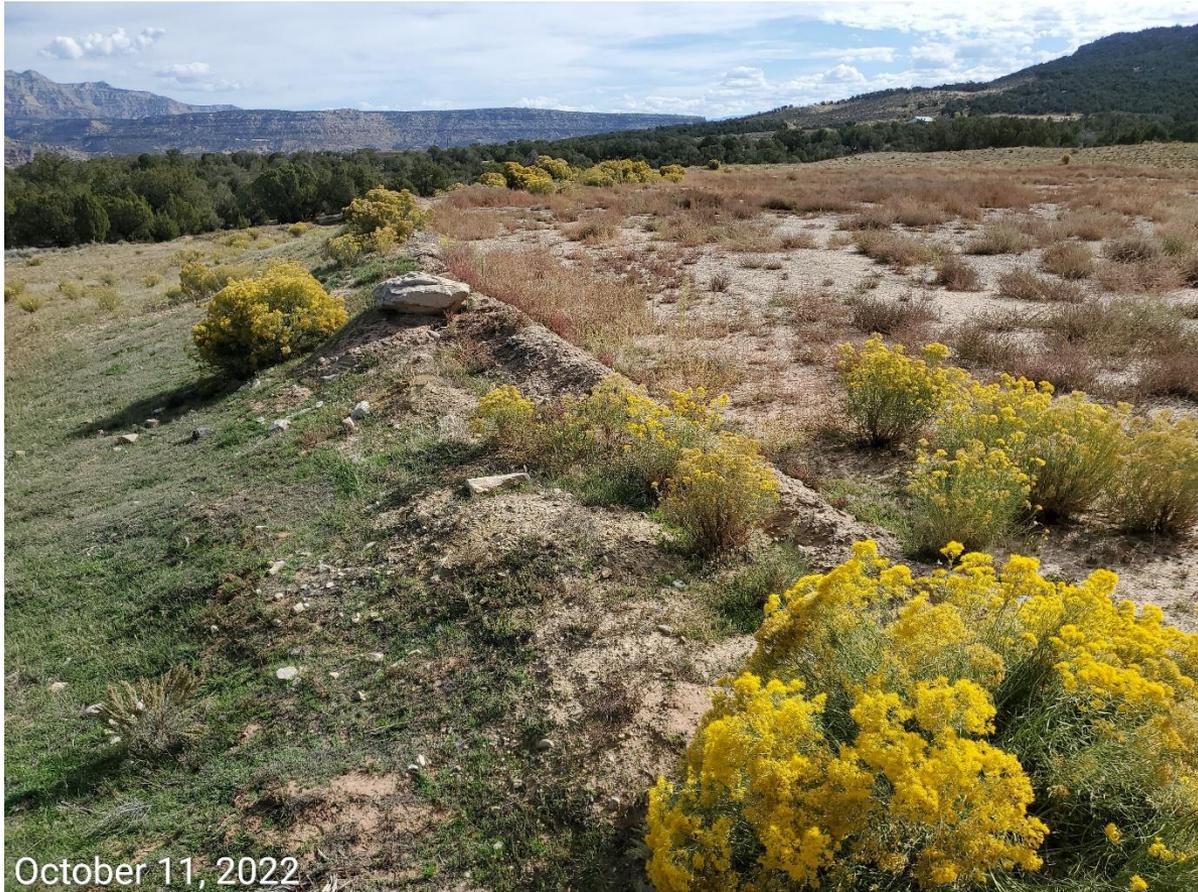
**Photo 6:** Photo taken from the north end of the Location, facing east. Photo shows fill slopes; location has not been recontoured/regraded and reclaimed.
