FIR Doc #707900052, Loc ID: 322234 Name: RAINBOW 27-20; API #05-043-06150

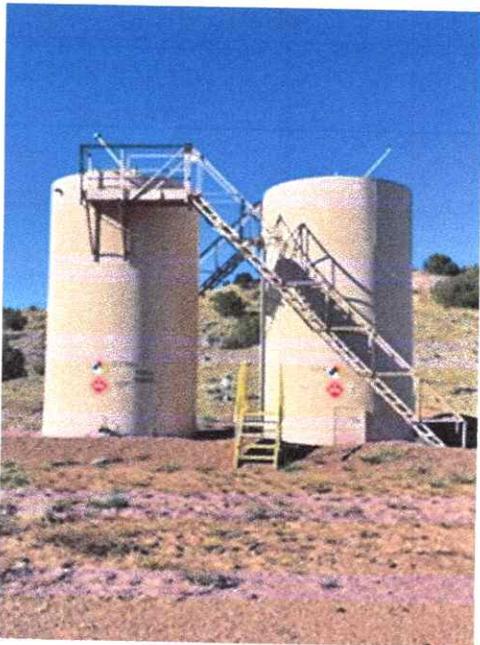
INSPECTOR COMMENT: Sign not posted or information inaccurate at battery no volume sign and NFPA placards are faded

CA 1): Install sign to comply with Rule 605.d. by 11/11/22

Operator immediately replaced faded placards with new placards and identified tank contents and tank volume capacity by end of day on 10/11/22.

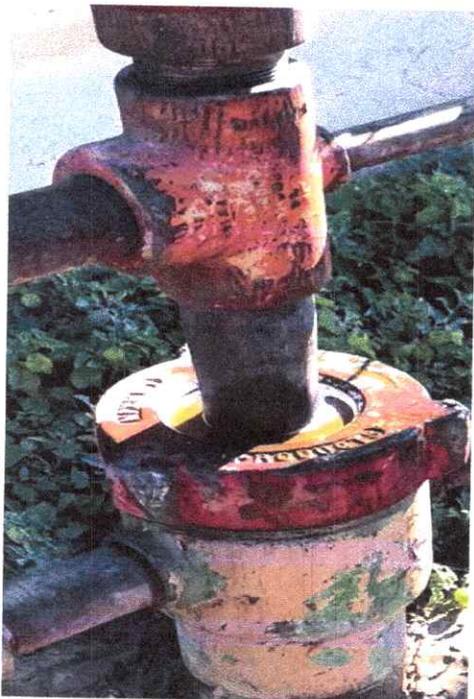
INSPECTOR COMMENT: mechanical issue Well head leaking around tubing

CA 2: Securely fasten all valves, pipes, fittings, and Production Facilities to ensure good mechanical condition, inspect at regular intervals and maintain in good mechanical condition per Rule 608.e. by end of day 10/12/22

Operator was contacted by phone to remedy mechanical issue within 24 hrs. Operator responded immediately and tightened all valves pipes and fittings and hammered wellhead tight. Re-inspected with soapy water and confirmed repair.

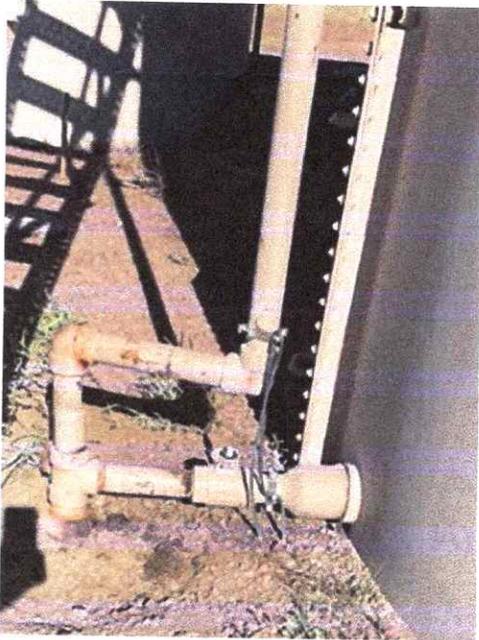
INSPECTOR ALSO COMMENTED that valves on back of oil tank could not be left open-ended and needed to be plugged. **Did not issue a corrective action.**

Operator nipped up fittings that had been disconnected for tank drainage and made sure no open-ended valves were left.
