Inspection Photos and Issue Report

Operator: LARAMIE ENERGY LLC - 10433

Location #427315

COGCC

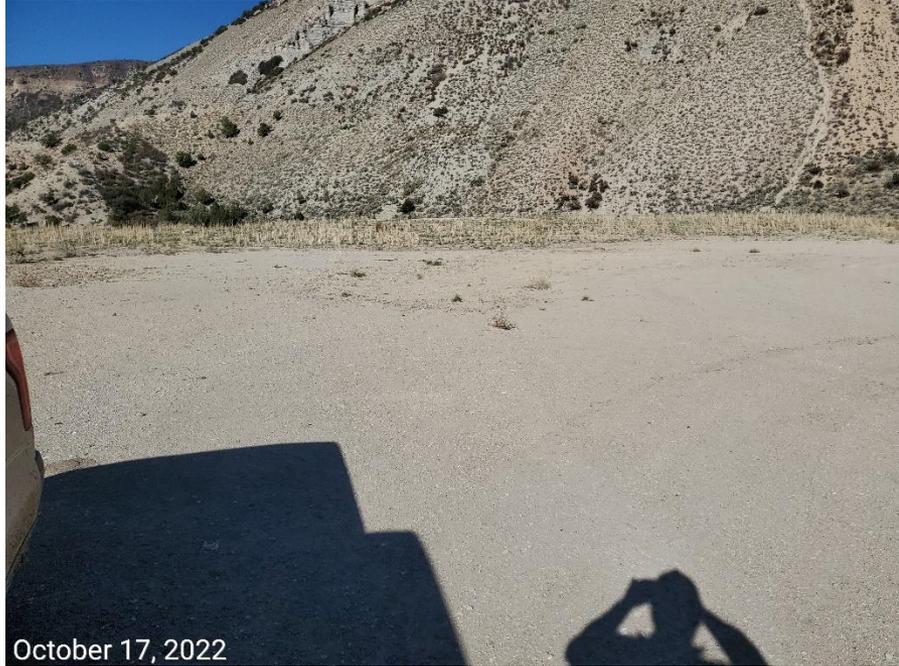
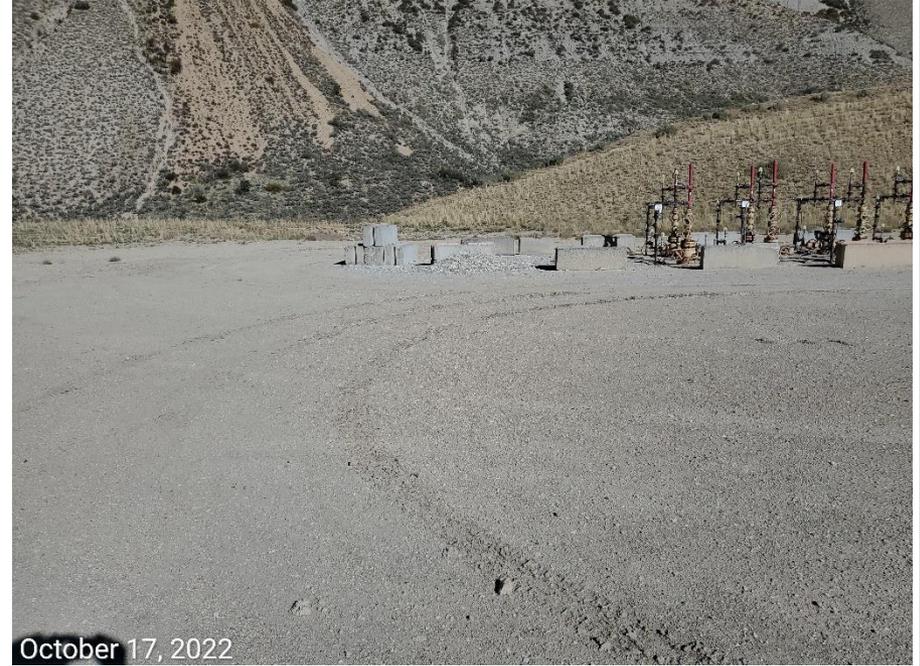
Photo 1: Photos 1-2 taken from the south end of the Location. Photos provide an overview of the Location from west, northwest, northeast to east. Photos also show areas not needed for production have been reduced per 1003 requirements and CAs.

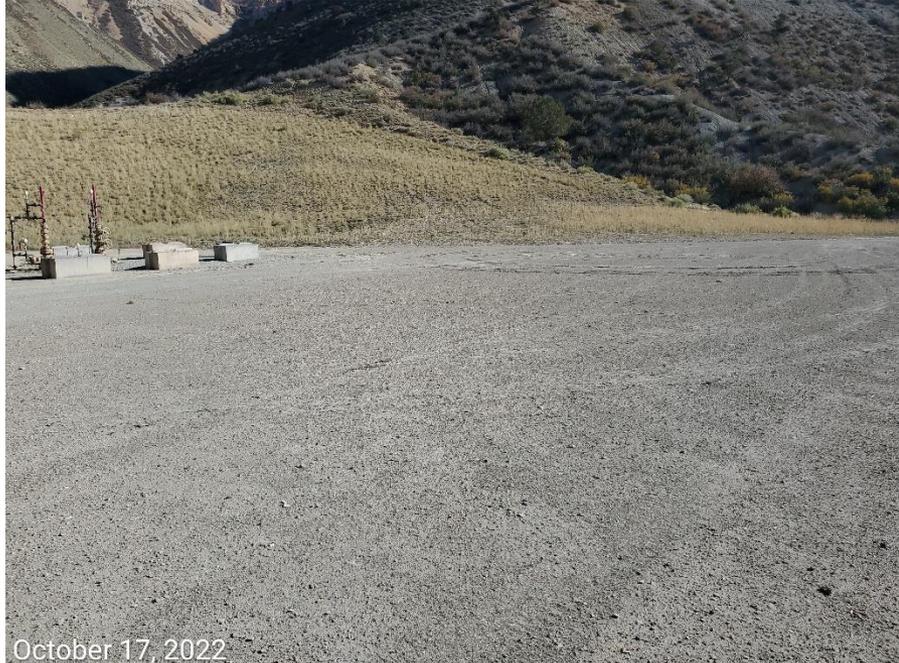
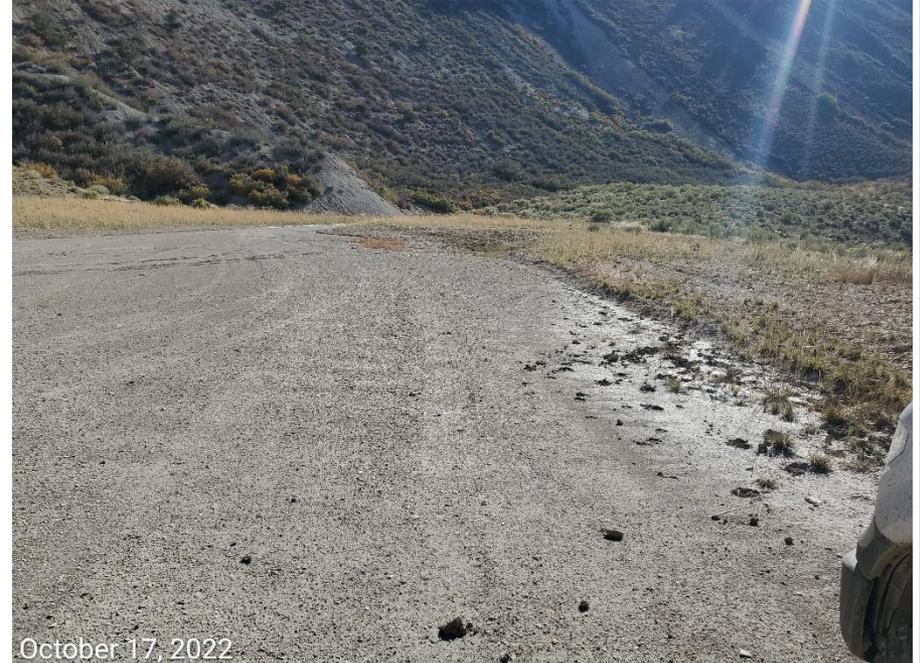
Photo 2: See comments under photo 1.

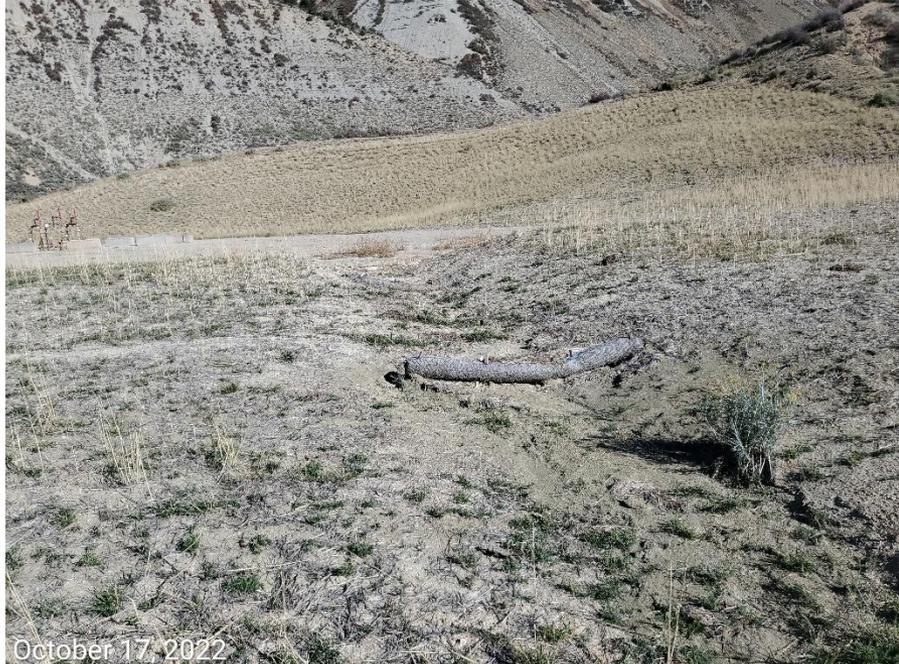
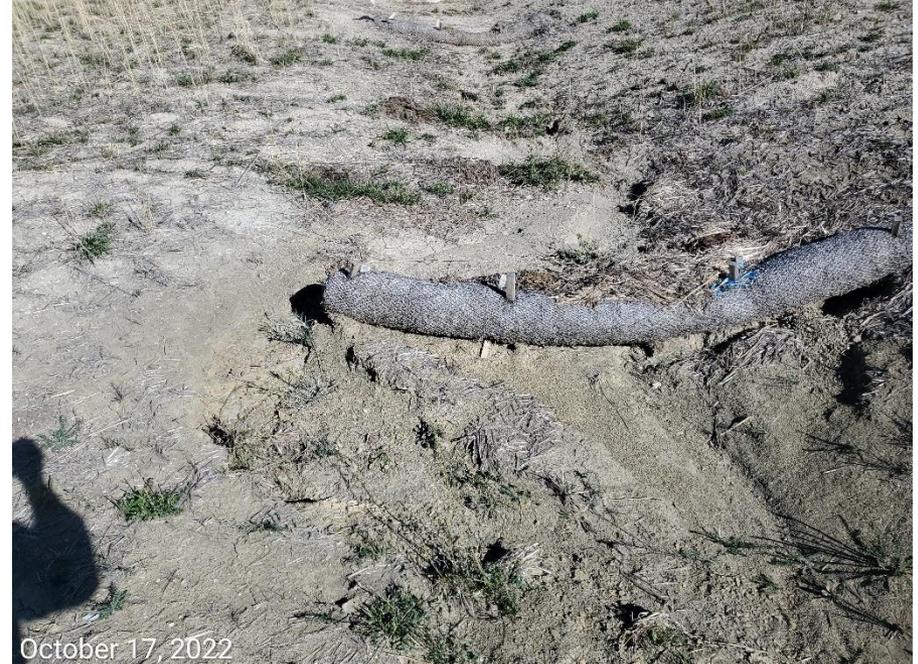
Photo 3: Photo taken from the southeast end of the Location. Photo shows stormwater discharge point from the Location has not been constructed with a properly engineered outlet per good engineering practices, or maintained in a proper functioning condition, resulting in erosion and degradation. Photo right shows stormwater is being diverted around the wattle control, resulting in degradation.

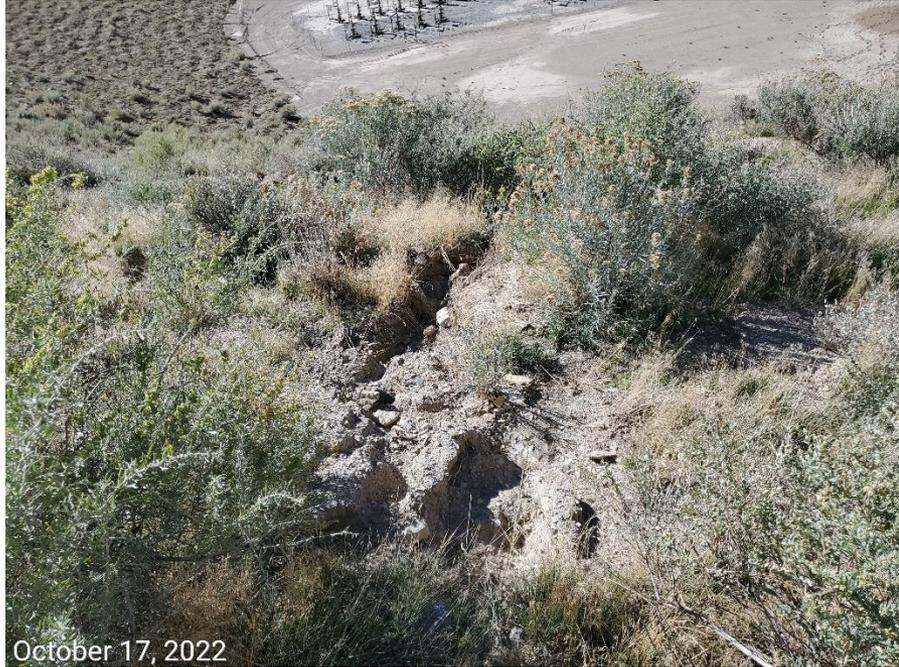
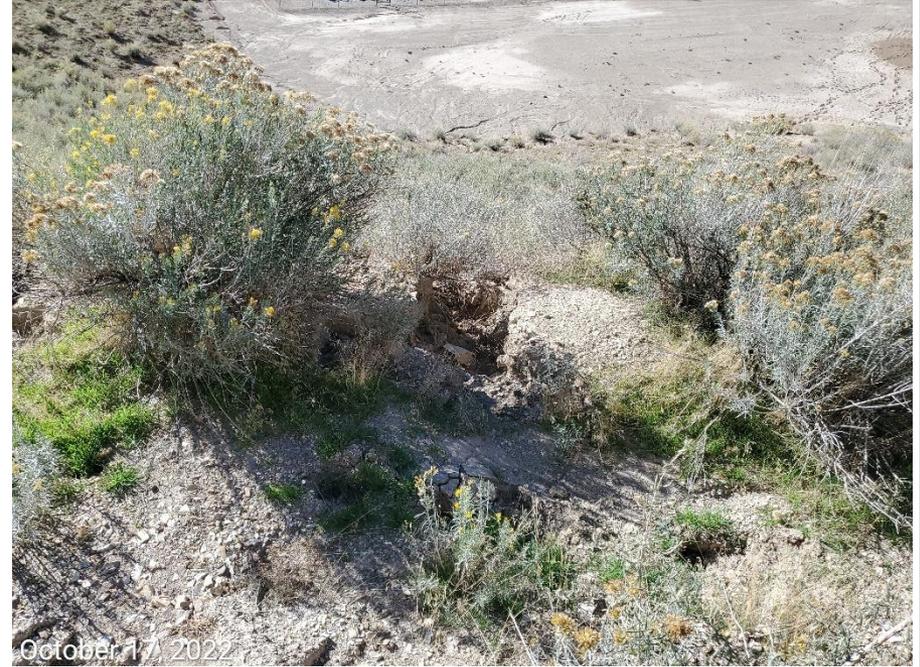
Photo 4: Continued from photo 3. Photos taken from the slopes southeast of the Location. Photos show discharge point has not been constructed with a properly engineered outlet, resulting in erosion and degradation to the slopes south of the Location

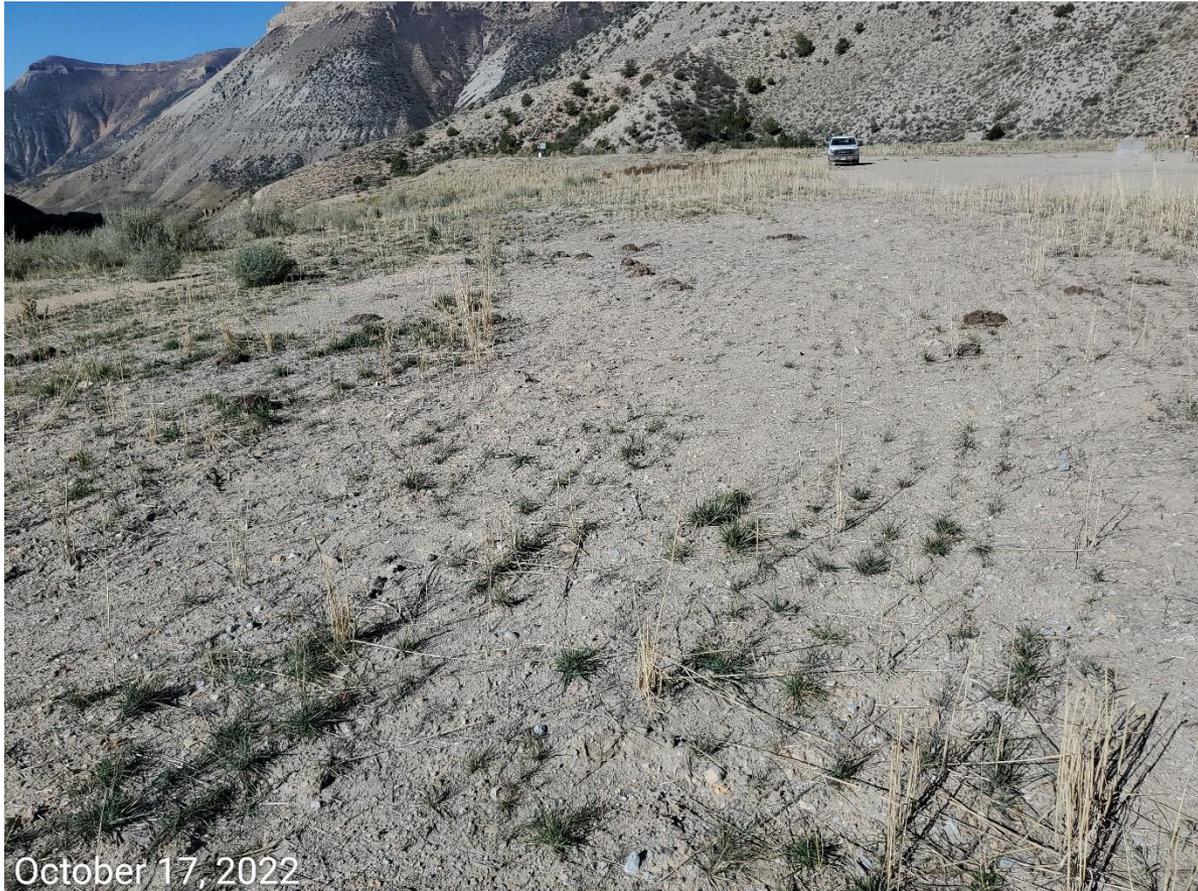
Photo 5: Photo taken from the southeast end of the Location. Photo shows areas that do not appear to be progressing towards 1003 standards; livestock use is evident within these areas and may be hindering reclamation.

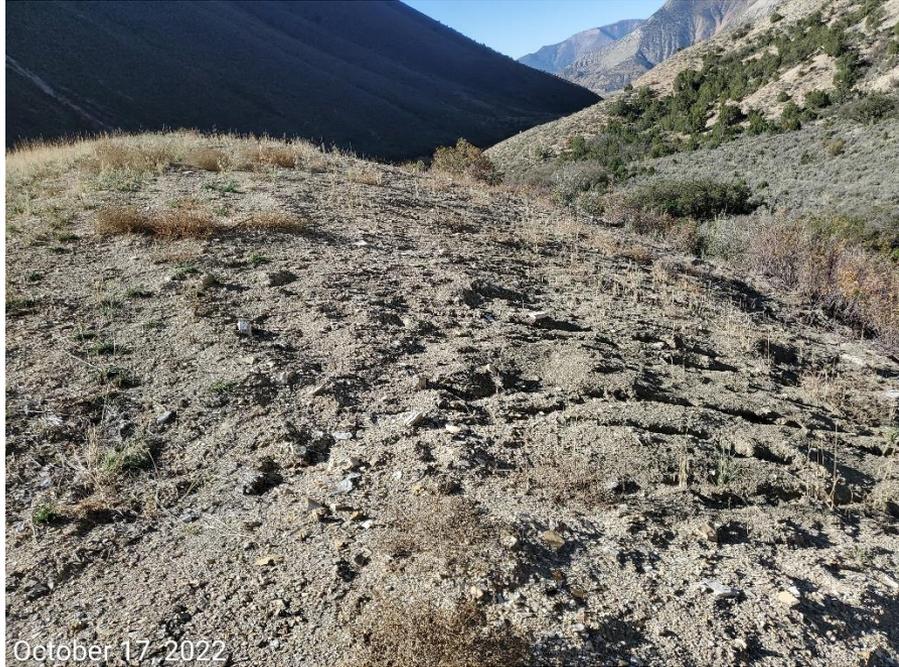
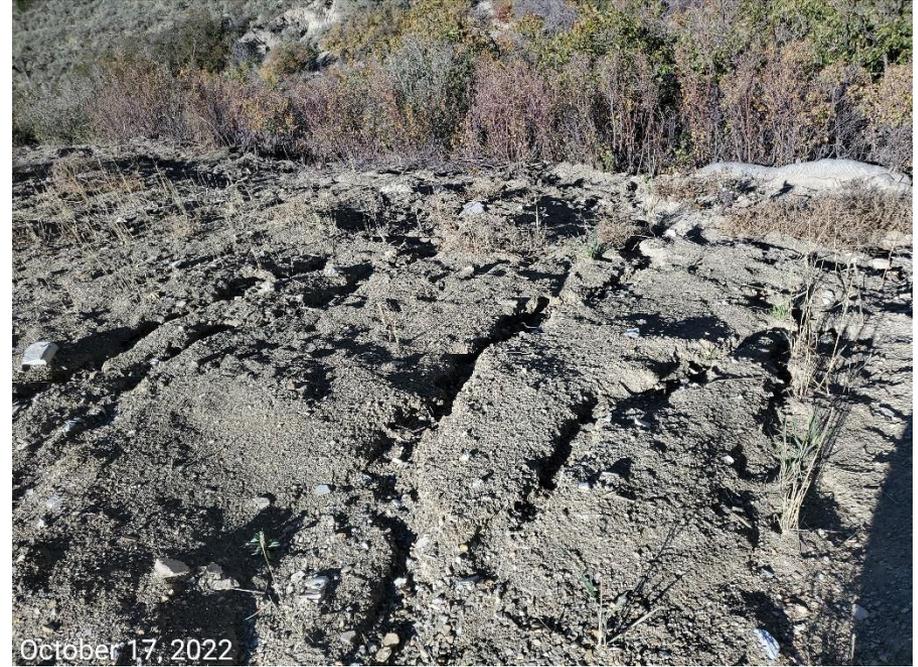
Photo 6: Photos taken from the west end of the Location. Photos show areas are bare and exposed, and not progressing towards 1003 revegetation standards. Stormwater and erosion control BMPs are also missing or insufficient, resulting in erosion and degradation due to runoff. Additional stormwater management and reclamation required.

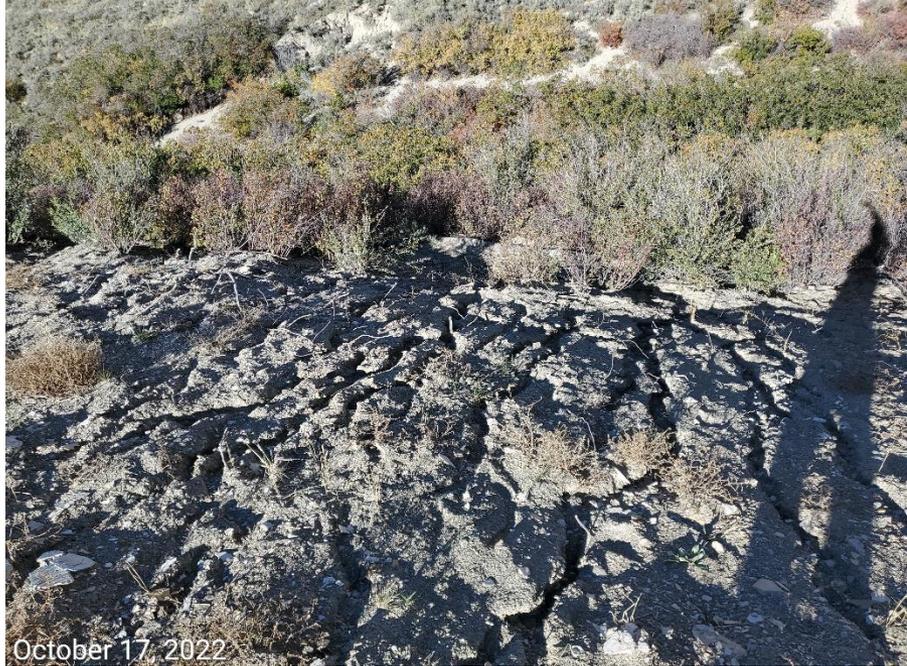
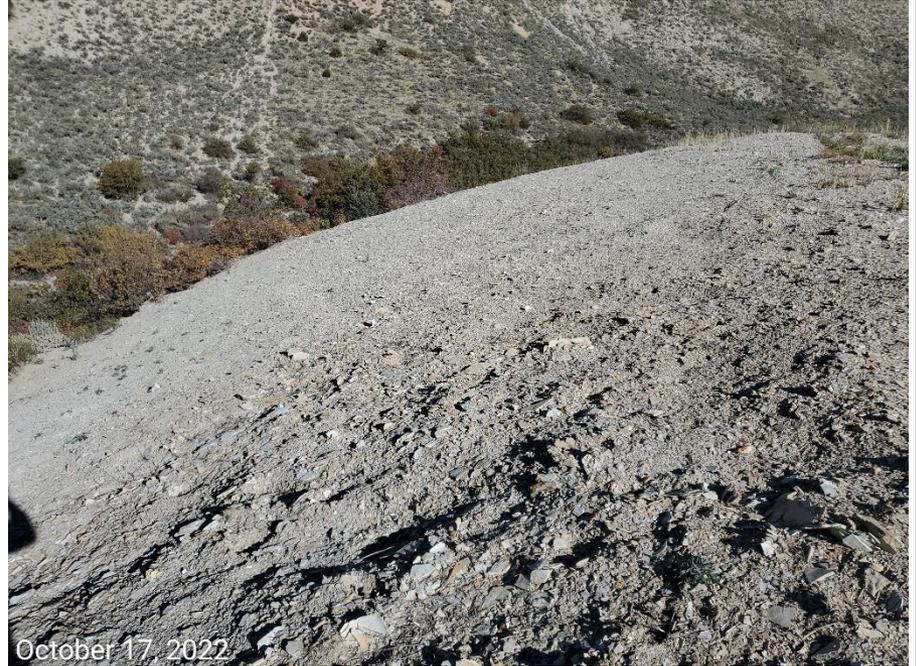
Photo 7: See comments under photo 6.
