Inspection Photos

Operator: Mull Drilling Company Inc - #61250

Location Name: STATE AVALANCHE-612N92W/24SESE

Inspection Document #: 702800840

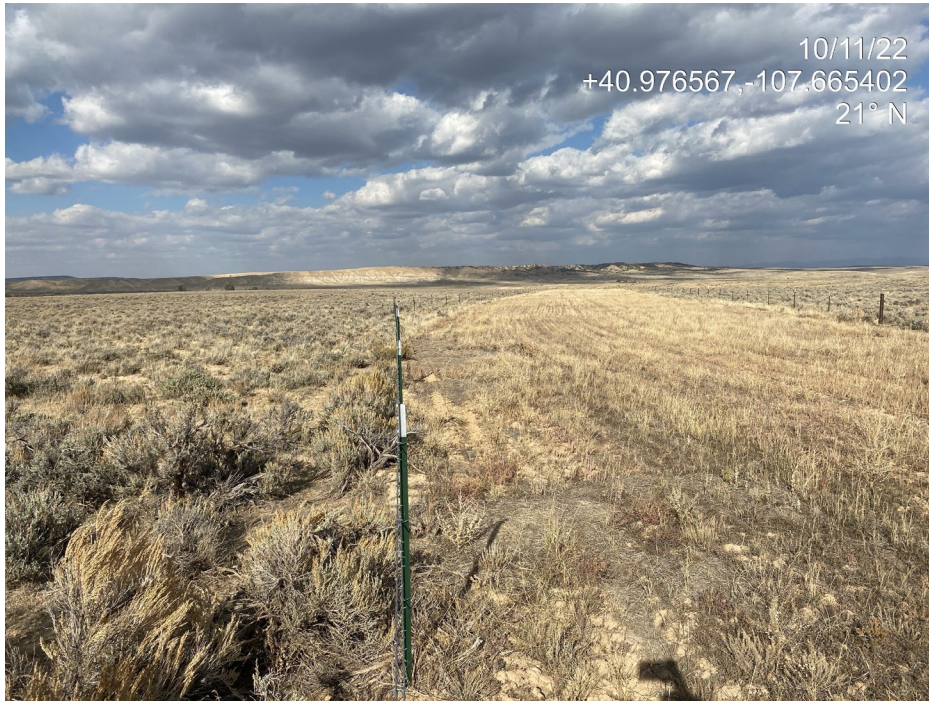
Photo 1. Photo taken from the south shows the reclaimed access road. The entire Location has been fenced to exclude livestock.

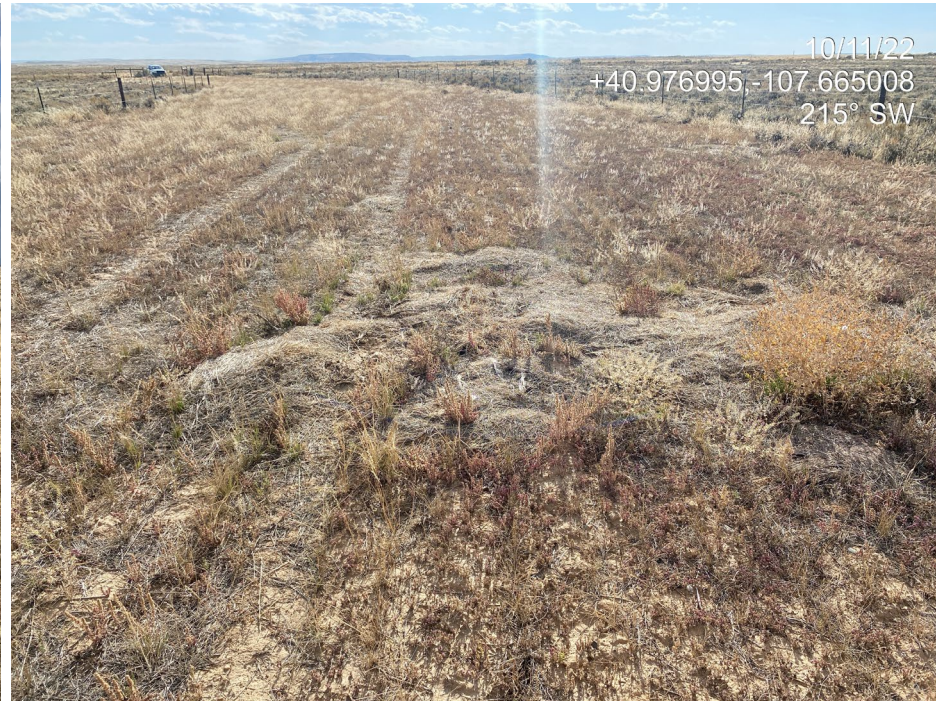
Photo 2. Photo taken from the south shows the vegetation community on the reclaimed access road. Seeded western wheatgrass is common as well as a variety of annual undesirable plant species and noxious weeds. Note dense cover of mulch smothering vegetation in some areas.

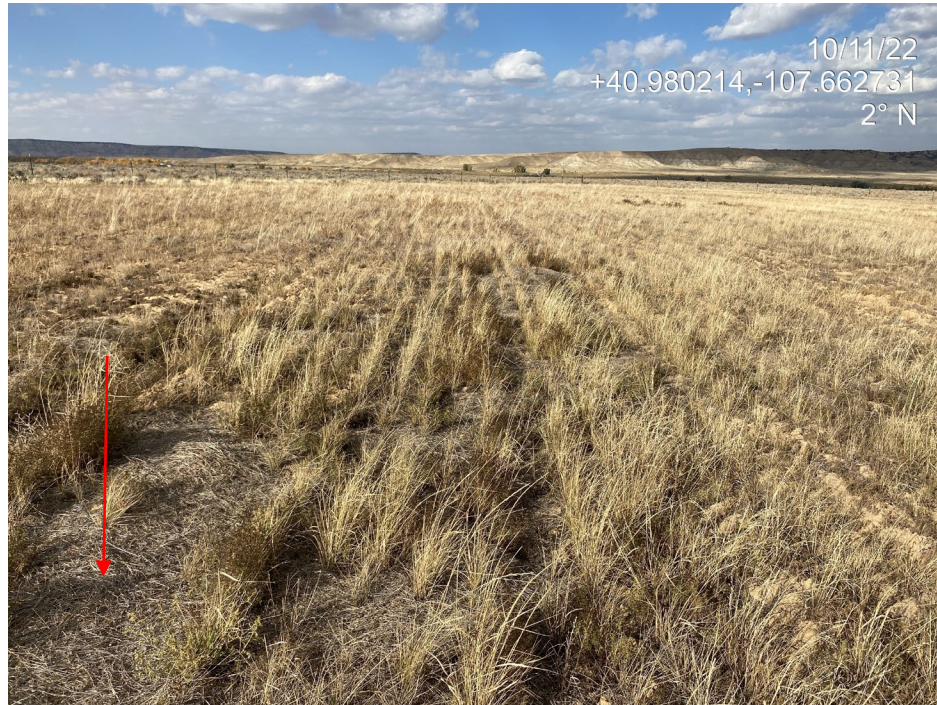
Photo 3. Photo shows an example of an area with relatively good perennial establishment. Perennial grasses are the yellowish-tan plant. Weeds are darker brown. Note also dense mulch.

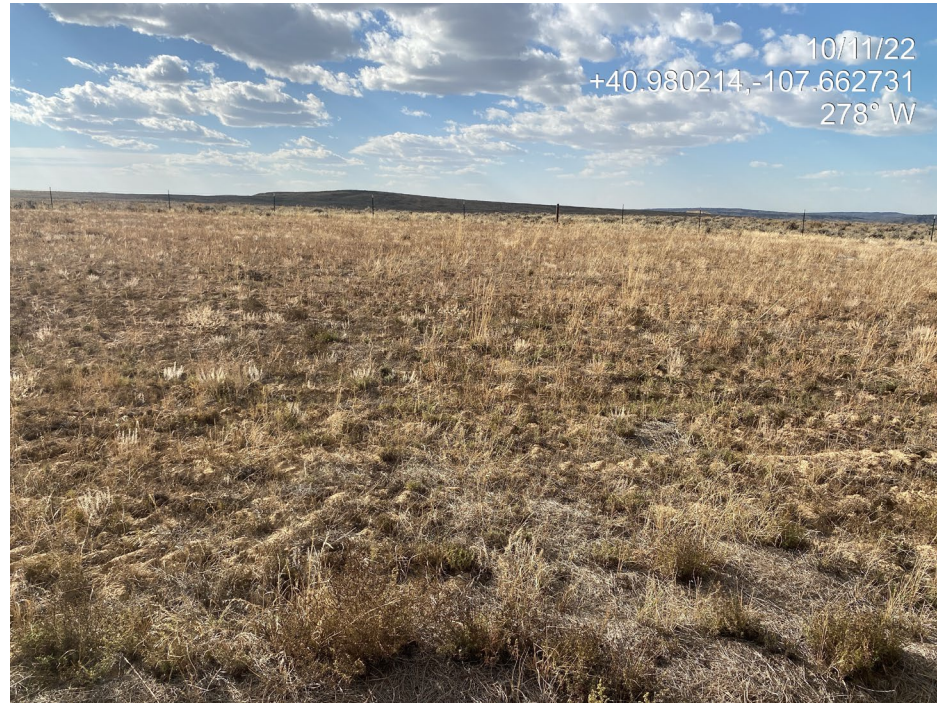
Photo 4. Photo shows an example of an area with relatively poor perennial establishment. Perennial grasses are the yellowish-tan plant. Weeds are darker brown.

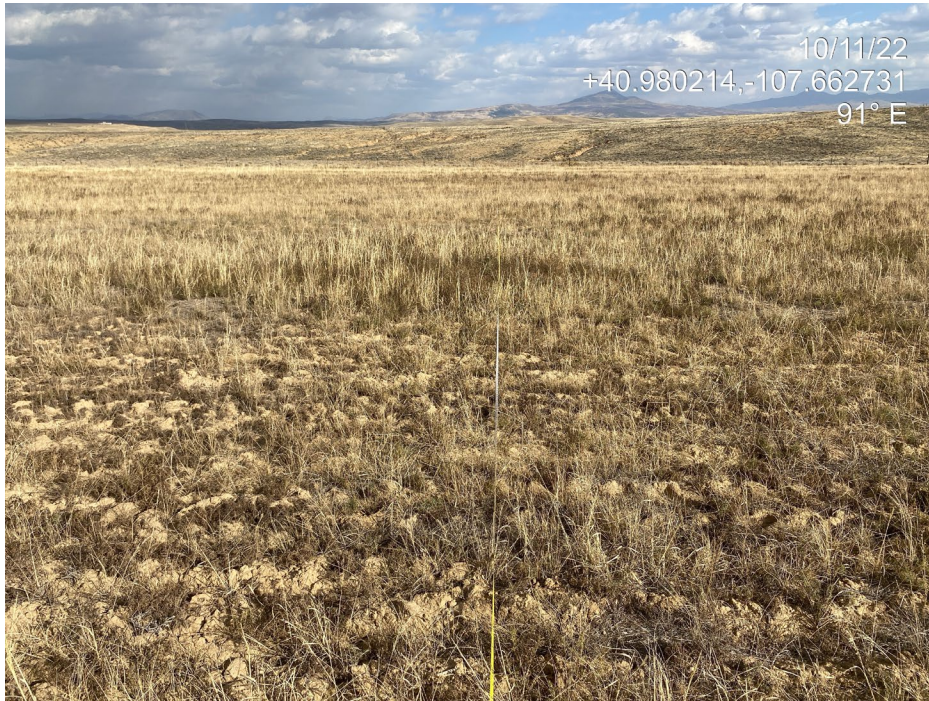
Photo 5. Photo taken from the center of the Location shows the start of disturbed area vegetation monitoring transect #1.

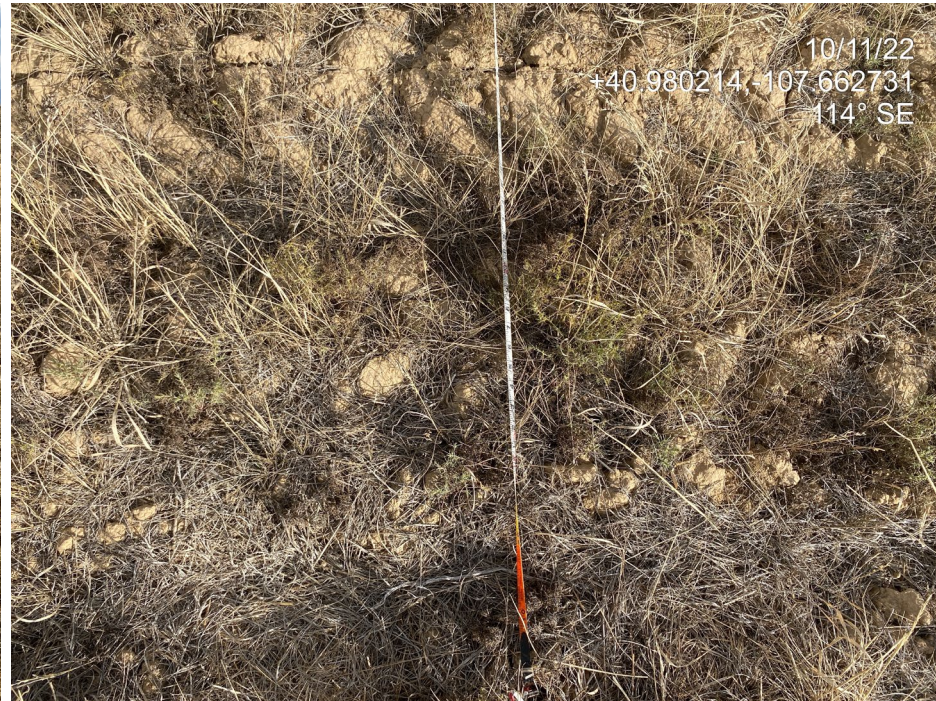
Photo 6. Photo taken from the center of the Location shows the ground surface at the start of disturbed area vegetation monitoring transect #1.

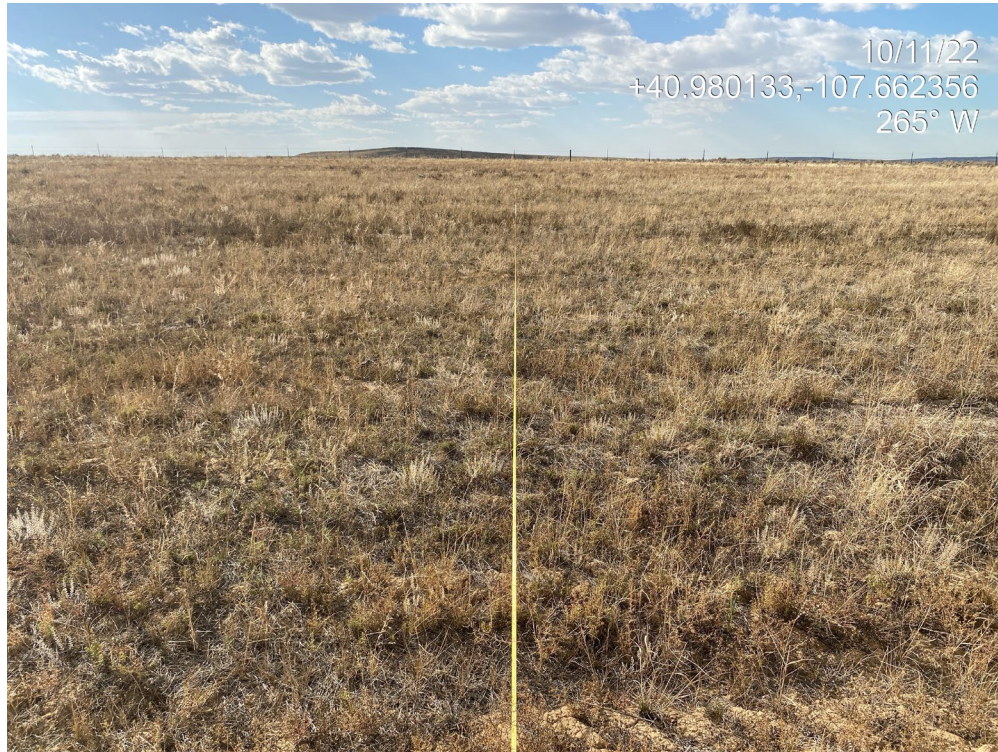
Photo 7. Photo taken from the center of the Location shows the end of disturbed area vegetation monitoring transect #1.

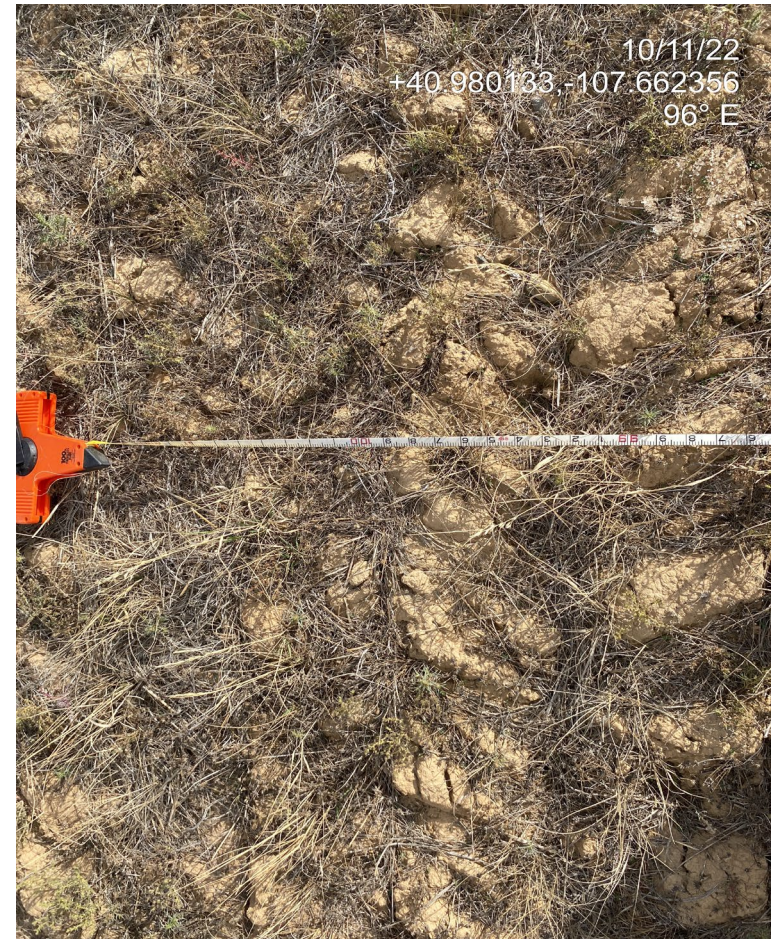
Photo 8. Photo taken from the center of the Location shows the ground surface at the end of disturbed area vegetation monitoring transect #1.

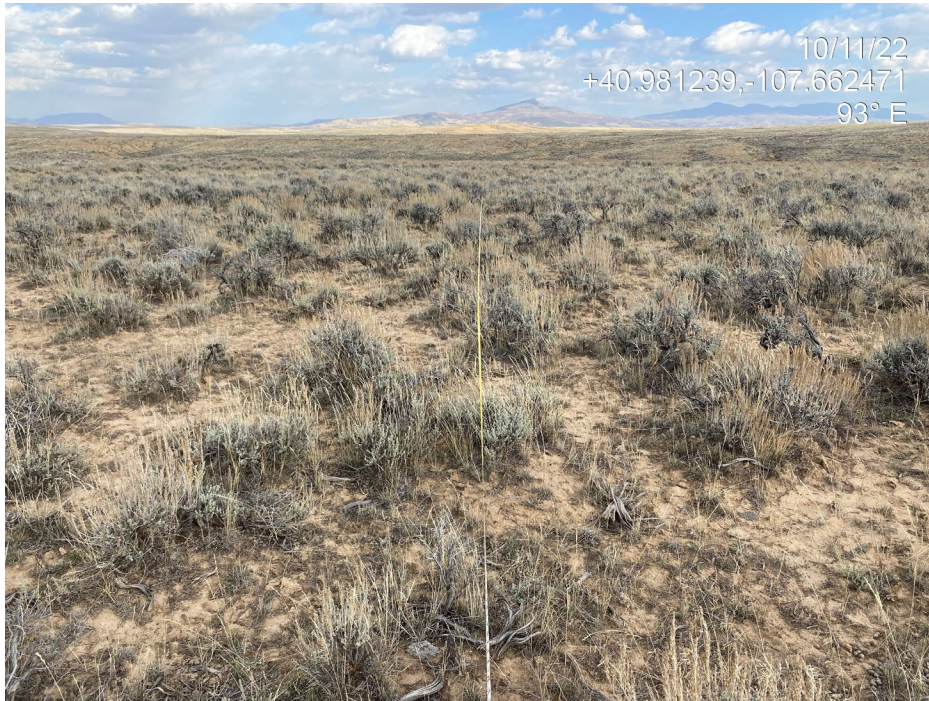
Photo 9. Photo taken to the north of the Location shows the start of reference area vegetation monitoring transect #1.

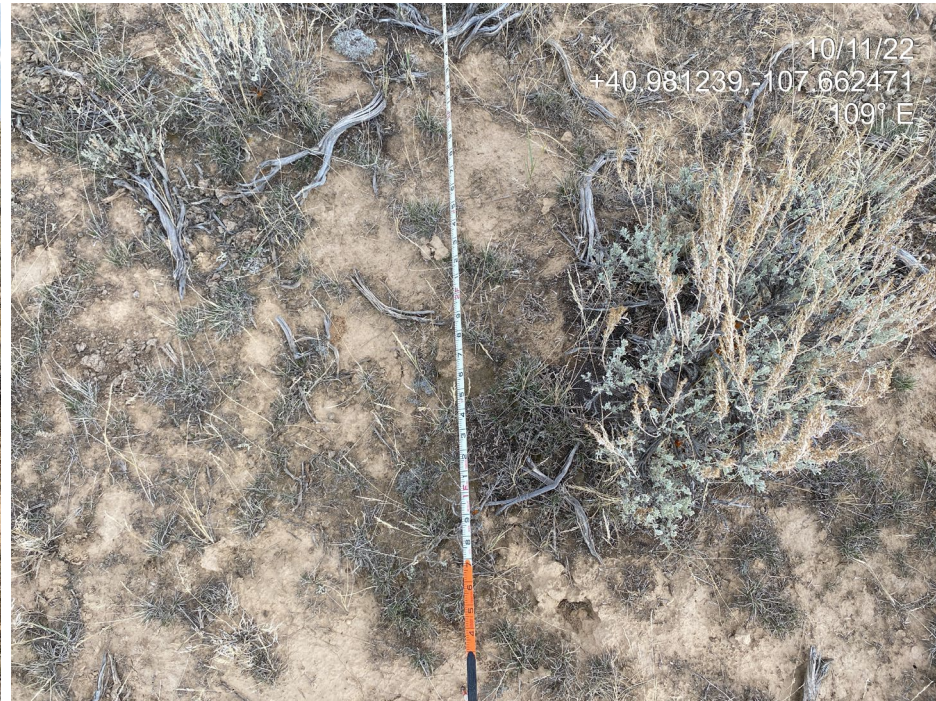
Photo 10. Photo taken to the north of the Location shows the ground surface at the start of reference area vegetation monitoring transect #1.

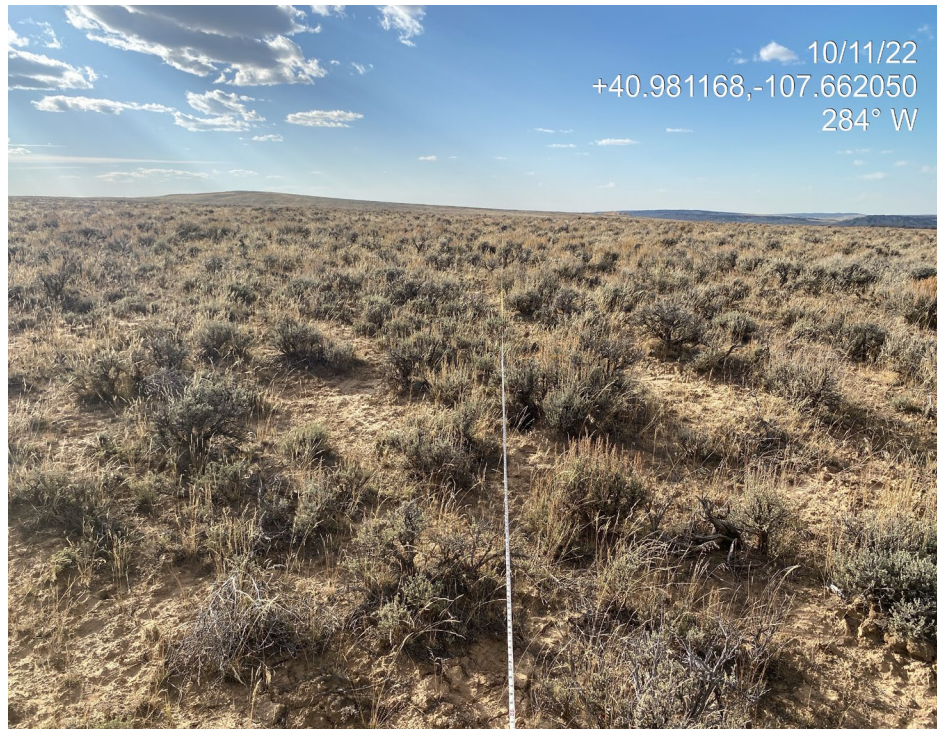
Photo 11. Photo taken to the north of the Location shows the end of reference area vegetation monitoring transect #1.

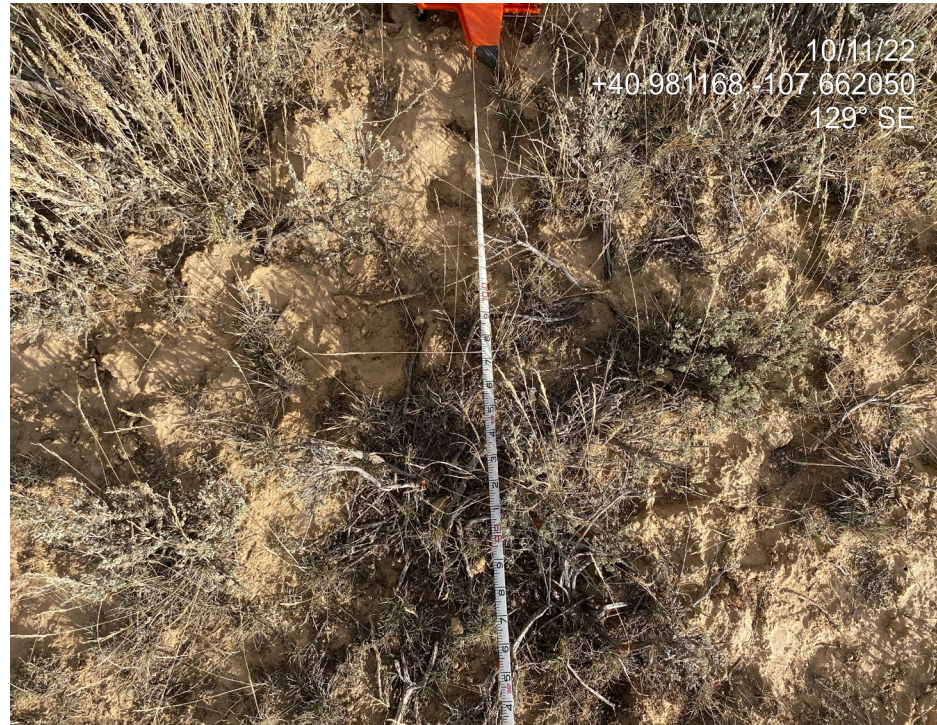
Photo 12. Photo taken to the north of the Location shows the ground surface at the end of reference area vegetation monitoring transect #1.
