Inspection Photos

Operator: Mull Drilling Company Inc - #61250

Location Name: STATE AVALANCHE-612N92W/24NWNE

Inspection Document #: 702800841

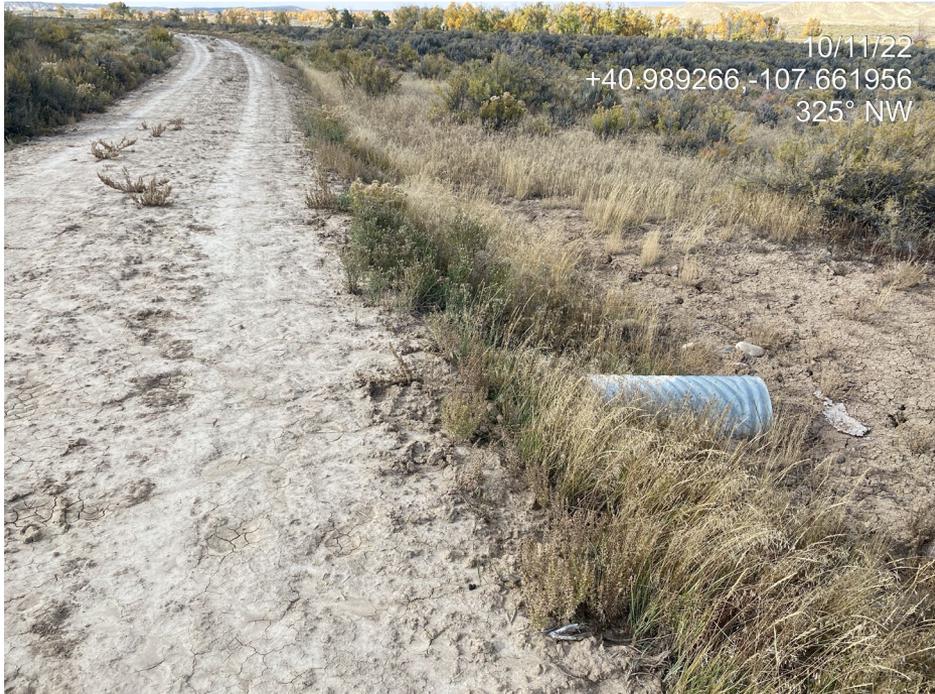
Photo 1. Photo taken to the east shows the access road remains, including multiple culverts. It appears soil has been spread over the top of the original gravel road. Vehicle tracks were evident.

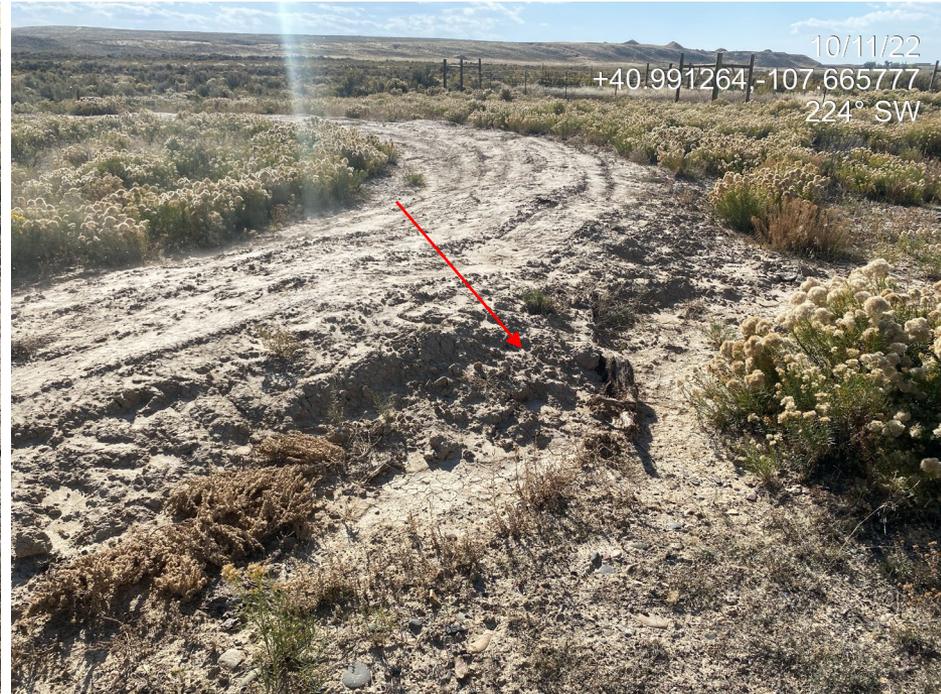
Photo 2. Photo taken from the center of the Location. It appears that road was not properly reclaimed, and that soil was spread over the top of it. The original, compacted, gravel road is evident beneath the soil. Vehicle tracks were evident.

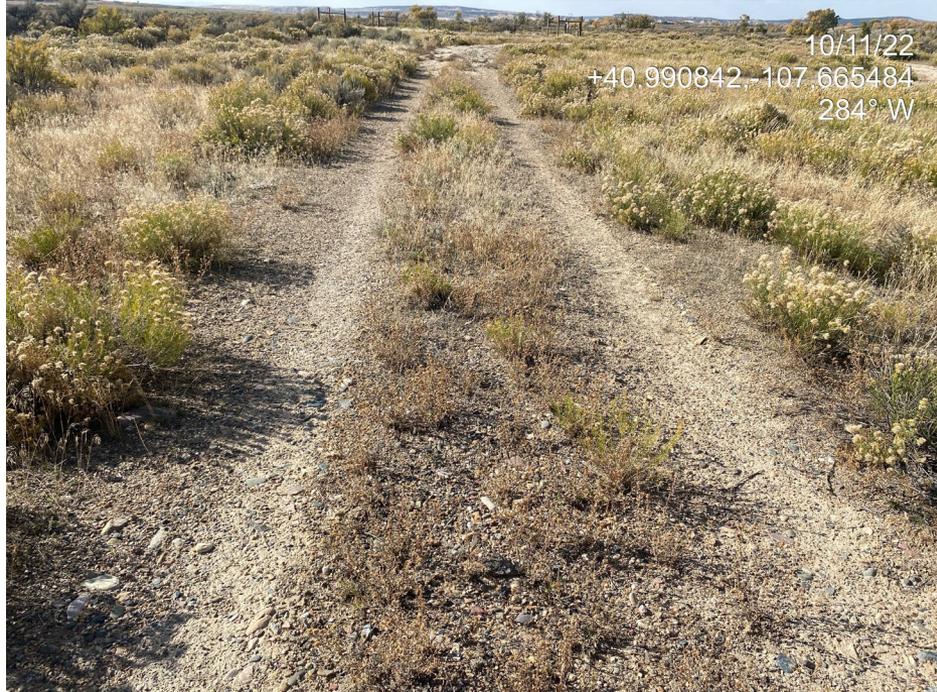
Photo 3. Photo shows a portion of the access road at the southeast. Some areas have soil spread over the top of the pad and road, while others do not. Photo shows the original compacted, graveled access road.

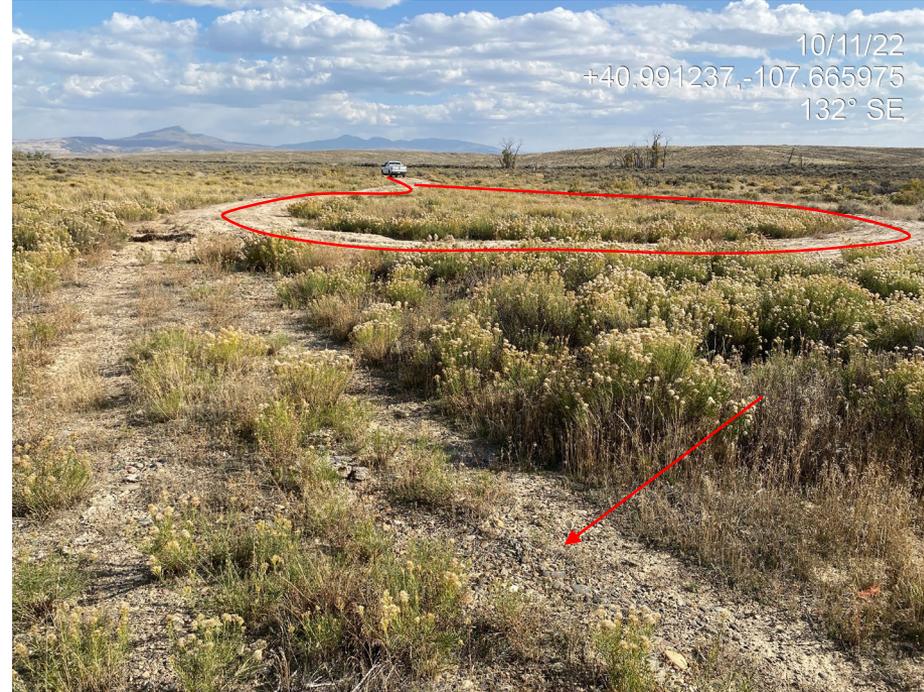
Photo 4. Photo taken to the west shows the access road remains. Soils has been spread over the top. Also pictured in the foreground is an unreclaimed access road to another Location operated by Mull Drilling Company to the west. The portion of access road pictured is on Location 313080. Soils are compacted and gravel remains.

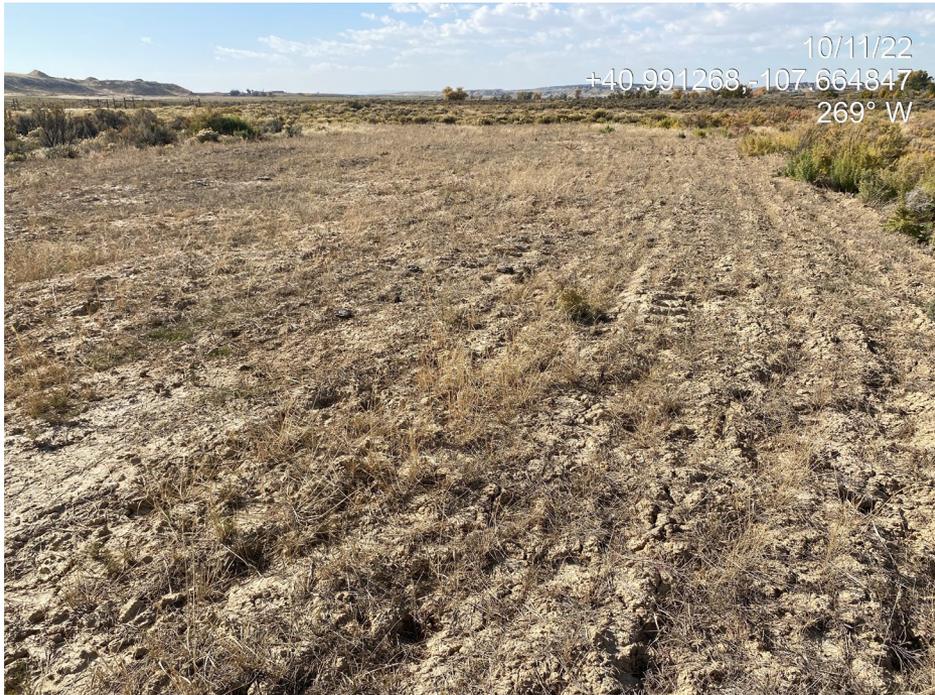
Photo 5. Photo shows a portion of the Location at the northeast. Soil appears to have been spread over the pad surface. Western wheatgrass appears to have been seeded and is well established in areas but not uniform. Bare ground and undesirable plant species/weeds are also common.

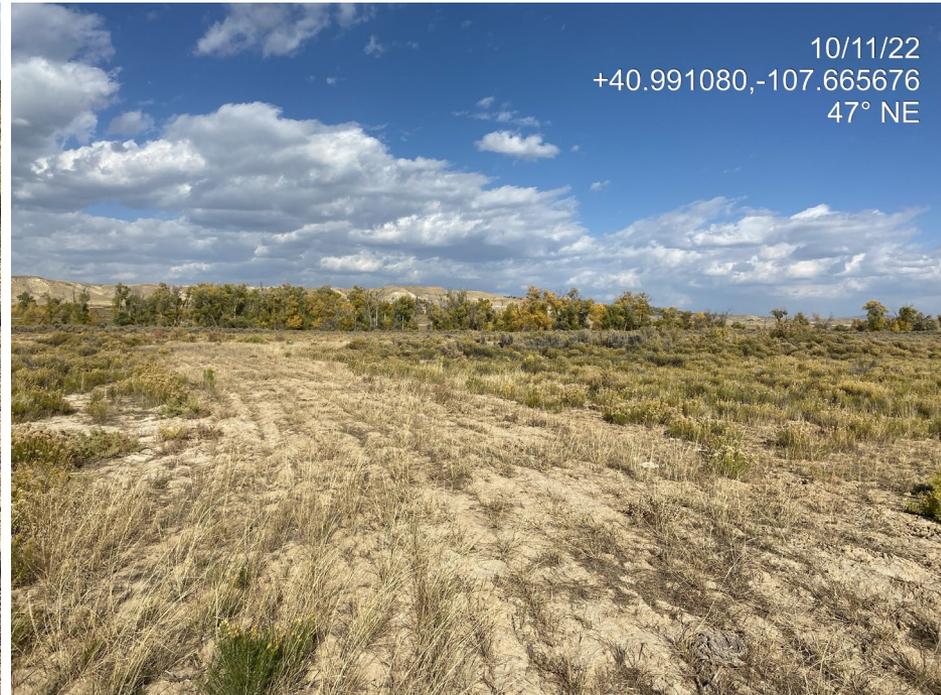
Photo 6. Photo shows a portion of the Location leading north to the area shown in Photo 5. Western wheatgrass is well established but not uniform. Bare ground and undesirable plant species/weeds are also common.

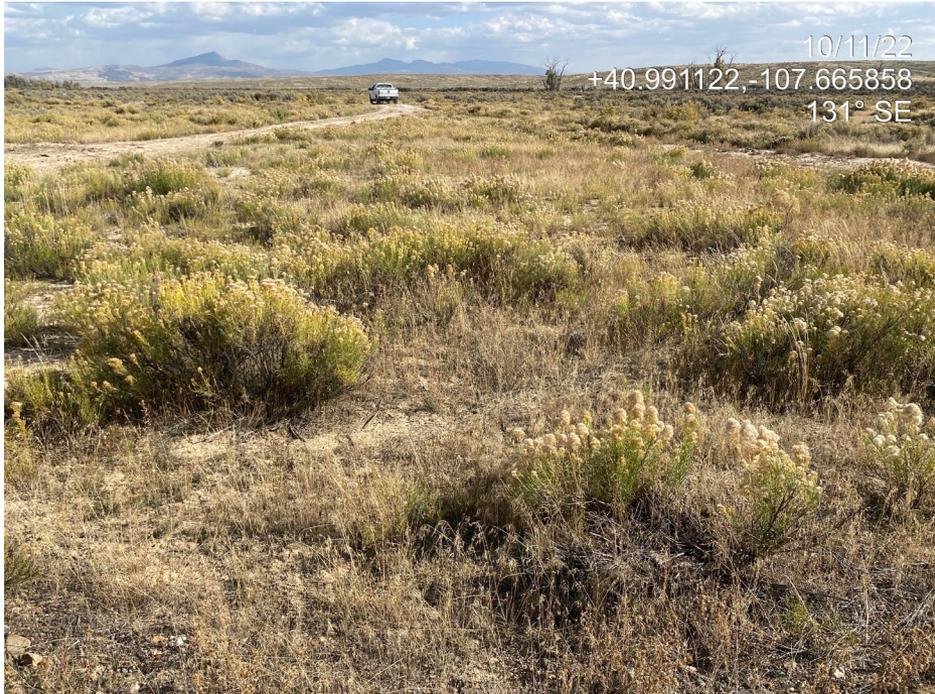
Photo 7. Photo shows areas of the Location which were not a part of the “working pad area” but which were part of the disturbance. They appear to have been colonized by rabbitbrush, with an understory of cheatgrass (List C Noxious). Additional seeding may be necessary in these areas to achieve 80% similarity to reference areas.

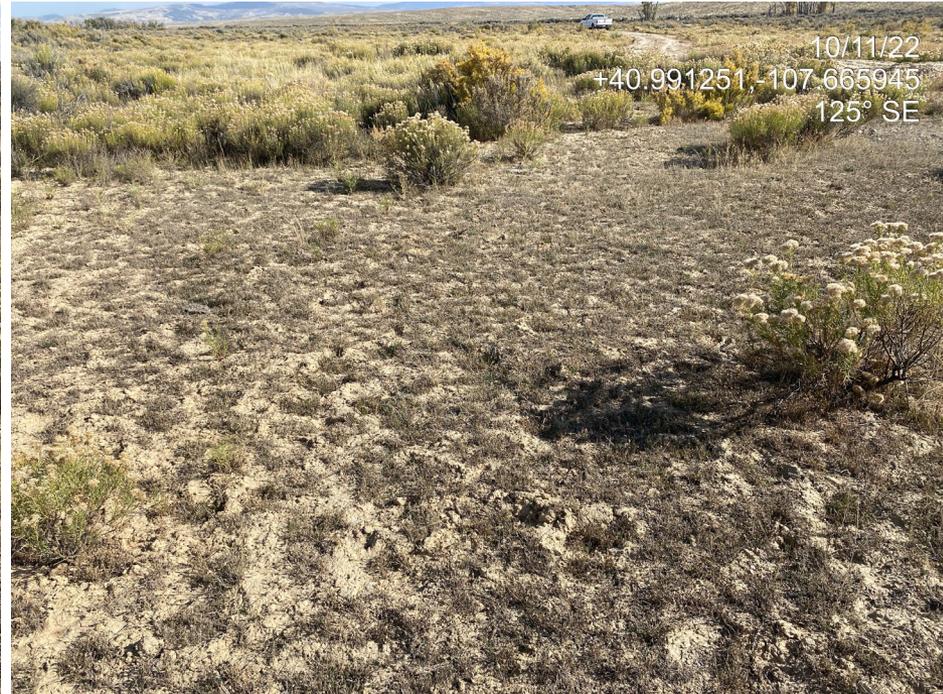
Photo 8. Photo shows areas described in Photo 7 at the northwest. The vegetation community is dominated by annual wheatgrass (annual undesirable plant species/weed).

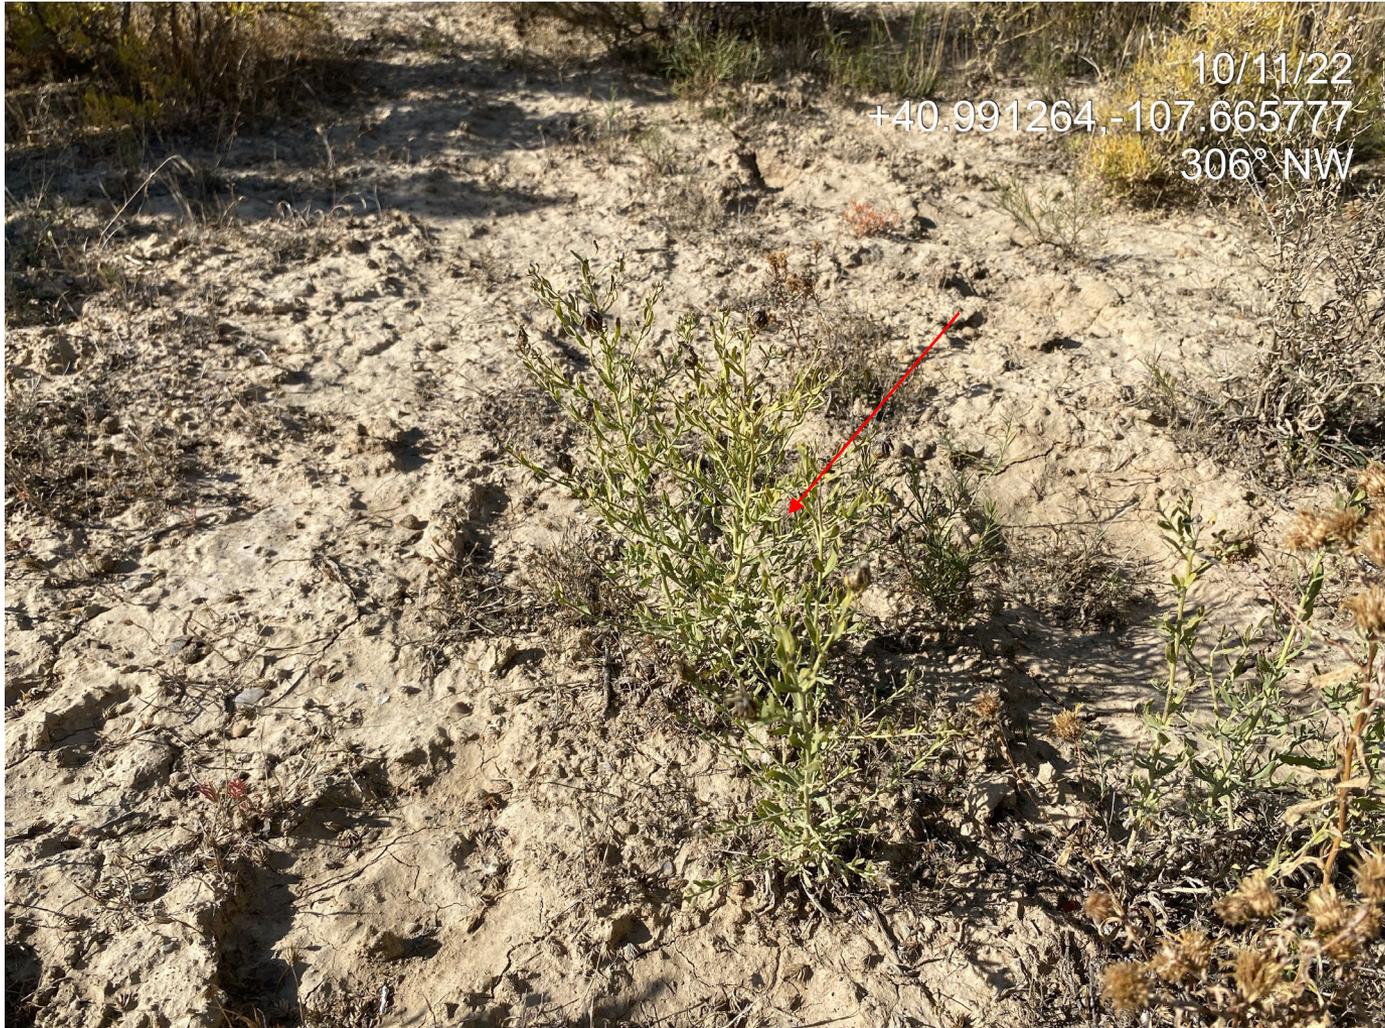
Photo 9. Photo taken at the northwest of the Location shows Russian knapweed (List B Noxious).

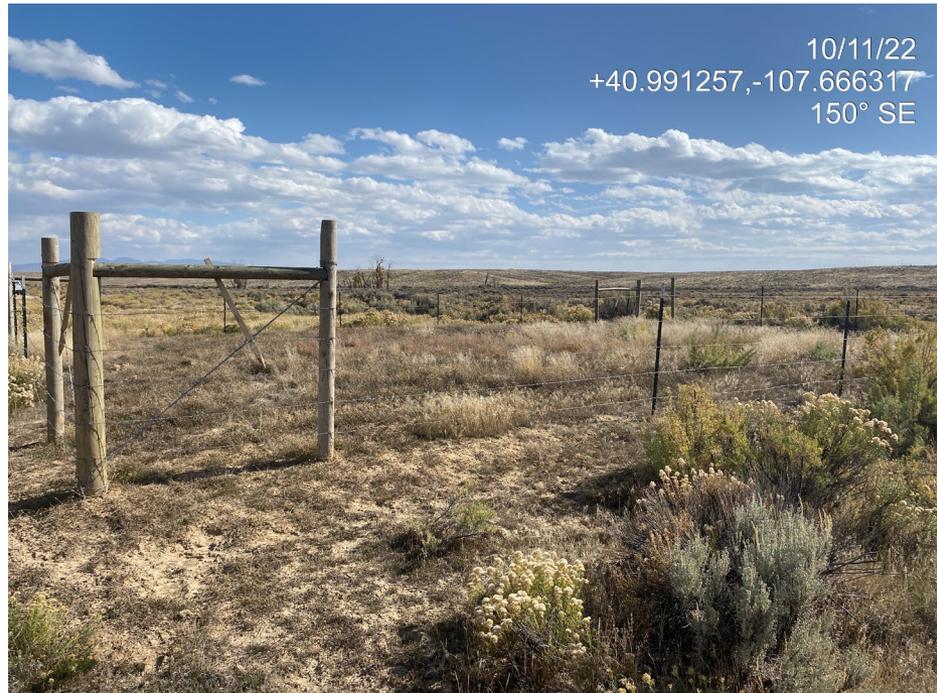
Photo 10. Photo taken at the west shows the former tank battery site. The fence still remains and annual undesirable plant species/weeds colonize the area. Desirable perennial species were very rare. The fence must be removed for the site to pass final reclamation.

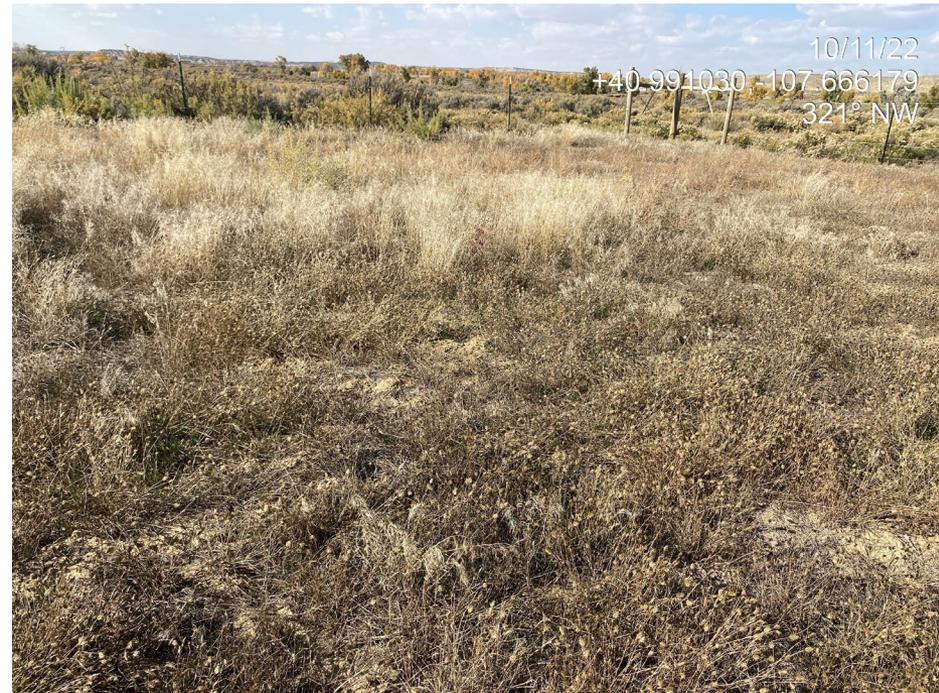
Photo 11. Photo shows the vegetation community within the former tank battery fence. Species pictured include cheatgrass (List C Noxious) and annual wheatgrass (undesirable plant species/weed).

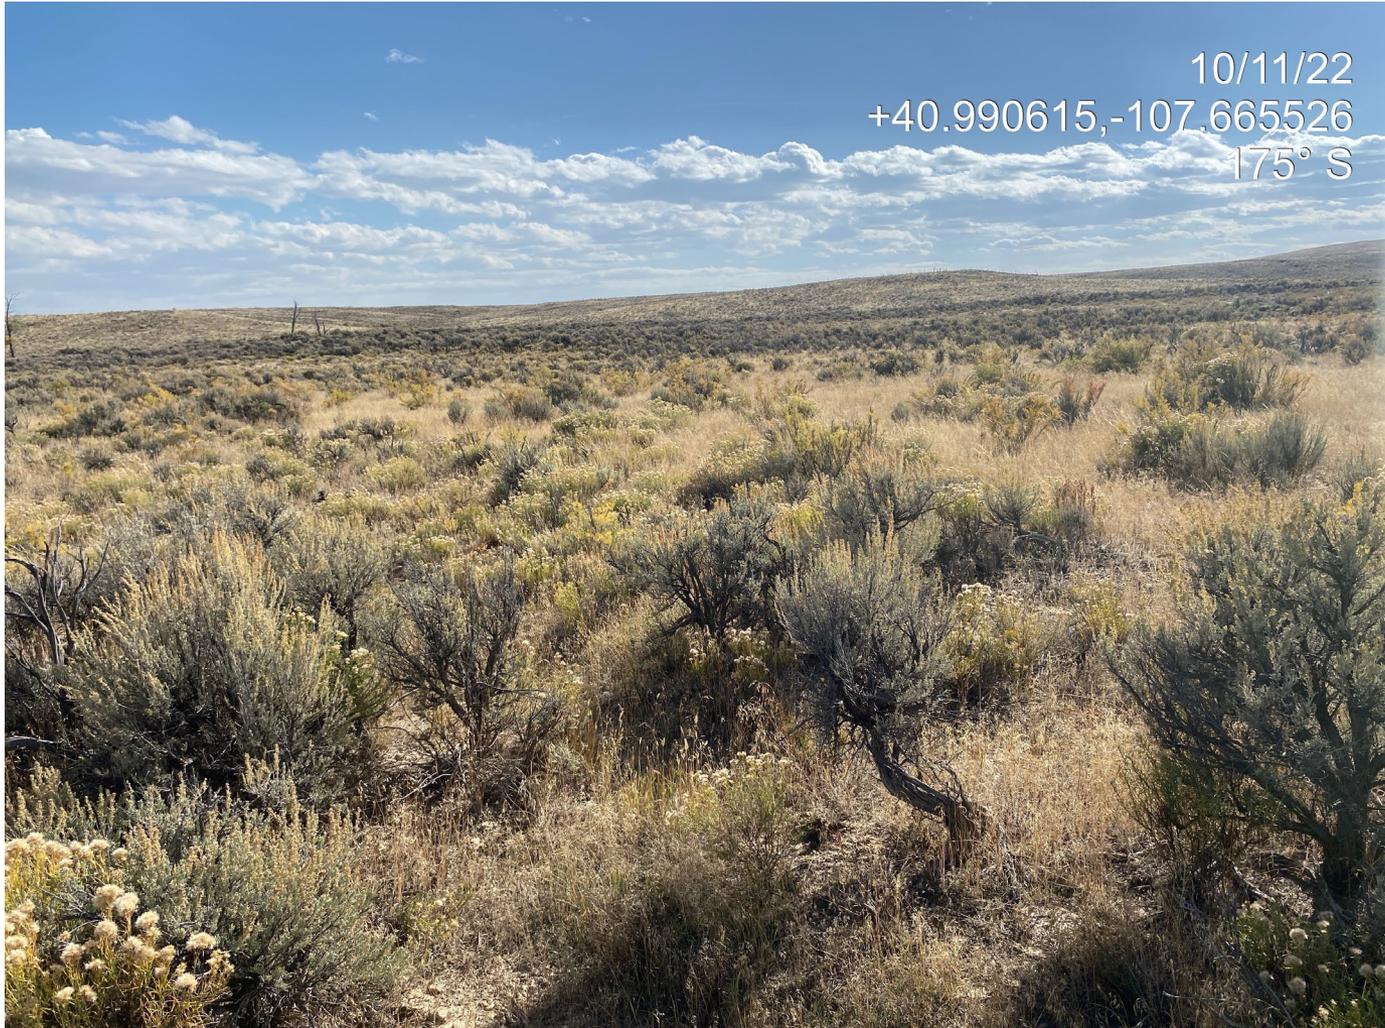
Photo 12. Photo taken to the south shows reference area vegetation.
