Inspection Photos

Location Name: BAKERS PEAK-611N91W/13SWNE

Inspection Document #: 702800845

**Oil & Gas Conservation
Commission**

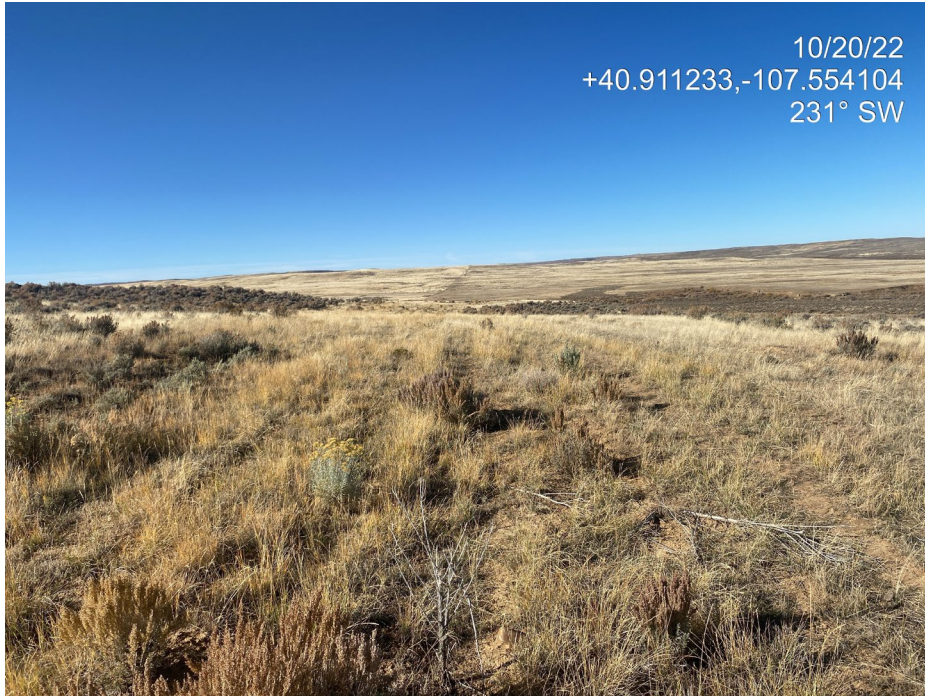
Photo 1. Photo taken to the west shows the reclaimed access road. Photo shows an area with good perennial establishment, lacking annual undesirable plant species and noxious weeds.

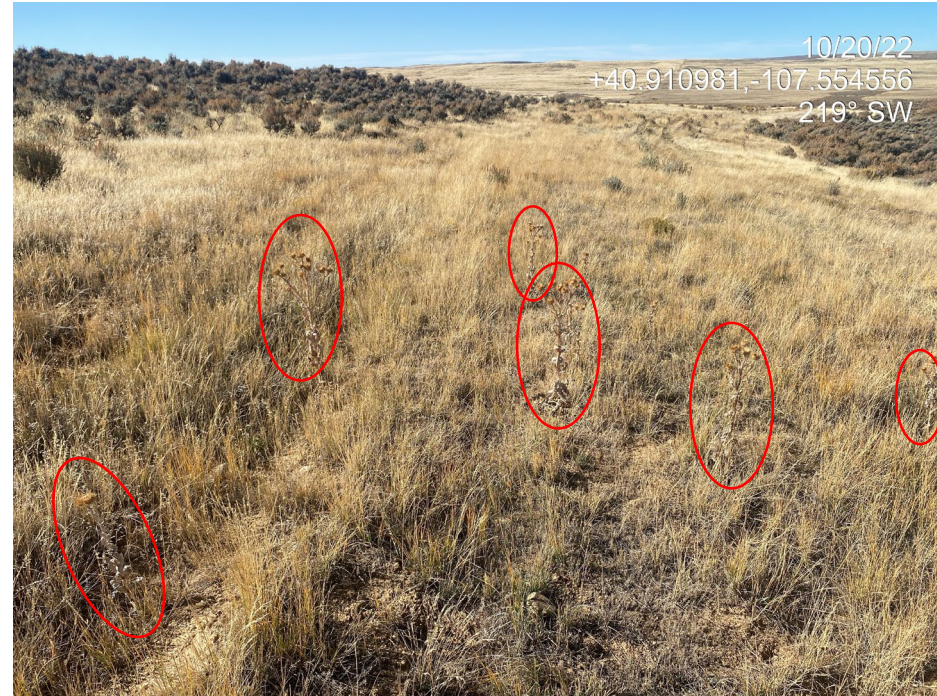
Photo 2. Photo taken to the west shows the reclaimed access road. Photo shows an area with good perennial establishment, however, a patch of Scotch thistle (List B Noxious) is present.

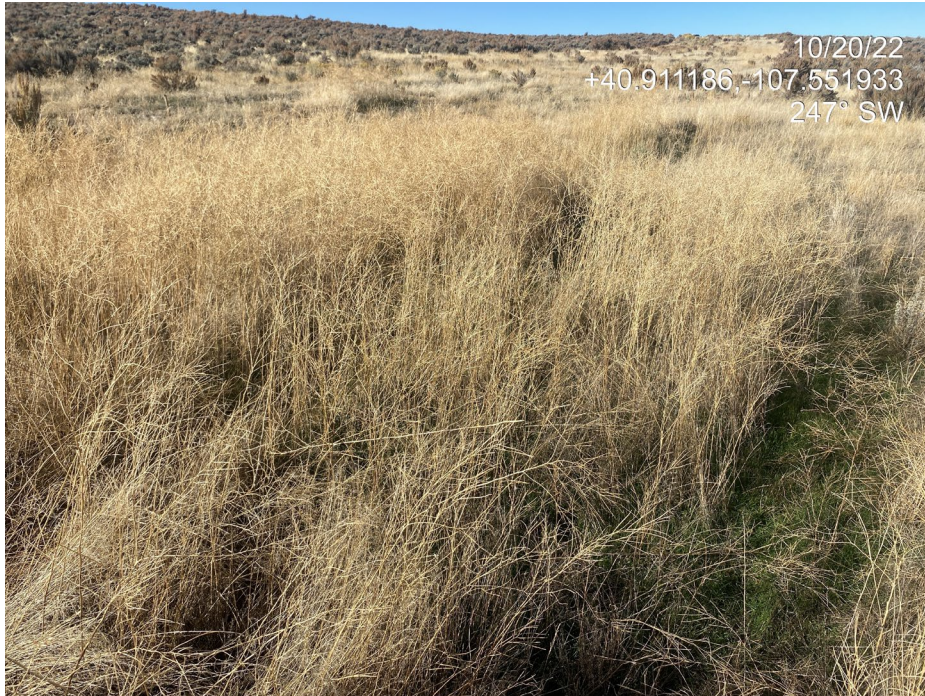
Photo 3. Photo shows the easternmost portion of the access road at the Location entrance. The area is densely covered in annual undesirable plant species (tall tumblemustard) and noxious weeds (cheatgrass) with little to no perennial establishment.

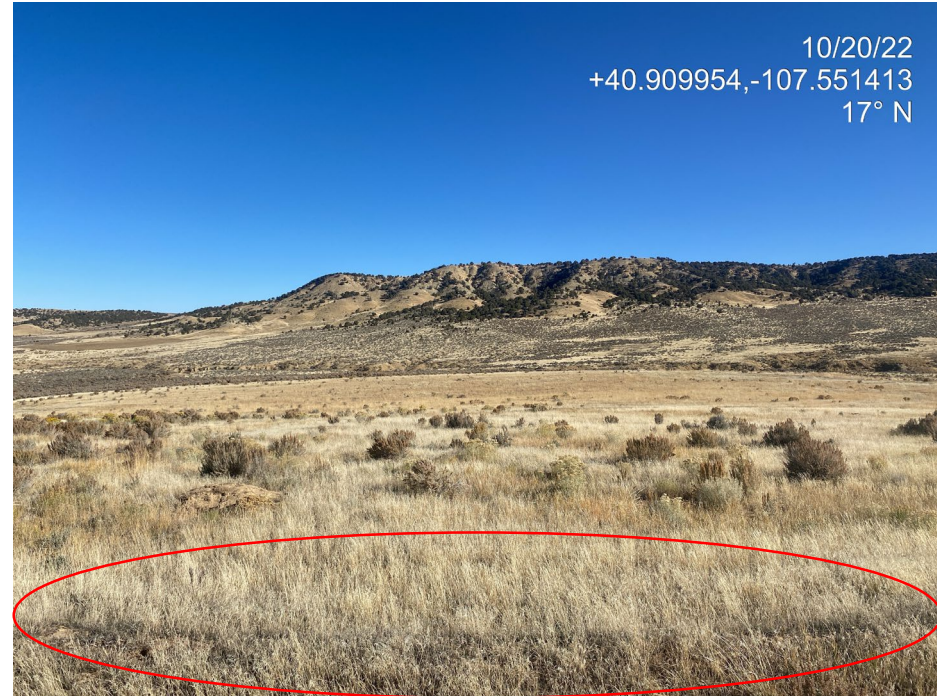
Photo 4. Photo taken from the south shows an overview of the reclaimed Location. Overall perennial species are very well established, however portions of the Location lack perennial species and are dominated by weeds. Weedy species are the lighter tan color, while perennial grasses are the darker, orange-tan color. Note dense patch of cheatgrass in foreground.

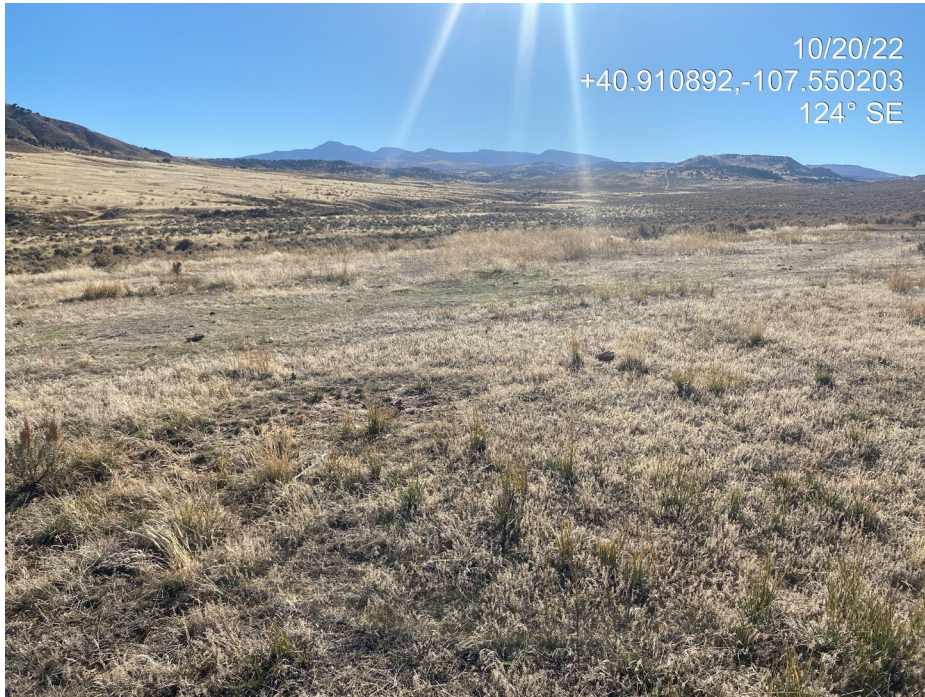
Photo 5. Photo taken from the northeast shows the largest and most continuous area lacking perennial species and dominated by annual undesirable plant species and noxious weeds.

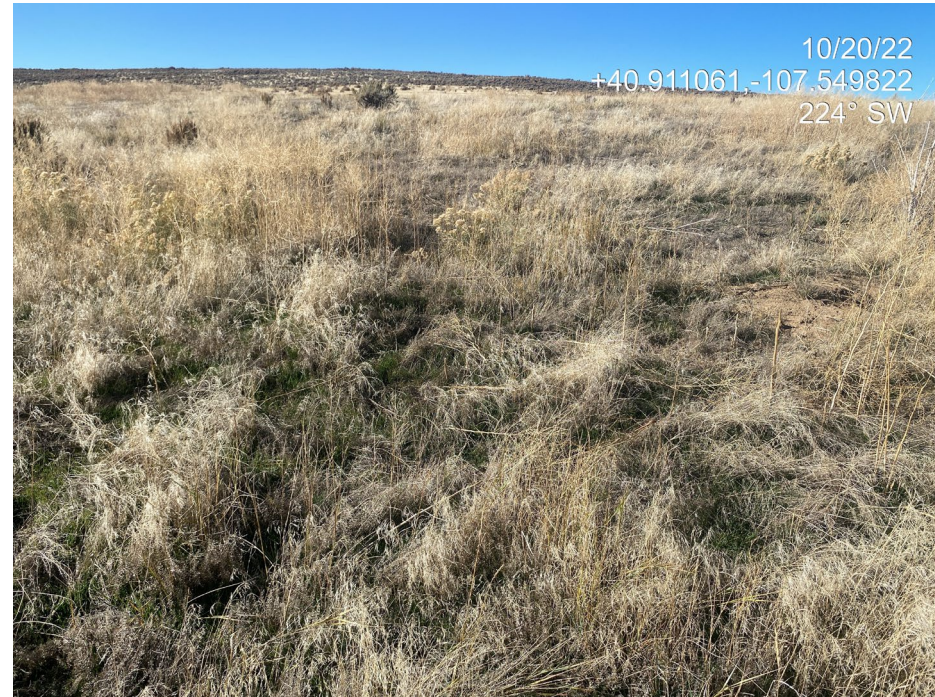
Photo 6. Photo shows the area at the northeast of the Locations is densely colonized by cheatgrass and tall tumblemustard.

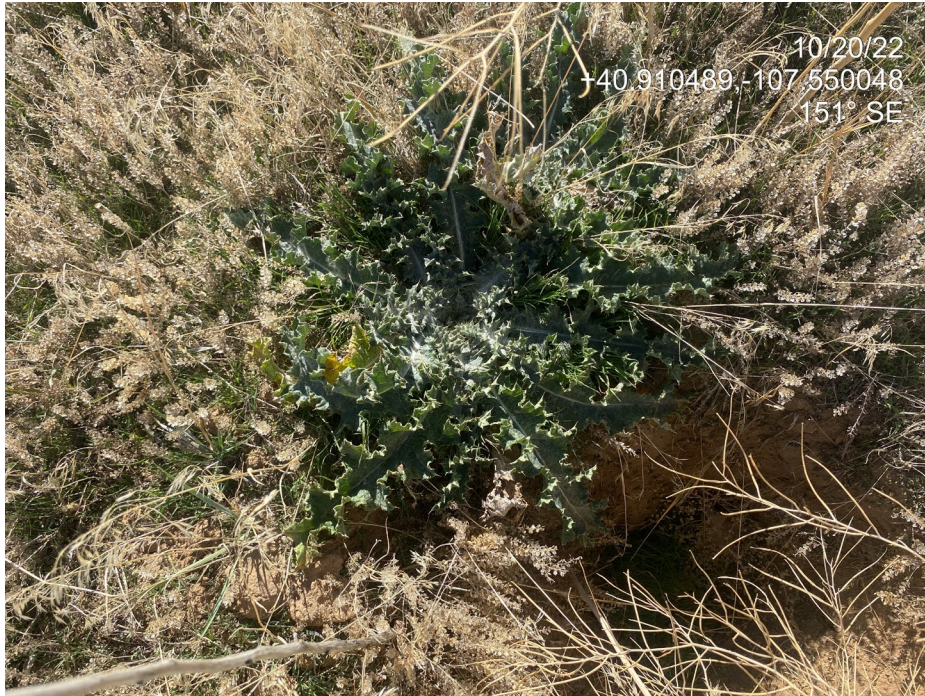
Photo 7. Photo shows an example of a Scotch thistle (List B Noxious) rosette on Location.

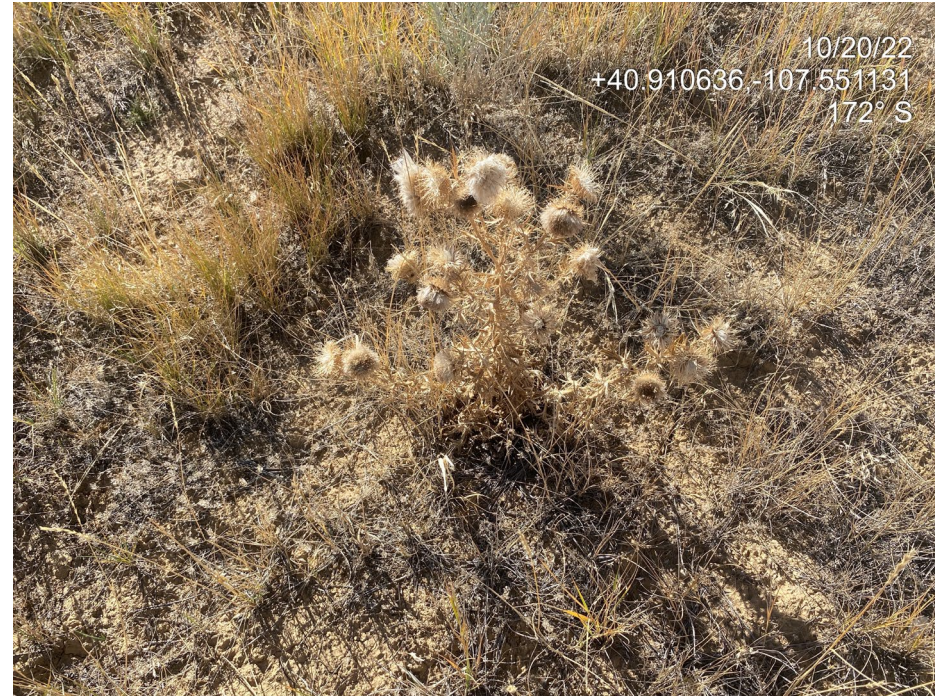
Photo 8. Photo shows an example of a bull thistle (List B Noxious) plant which has gone to seed and is acting as a seed source.

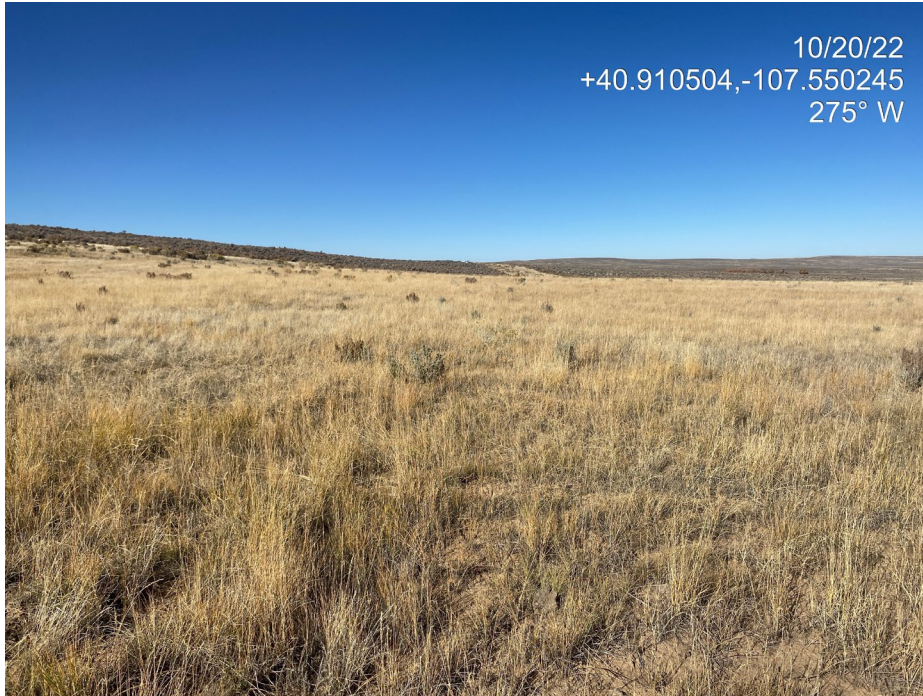
Photo 9. Photo shows an example of an area with excellent perennial establishment at the west of the Location.

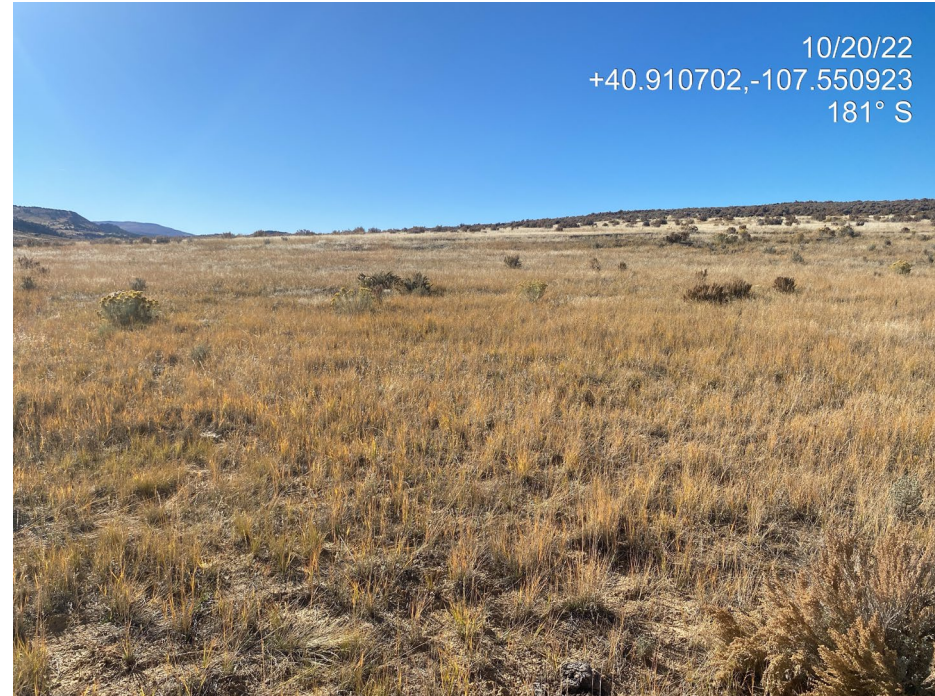
Photo 10. Photo shows an example of an area with excellent perennial establishment at the center of the Location.

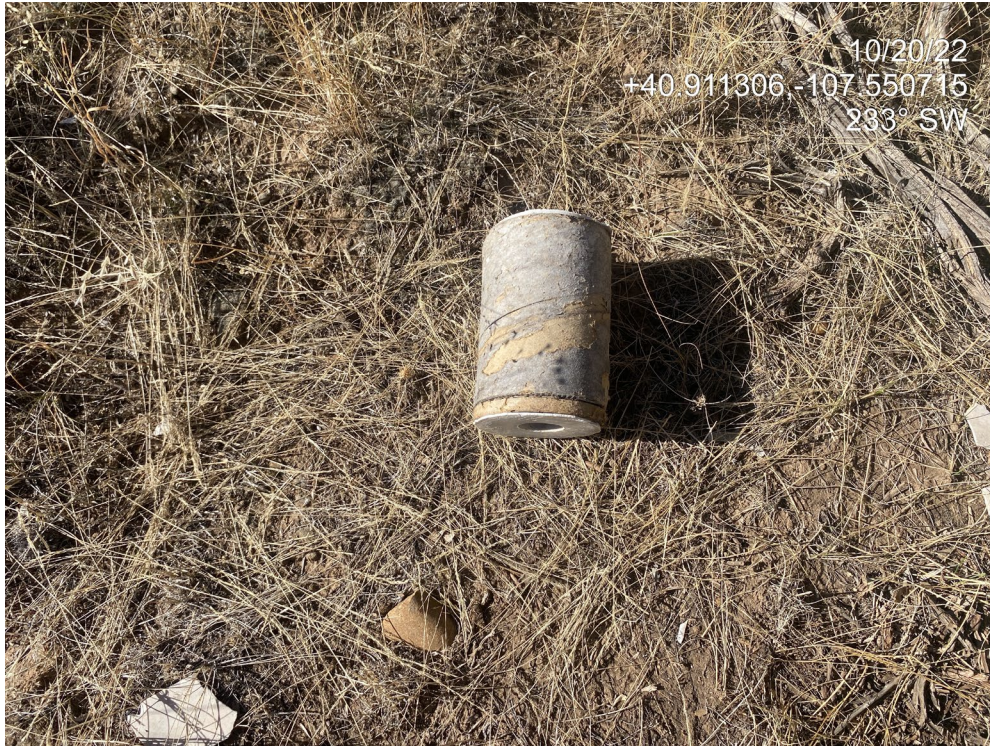
Photo 11. Photo shows an example trash/debris on Location.

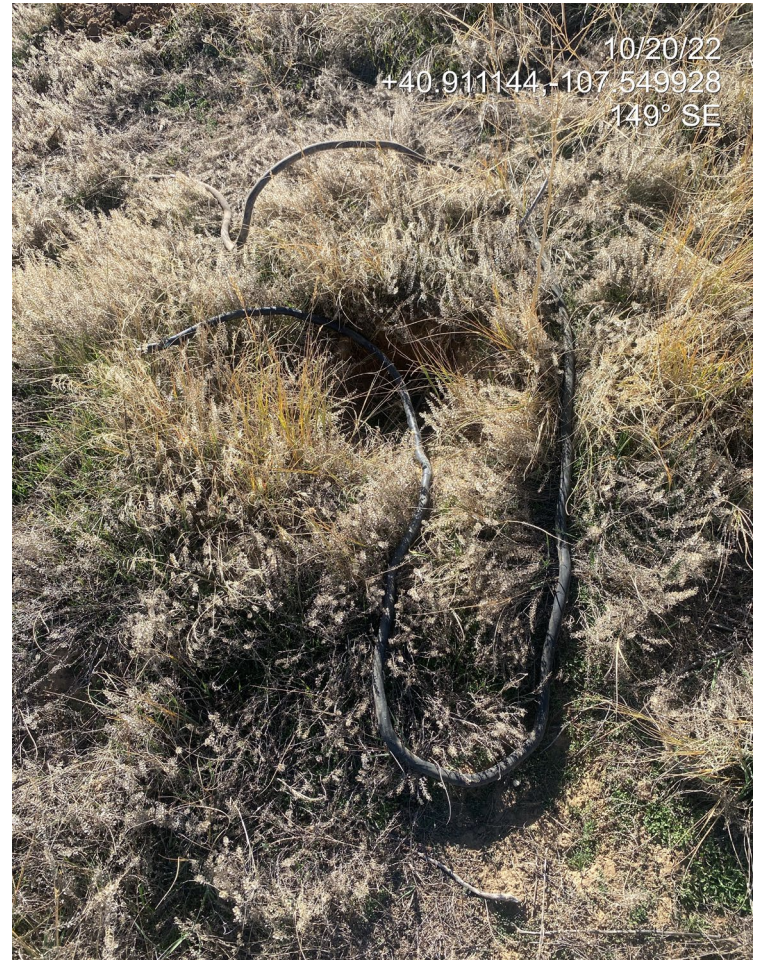
Photo 12. Photo shows an example trash/debris on Location.

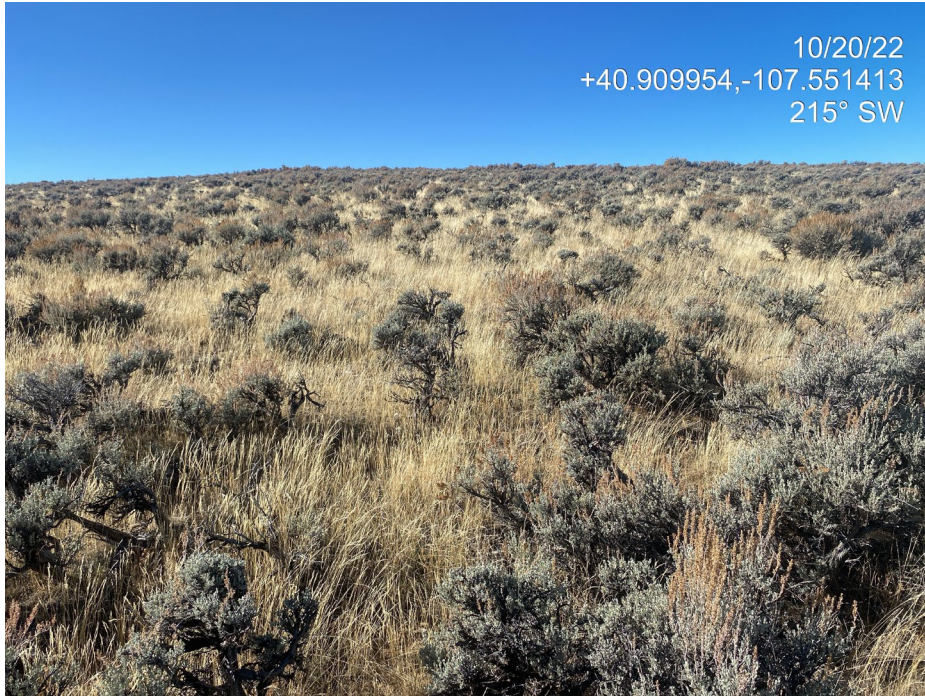
Photo 13. Photo taken to the south shows the reference area vegetation community is native rangeland. The herbaceous understory is densely colonized by native perennial grasses and forbs. Noxious weeds are absent.

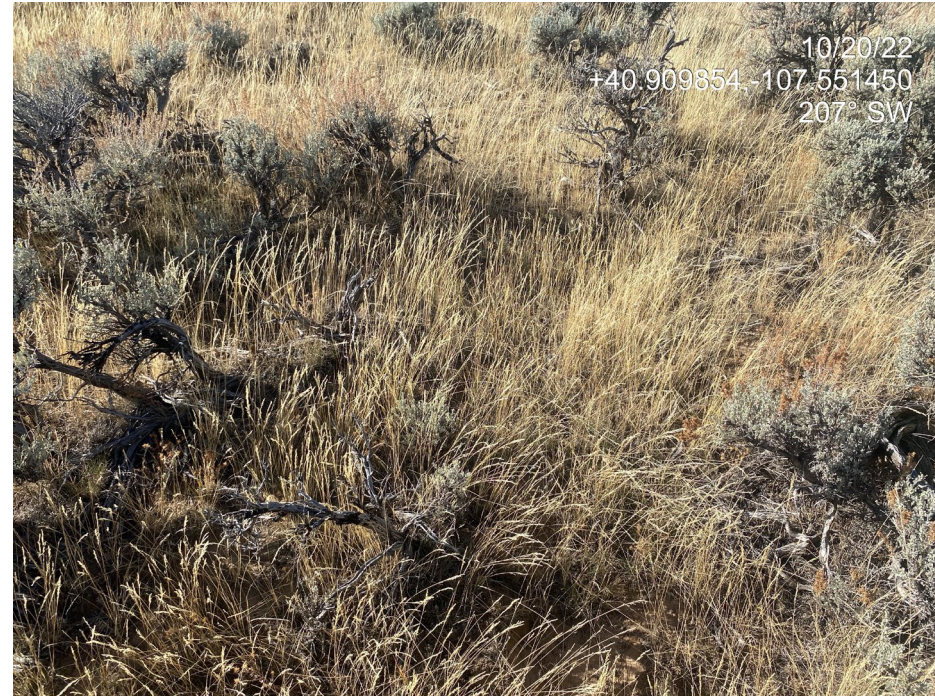
Photo 14. Photo shows a close-up of the vegetation community in Photo 13. The grass in the photo is Sandberg bluegrass (native, perennial bunchgrass).
