**COGCC 6/16/2022 Follow up Inter Rec Inspection Notices Received**

**Oxnard East Pad – Facility ID 452516 – Status: PR**

**Fir Doc #: 697504028**

**Follow up to field Inspection Report Doc#  
697503532**

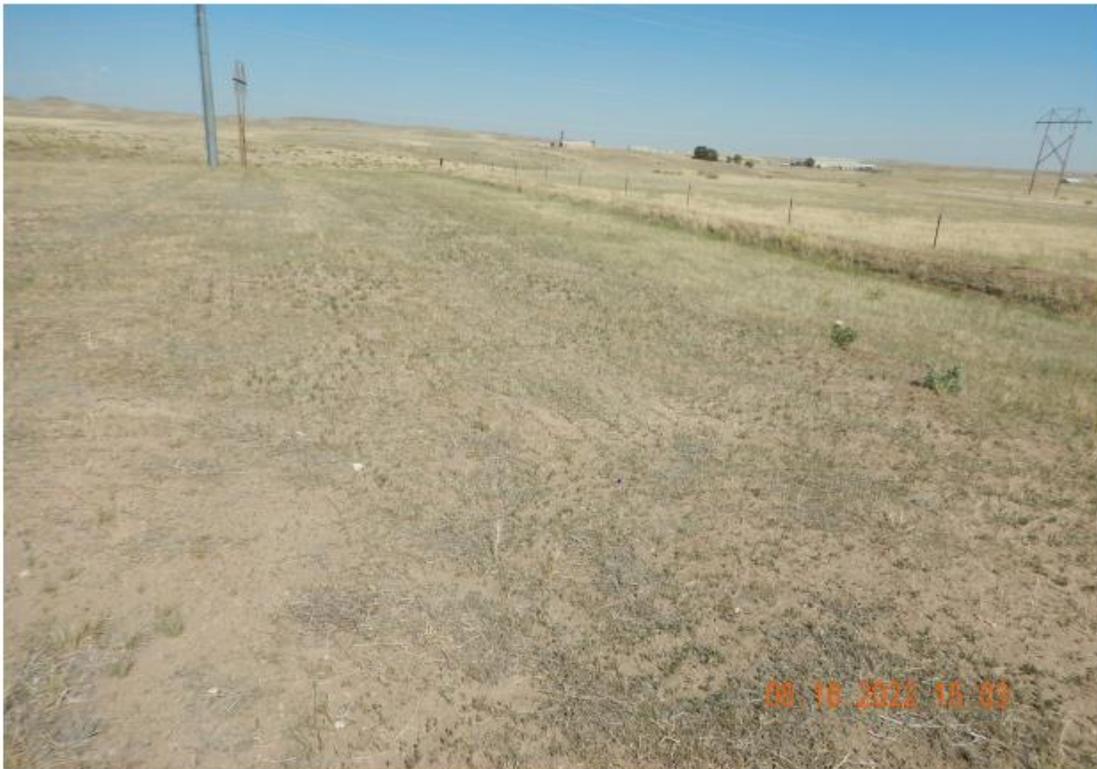
**Photo 1.** Photo taken from the southeastern interim reclamation area, facing East. Photo illustrates Operator has responded to the previous corrective action to perform additional interim reclamation activities; however, there was little to no germination throughout the interim reclamation area.

**Corrective Action 1** – Comply with Rule 1003. Operator shall redo the revegetation in accordance to Rule 1003. Establish vegetation with total perennial, non-invasive uniform plant cover of at least eighty (80) percent of reference area levels. Use the approved seed mixture provided by the surface owner. Ensure erosion controls are implemented to stabilize the seeded soil, and continue to monitor and manage this site until the location meets Rule 1003 standards, including stormwater and weed management. Native seed mix should only be planted to a depth of ¼ to ½ an inch

The corrective action was completed on 10/29/2022 by CB Services. Re seeding was done in accordance with the approved seed mixture by the landowner.

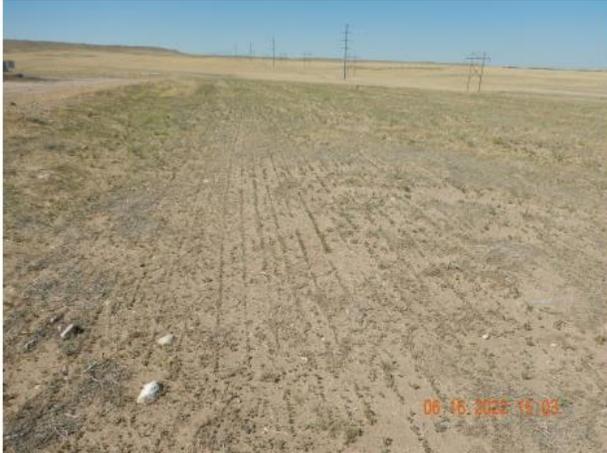
**Photo 2.** Photo taken from the southeastern interim reclamation area, facing North. See comments under Photo 1.

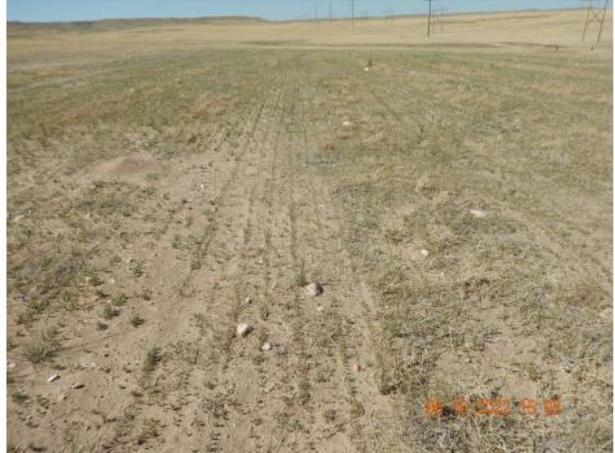
**Photo 3.** Photo taken from the eastern interim reclamation area, facing North. See comments under Photo 1.

Note: the Kochia seedlings are coming up in the drill rows, which is not desirable vegetation.

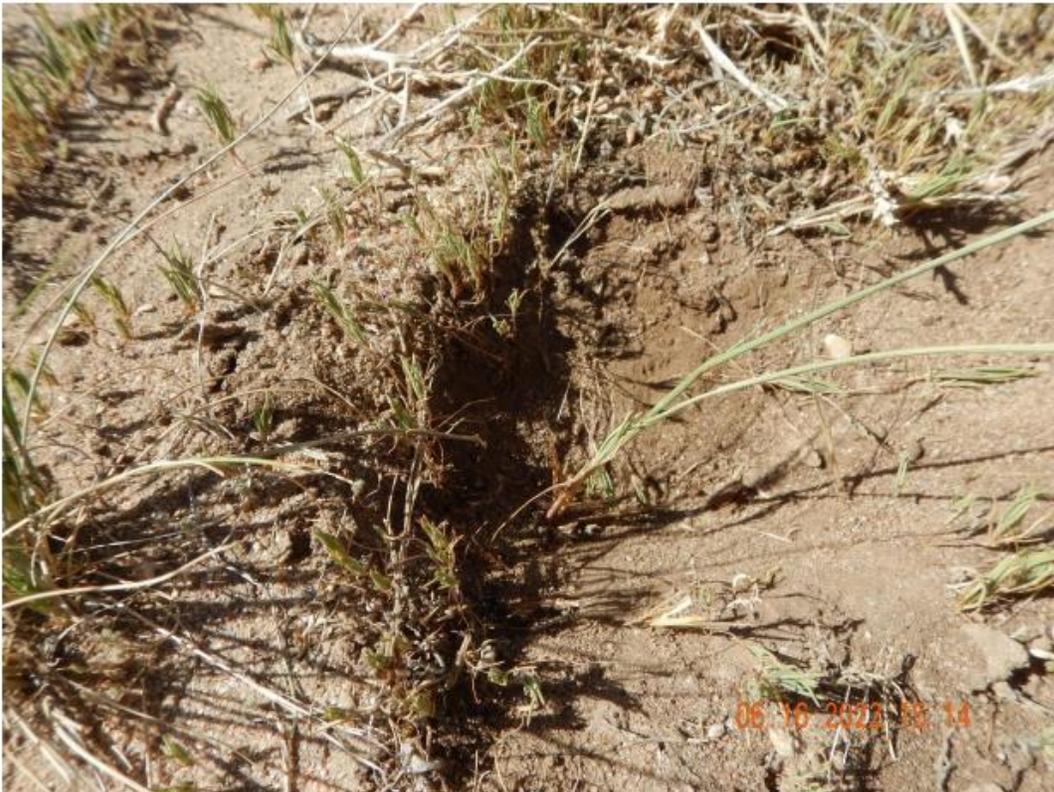
**Photo 4.** Photo taken from the interim reclamation area. Photo illustrates that one of the desirable grass species was planted deeper than 1.5 inches. Native seeds should not be planted that deep and maybe why this attempt failed.

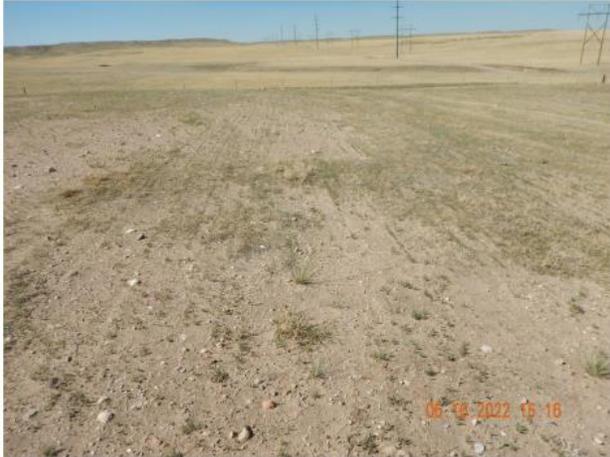
**Photo 5.** Photo taken from the northeastern interim reclamation area, facing North. See comments under Photo 1.

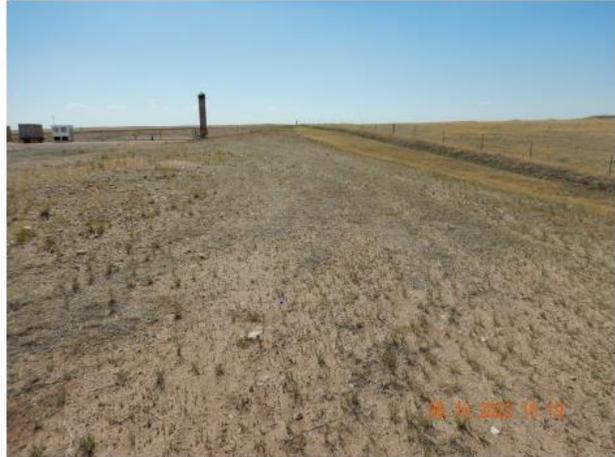
**Photo 6.** Photo taken from the northeastern interim reclamation area, facing West. See comments under Photo 1.
