Inspection Photos

Operator: Argali Exploration Company - #3975

Location Name: OKES-68N90W/6SWNW

Inspection Document #: 702800881

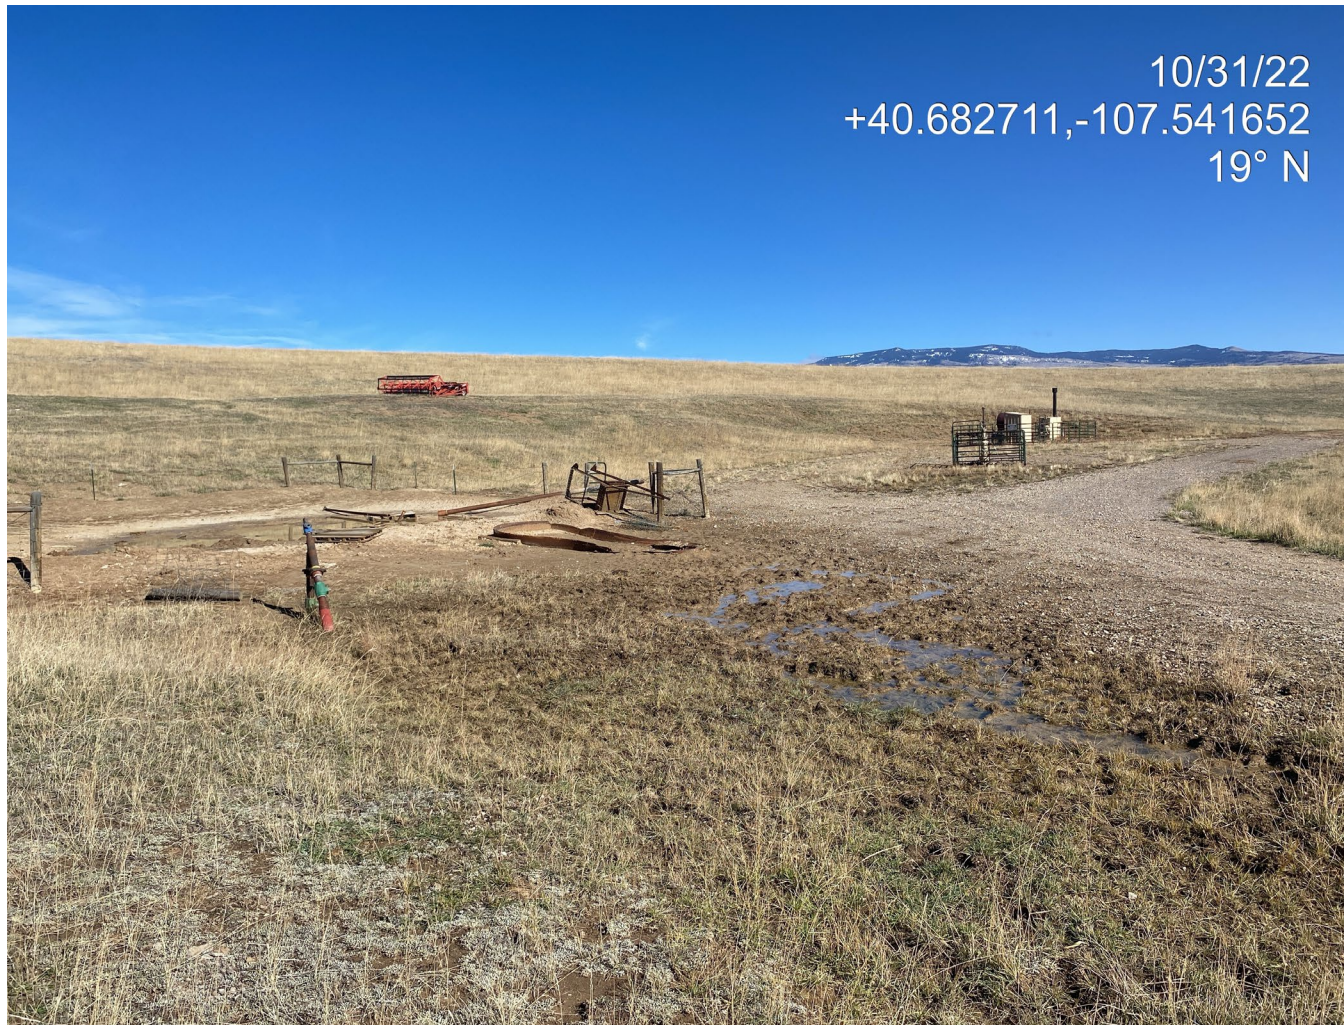
Photo 1. Photo taken from the southwest shows an overview of the Location.

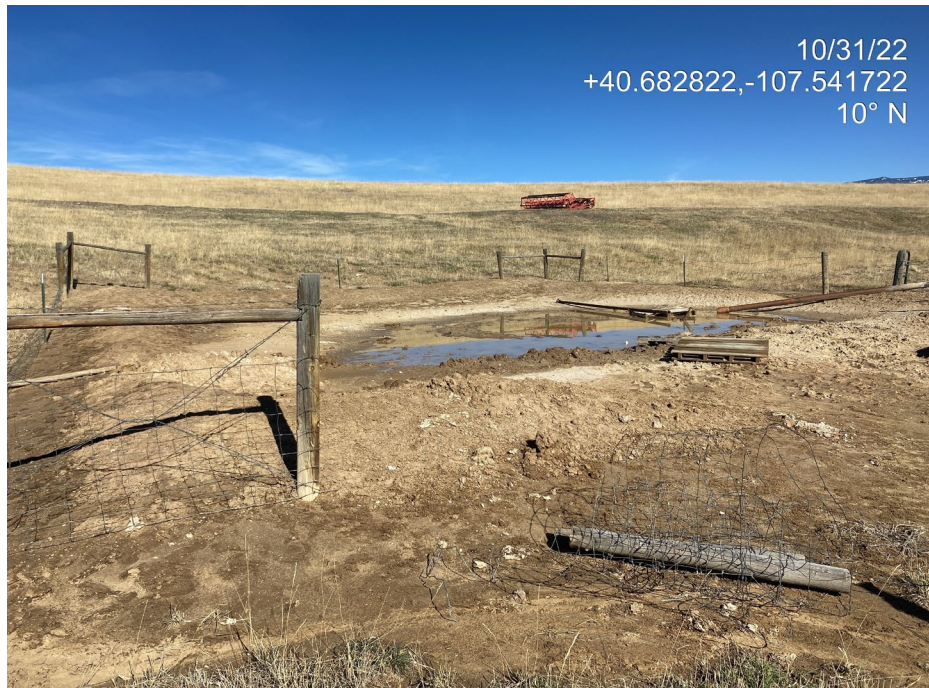
Photo 2. Photo taken from the northwest shows a decommissioned produced water tank facility. Decommissioned facilities require site investigation and remediation followed by interim reclamation after compliance with 915-1 standards. Photo also shows waste/debris.

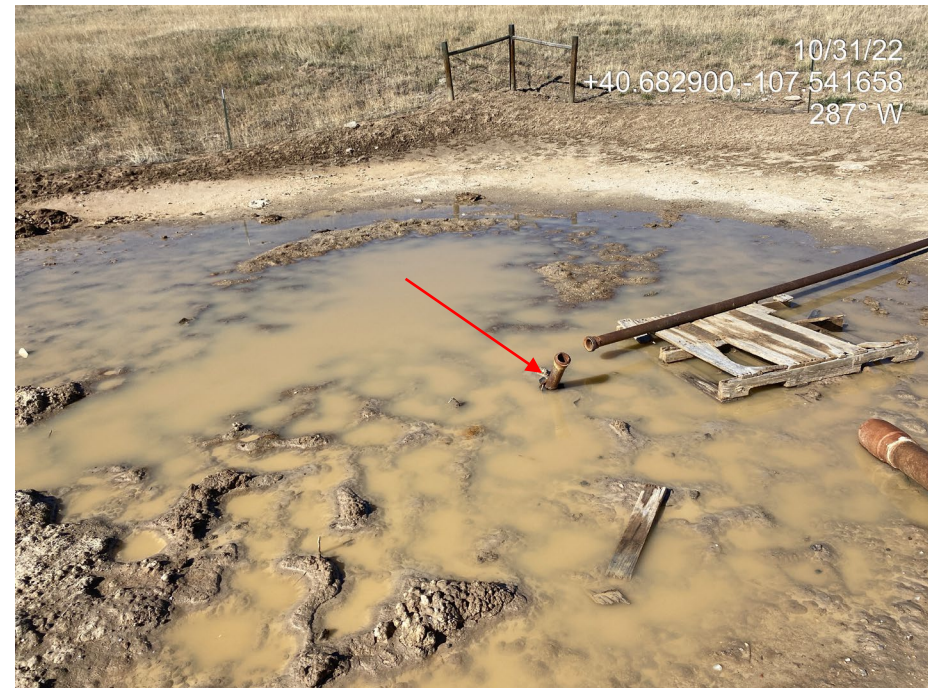
Photo 3. Photo taken from the northwest shows a pipe remaining at the produced water tank facility. Pipe must be removed. Photo also shows waste/debris.

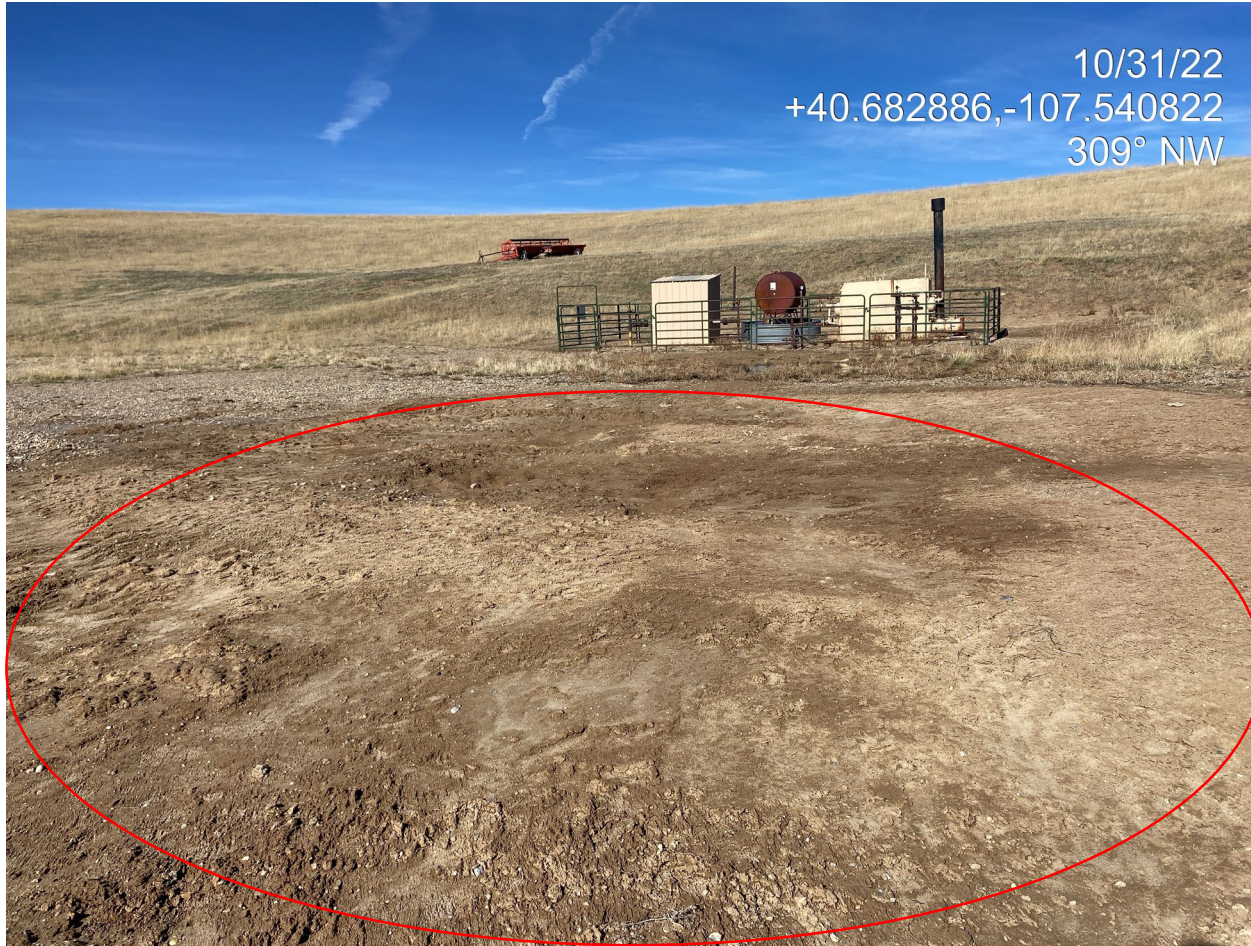
Photo 4. Photo taken from the southeast of the Location shows a decommissioned partially buried vessel facility. Decommissioned facilities require site investigation and remediation followed by interim reclamation after compliance with 915-1 standards.

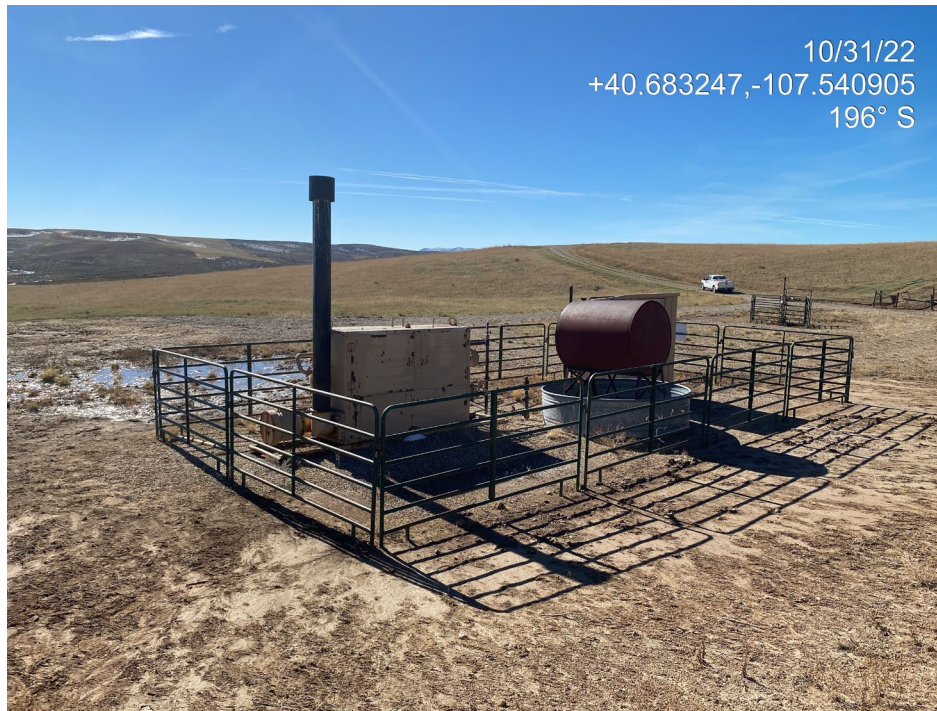
Photo 5. Photo taken from the northeast shows equipment.

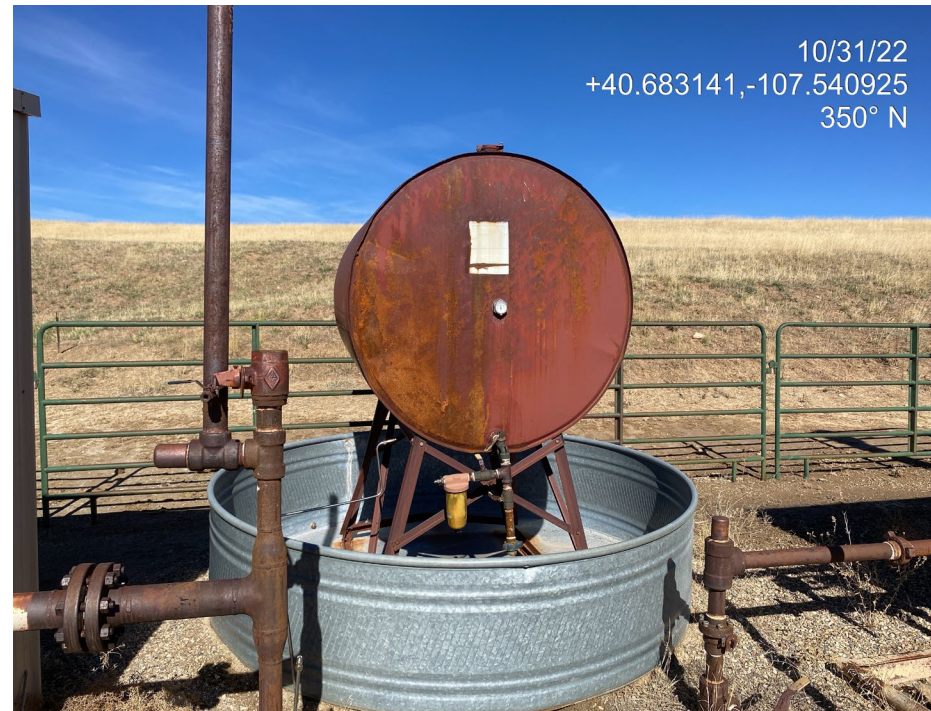
Photo 6. Photo taken from the northeast. The methanol tank secondary containment lacks wildlife protection BMPs. Tank label is faded and illegible.

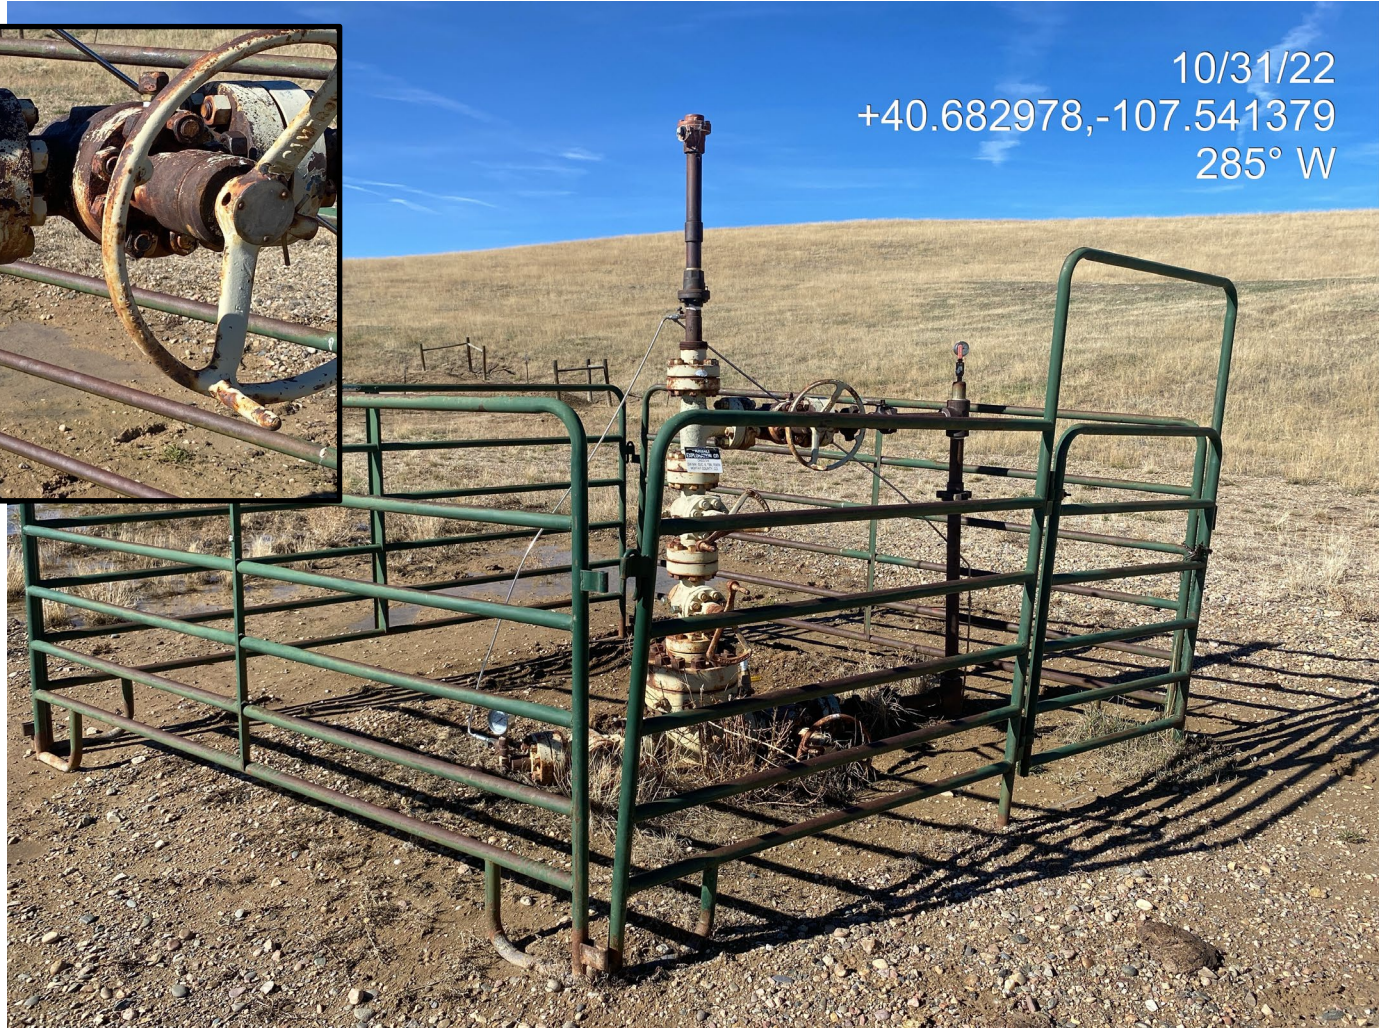
Photo 7. Photo shows the wellhead. Wellhead sign does not comply with Rule 605.d.

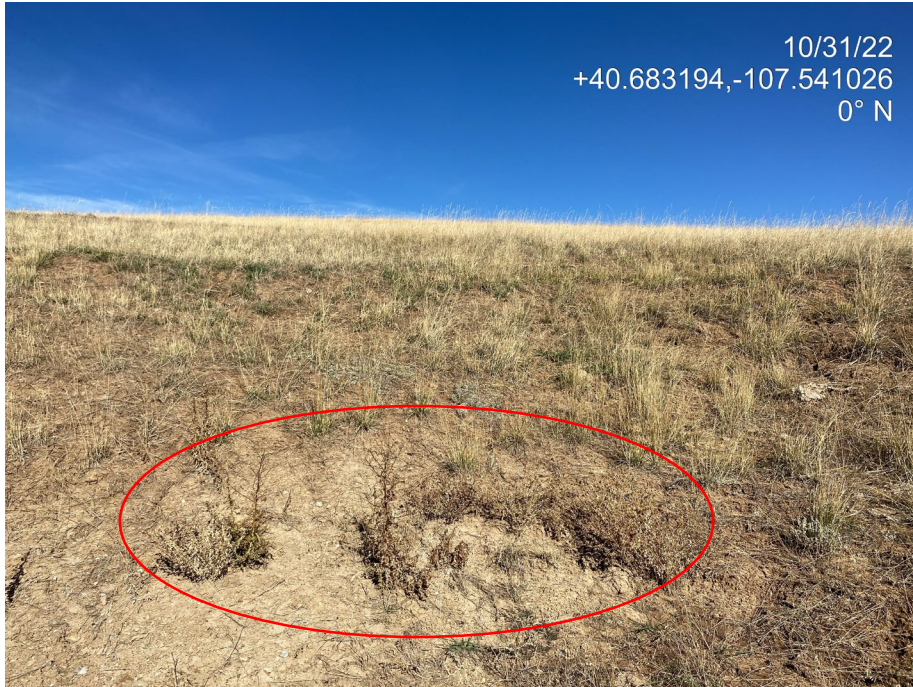
Photo 8. Photo shows an example of Canada thistle (List B Noxious) found occasionally throughout the Location.

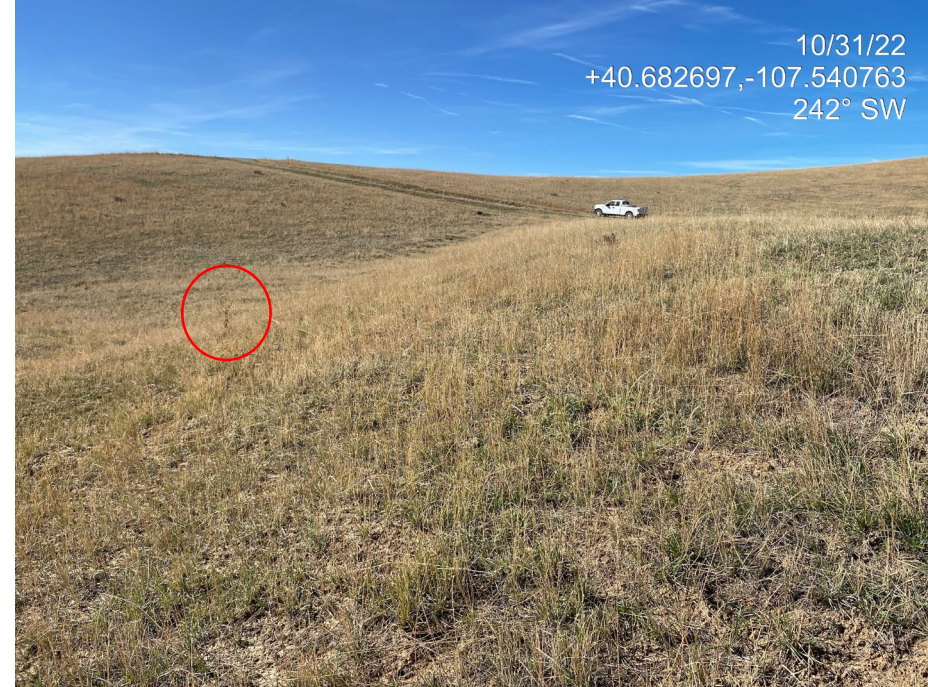
Photo 9. Photo shows interim areas at the south of the Location are well vegetated with perennial grasses. Red circle indicates a List B noxious thistle.
