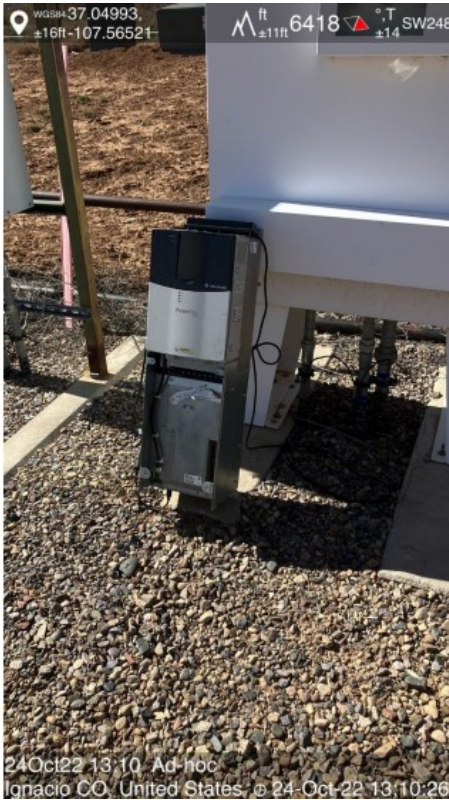
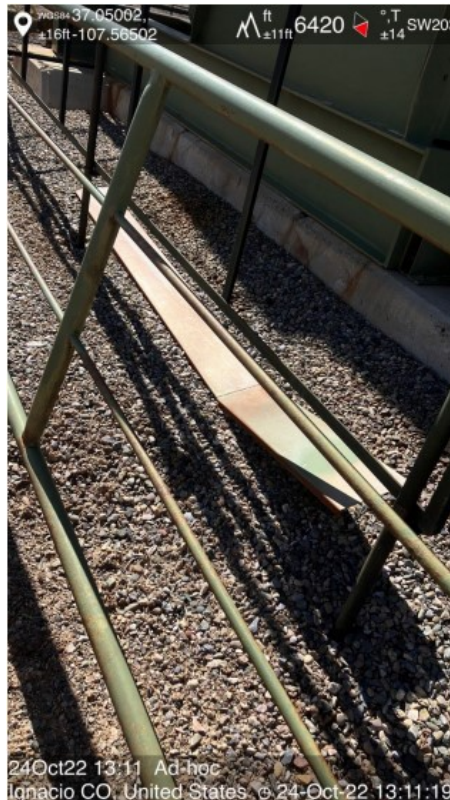
Comment: Unused electrical equipment at pump control panels (IMG 03), unused metal panel at wellhead (IMG 04).

Pictures from the INC showing the unused electrical equipment and metal panel.

Corrective Action: All unused equipment must be returned to use or stored off location per rule 606.
