Construction and Stormwater Inspection

Operator: BAYSWATER EXPLORATION AND PRODUCTION LLC - #10261

Location ID: 483006

Inspection Document #: 697504328

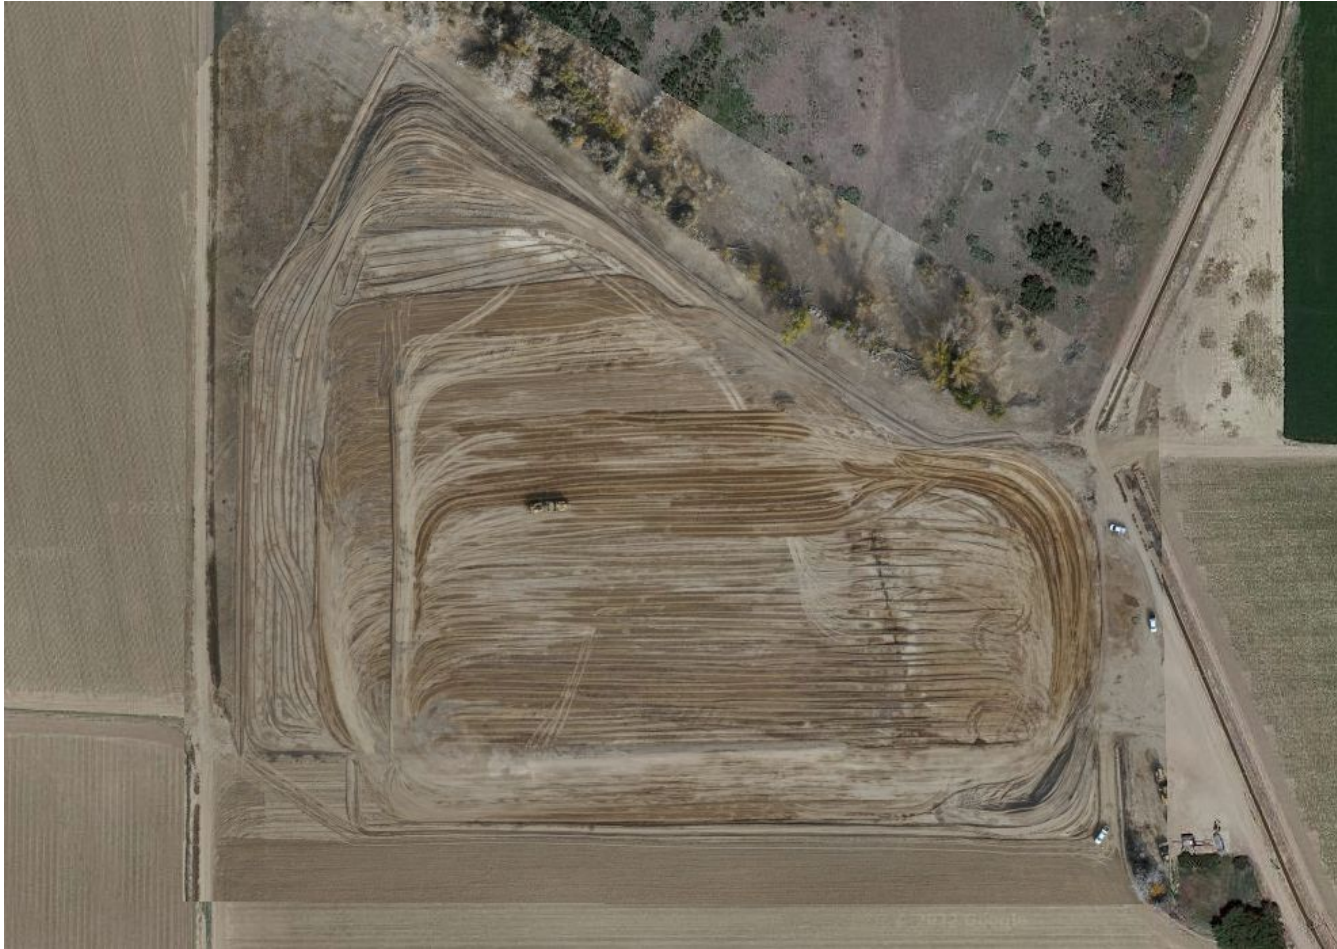
Photo 1. Drone aerial imagery illustrates the Garnet/21-K Pad with an approximate disturbance area of 12.95 acres. There are two topsoil stockpiles located along the north and southeastern location.

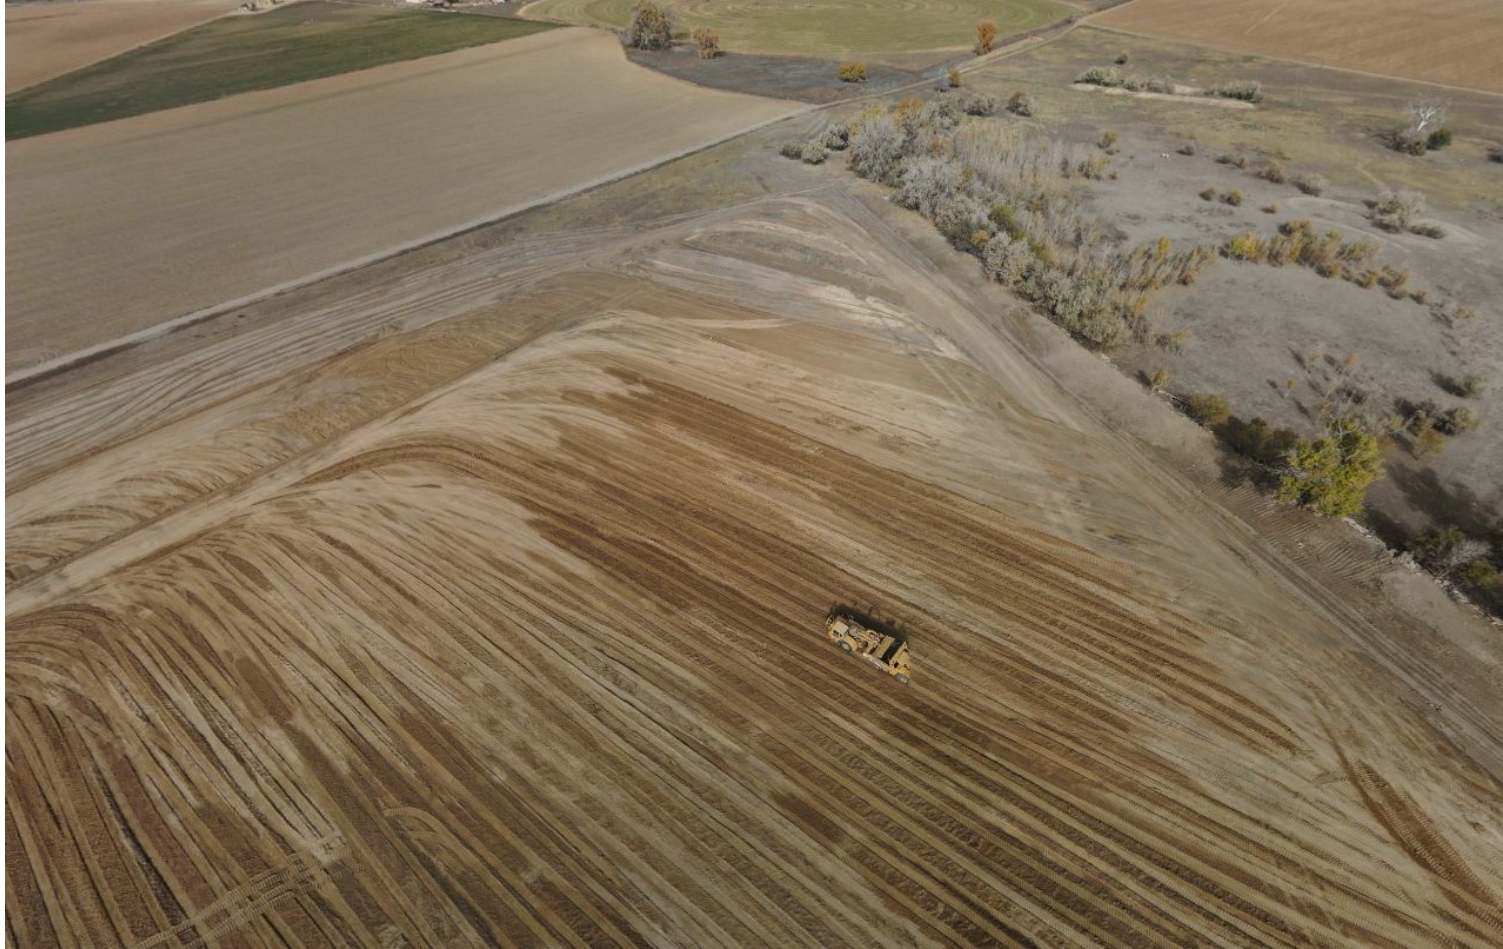
Photo 2. Drone aerial imagery illustrates the Garnet/21-K Pad, facing Northwest.

Note: the Weld County detention pond will be constructed along the western perimeter of location.

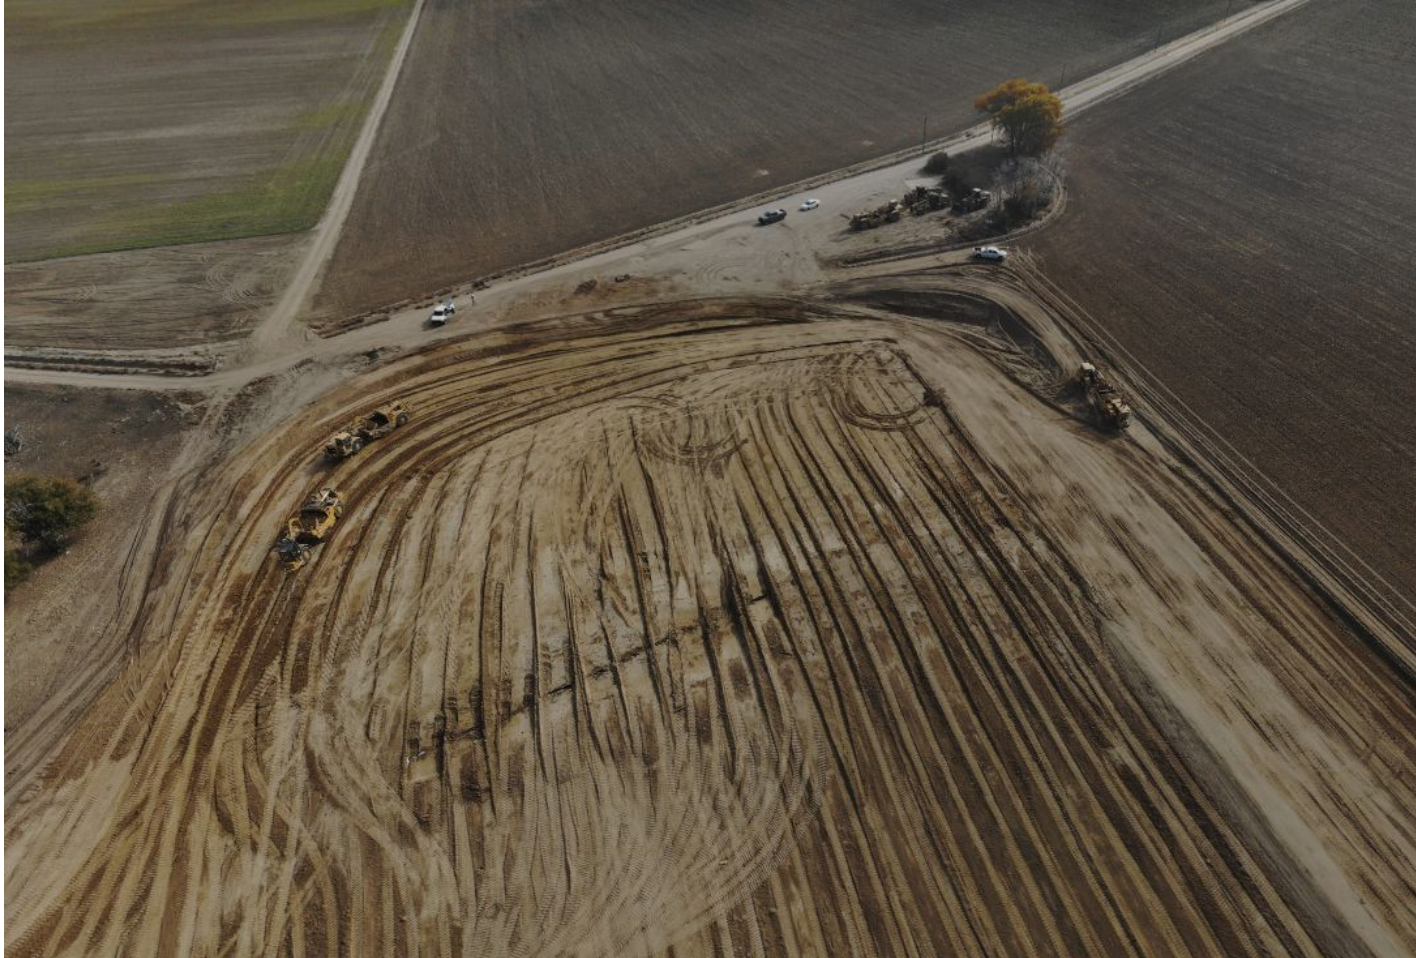
Photo 3. Drone aerial imagery illustrates the Garnet/21-K Pad, facing Southeast.

Note- the existing buildings have been removed.

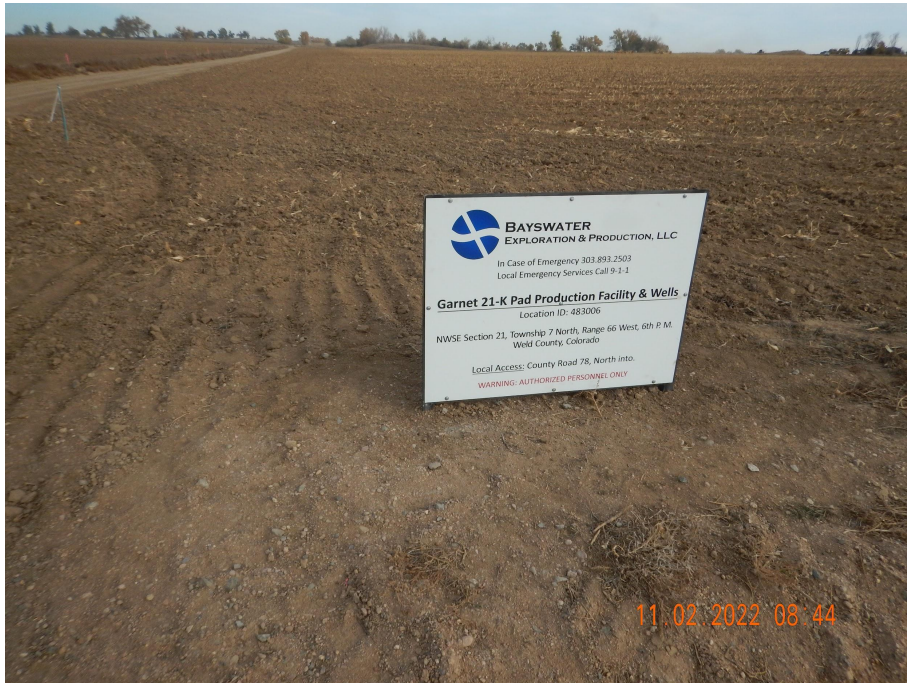
Photo 4. Photo taken from the proposed access road, facing North. Photo illustrates the Operator sign. Staff did not observe permits on location per Rule 406.

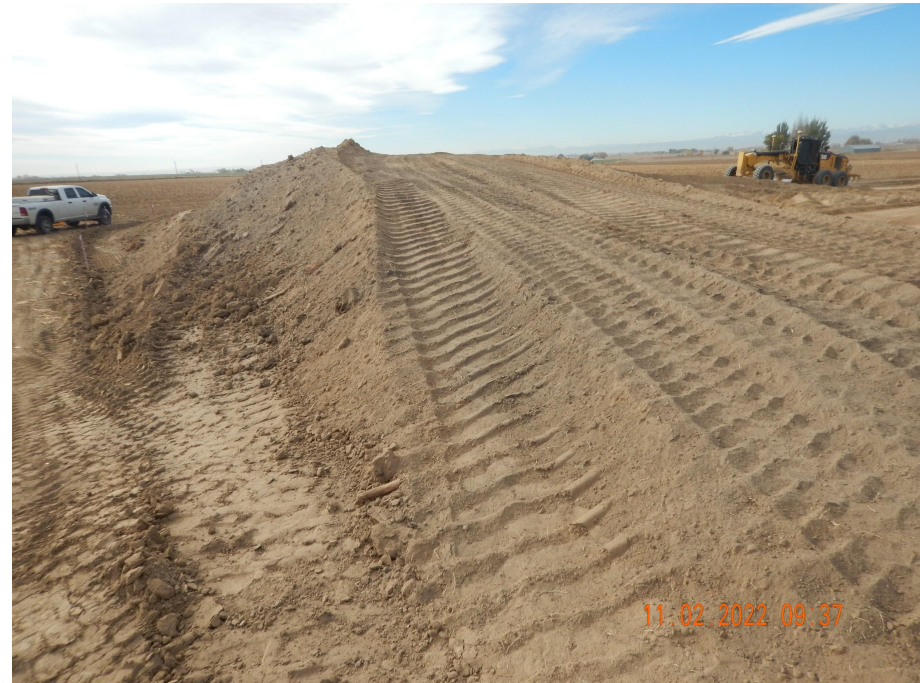
Photo 5. Photo taken from the southeastern topsoil stockpile, facing South. Operator shall comply with Rule 1002.c.

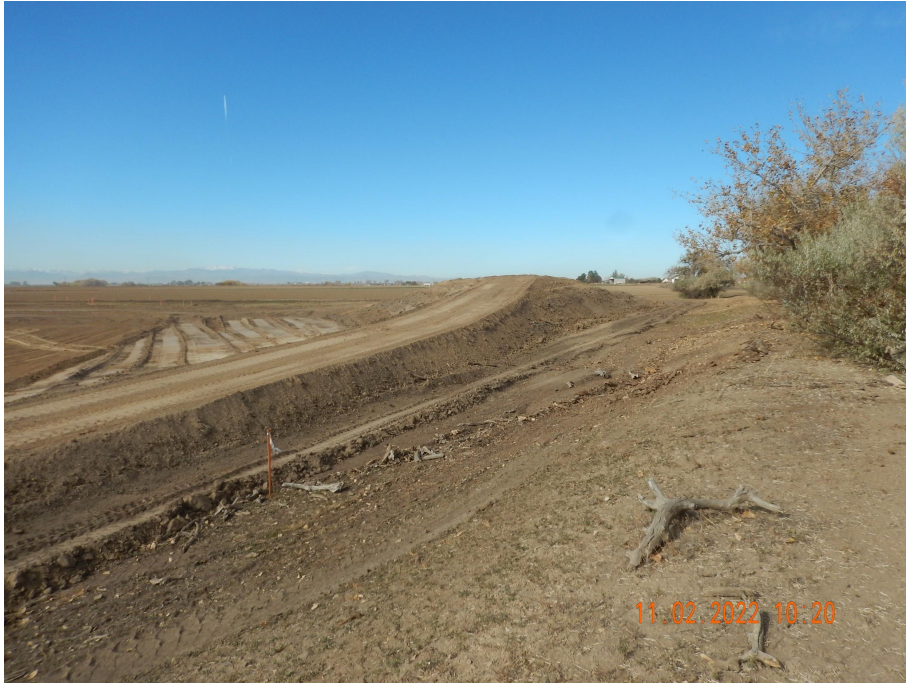
Photo 6. Photo taken from the northern location, facing West. Photo illustrates the northern topsoil stockpile. Operator shall comply with Rule 1002.c.

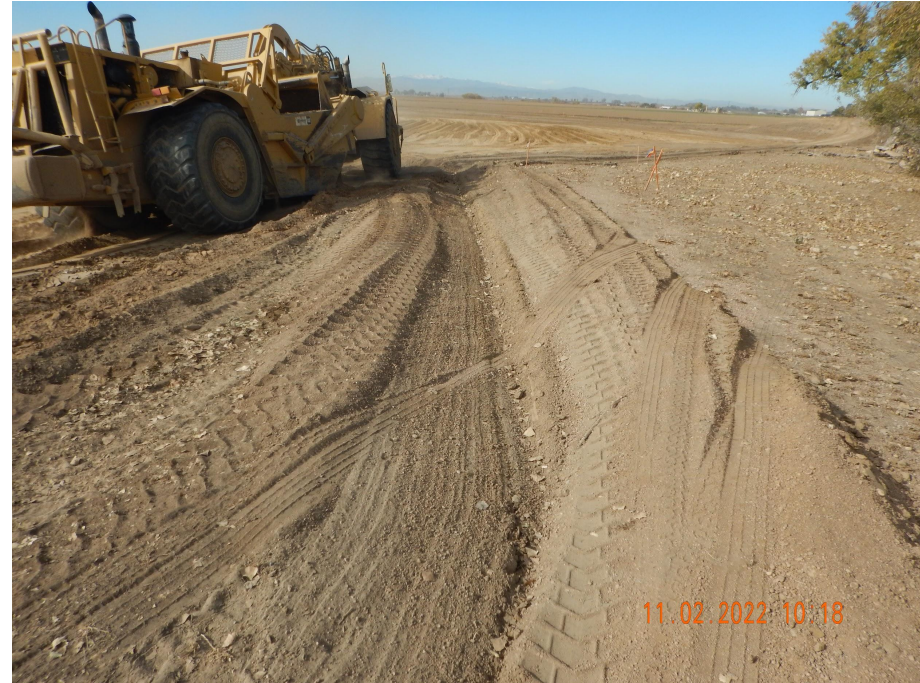
Photo 7. Photo taken from the northeastern location, facing West. Photo illustrates a ditch and berm BMP installed around the entire perimeter of location.
