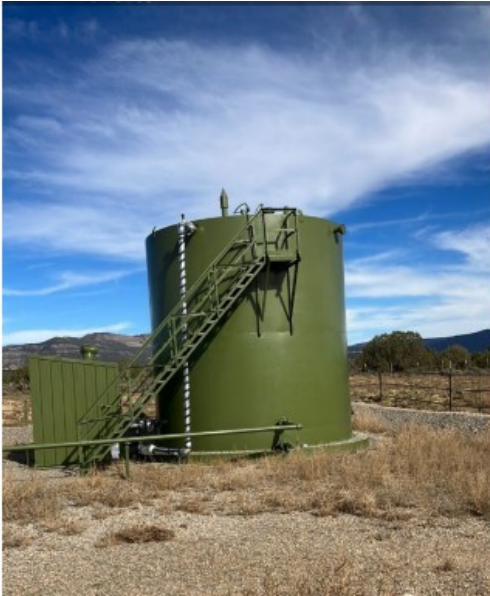
Comment: Produced water tank has no tank sign/placard (IMG 06 and IMG 07).

Picture from INC of missing tank sign.

Corrective Action: Install sign to comply with Rule 605.h. **Date:** 12/07/2022

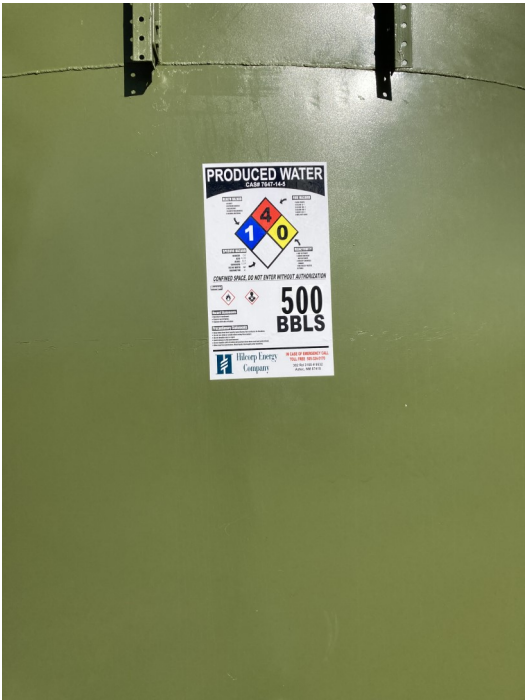
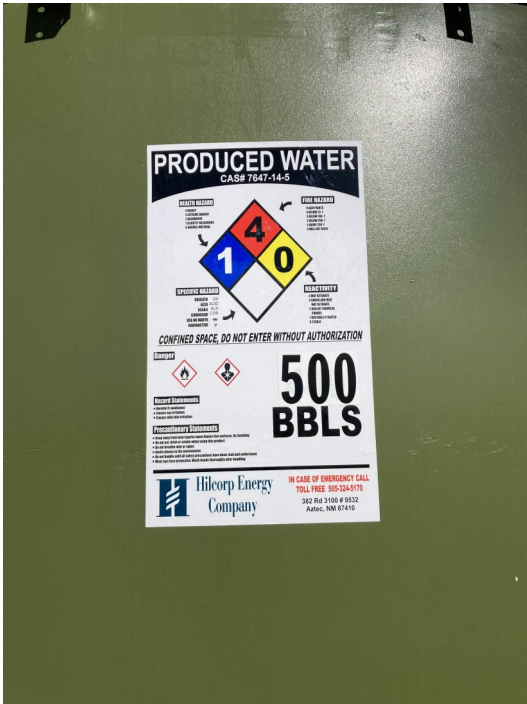
Pictures showing the new tank sign on the tank.

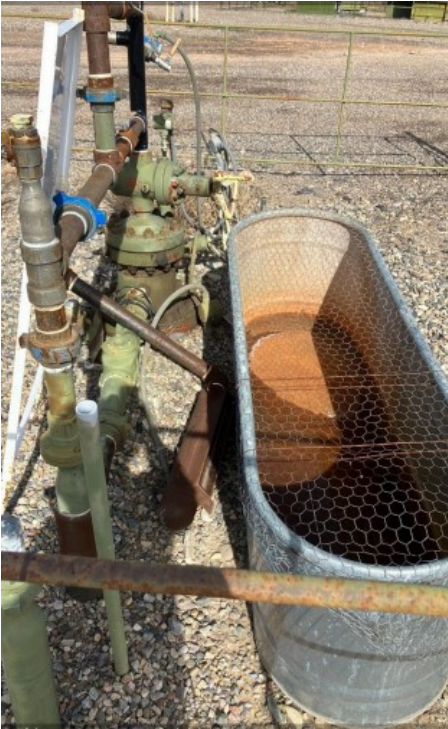
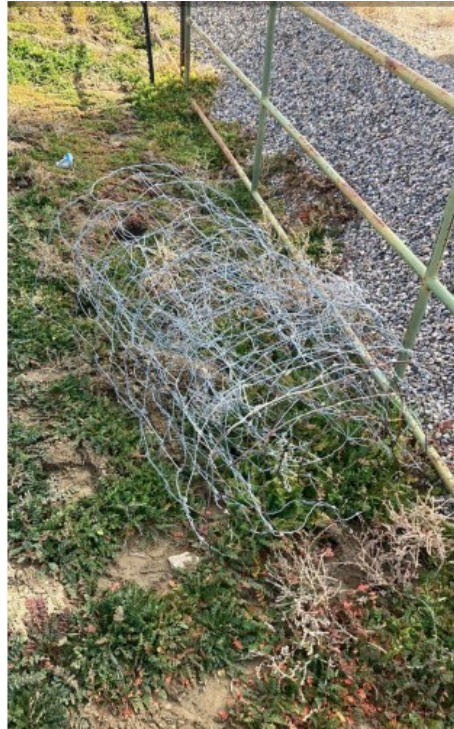
Comment: Trough, 2" pipe. and pipe attachment at 2-17 wellhead are not in use. Unused wire fencing at produced water tank (IMG 04).

Picture from INC showing the unused equipment on location.

Corrective Action: All unused equipment must be returned to use or stored off location per rule 606. **Date:** 11/15/2022

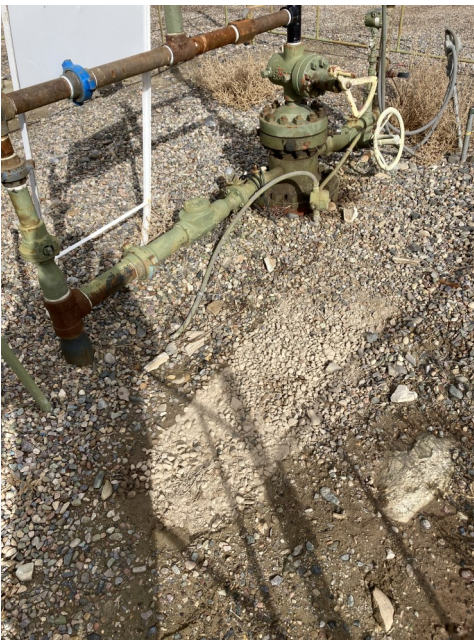
Pictures showing that unused equipment has been removed from location.

Picture 1 shows that the trough and pipe have been removed.

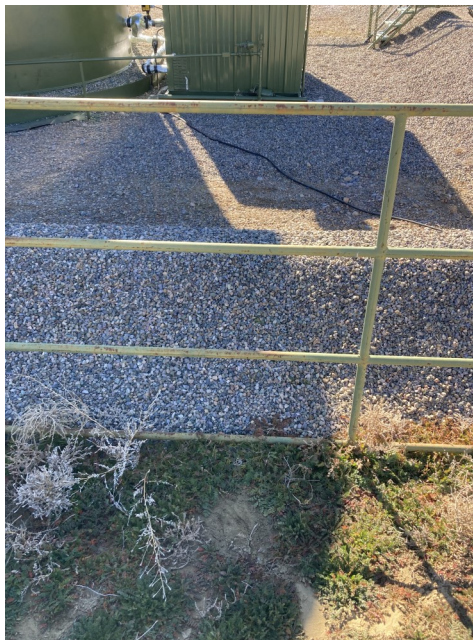
Picture 2 shows that the unused fence has been removed.

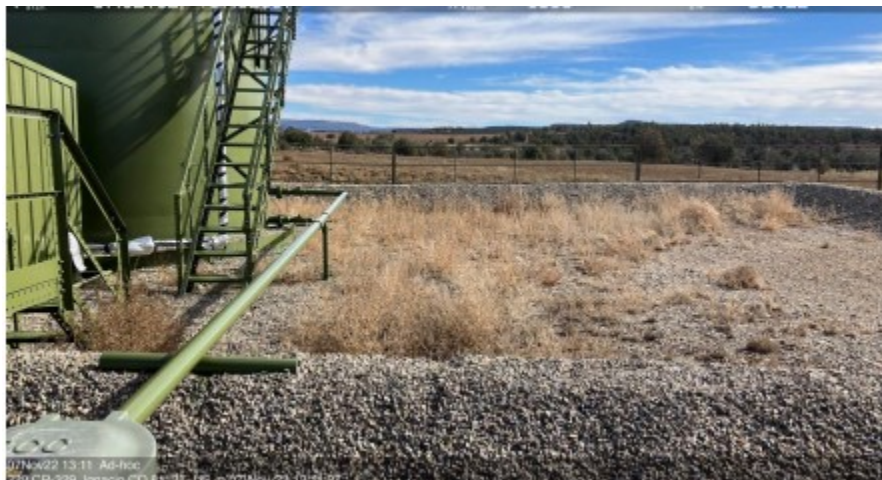
Comment: Weeds at produced water tank (IMG 05).

Picture from INC showing the weeds around the tank.

Corrective Action: Ensure within 25' of wellhead, tanks, and separators are free of combustible material per rule 610.k. **Date:** 11/15/2022.

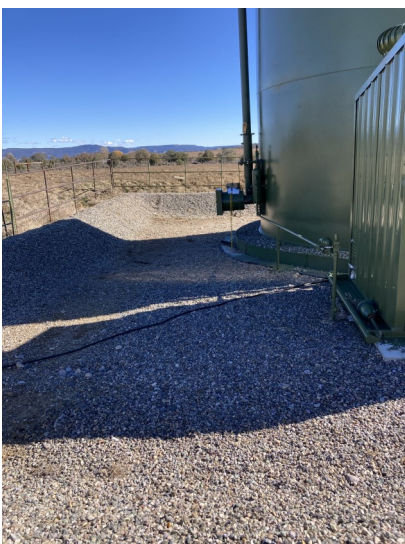
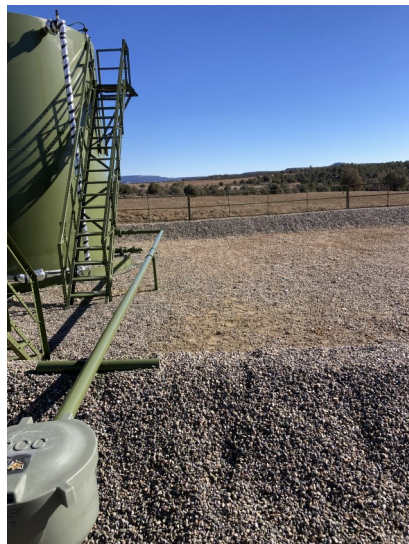
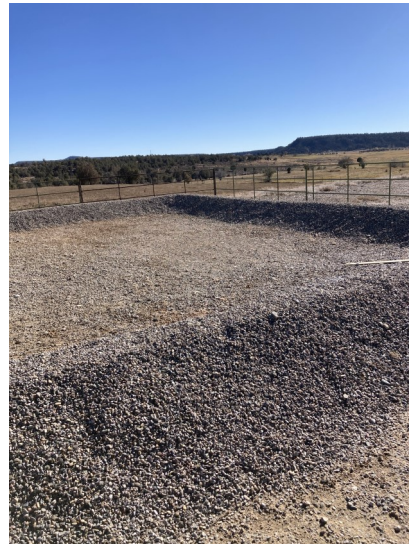
Pictures showing that the weeds have been removed from around the tank.
