TECHNICAL MEMORANDUM

Re: MGP Enterprise A-4 Well Pad 2022 Reseeding

WSP Project No.: 32700182

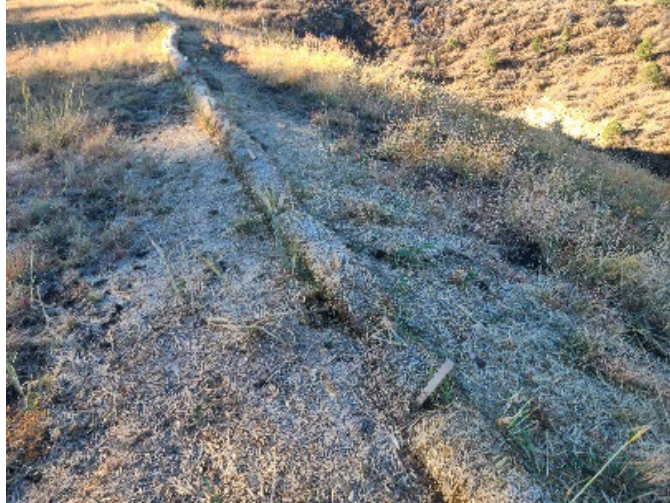
Photo 1: Top wattles before replacement. 11/1/2022

- Initial safety meeting, explanation to contractors of safety guidelines, accountability for safety
 - Working at heights
- Repairs made to water trucks
 - Missing caps, unable to prime pump
- Seed, Flexterra, and Promatrix delivered to site
- Top wattle on the west and south slopes replaced
- Replaced wattle on west slope where existing wattle was damaged

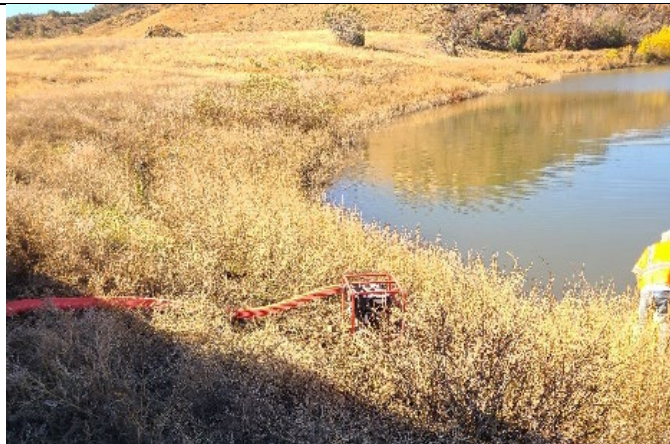
Photo 2: Pumping water from pond. 11/1/2022

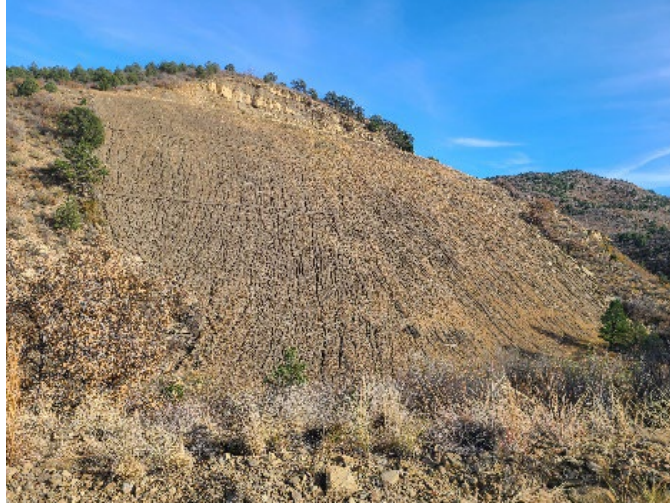
Photo 3: West aspect hill from northwest. 11/1/2022

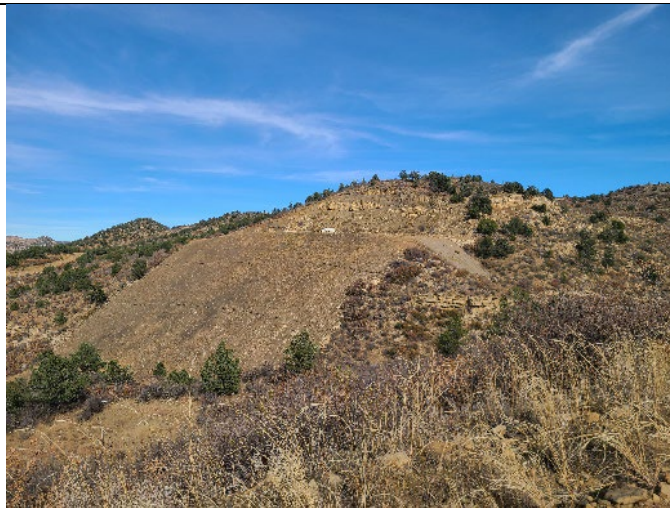
Photo 4: West aspect hill from southwest. 11/1/2022

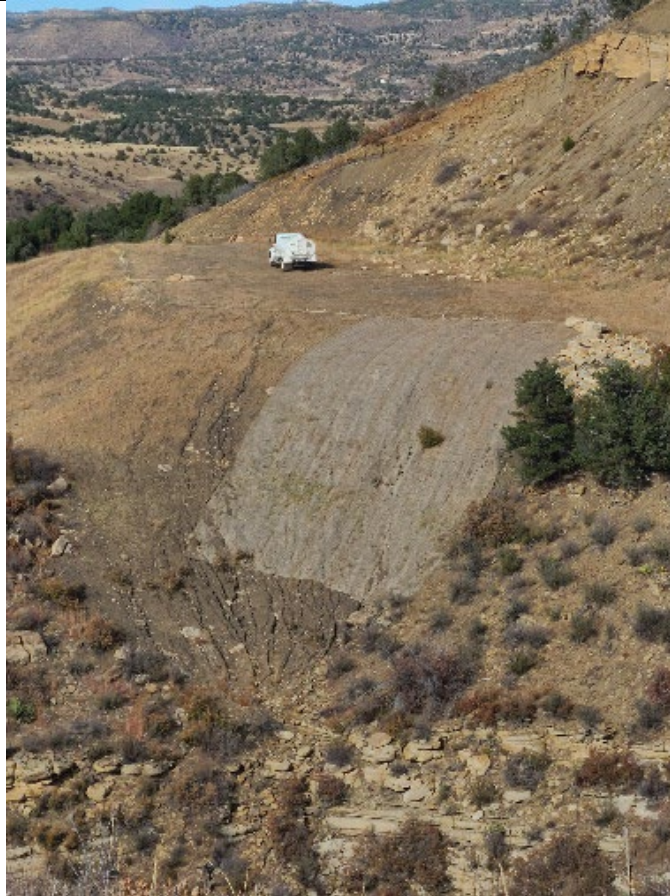
Photo 5: South aspect slope. 11/1/2022

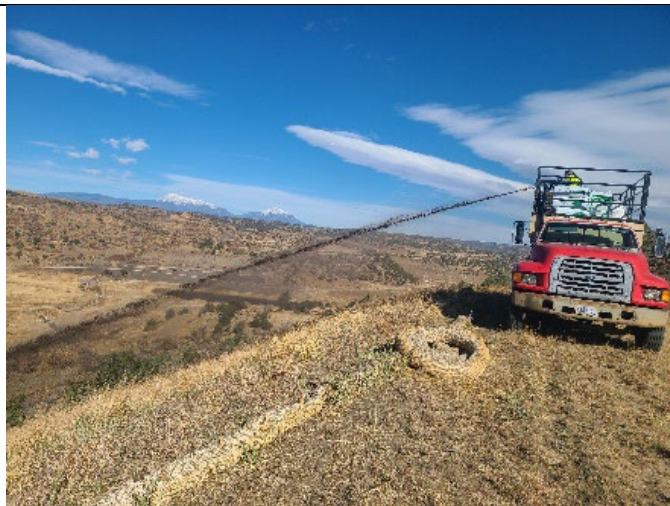
Photo 6: Application of Promatrix onto west aspect slope. 11/2/2022

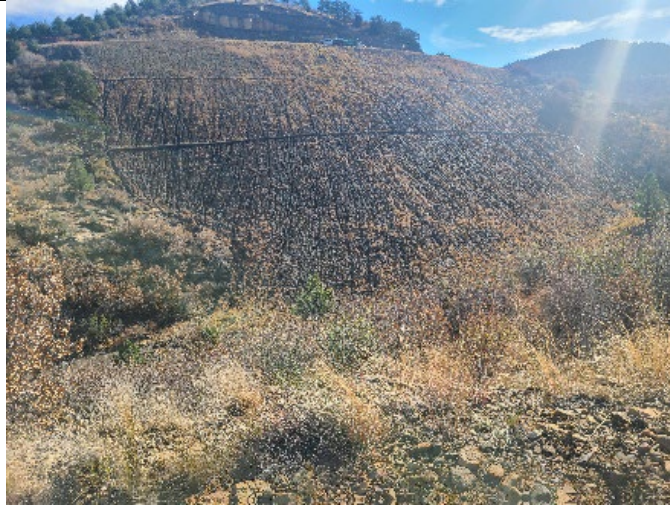
Photo 7: West aspect slope after being covered with Promatrix. 11/2/2022

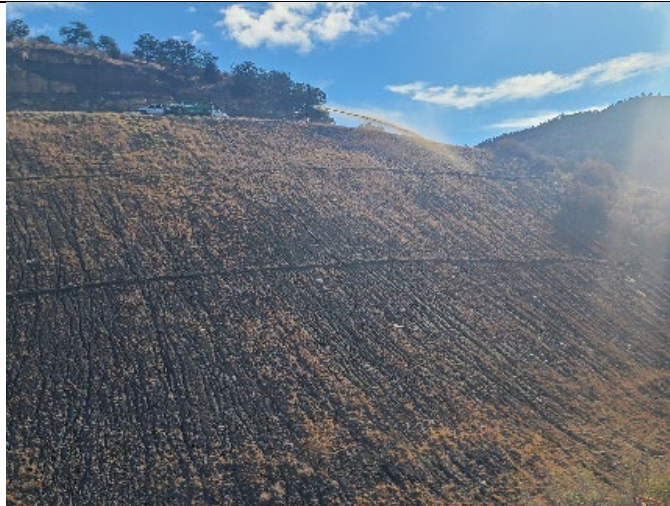
Photo 8: West aspect slope after being covered with Promatrix. 11/2/2022

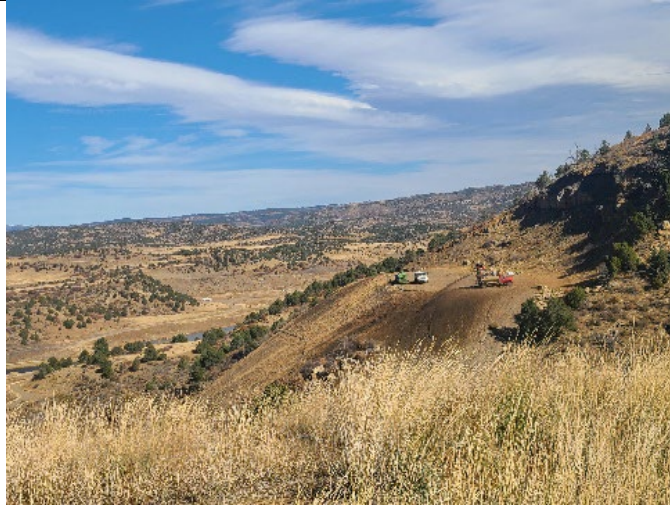
Photo 9: South aspect slope after being covered with Promatrix. 11/2/2022

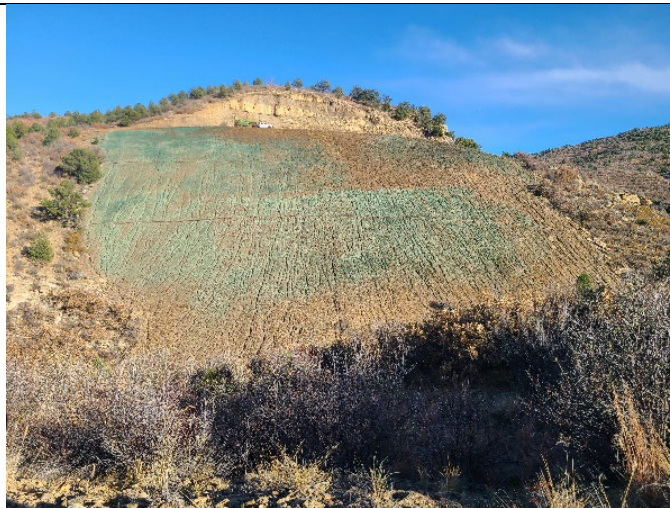
Photo 10: West aspect slope after being covered with Flexterra. 11/3/2022

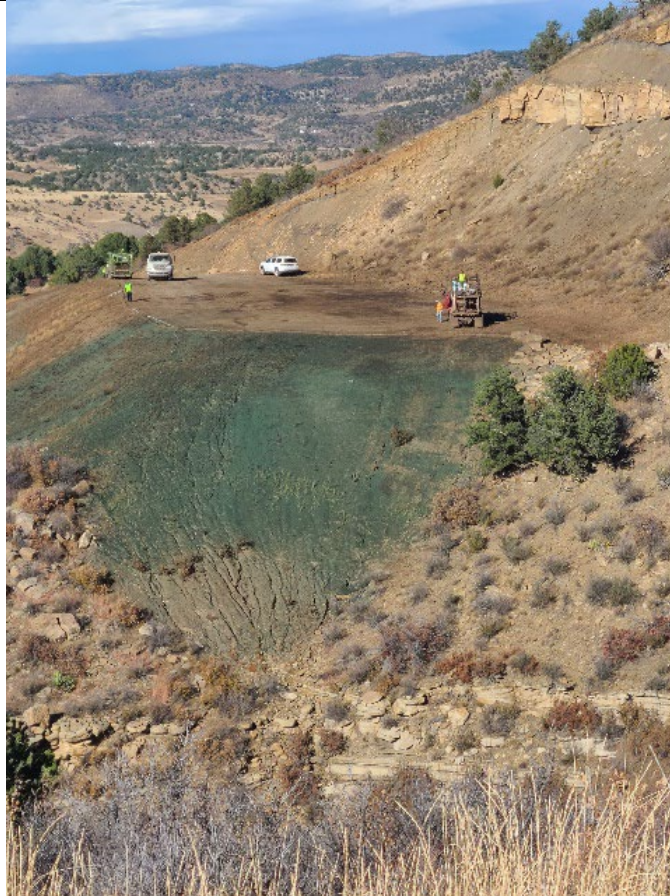
Photo 11: South aspect slope after being covered with Flexterra. 11/3/2022

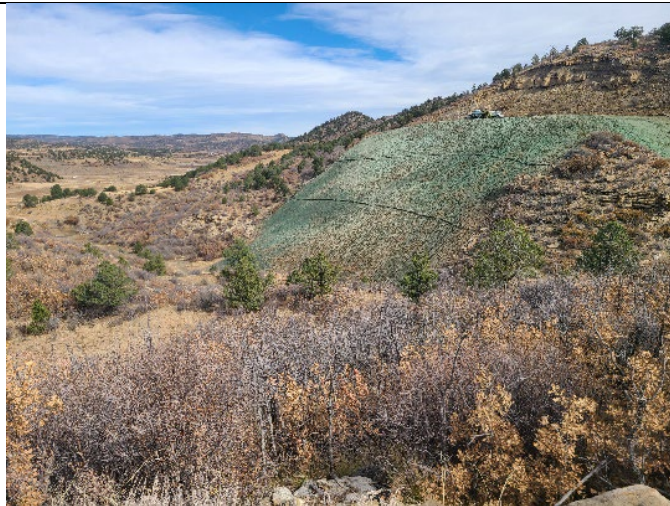
Photo 12: West aspect slope after being covered with Flexterra from northwest. 11/5/2022

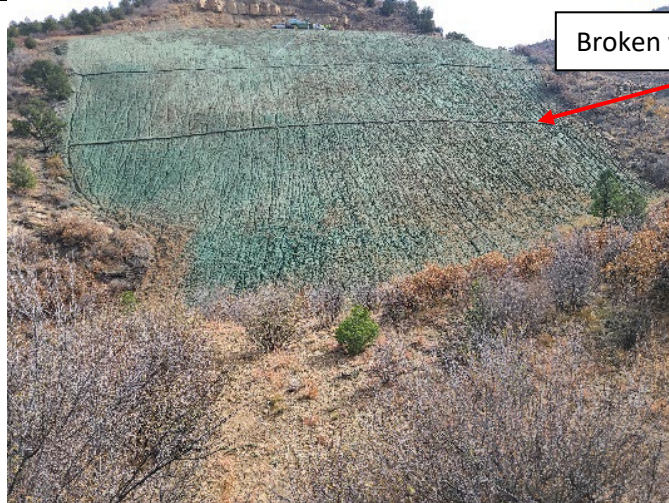
Photo 13: West aspect slope after being covered with Flexterra. 11/5/2022

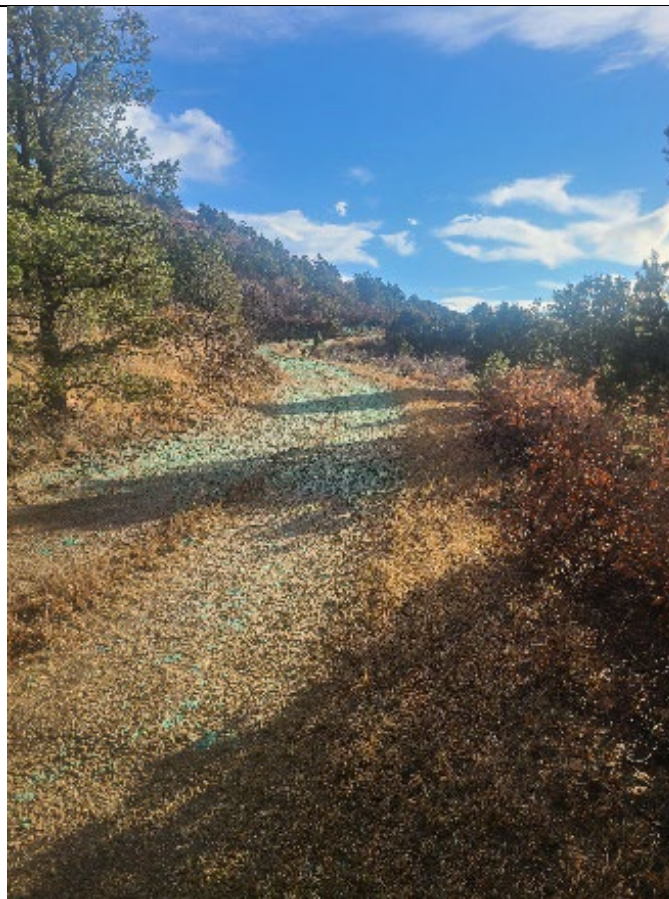
Photo 14: Top part of road after being covered by Flexterra. 11/5/2022

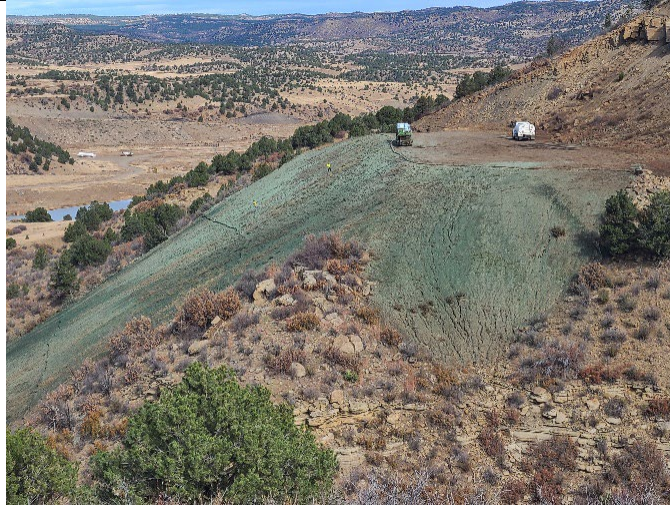
Photo 15: South aspect slope after being covered with Flexterra. 11/5/2022

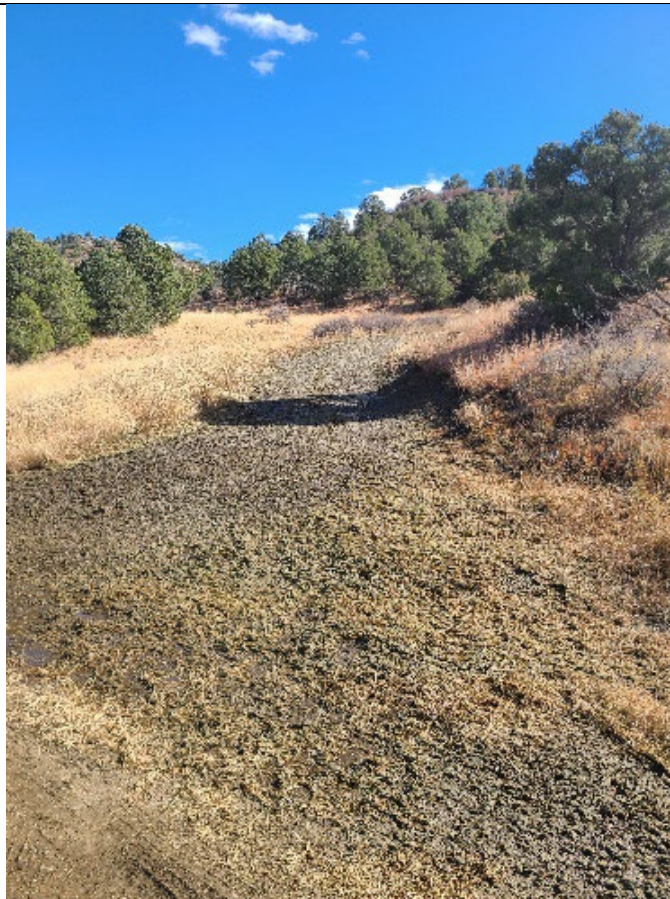
Photo 16: Bottom section of road after being covered by Flexterra and Promatrix. 11/6/2022

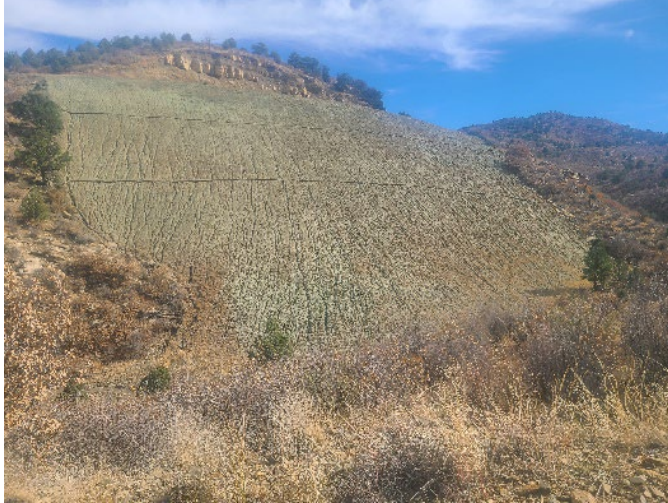
Photo 17: West aspect slope one day after completion of covering. 11/6/2022

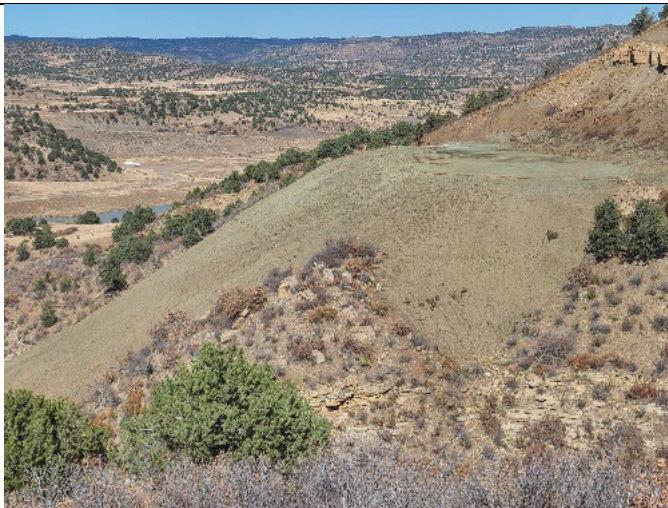
Photo 18: South aspect slope one day after completion of covering. 11/6/2022
