Final Reclamation and Stormwater Inspection

Date: 11/16/2022

Operator: EXTRACTION OIL & GAS INC - 10459

Location ID: 320530

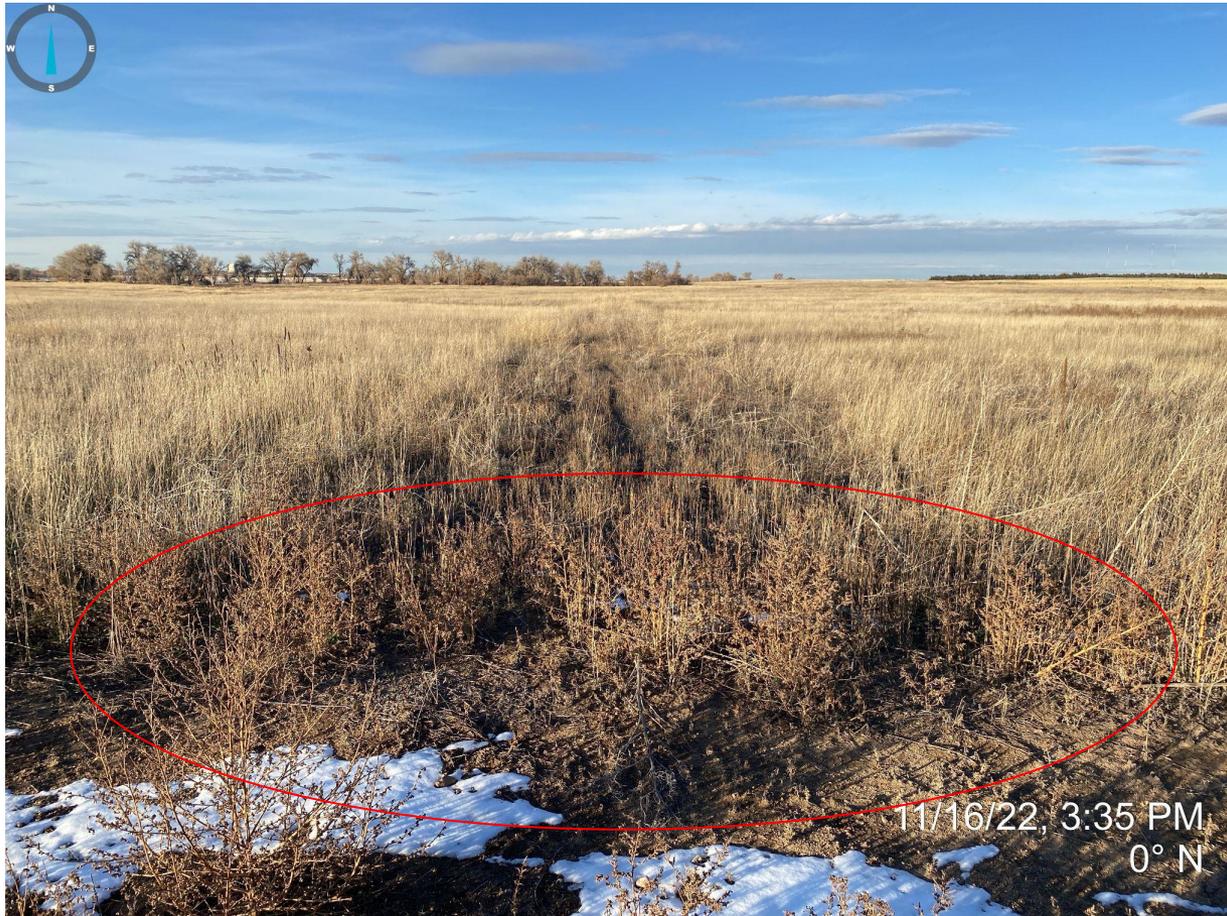
Photo 1. Taken from the beginning of the access road, facing north. Photo illustrates the access road has not revegetated to reflect reference areas, with presence of undesirable vegetation (eg. kochia and russian thistle) observed.

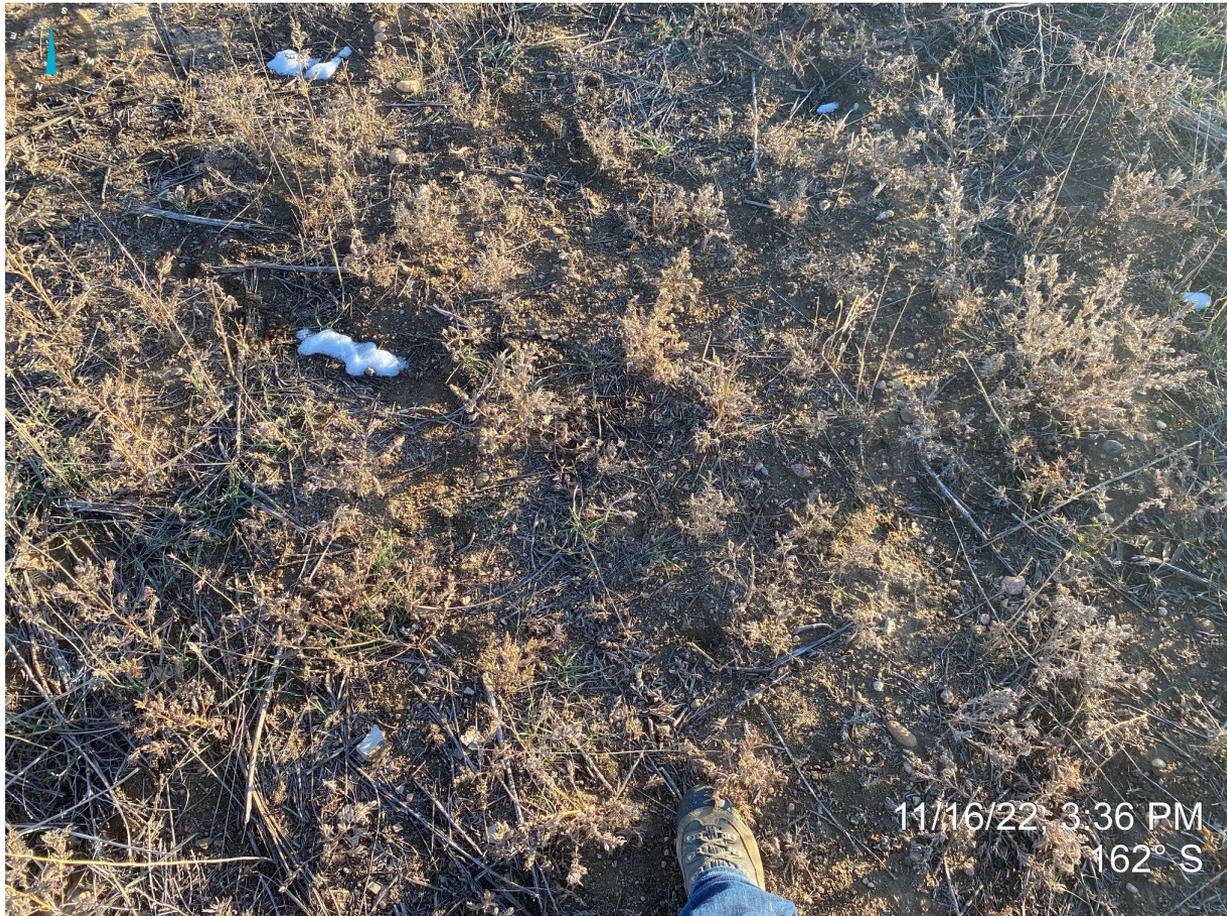
Photo 2. Close up photo of gravel/road base and undesirable vegetation observed approximately 75' North from the access road entrance.

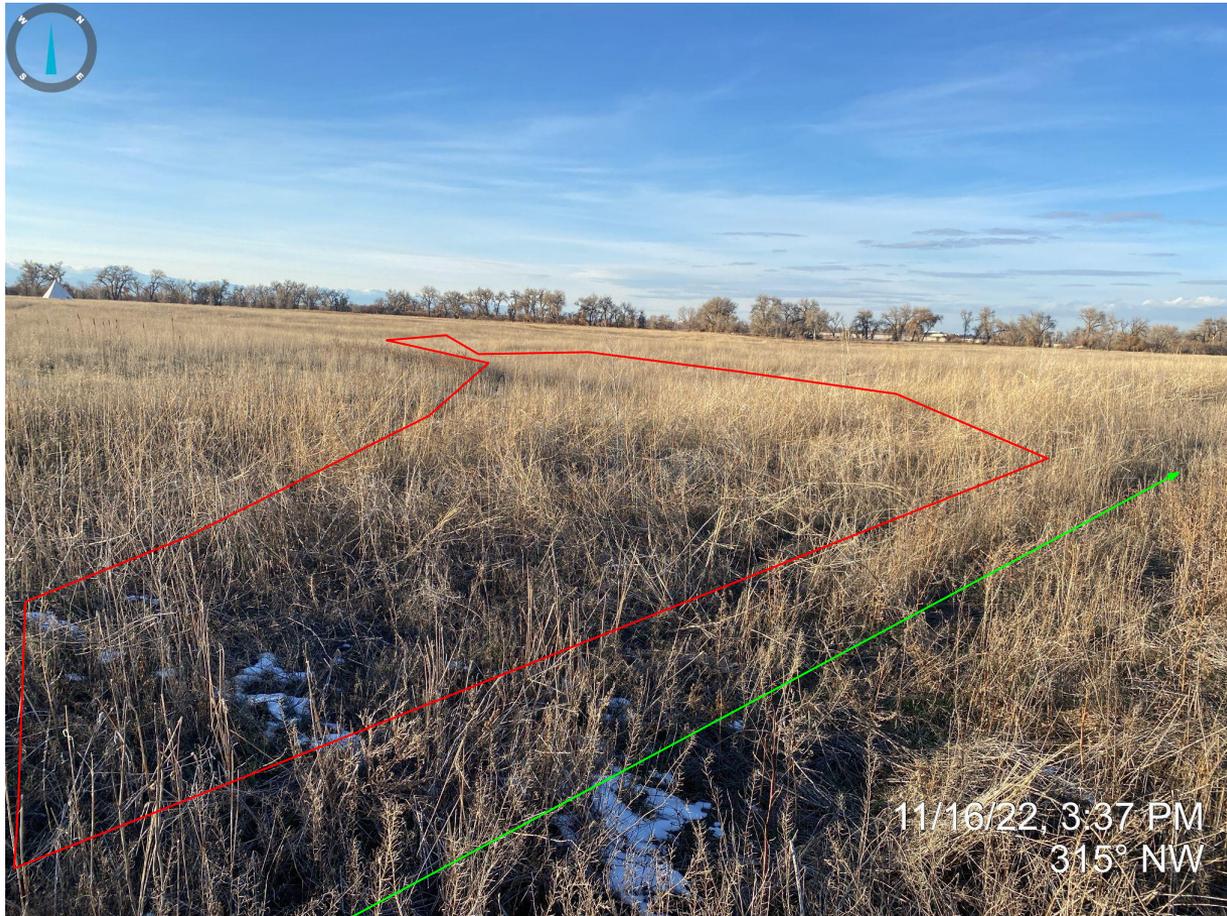
Photo 3. Taken from the access road, facing northwest. Photo illustrates the access road has not been recontoured to reflect reference areas. The portion of the access road appears to have been built in a natural swale and will need to be graded and contoured in order to meet final reclamation standards. Refer to Photo 5 for an aerial view. Green arrow shows approximate western edge of access road and direction of travel.

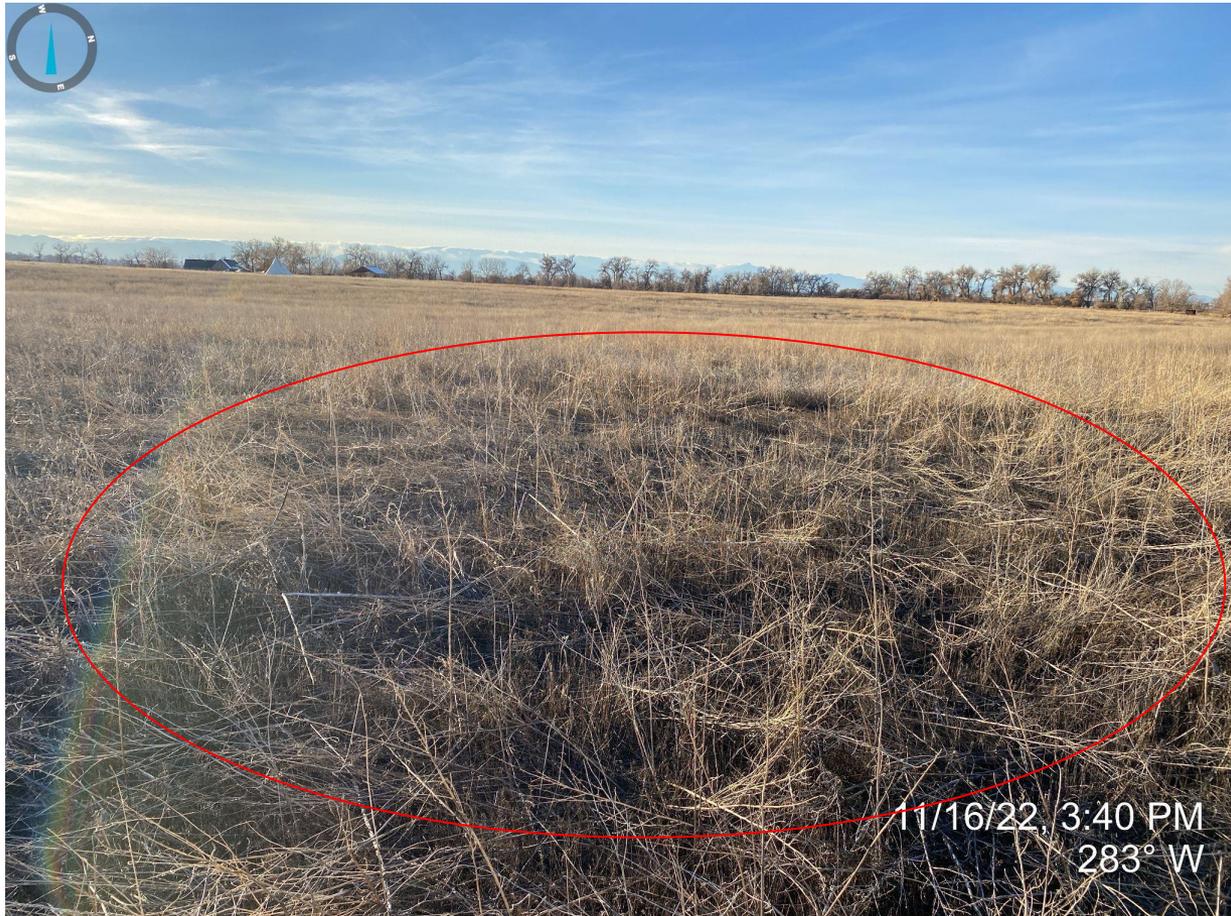
Photo 4. Taken from the well location, facing west. Photo illustrates the location has failed to revegetate to reference area levels with the presence of undesirable vegetation (darker vegetation) predominantly kochia with some russian thistle observed.

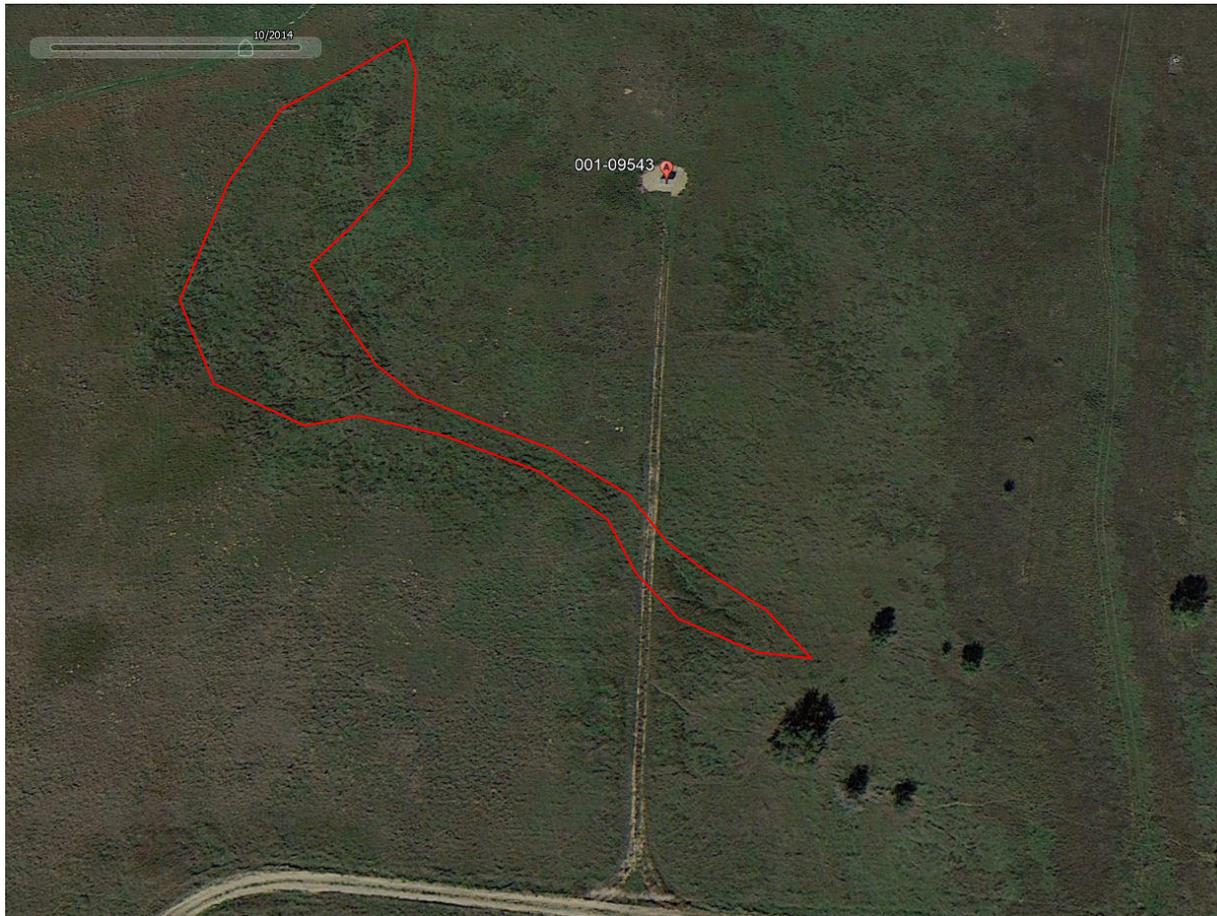
Photo 5. Google Earth aerial imagery taken circa 10/2014. Aerial illustrates the natural feature (e.g. swale) that has been disconnected by the access road to the location. Based on field observations and desktop review, this portion will need to be recontoured and graded to reflect reference areas.
