Inspection Photos

12/5/2022

Operator: PRE RESOURCES INC - 10241

Location #322302

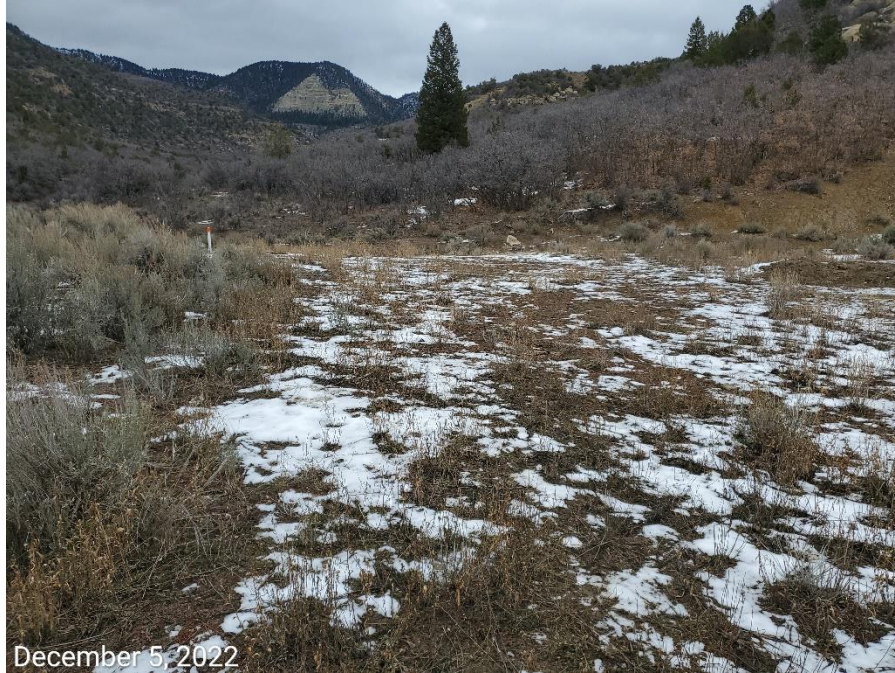
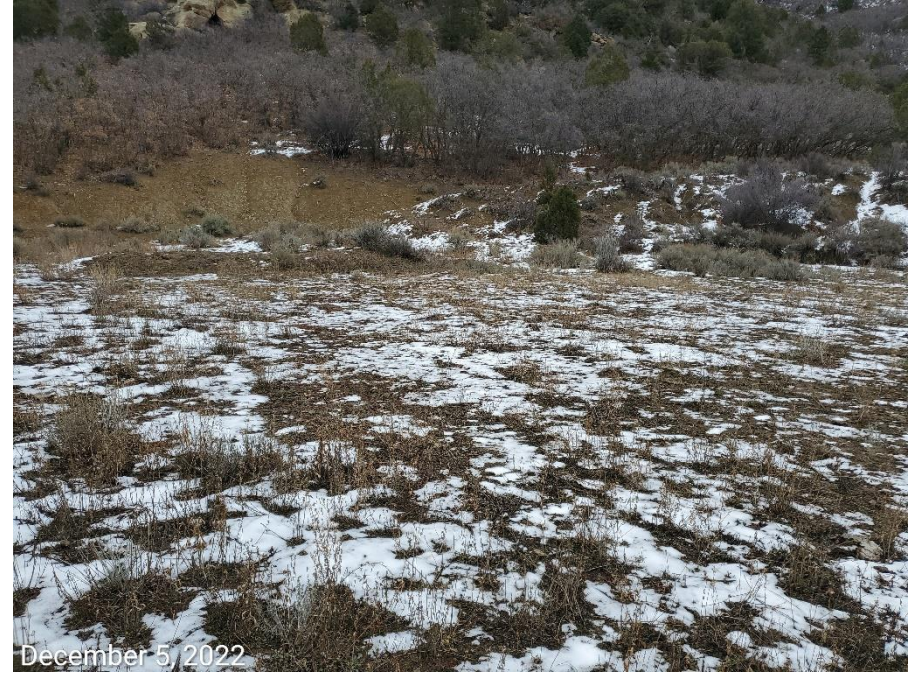
Photo 1: Photos 1-2 taken from the west end of the Location. Photos provide an overview of the Location from north, northeast, southeast to south. Photos show final reclamation work including, but not limited too, compaction alleviation, recontouring, and reclamation has not been performed on the Location.

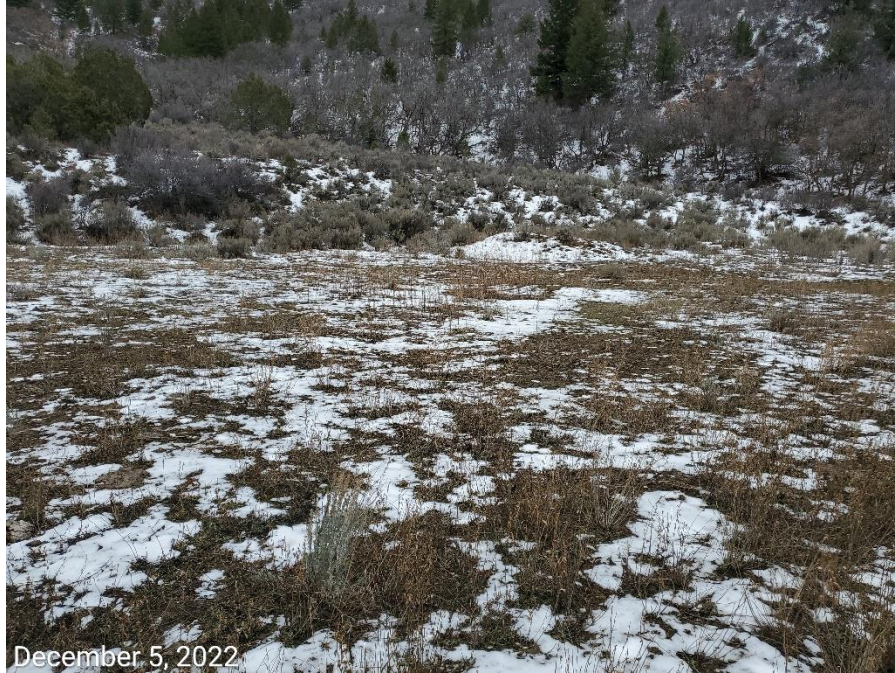
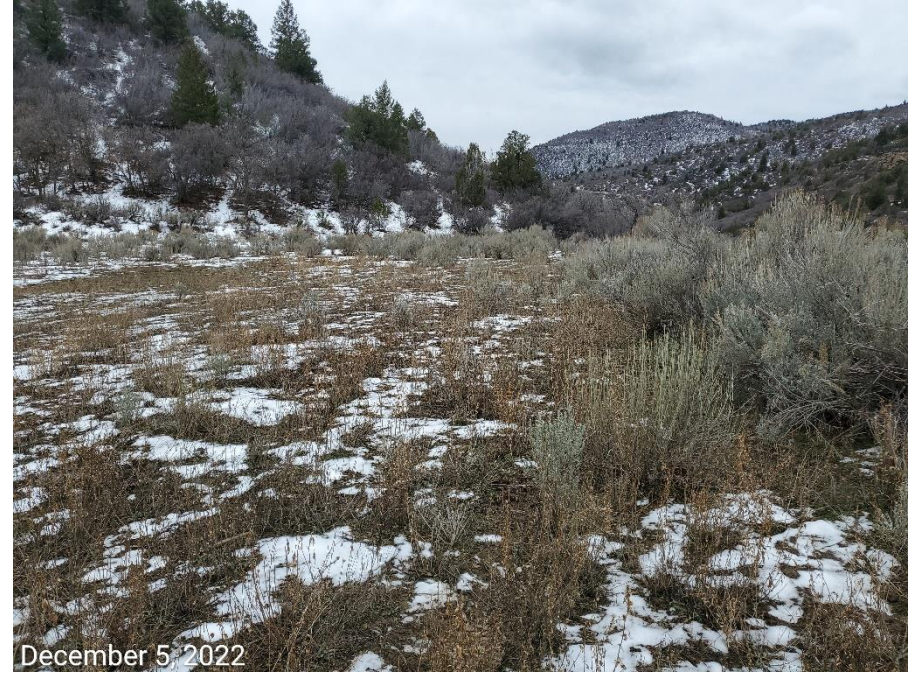
Photo 2: See comment under photo 1.

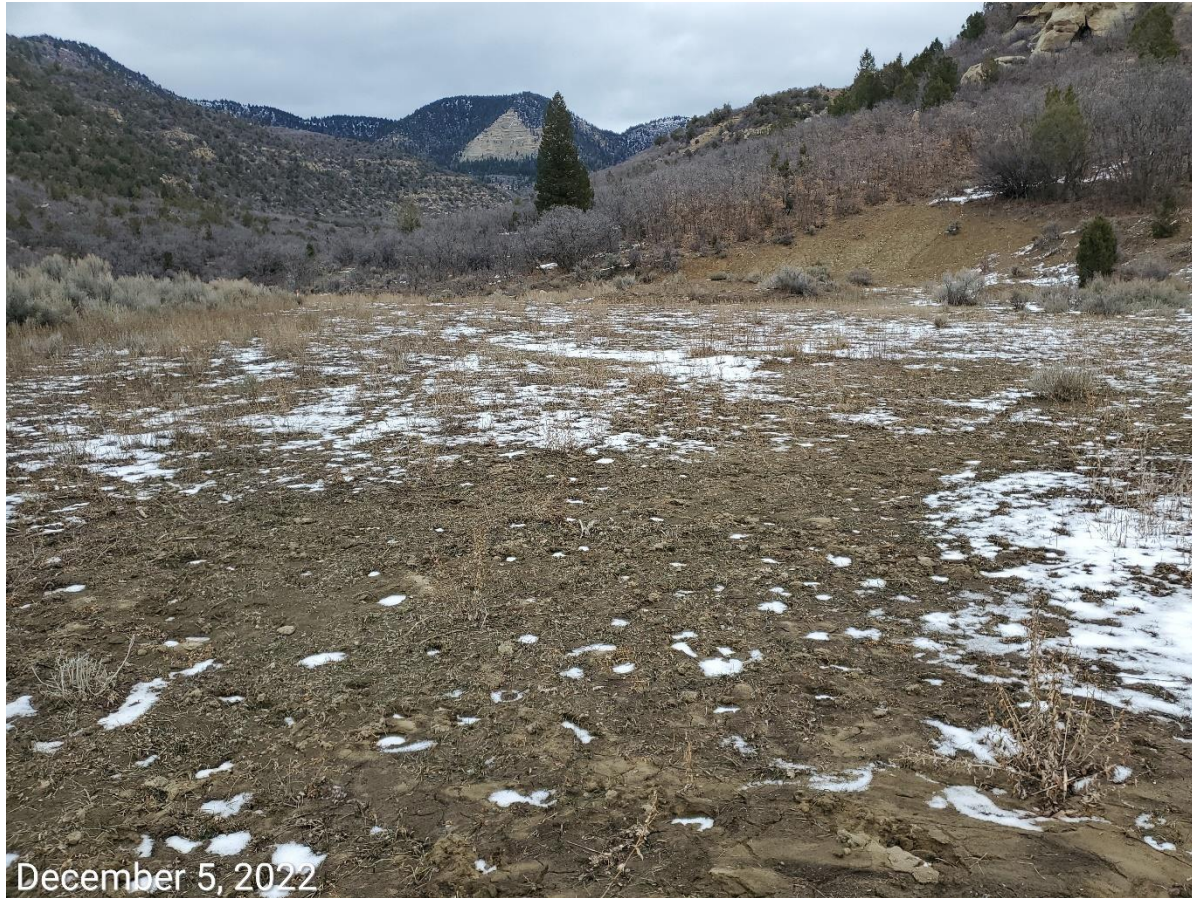
Photo 3: Photo taken from the south end of the Location, facing north. Photo shows final reclamation work including, but not limited too, compaction alleviation, recontouring, and reclamation has not been performed on the Location.

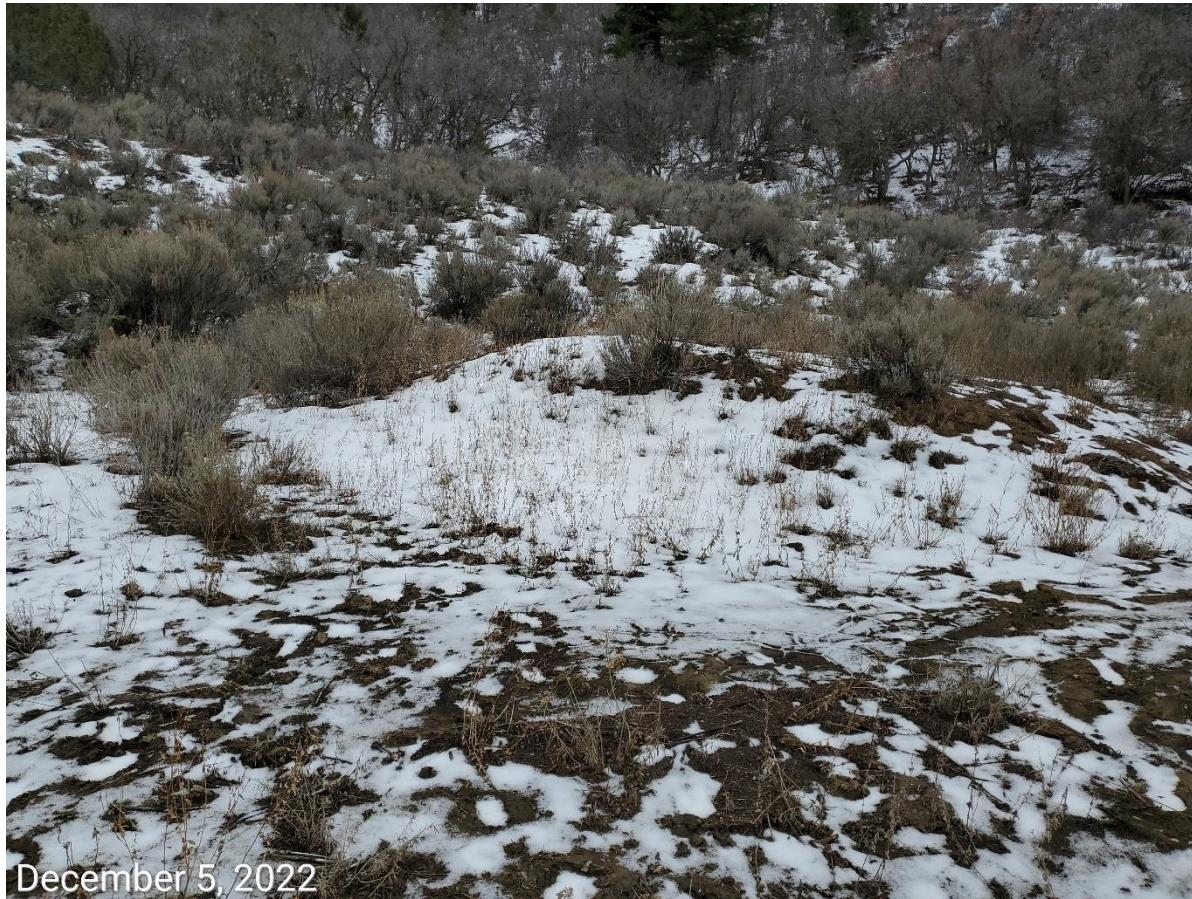
Photo 4: Photo shows soil stockpile (possibly topsoil?) that remains stored on the east end of the Location; site has not been recontoured/regraded and reclaimed.

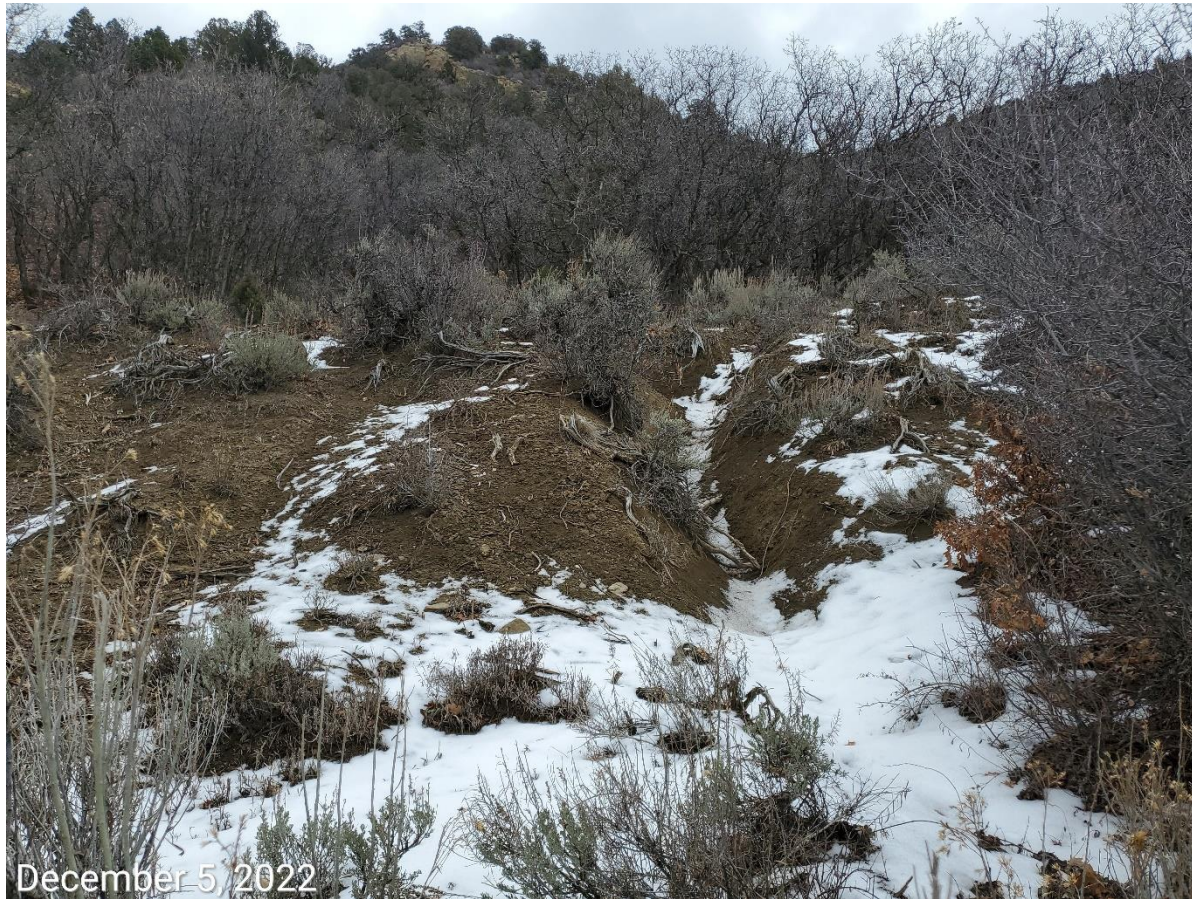
Photo 5: Gully erosion/erosion degradation remains evident throughout the eastern areas of the Location, including the cut slopes.

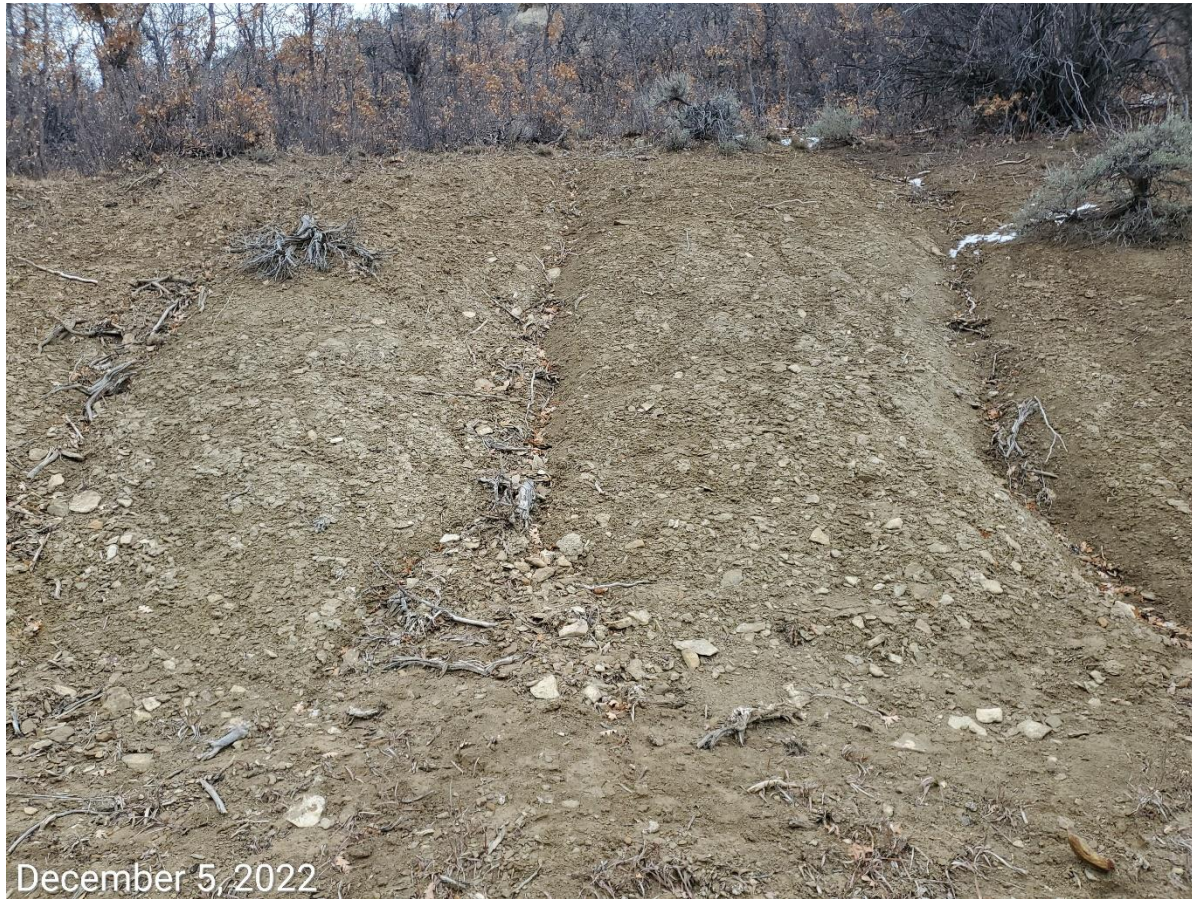
Photo 6: Photo taken from the northeast end of the Location. Photo shows cut slope remaining. Photo also shows erosion degradation along the slopes.

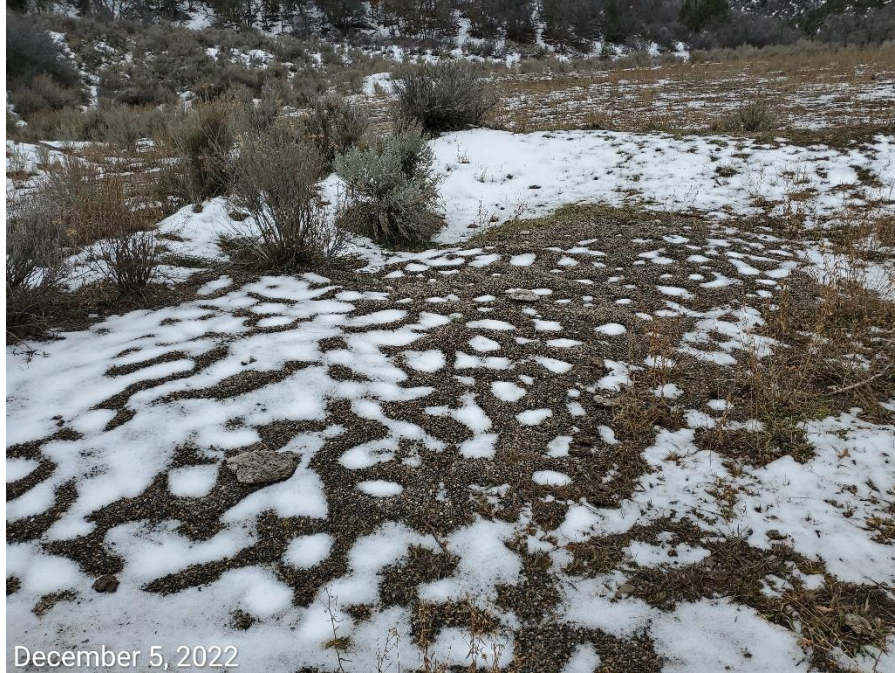
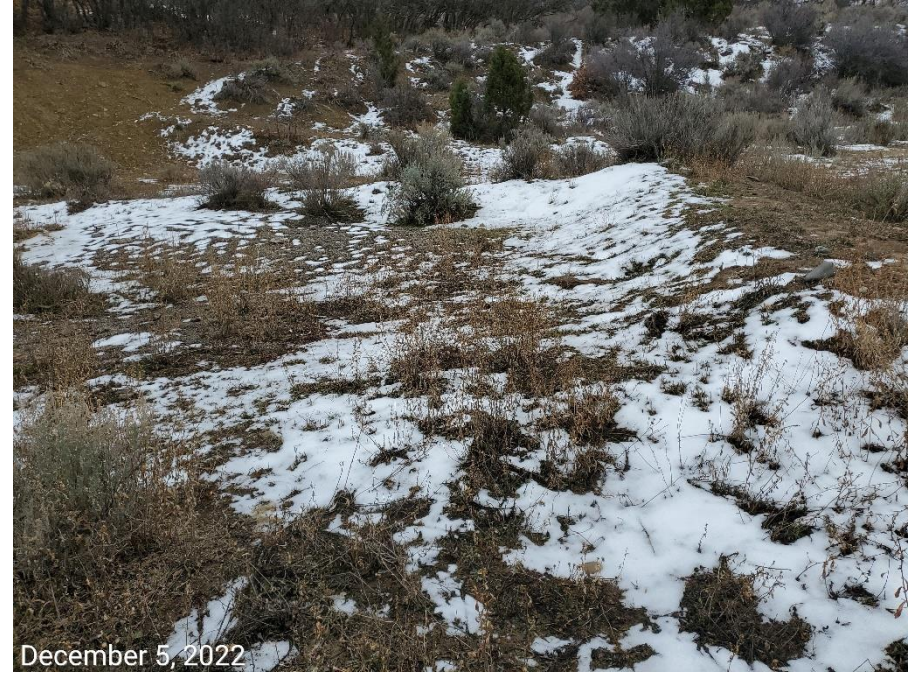
Photo 7: Photos taken from the northeast end of the Location. Photo shows secondary containment berms for facilities on the Location remain evident, as well as gravel.

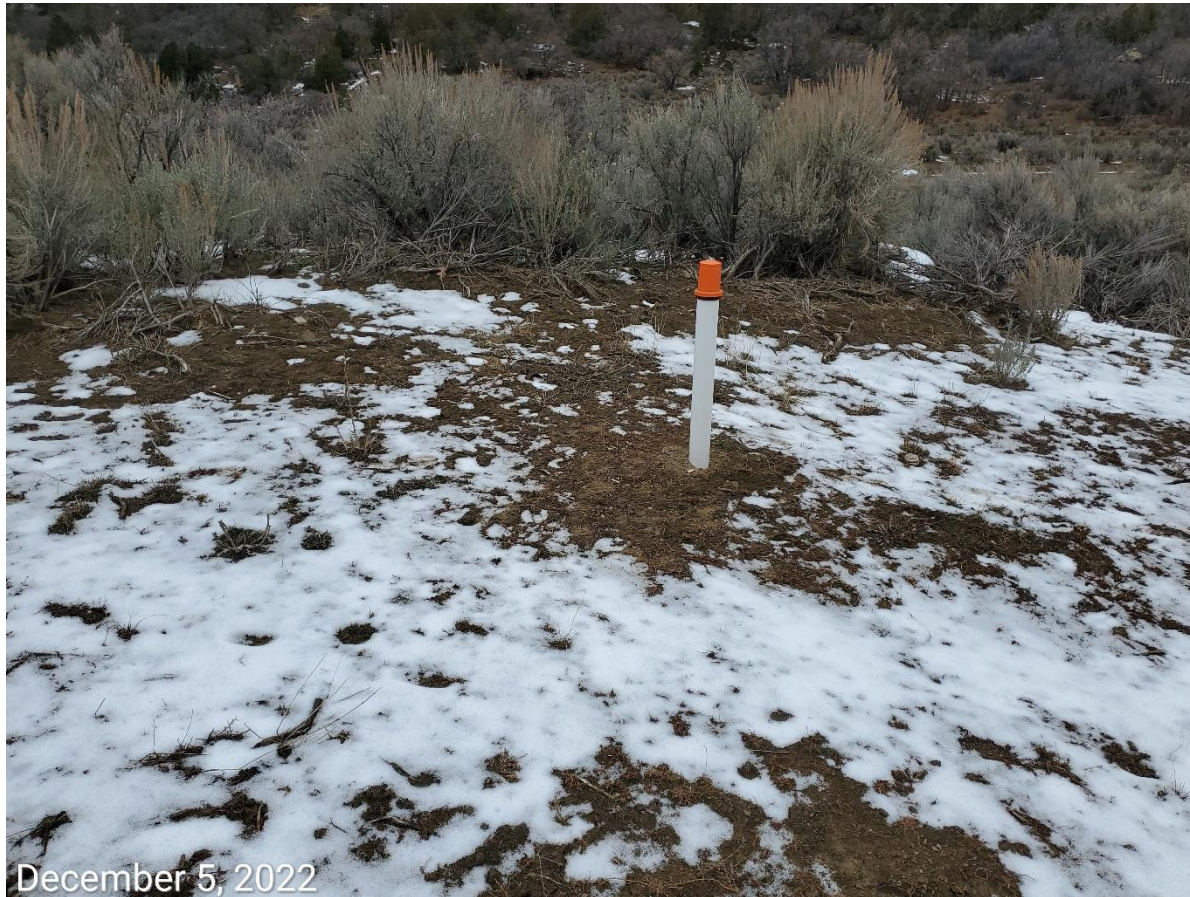
Photo 8: Photo shows remaining surface equipment on the Location.

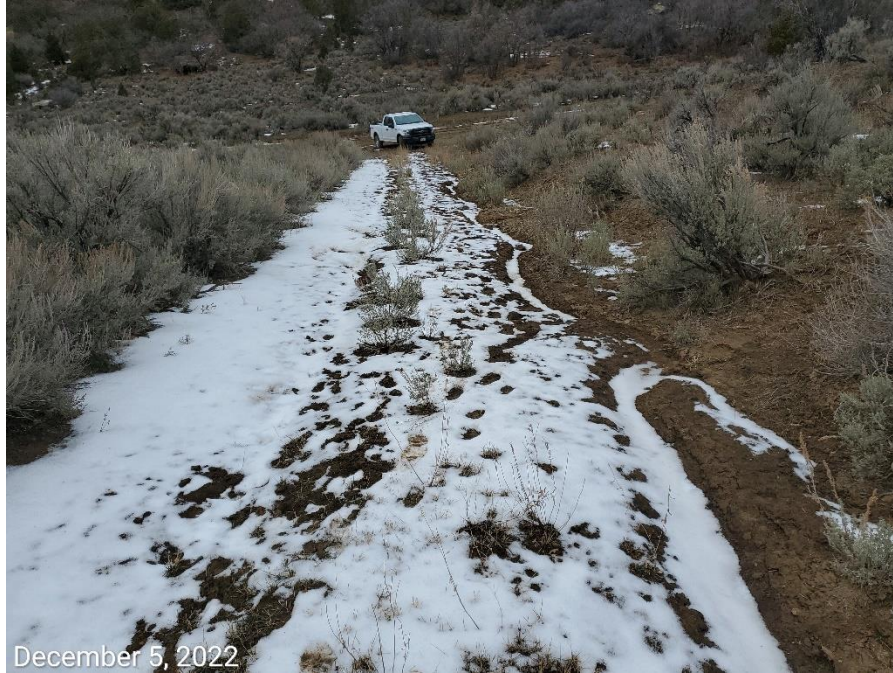
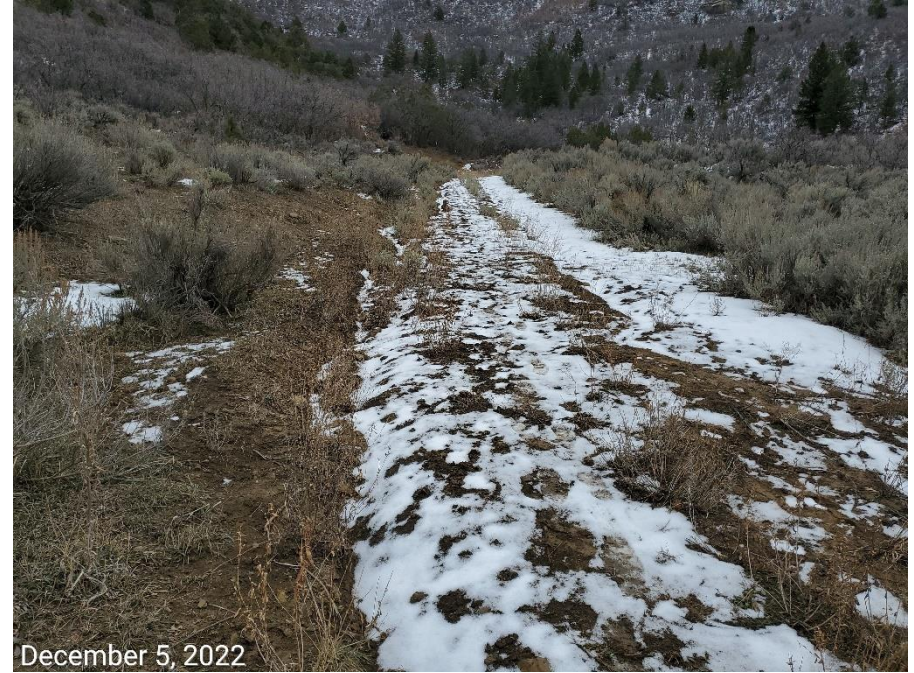
Photo 9: Photos taken from the access road on the north end of the Location. Photo shows access road has not been reclaimed. Photo also shows erosion degradation has persisted.
