Final Reclamation and Stormwater Inspection

Operator: FUNDARE RESOURCES OPERATING COMPANY- 10773

Location ID: 420175

Weld County, CO

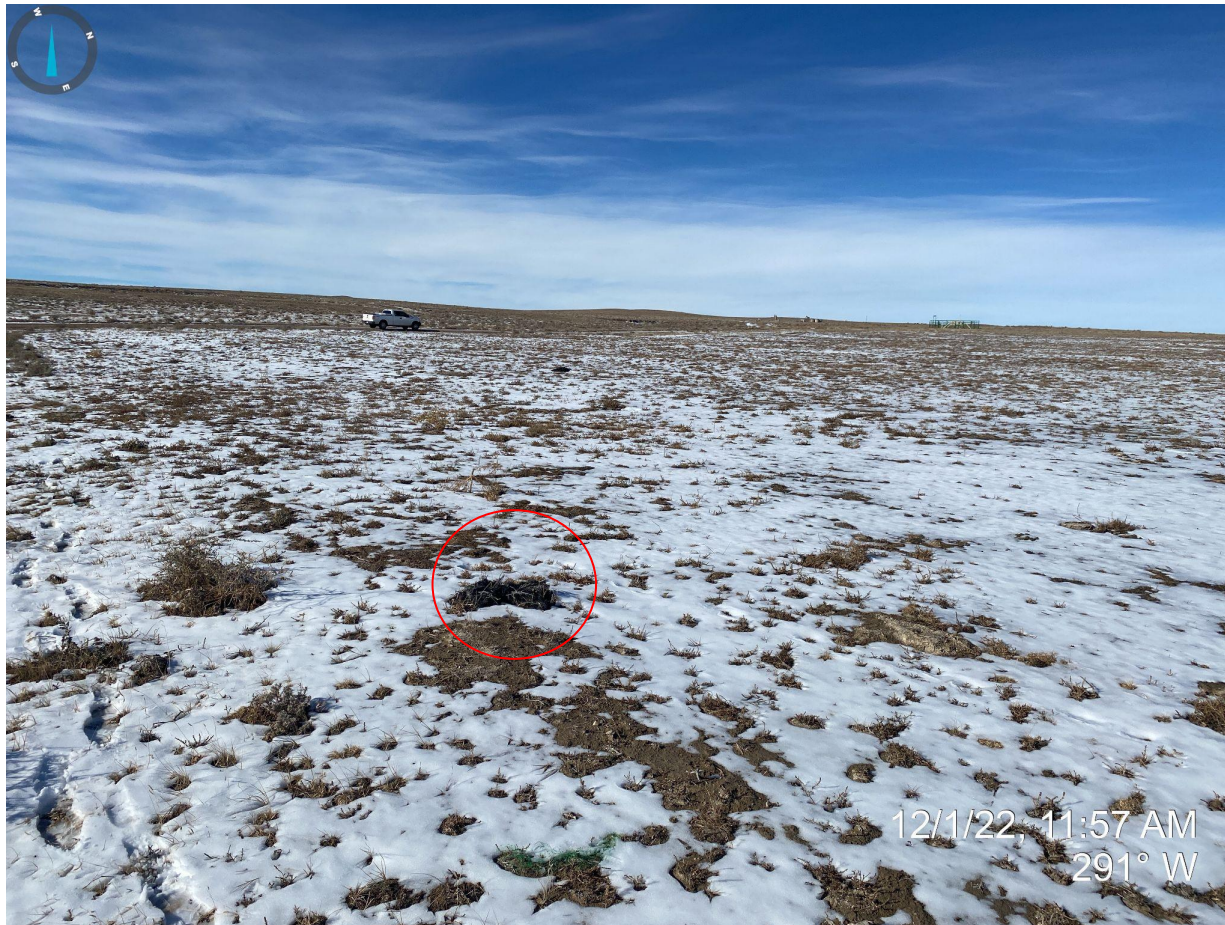
Photo 1. Taken from the southern portion of the location, facing west. Photo illustrates debris (e.g. netting) observed on location that needs to be removed and properly disposed of.

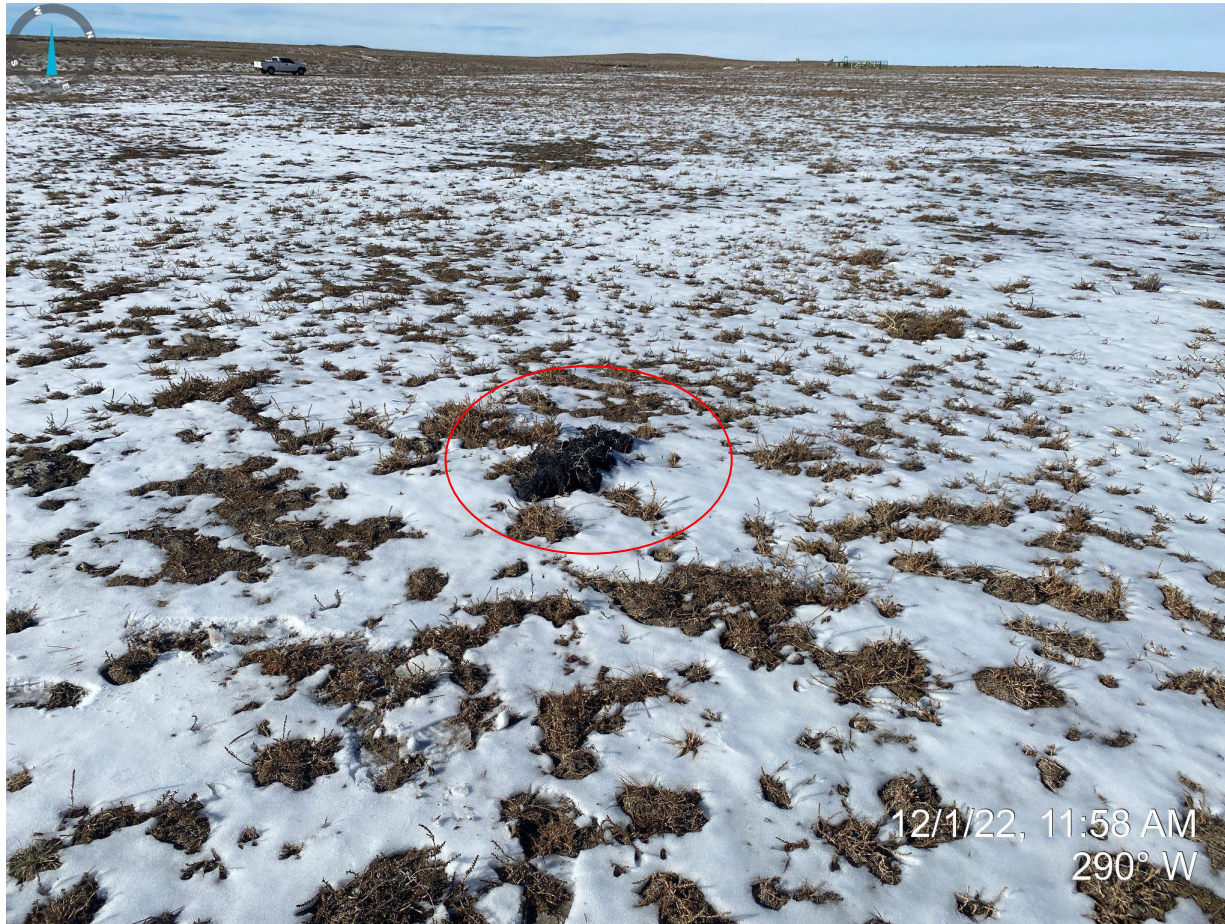
Photo 2. Taken near the southeastern corner of the location, facing west. See comments in Photo 1.

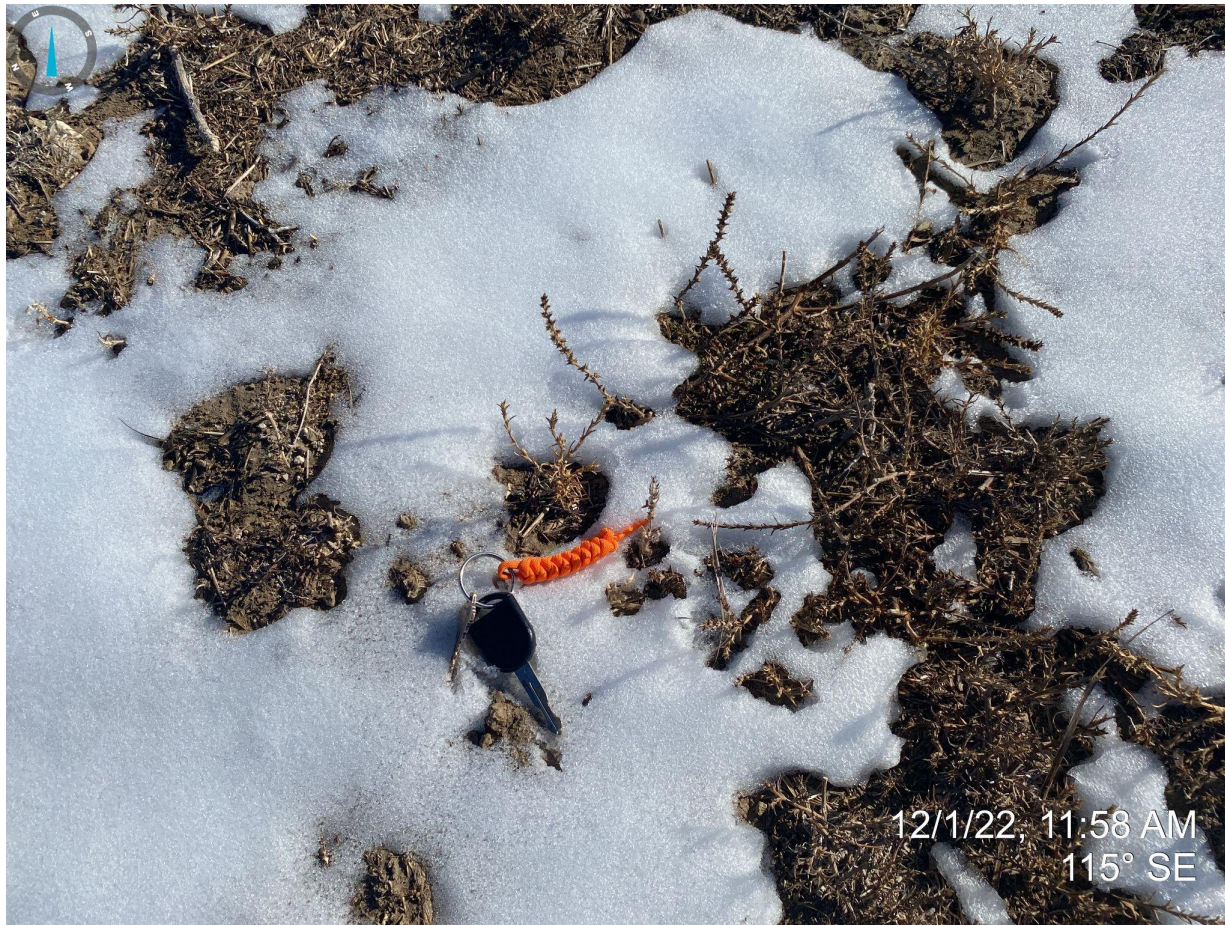
Photo 3. Close up photo of russian thistle, key for scale. The location consisted predominantly of russian thistle and bare soil. Some desirable vegetation was also observed in sparse amounts.

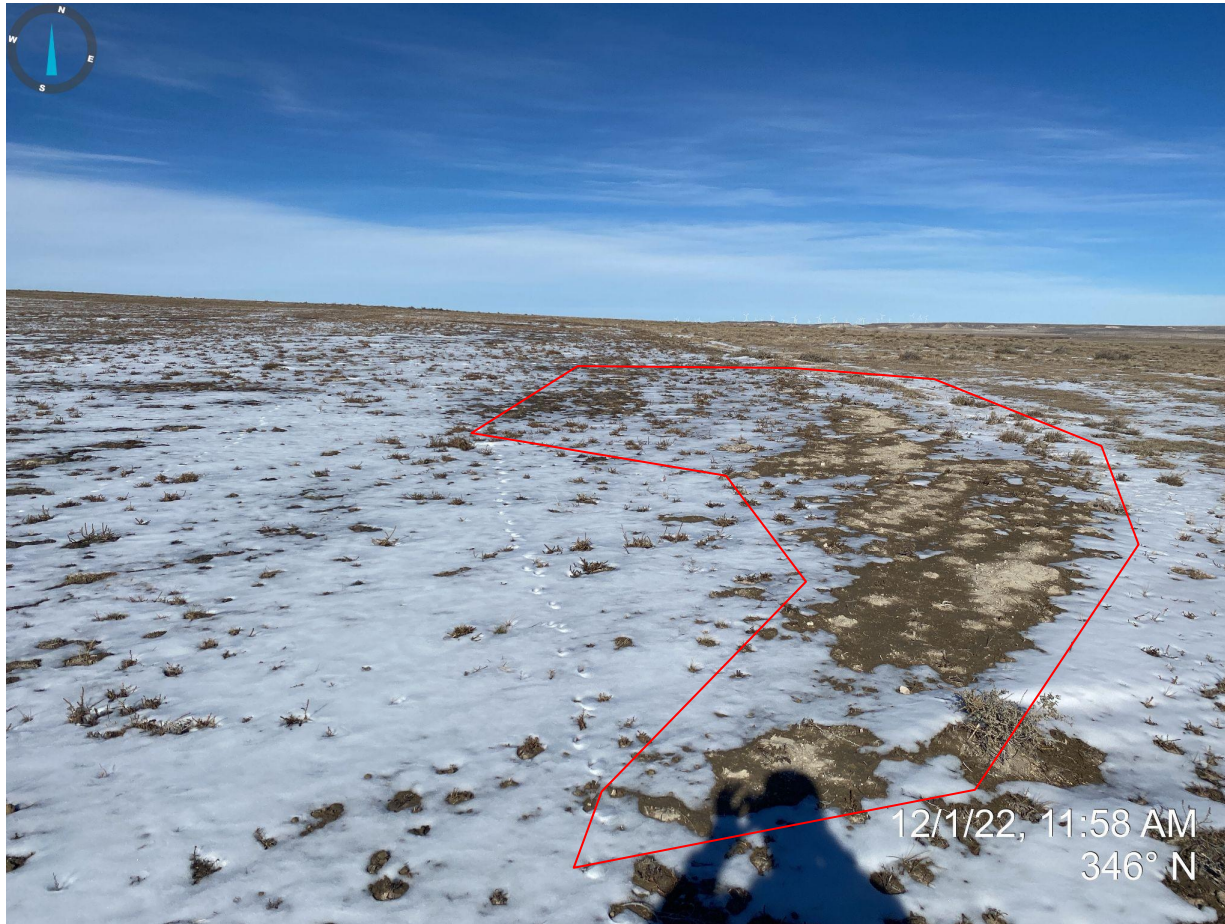
Photo 4. Taken from the southeast corner, facing north. Photo illustrates presence of bare soil resulting from lack of uniform vegetation cover.

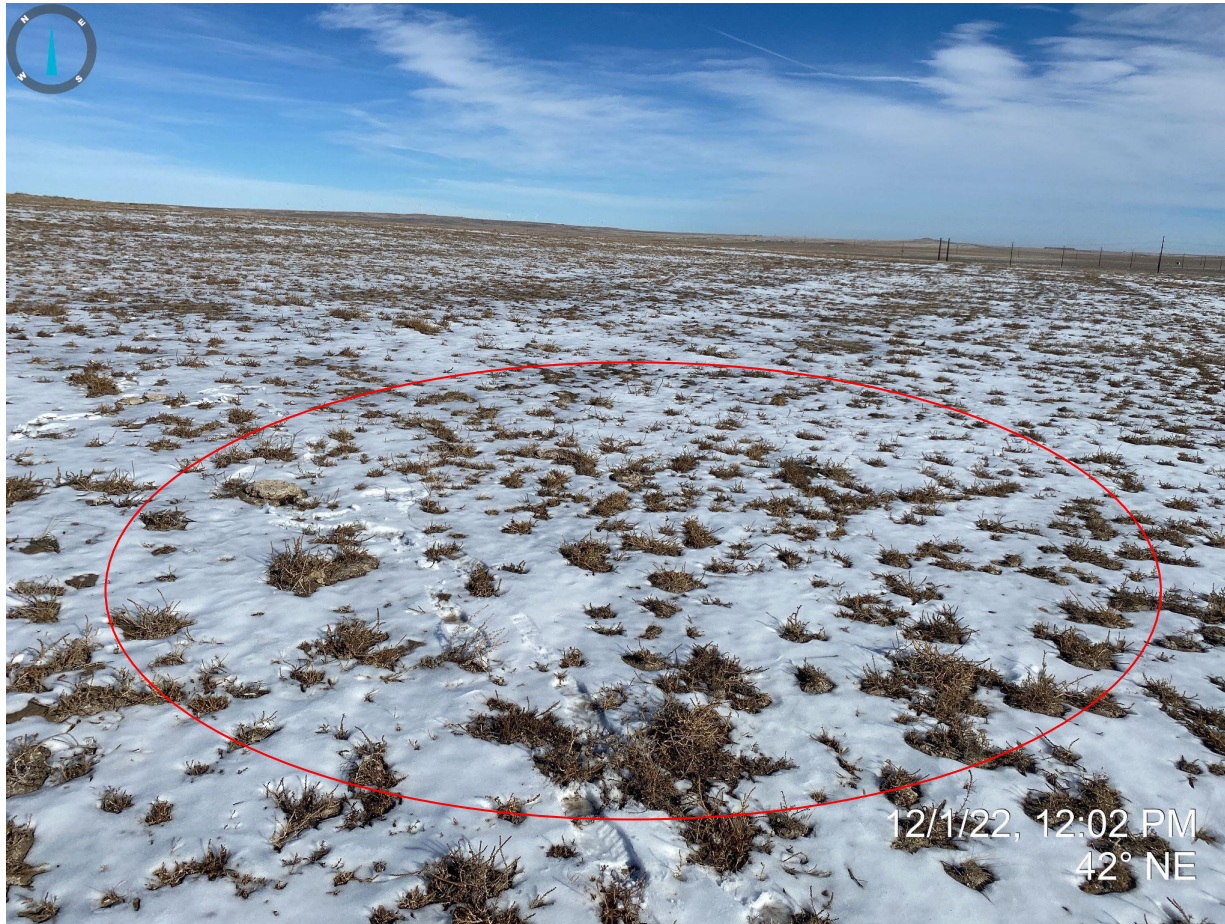
Photo 5. Taken from the northwest corner, facing northeast. Photo illustrates presence of russian thistle throughout the location.

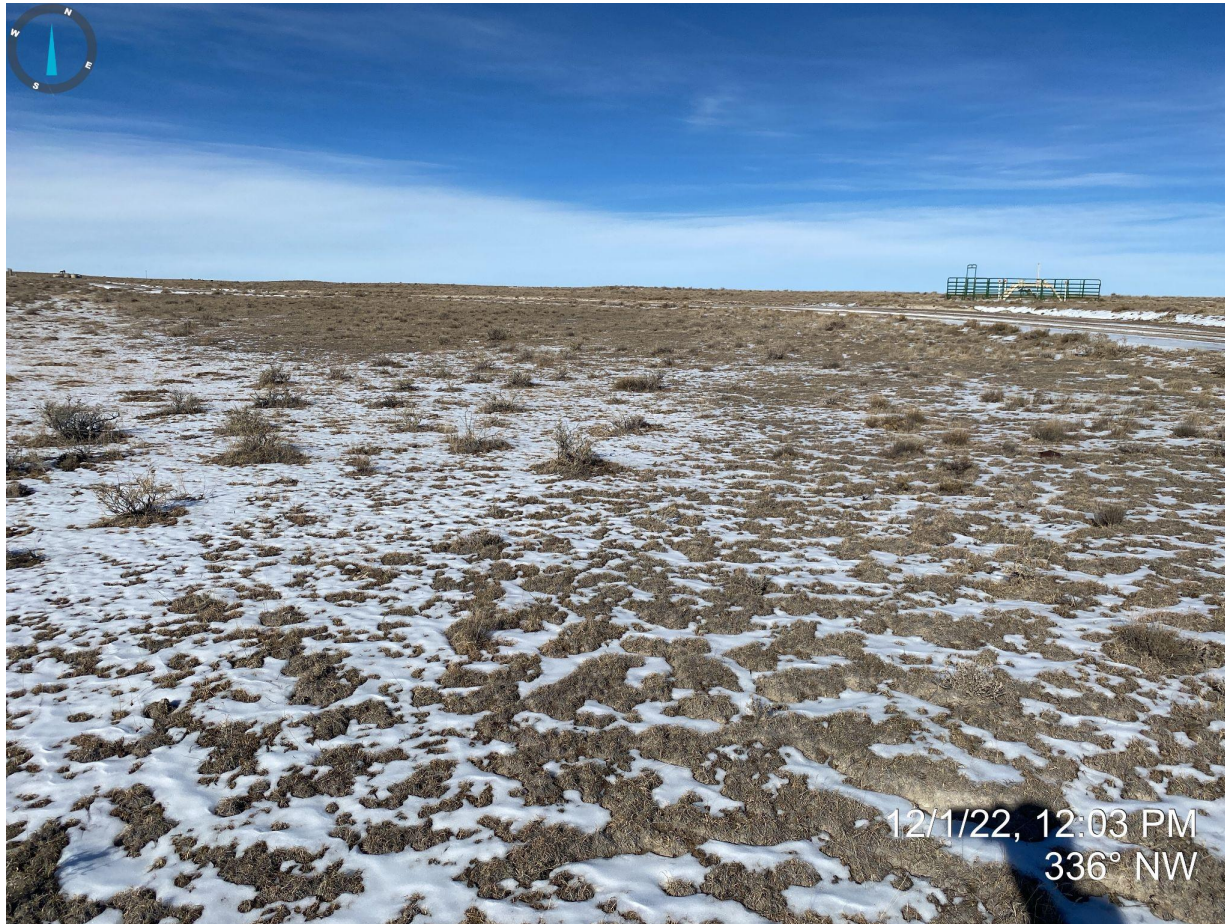
Photo 1. Reference area photo taken west of location, facing north. Reference area is predominantly buffalo grass with sand sagebrush and fourwing saltbrush also identified.
