Final Reclamation and Stormwater Inspection

Operator: FUNDARE RESOURCES OPERATING COMPANY - 10773

Location ID: 330859

Inspection Photos
Location Name: Walker #1
Location ID: 330859

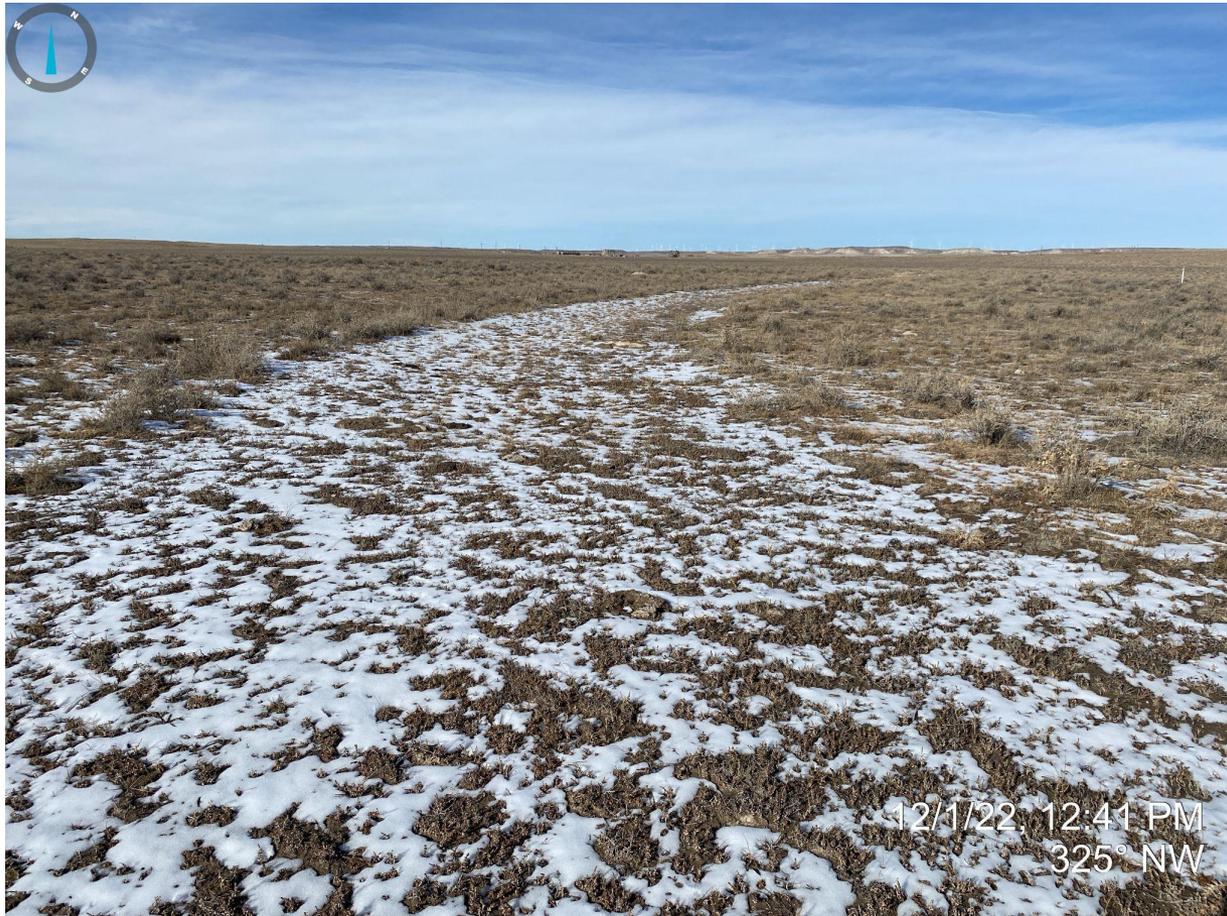
Photo 1. Taken from the southern access road entrance, facing northwest. Photo illustrates the access road has not revegetated and does not meet 1004 reclamation standards. Undesirable vegetation (e.g. russian thistle and kochia) was observed throughout the majority of the former access road.

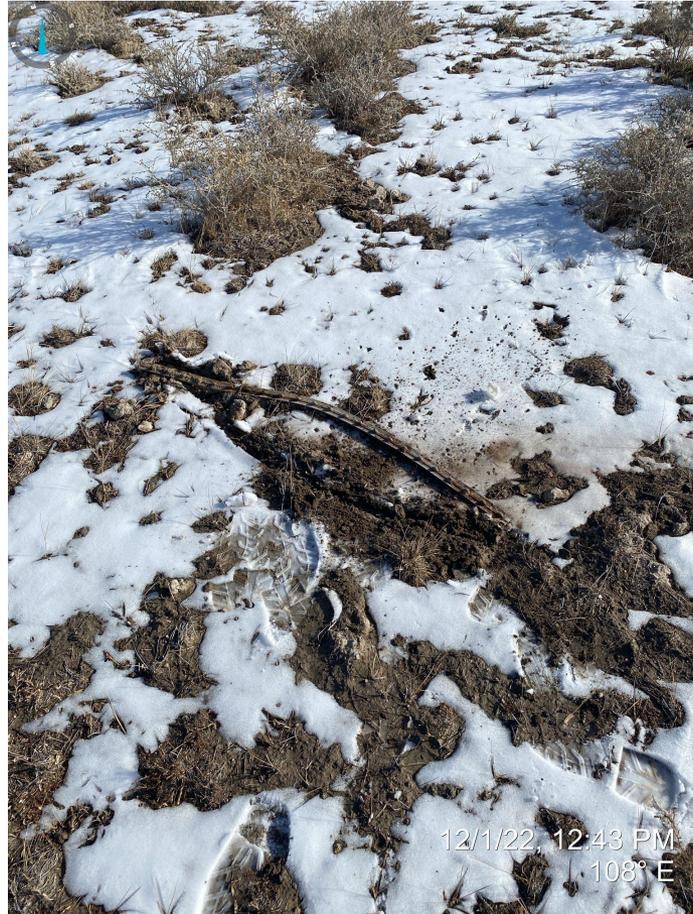
Photo 2. Close-up photo of t-post found partially buried on former well location.

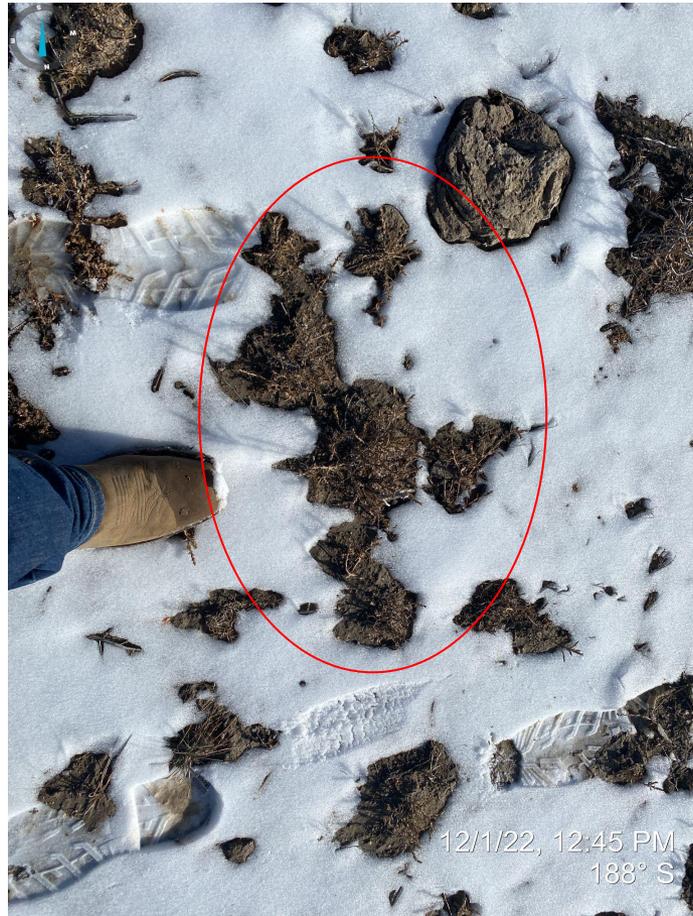
Photo 3. Close-up photo of russian thistle observed on location.

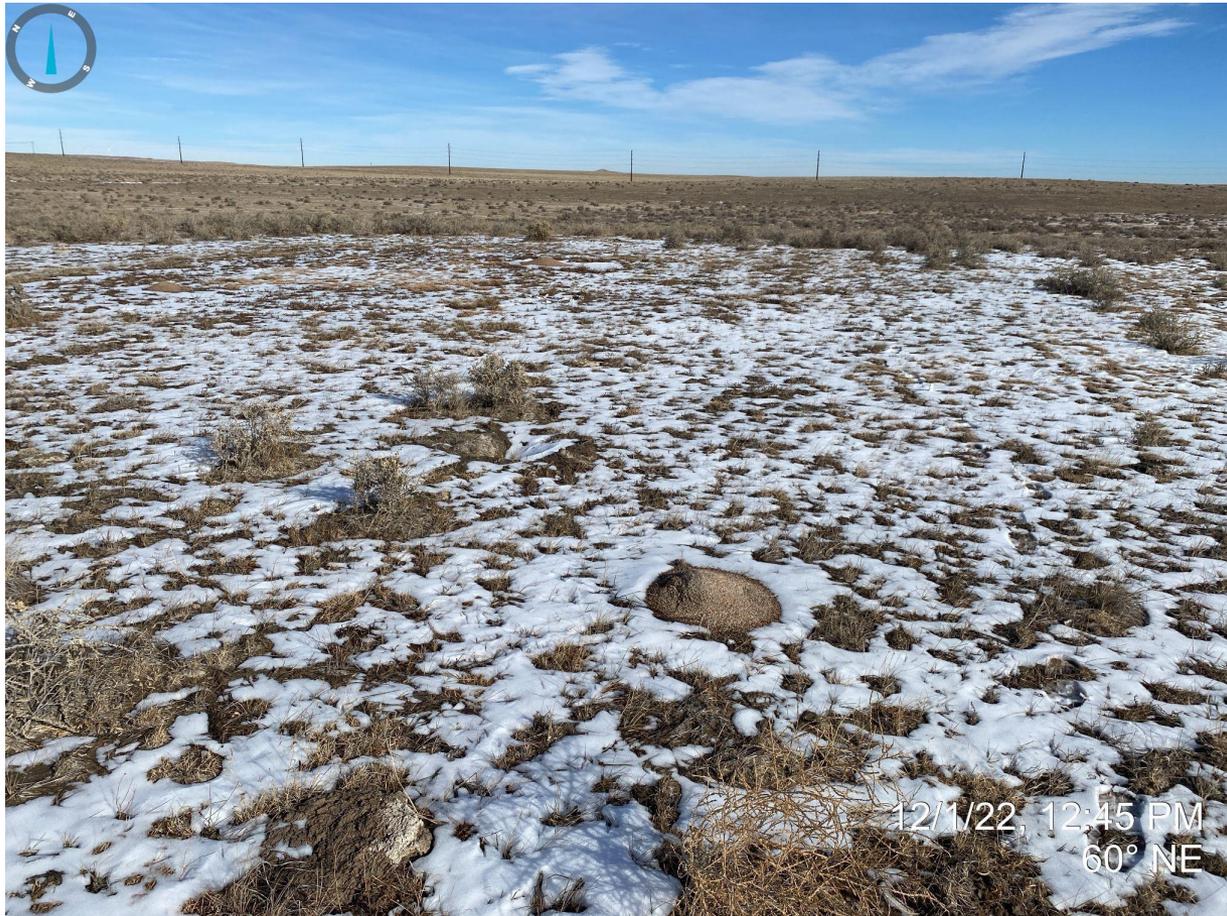
Photo 4. Taken from southwestern portion of location, facing northeast. Photo illustrates the location does not meet 1004 rules and requirements for vegetation establishment; undesirable vegetation (e.g. russian thistle and kochia) observed throughout the reclaimed area.
