# Final Reclamation and Stormwater Inspection

Operator: FUNDARE RESOURCES OPERATING  
COMPANY- 10773

Location ID: 330800

Inspection Photos  
Location Name: UHL #1  
Location ID: 330800

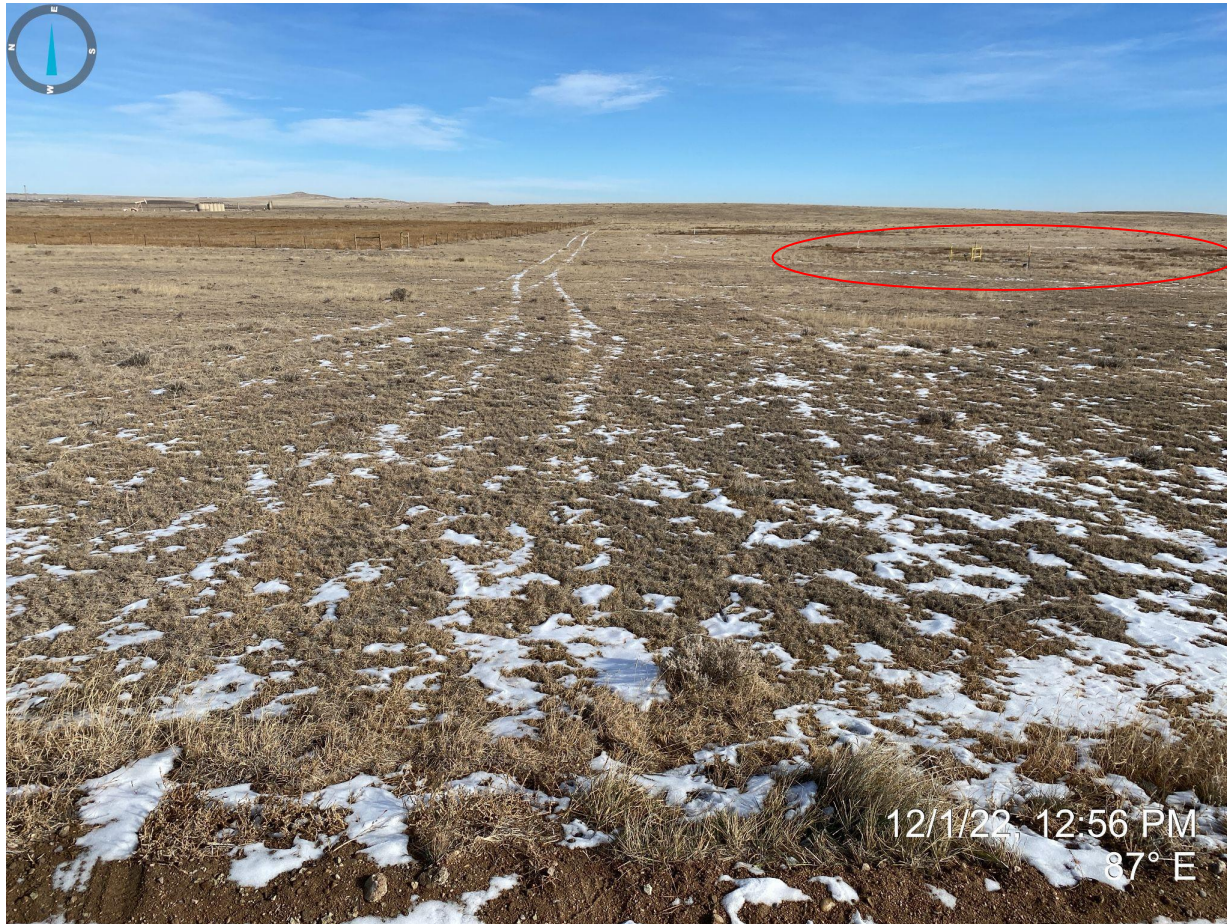
**Photo 1.** Facing east from county road. Oil and gas equipment (pipeline risers, cages/barriers) remain on location, outlined in red. Two track road on left of photo appears to be used by surface owner.

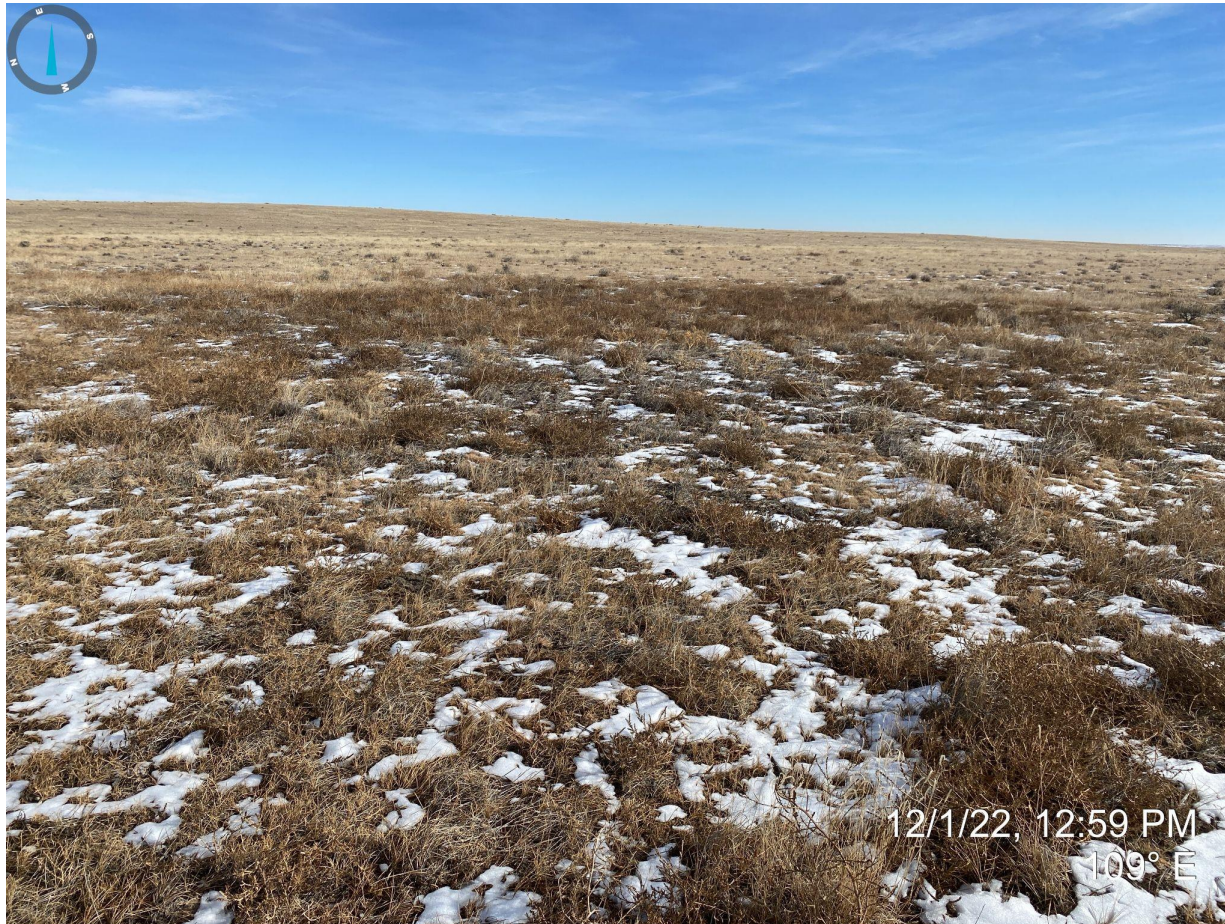
**Photo 2.** Facing east from well location. Photo illustrates presence of undesirable vegetation, predominantly russian thistle with minute amounts of desirable vegetation also observed.

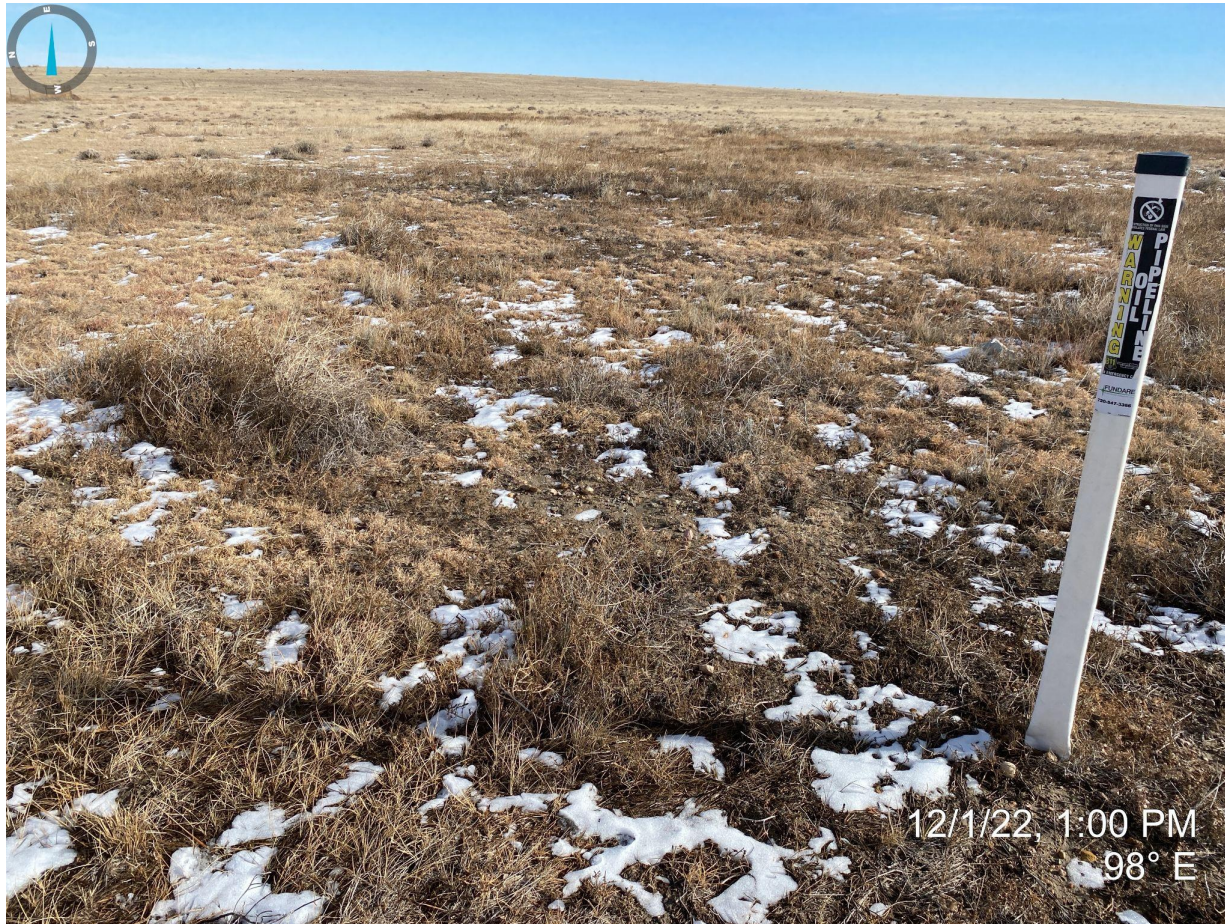
**Photo 3.** Facing east from well location. All oil and gas equipment needs to be removed from location in order to comply with 1004 Rules.
