Final Reclamation and Stormwater Inspection

Operator: FUNDARE RESOURCES OPERATING
COMPANY- 10773

Location ID: 330979

Inspection Document #: 696105642

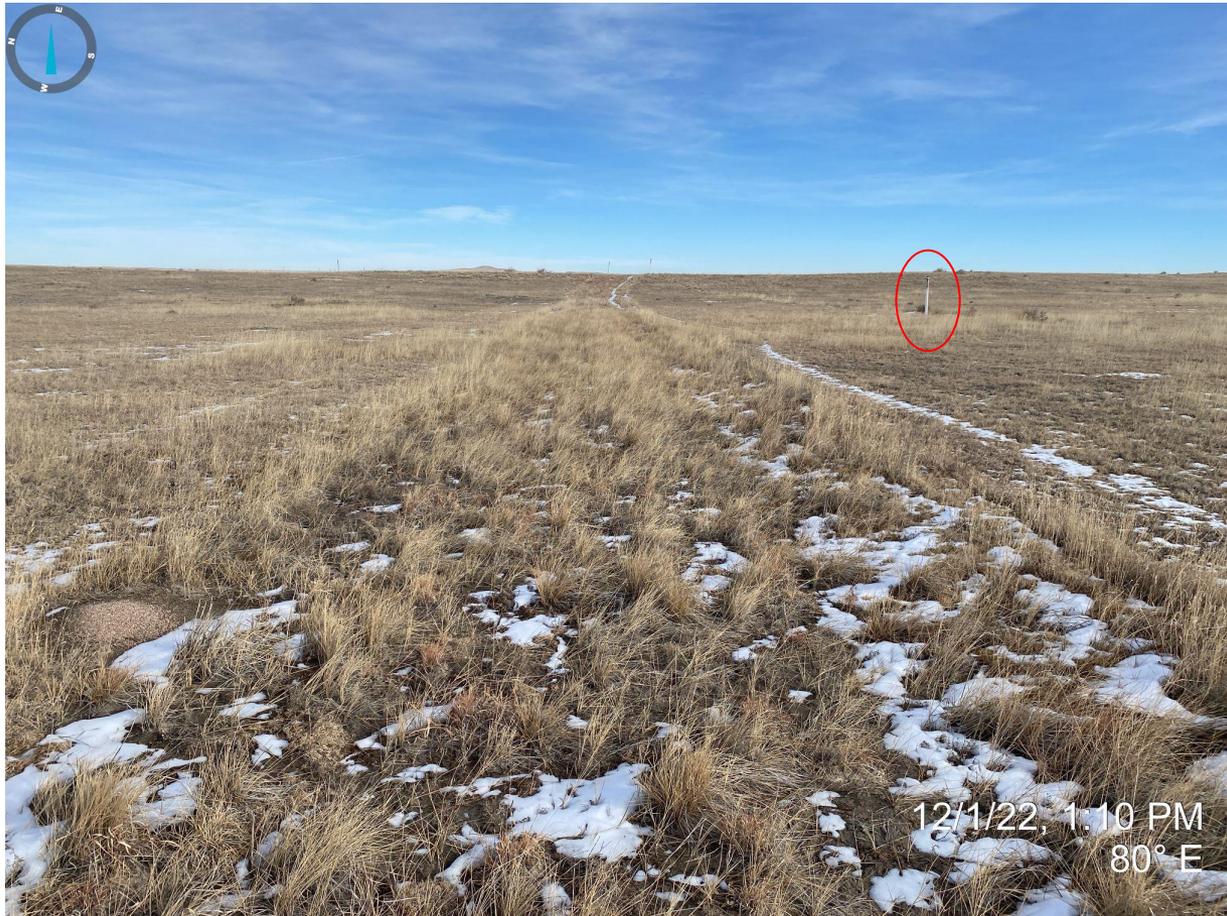
Photo 1. Taken north of the tank battery, facing east. Photo illustrates that the access road has been reclaimed and revegetated with desirable species. Red outline indicates pipeline markers that need to be removed.

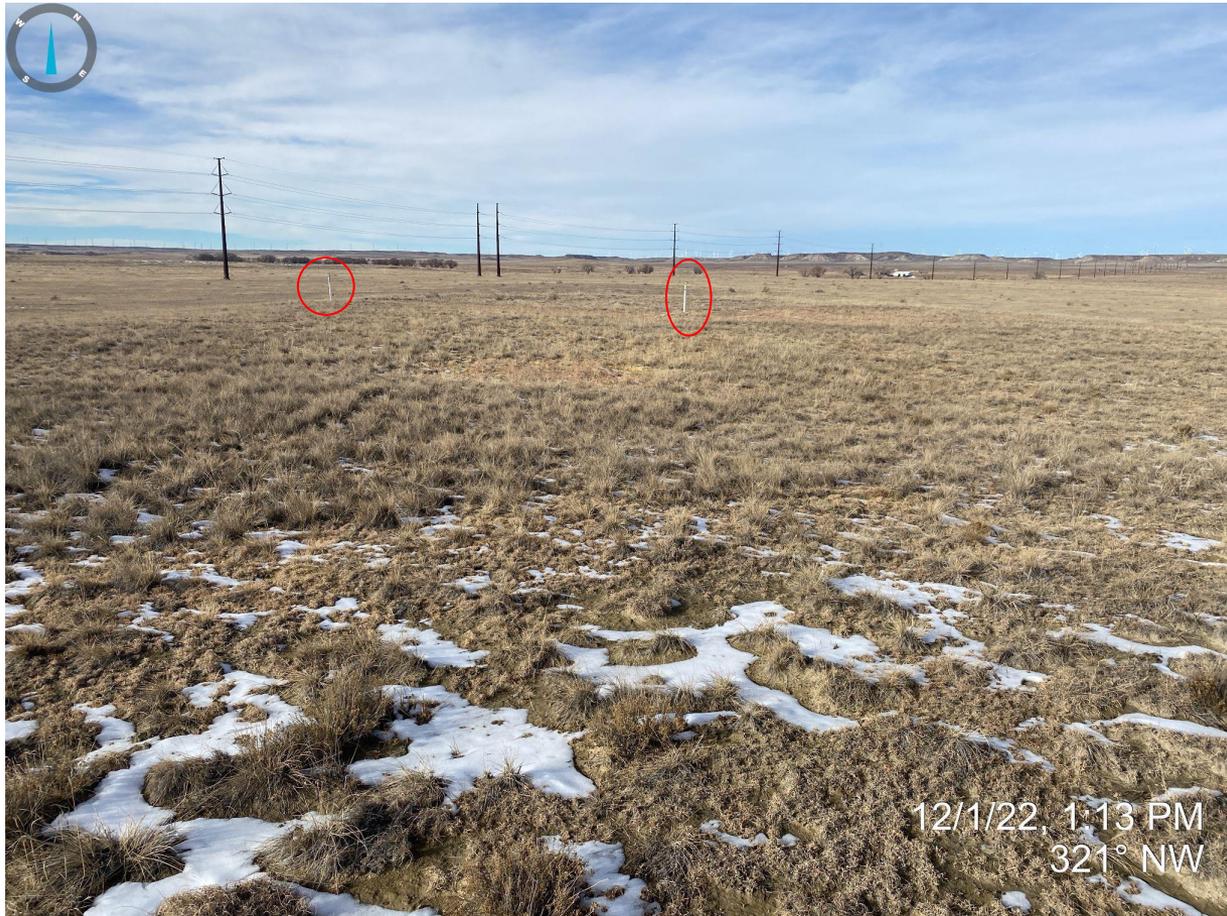
Photo 2. Taken from the southern portion of the well location, facing north. Photo illustrates the location has been reclaimed with presence of desirable vegetation (e.g. buffalo grass, sand drop seed, etc). The red outlined pipeline markers need to be removed.

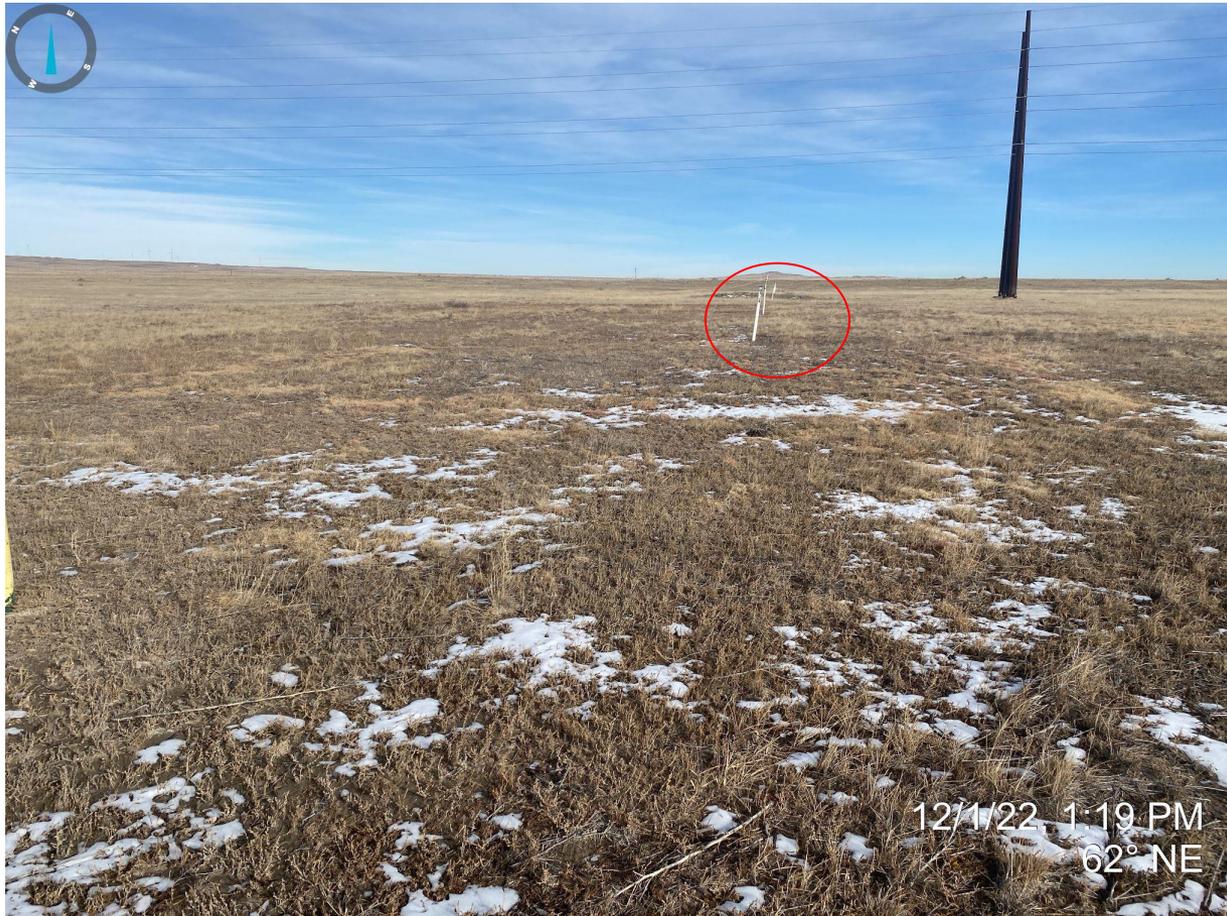
Photo 3. Taken from the tank battery location, facing northeast. Photo illustrates the location has not revegetated with desirable species as evidenced by russian thistle and areas of bare soil. Red outline indicates pipeline markers that need to be removed.

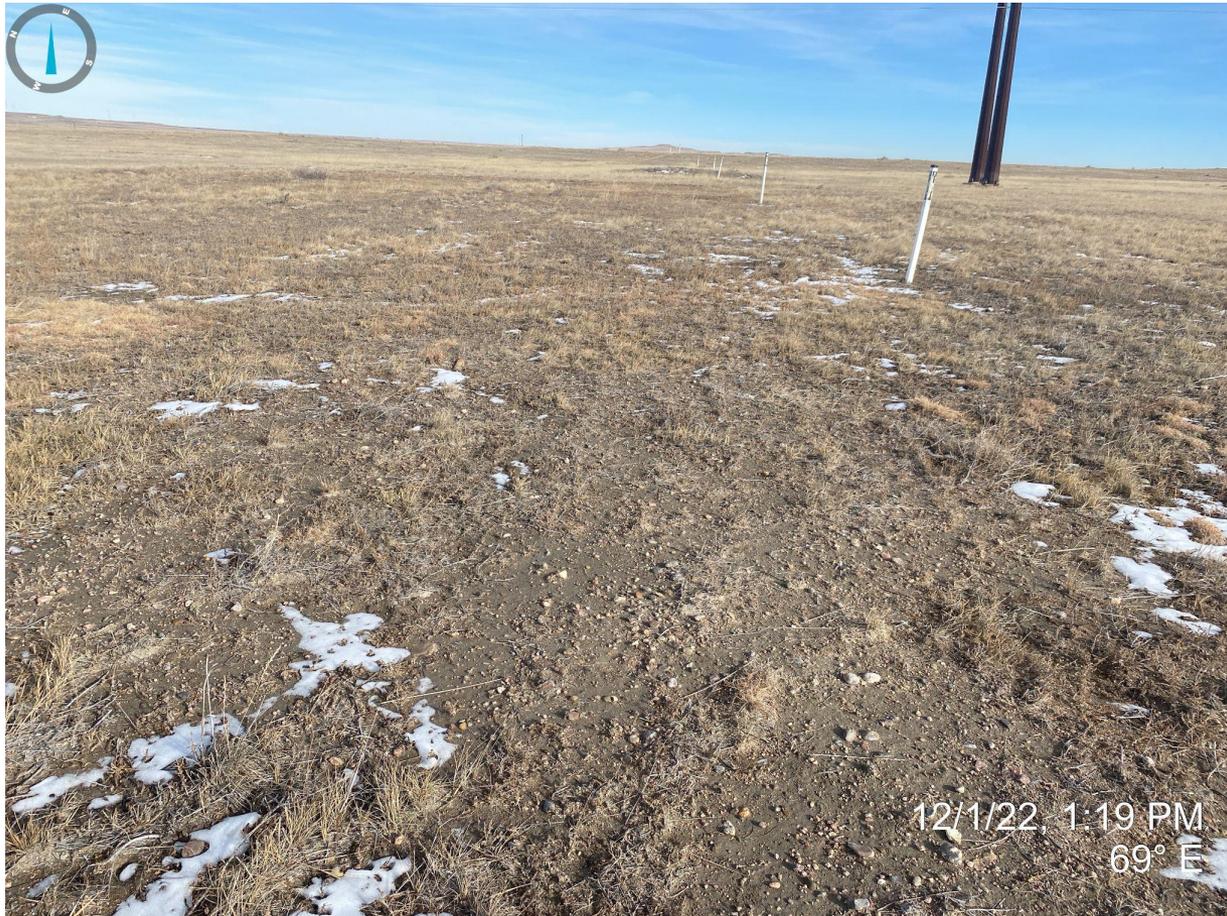
Photo 4. Facing east, see comments in Photo 3.

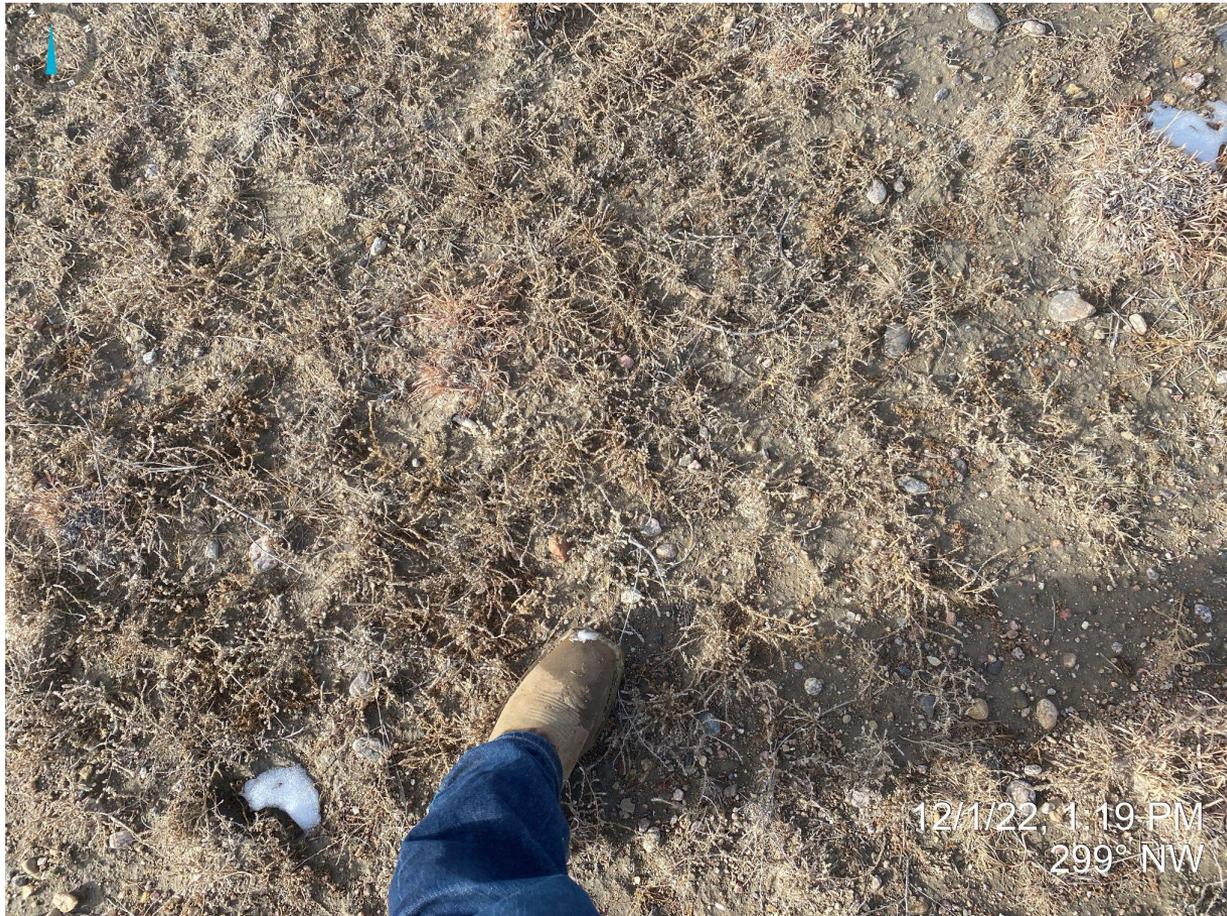
Photo 5. Close-up photo of bare soil and russian thistle.
