Inspection Photos

12/19/2022

Operator: CAERUS PICEANCE LLC - 10456

Location #334104

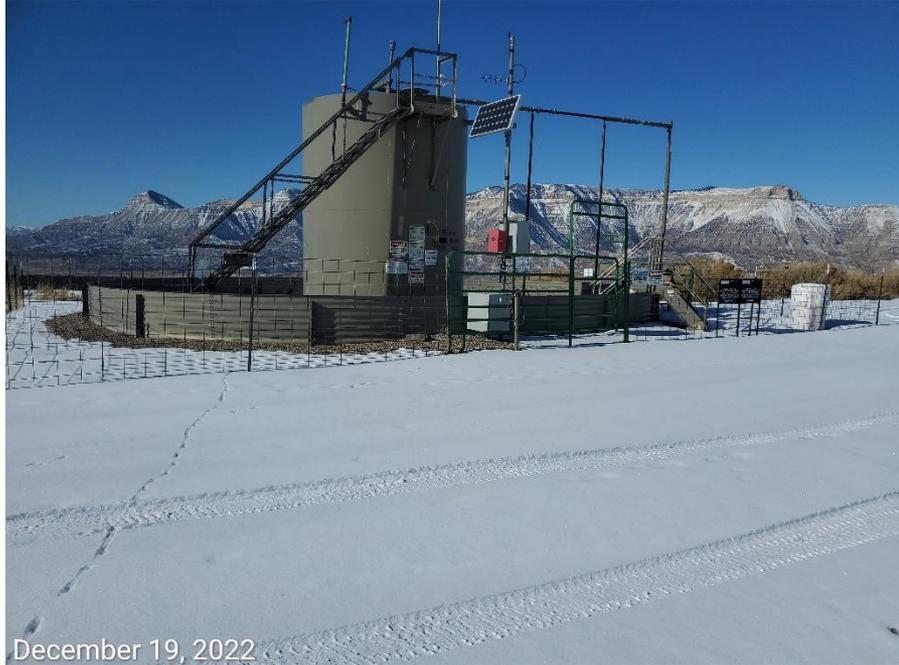
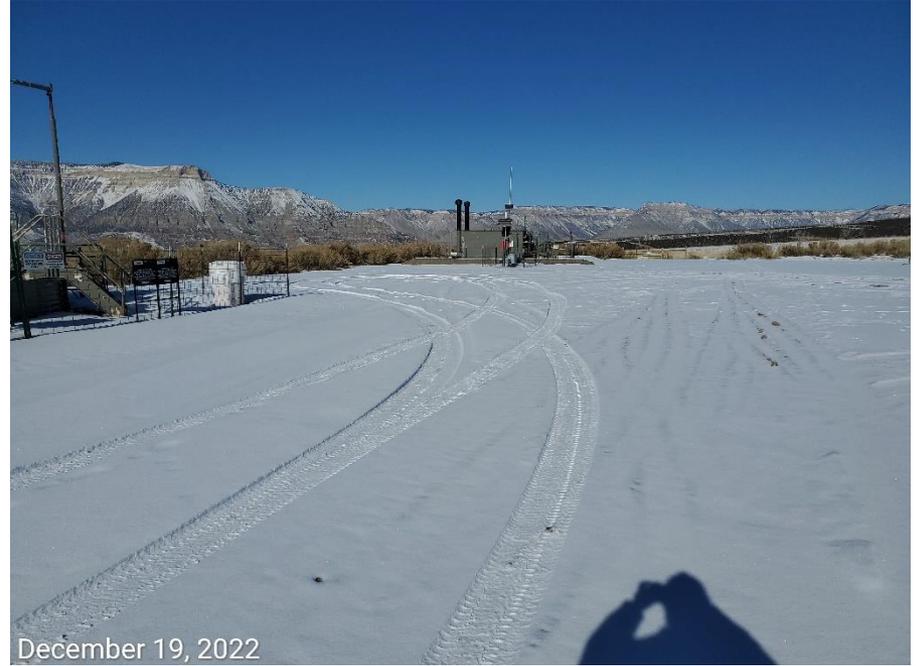
Photo 1: Photos 1-2 taken from the south end of the Location. Photos provide an overview of the location from west, northwest, northeast to east.

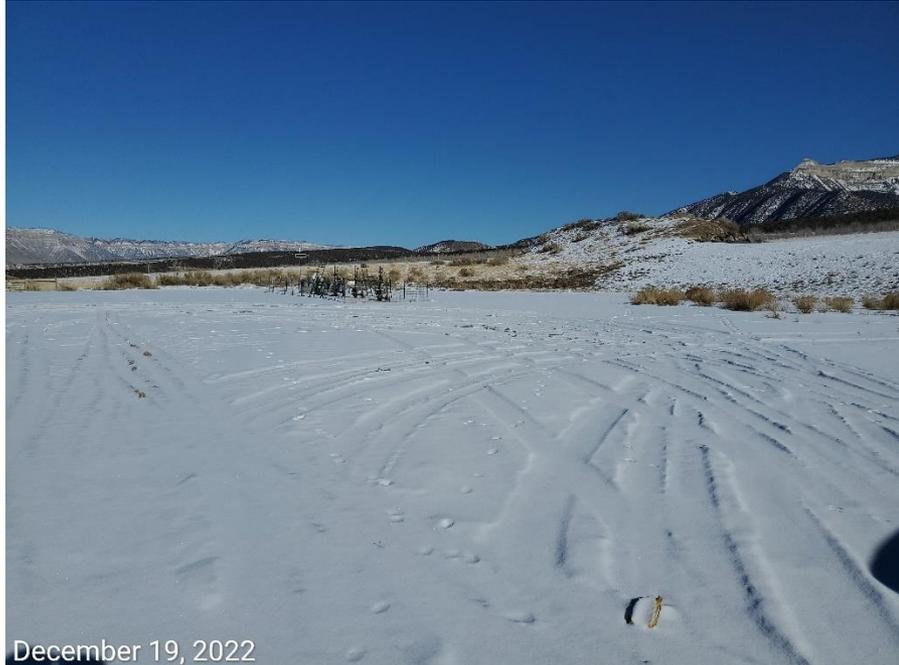
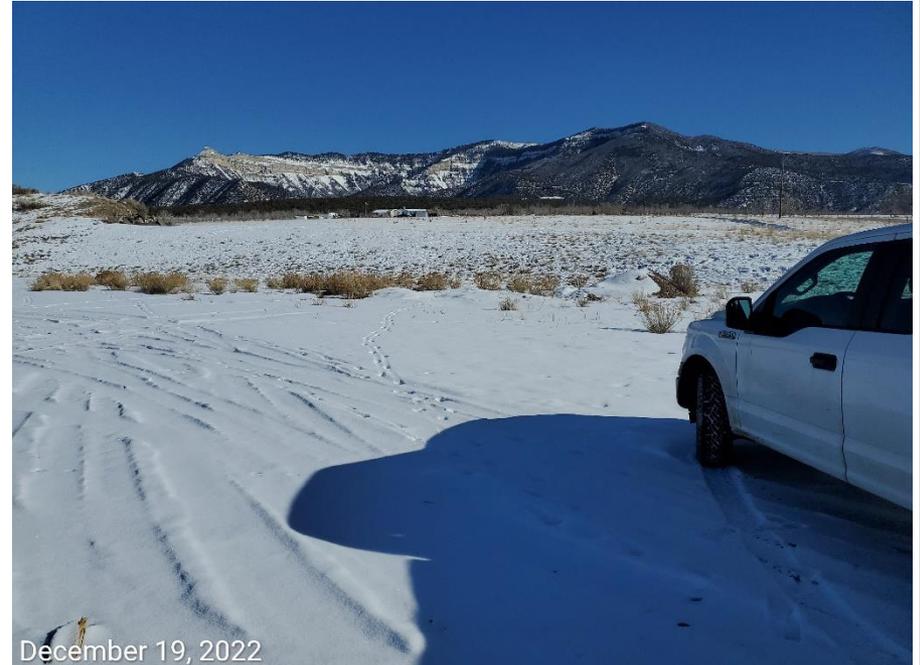
Photo 2: See comment under photo 1.

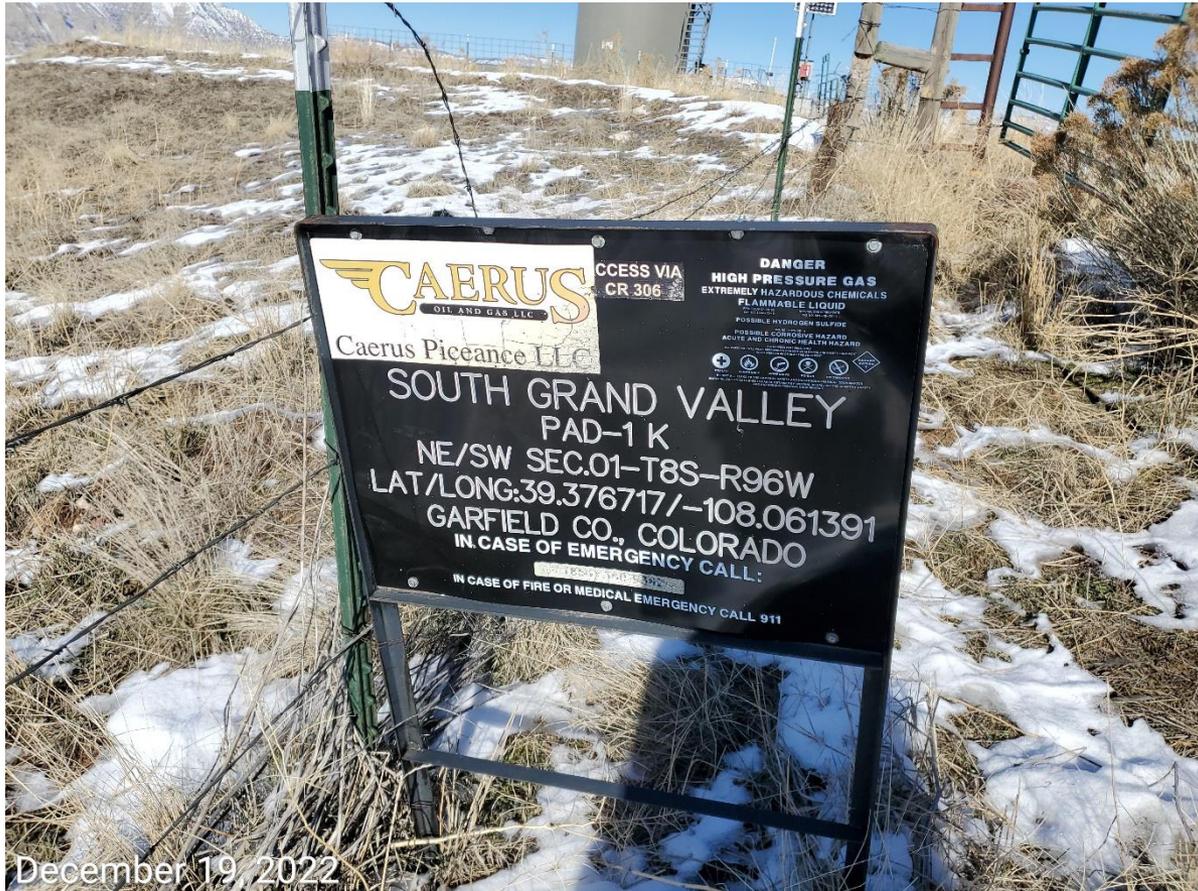
Photo 3: Signage at Location entrance. Emergency contact number no longer legible. Battery signage indicates presence of H₂S; H₂S signage at Location entrance not posted.

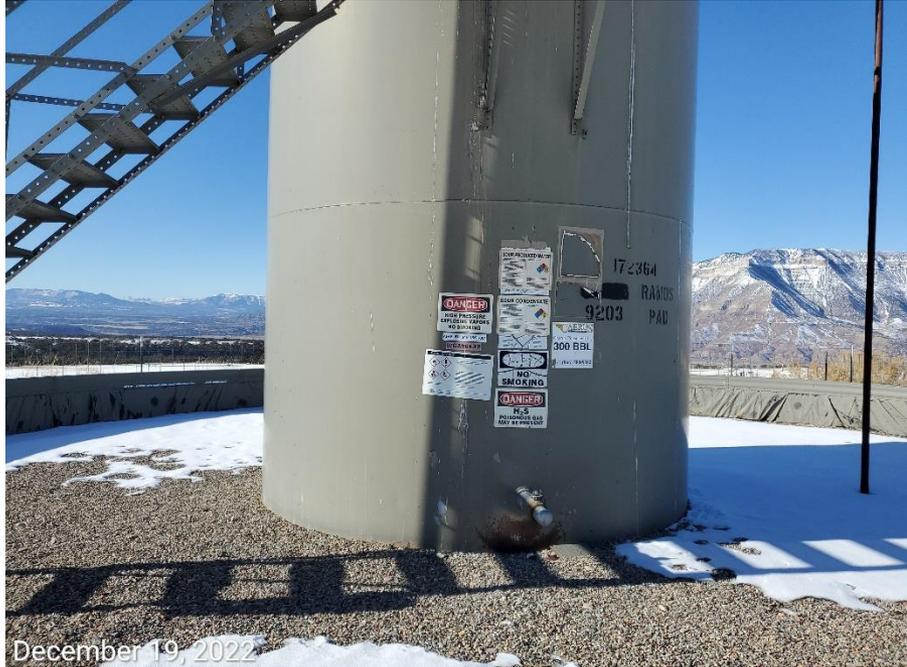
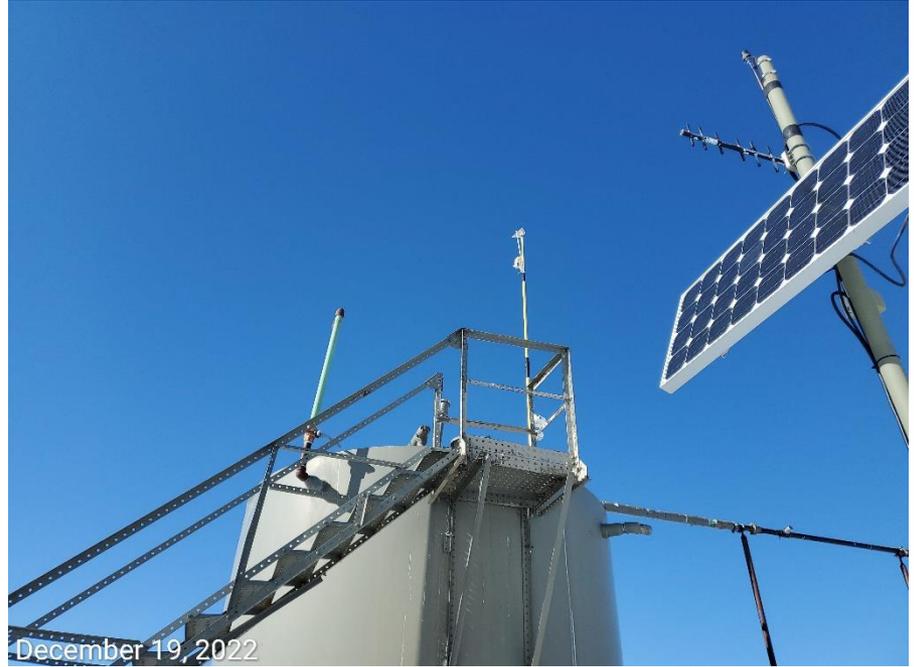
Photo 4: Tank battery. Signage at battery indicates presence of H2S. Photo right shows Wind Direction Indicator on Location is not longer in proper functioning condition.

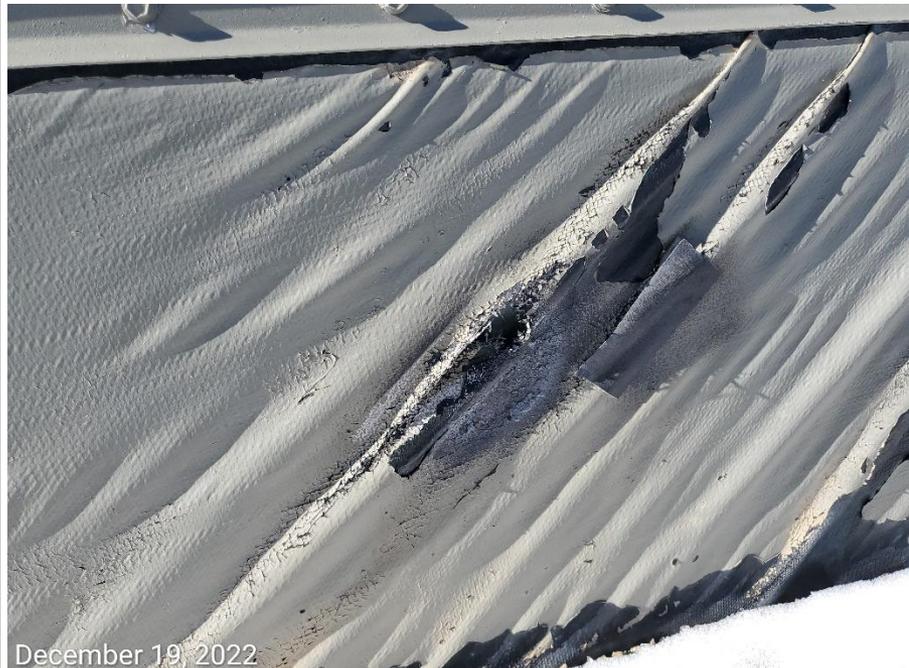
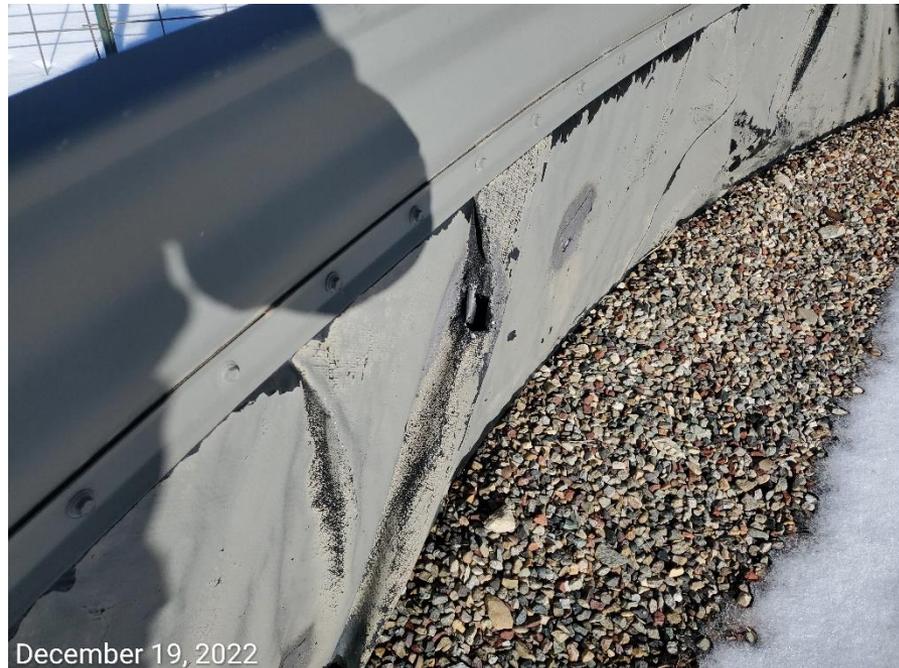
Photo 5: Photo example showing holes observed throughout entire liner at the tank battery.

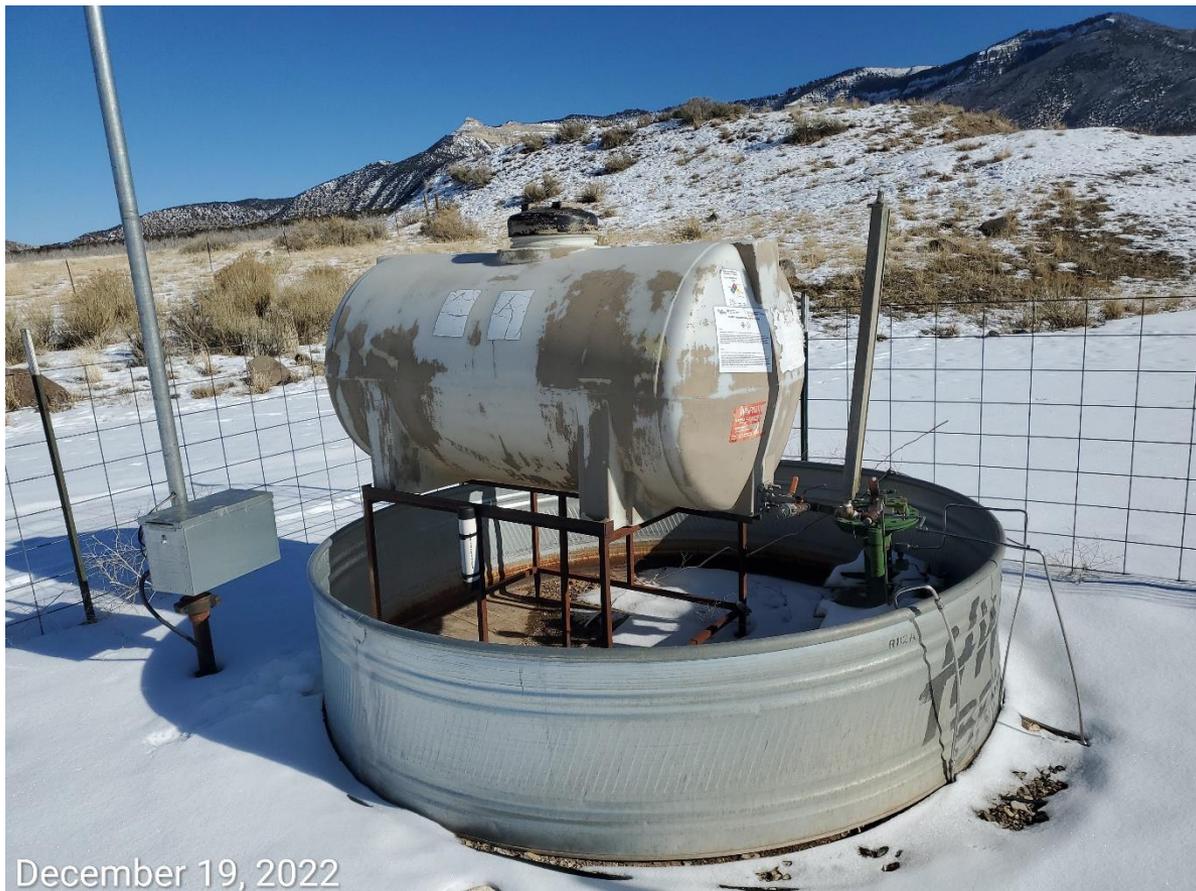
Photo 6: H2S Scavenger tank. Wildlife protection devices to prevent wildlife access to the secondary containment of the "H2S Scavenger" tank missing or insufficient.

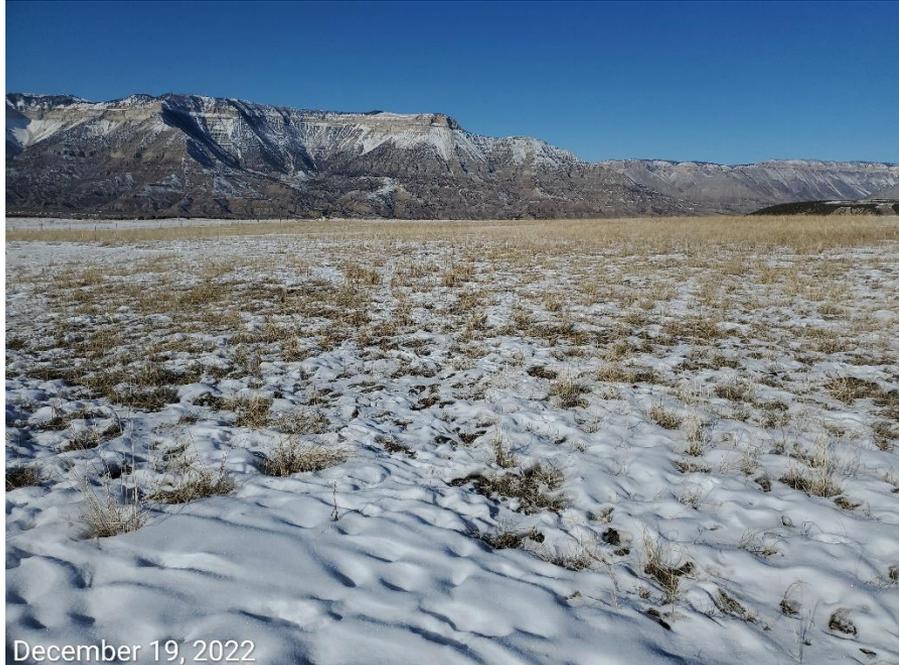
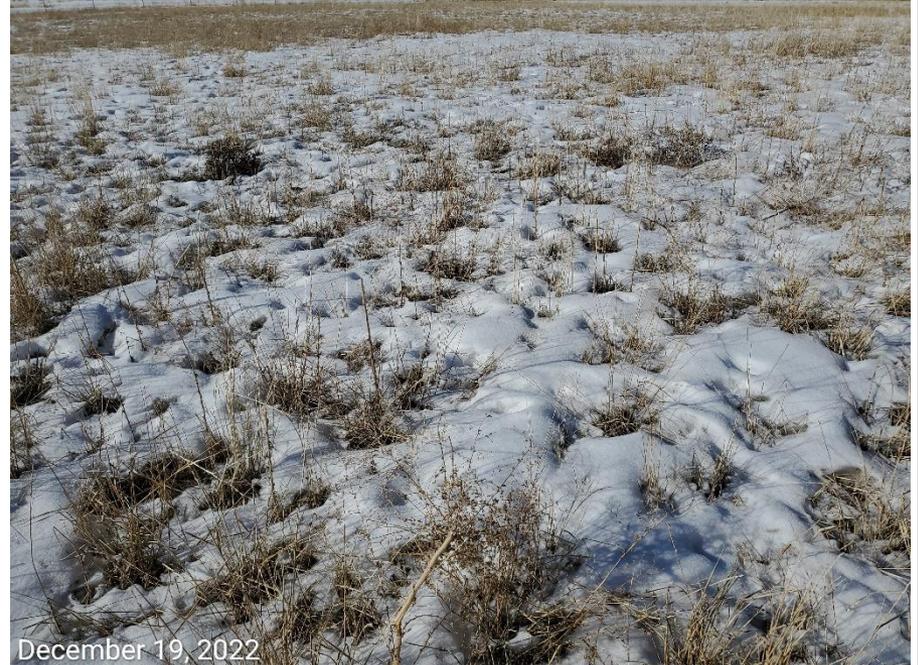
Photo 7: Photos taken from the former storage pad north of the Location. Photo shows areas have since been reclaimed, though vegetation observed above snow appears to be predominantly weedy plant species.
