# Inspection Photos

Operator: Caerus Piceance LLC - #10456

Location Name: SHIDELER-67S93W/25NWNE

Inspection Document #: 702801086

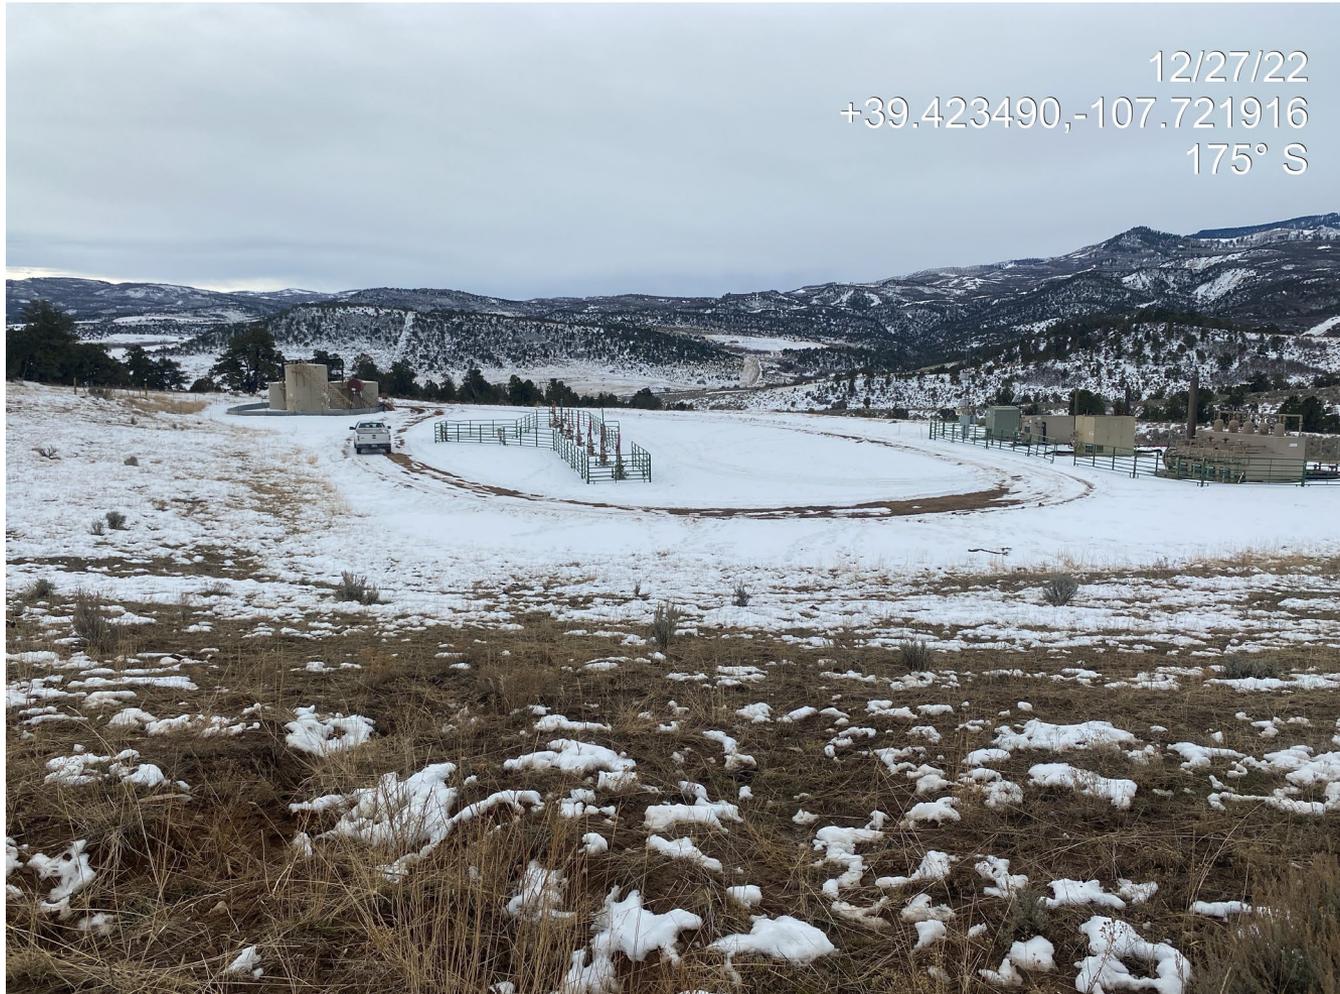
**Photo 1.** Photo taken from the north shows an overview of the location.

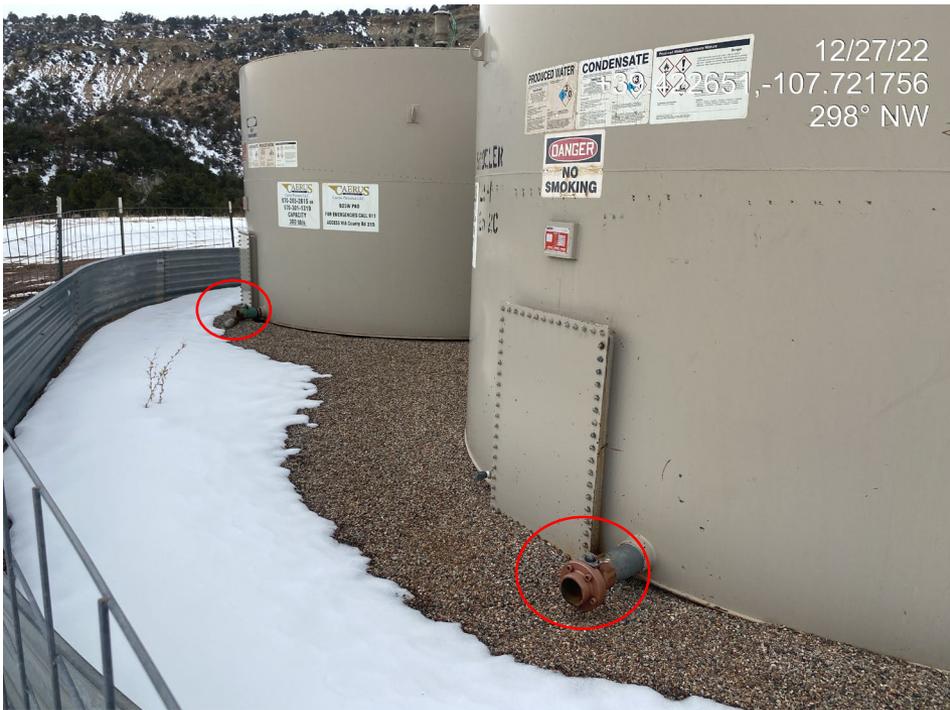
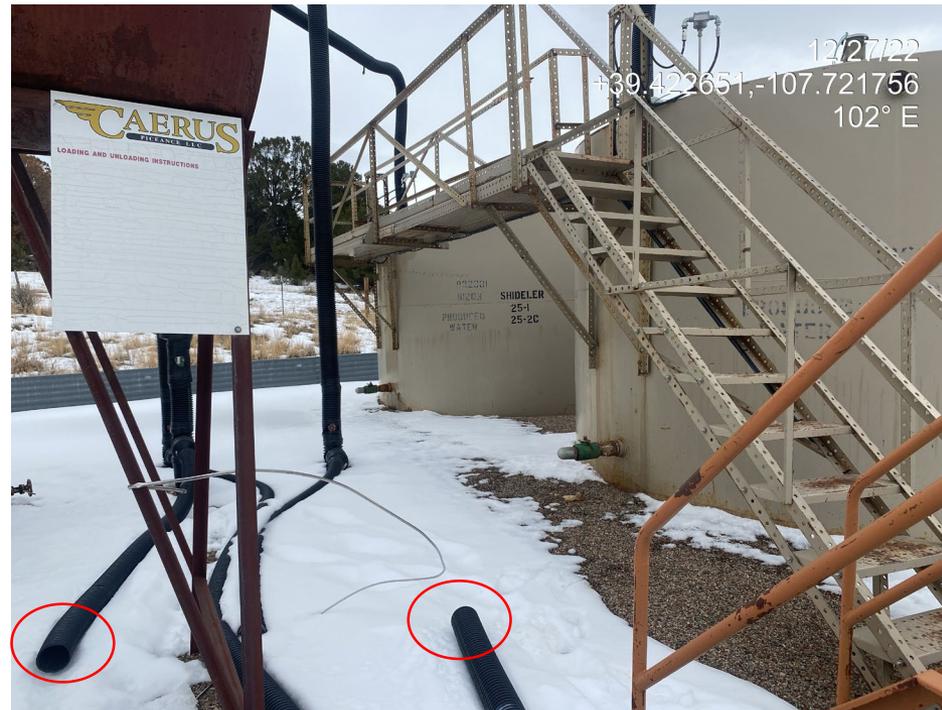
**Photo 2.** Photos show bull plugs not installed on tank drain lines (left) and open ended piping at tank battery (right).

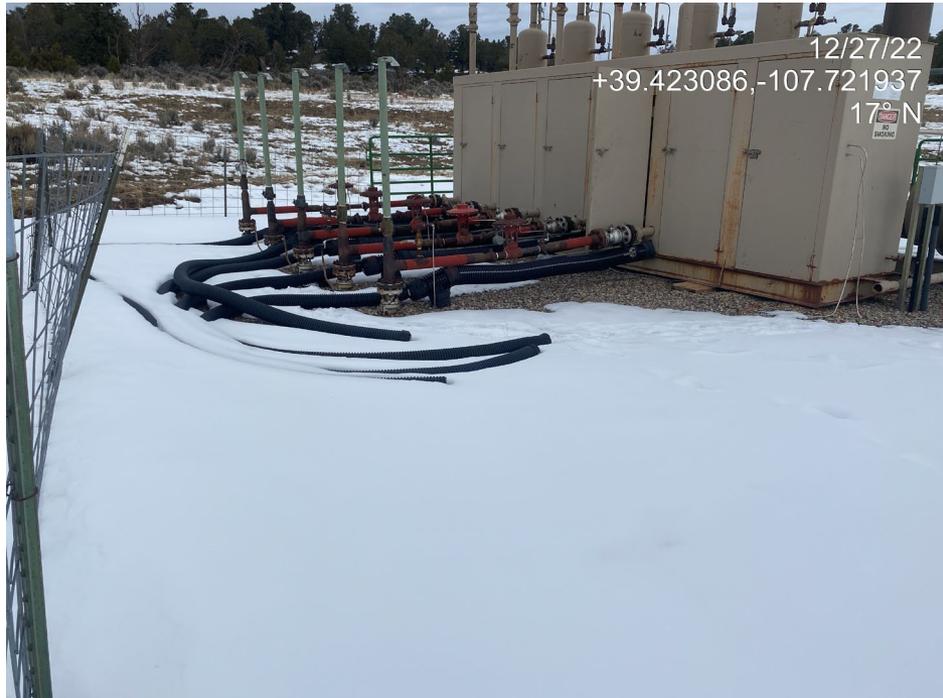
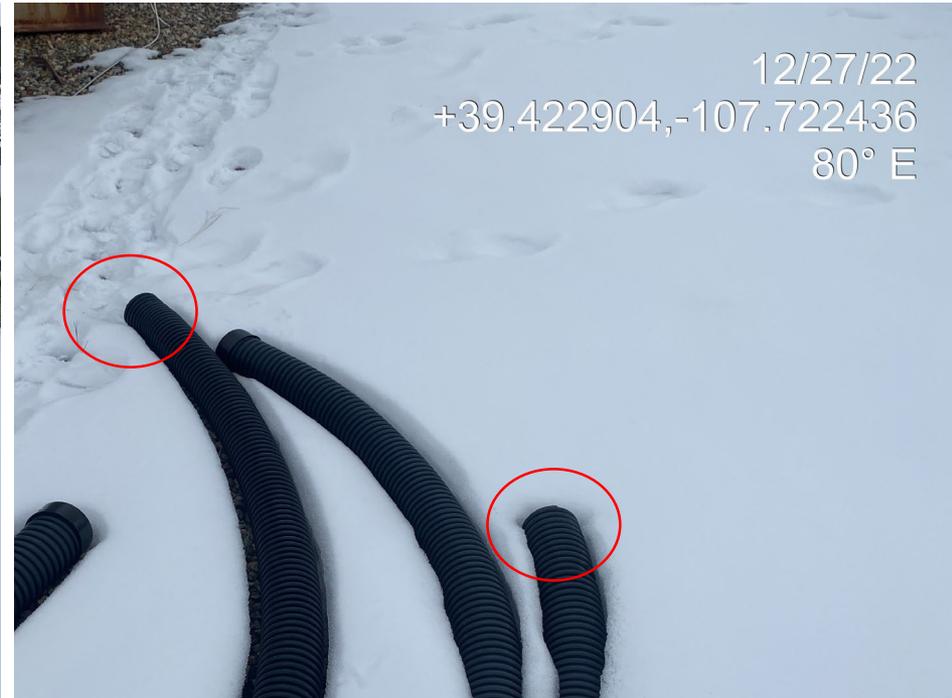
Photo 3. Photos shows open ended piping at separators.

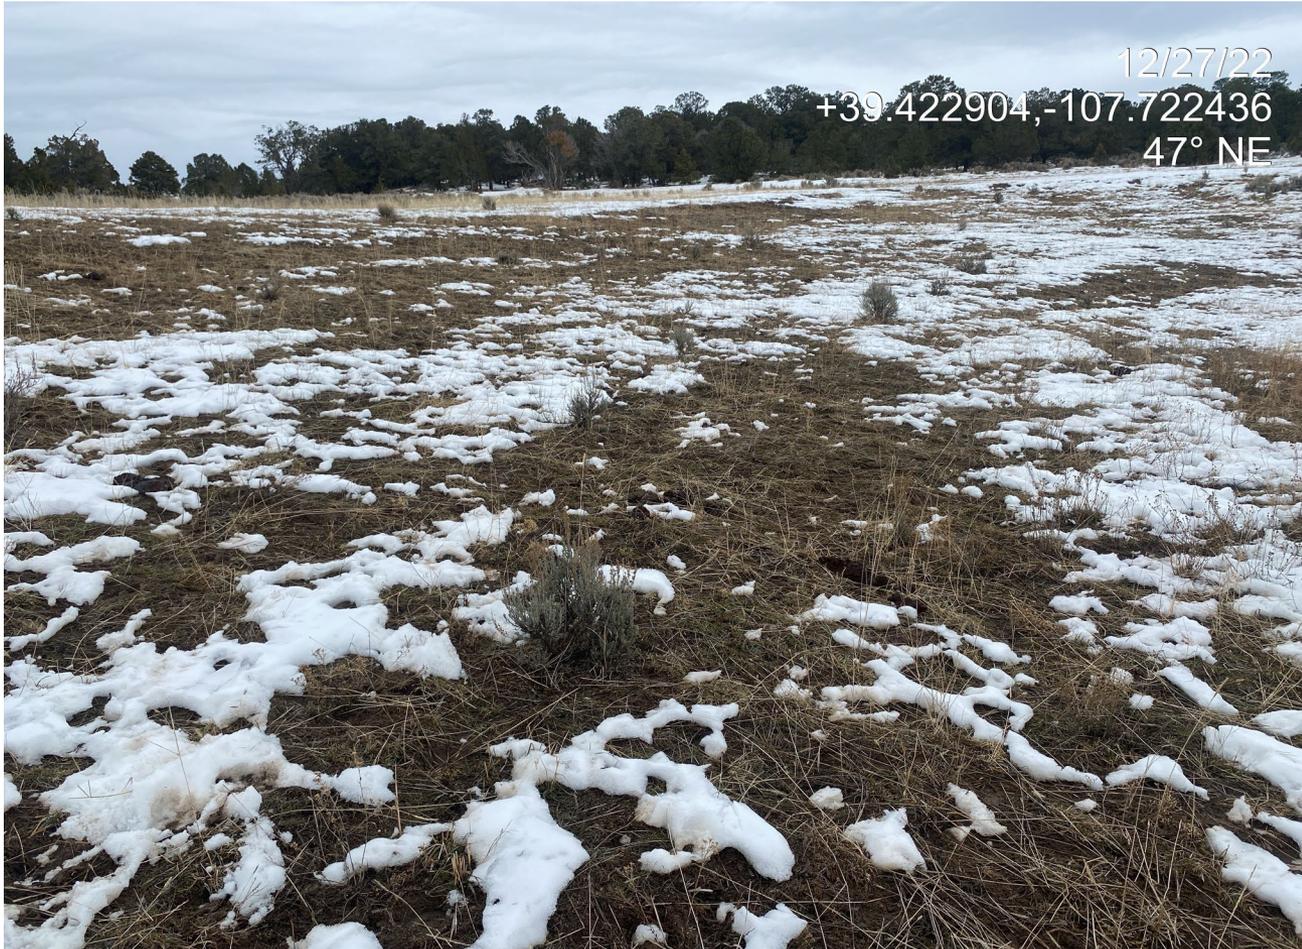
**Photo 4.** Photo shows interim areas at the north of the location. Perennial grasses are present, however low residual cover from grazing and dormant season prevented full vegetation assessment.
