Inspection Photos

STATE 36-05 BIG PIT

Operator: PETROGLYPH OPERATING CO

Inspection Date: 1/6/2023

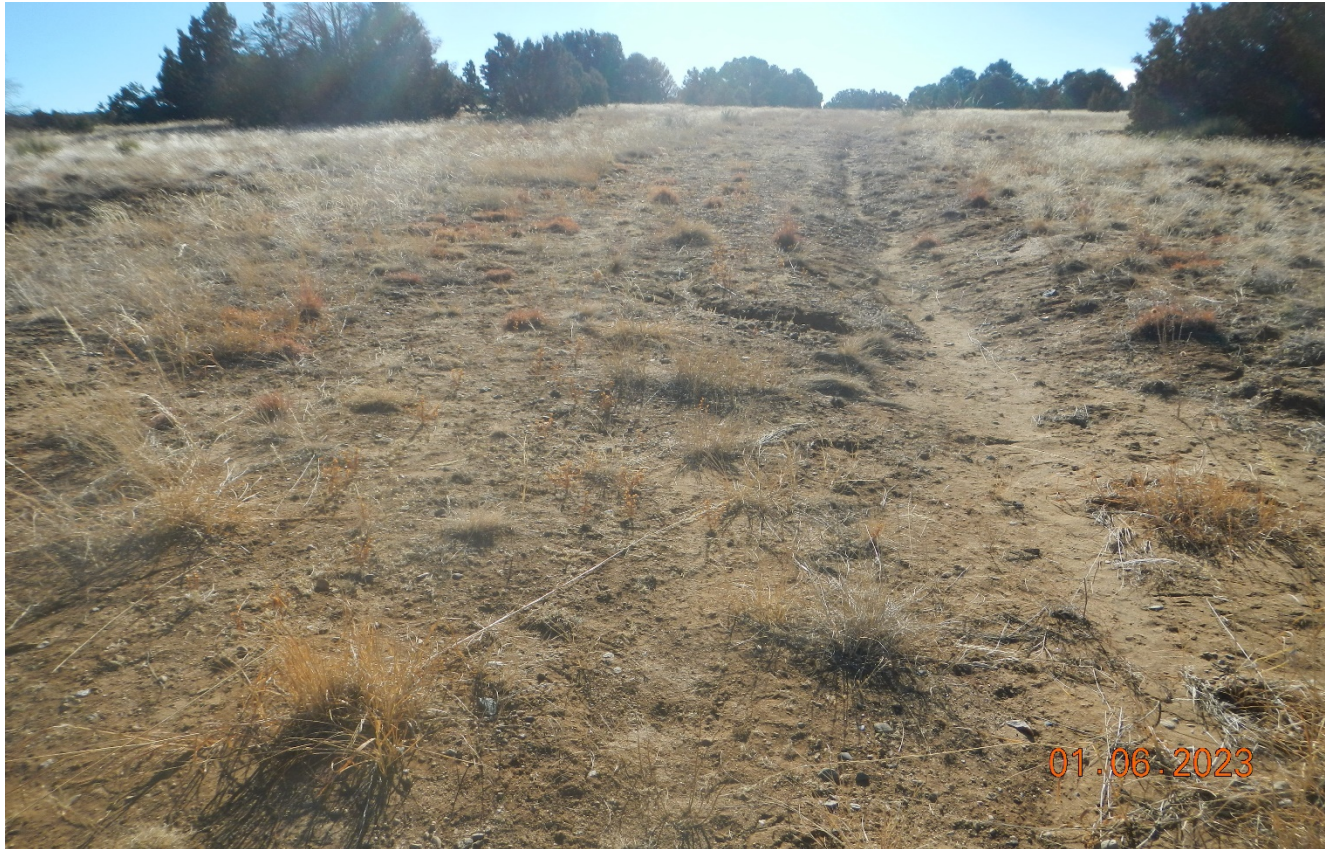
Photo 1. Facing south at the beginning of the access road. There is erosion in this area nag vegetation has not fully established.

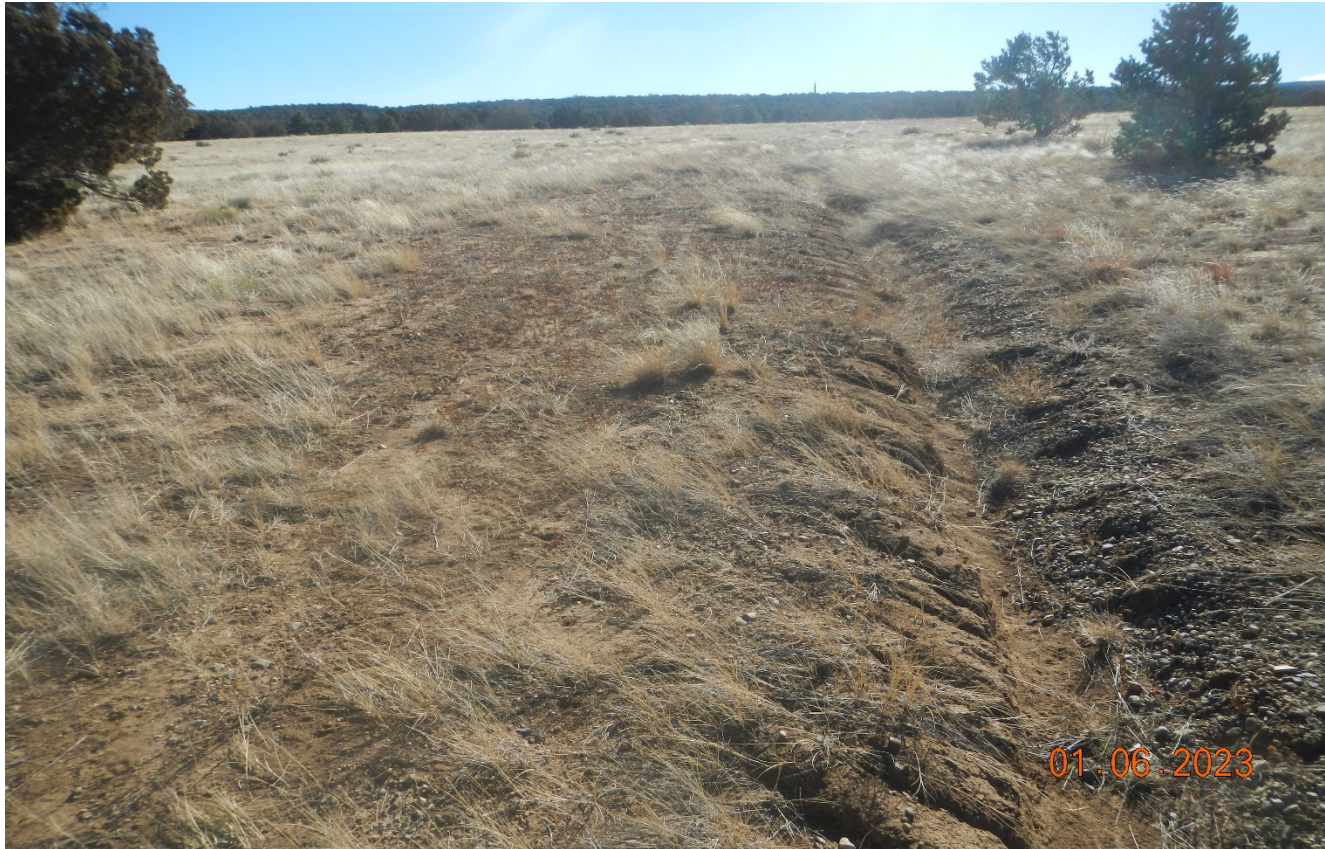
Photo 2. There is an erosion channel along the former road. This needs to be repaired and reclaimed. Previous corrective action was not completed.

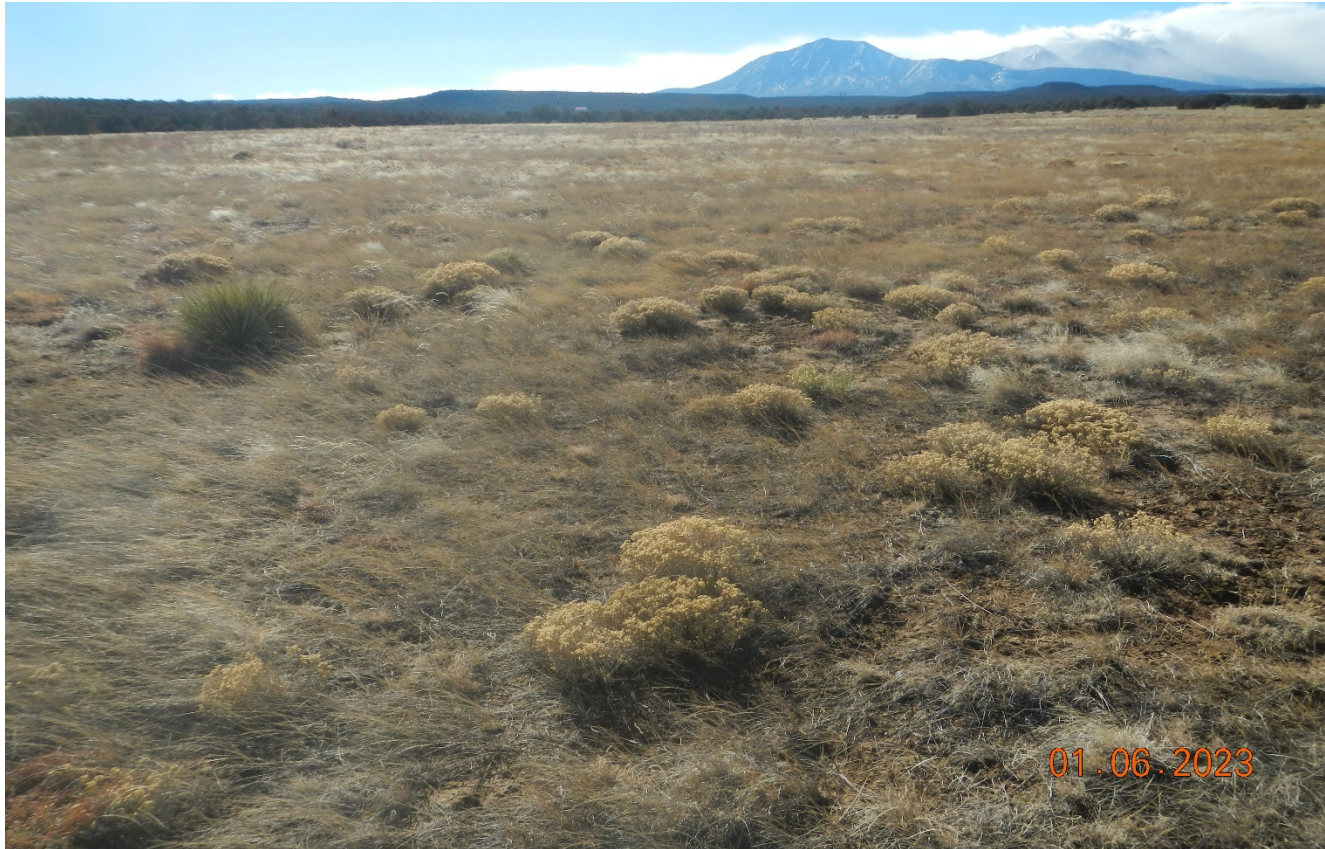
Photo 3. Facing south toward the Big Pit location. Perennial vegetation is progressing throughout this area.

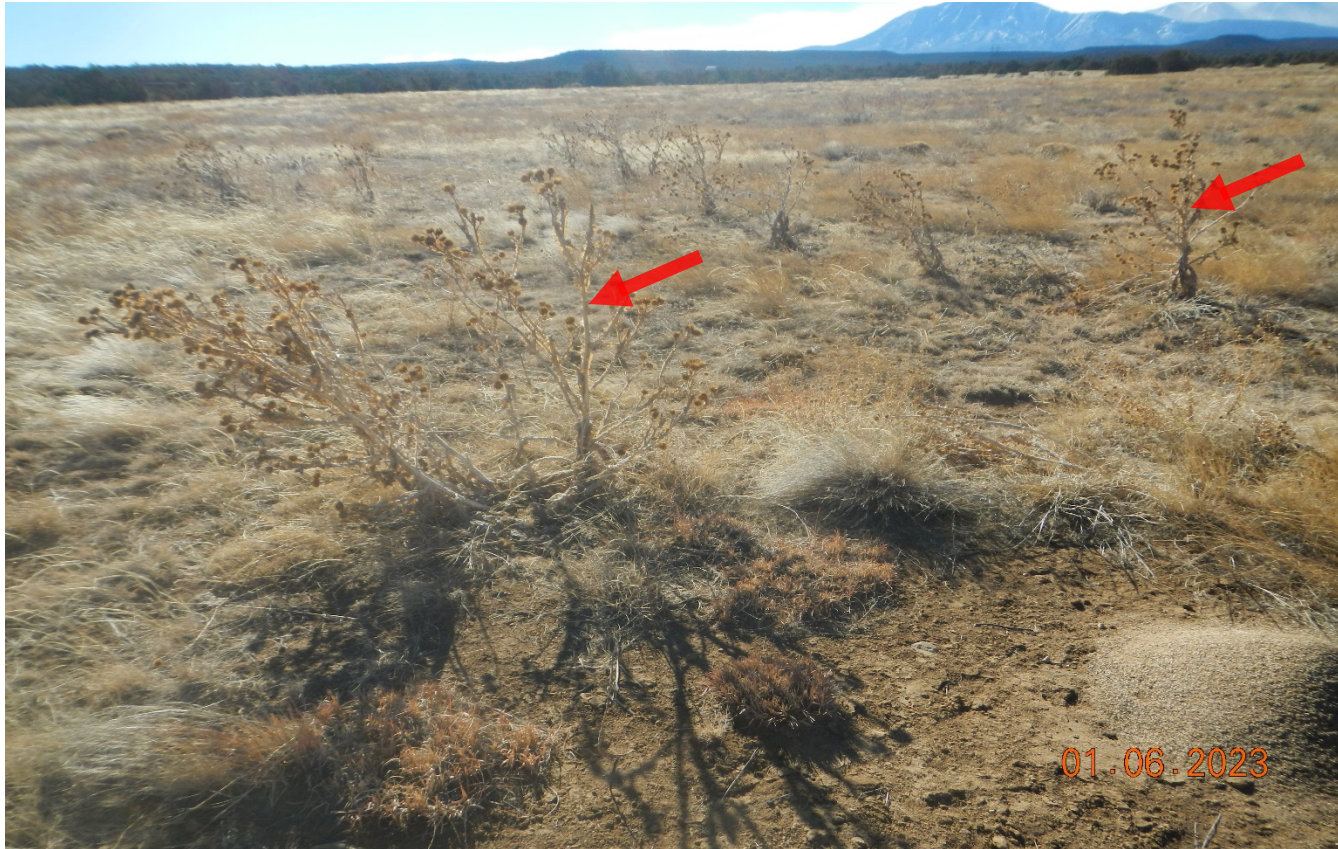
Photo 4. Center of the Big Pit location. There are numerous noxious weeds (Scotch thistle) that have not been controlled.

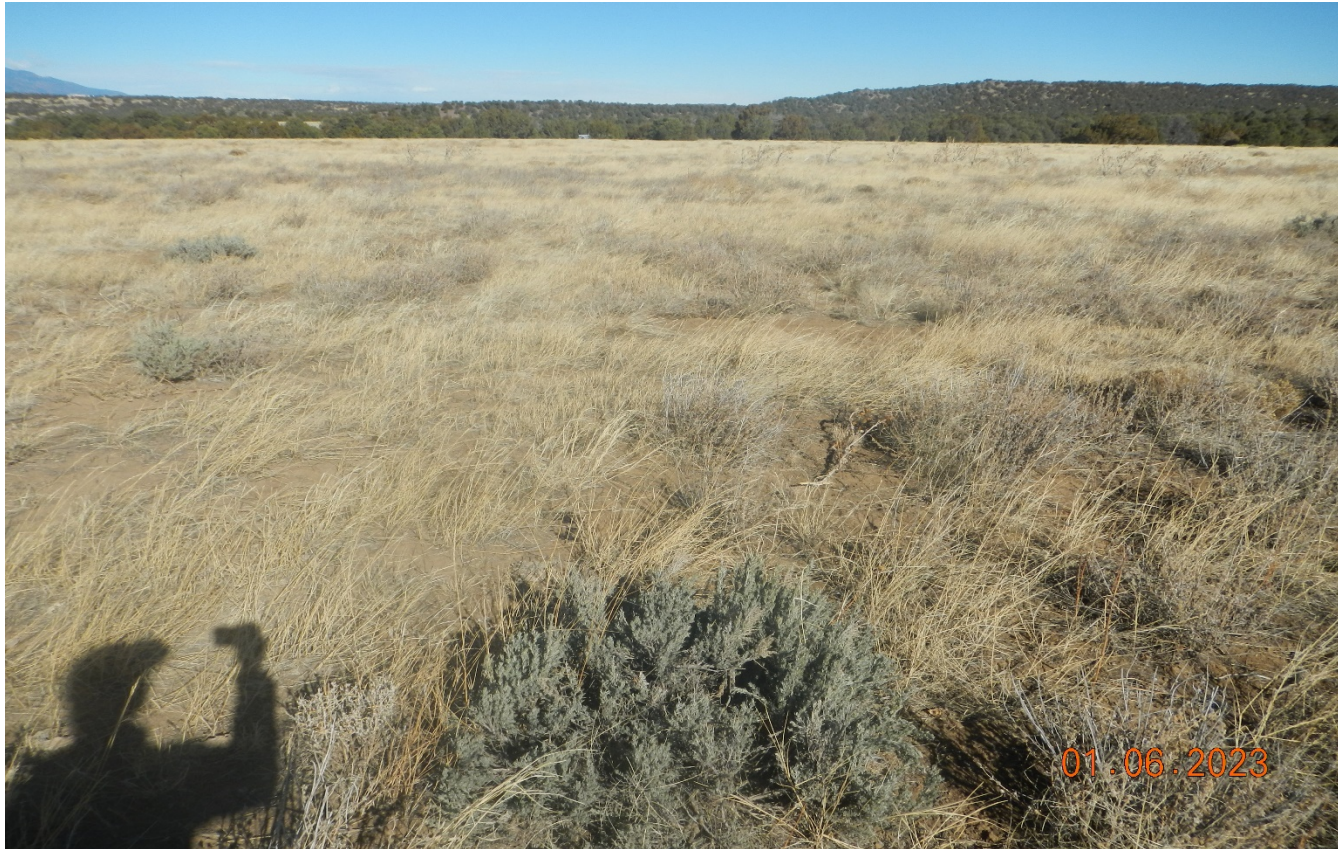
Photo 5. Facing north toward the reclaimed STATE 36-05 BIG PIT. Perennial vegetation is progressing throughout this area.
