Inspection Photos

Location Name: SHAEFFER-67S93W/12NWNW

Inspection Document #: 702801158

Anna O'Malley
Reclamation Specialist, COGCC

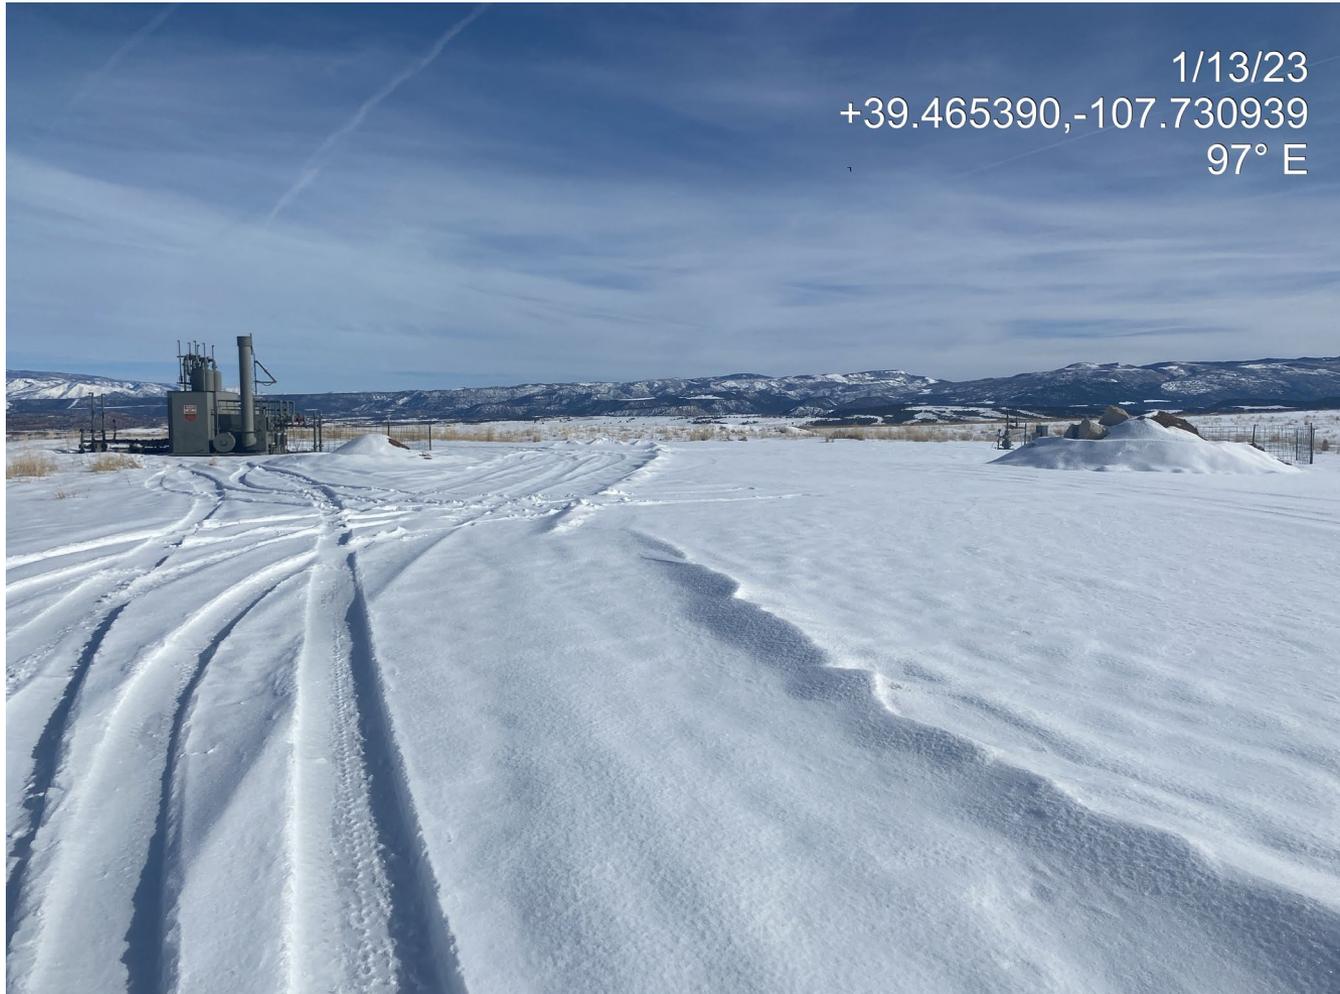
Photo 1. Photo taken from the west shows an overview of the location.

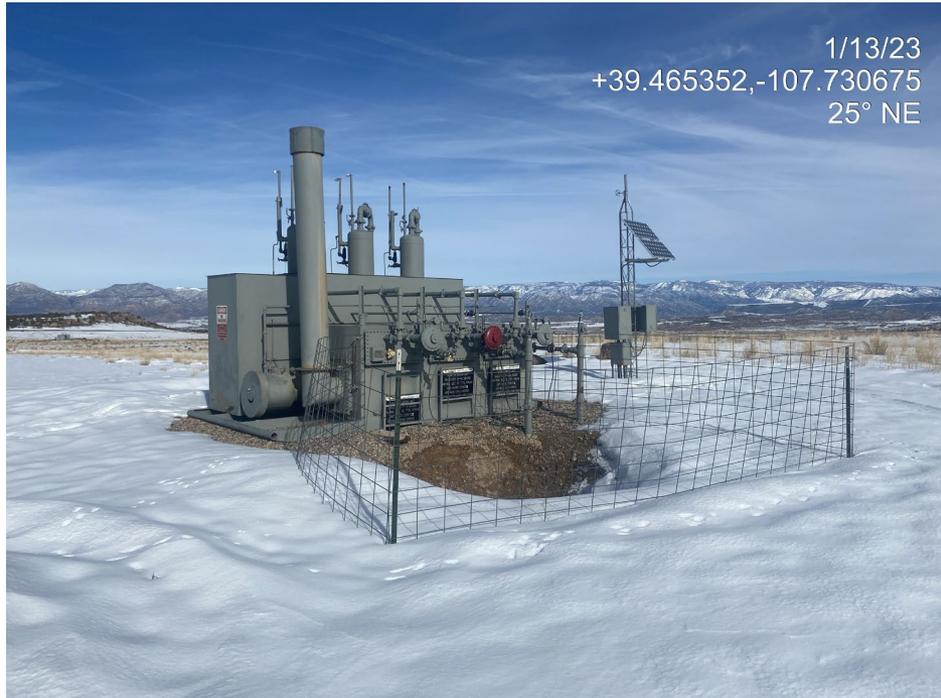
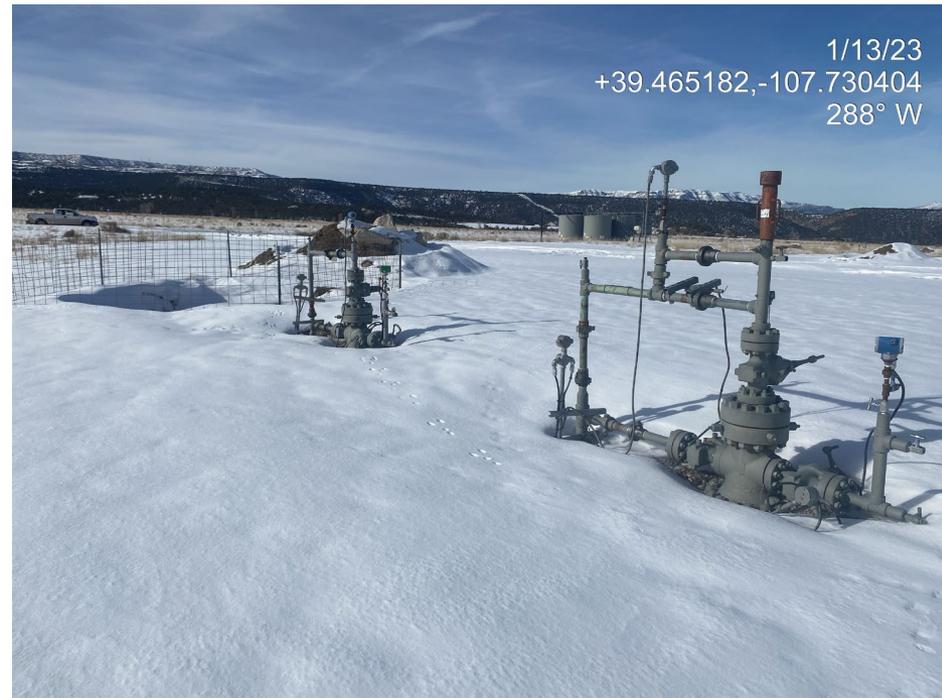
Photo 2. Photos show production areas. Excavations at the separator and wellhead are for decommissioning of plugged and abandoned well API # 045-09133 and the associated flowline.

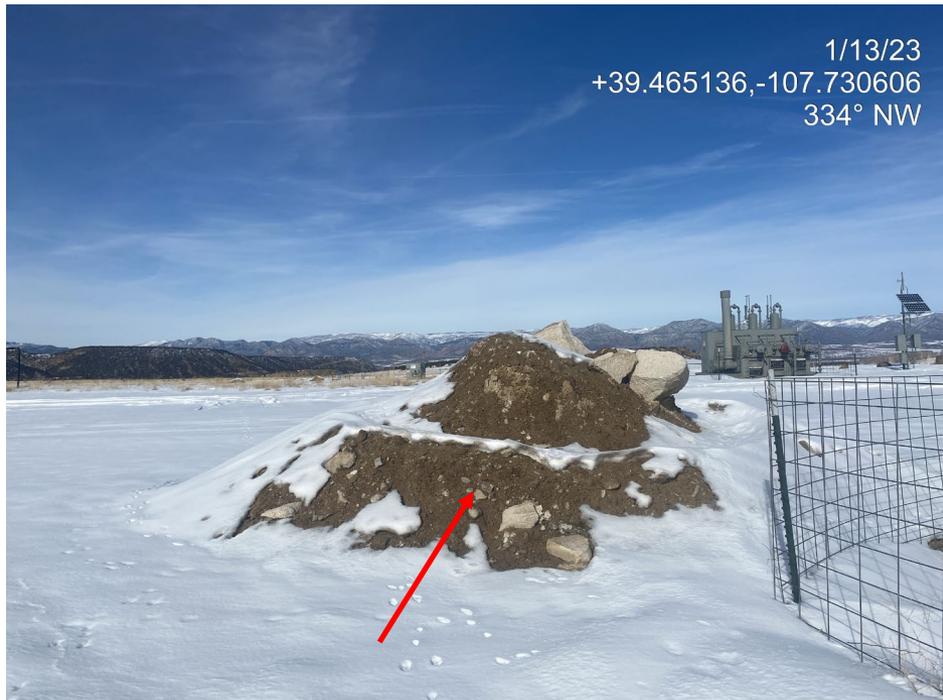
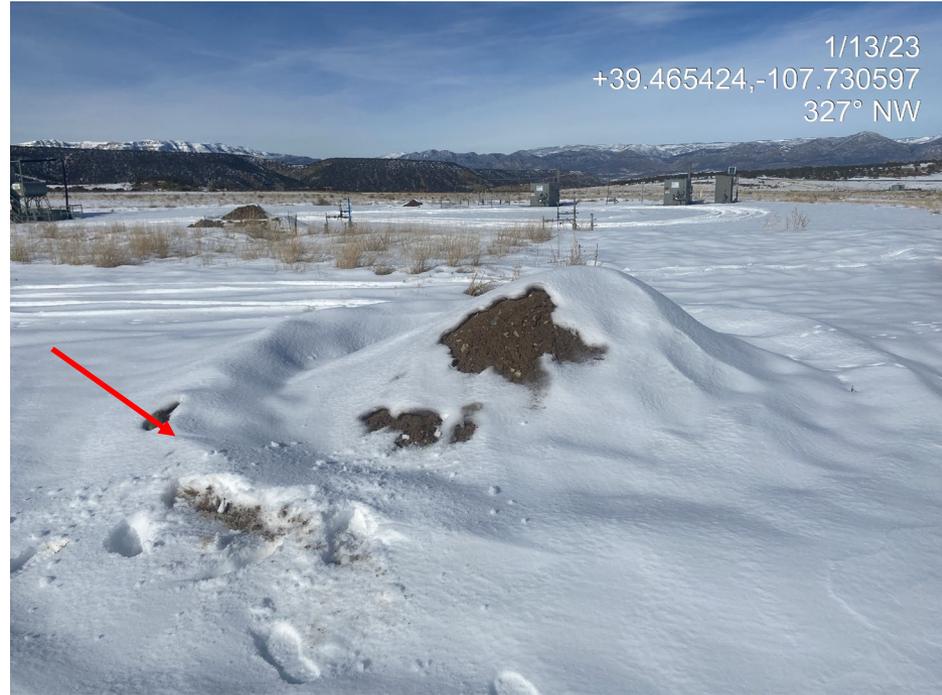
Photo 3. Photos show soil stockpiles from the plugged and abandoned well (left) and flowline (right) excavations. Excavated soil is surrounded by a berm of loose, unconsolidated soil.

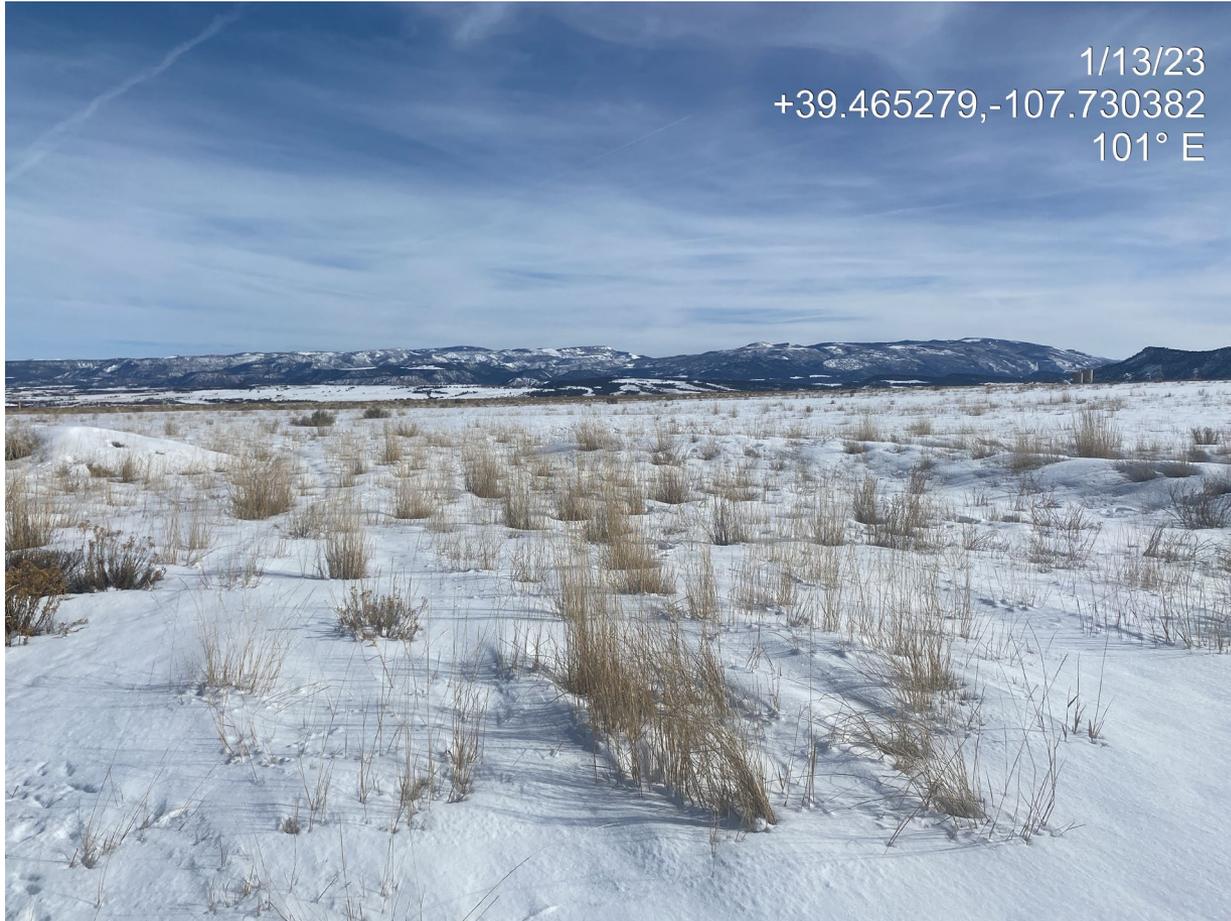
Photo 4. Photo shows an example of location interim areas. Introduced perennial grasses appear established.
