Attachment B

SITE NAME: Totems 44-24 Tank Battery							DATE: 10/21/2022	REM. PROJECT #: 24688		WEATHER: Sunny, 70's	
SITE DIRECTIONS: CR 6 & CR13 W 0.2 N into							CLIENT: PDC				
LEGALS AND LAT/LONG: (40.0295530, -104.9493141)							TASMAN PERSONNEL: AO				
SOIL TYPES: Lean Clay - CL							SURFACE GRADIENT: Northwest				
SOIL SAMPLING							FACILITY INFRASTRUCTURE				
Date/Time	Soil Sample ID	PID (ppm)	Visual	Olfactory	Photo?	Grab or Lab Sample?	EQUIPMENT		Quantity		
							Above Ground Storage Tank (AST)		1		
10/21/2022 13:12	SEP01-FL@4'	0.2	No Staining	No Odor	Yes	Lab	Buried or Partially Buried Vessel		1		
							Separator		1		
10/21/2022 12:23	MH01@0-6"	0.0	No Staining	No Odor	Yes	Grab	Emission Control Device (ECD)				
10/21/2022 12:25	AST01@0-6"	0.0	No Staining	No Odor	Yes	Lab	Dump Line		1		
							Wellhead				
							Flowline				
							Other: Meterhouse		1		
							Soil Loads Removed				
							IMPACTED SOIL IDENTIFIED?

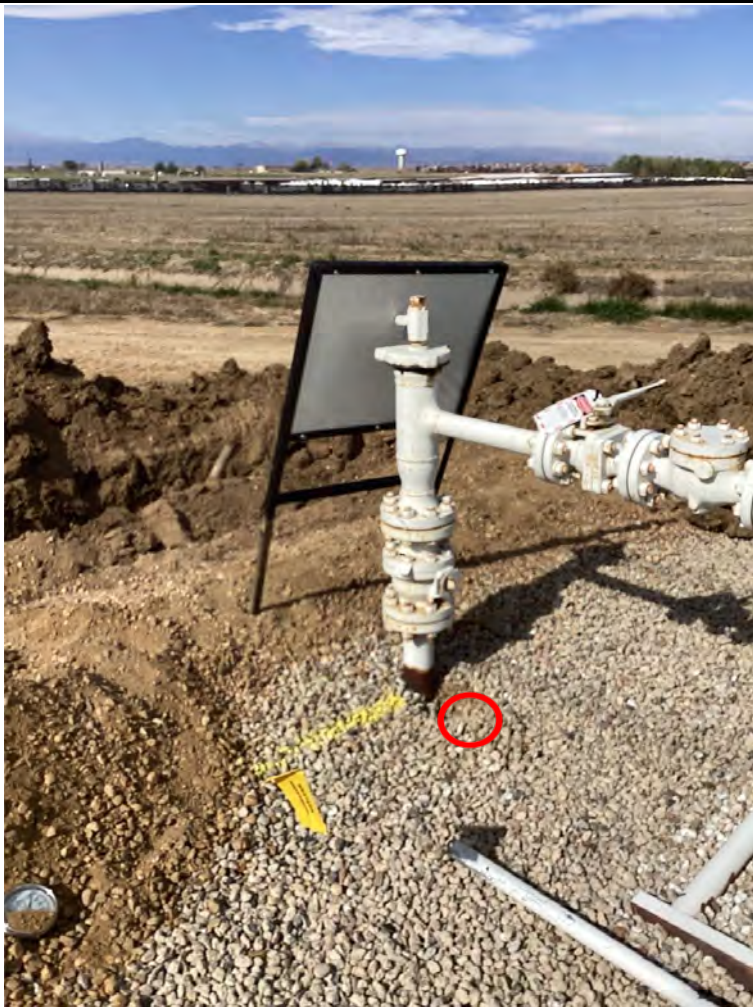
Equipment ID:		Equipment Type:	
Material:	Volume:	Contents:	
Notes/Conditions: MH01

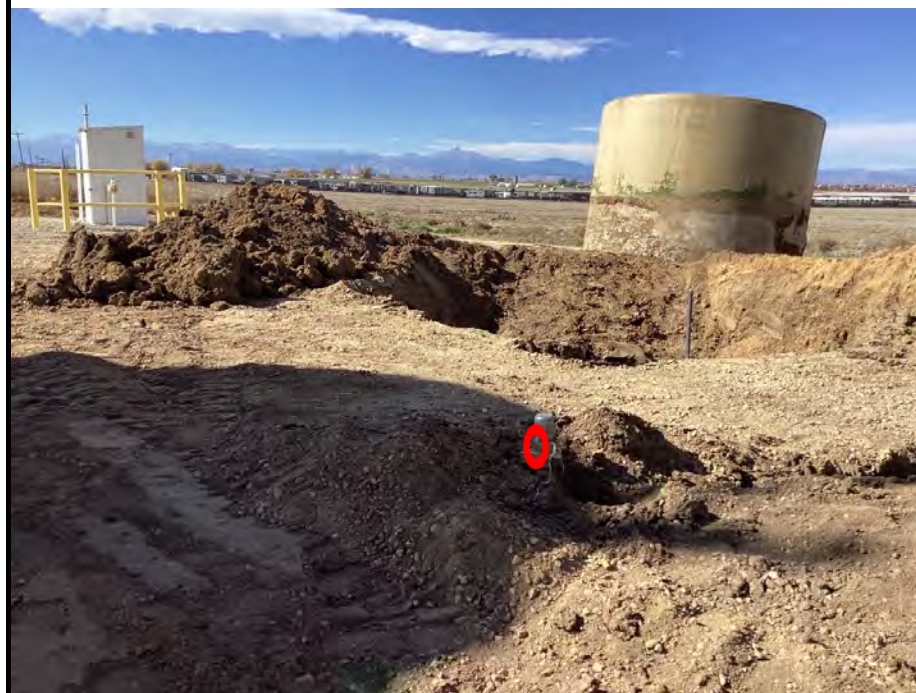
Equipment ID:		Equipment Type:	
Material:	Volume:	Contents:	
Notes/Conditions: AST01

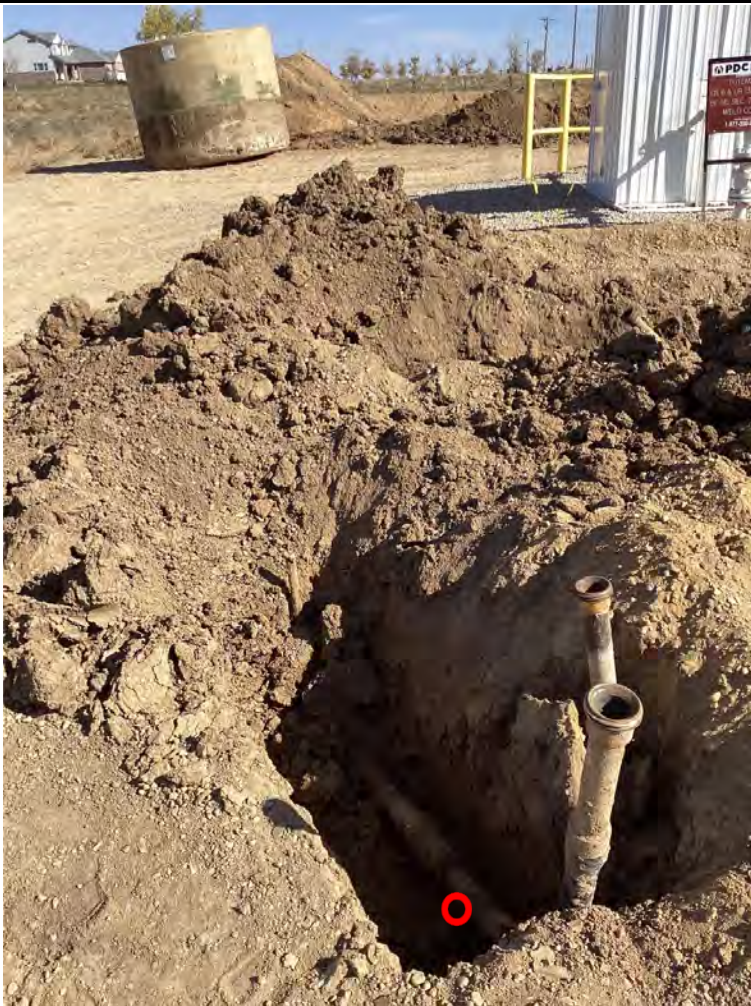
Equipment ID:		Equipment Type:		Equipment ID:		Equipment Type:	
Material:	Volume:	Contents:		Material:	Volume:	Contents:	
Notes/Conditions: SEP01-FL				Notes/Conditions:

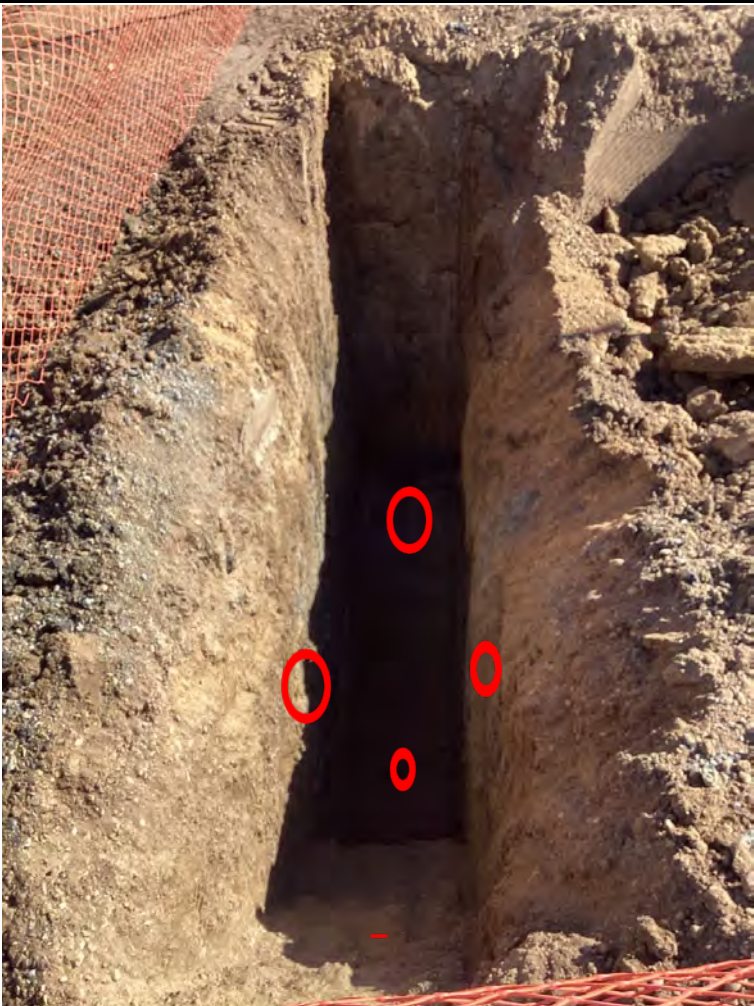
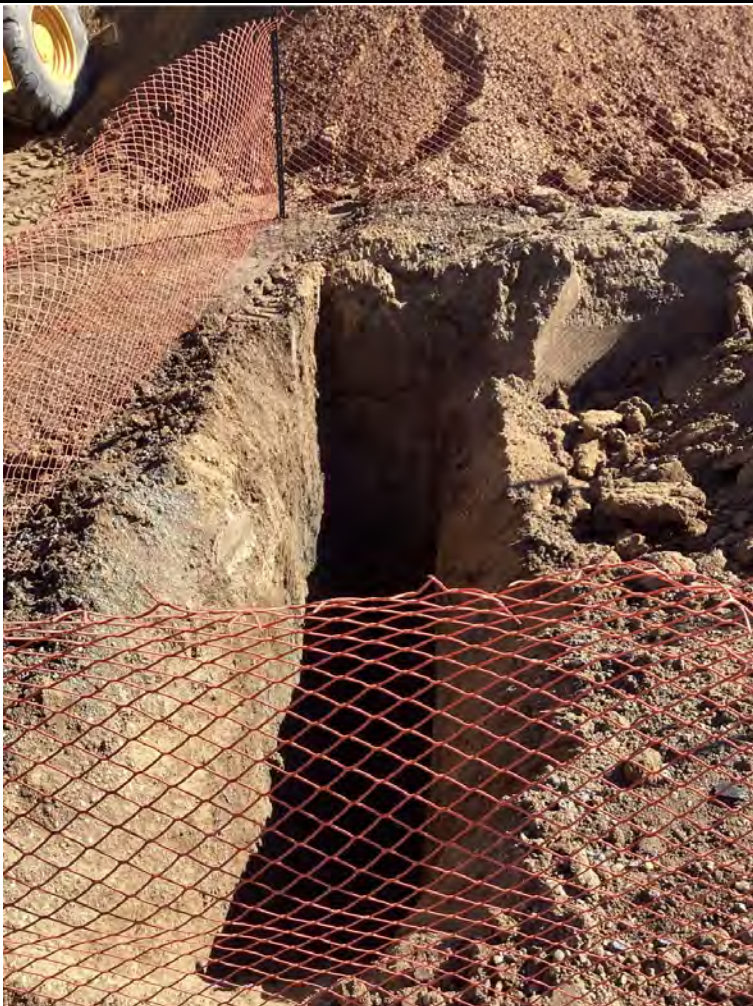
Equipment ID:		Equipment Type:		Equipment ID:		Equipment Type:	
Material:		Volume:		Material:		Volume:	
		Contents:				Contents:	
Notes/Conditions: Top = PWV-W, Bottom= PWV-E, Left = PWV-S, Right = PWV-N, Center = PWV-B				Notes/Conditions:

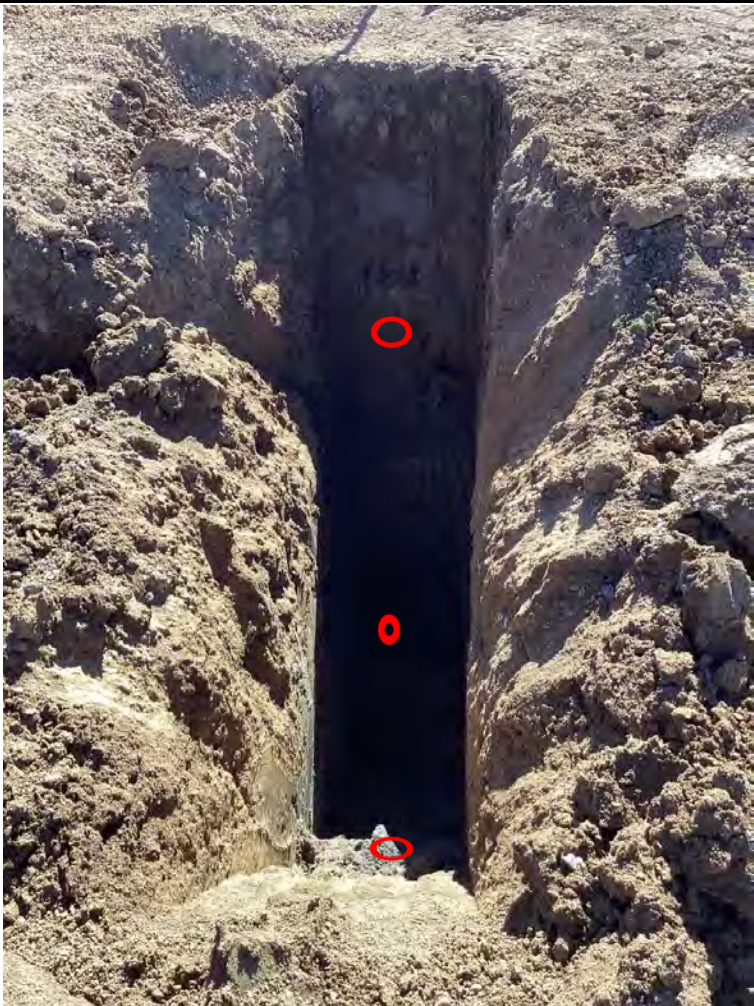
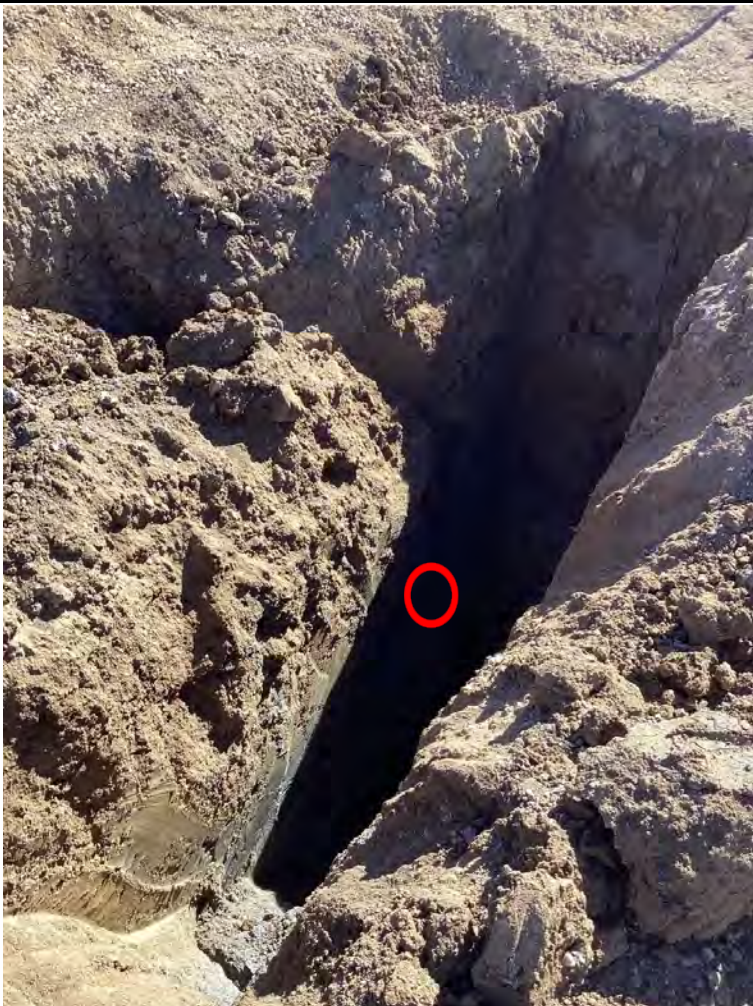
Equipment ID:		Equipment Type:		Equipment ID:		Equipment Type:	
Material:		Volume:		Material:		Volume:	
		Contents:				Contents:	
Notes/Conditions: Top: SEP-DL-S, Bottom: SEP-DL-N, Center: SEP-DL-B				Notes/Conditions: SEP-DL-E

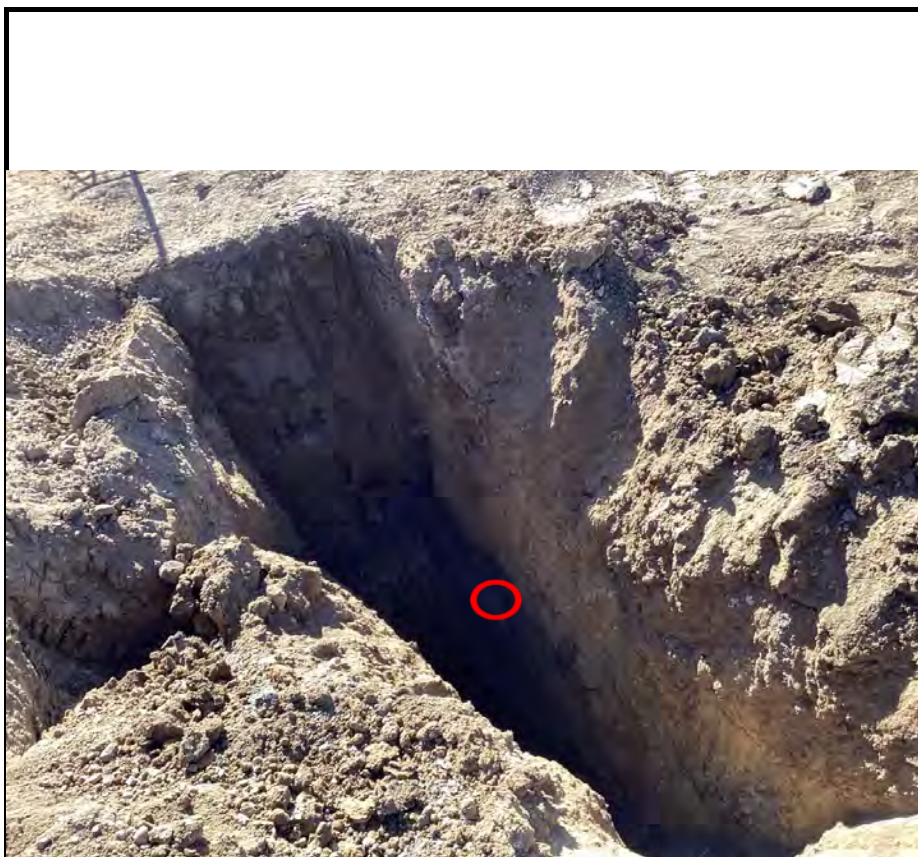
Equipment ID:		Equipment Type:		Equipment ID:		Equipment Type:	
Material:	Volume:	Contents:		Material:	Volume:	Contents:	
Notes/Conditions: SEP-DL-W				Notes/Conditions: BKG01

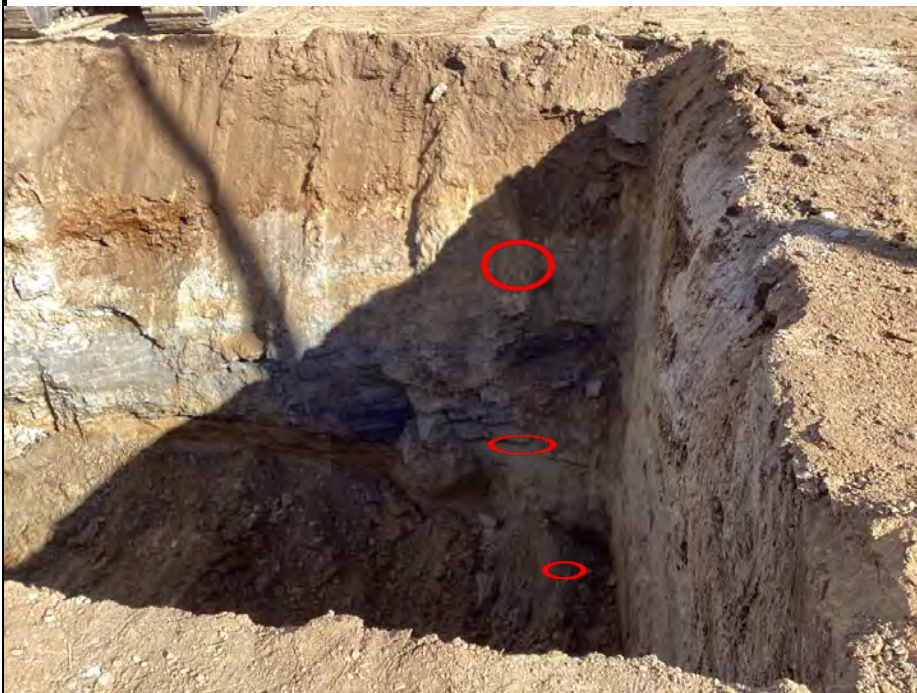
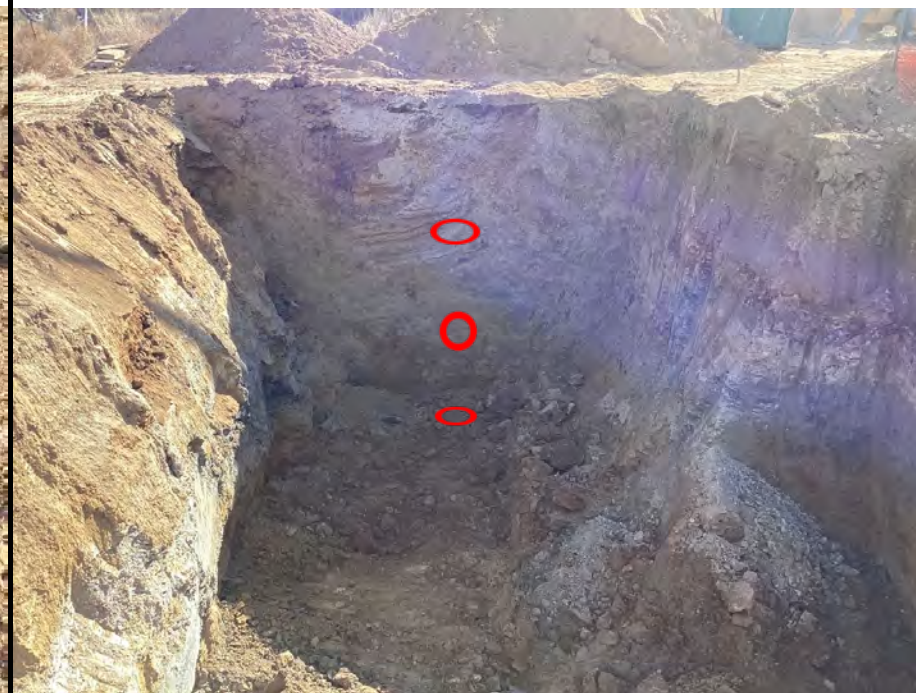
Equipment ID:		Equipment Type:		Equipment ID:		Equipment Type:					
Material:		Volume:		Contents:		Material:		Volume:		Contents:	
Notes/Conditions: Top:SS09, Middle:SS10, Bottom:SS11						Notes/Conditions: Top: SS04, Middle SS05, Bottom SS06

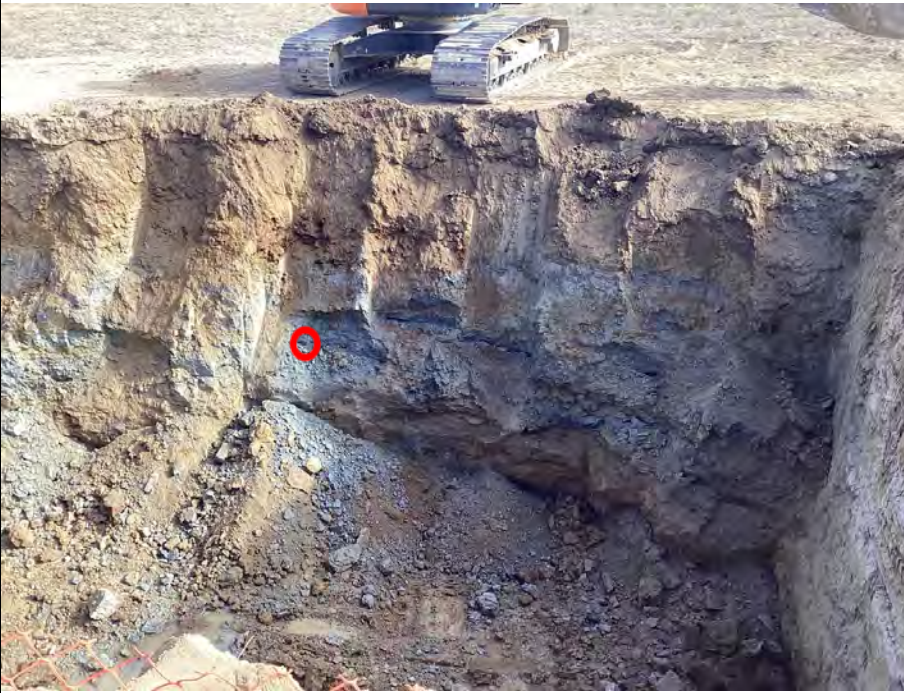
Equipment ID:		Equipment Type:		Equipment ID:		Equipment Type:	
Material:		Volume:		Material:		Volume:	
		Contents:				Contents:	
Notes/Conditions: GS28@10.5				Notes/Conditions: GS29@10.5

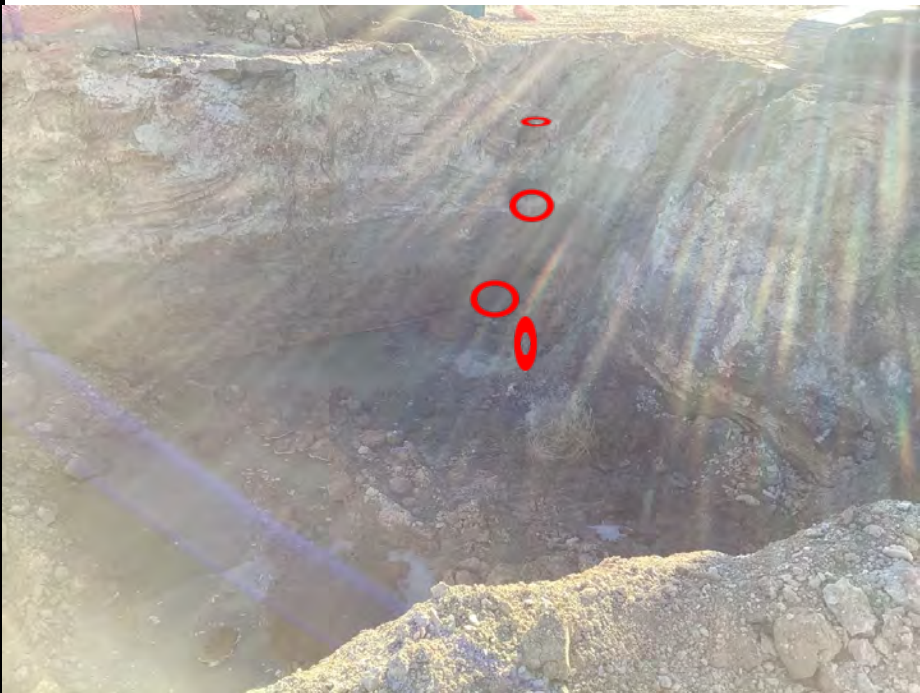
Equipment ID:		Equipment Type:		Equipment ID:		Equipment Type:					
Material:		Volume:		Contents:		Material:		Volume:		Contents:	
Notes/Conditions: Top:SS21 Middle:SS22 Bottom:SS23 Bottom-Right:SS24						Notes/Conditions:

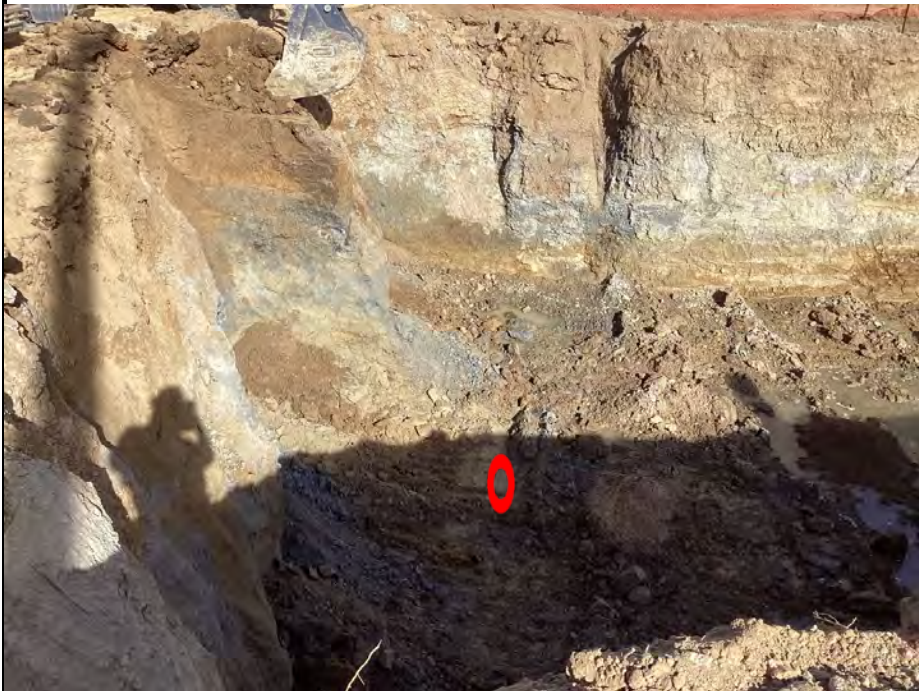
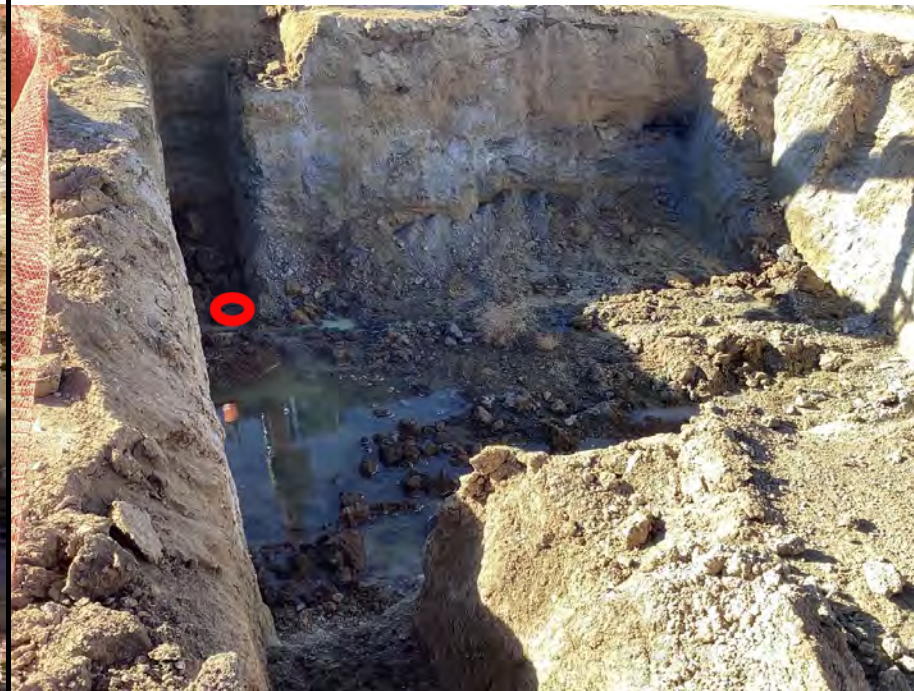
Equipment ID:		Equipment Type:		Equipment ID:		Equipment Type:					
Material:		Volume:		Contents:		Material:		Volume:		Contents:	
Notes/Conditions: SS24						Notes/Conditions: SS25

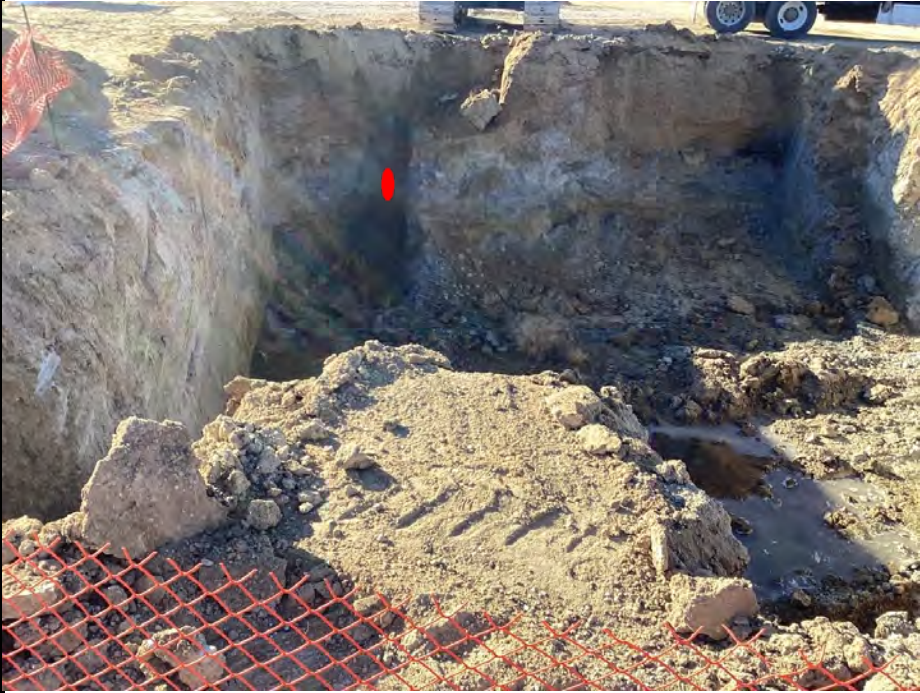
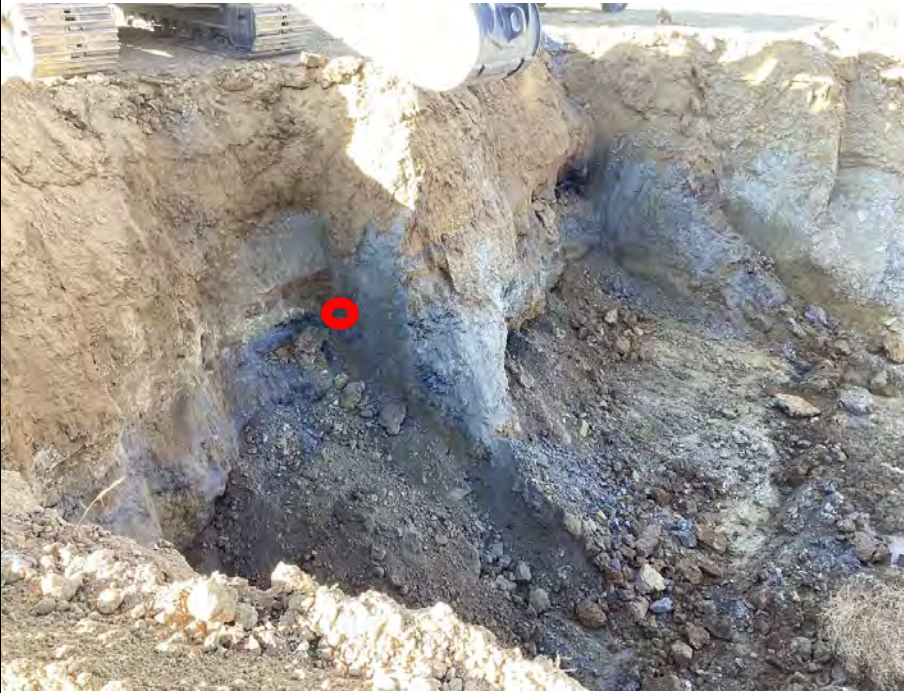
Equipment ID:		Equipment Type:		Equipment ID:		Equipment Type:	
Material:	Volume:	Contents:		Material:	Volume:	Contents:	
Notes/Conditions: GS36@10.5				Notes/Conditions: GS37

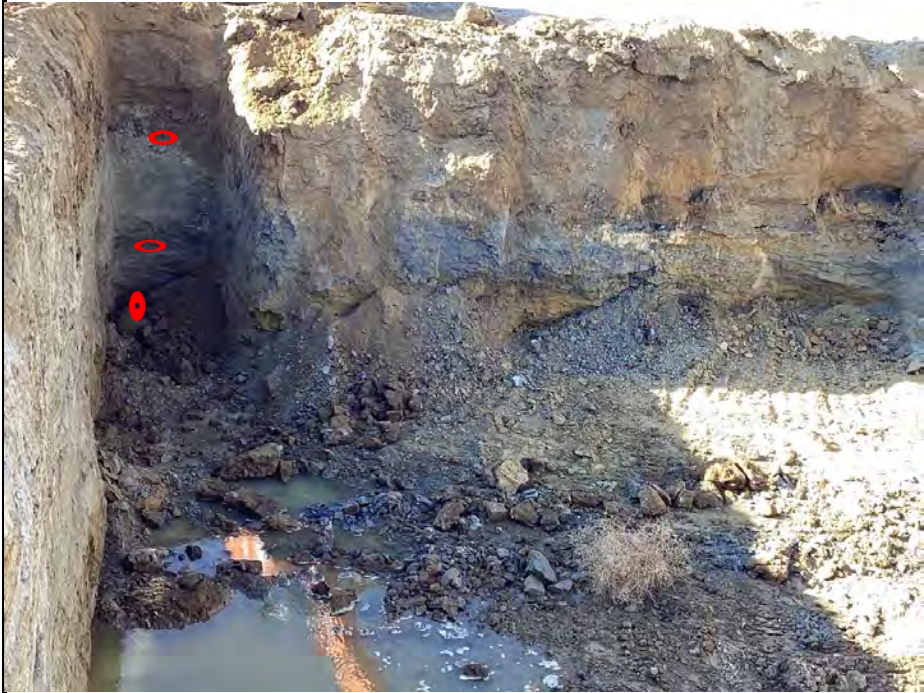
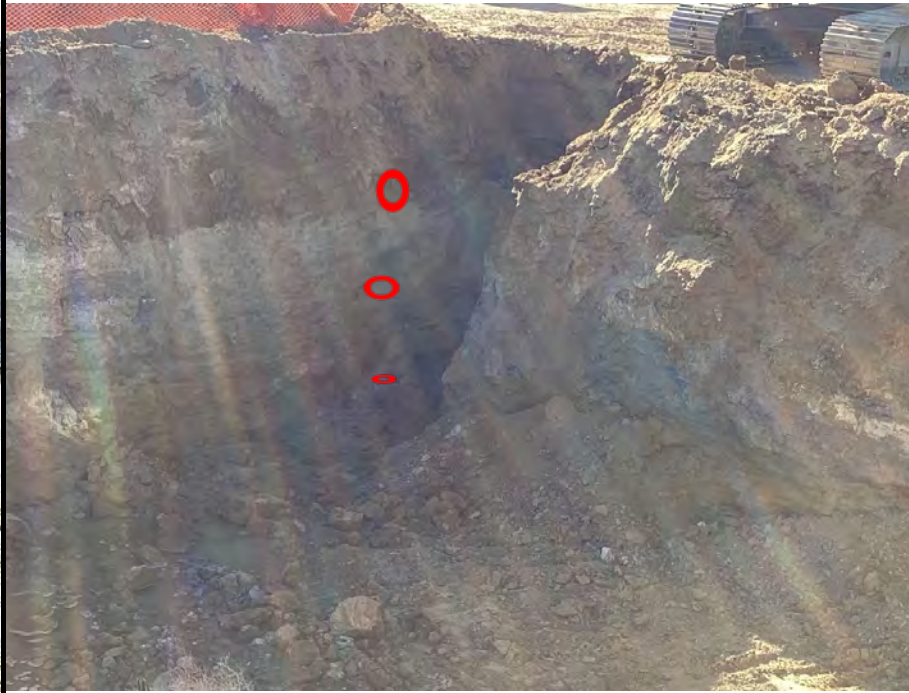
Equipment ID:		Equipment Type:		Equipment ID:		Equipment Type:	
Material:	Volume:	Contents:	Material:	Volume:	Contents:		
Notes/Conditions: Top SS26, Middle SS27, Bottom SS28			Notes/Conditions: Top SS29, Middle SS30, Bottom SS31

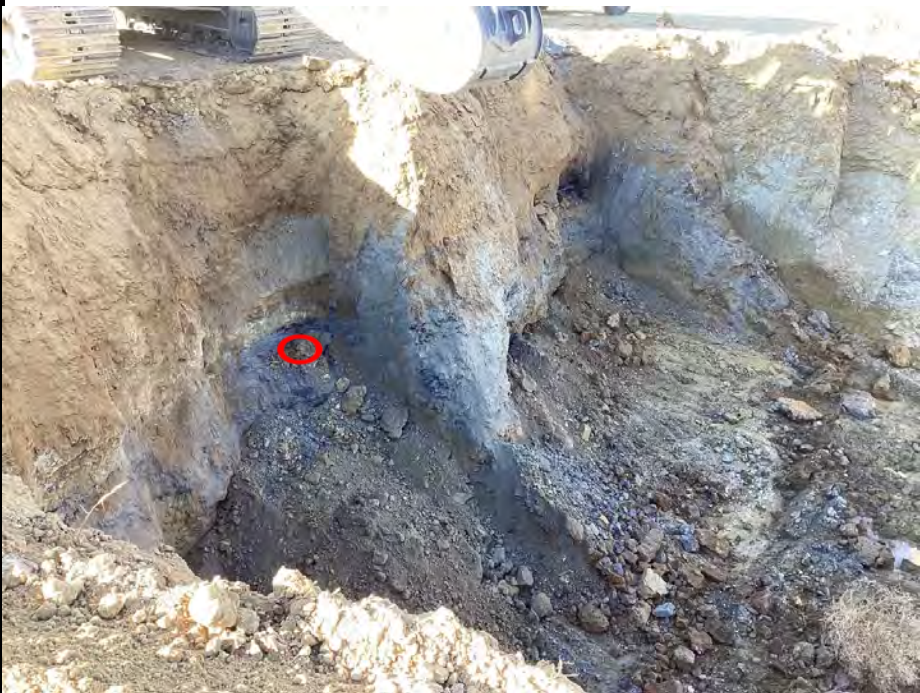
Equipment ID:		Equipment Type:		Equipment ID:		Equipment Type:					
Material:		Volume:		Contents:		Material:		Volume:		Contents:	
Notes/Conditions: GS38						Notes/Conditions:

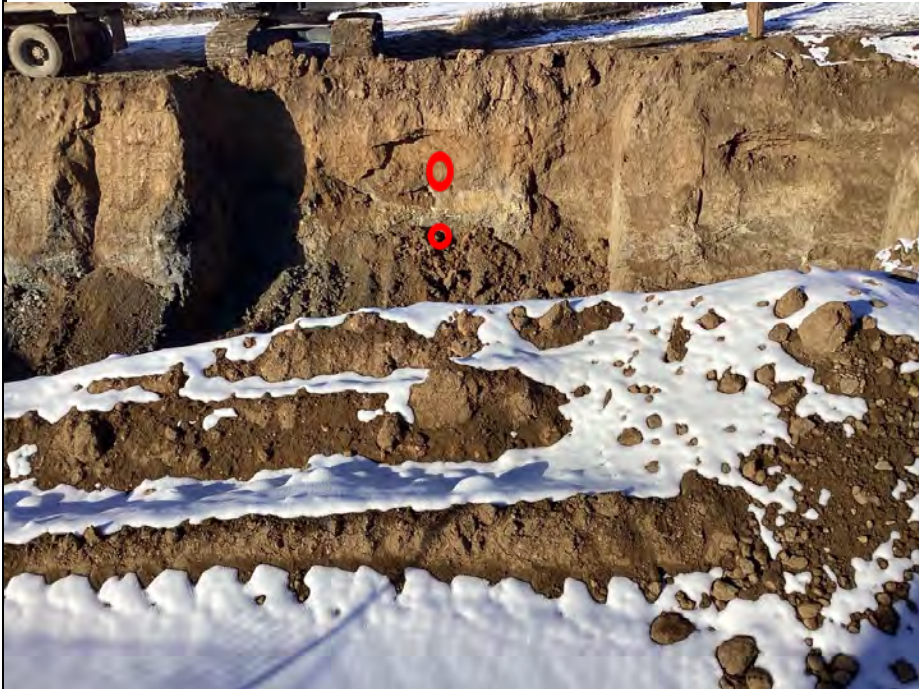
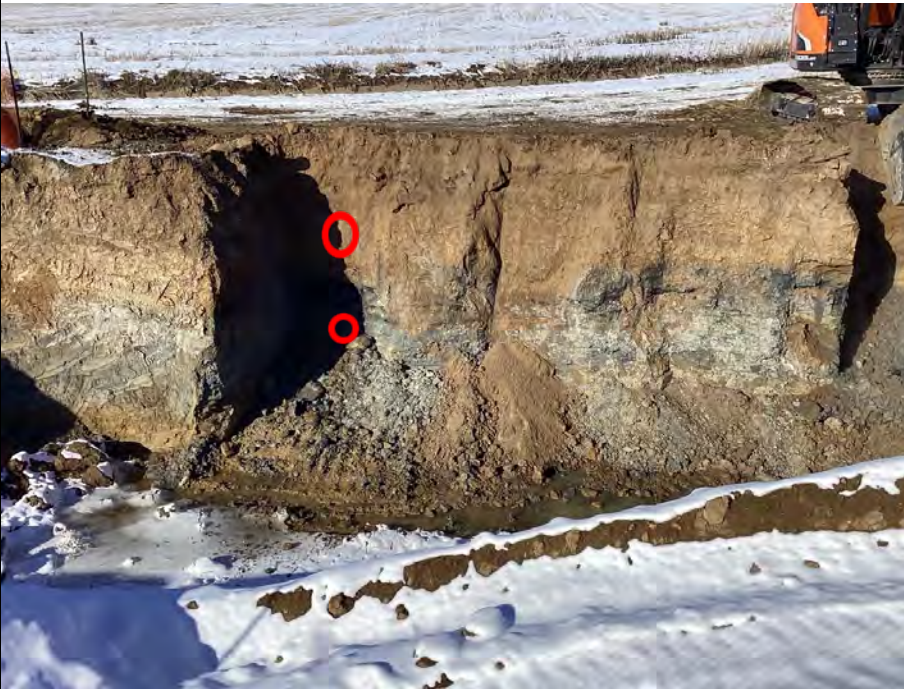
Equipment ID:		Equipment Type:		Equipment ID:		Equipment Type:			
Material:		Volume:		Material:		Volume:		Contents:	
Notes/Conditions: Top:GS42, Bottom:GS43					Notes/Conditions: Top:GS44, Bottom:GS45

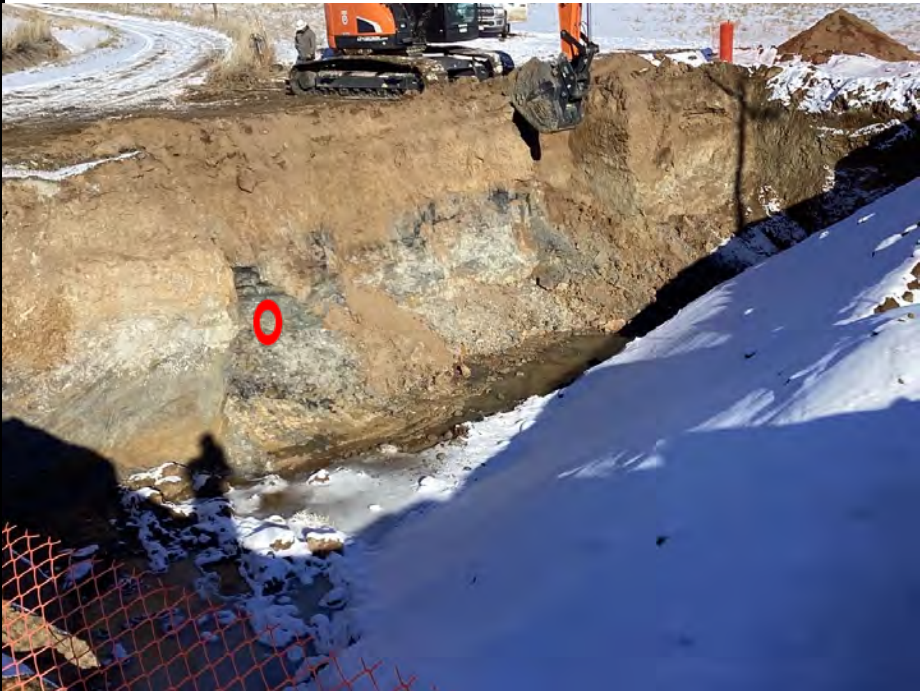
Equipment ID:		Equipment Type:		Equipment ID:		Equipment Type:					
Material:		Volume:		Contents:		Material:		Volume:		Contents:	
Notes/Conditions: GS46						Notes/Conditions:

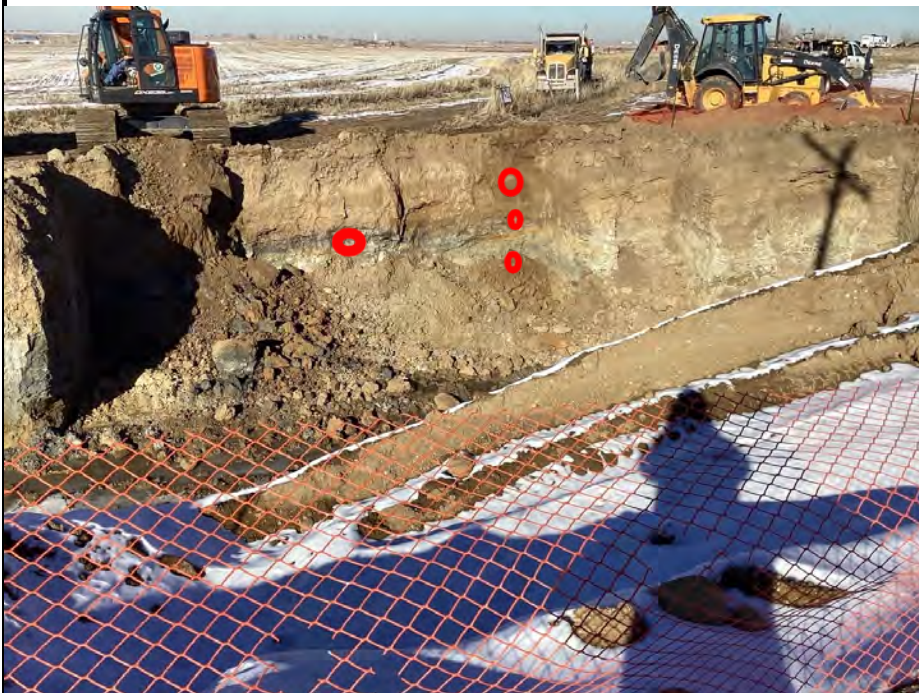
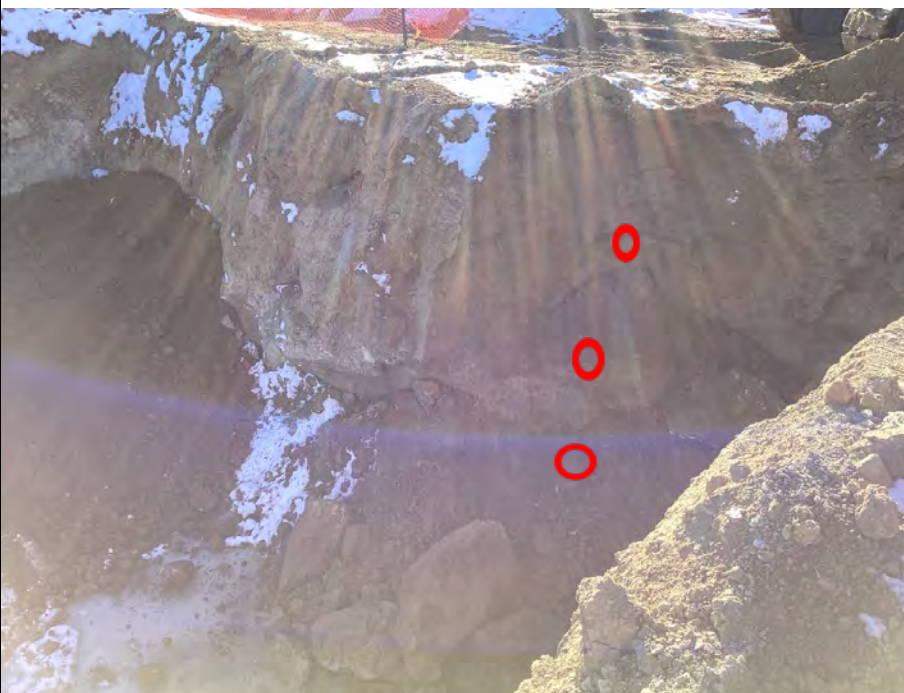
Equipment ID:		Equipment Type:		Equipment ID:		Equipment Type:			
Material:		Volume:		Material:		Volume:		Contents:	
Notes/Conditions: Top: SS44 Middle: SS45, Bottom: SS46 Left: GS47					Notes/Conditions: Top: SSS47, Middle: SS48, Bottom: SS49

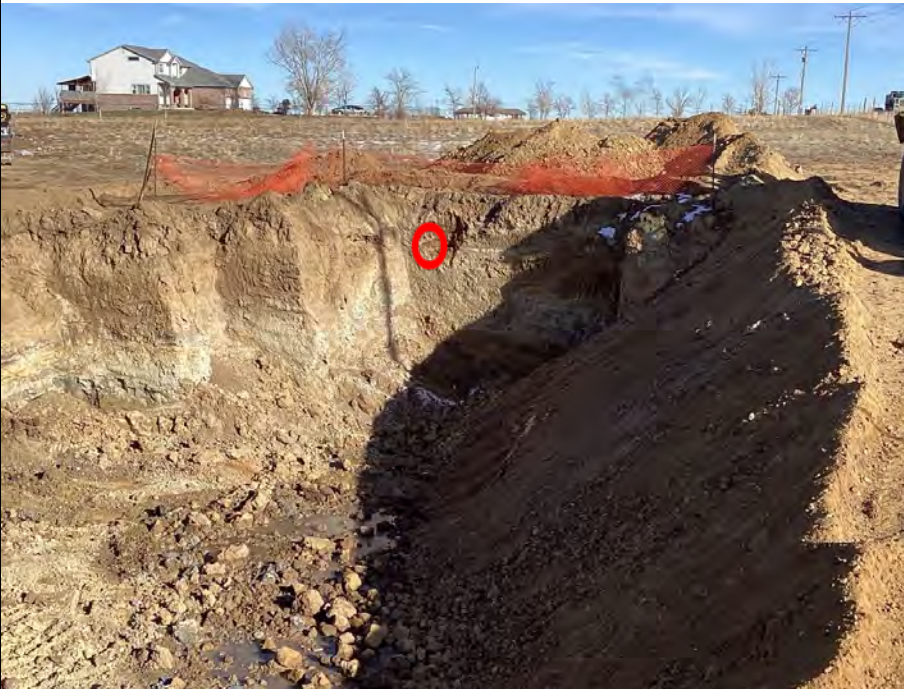
Equipment ID:		Equipment Type:		Equipment ID:		Equipment Type:	
Material:	Volume:	Contents:		Material:	Volume:	Contents:	
Notes/Conditions: Top to Bottom: SS50 SS51 SS52 SS53				Notes/Conditions: SS54

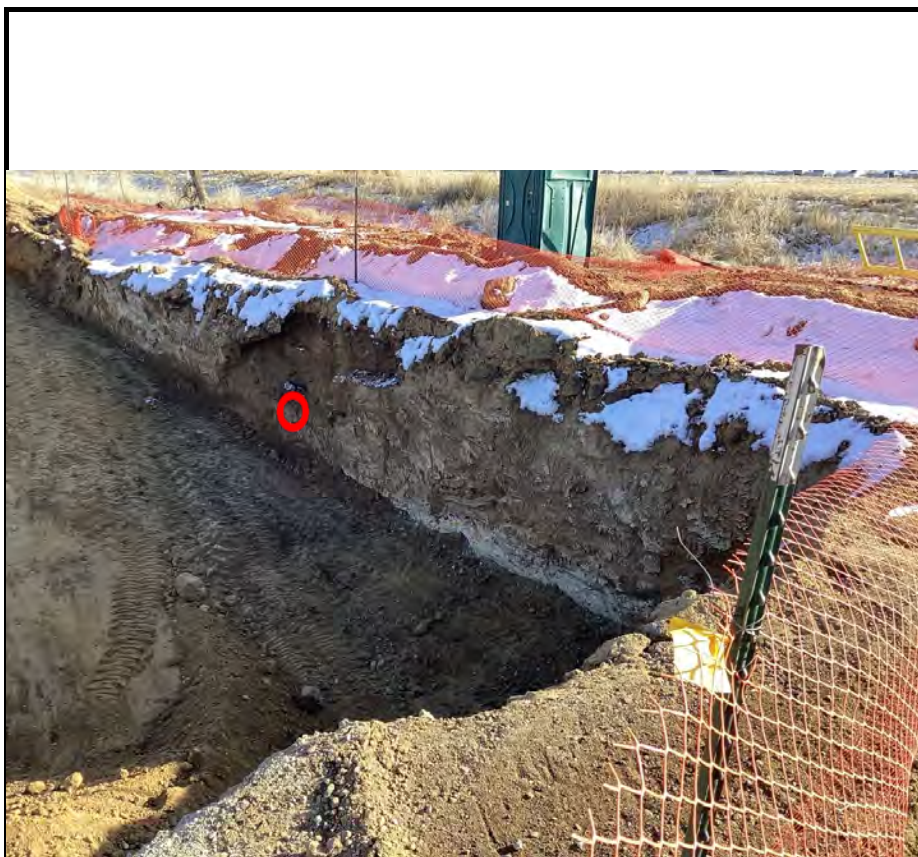
Equipment ID:		Equipment Type:		Equipment ID:		Equipment Type:	
Material:	Volume:	Contents:		Material:	Volume:	Contents:	
Notes/Conditions: SS55				Notes/Conditions:

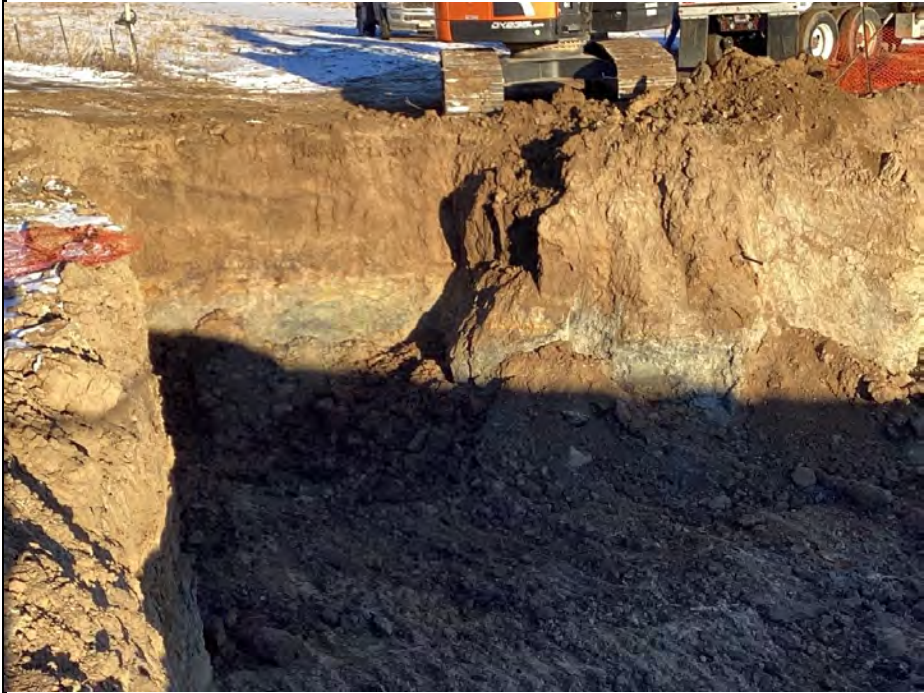
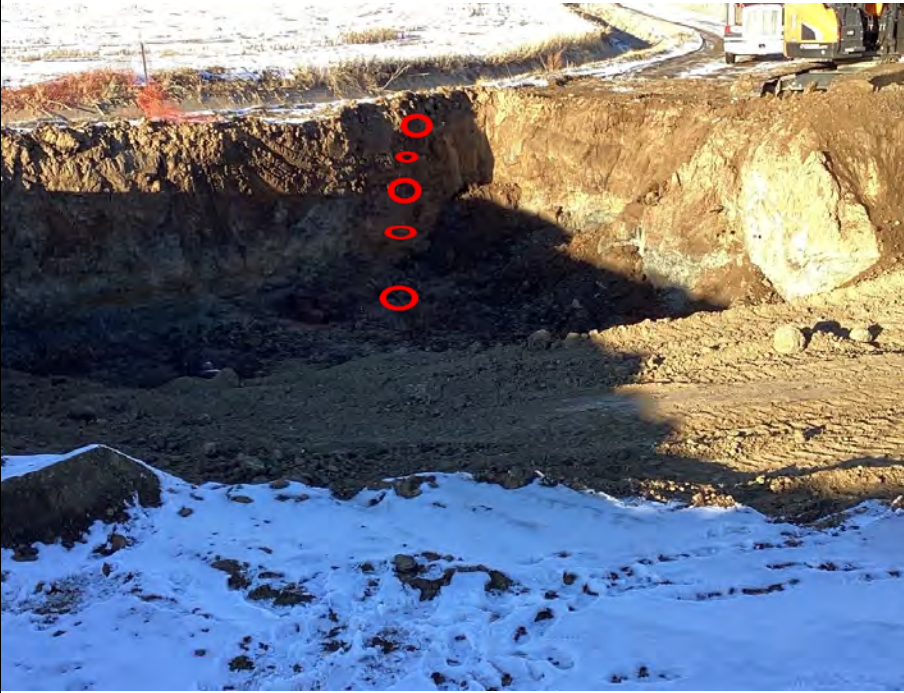
Equipment ID:		Equipment Type:		Equipment ID:		Equipment Type:	
Material:		Volume:		Material:		Volume:	
		Contents:				Contents:	
Notes/Conditions: North Wall Facing East				Notes/Conditions: Top to Bottom: SS65, SS66, SS67, SS68, SS69

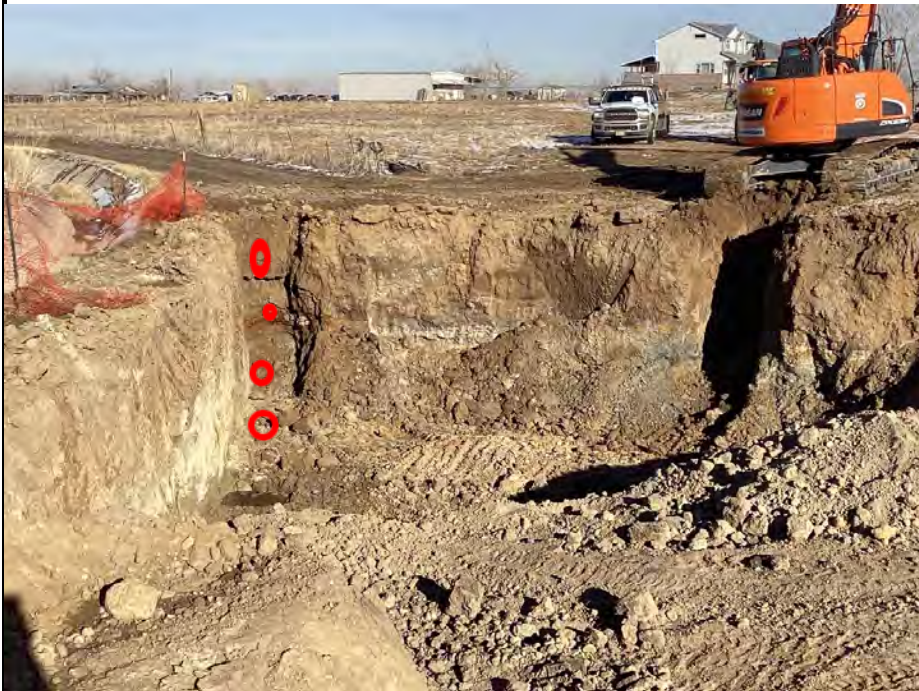
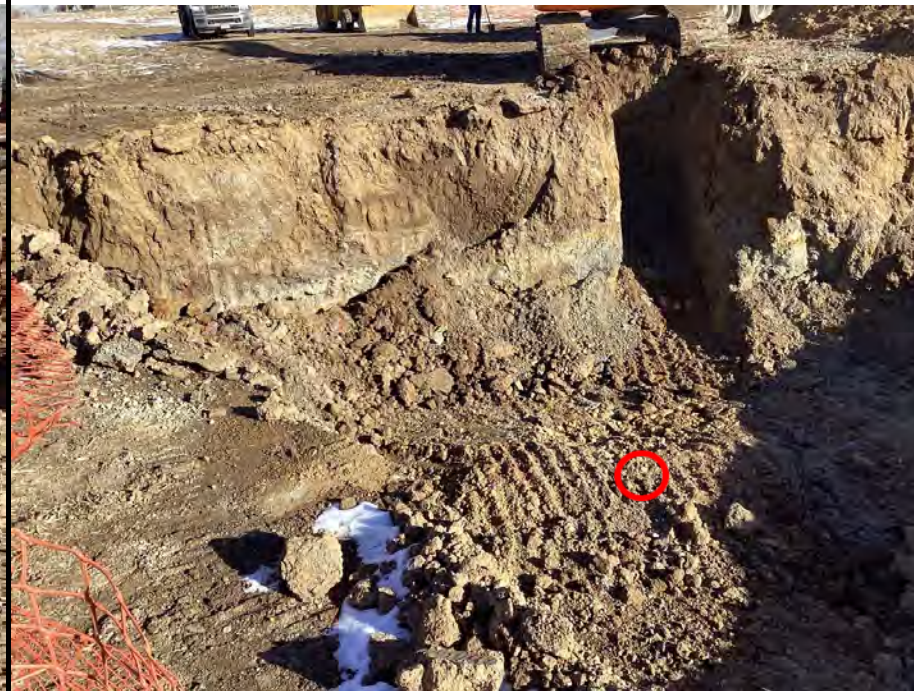
Equipment ID:		Equipment Type:		Equipment ID:		Equipment Type:	
Material:	Volume:	Contents:		Material:	Volume:	Contents:	
Notes/Conditions: Top to Bottom: SS72 SS73 SS74, SS71				Notes/Conditions: SS70
