# Inspection Photos

February 7, 2023

Location Name: CLOUGH-66S94W/20SWSW

Inspection Document #: 702801246

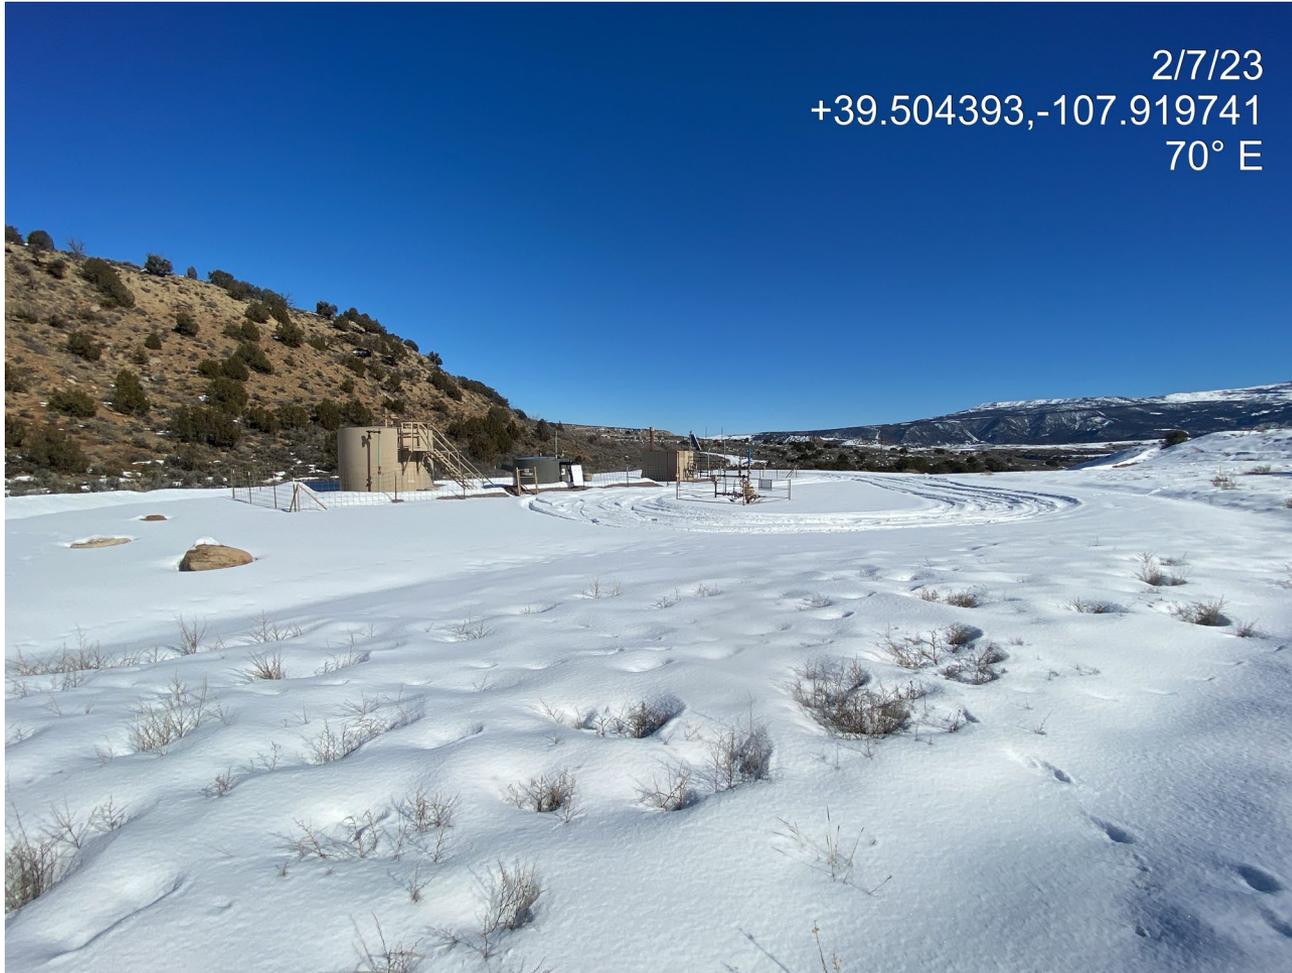
**Photo 1.** Photos taken from the west shows an overview of production areas.

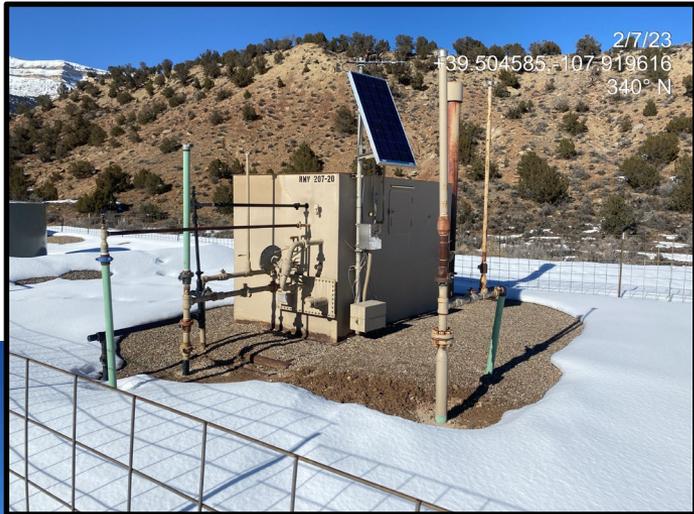
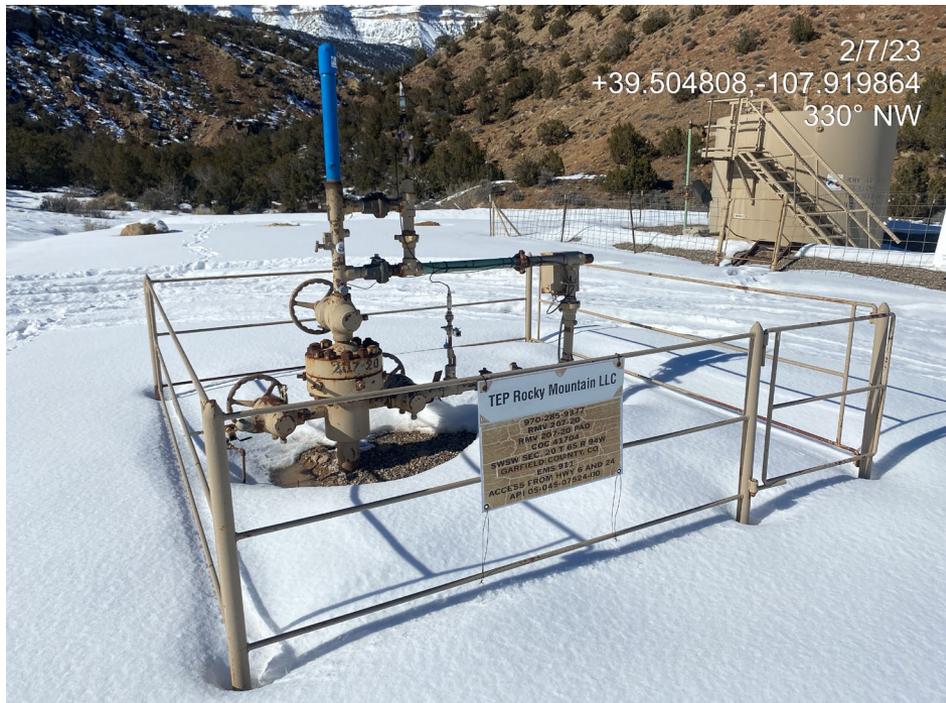
Photo 2. Photos show production areas.

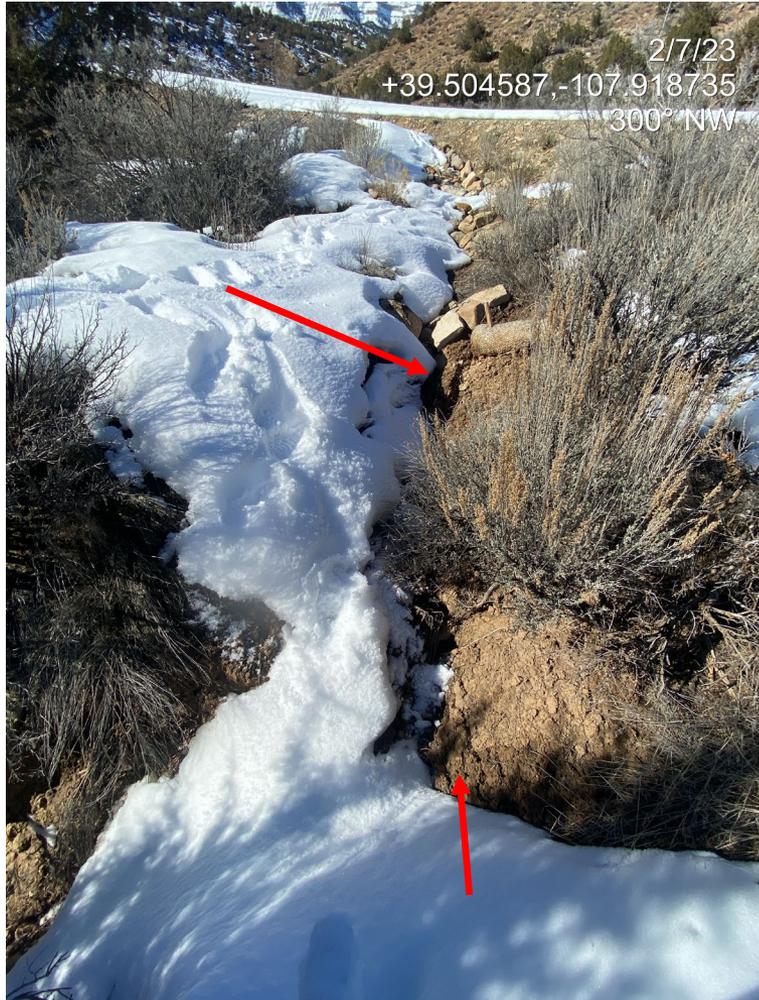
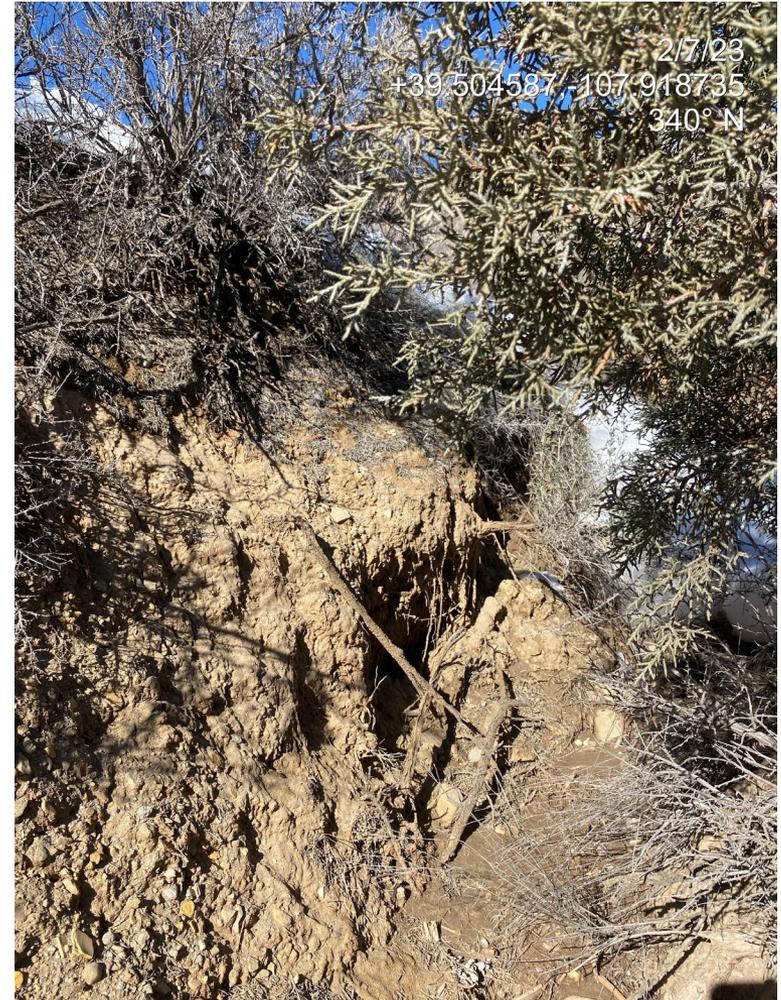
**Photo 3.** Photos show stormwater BMPs to the south of the access road. Stormwater discharged from the BMPs is causing scouring resulting in gully erosion (right).

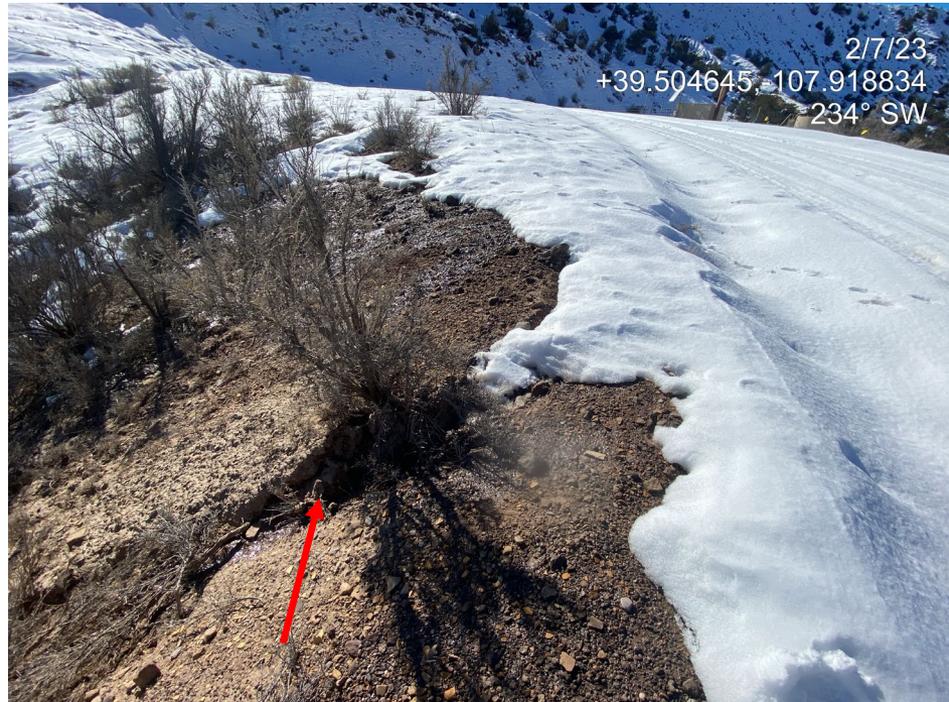
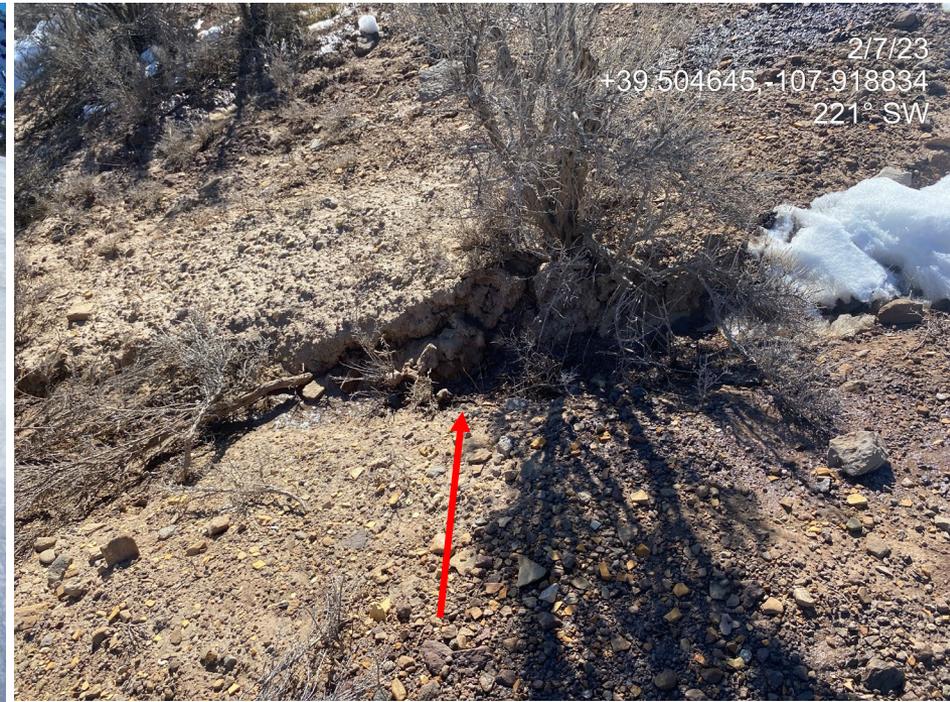
Photo 4. Photos show runoff from the access road causing erosion.

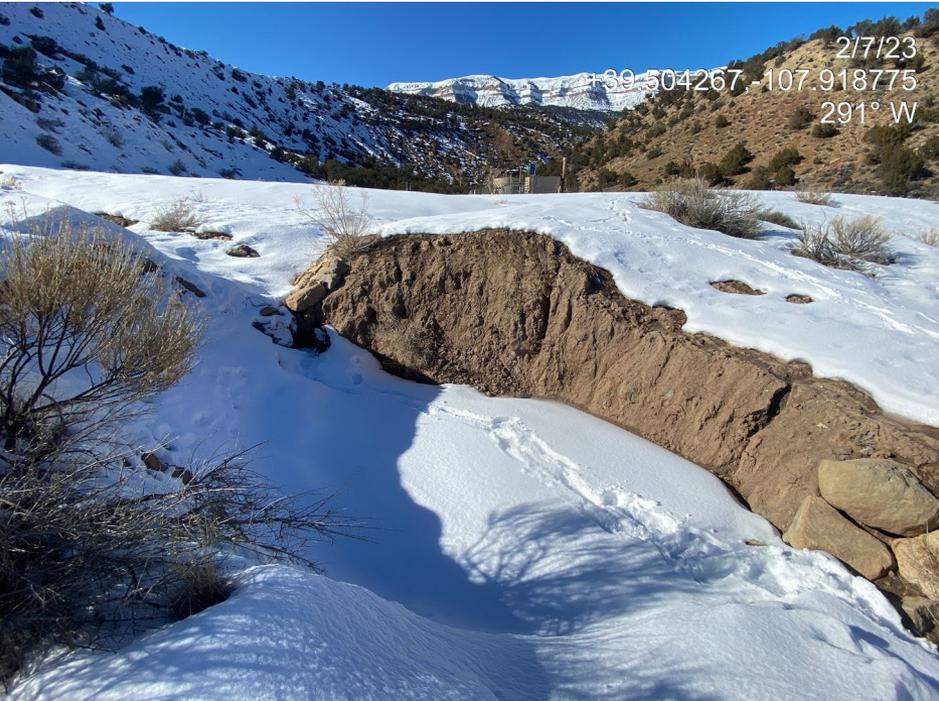
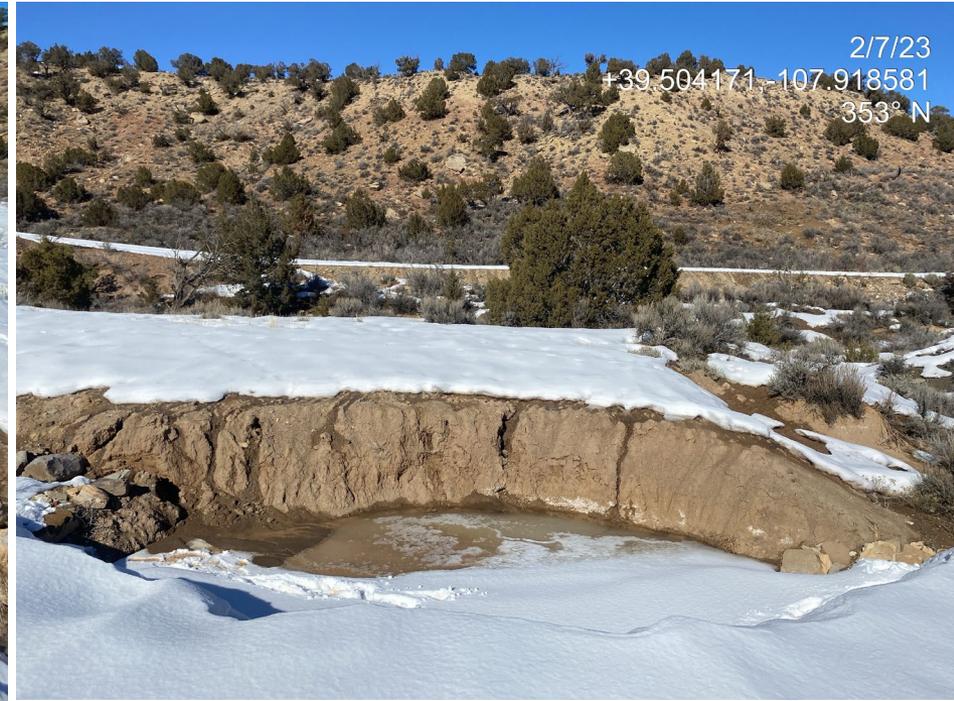
**Photo 5.** Photos show rill erosion occurring throughout BMPs to the southeast of the location, particularly on sediment trap walls. Trap erosion is acting as an additional sediment source.

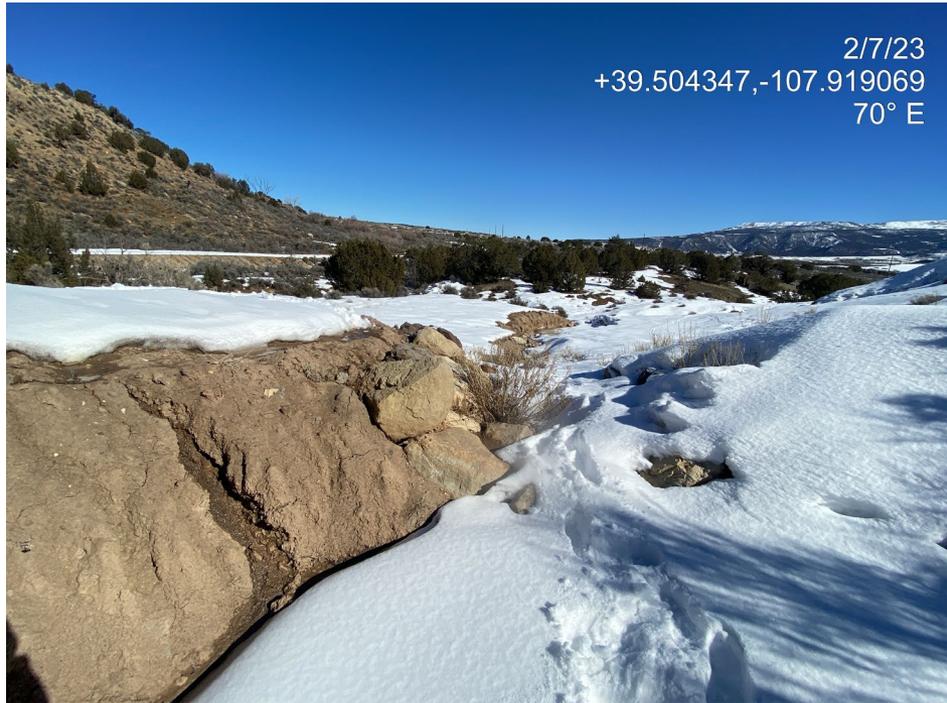
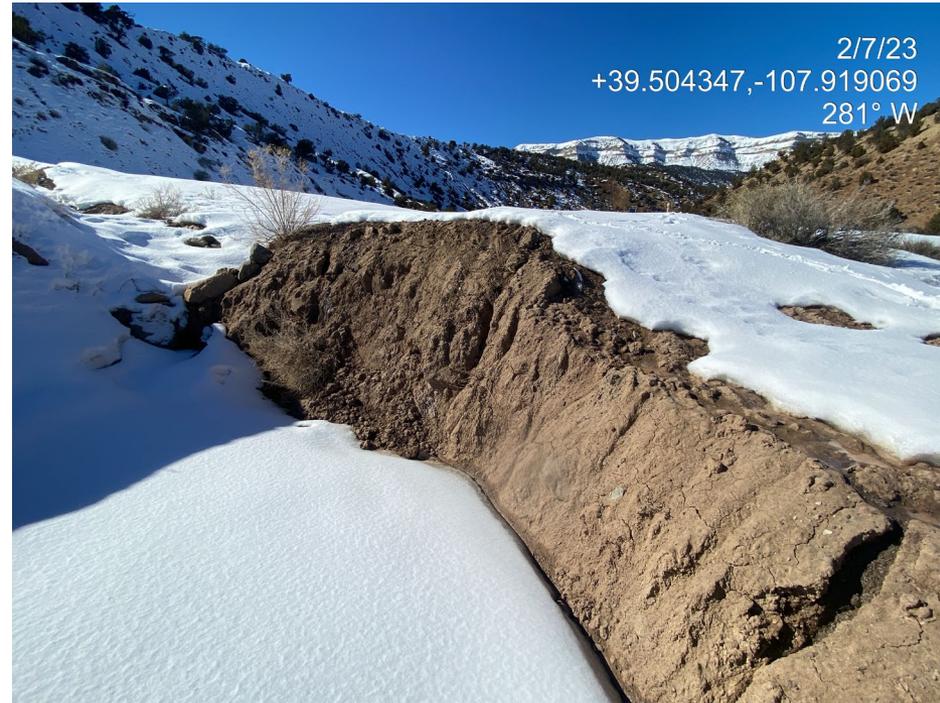
**Photo 6.** Photos show rill erosion occurring throughout BMPs to the southeast of the location, particularly on sediment trap walls. Trap erosion is acting as an additional sediment source.

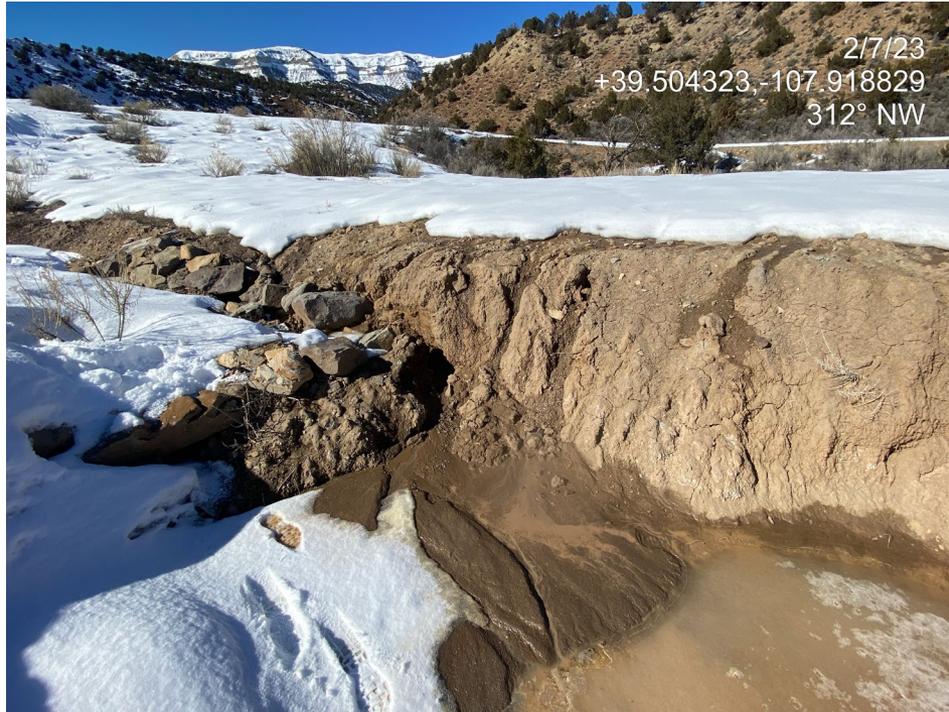
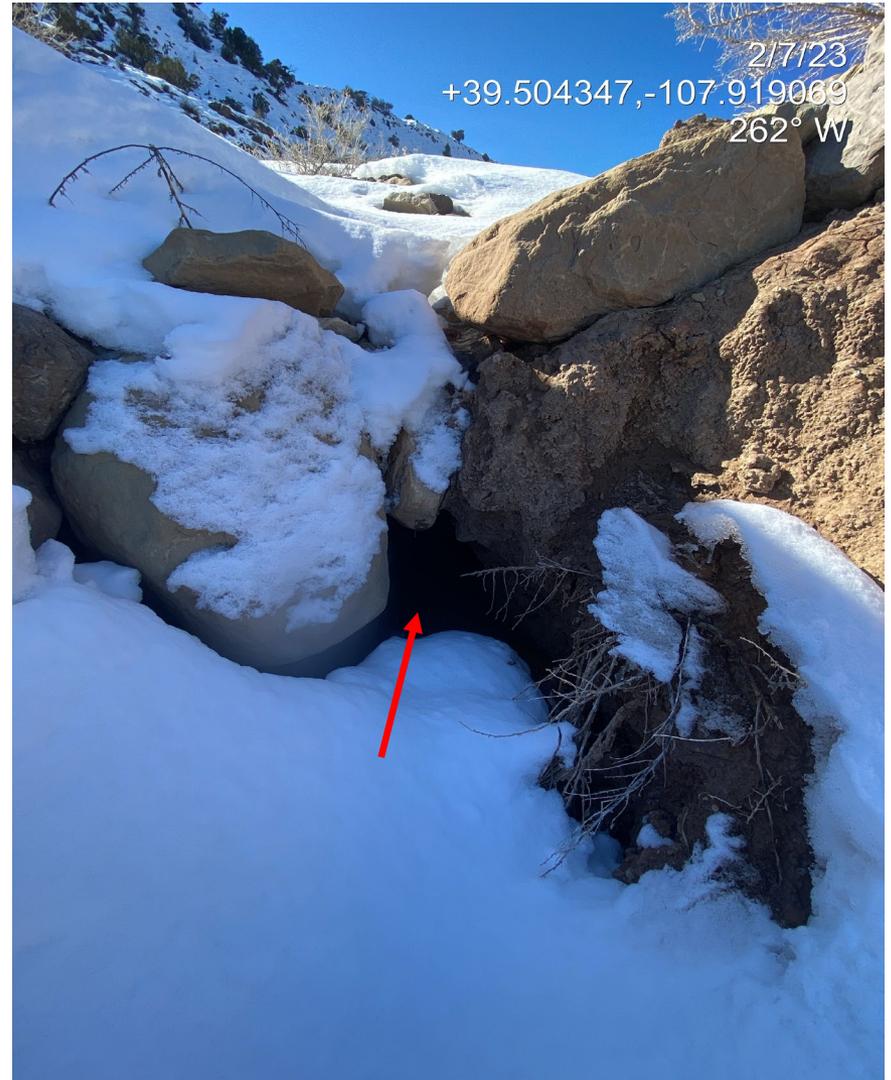
Photo 7. Photos show rill erosion, scouring and undercutting of rock armor occurring throughout BMPs to the southeast of the location.

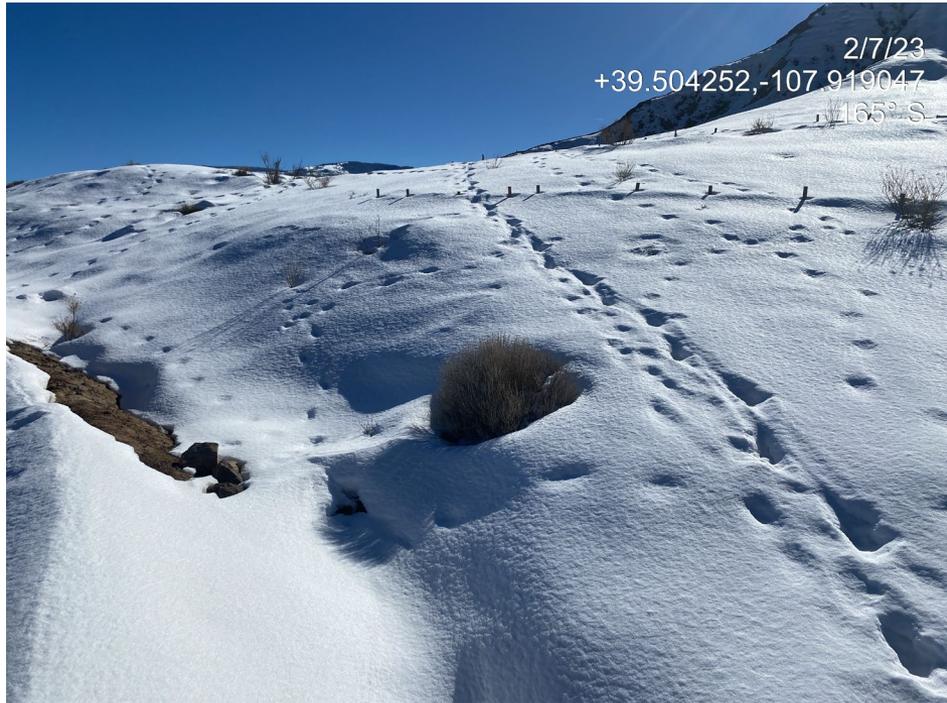
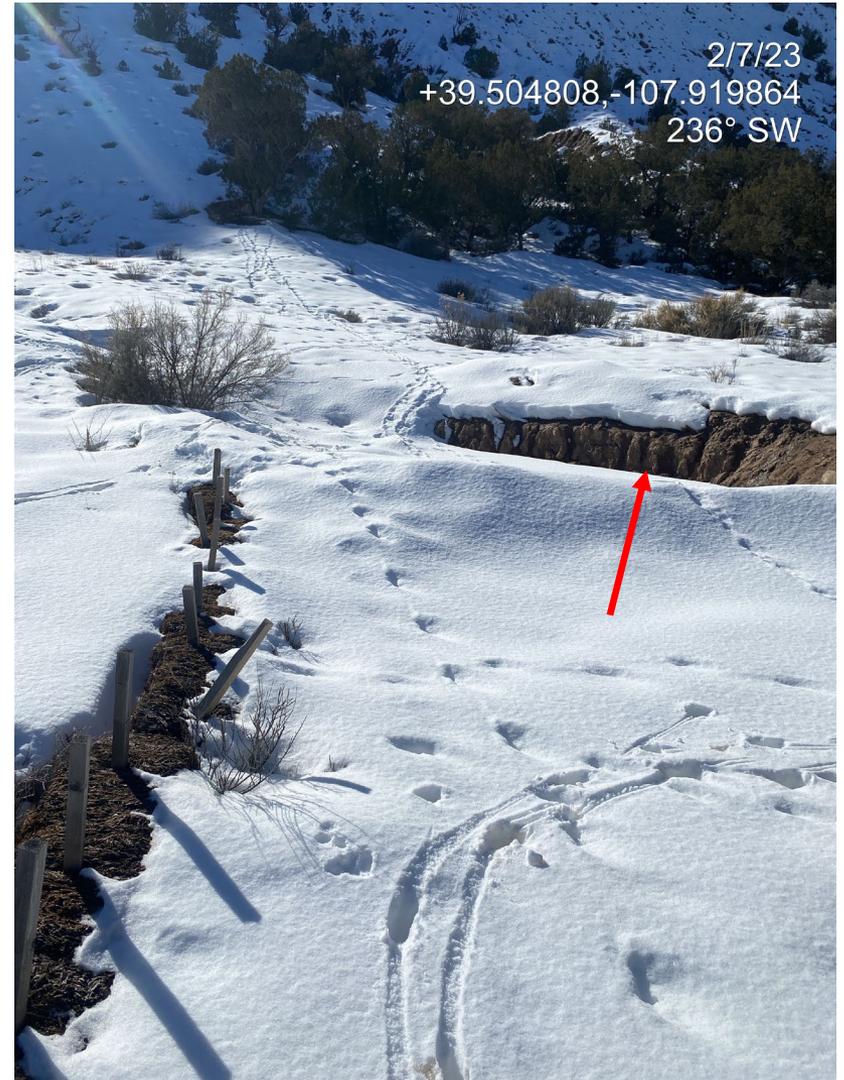
**Photo 8.** Photos shows additional BMPs which are snow covered. Follow up inspection required to assess snow covered areas. Note erosion degradation in sediment trap to the northwest (right).
