# Interim Reclamation and Stormwater Inspection

Operator: CIVITAS NORTH LLC - 10661

Location ID: 455519

Inspection Photos  
Location Name: Boomslang Fed 8-60 14B  
Location ID: 455519

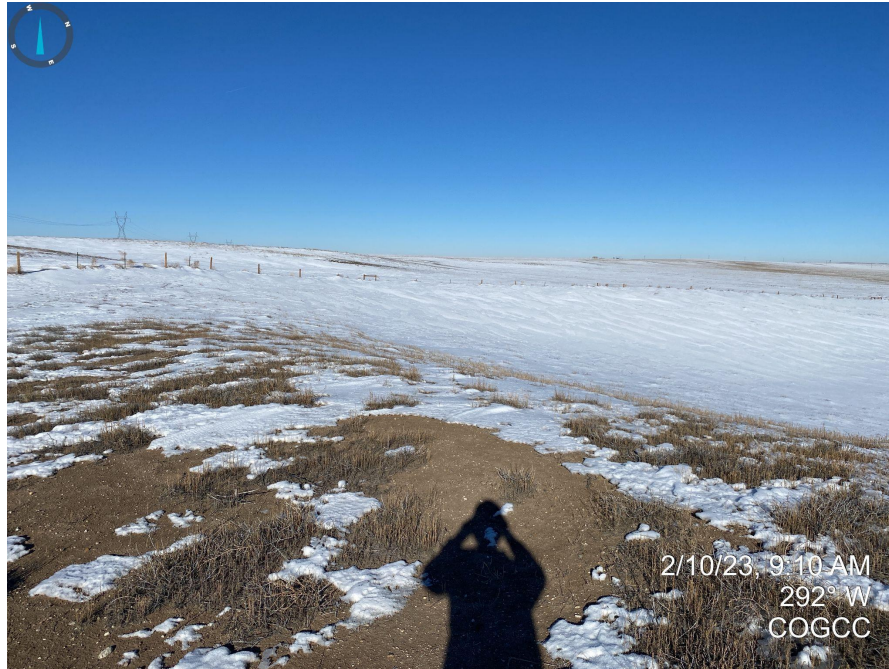
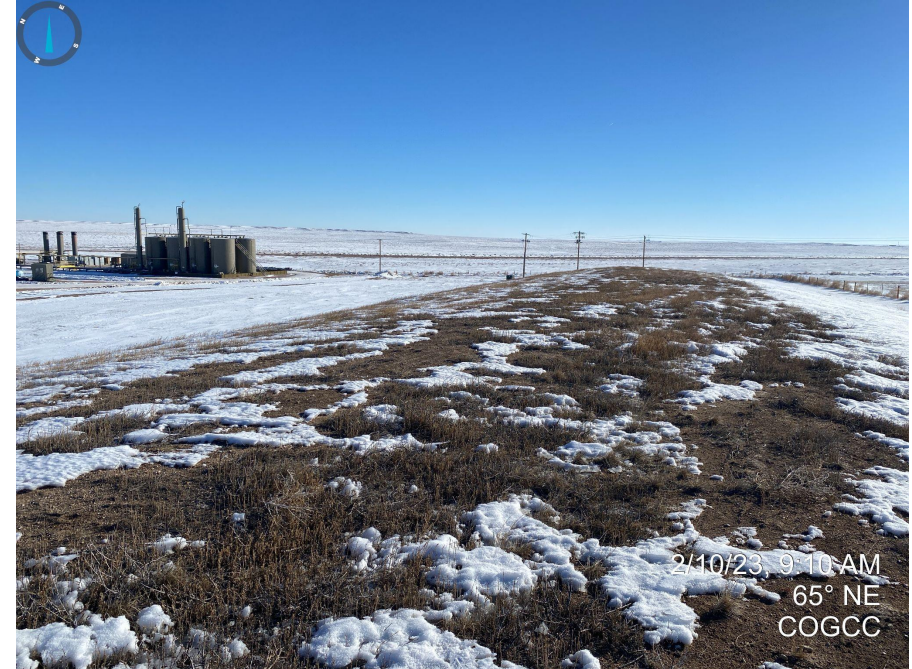
**Photos 1 & 2.** Facing west and northeast from top of topsoil stockpile. Photos illustrate that areas of bare soil and undesirable vegetation (e.g. russian thistle and kochia) were observed during this inspection.

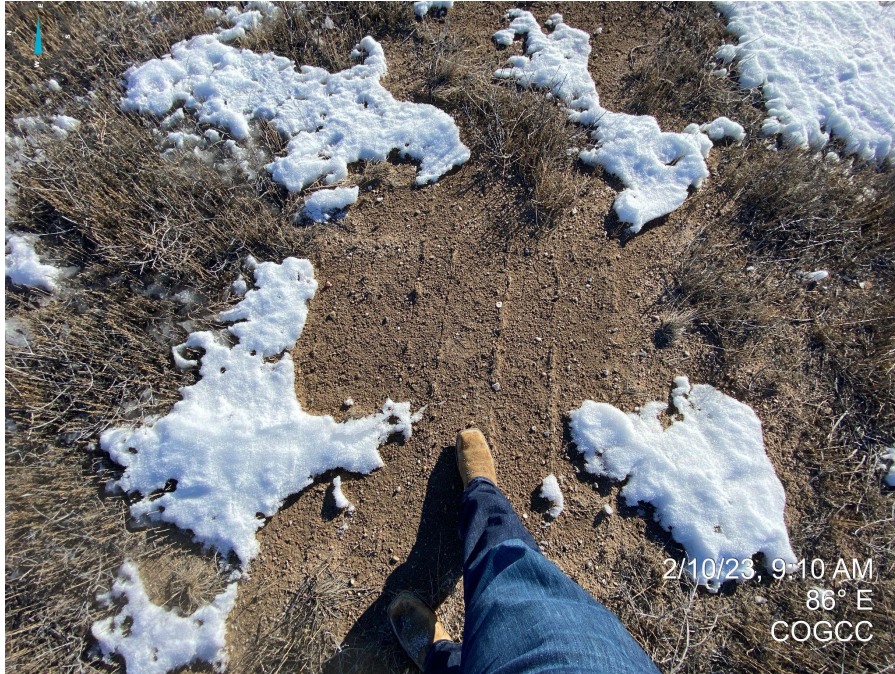
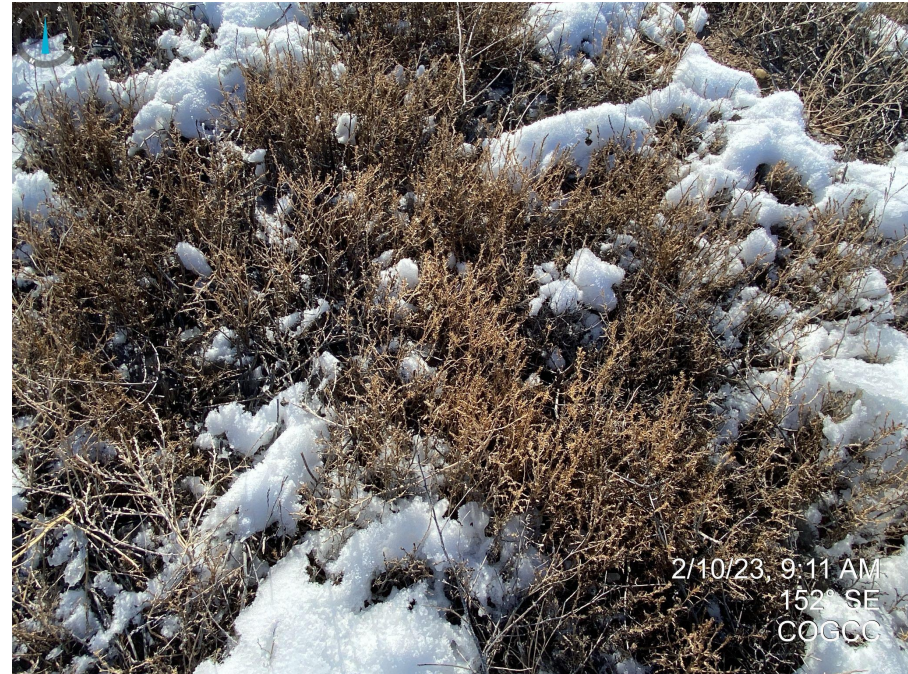
**Photos 3 & 4.** Close-up photos taken from topsoil stockpile on southern portion of the location. See comments in Photos 1 & 2.

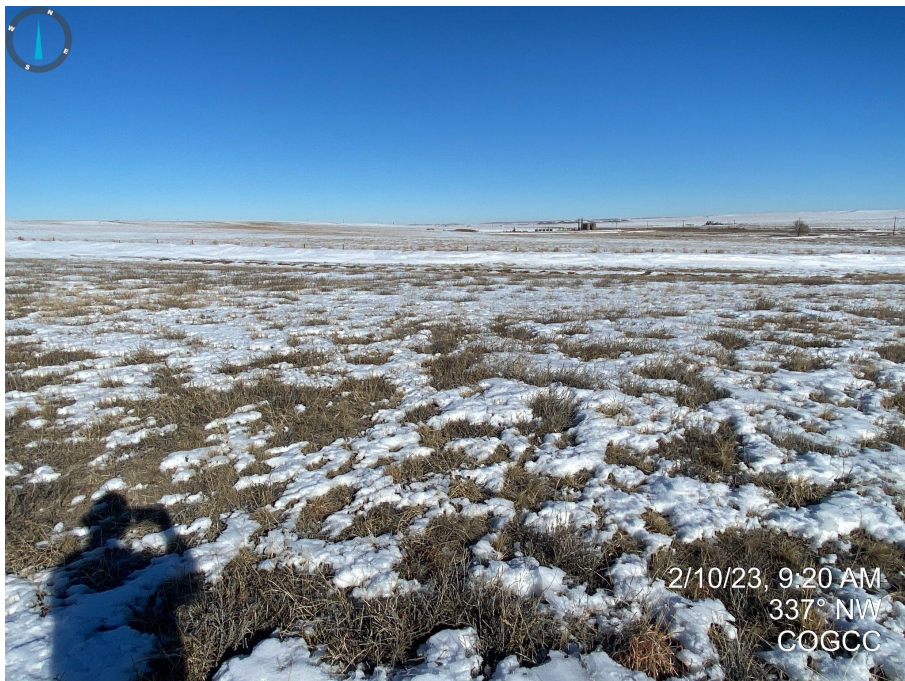
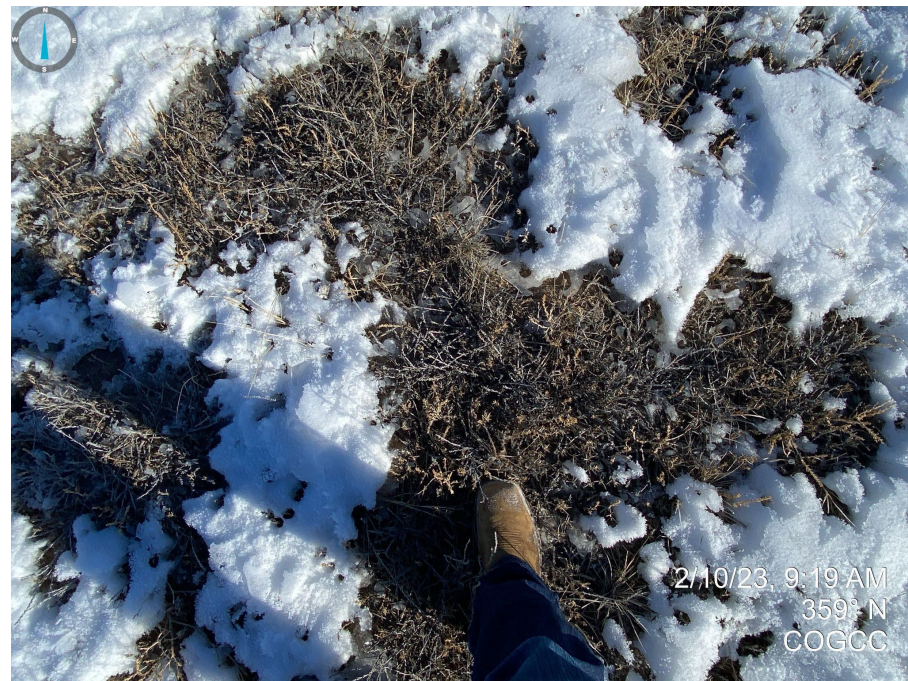
**Photos 5 & 6.** Facing northwest from the northern portion of the location. Photos taken from the interim area illustrating some undesirable vegetation (e.g. russian thistle and kochia) observed; the operator will have to manage for weedy vegetation during the 2023 growing season.

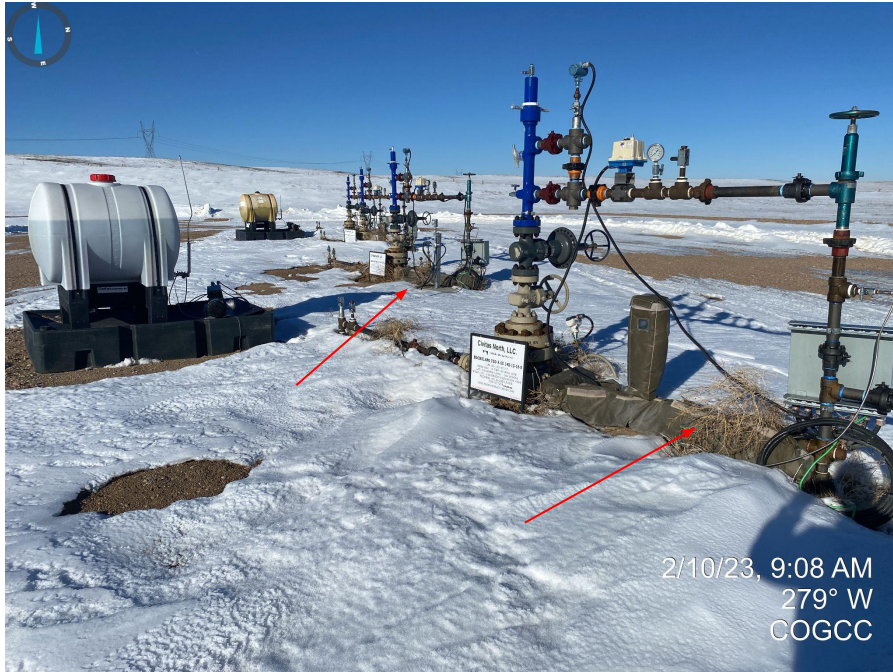
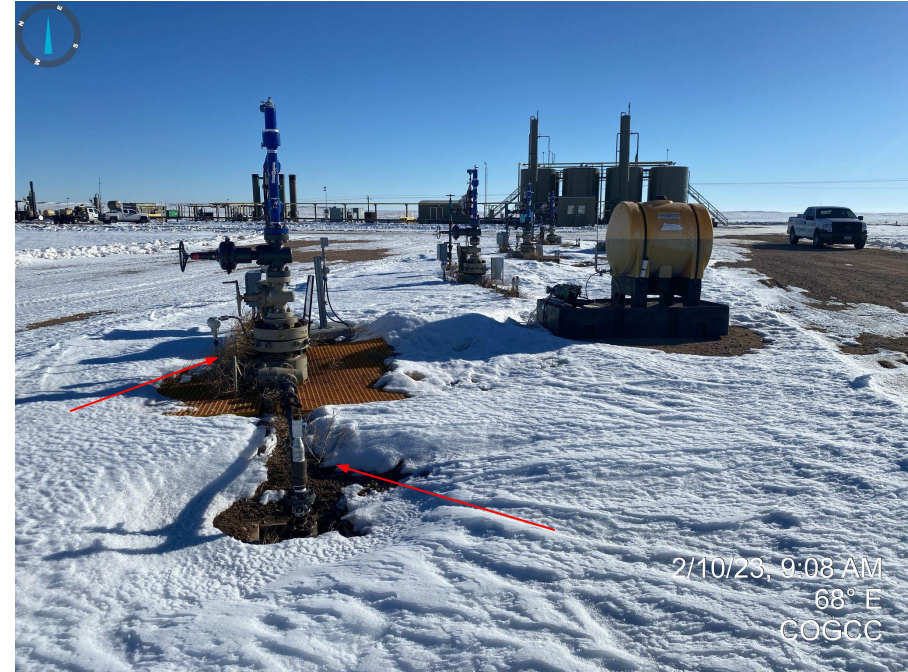
**Photos 7 & 8.** Facing west and east near the wellheads. Photos illustrates tumbleweed accumulations around equipment. This is considered debris and needs to be removed as it presents a fire hazard.

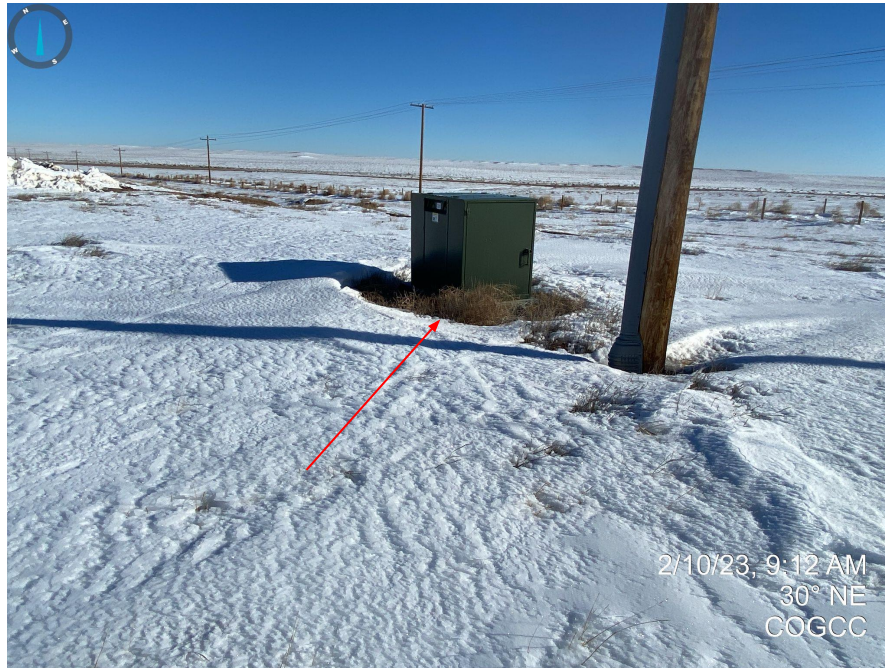
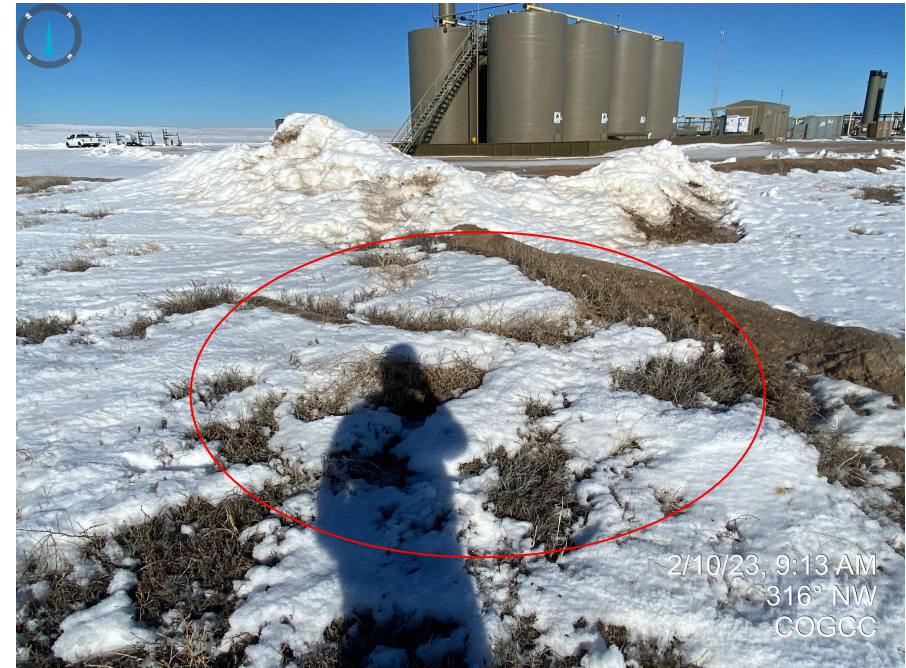
**Photos 9 & 10.** Facing northeast and northwest from the southeastern portion of the location. See comments in Photos 7 & 8.

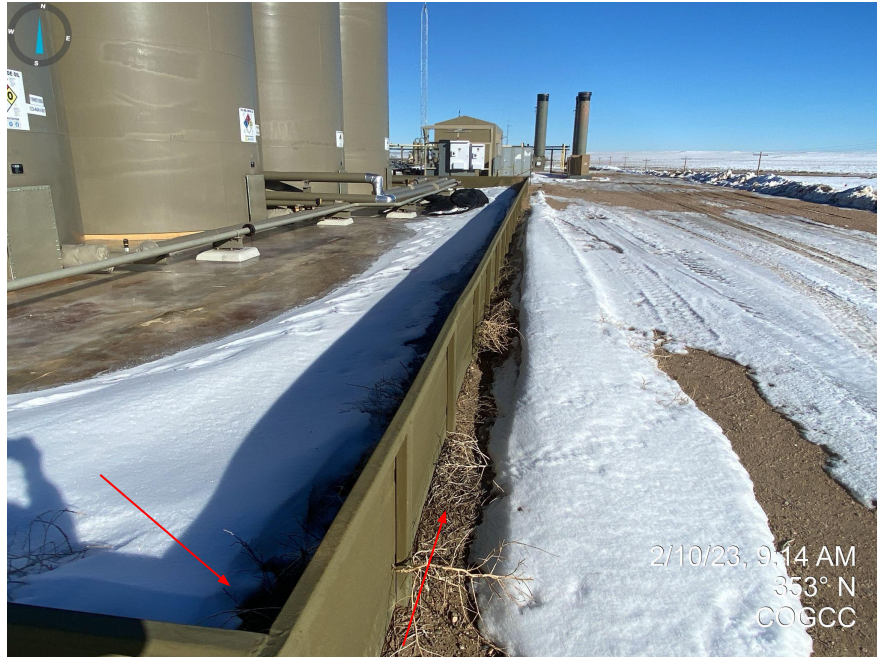
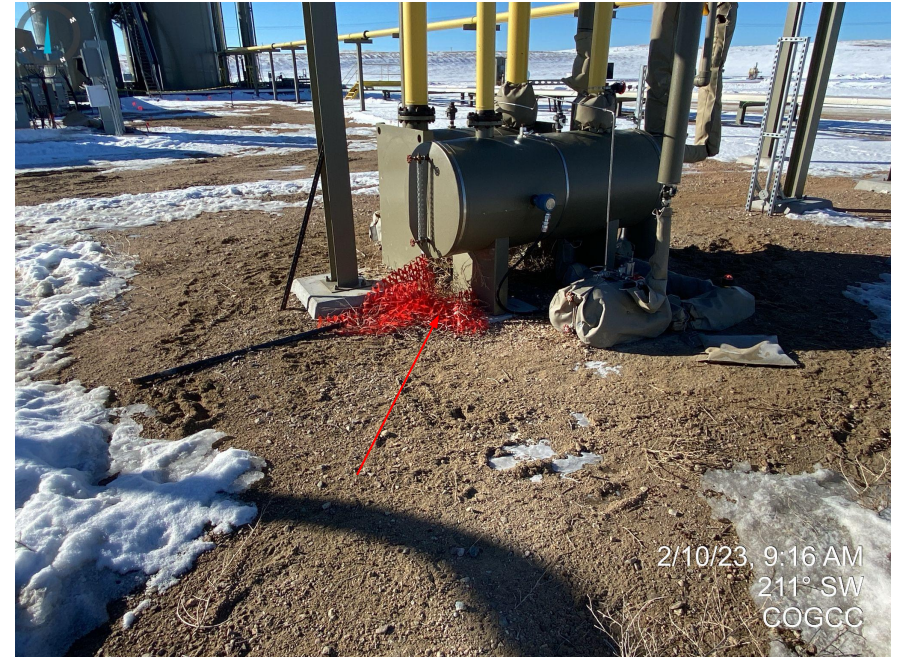
**Photos 11 & 12.** See comments in Photos 7 & 8.

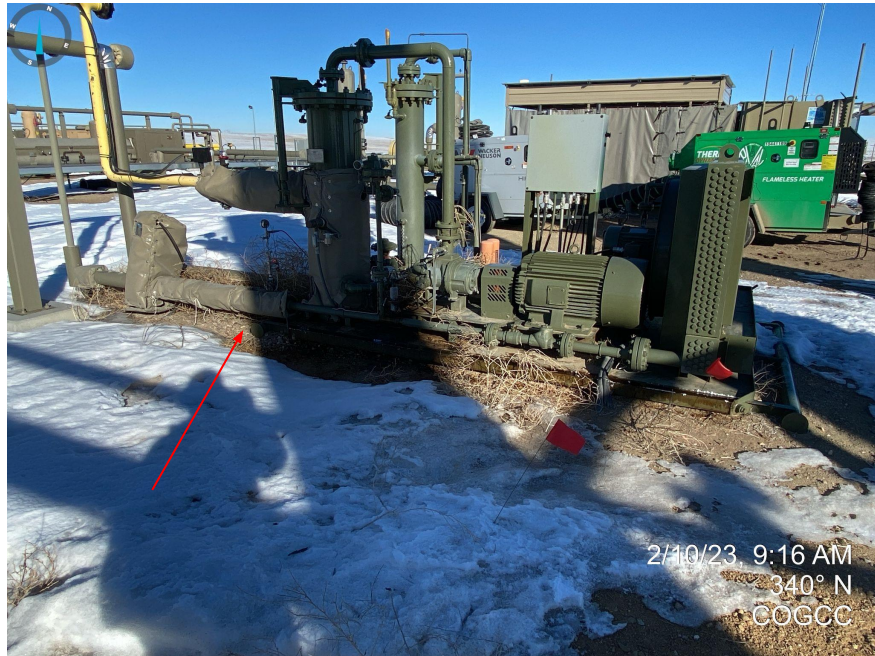
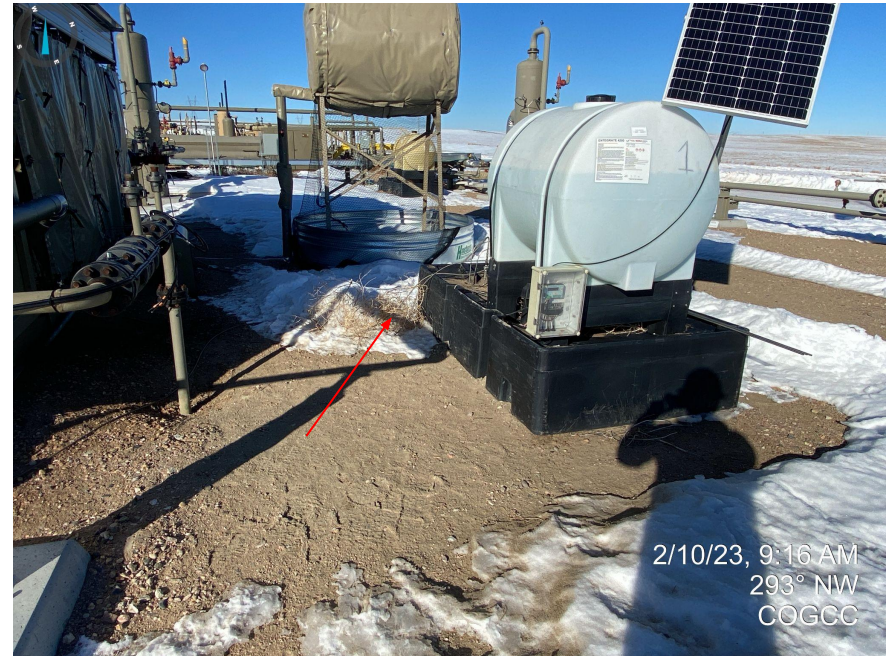
**Photos 13 & 14.** See comments in Photos 7 & 8.

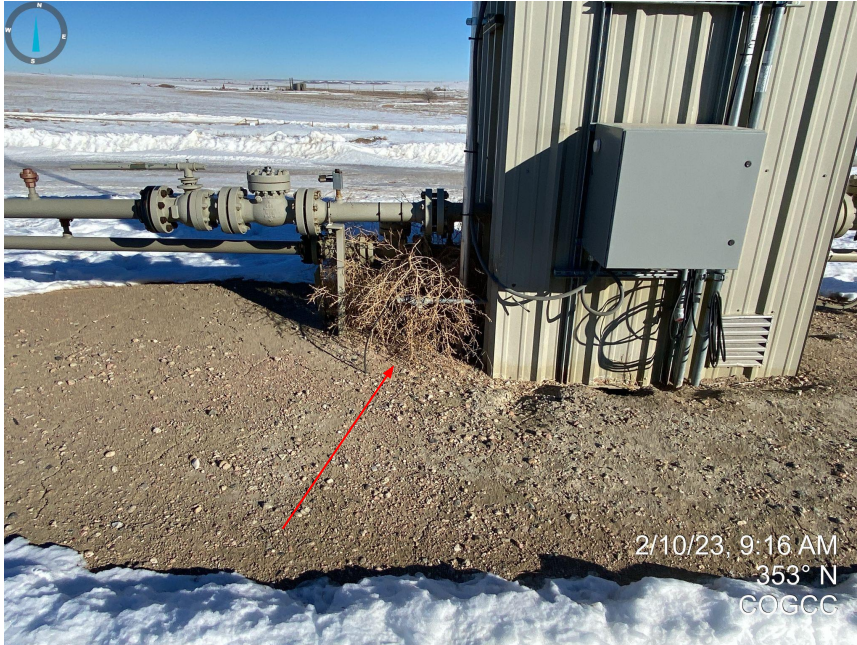
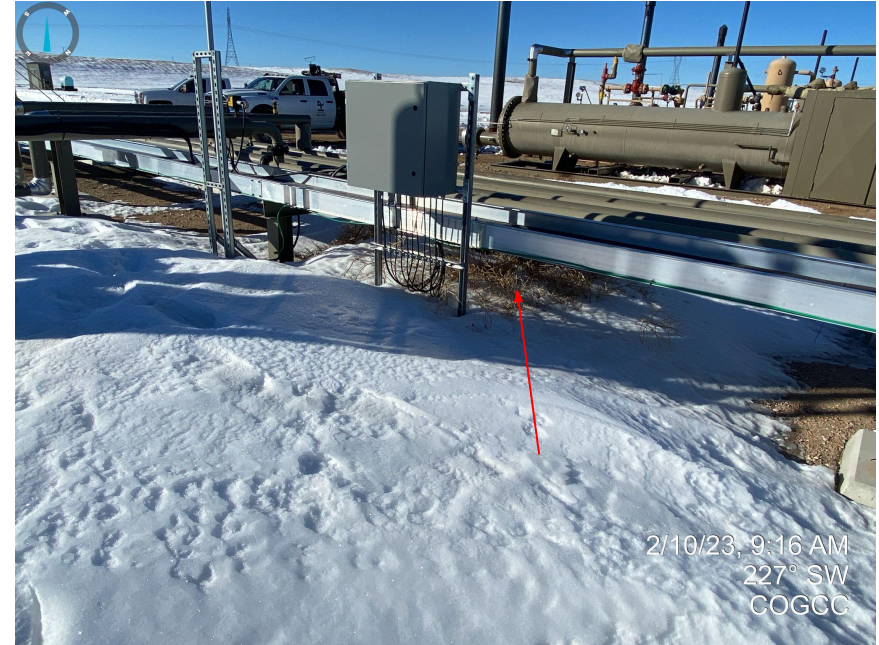
**Photos 15 & 16.** See comments in Photos 7 & 8.

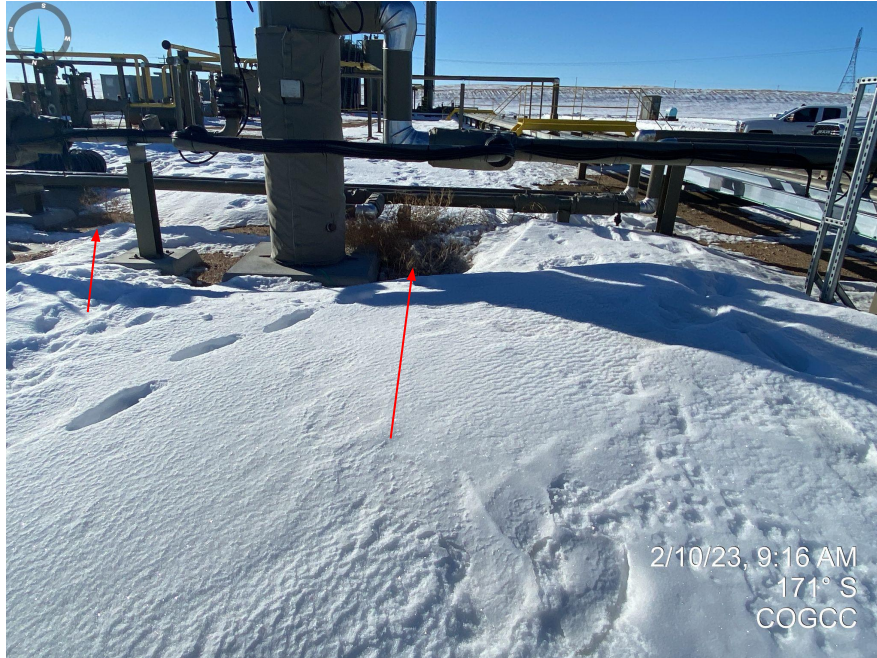
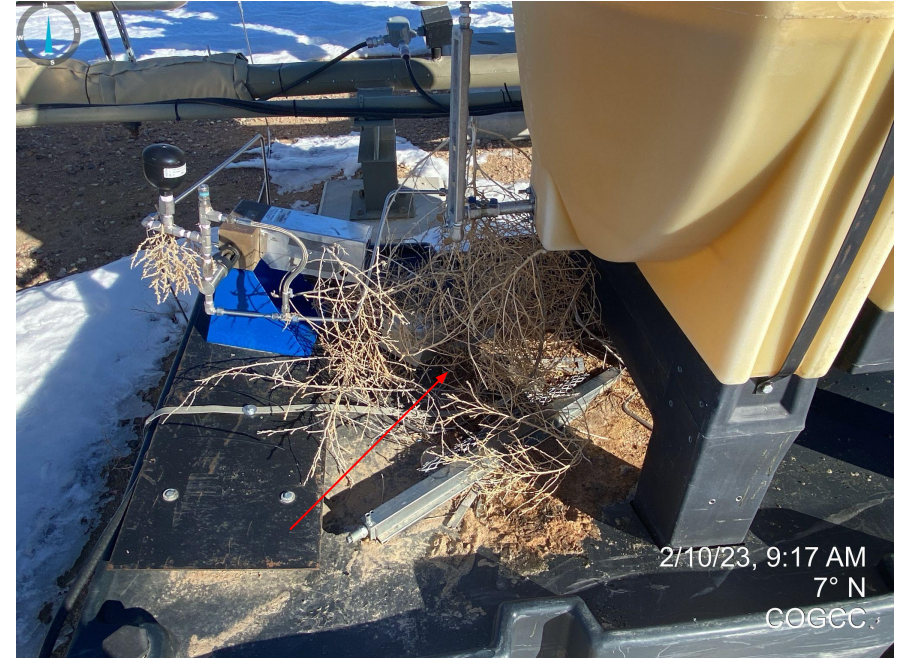
**Photos 17 & 18.** See comments in Photos 7 & 8.

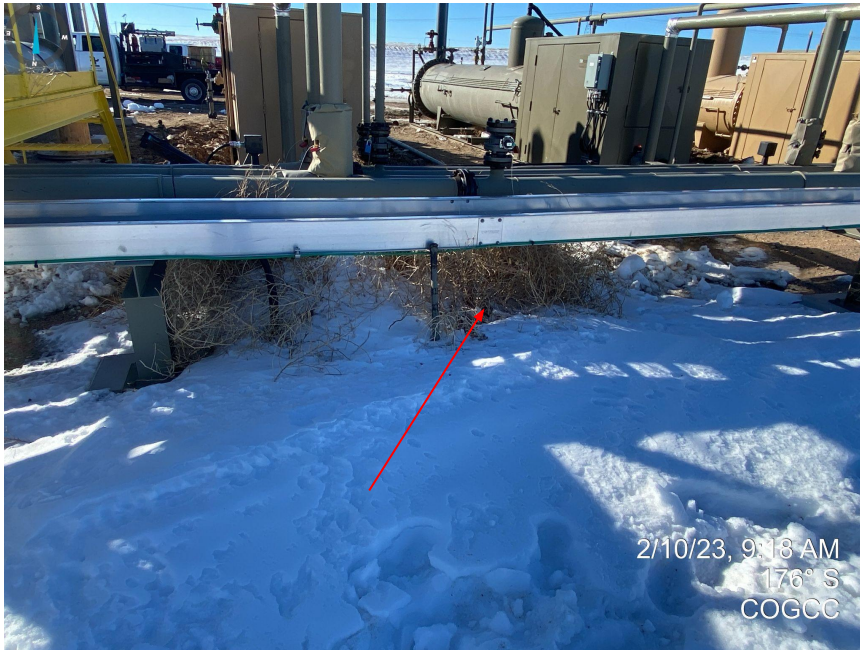
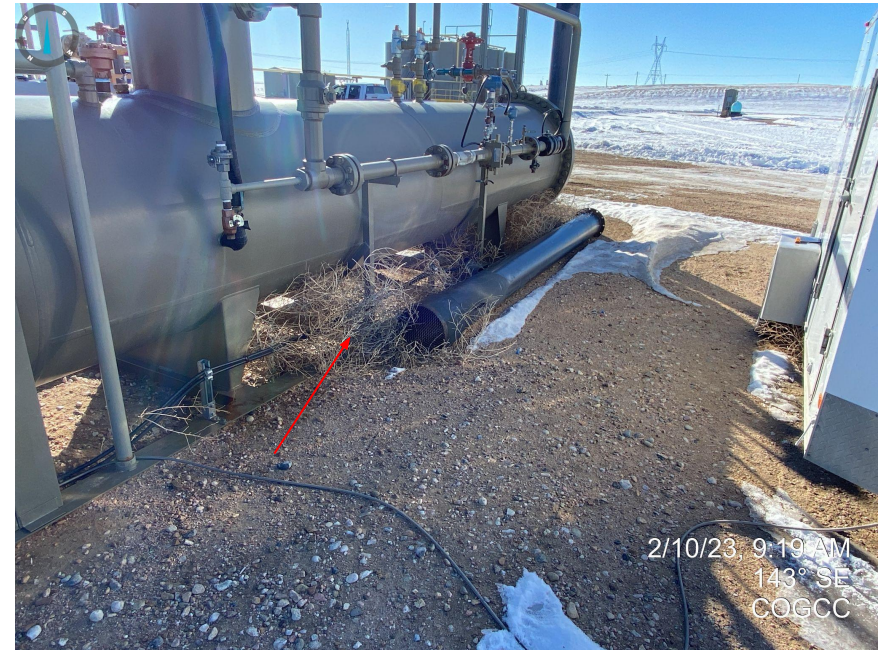
**Photos 19 & 20.** See comments in Photos 7 & 8.

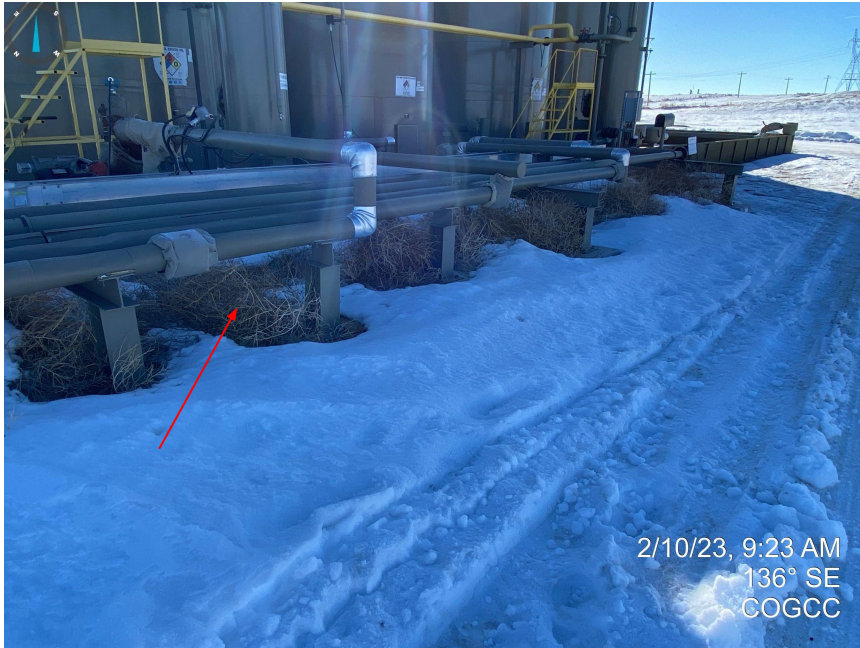
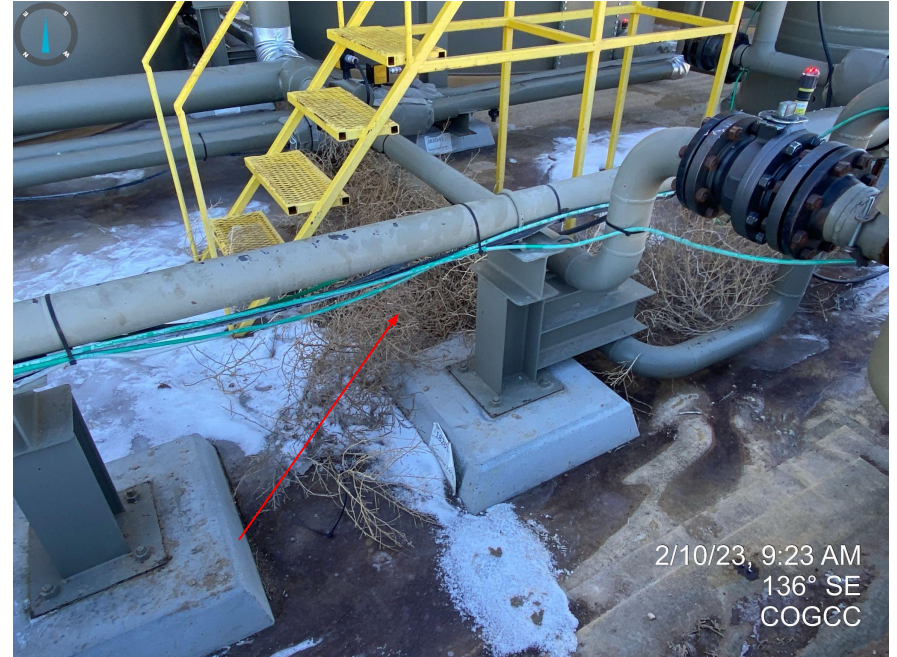
**Photos 21 & 22.** See comments in Photos 7 & 8.

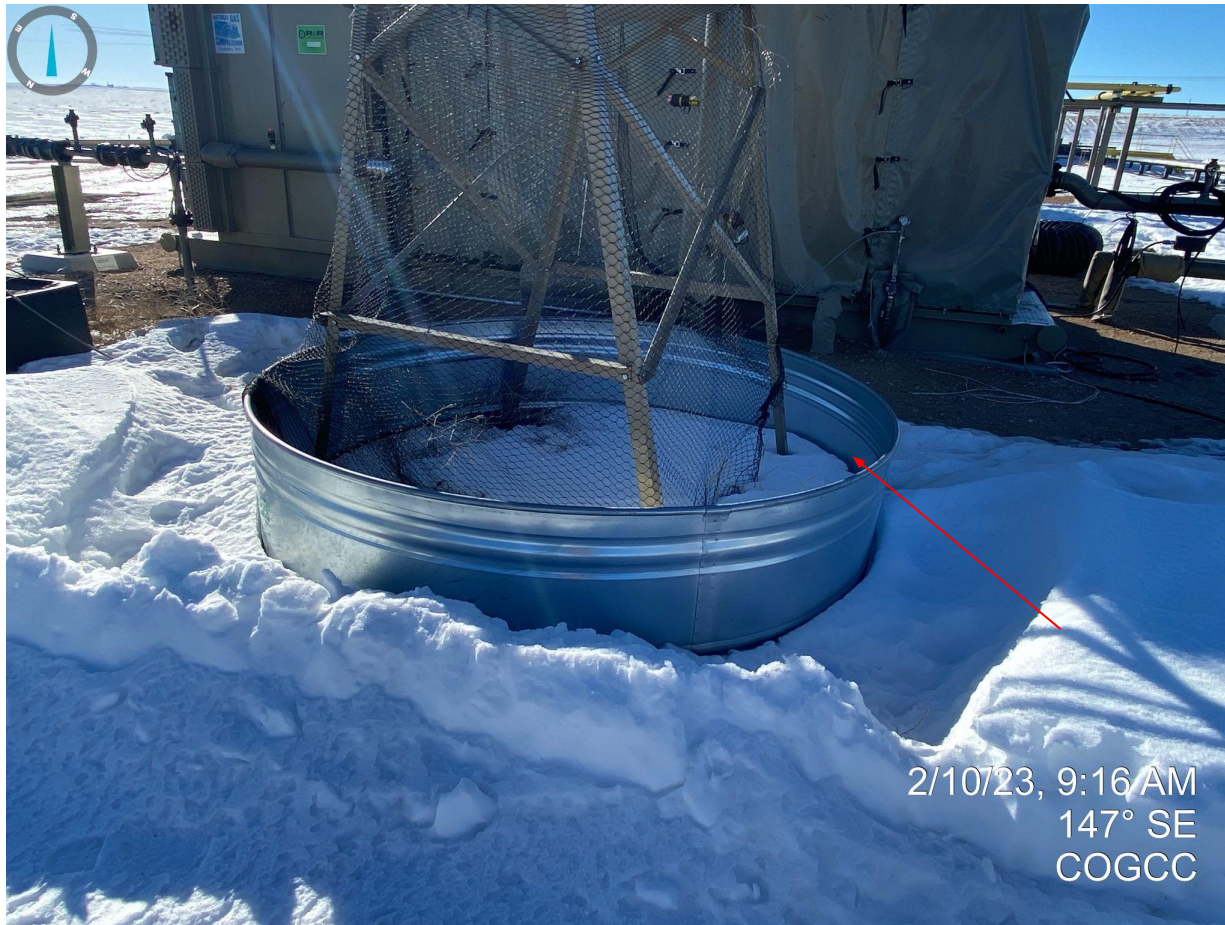
**Photo 23.** Facing southeast near the production equipment. Photo illustrates the the wildlife netting is inadequate and needs to be repaired to exclude wildlife entry to the secondary containment area.
