Interim Reclamation and Stormwater Inspection

Operator: SUMMIT OIL & GAS - 10774

Location ID: 465272

Inspection Photos
Location Name: Castor 7-59 12
Location ID: 465272

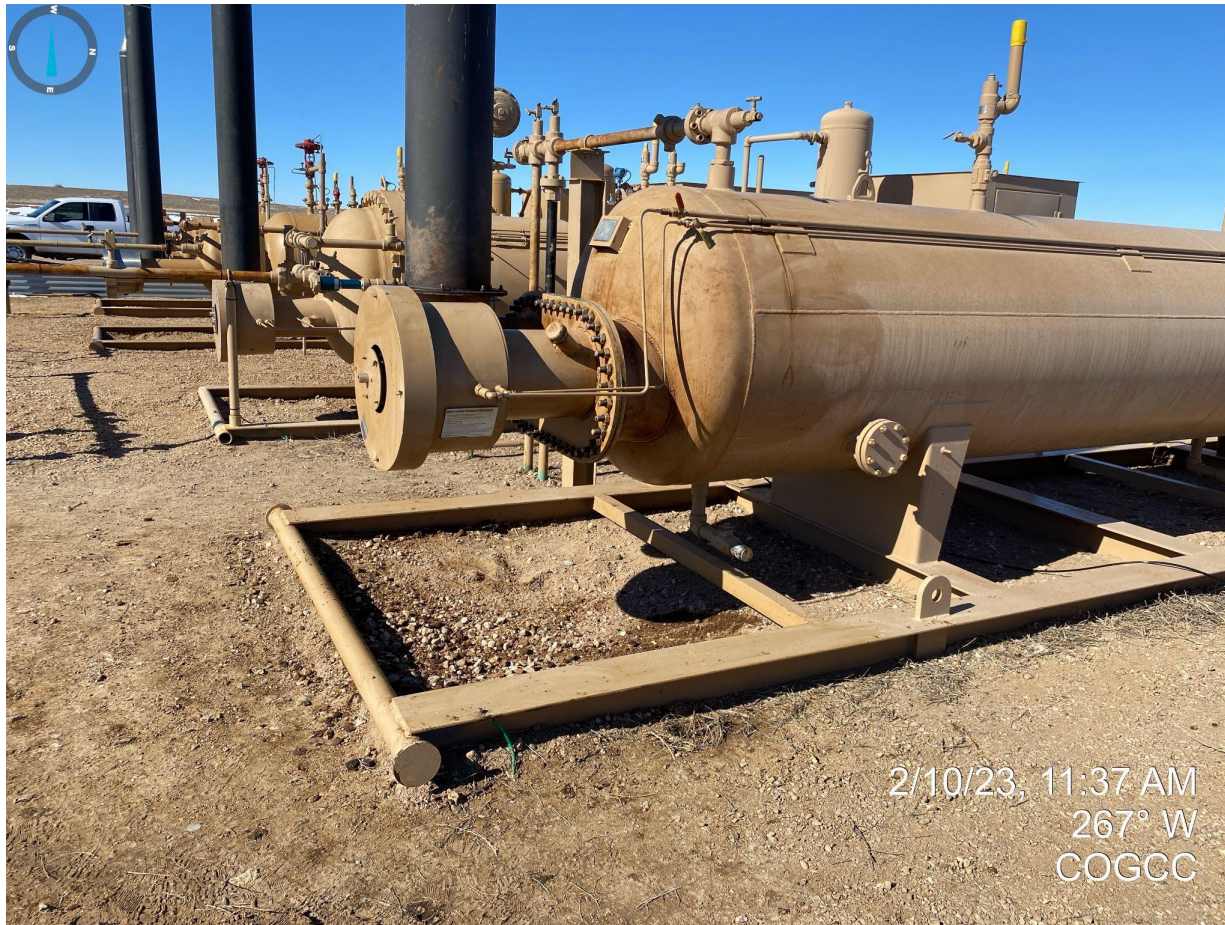
Photo 1. Facing west at treater; Photo illustrates that the stained soil and equipment has been cleaned up. Operator stated on FIRR (Doc #403313860) that treater has been repaired.

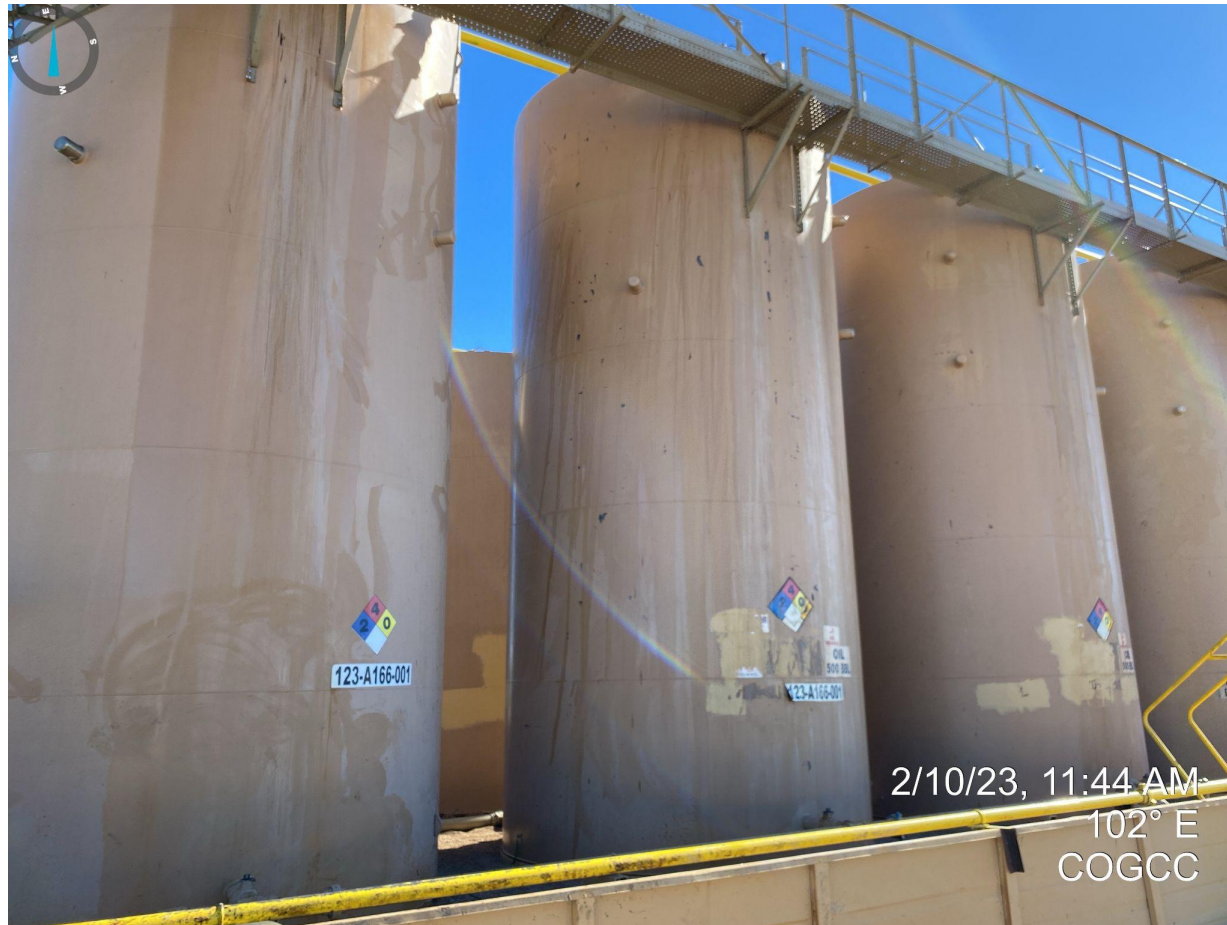
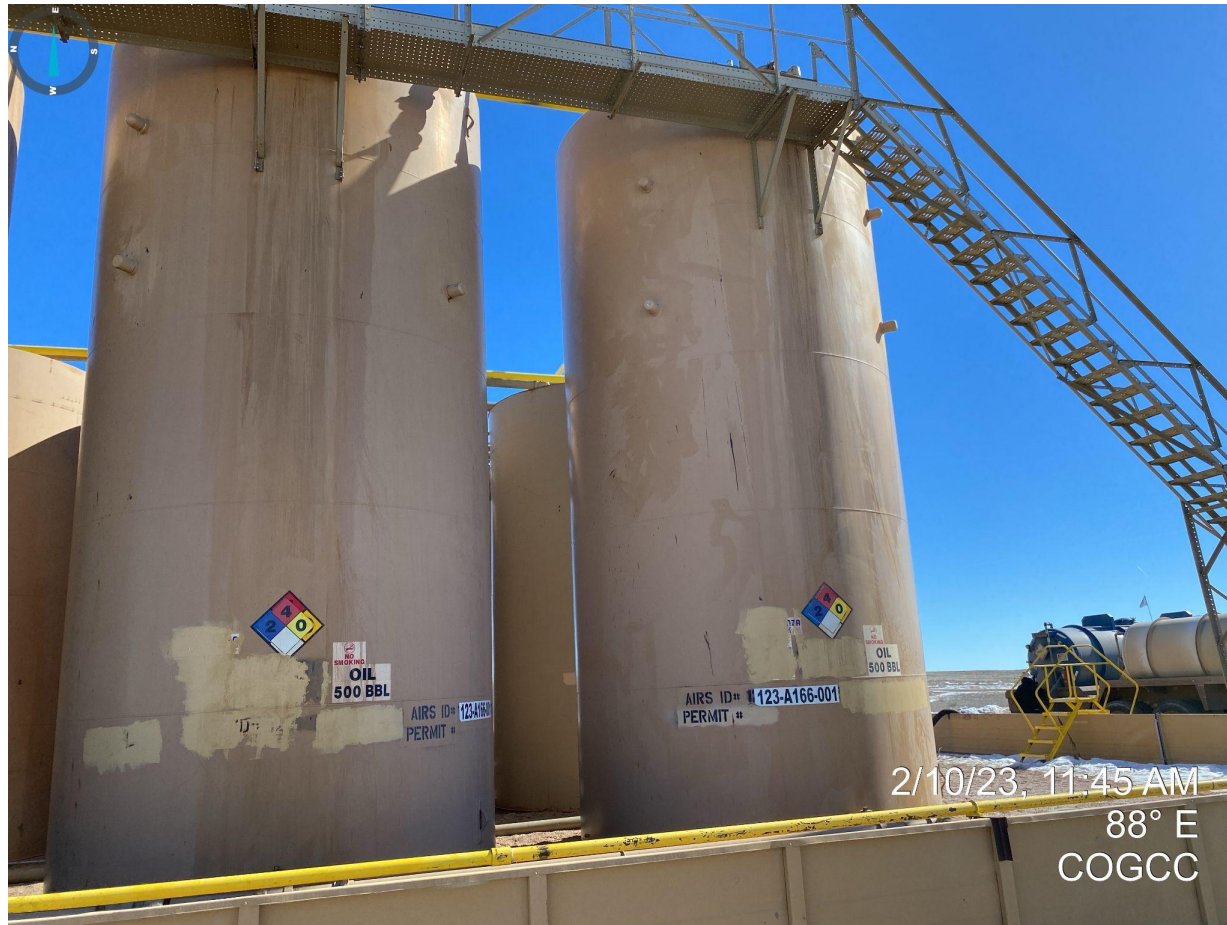
Photo 2. Facing east at the tank battery; it appears the operator has performed the previous corrective action and has cleanup up the free fluid on the tanks. Operator also stated on FIRR (Doc #403313860) that equipment has been repaired.

Photo 3. See comments in Photo 2.

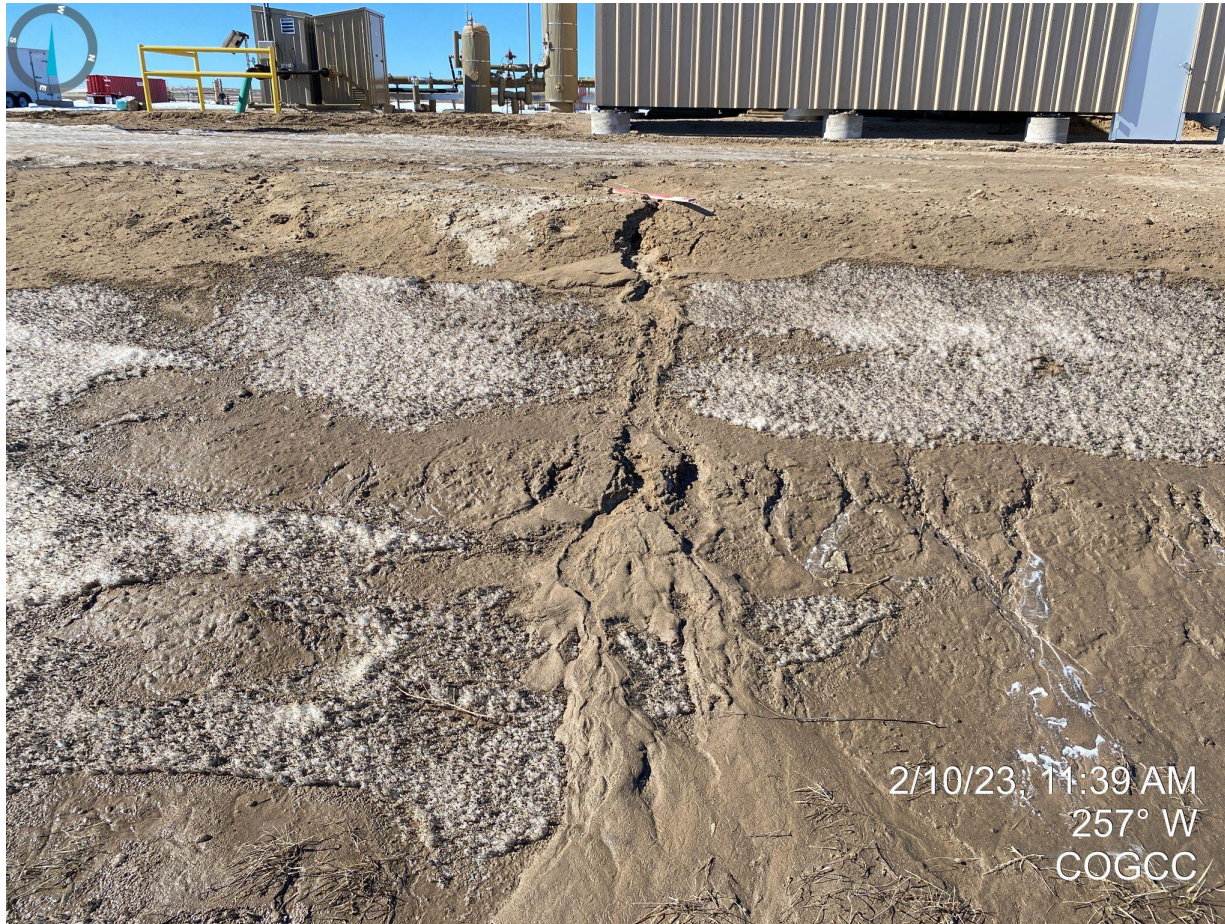
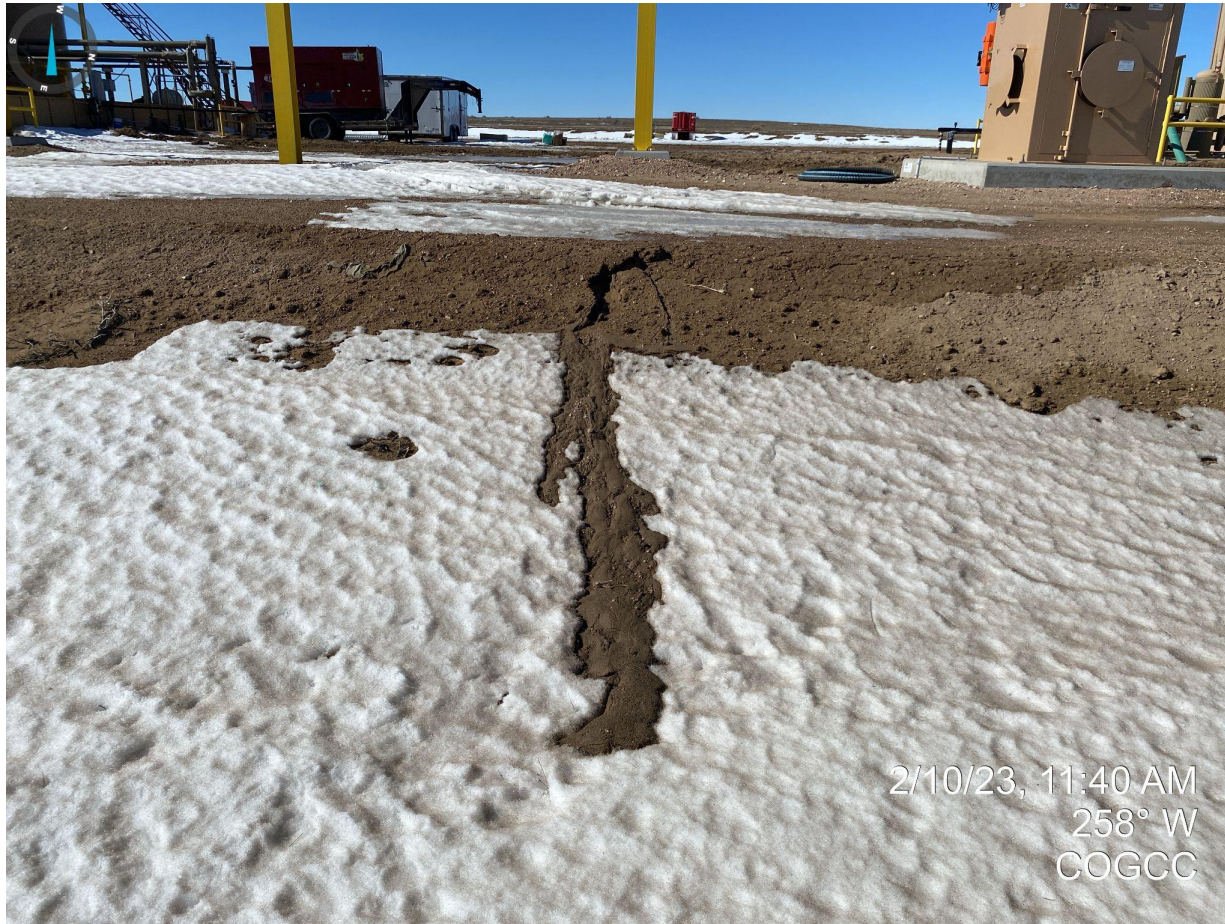
Photo 4. Facing west from the northeastern corner of the location, near the tank battery. Photo illustrates rill erosion on the eastern wall of the perimeter ditch/berm. This BMP will need to be repaired/maintained to prevent sediment from traveling off location.

Photo 5. See comments in Photo 4.

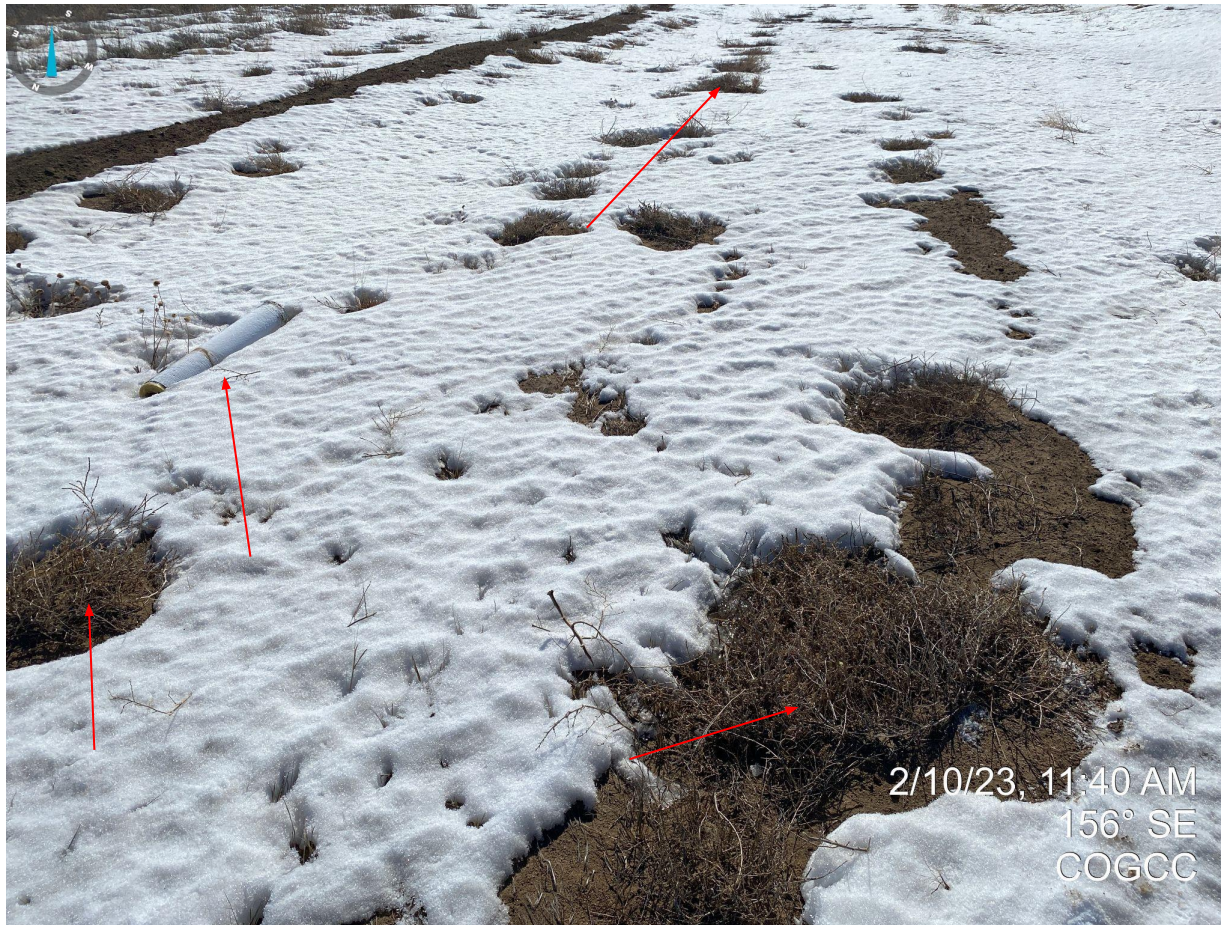
Photo 6. Facing southeast near the eastern side of the location. Trash was observed throughout the location and will need to be picked up. Also pictured, undesirable vegetation (e.g. russian thistle and kochia) was observed throughout and will need to be managed during the next growing season. A follow-up inspection will be performed at a later date to ensure compliance with Rule 1003, including weed management.

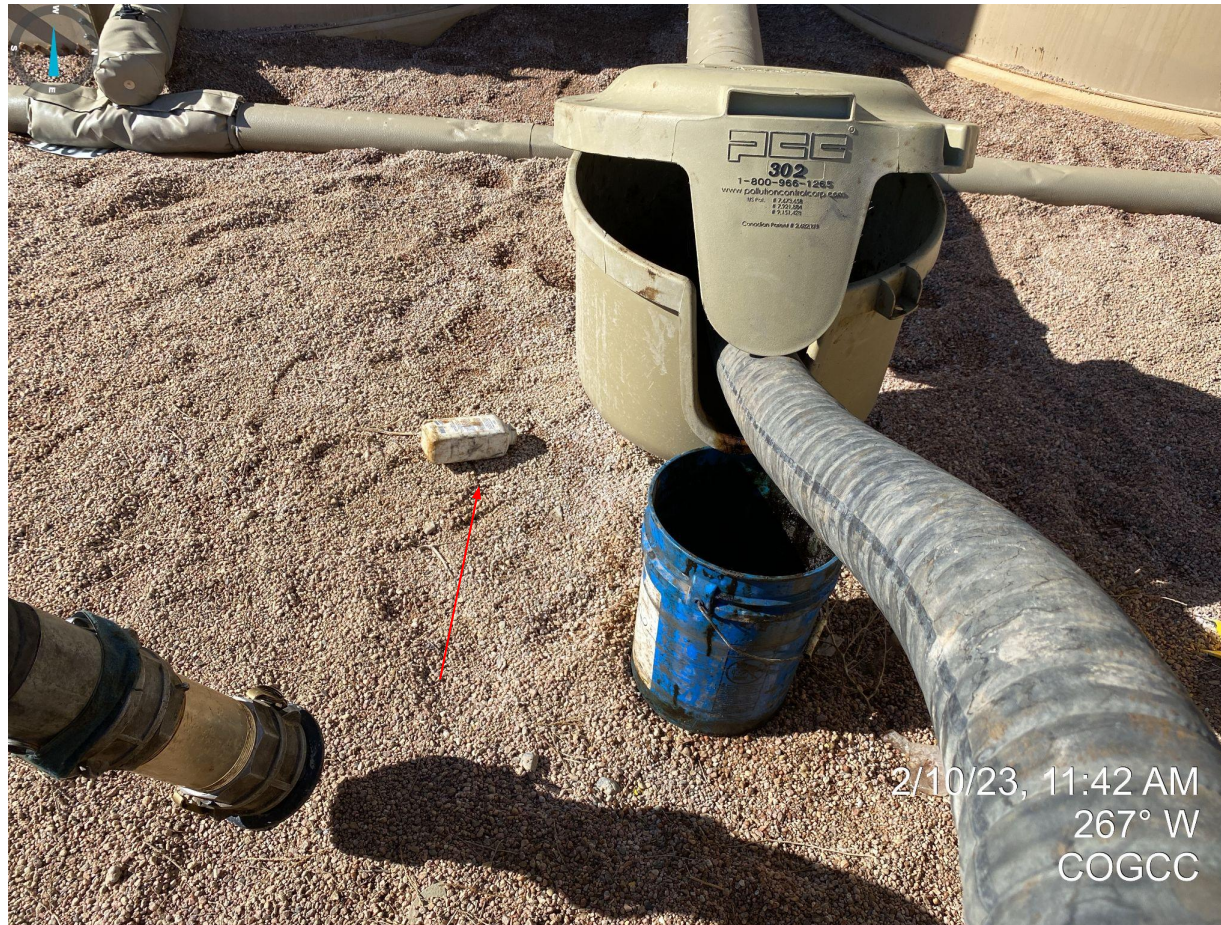
Photo 7. Trash observed within the tank battery secondary containment area.

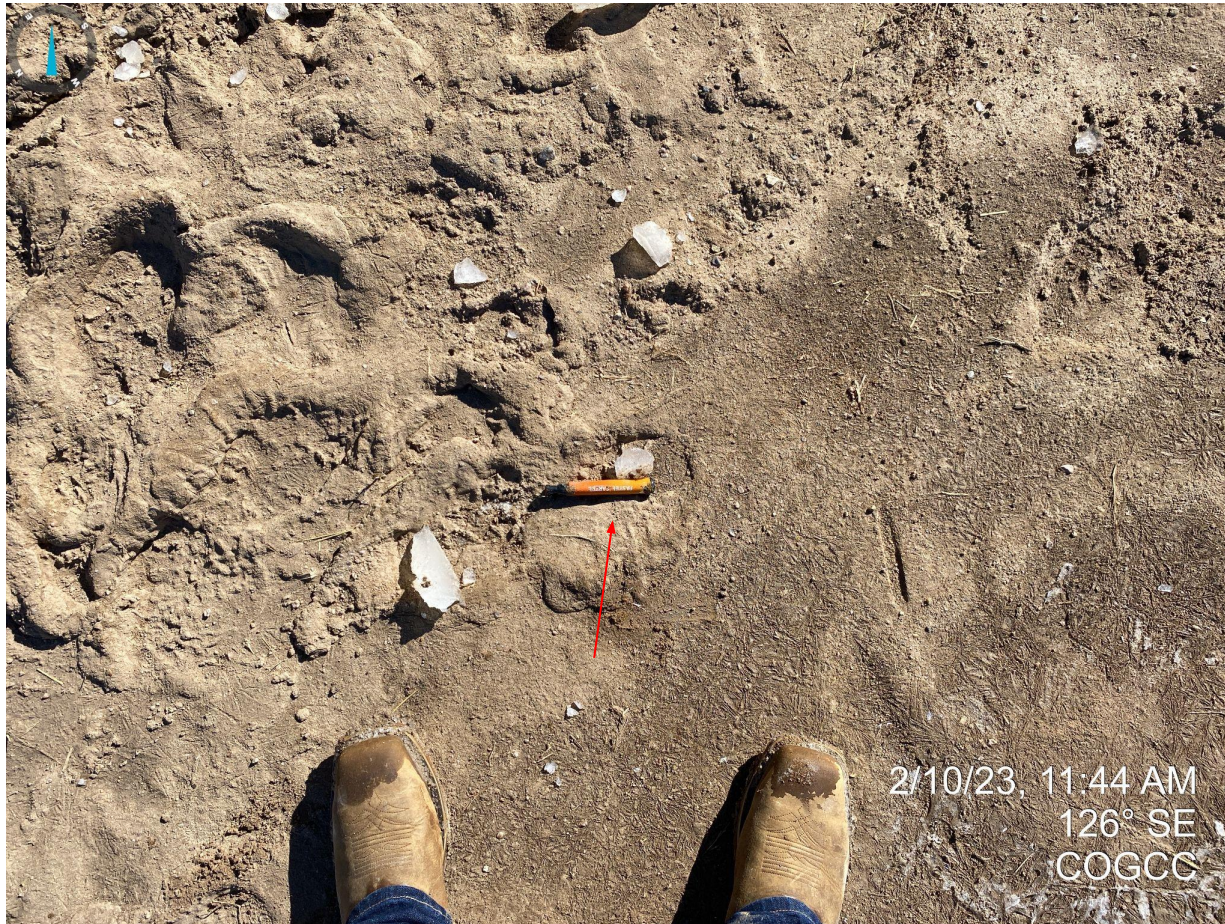
Photo 8. Close-up photo of trash observed on the west side of the tank battery.

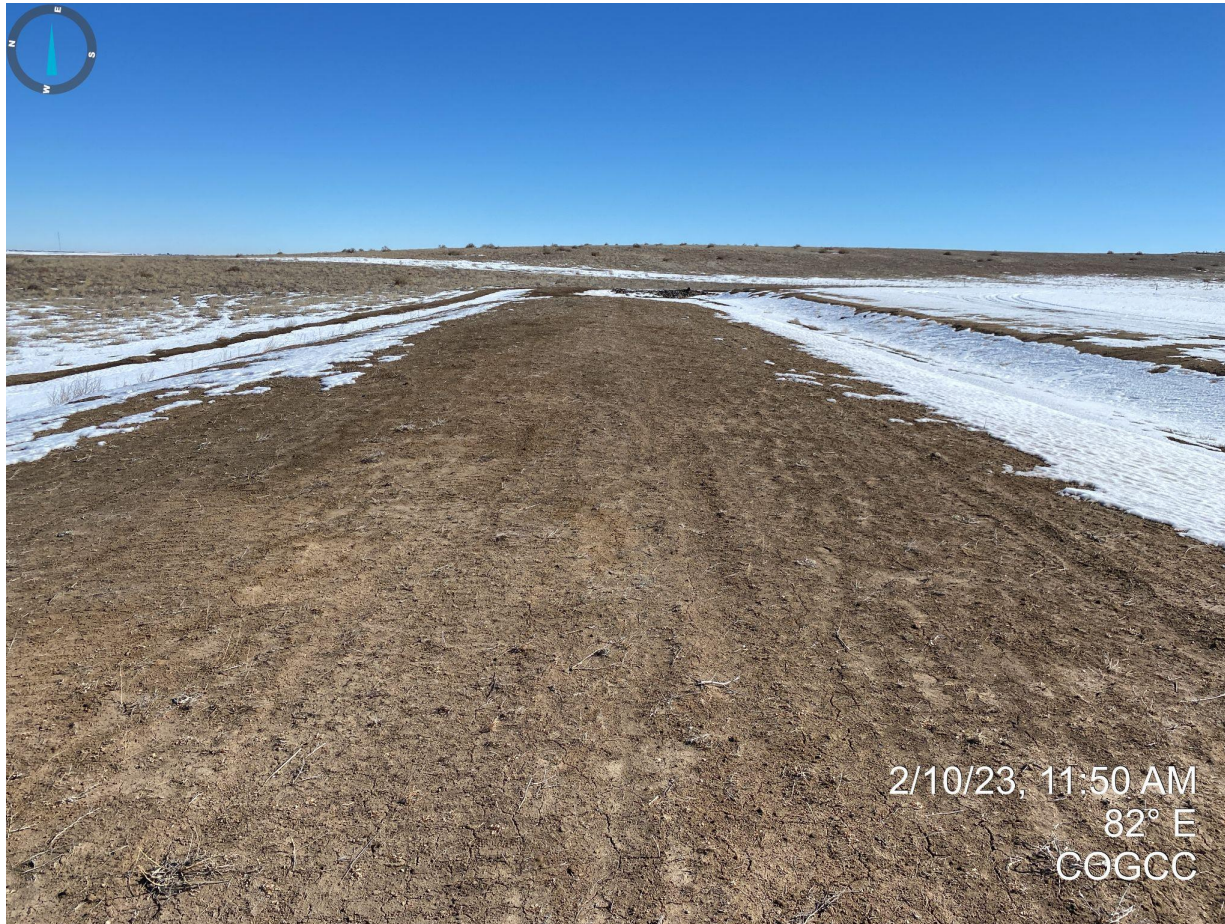
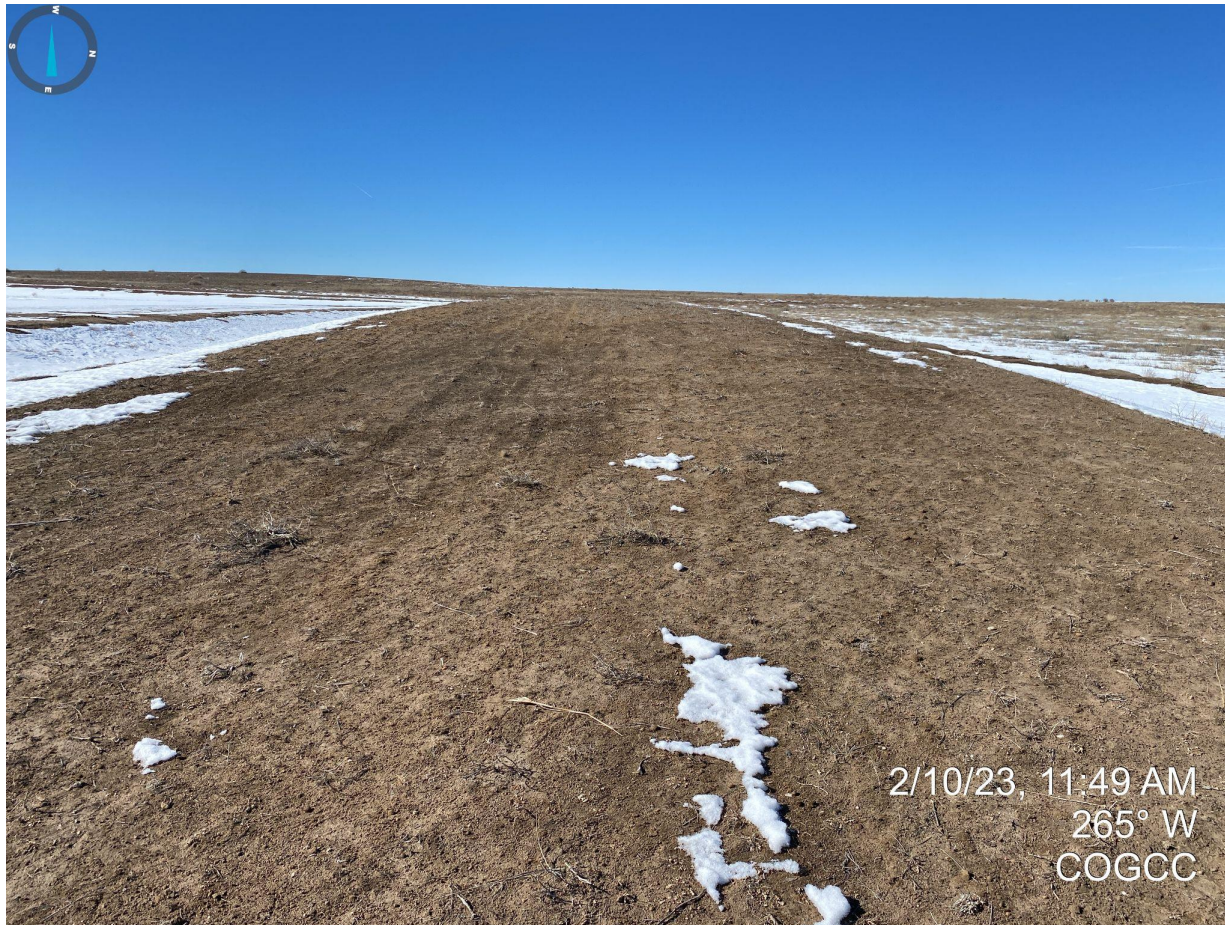
Photo 9. Facing east from the top of the topsoil stockpile. The topsoil stockpile is void of vegetation resulting in large areas of bare soil.

Photo 10. Facing west, see comments in Photo 9.
