Final Reclamation Inspection

Operator: NOBLE ENERGY INC- 100322

Location ID: 323153

Inspection Photos
Location Name: AMIGO 2
Location ID: 323153

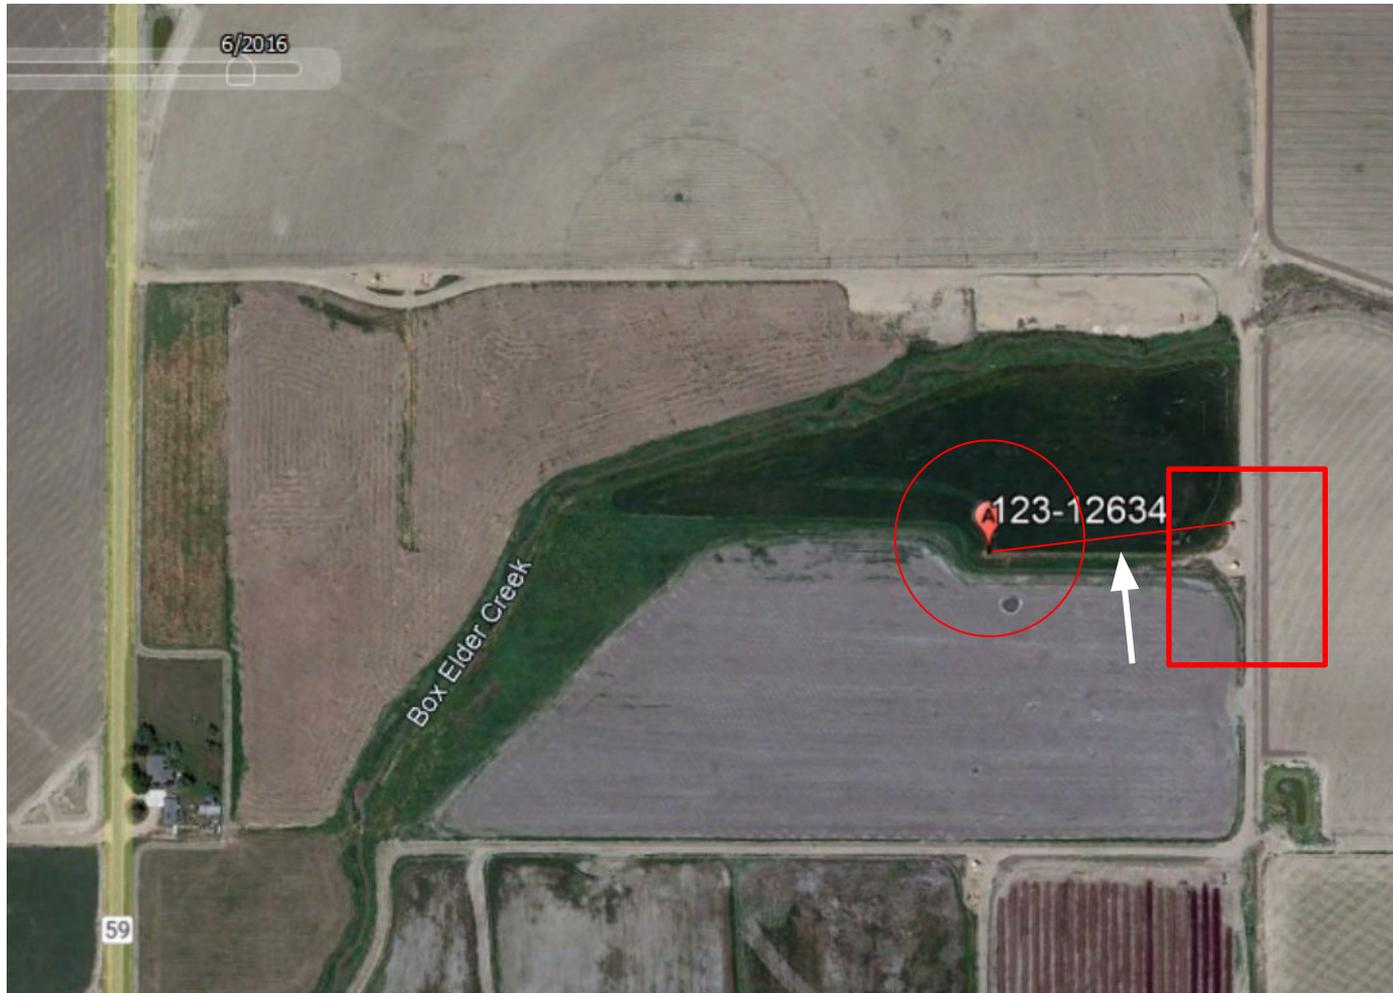
Photo 1. Google Earth aerial imagery taken 6/2016 during active operations. Photo illustrates the well location (red circle), tank battery (red square), flowline (red line), and well location access road (white arrow).

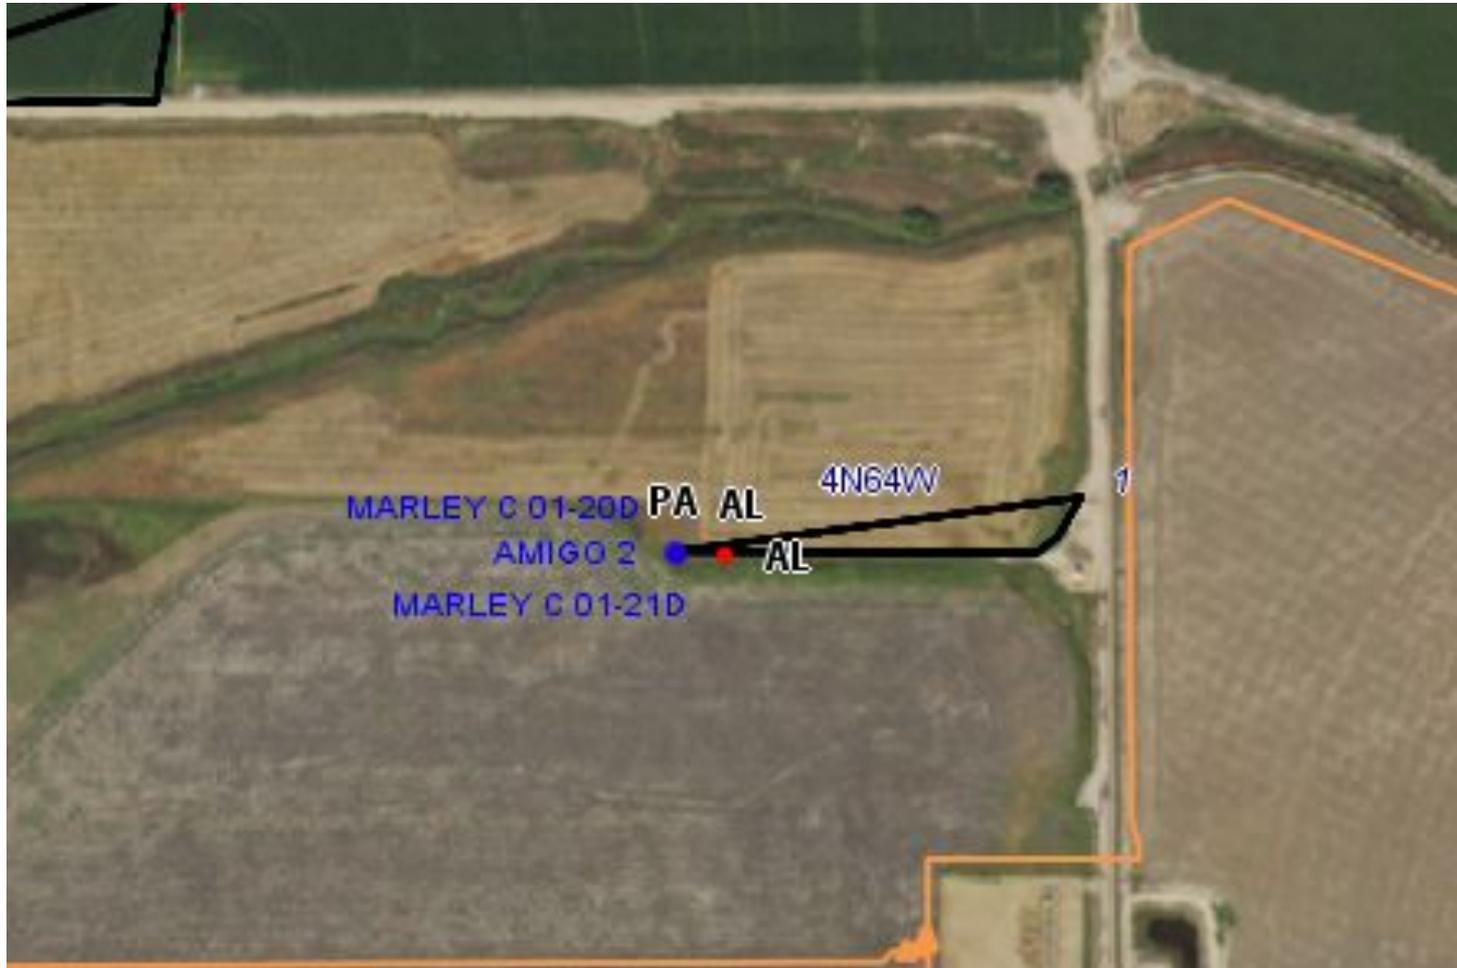
Photo 2. COGCC Online Map aerial imagery 2019 with related wells (red dots), subject well (blue dot), tank battery (near 1) and flowlines (black lines). Flowline abandonment/removal not submitted.

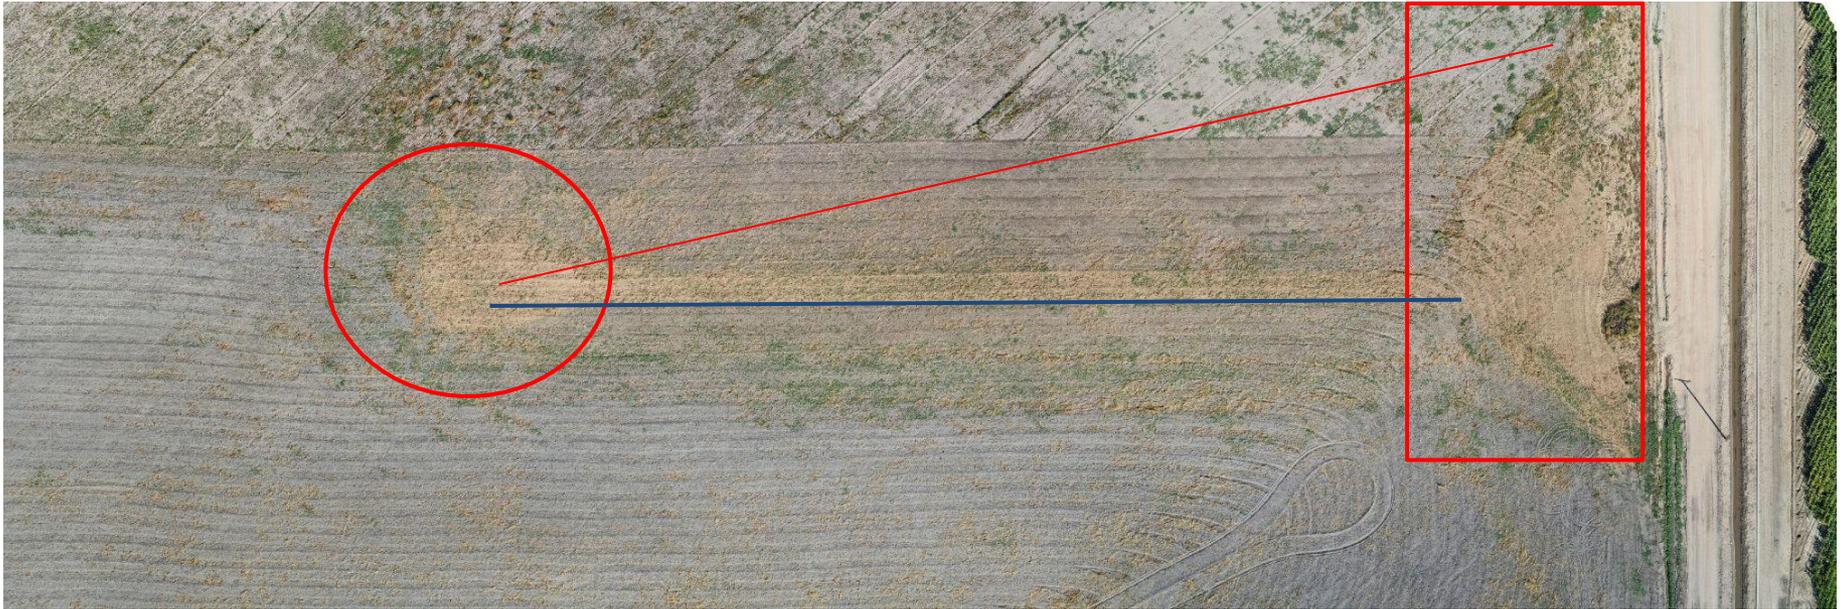
Photo 3. Orthomosaic drone aerial imagery taken from 200 ft (Sept 2022). Photo illustrates growth on and around the well location (red circle), flowline, tank battery (red rectangle) and access road. Re-vegetation has not fully occurred on well site, access road or tank battery. Red line is approximate flowline; Blue line is approximate flowline and access road.

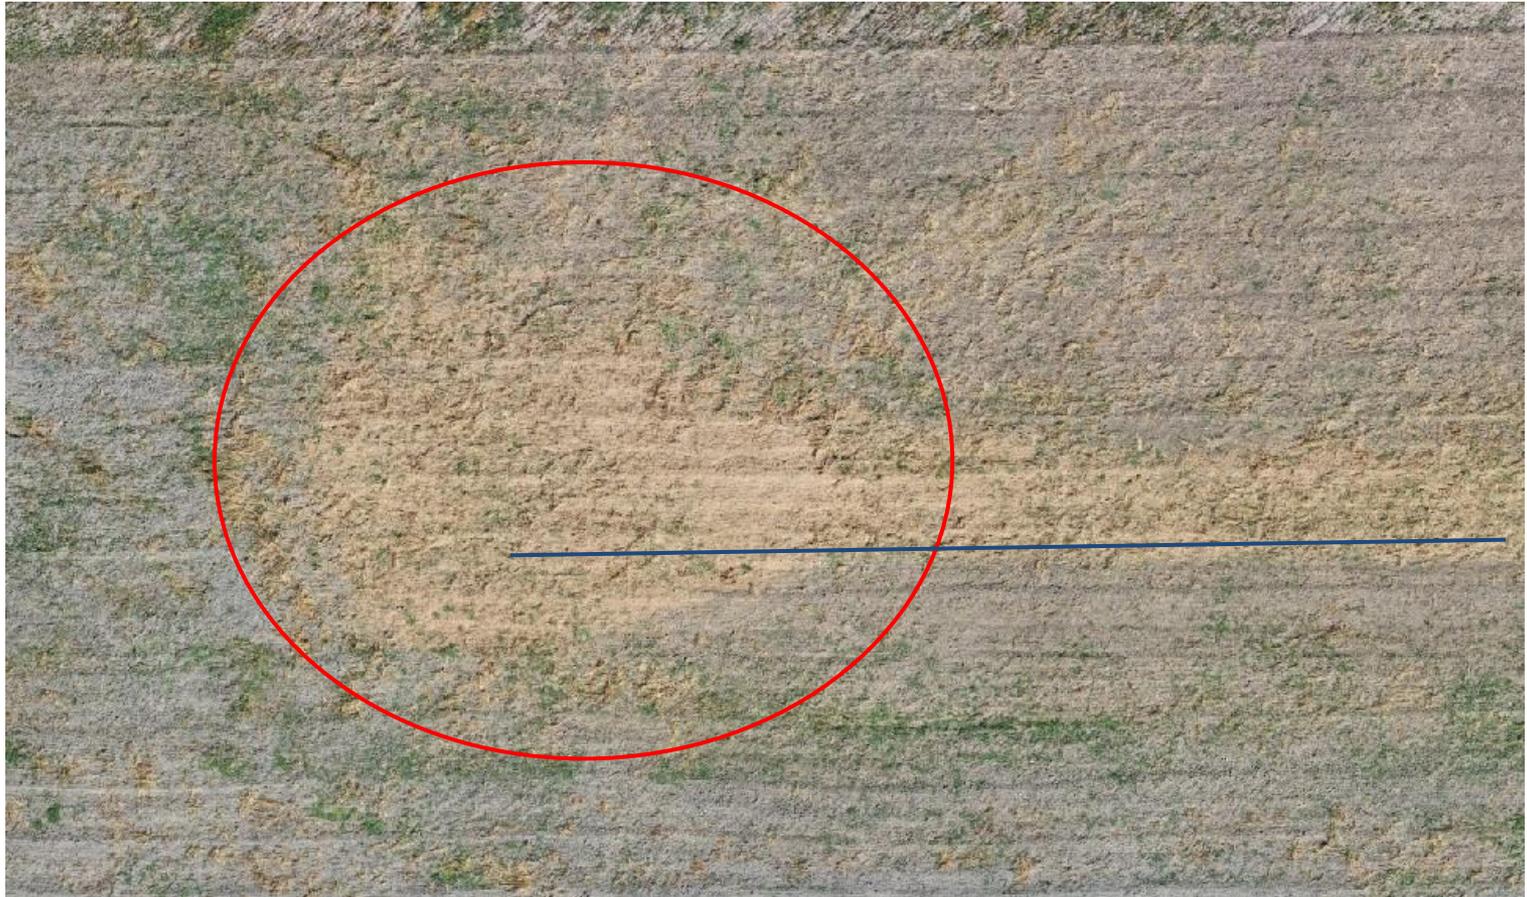
Photo 4. Zoomed in Orthomosaic drone aerial imagery taken from 200 ft (Sept 2022). Illustrates lack of full growth on and around the well location (red circle) and access road (blue line).

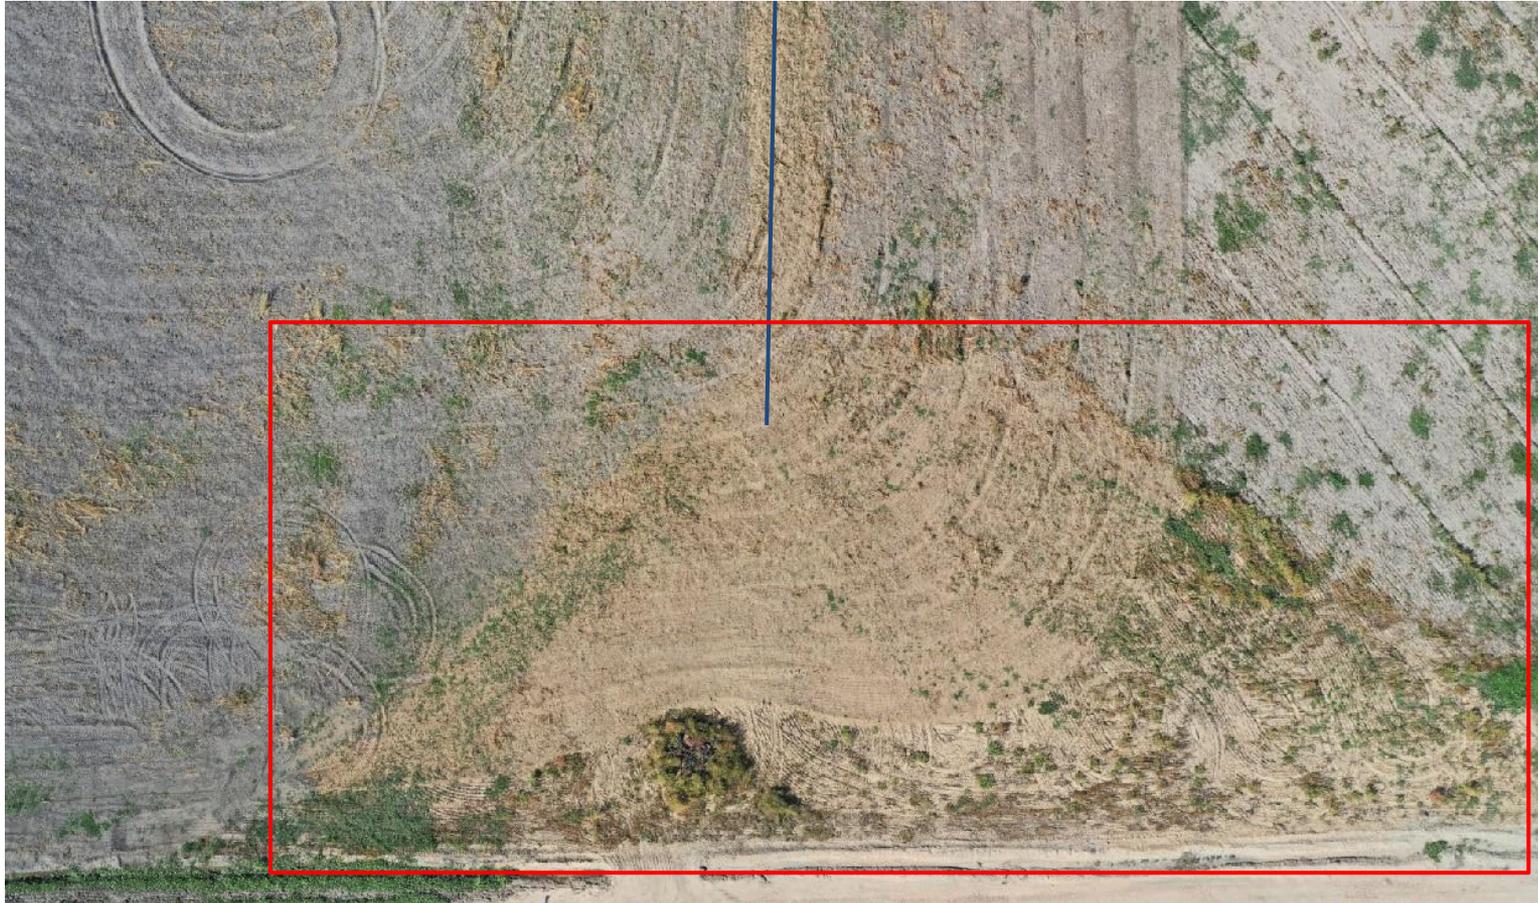
Photo 5. Zoomed in Orthomosaic drone aerial imagery taken from 200 ft (Sept 2022). Illustrates lack of growth on and around the tank battery (red rectangle) and access road (blue line).
