KODA Exploration LLC (10720)

WHP Misty 2-7 Pad

(Location ID:477611)

2022 Post-Reclamation Update

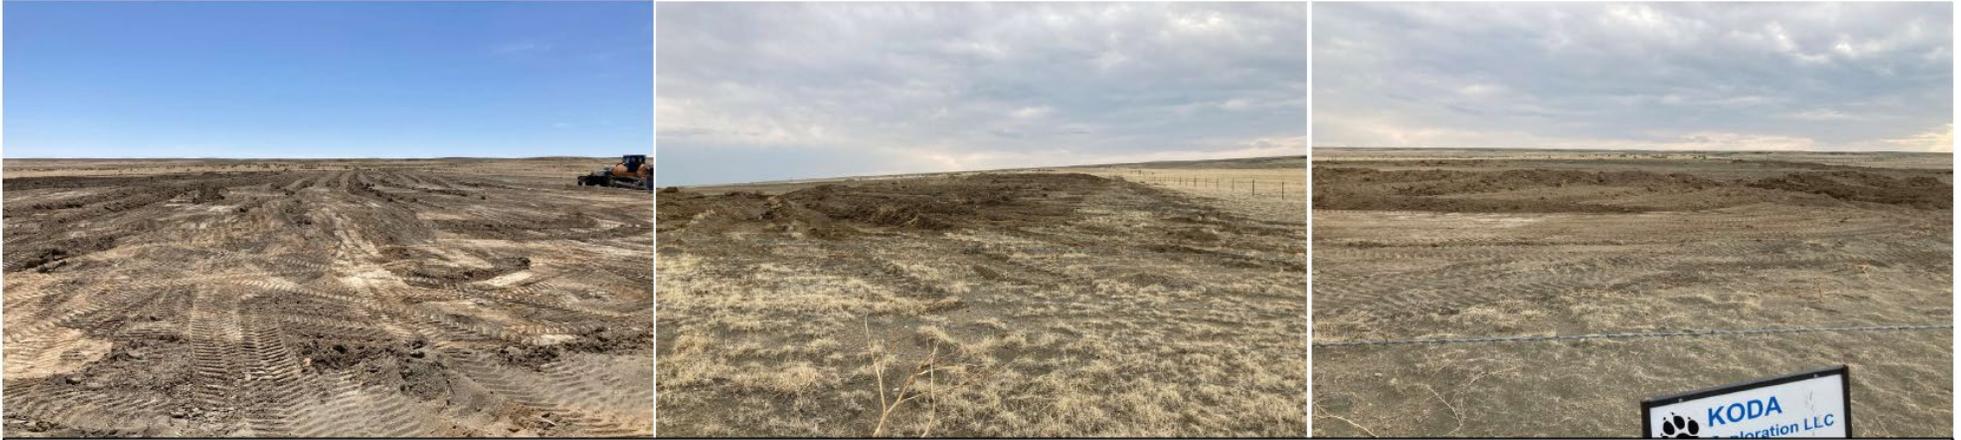
Exhibit B

5/11/2022 - 5/17/2022 WHP Misty 2-7 Recontouring Pad. Drill seeded pad on 5/18/22 (seeding attempt #1 of 2. no photos).

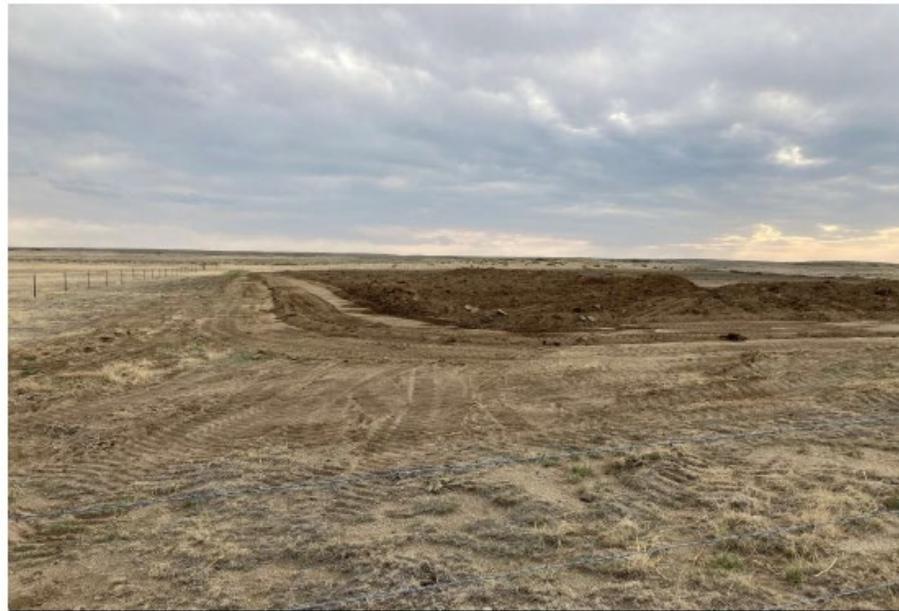
Exhibit C

5/16/2022 WHP Misty 2-7 Drill seeded pad on 5/18/22 (seeding attempt #1 of 2. no photos).

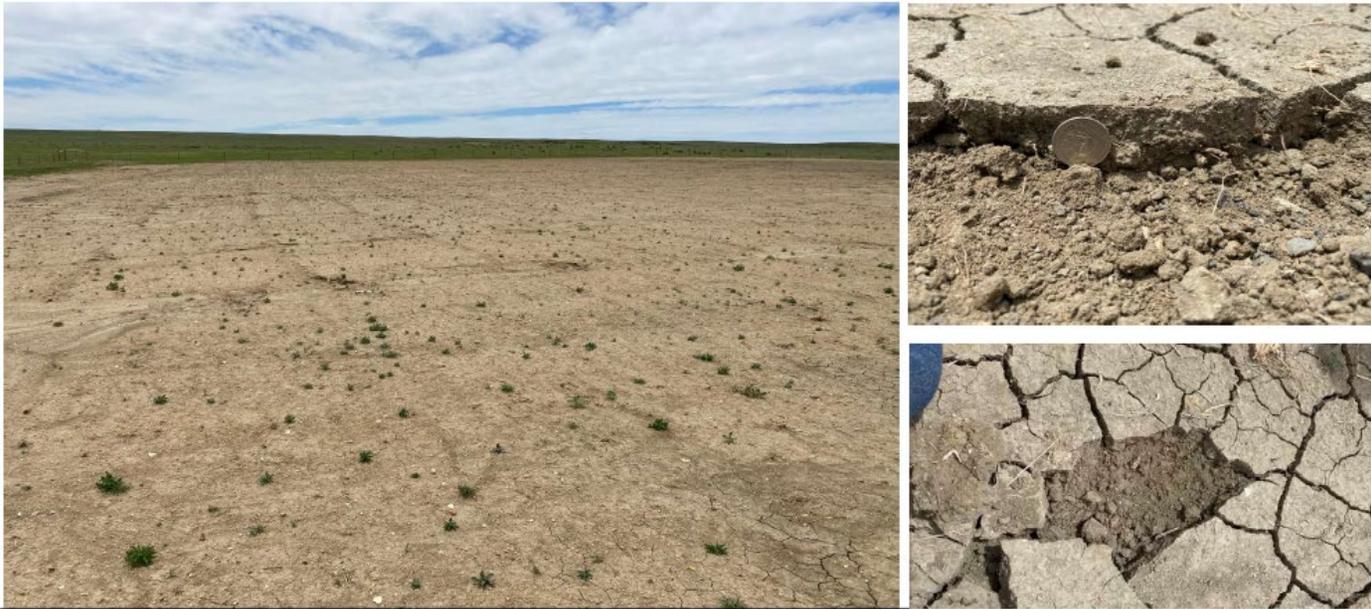
Exhibit D

6/20/2022 WHP Misty 2-7 Post seeding inspection (note grass seeds having difficulty germinating due to thick/hard shale crust formed after hail storm).

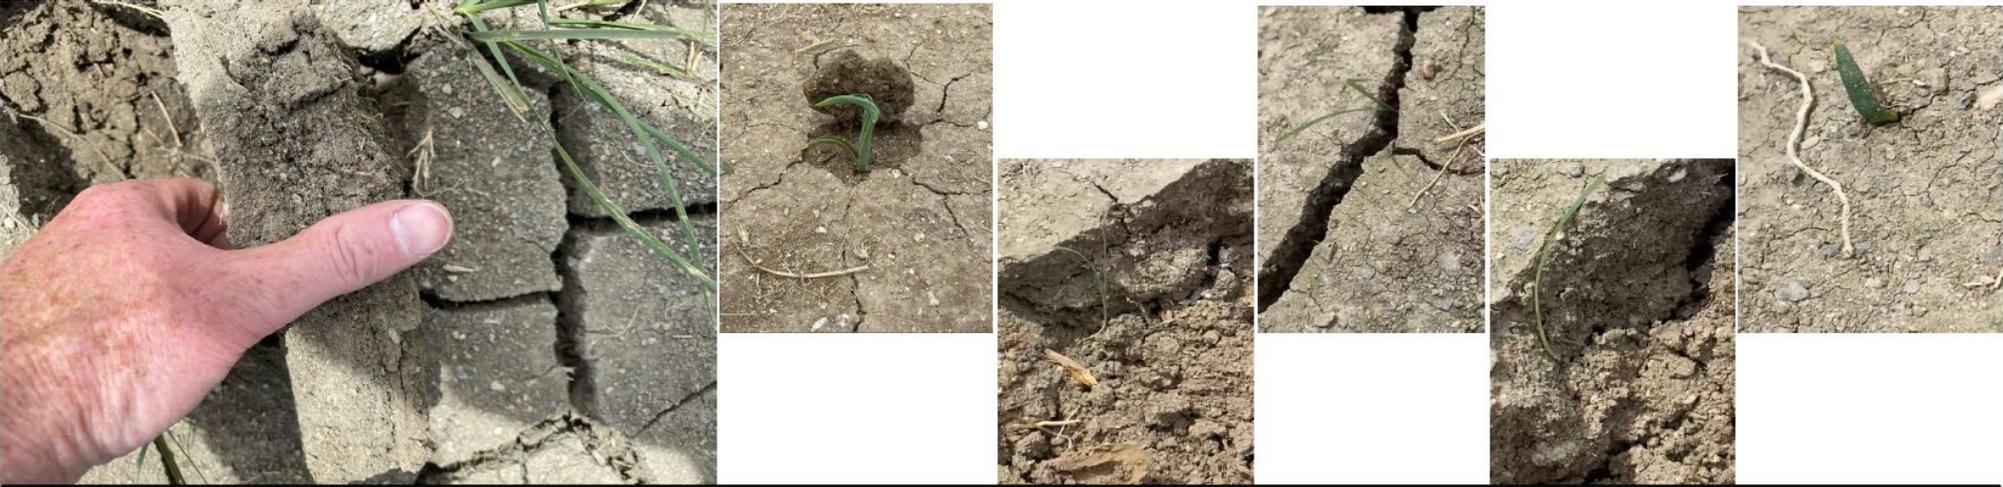
Exhibit E

6/20/2022 WHP Misty 2-7 Post seeding inspection (note grass seeds having difficulty germinating due to thick/hard shale crust formed after hail storm).

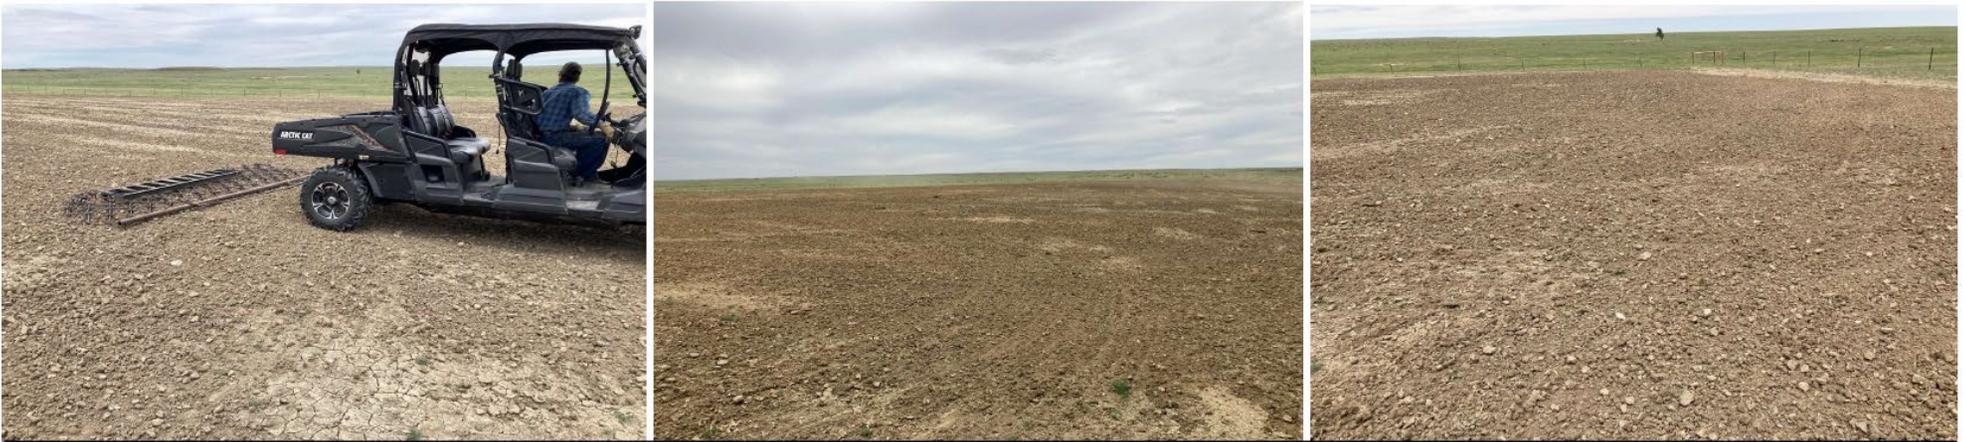
Exhibit F

6/25/2022 WHP Misty 2-7 Broke surface crust with harrow and reseeded pad again (seed attempt #2 of 2).
