# Inspection Photos

3/06/2023

Operator: CAERUS PICEANCE LLC - 10456

Location #335596

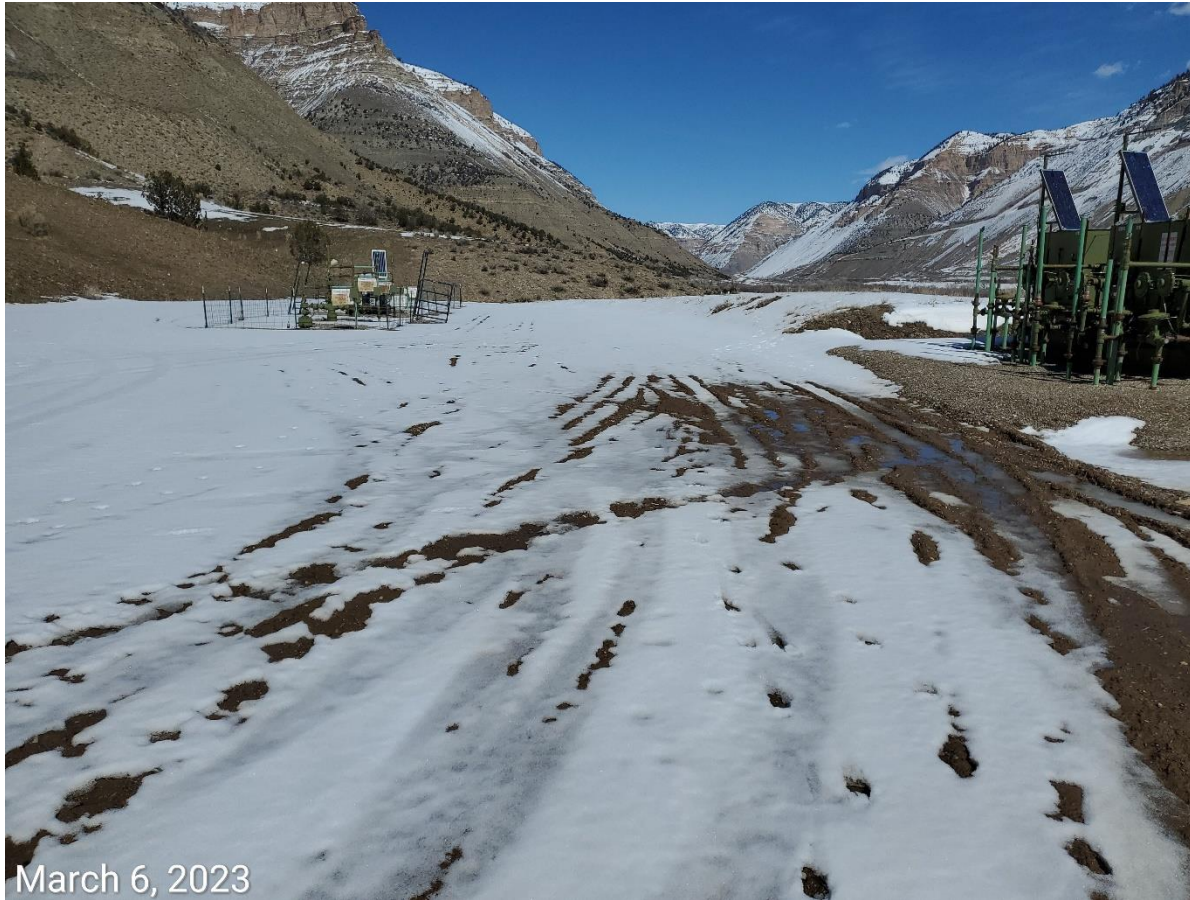
**Photo 1:** Location overview; BMPs to stabilize the working pad, as well as to minimize degradation, tracking and sediment transport do not appear to be adequate during wet conditions.

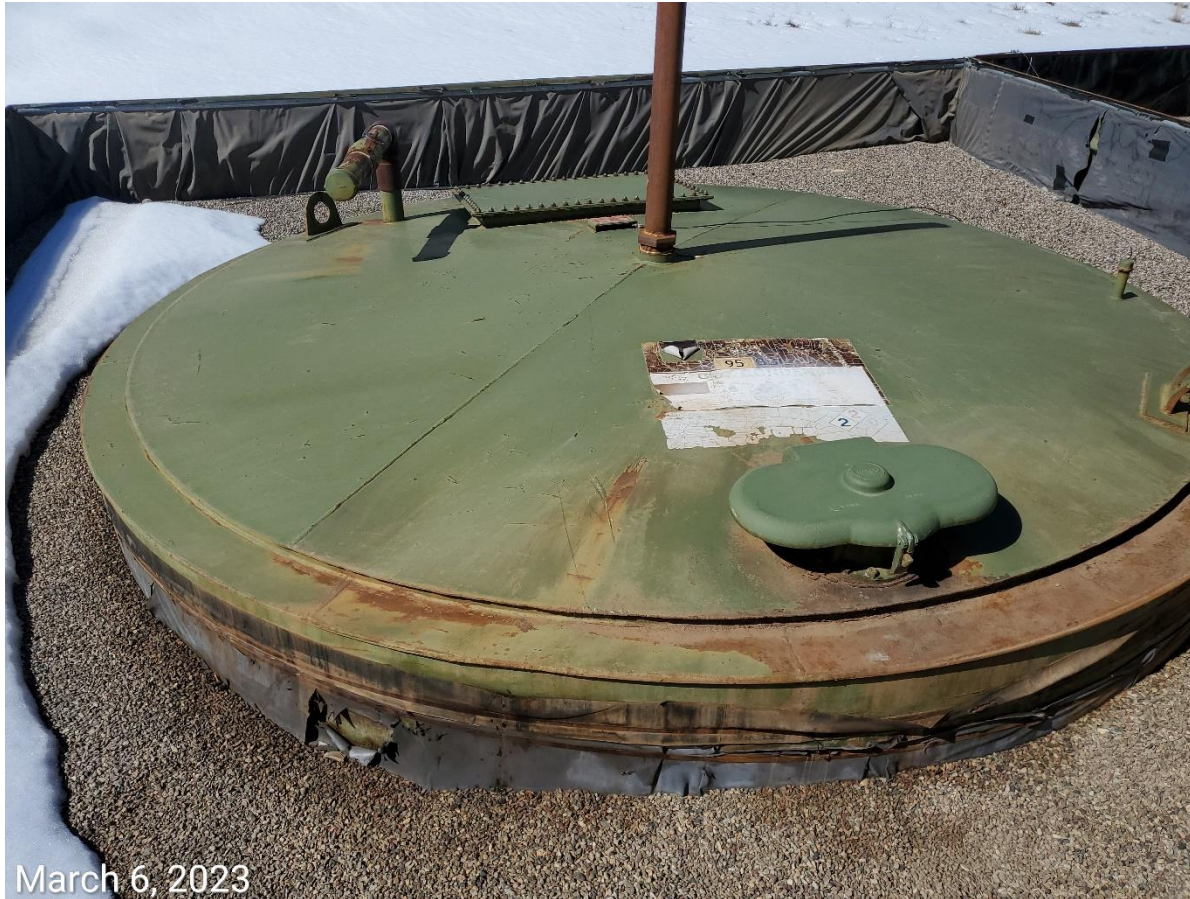
**Photo 2:** Sign/Label at tank no longer legible.

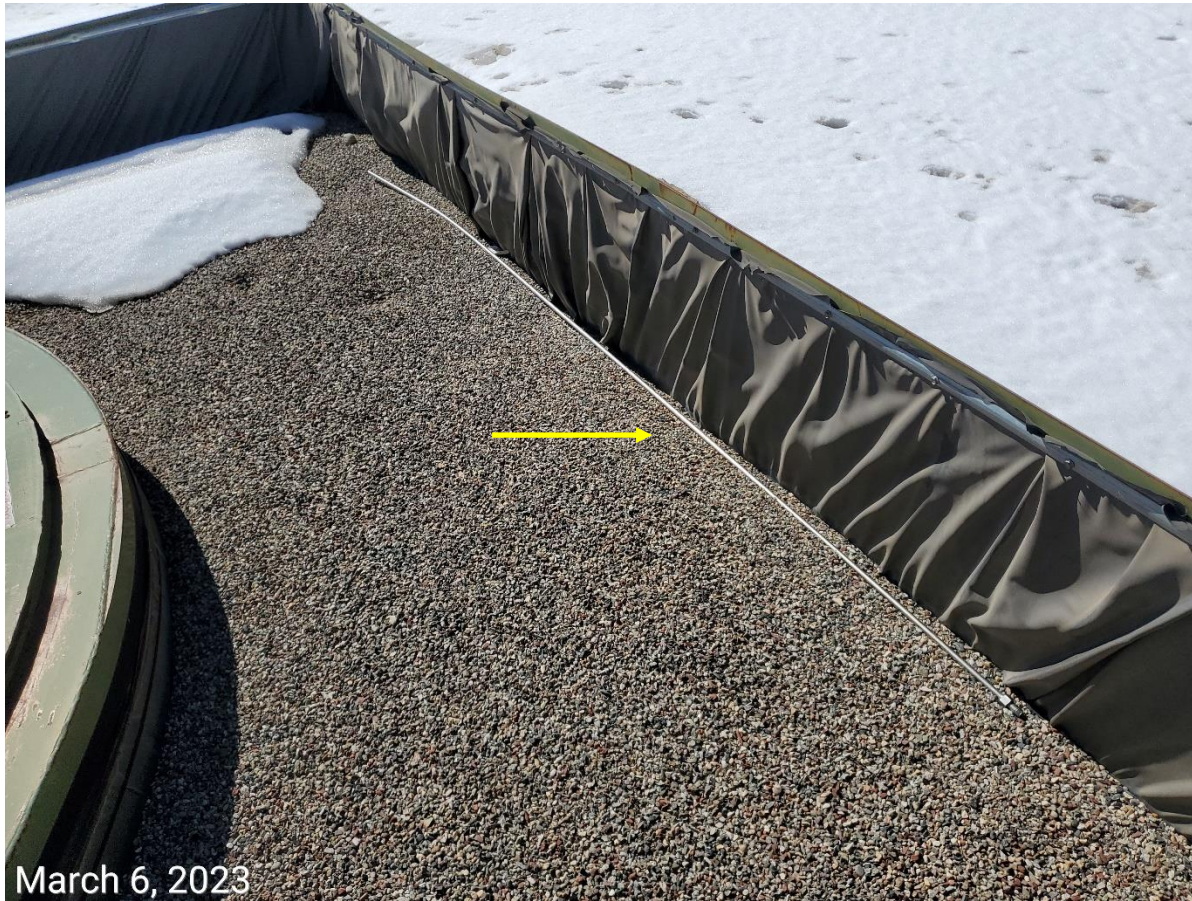
**Photo 3:** Unused pipe equipment stored within containment berm.

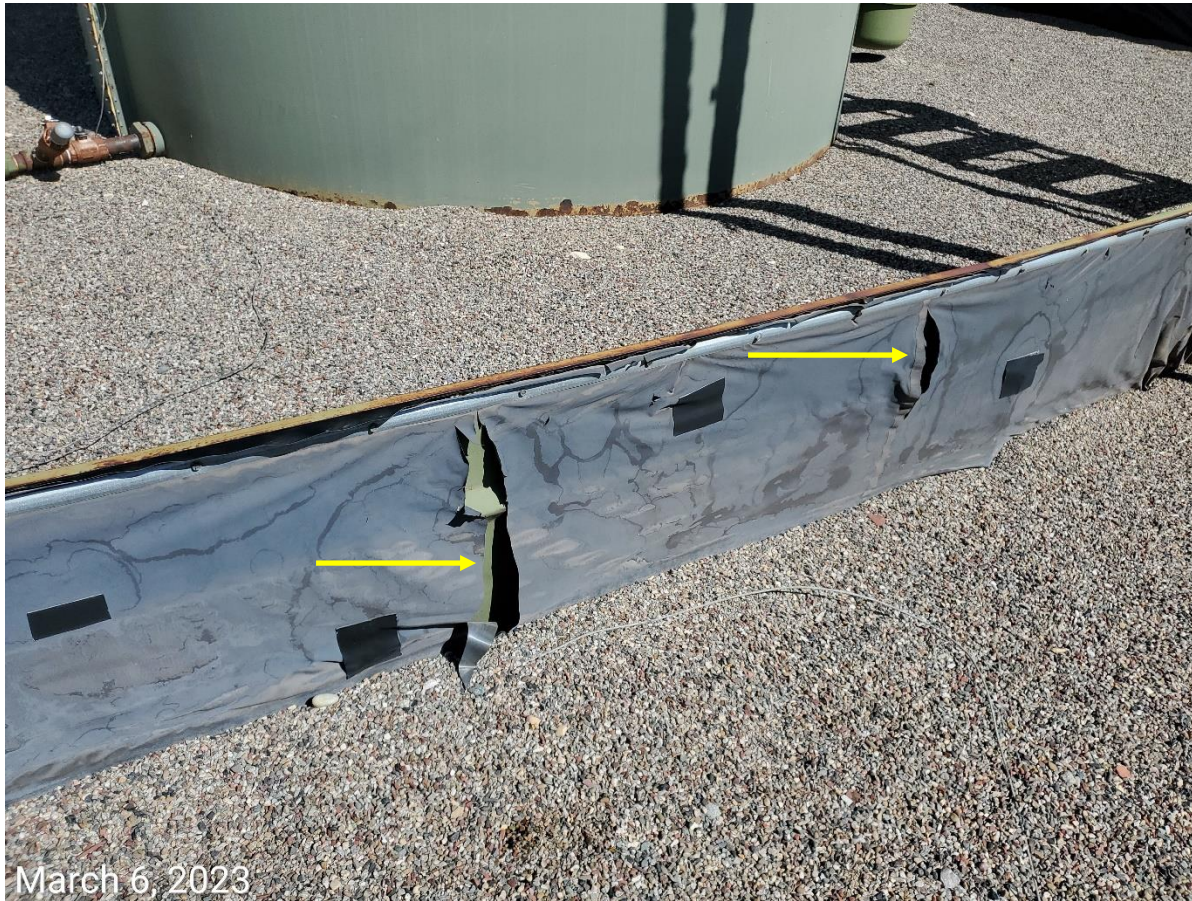
**Photo 4:** Photo shows various tears/holes observed within liner; liner no longer impervious to contain a spill.

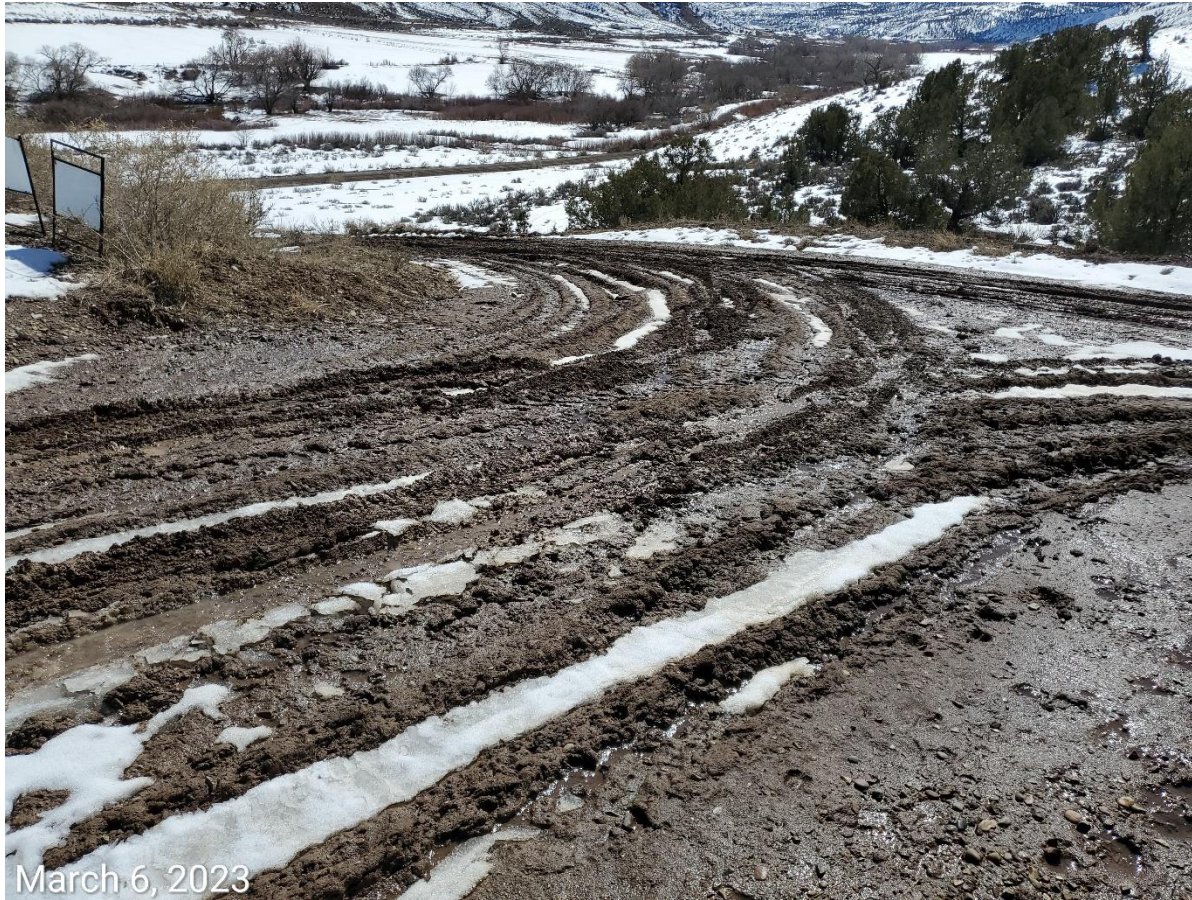
**Photo 5:** Photo taken from the location entrance. Photo shows BMPs to minimize degradation, tracking and sediment transport are missing or insufficient at the Location and access road.

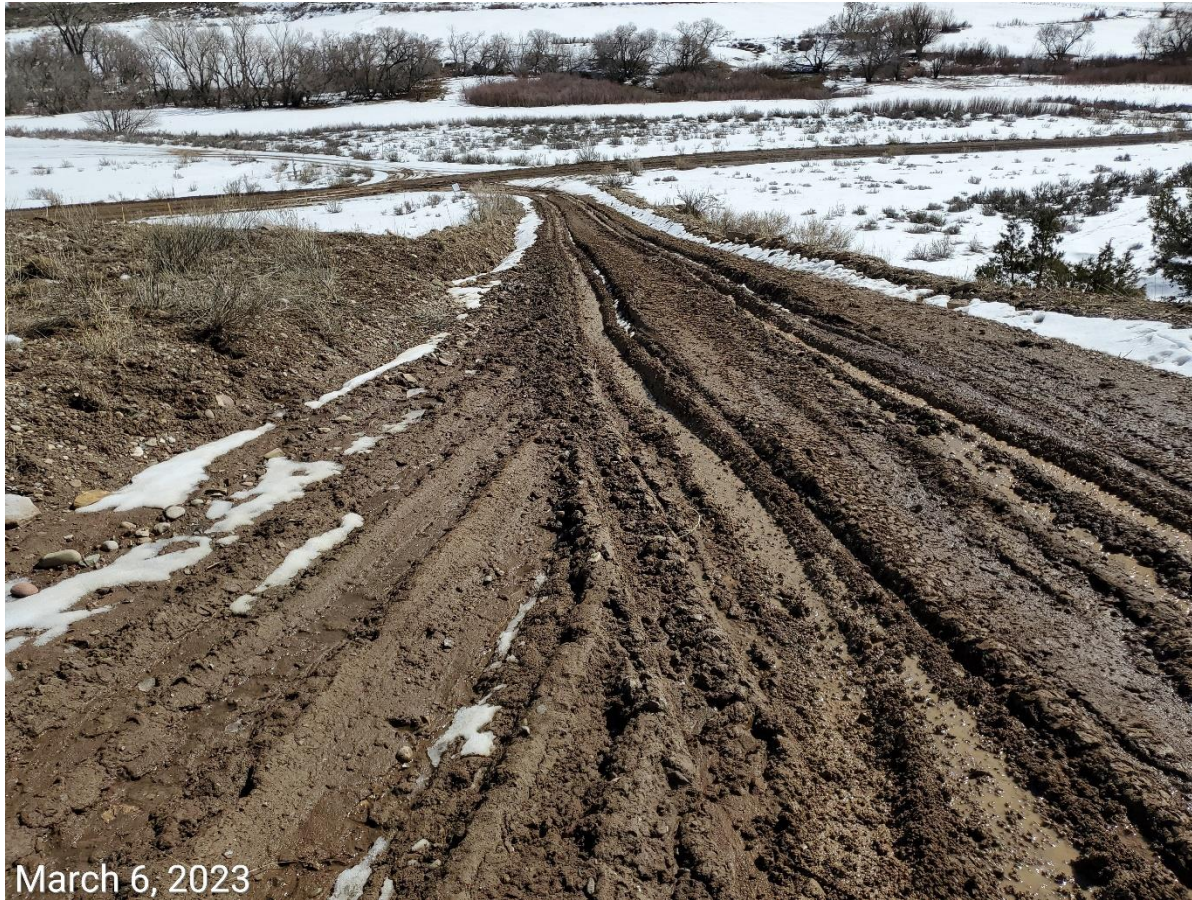
**Photo 6:** Photos 6-11 examples showing BMPs to manage runoff, minimize degradation, tracking and sediment transport are missing or insufficient at the access road.
