Inspection Photos

3/06/2023

Operator: CAERUS PICEANCE LLC - 10456

Location #335793

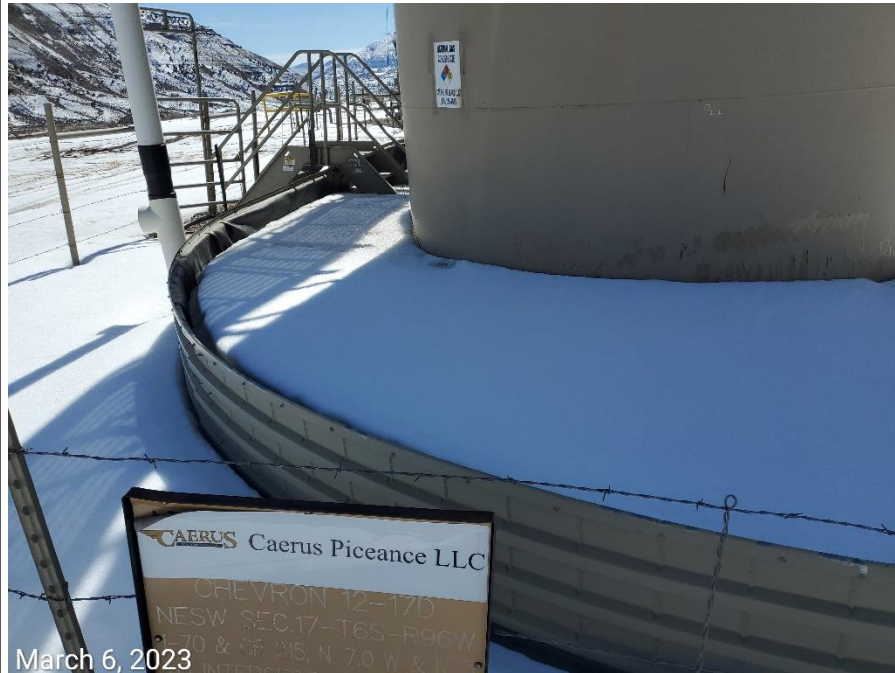
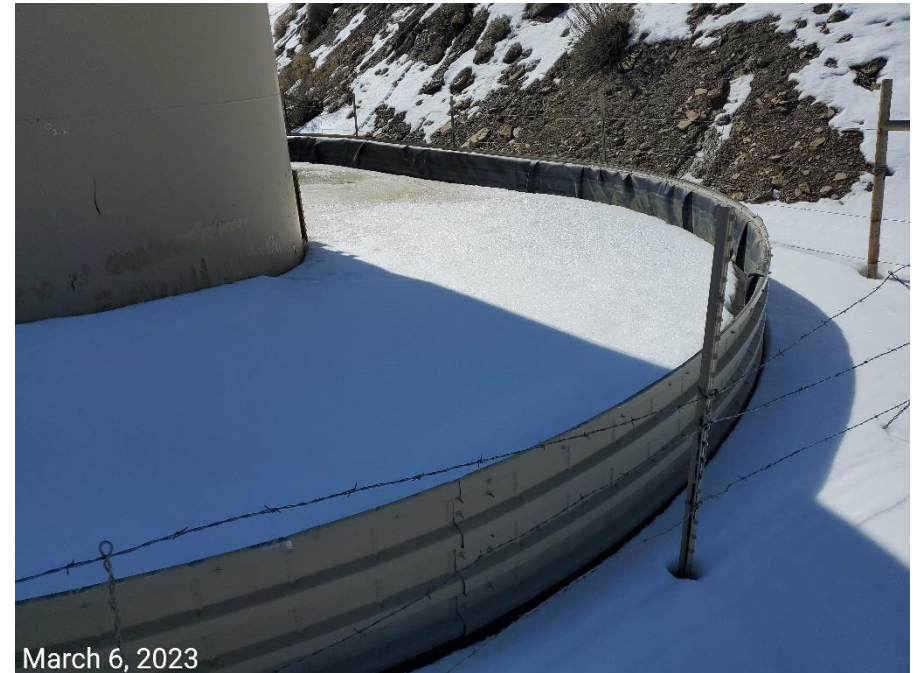
Photo 1: Photos shows secondary containment BMPs at the tank battery has filled with fluids/ice, and does not appear adequate to contain a spill.

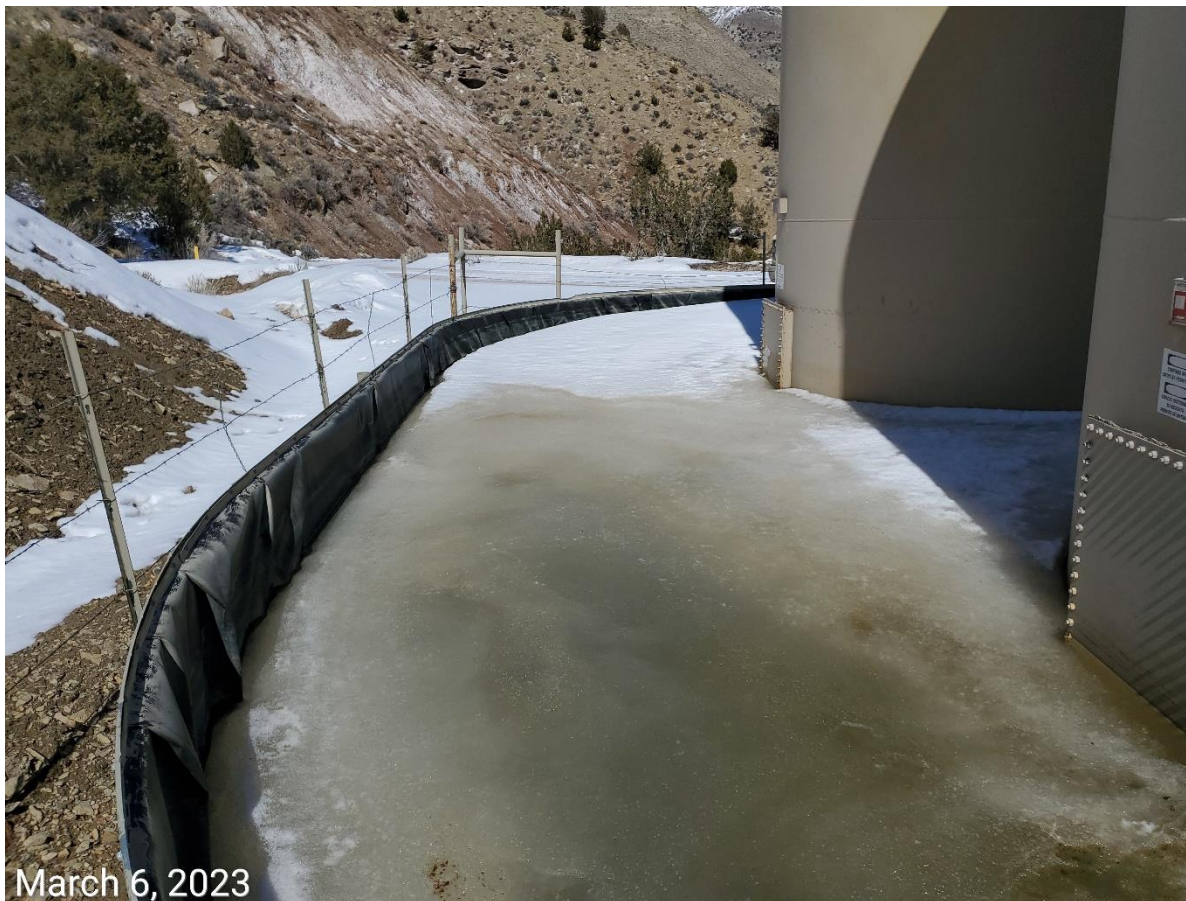
Photo 2: Photo shows secondary containment BMPs at the tank battery has filled with fluids/ice, and does not appear adequate to contain a spill.

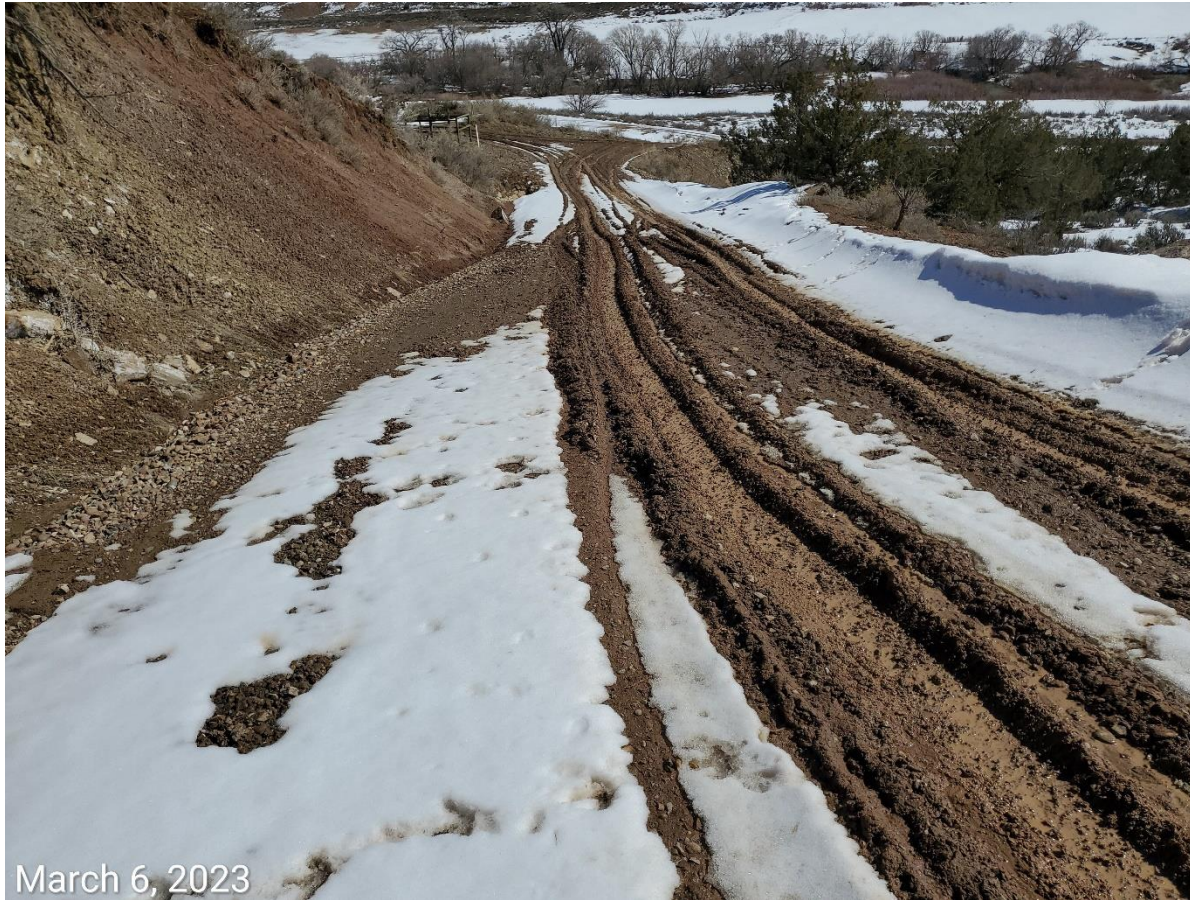
Photo 3: Photos 3-8 examples showing BMPs to manage runoff, minimize degradation, tracking and sediment transport are missing or insufficient at the access road.
