Inspection Photos

Operator: CHEVRON USA INC - 16700

Location #315317

Rio Blanco County, CO

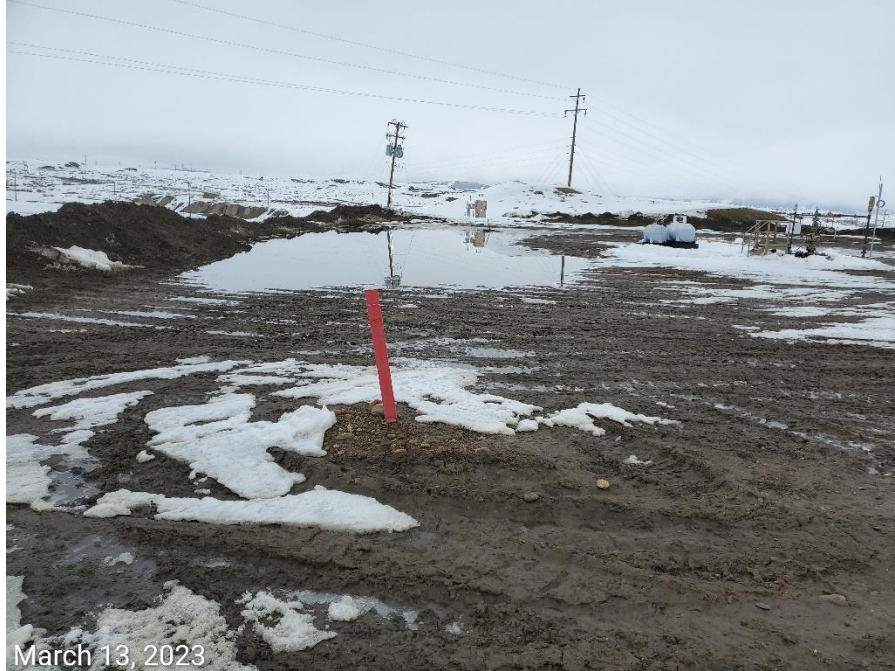
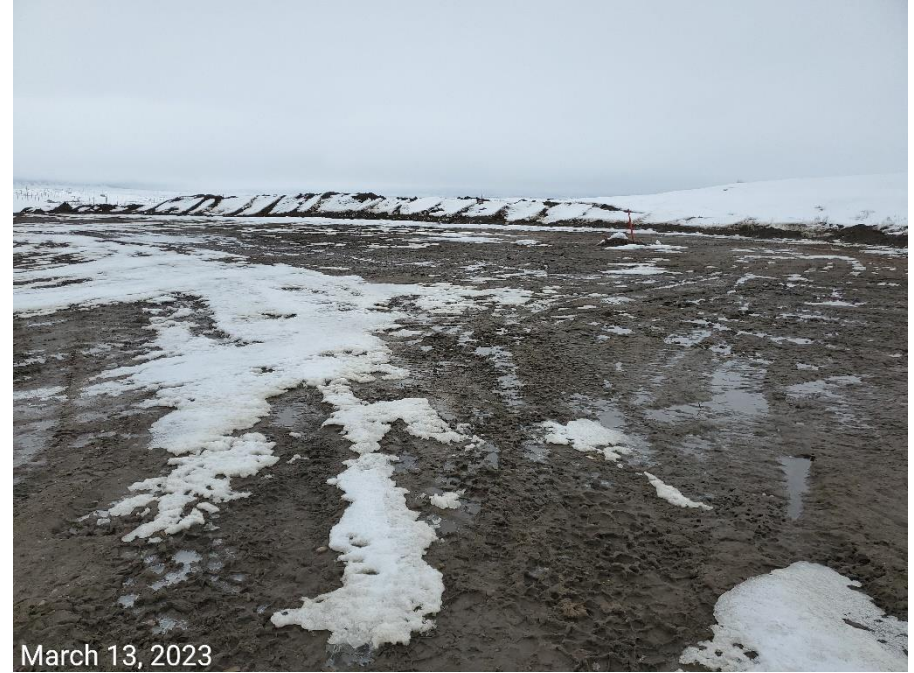
Photo 1: Photos provide overview of the Location. Photos also show BMPs to stabilize the Location, and to minimize tracking are missing or insufficient.

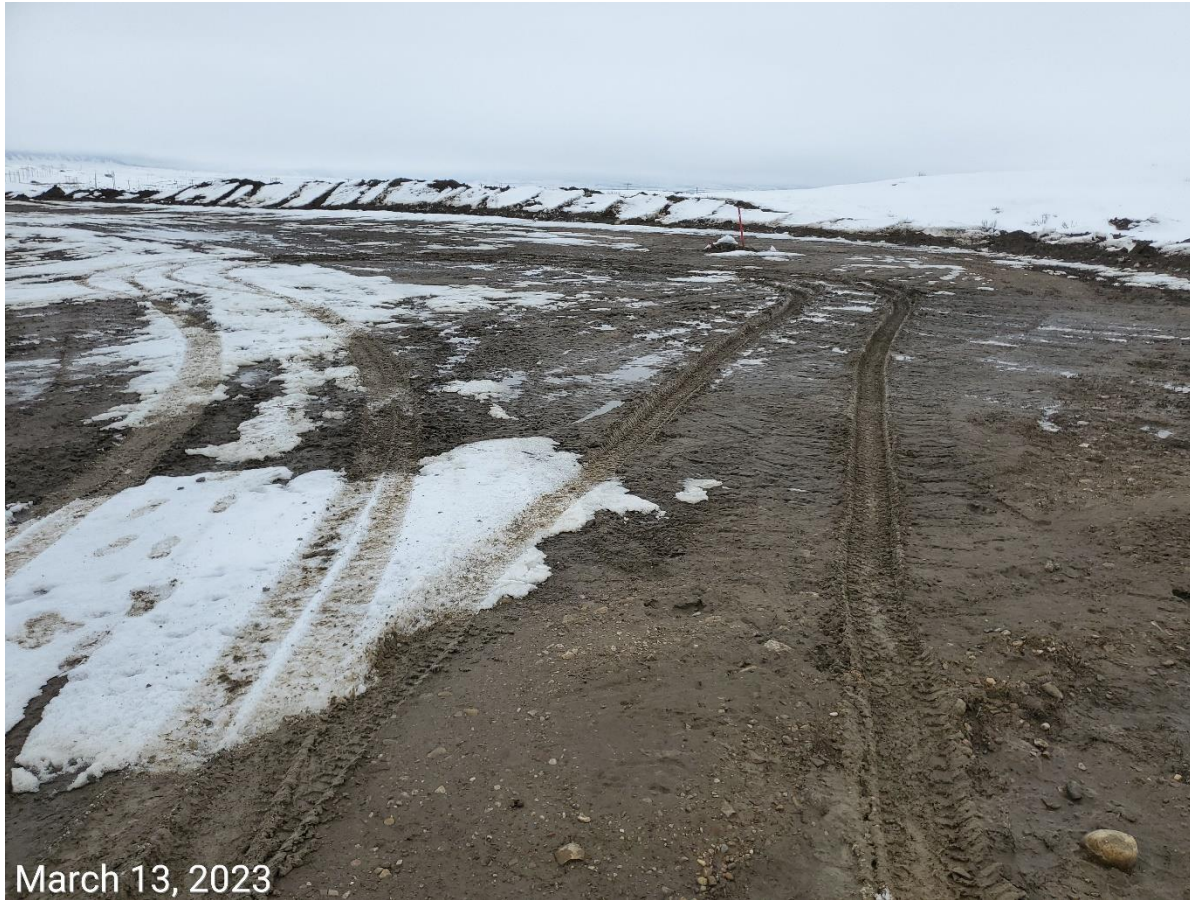
Photo 2: Tracking controls missing or insufficient.

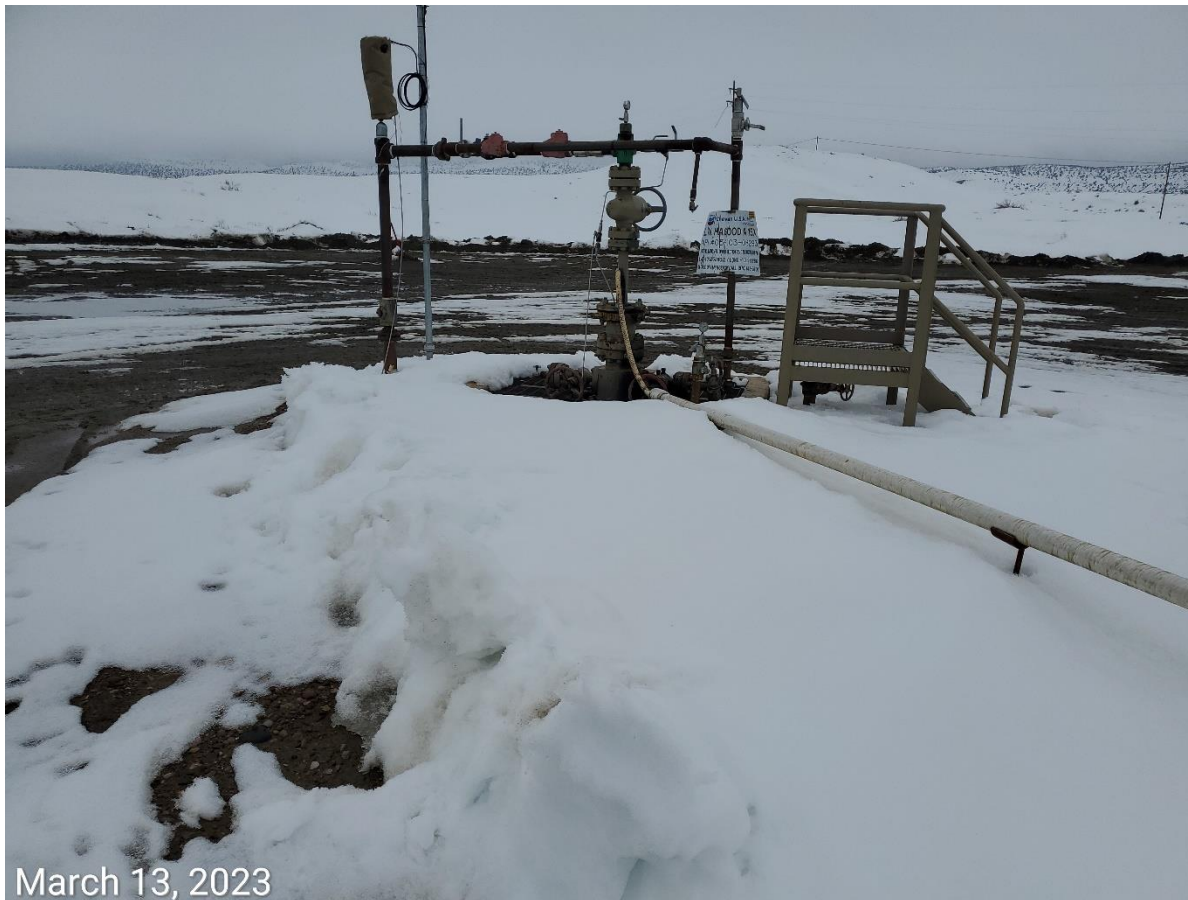
Photo 3: Wellhead

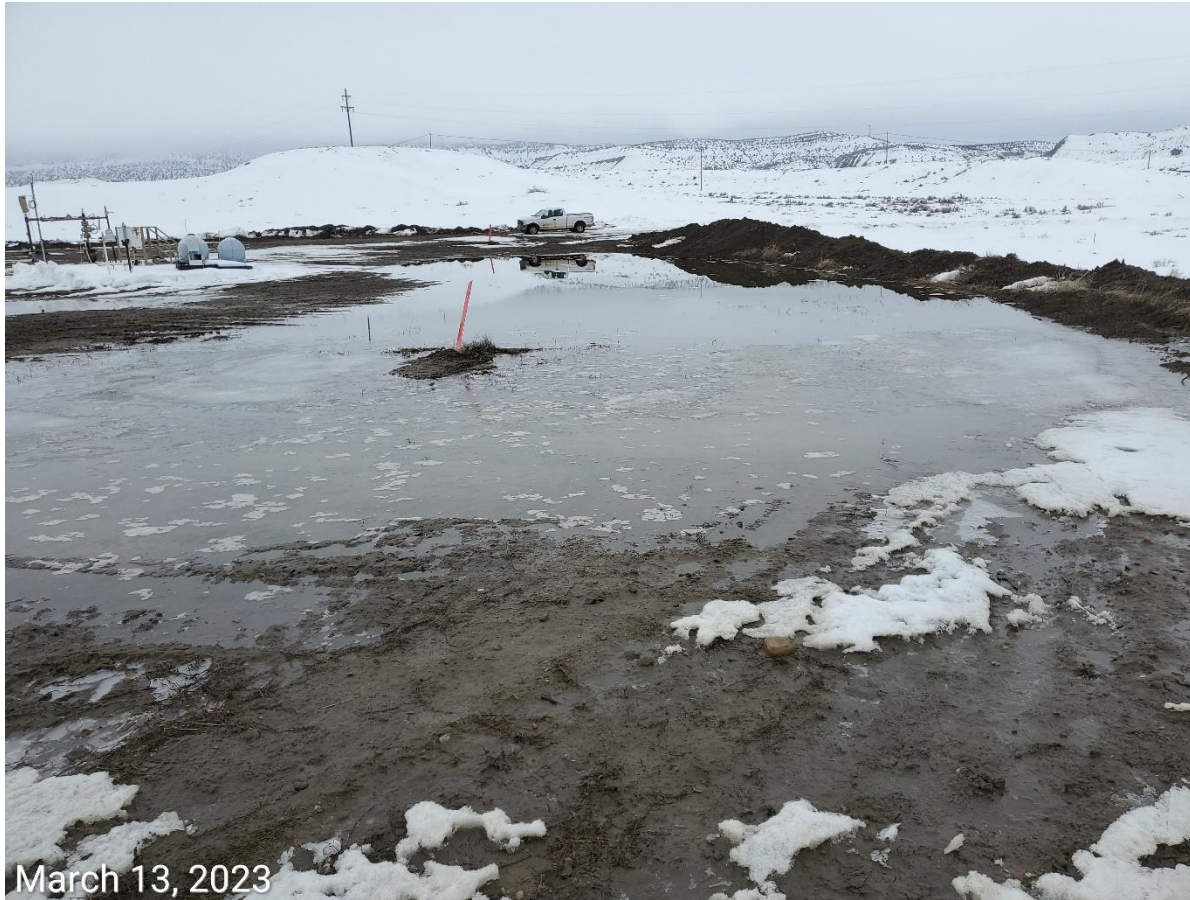
Photo 4: Photo taken from the north end of the Location. Approximately 1/3 of the Location covered in water; BMPs to allow for proper stormwater discharge from the Location are missing or insufficient, resulting in ponding and destabilization of the working pad area.

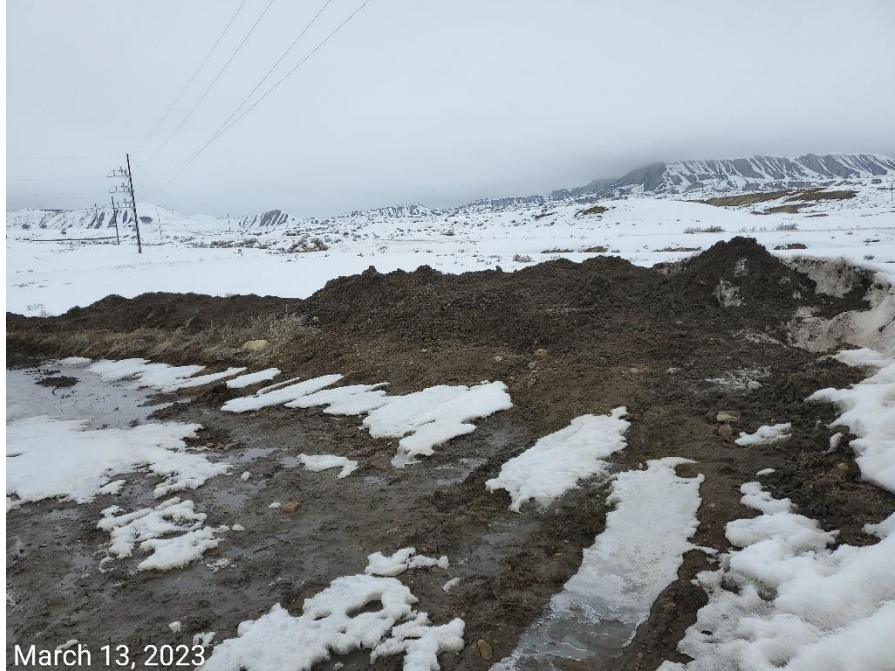
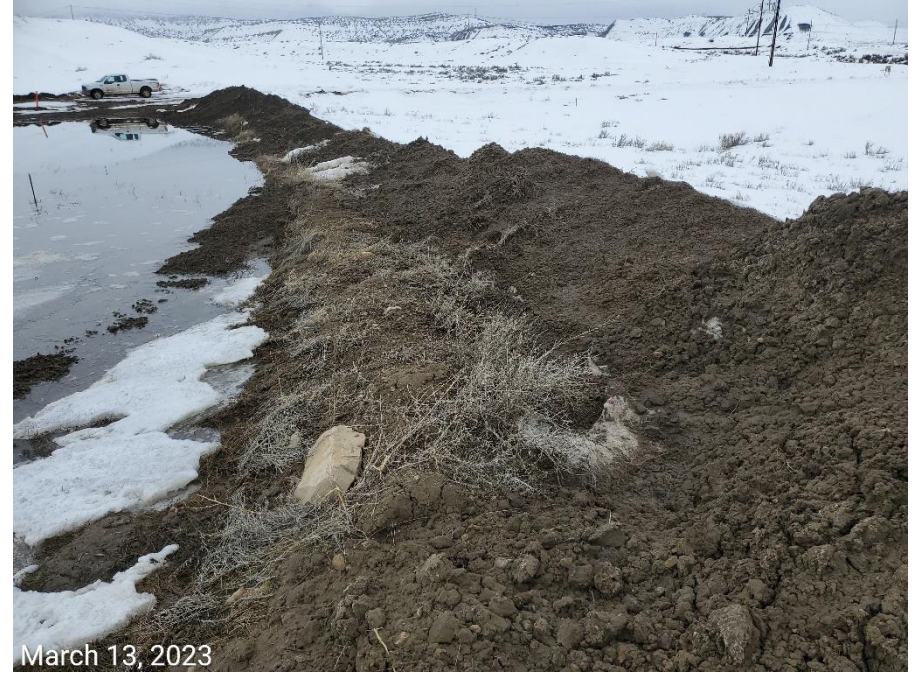
Photo 5: Photos taken from the north end of the Location. Photo shows Operator appears to have pushed soils beyond the perimeter of the working pad; soils observed covering vegetation; soils are unconsolidated and a pollutant source; BMPs to minimize sediment transport from the soils missing or insufficient.

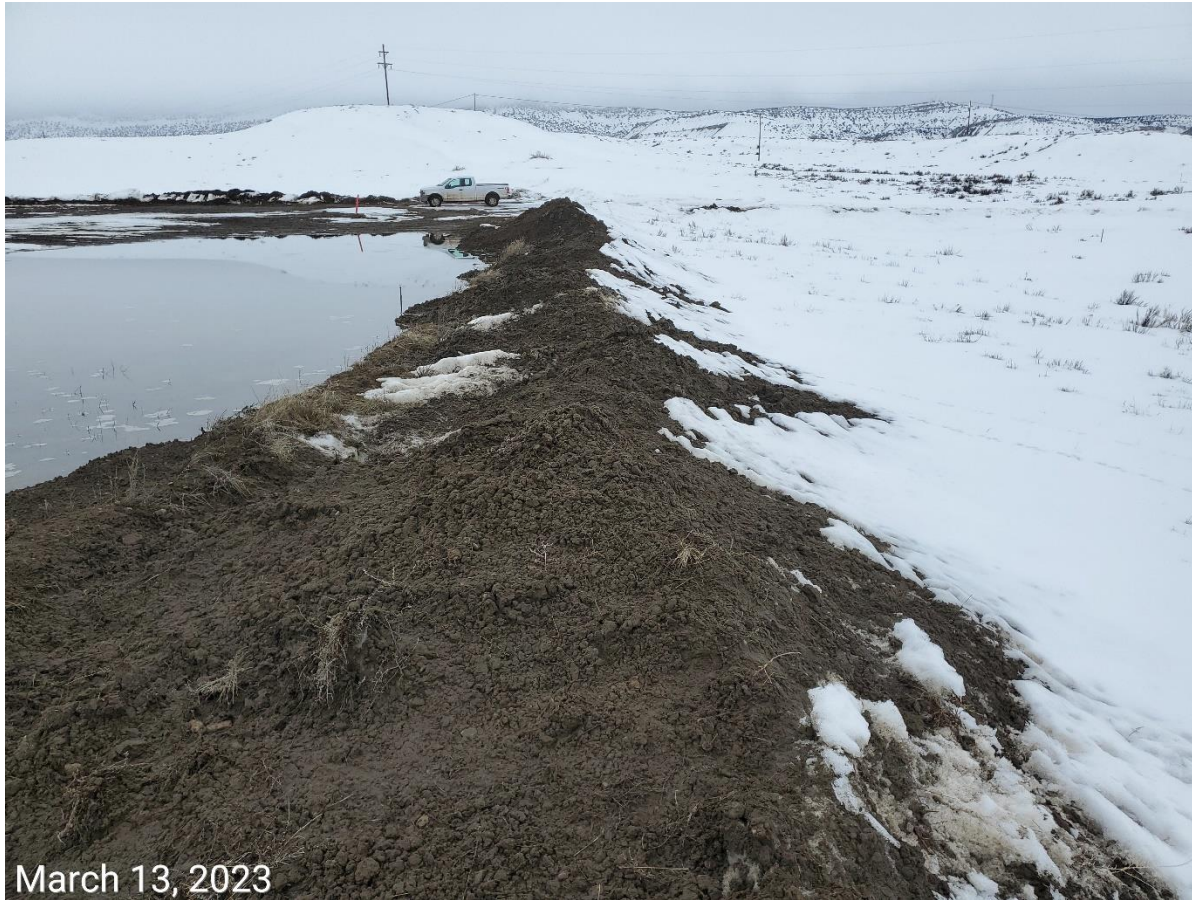
Photo 6: See comments under photo 5.
