Interim Reclamation and Stormwater Inspection

March 16, 2023

Operator: EDGE ENERGY II LLC- #10671

Location ID: 443574

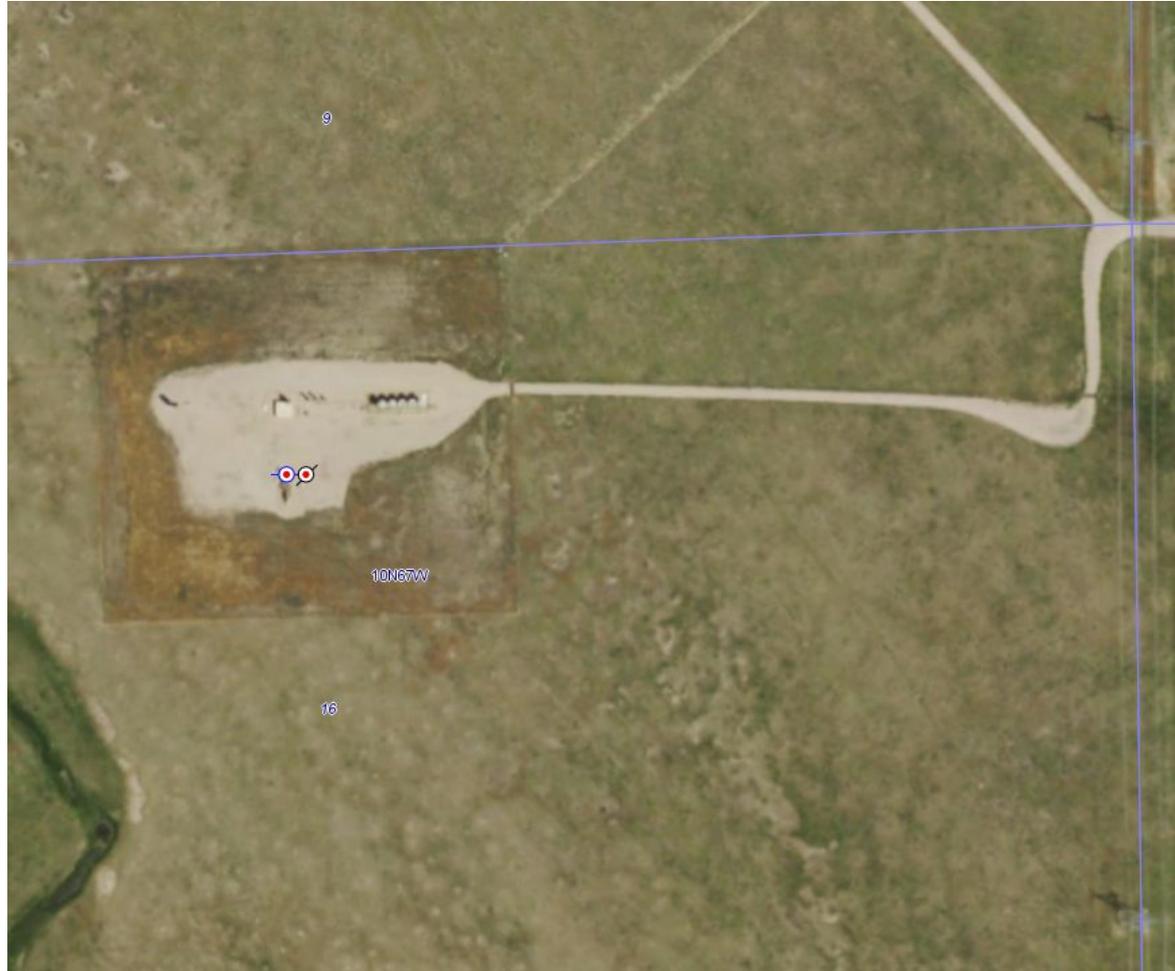
Photo 1. Aerial imagery from 2021 illustrates the Operator has performed interim reclamation to reduce the disturbance area only needed for production operations.

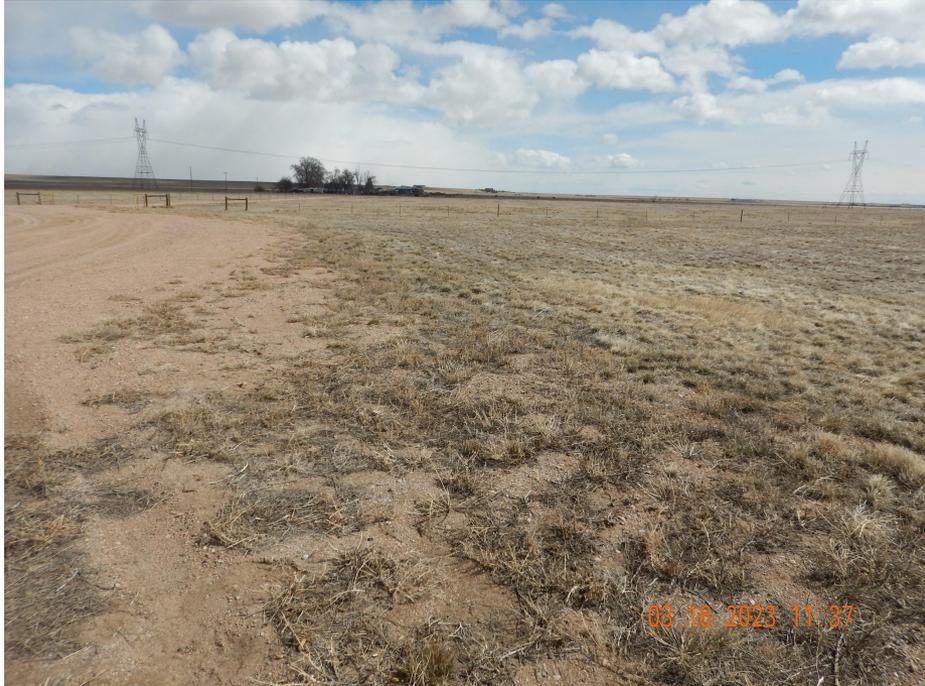
Photo 2. Photo taken along the southern interim reclamation area, facing East. Photo illustrates mowing operations have been conducted and the location appears to be managed. Undesirable vegetation (tumbleweeds) was observed within interim reclamation areas with perennial vegetation.

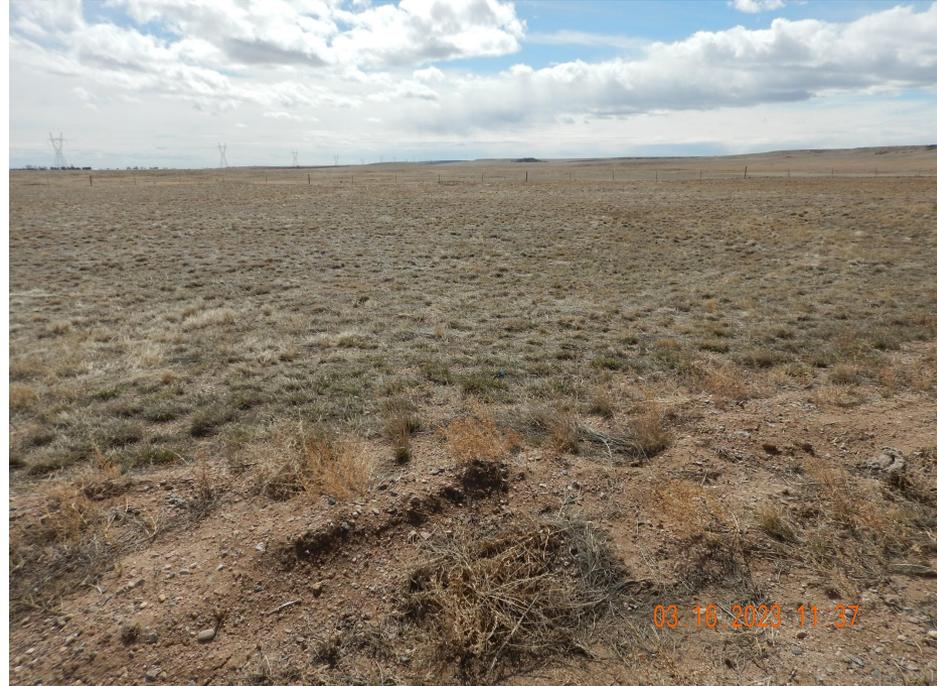
Photo 3. Photo taken along the southern interim reclamation area, facing South. See comments under Photo 2.

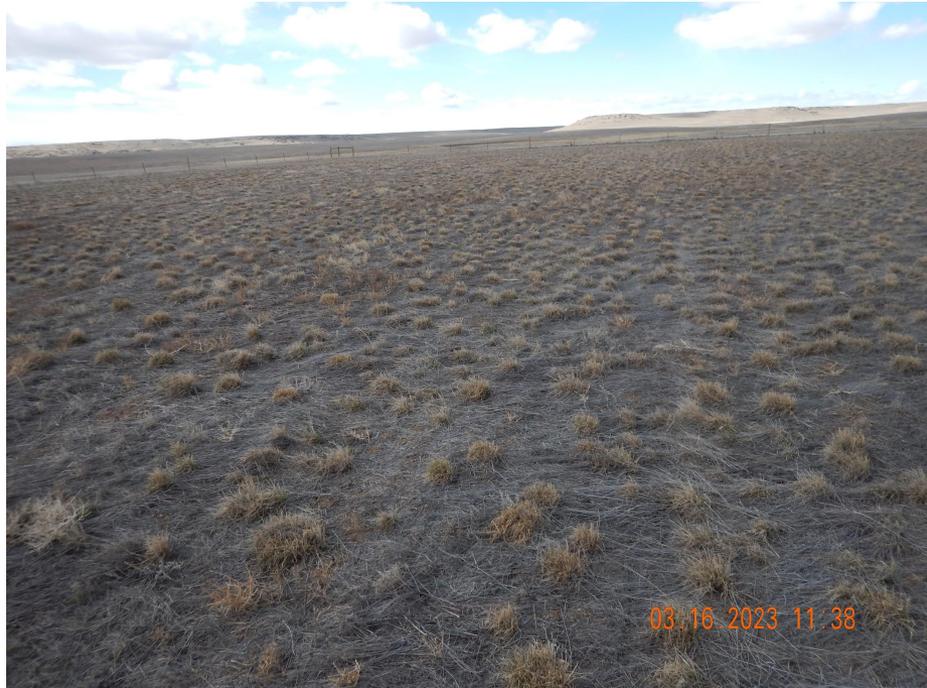
Photo 4. Photo taken along the southern interim reclamation area, facing West. See comments under Photo 2.

Note- introduced grass species (e.g., crested wheatgrass) were planted which are not reflective of reference areas.

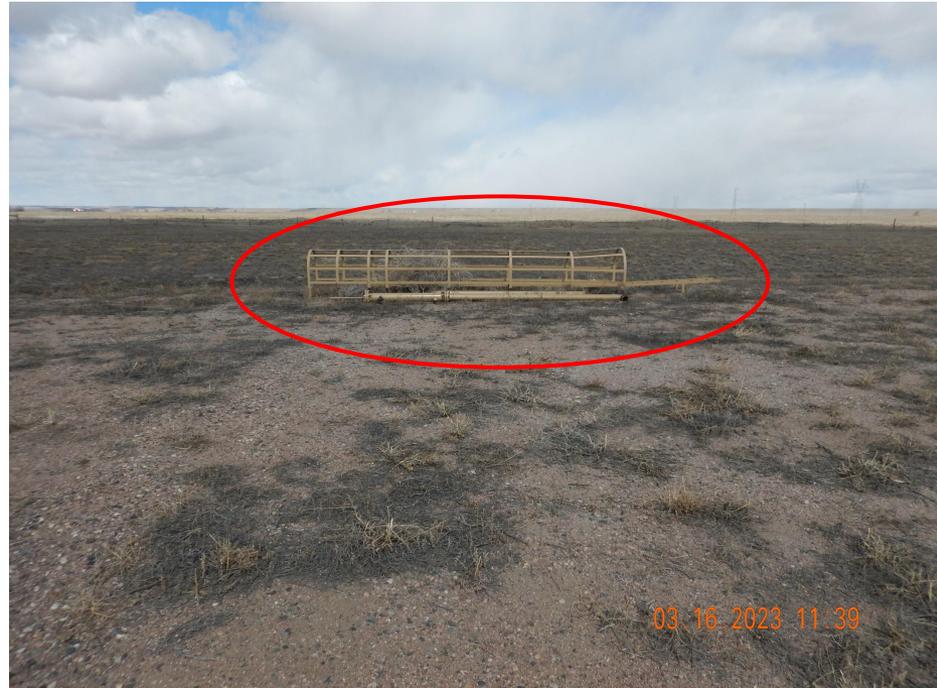
Photo 5. Photo taken along the northwestern well pad area, facing North. Photo illustrates unused equipment being stored on location.

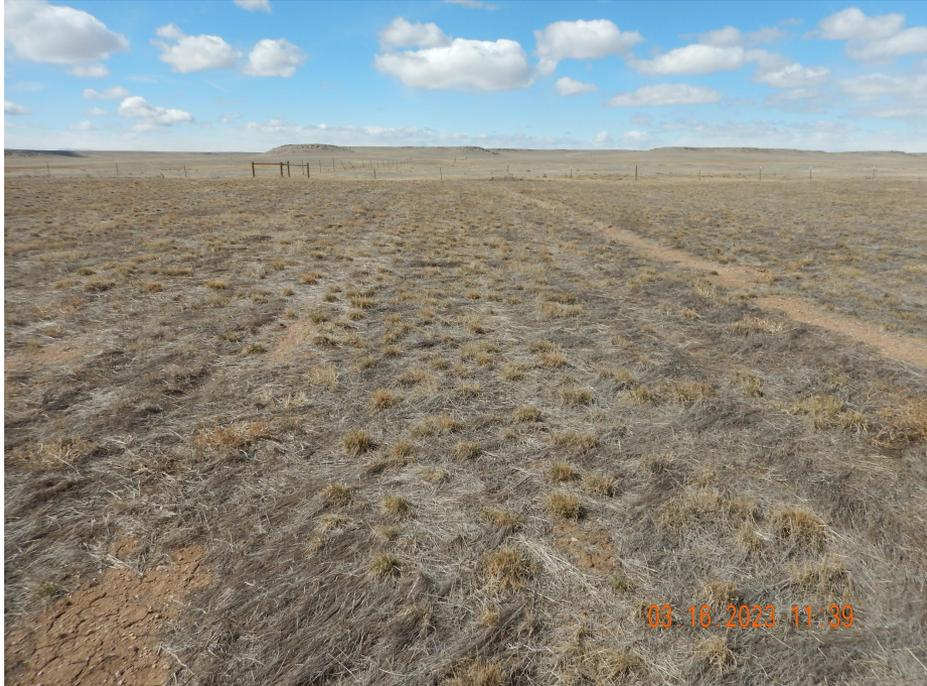
Photo 6. Photo taken along the northern interim reclamation area, facing West. See comments under Photo 2.

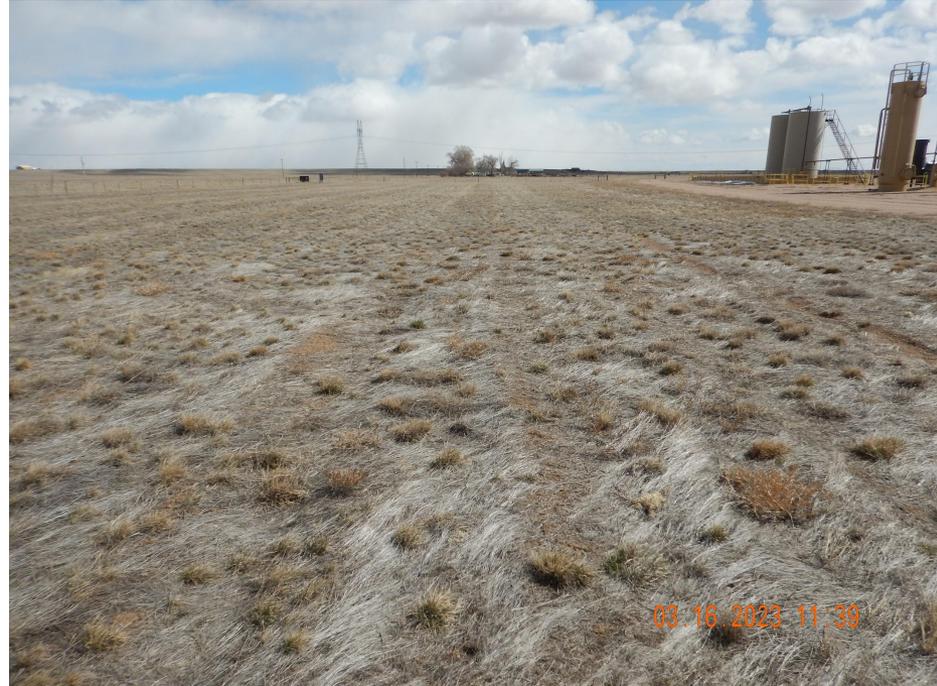
Photo 7. Photo taken along the northern interim reclamation area, facing East. See comments under Photo 2.

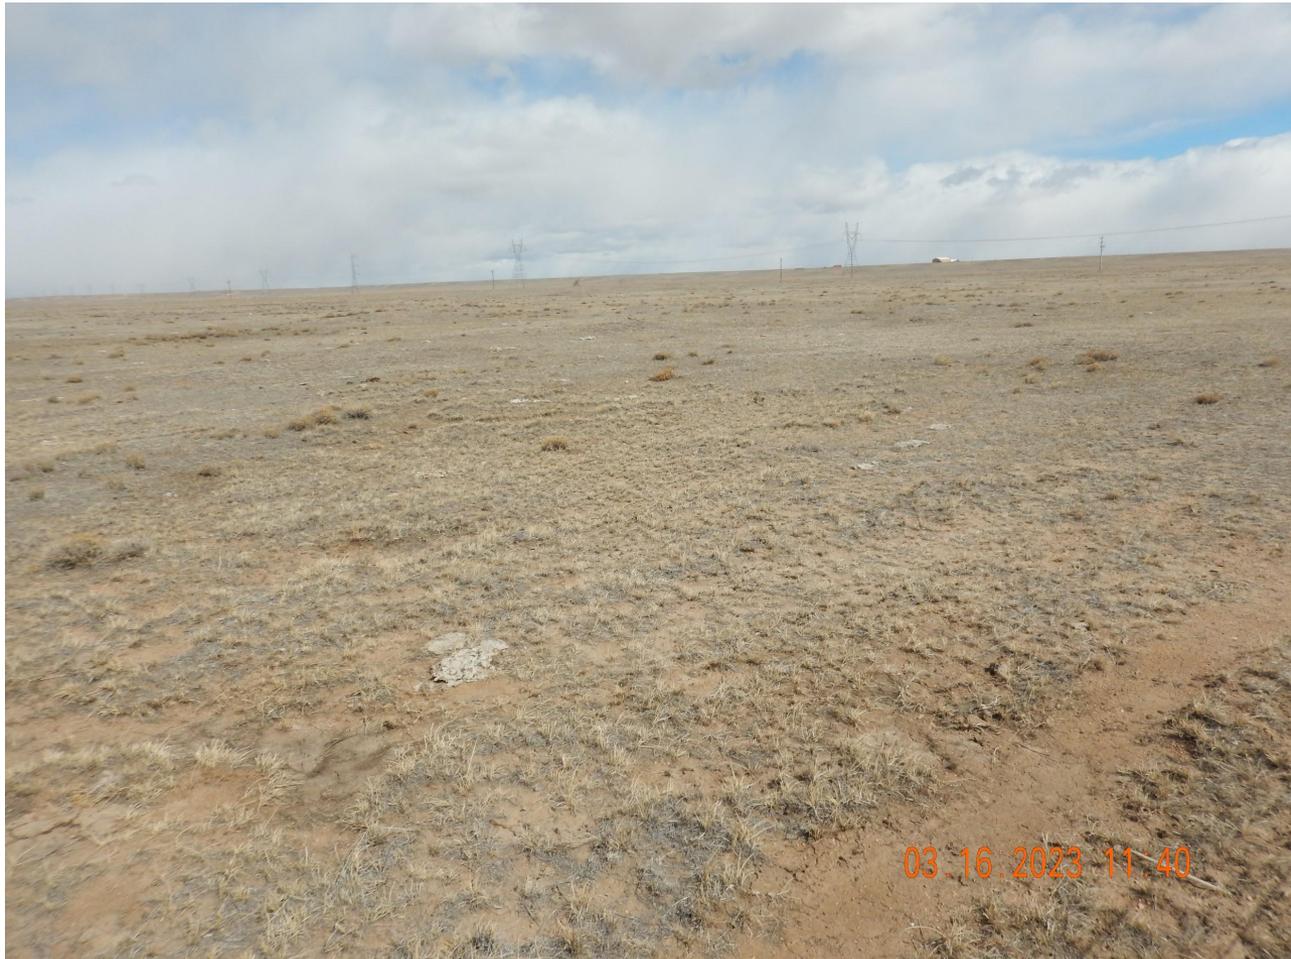
Photo 8. Reference photo taken from the northern location, facing East. Photo illustrates native, shortgrass prairie vegetation mostly consisting of Blue grama and Buffalo grass.
