Construction and Stormwater Inspection

Operator: MORNING GUN EXPLORATION- 10656

Location ID: 471039

Inspection Photos
Location Name: Castor 7-59 10
Location ID: 471039

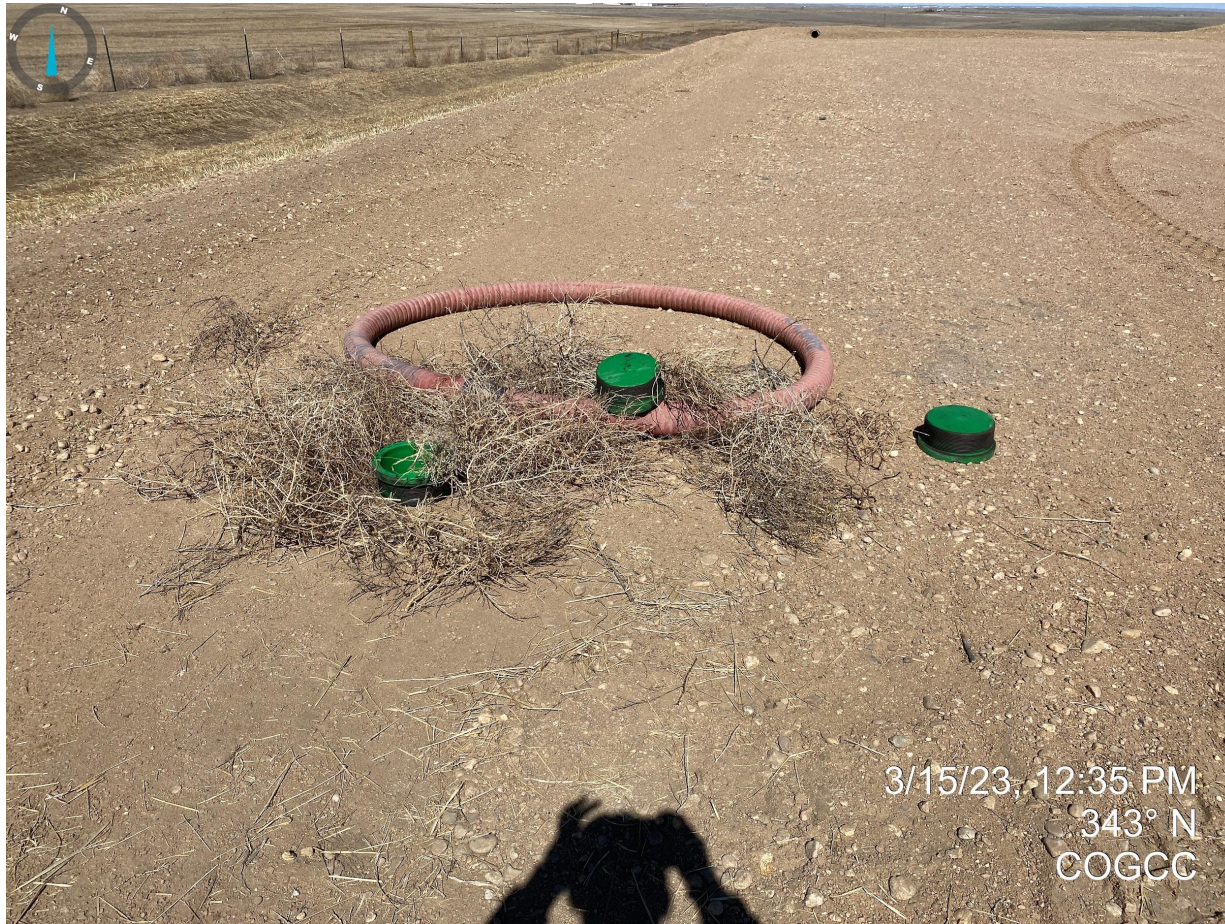
Photo 1. Facing north from the western side of the location. Unused equipment was observed on location during this inspection.

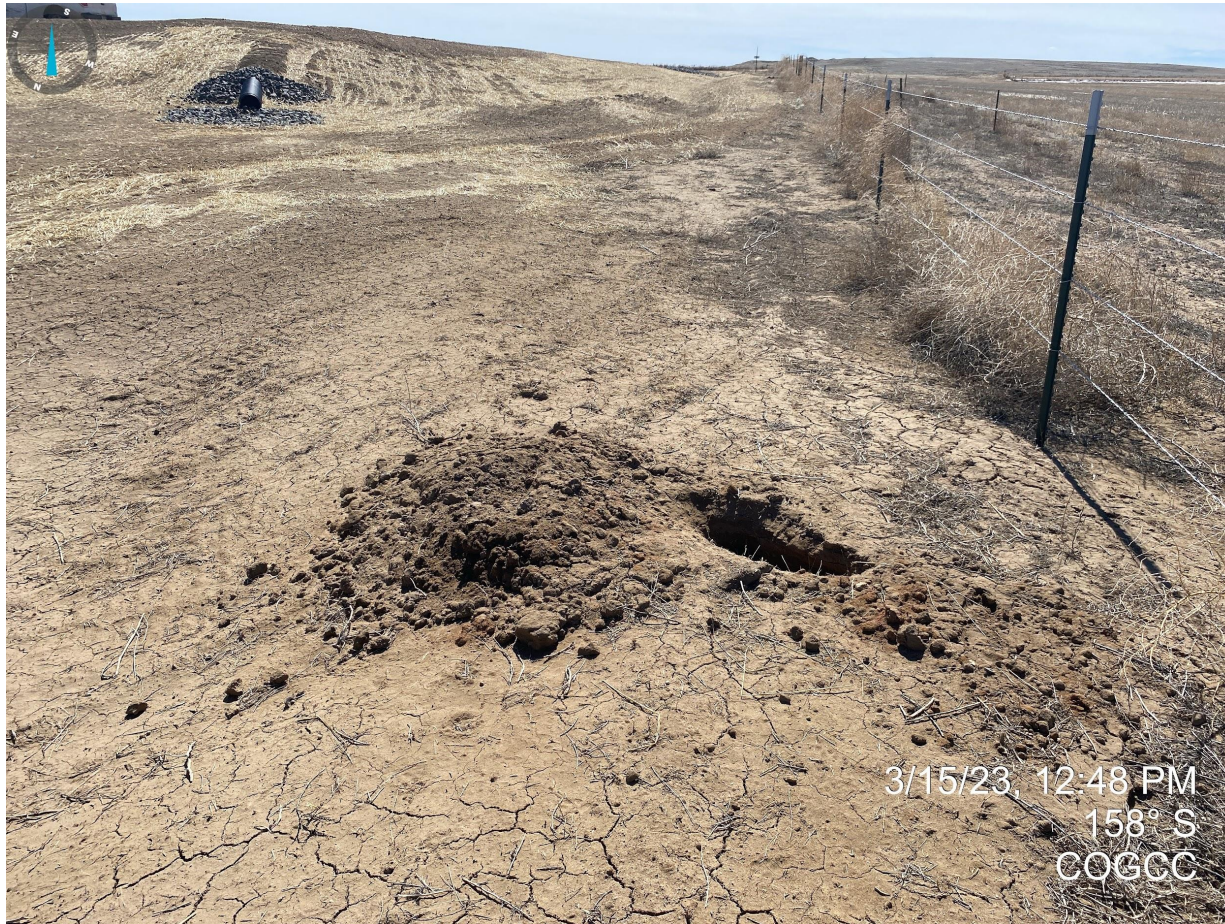
Photo 2. Facing south at the northwest corner of the location, near the sediment trap. An animal burrow was observed on the berm of the sediment trap and will need to be repaired per Rule 1002.f.(2)C.

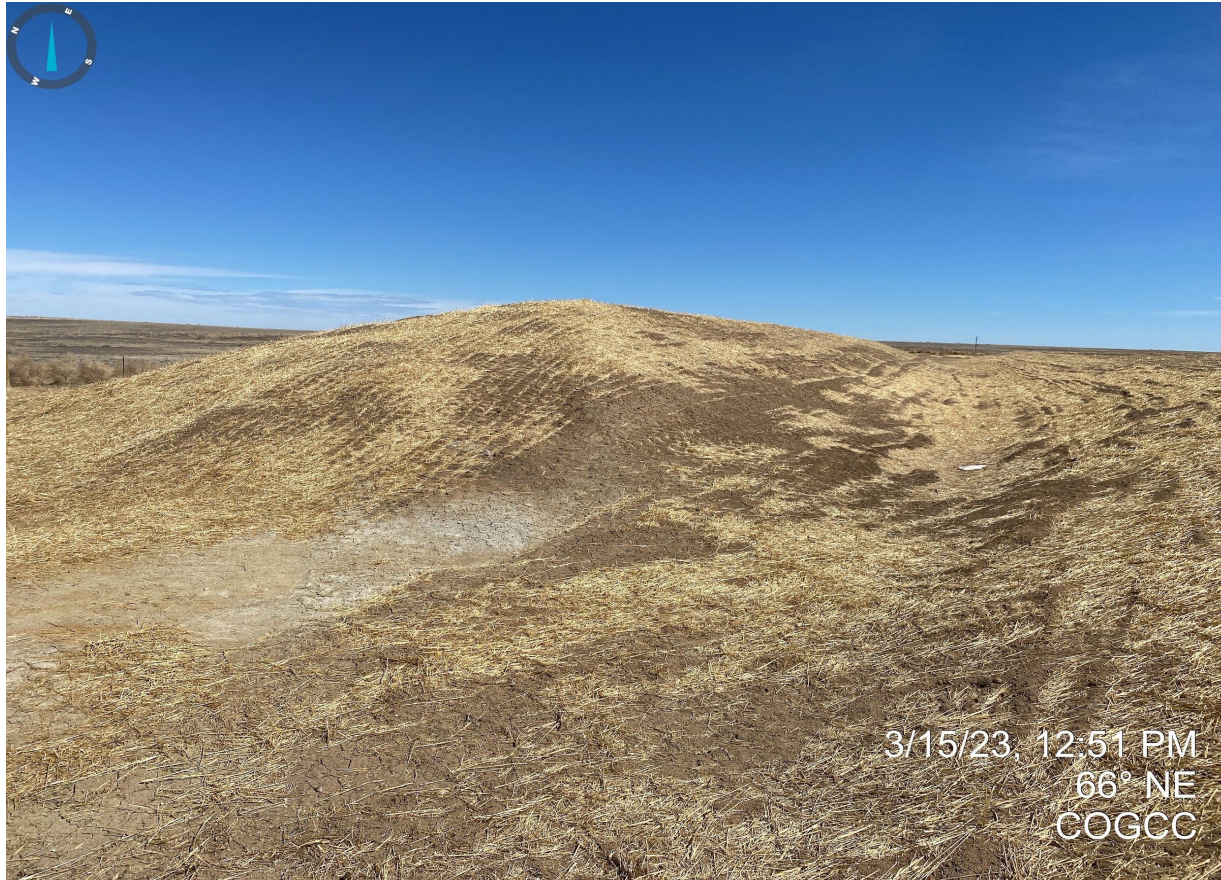
Photo 3. Facing northeast towards the topsoil stockpile. It does not appear the operator salvaged all of the topsoil from the location as staff calculated that the stockpile is approximately 5,925 cubic yards. The location should have had approximately 14,639 cubic yards of topsoil salvaged, not including the topsoil underneath the stockpile. The operator will need to import the difference (~8,700 cubic yards) to come into compliance with Rule 1002.b.

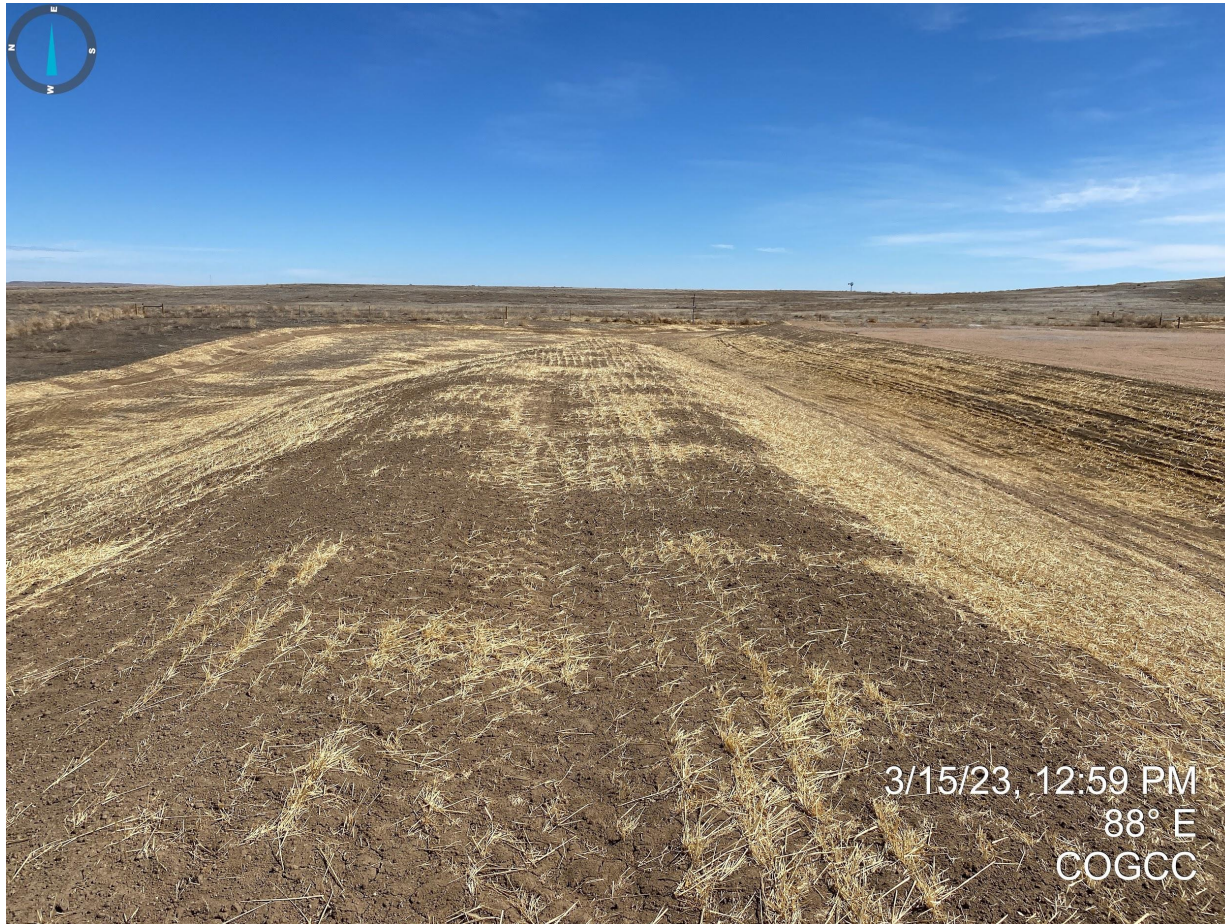
Photo 4. Facing east from topsoil stockpile. See comments in Photo 3.

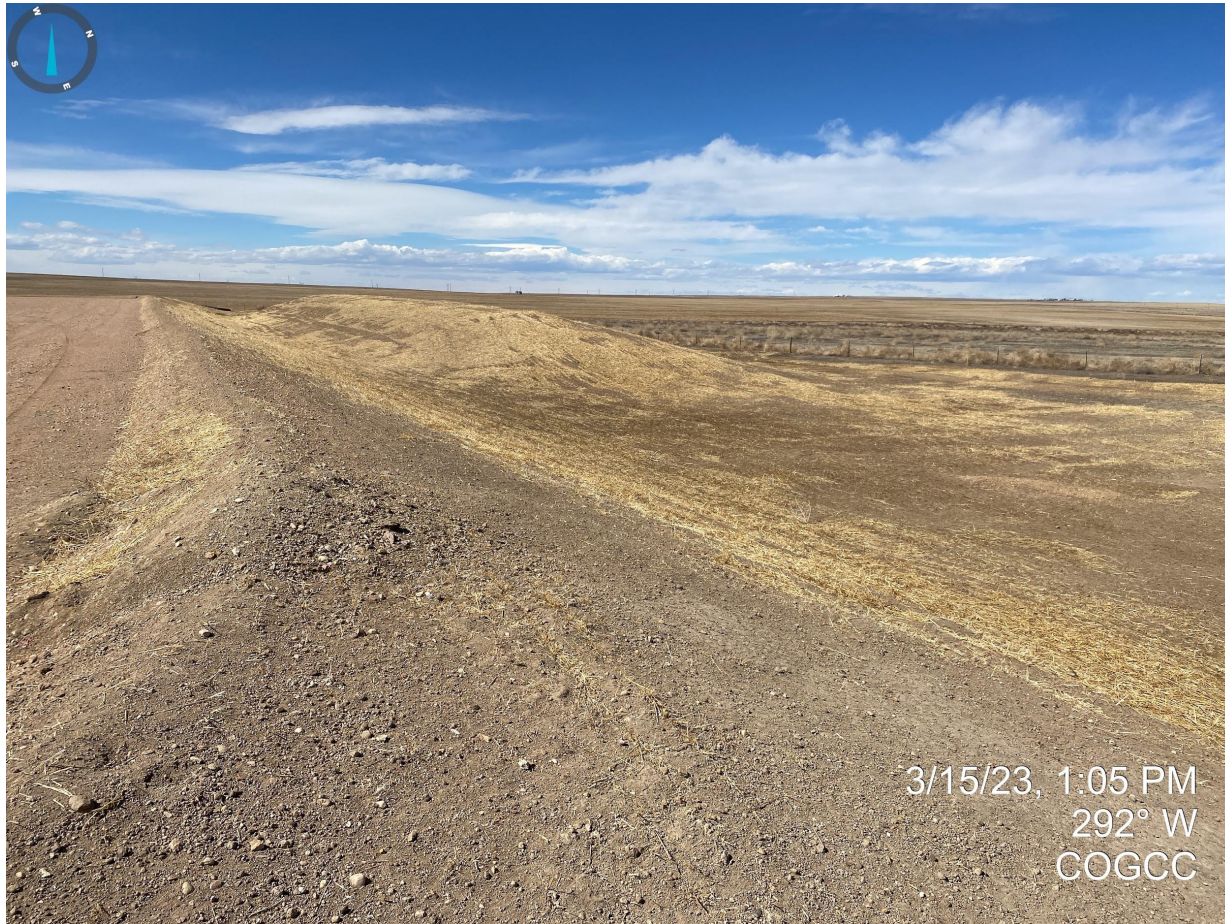
Photo 5. Facing west towards topsoil stockpile. See comments in Photo 3.

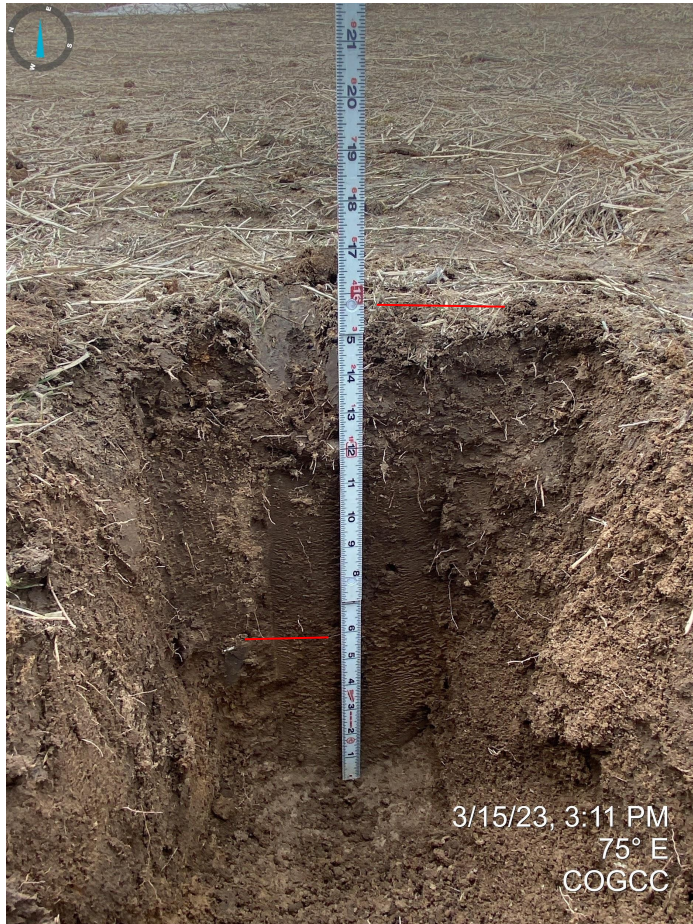
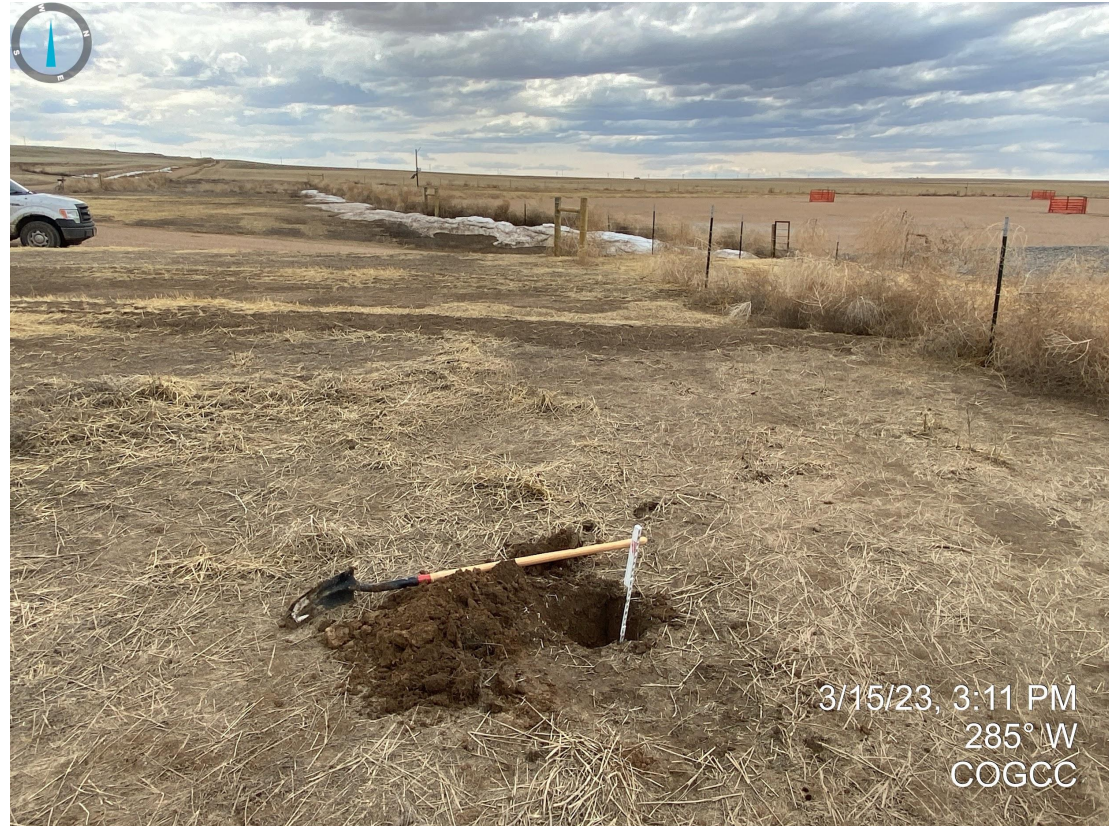
Photos 6 & 7. Close up photo of Staff soil pits, taken southeast of location entrance. Photo 6 (left) illustrates that approximately 10" of topsoil was observed from soil pit based on soil characteristics.

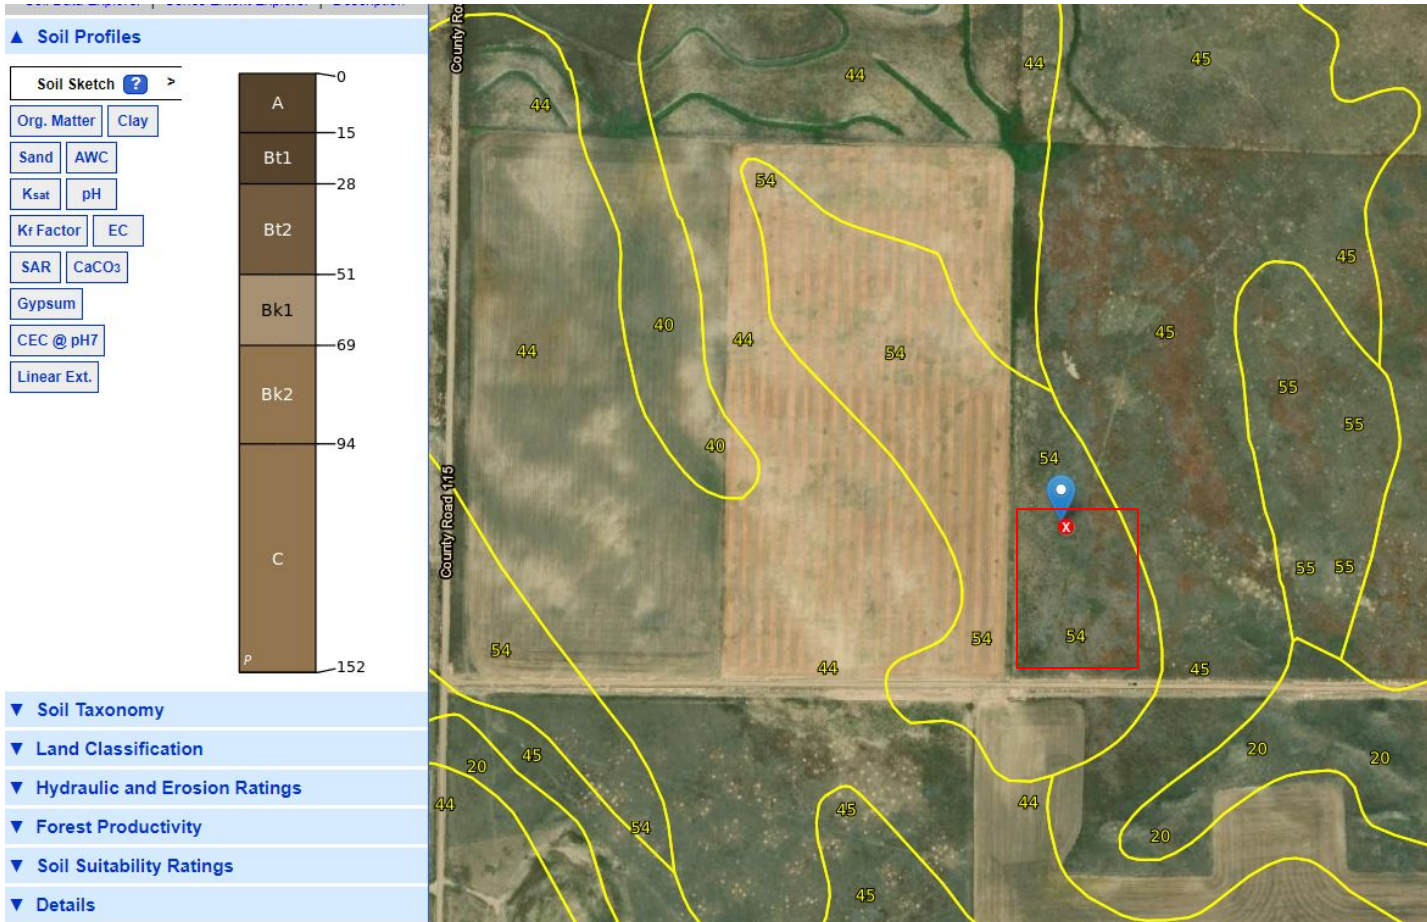
Photo 8. Screenshot taken from UC Davis SoilWeb illustrating approximate location (red outline) and soil properties. The topsoil layer in unit 54 consists of the A horizon and Bt1 horizon for an approximate depth of 28 cm or ~11 inches.

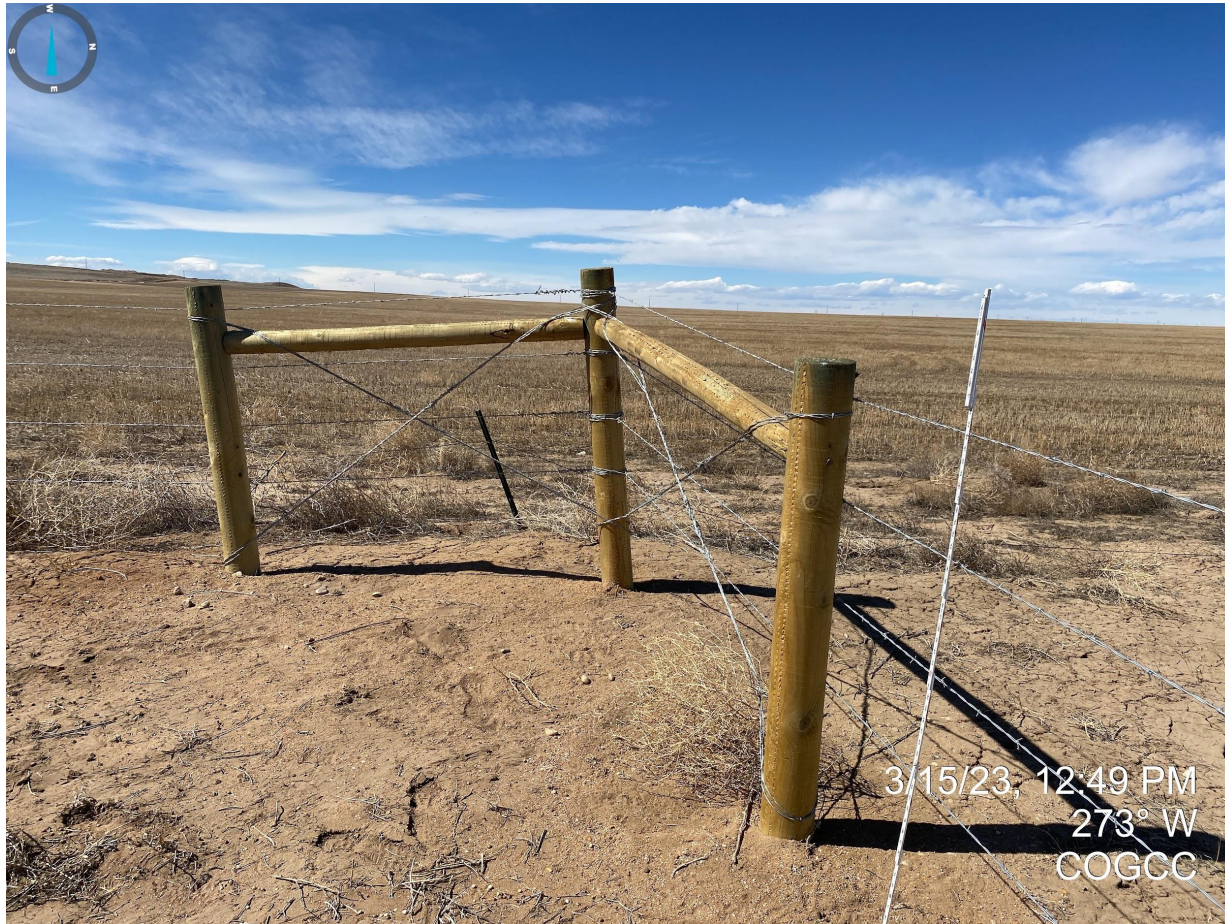
Photo 9. Facing west from the northwest corner of the location. Per Wildlife BMP/COA #9 on the Approved Form 2A (Doc #401906116), "The operator agrees to install raptor perch deterrents on equipment, fences, cross arms and pole tops in plains sharp-tailed grouse habitat". No raptor perch deterrents were observed along any of the fence line during this inspection.
