Inspection Photos

Operator: CHEVRON USA INC - 16700

Location #314697

Rio Blanco County, CO

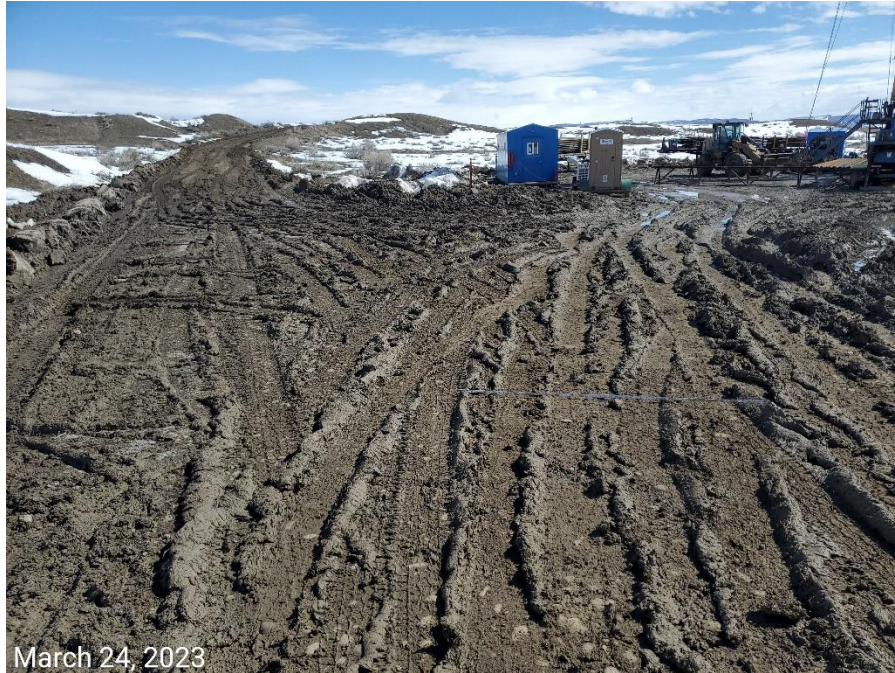
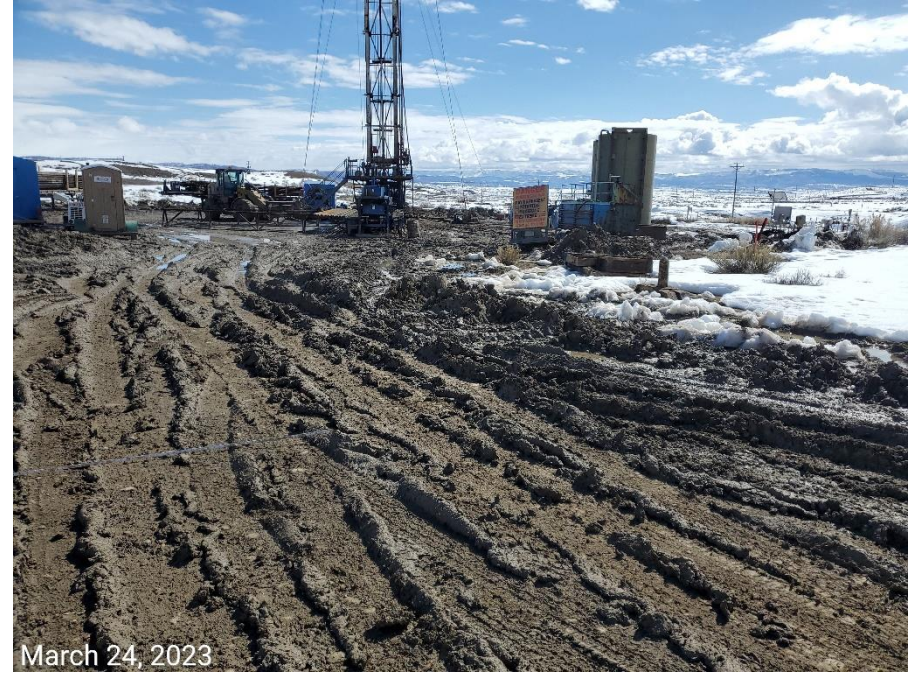
Photo 1: Photos 1-7 provide examples showing BMPs to stabilize, as well as to minimize degradation, tracking and off-site sediment transport are missing or insufficient.

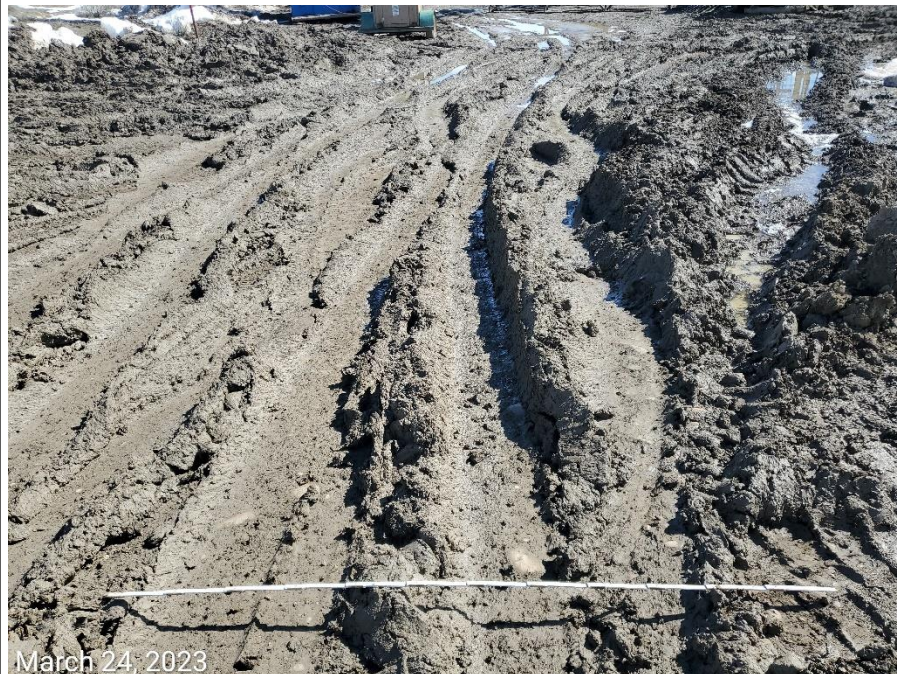
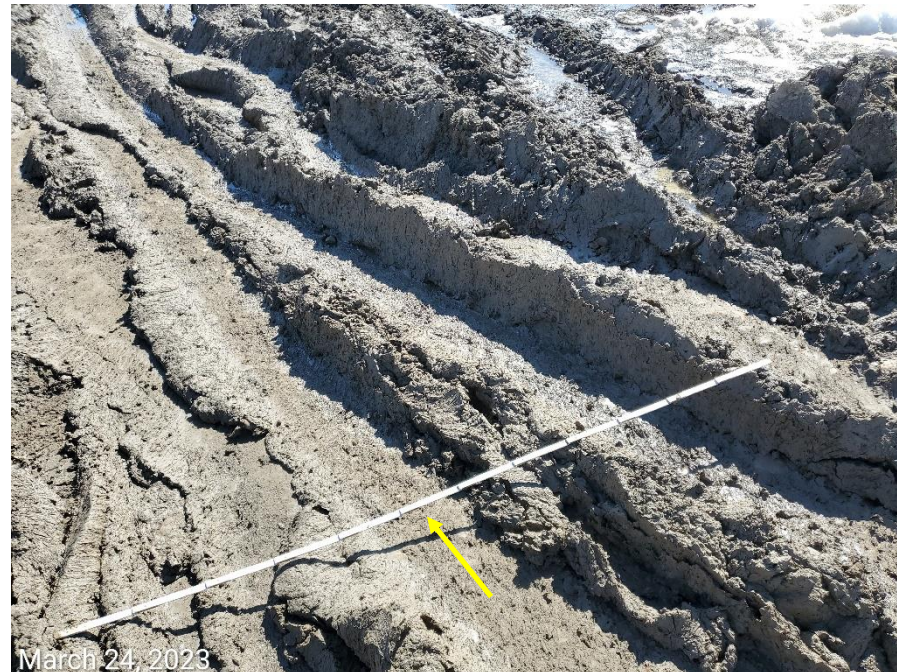
Photo 2: See comments under photo 1. 6 foot measuring stick for reference.

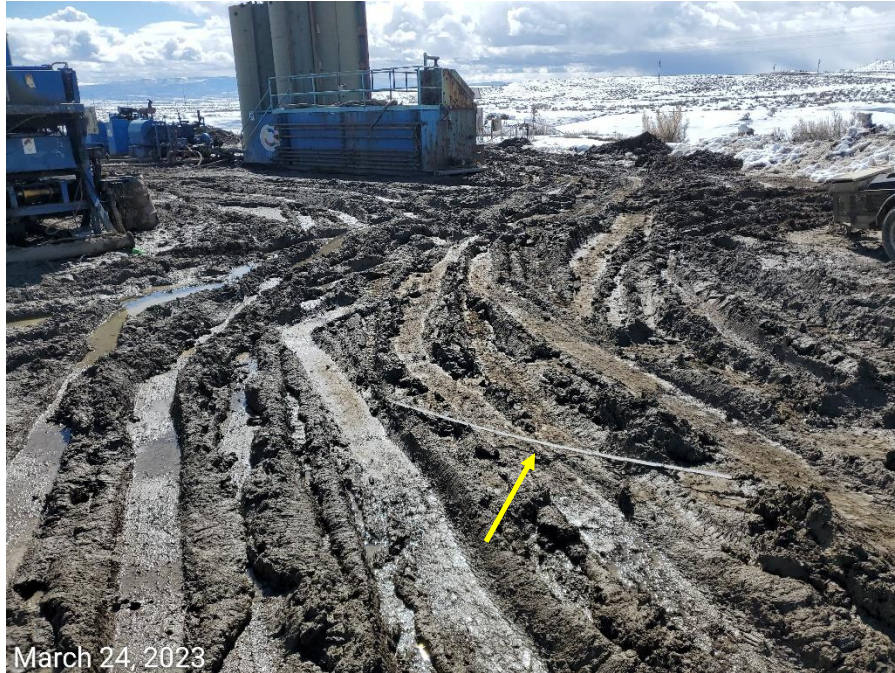
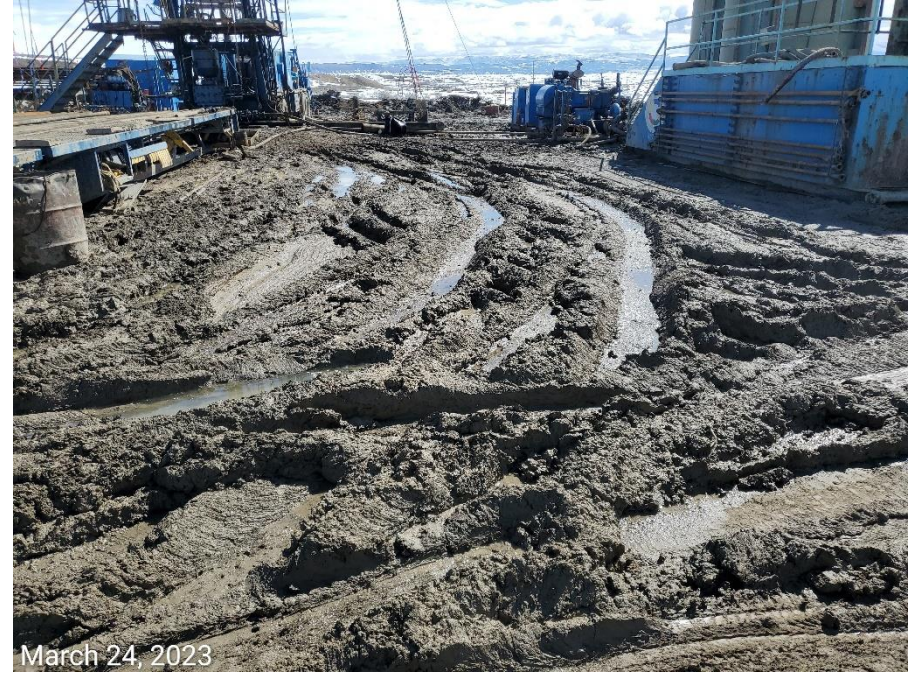
Photo 3: See comments under photo 1. 6 foot measuring stick for reference.

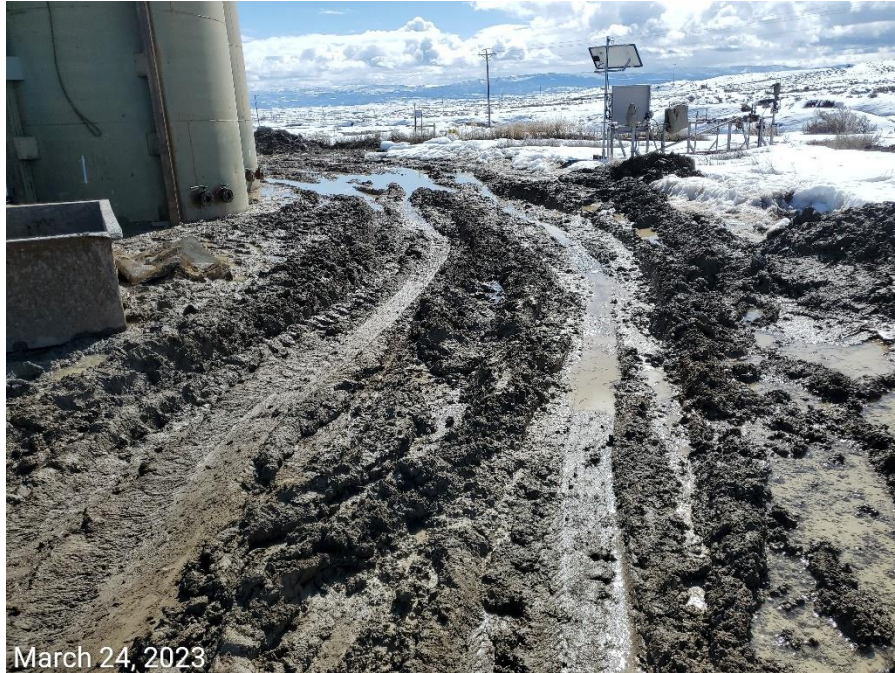
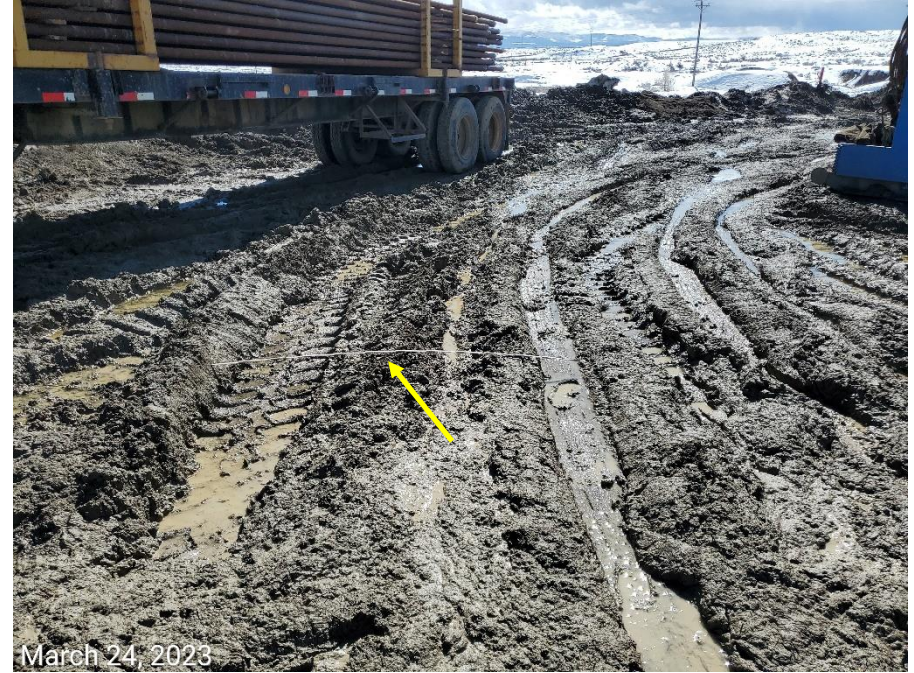
Photo 4: See comments under photo 1. 6 foot measuring stick for reference.

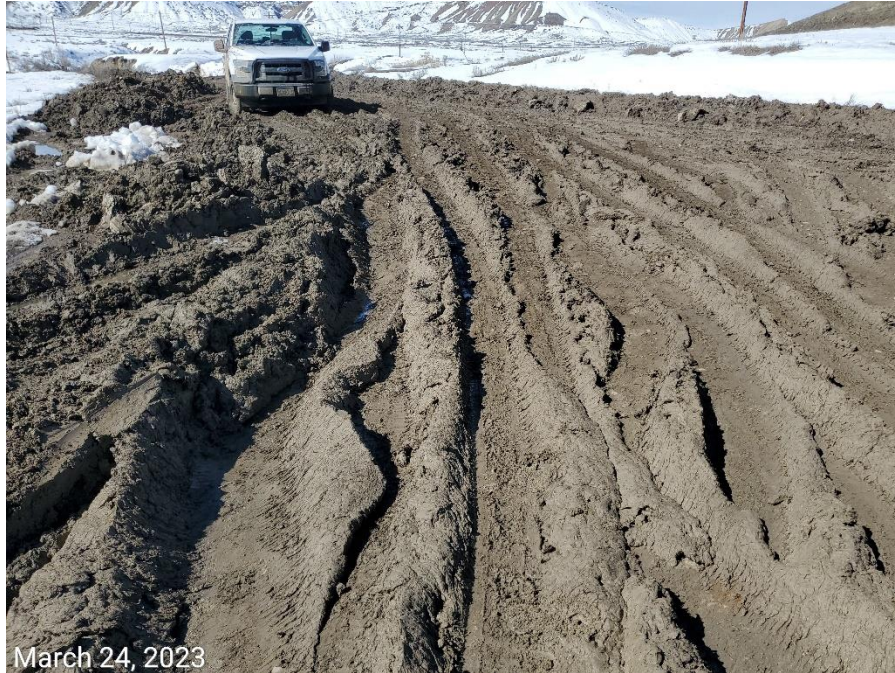
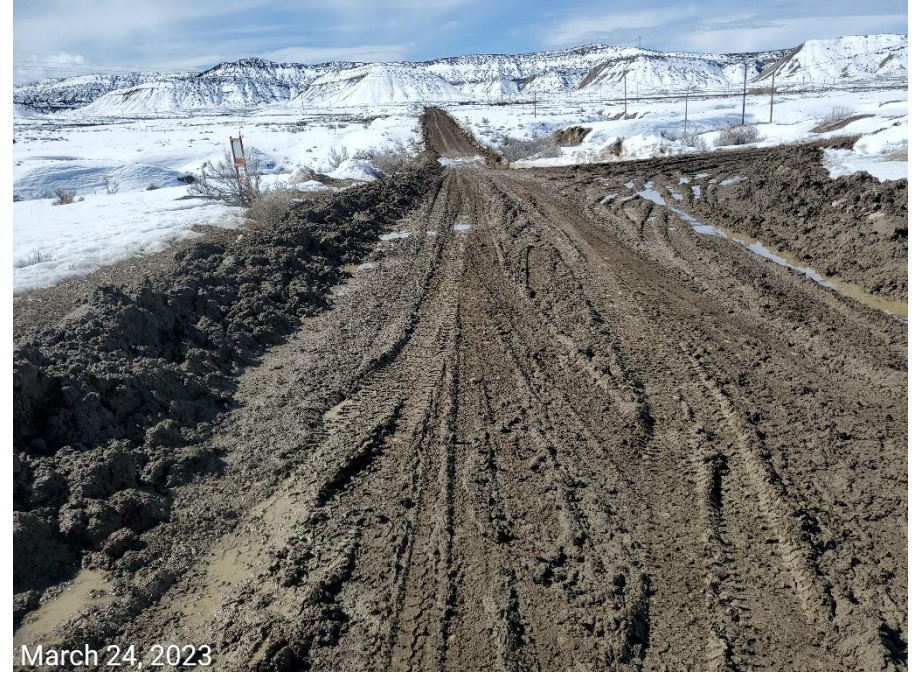
Photo 5: See comments under photo 1.

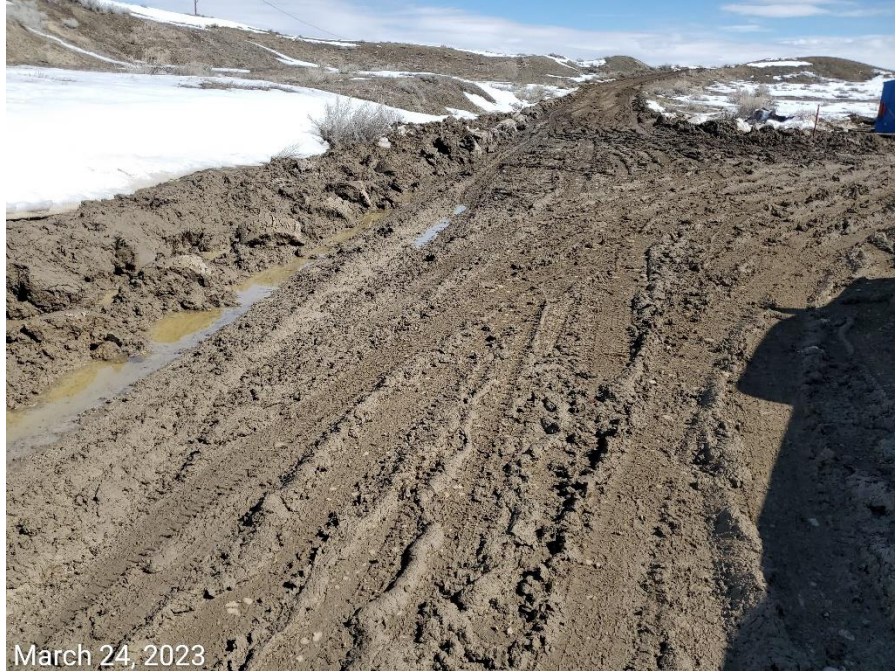
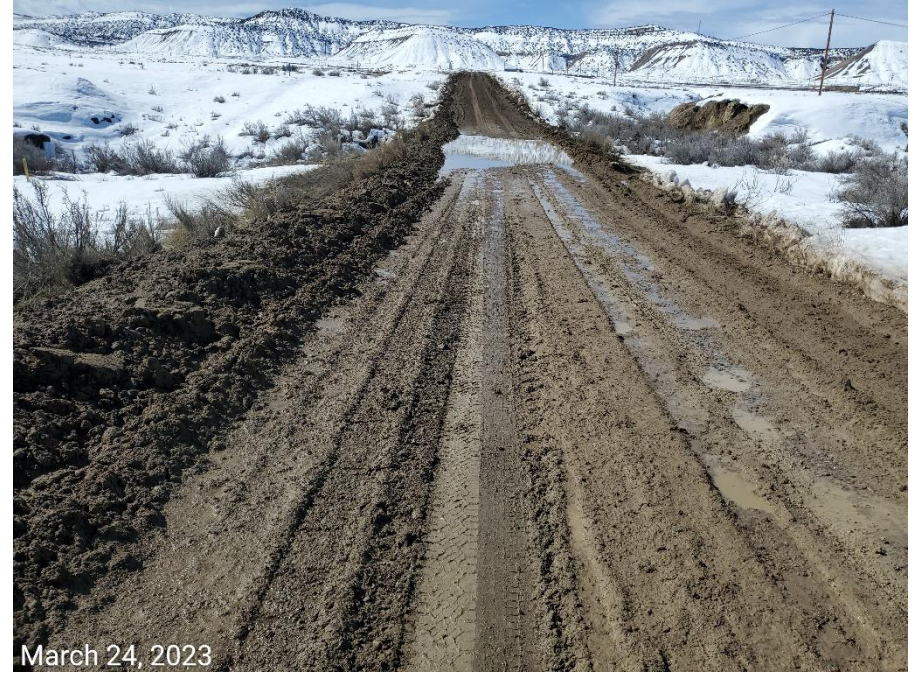
Photo 6: See comments under photo 1. Photo right also shows BMPs to allow for proper stormwater discharge from access road are missing or insufficient.

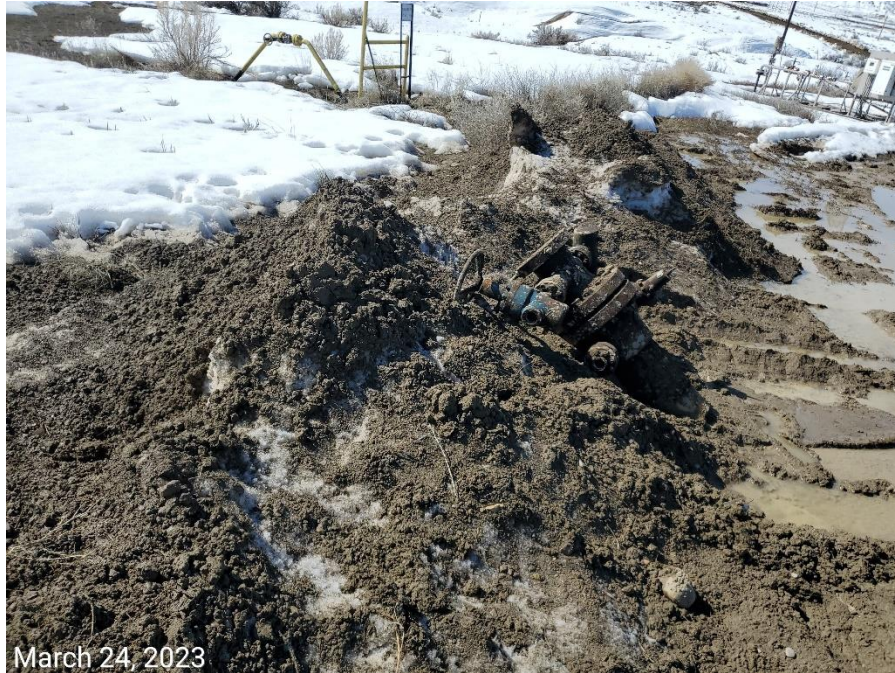
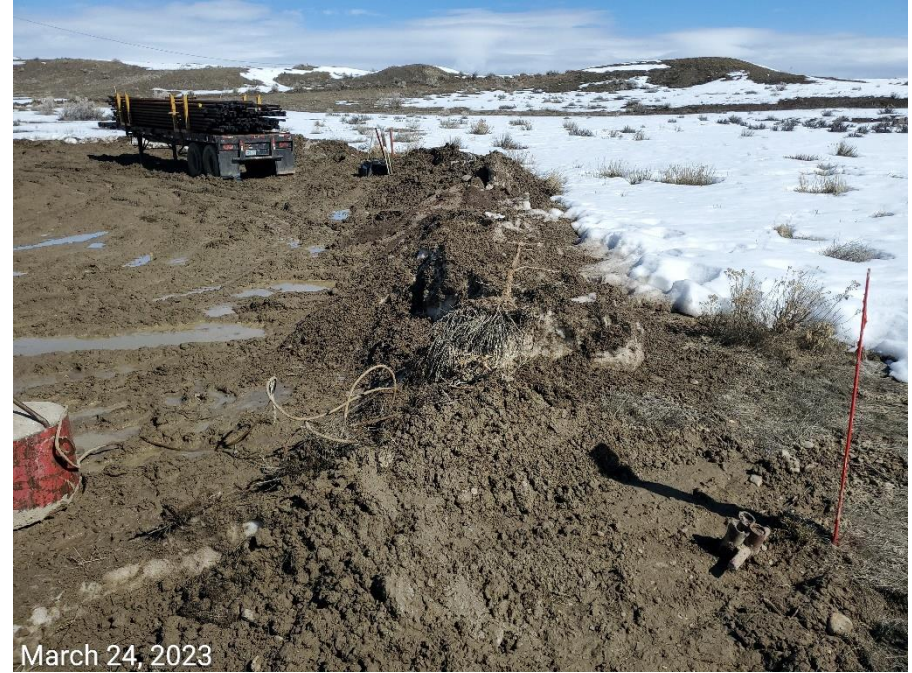
Photo 8: Photos examples showing soils stockpiles that have been pushed beyond the perimeter of the working pad, therefore expanding the disturbance of the Location. Photos show BMPs to minimize erosion, degradation and sediment transport are missing or insufficient.

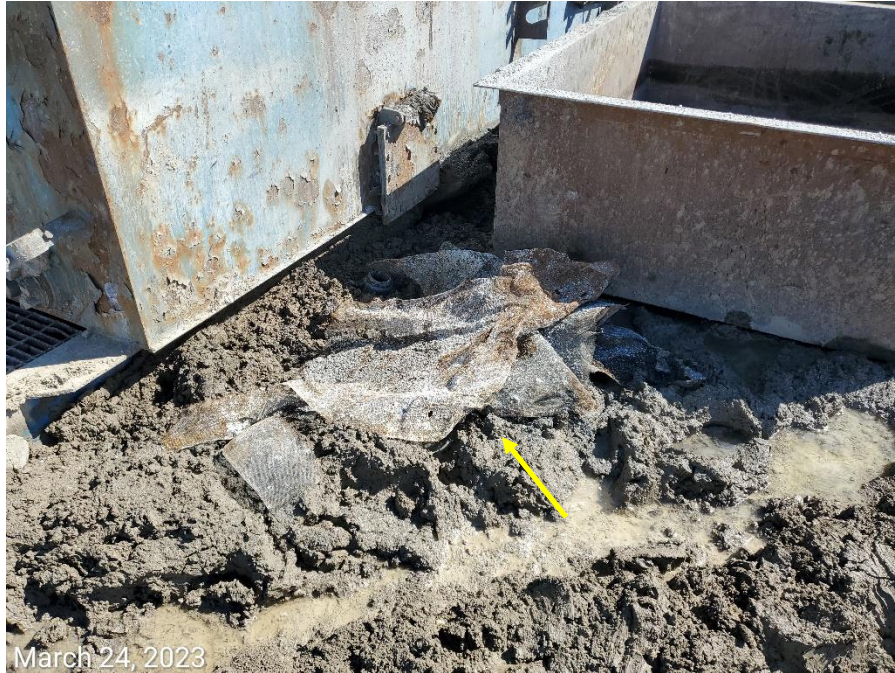
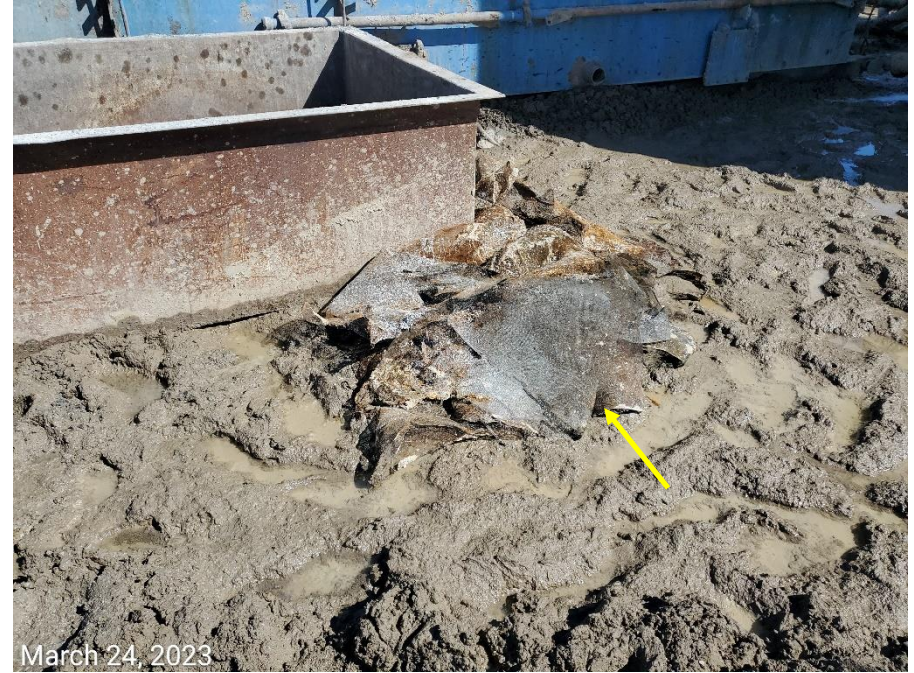
Photo 9: Trash debris on Location.

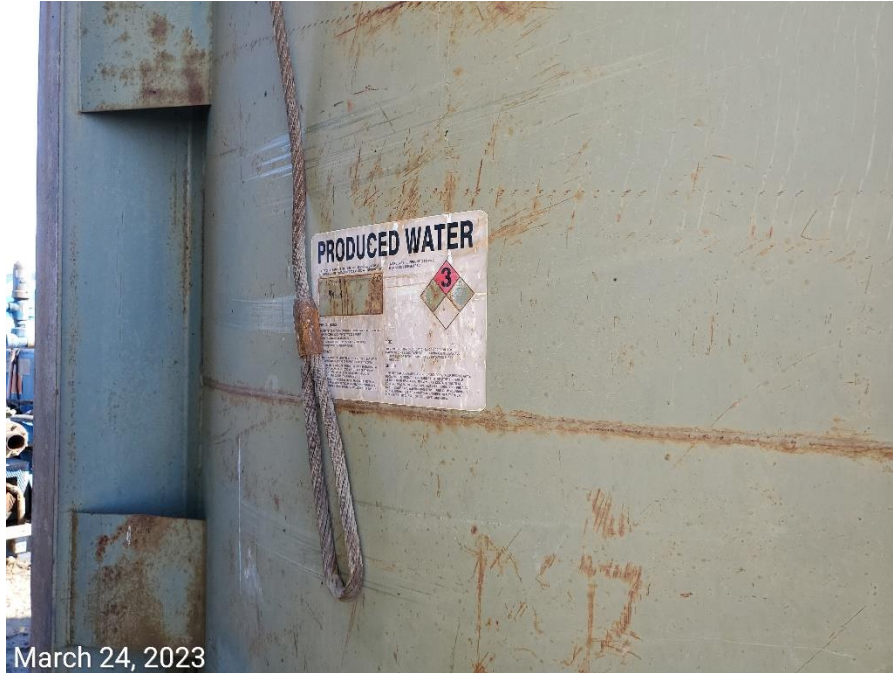
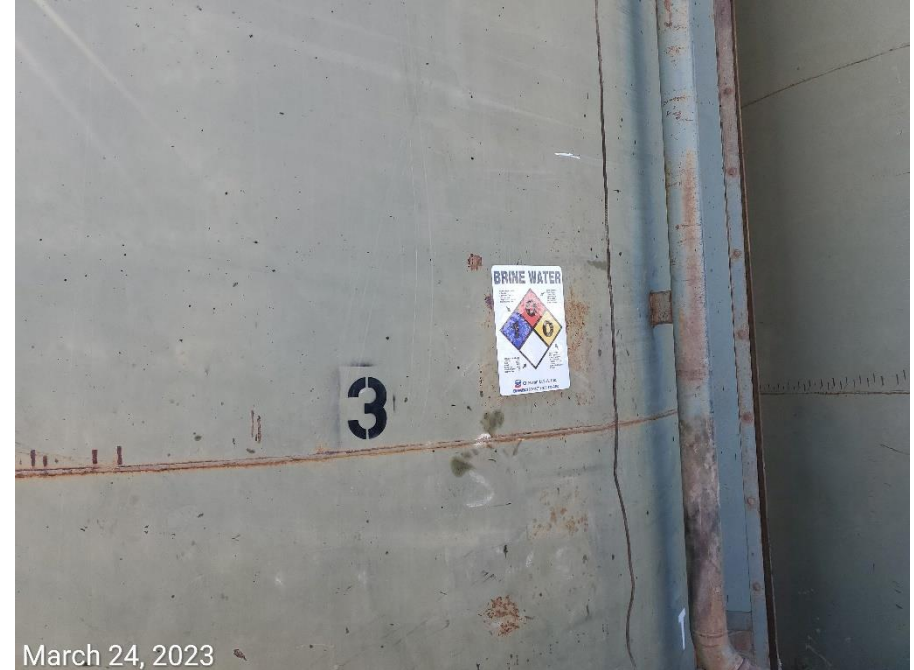
Photo 10: Photos 10 and 11 show tanks on Location. Photos also show all signage information per Rule 605.h have not been installed at tanks (e.g. Operator name, tank capacity, etc...)

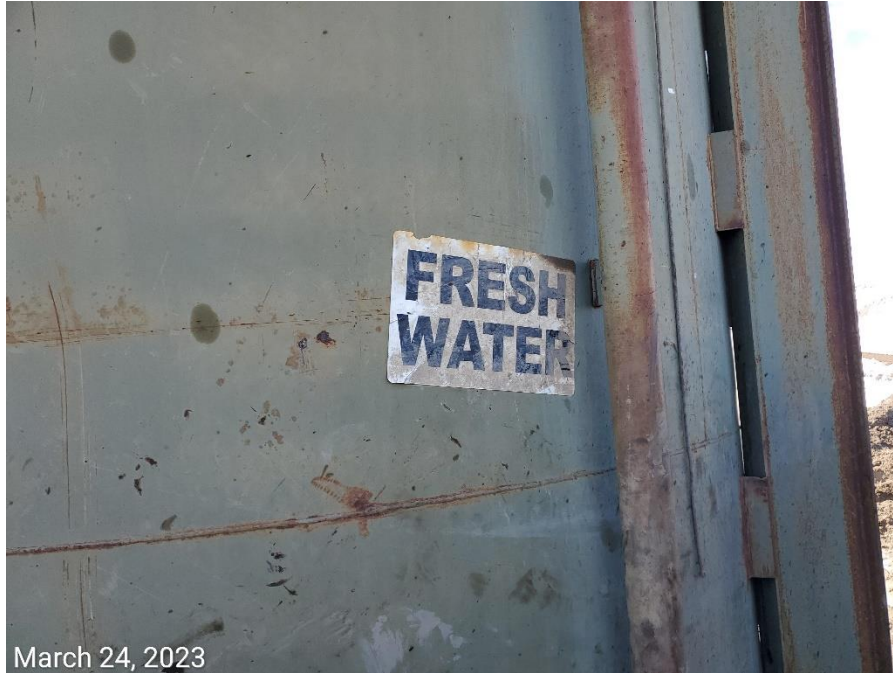
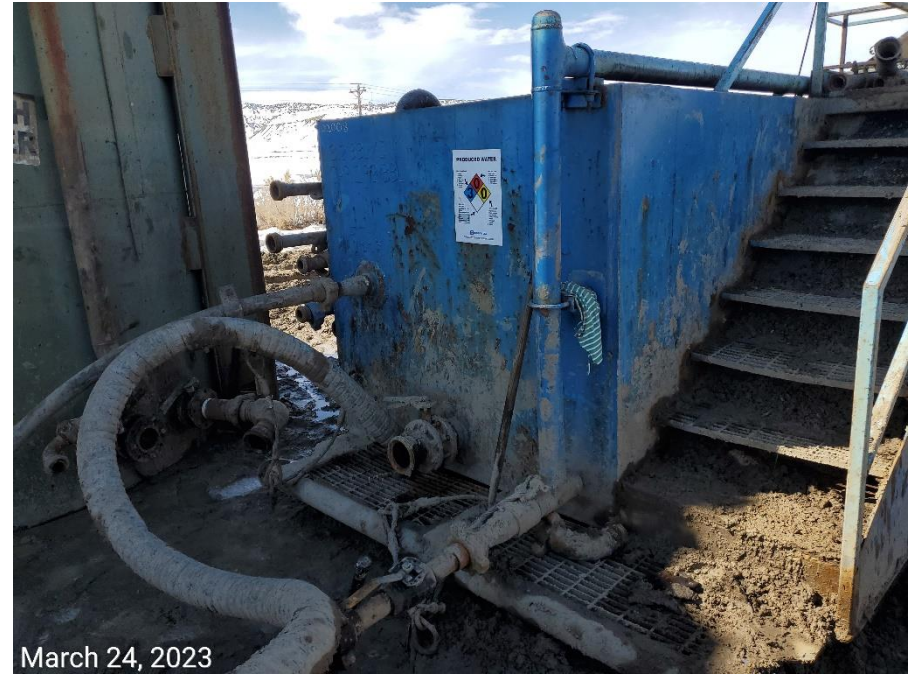
Photo 11: See comments under photo 10.

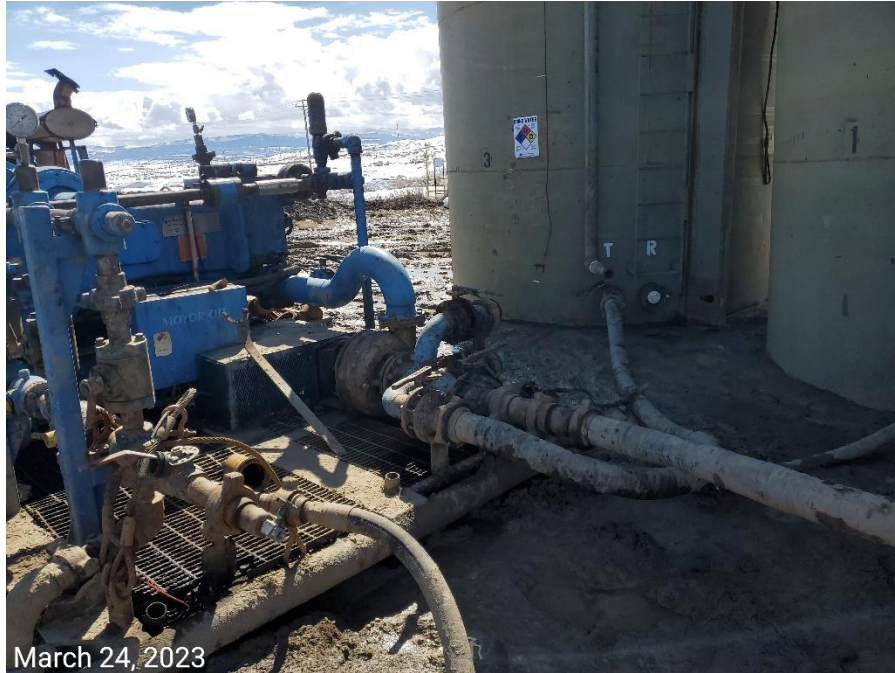
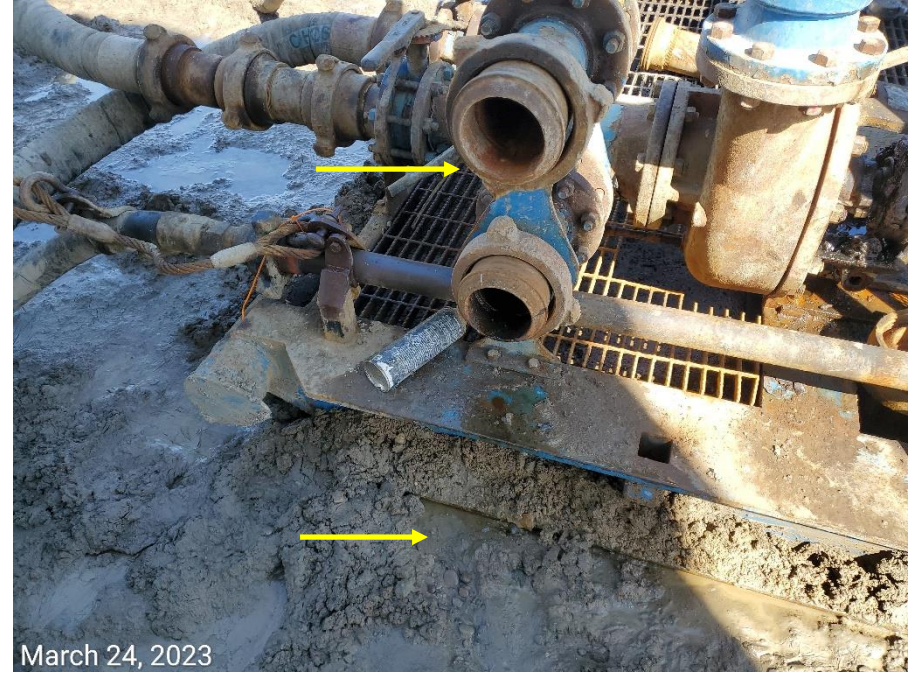
Photo 12: Photos show leak observed at pump equipment; equipment observed connected to “produced water/brine” tanks on Location; fluids observed discharging onto pad surface and impacting stormwater. Photo also shows BMPs to prevent or contain a spill at the tanks, such as secondary containment, are missing or insufficient.

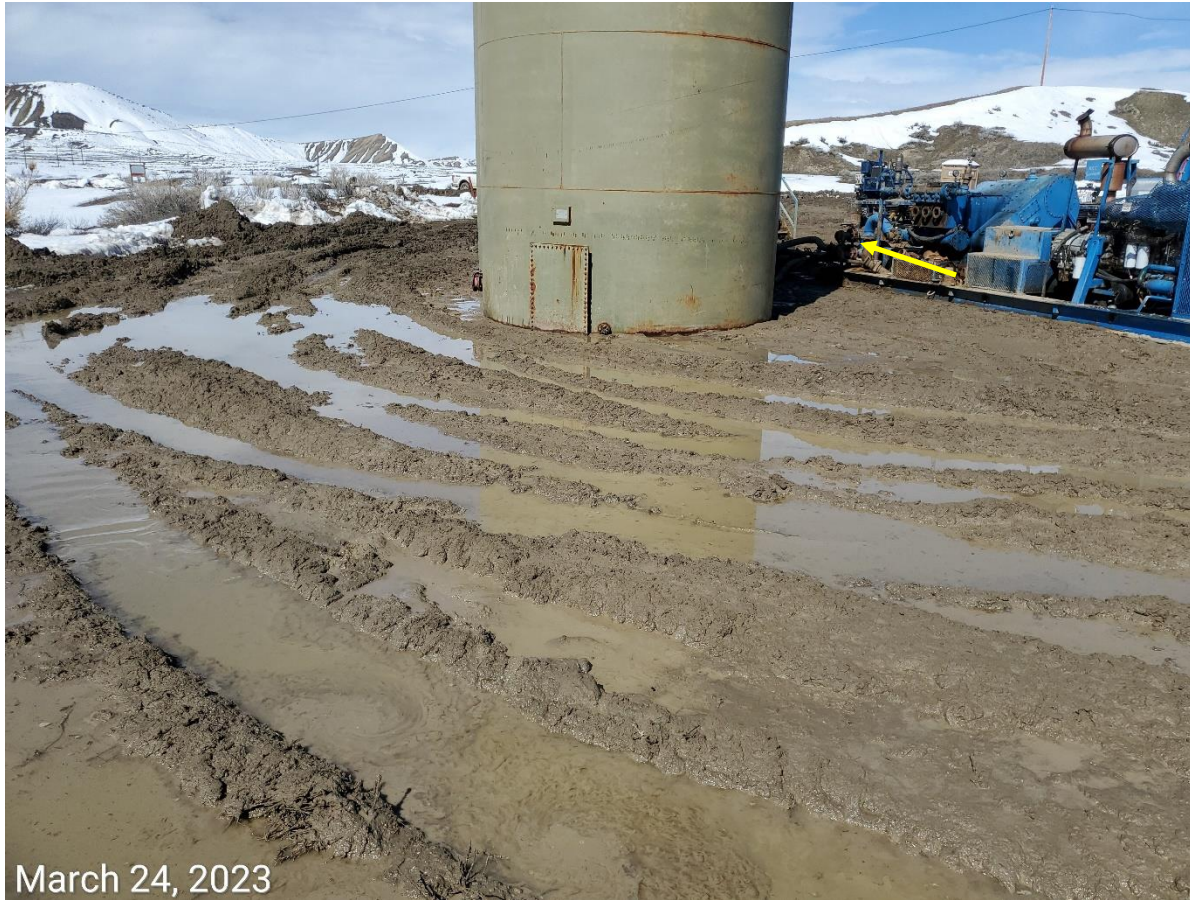
Photo 12.b: Continued from photo 12. Photo shows BMPs to prevent or contain a spill, such as secondary containment, are missing or insufficient at tanks on the Location. Arrow shows area of equipment observed leaking.

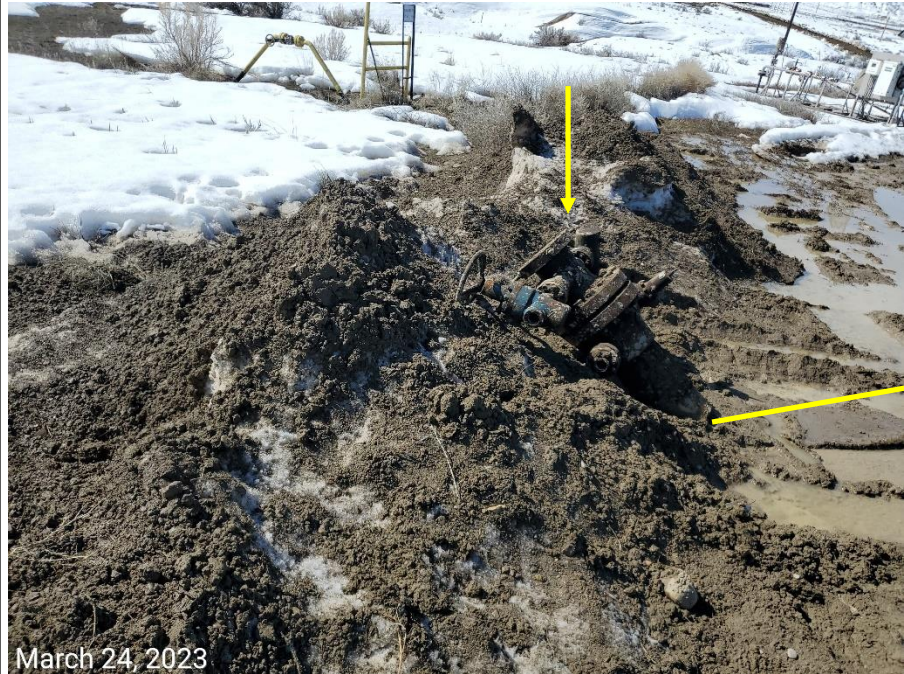
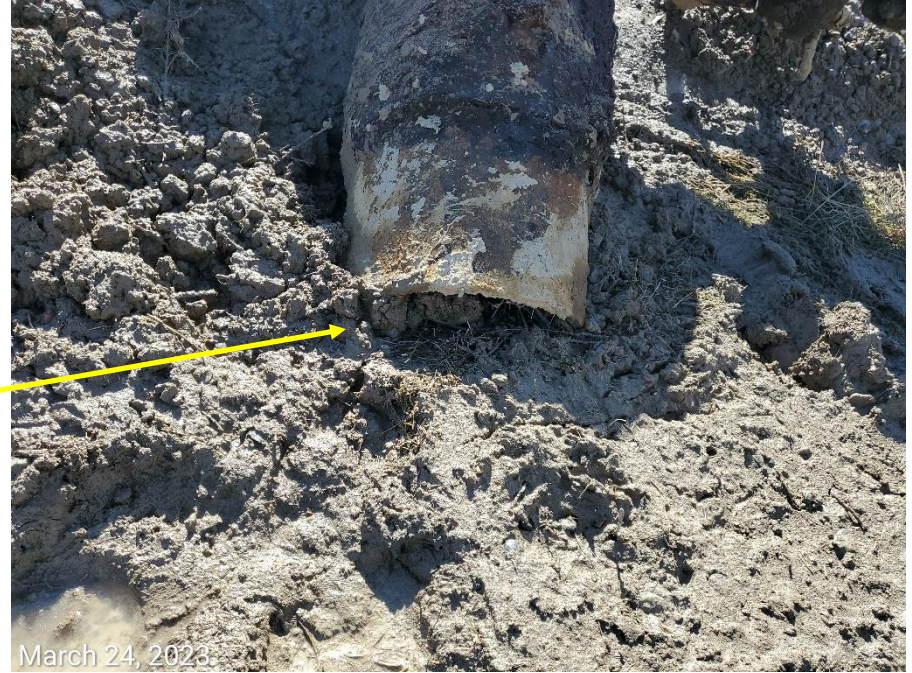
Photo 13: Photos taken from the east end of the Location. Photo shows disassembled well equipment improperly stored on the perimeter of the Pad. Equipment appears to have slid down, collecting soils within; soils now potentially impacted due to improper storage of production equipment.

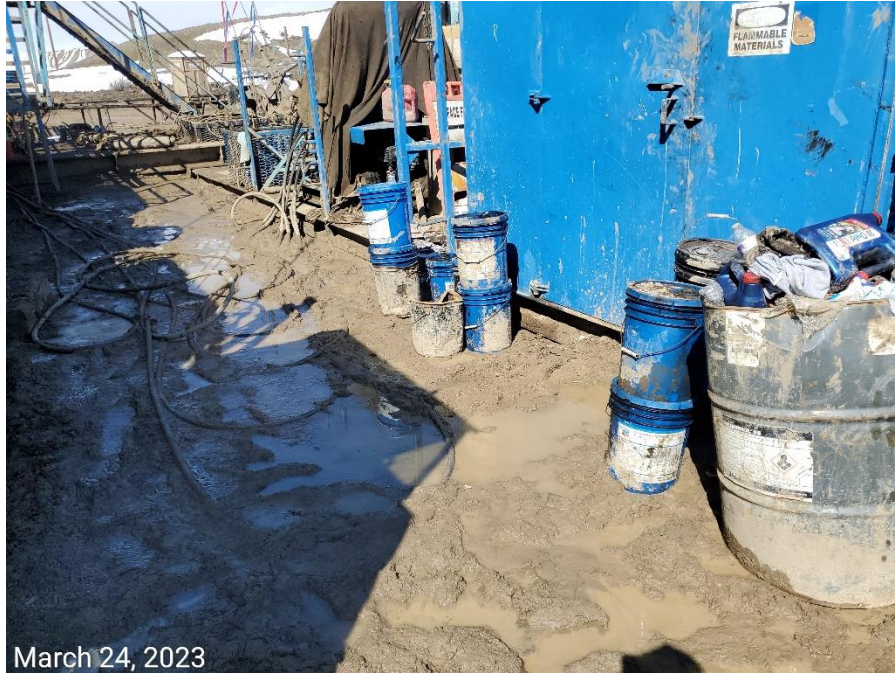
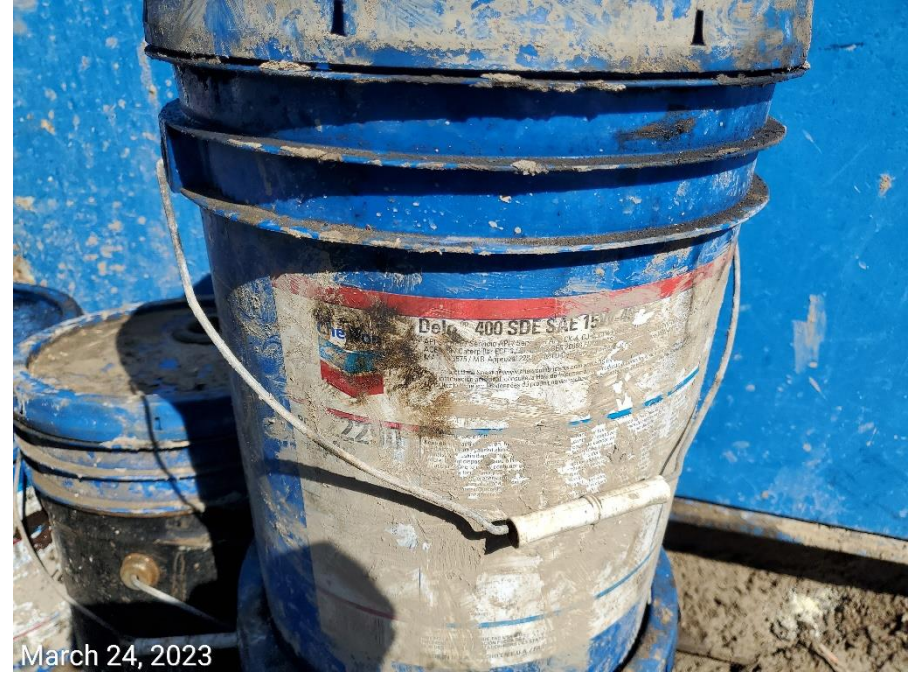
Photo 14: Photo shows chemical containers improperly stored on the Location; container labels identify contents as "400 SDE SAE 15W-48". Containers missing BMPs to prevent or contain a spill, such as secondary containment; some containers observed stored on their side, and/or missing plug within lid to contain contents.

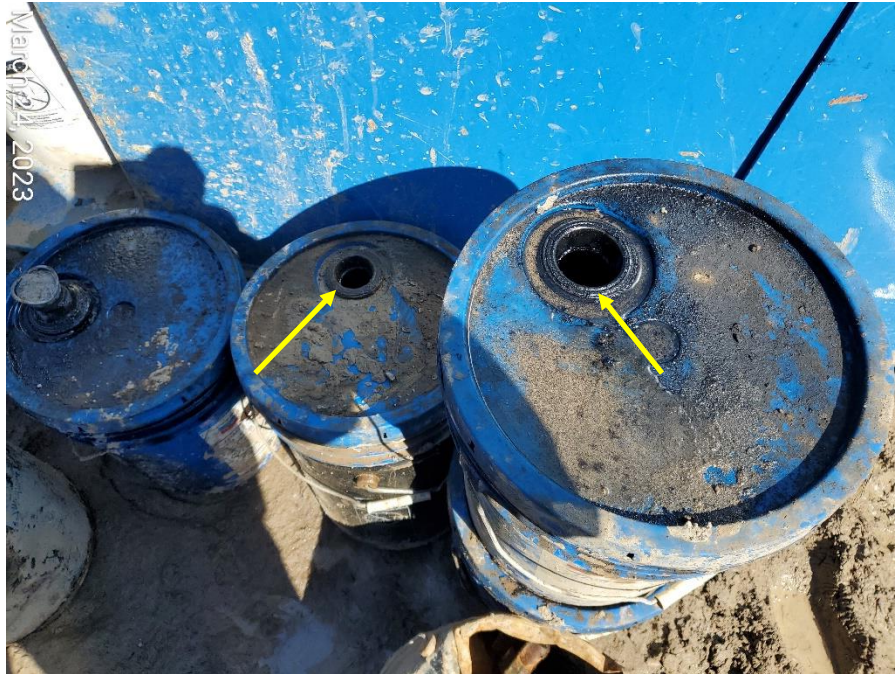
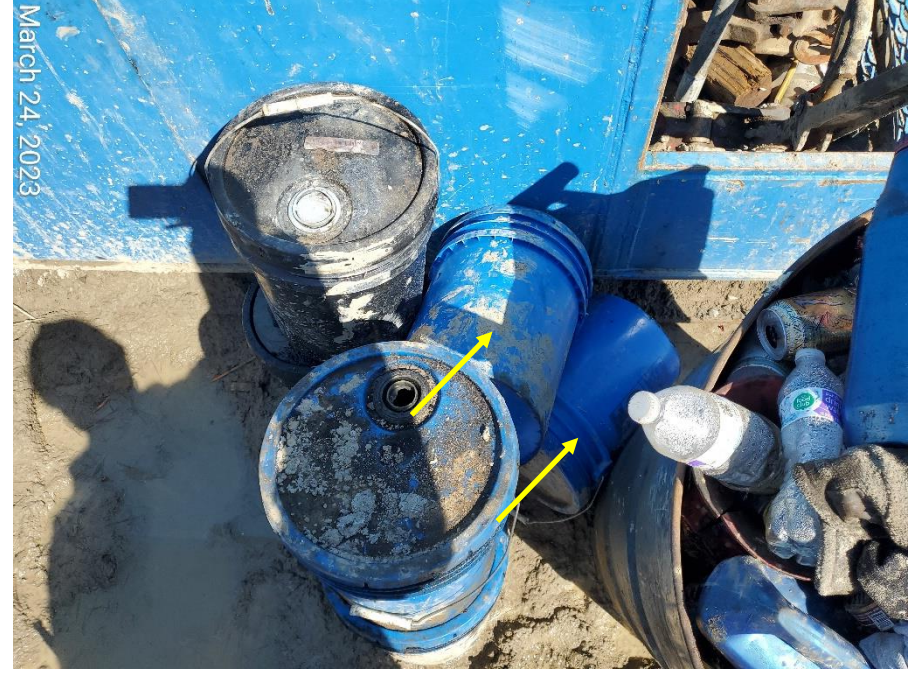
Photo 15: See comments under photo 14.

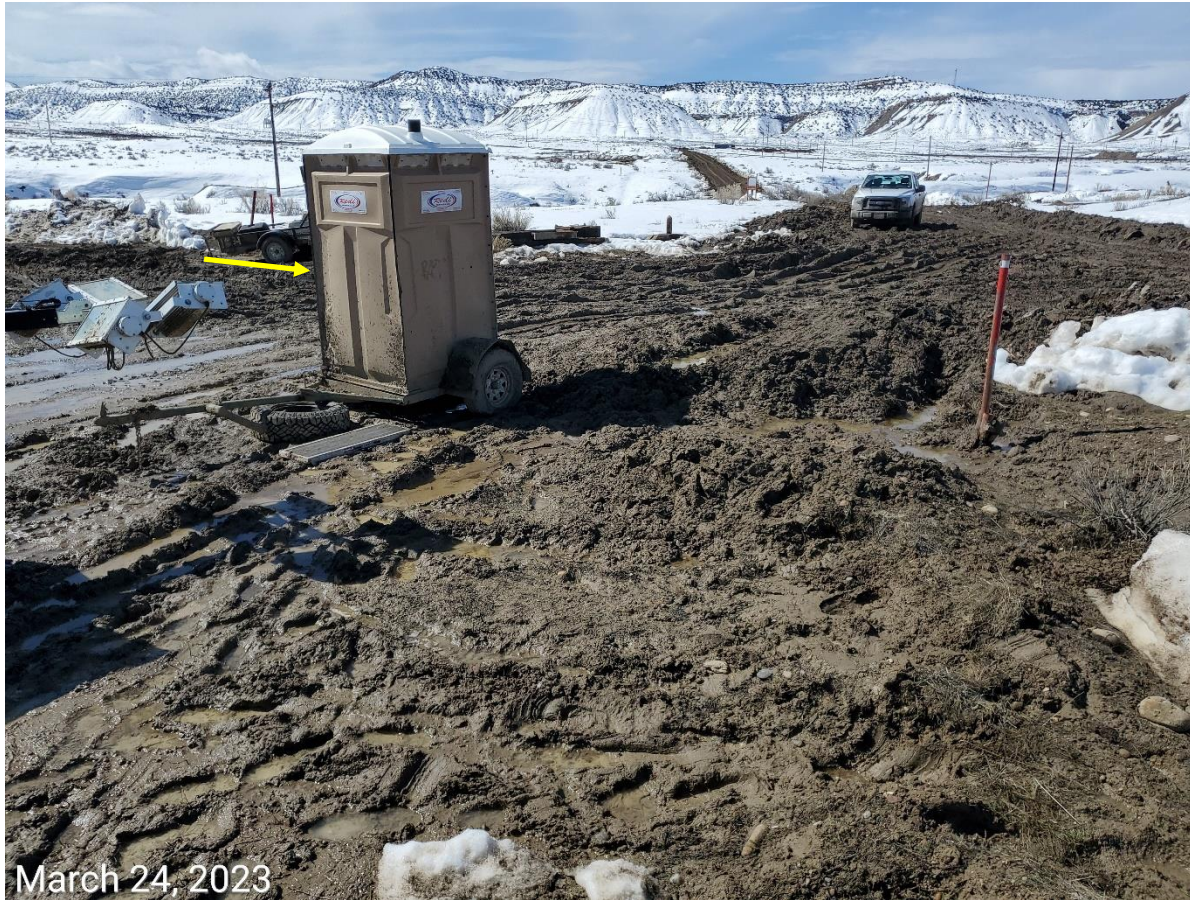
Photo 16: Photo shows porta-john unit stored on the west end of the Location; container currently stored on a small trailer; unable to observed BMPs to properly secure trailer/container to prevent a spill; no other BMPs to prevent or contain a spill observed.

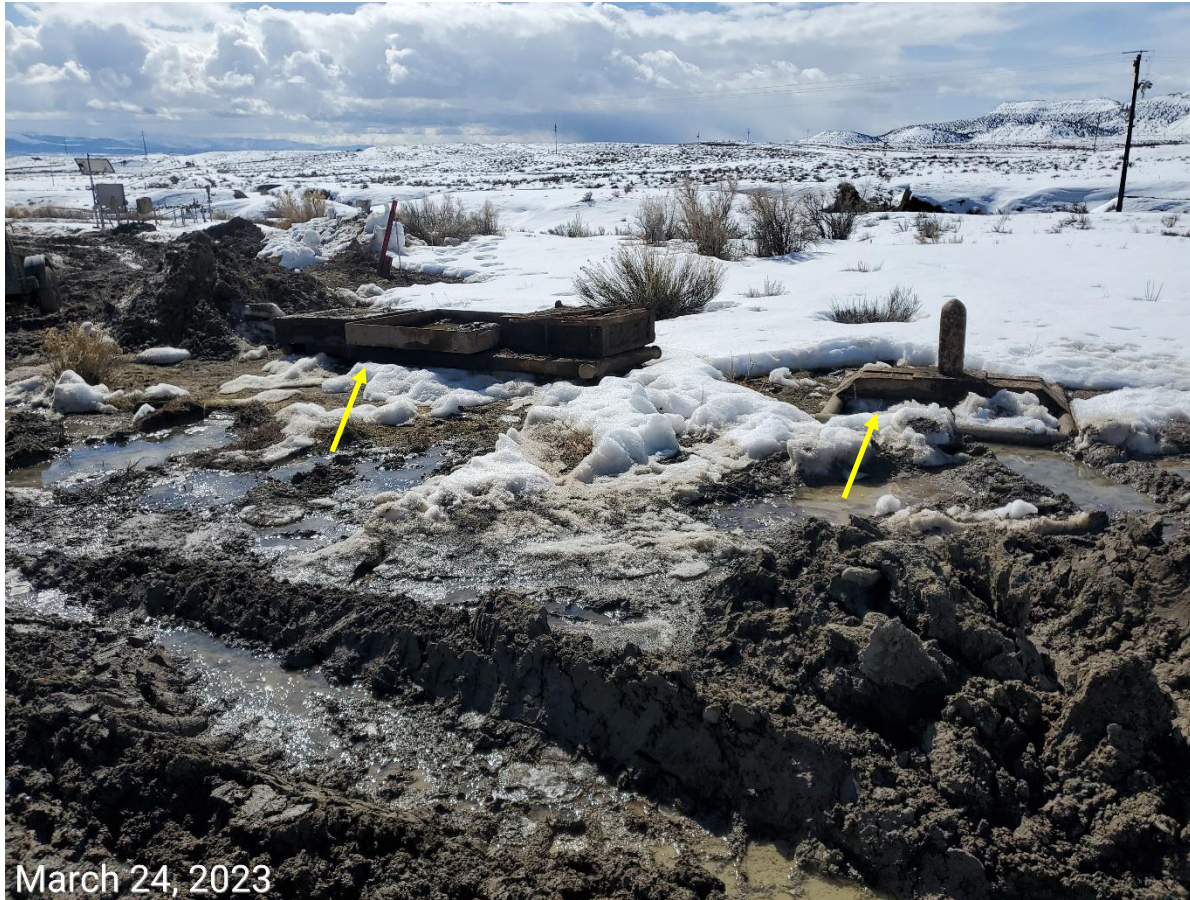
Photo 17: Photo shows equipment improperly stored on off-site of the designated working pad areas.
