Final Reclamation and Stormwater Inspection

Operator: P O & G OPERATING LLC - 10634

Location ID: 324936

Inspection Document #: 708200073

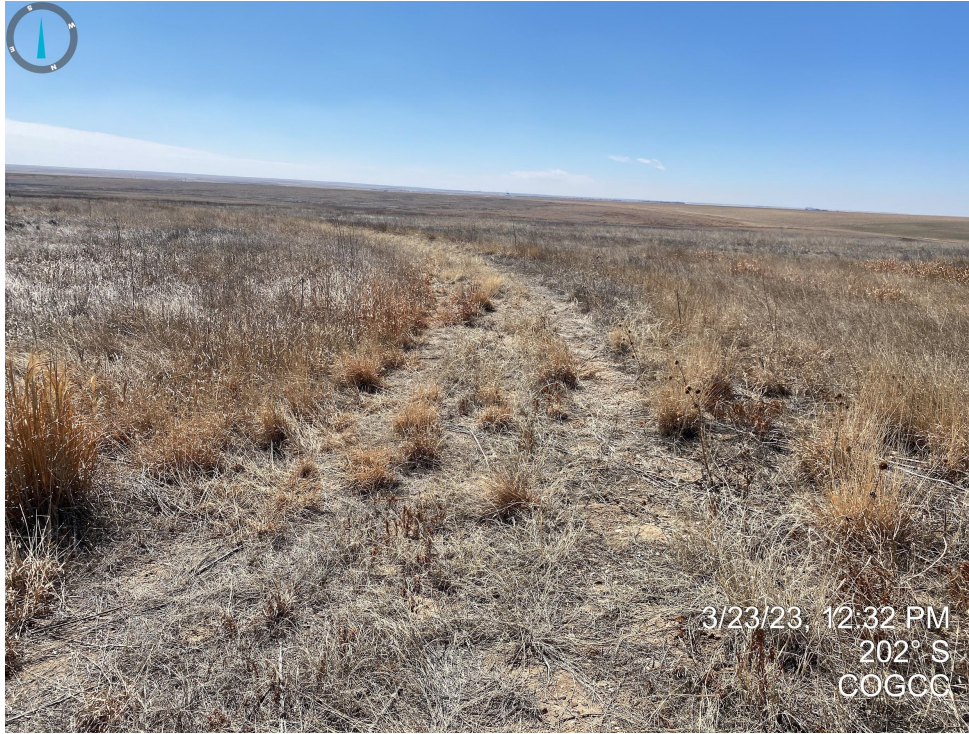
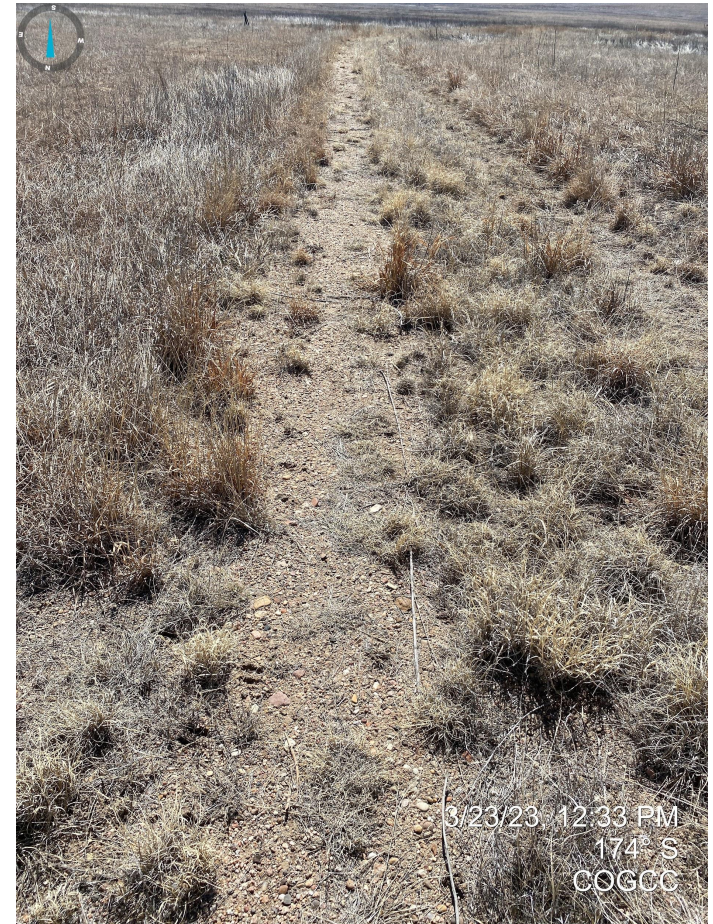
Photos 1 & 2. Facing south along the access road. Photos illustrate that the access road has not been reclaimed with evidence of road base.

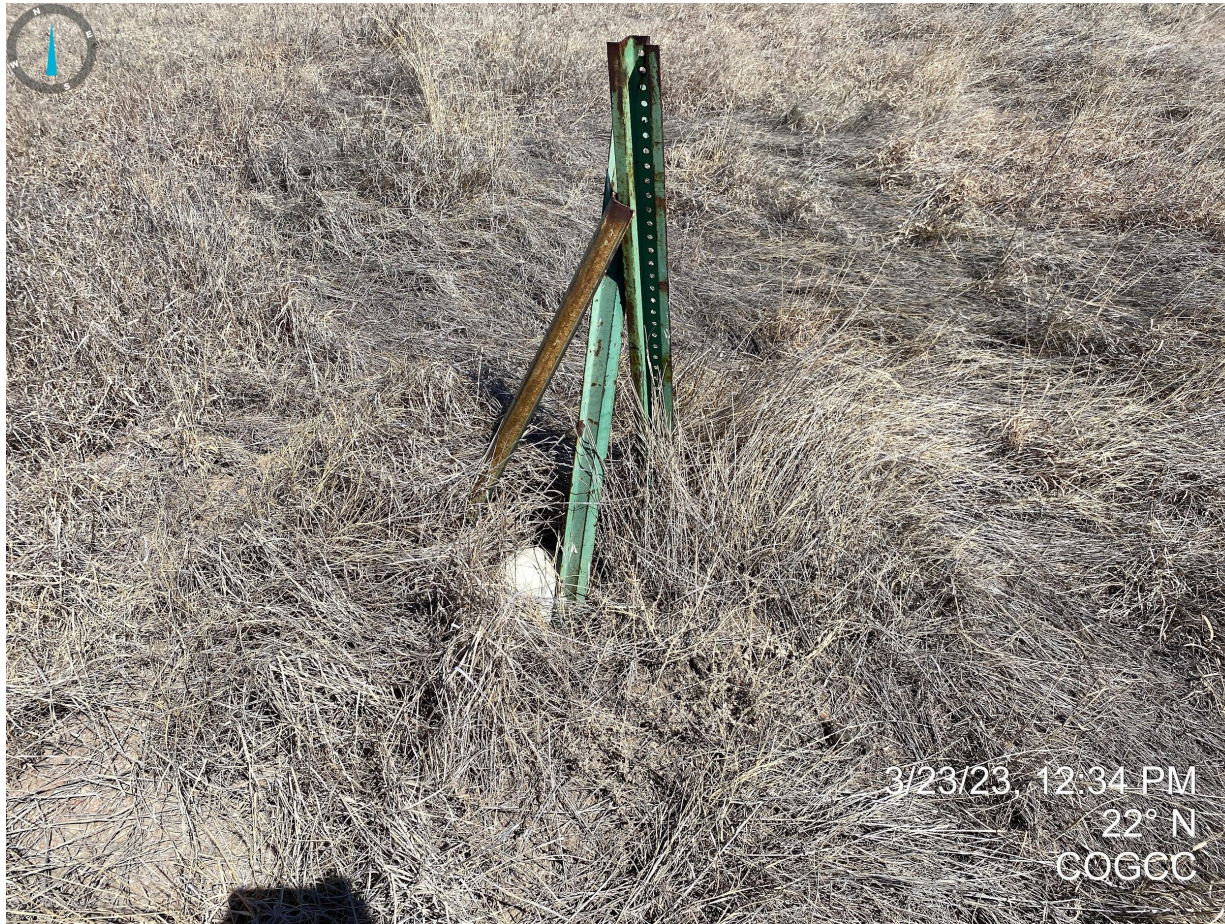
Photo 3. Facing north from the location. Unknown pvc pipe and posts remain on location and will need to be removed.

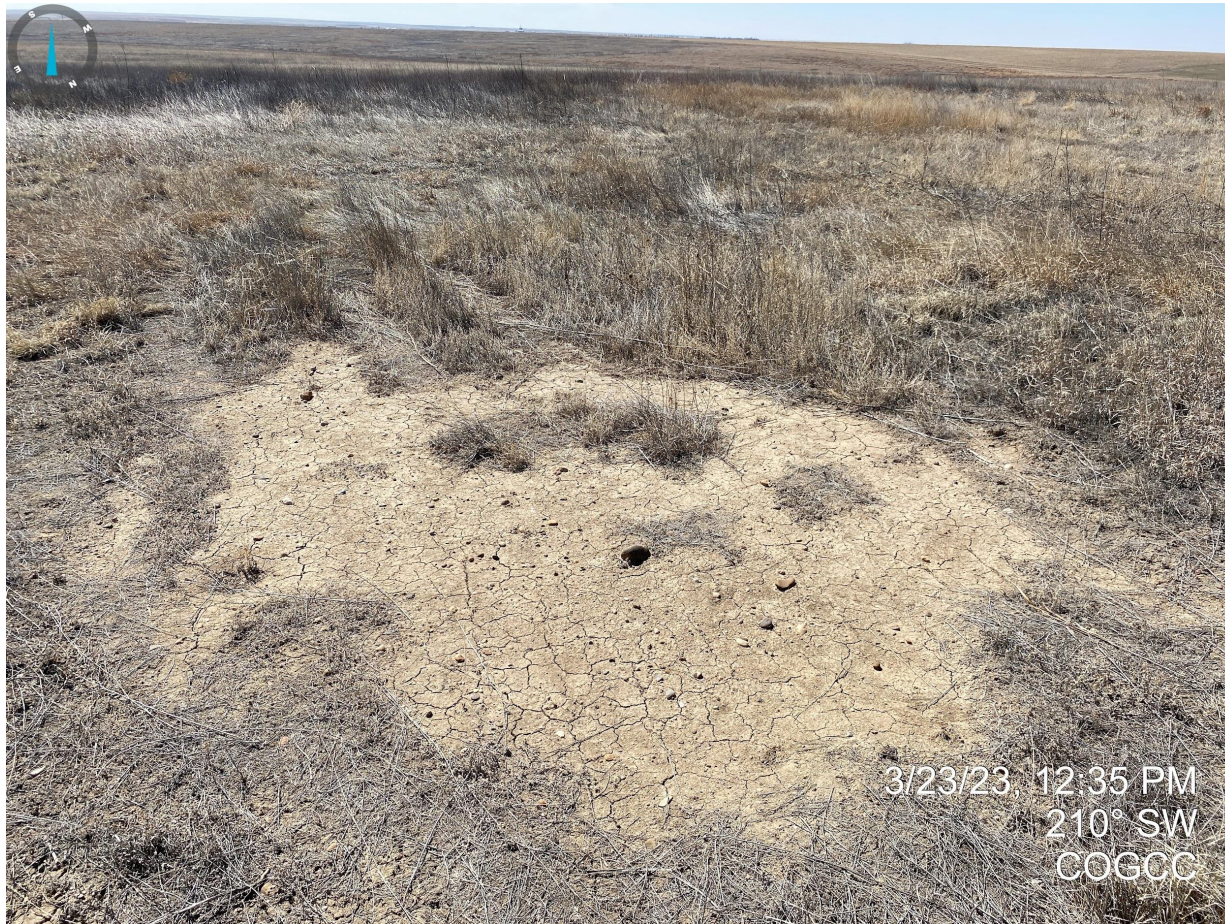
Photo 4. Facing southwest near the PA well. Photo illustrates non-uniform vegetation cover resulting in bare soil. Possible compaction or contaminated soil issues.

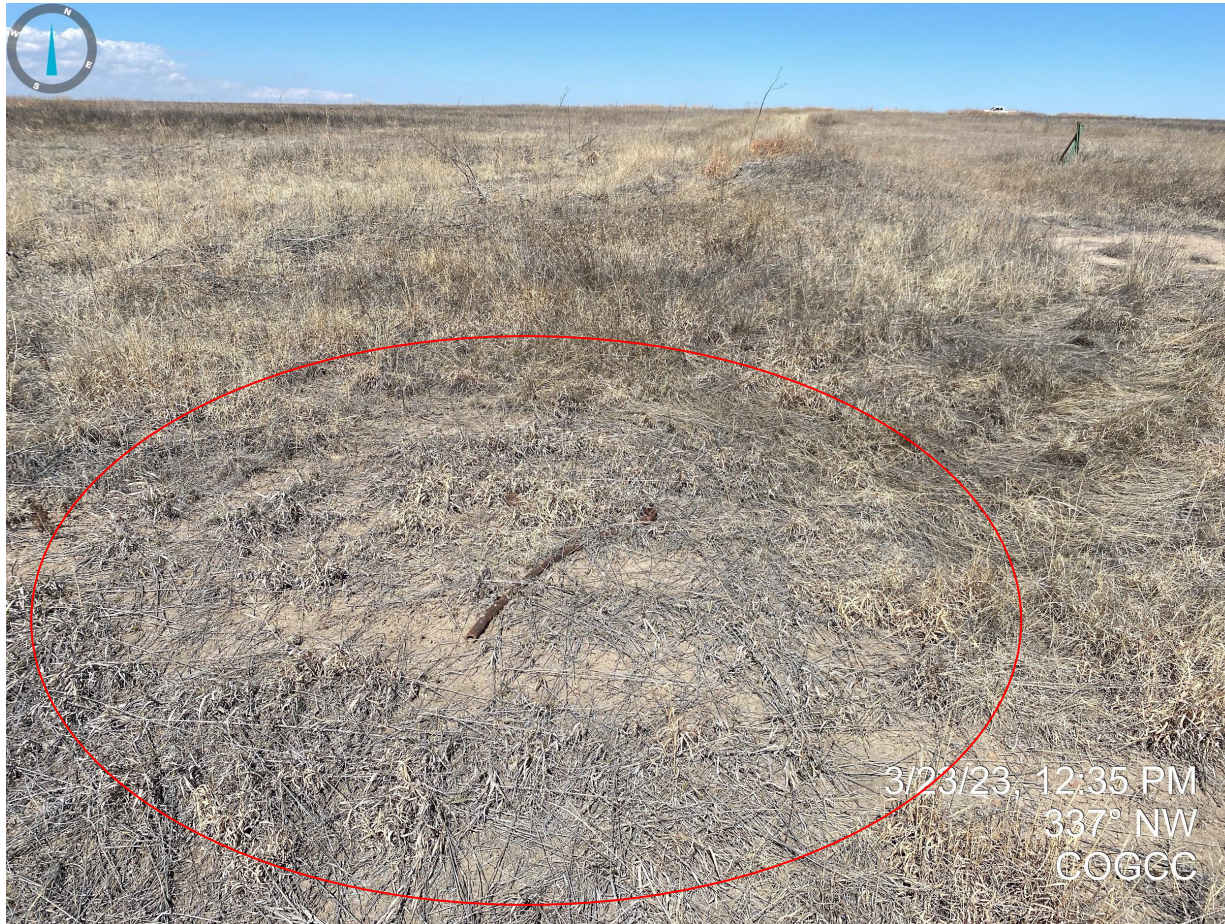
Photo 5. Facing northwest near the PA well. Photo illustrates undesirable vegetation (e.g. kochia) and debris observed on location.

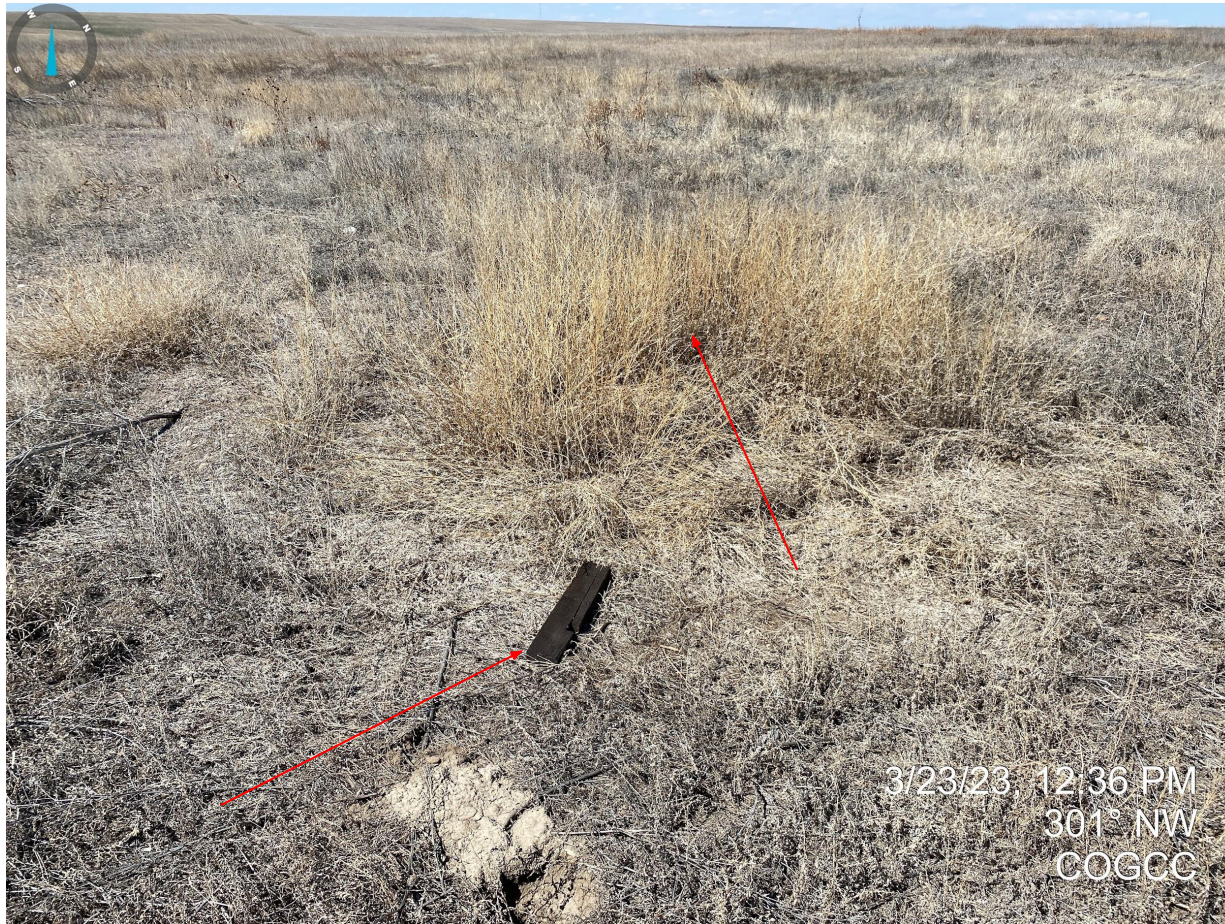
Photo 6. See comments in Photo 5.

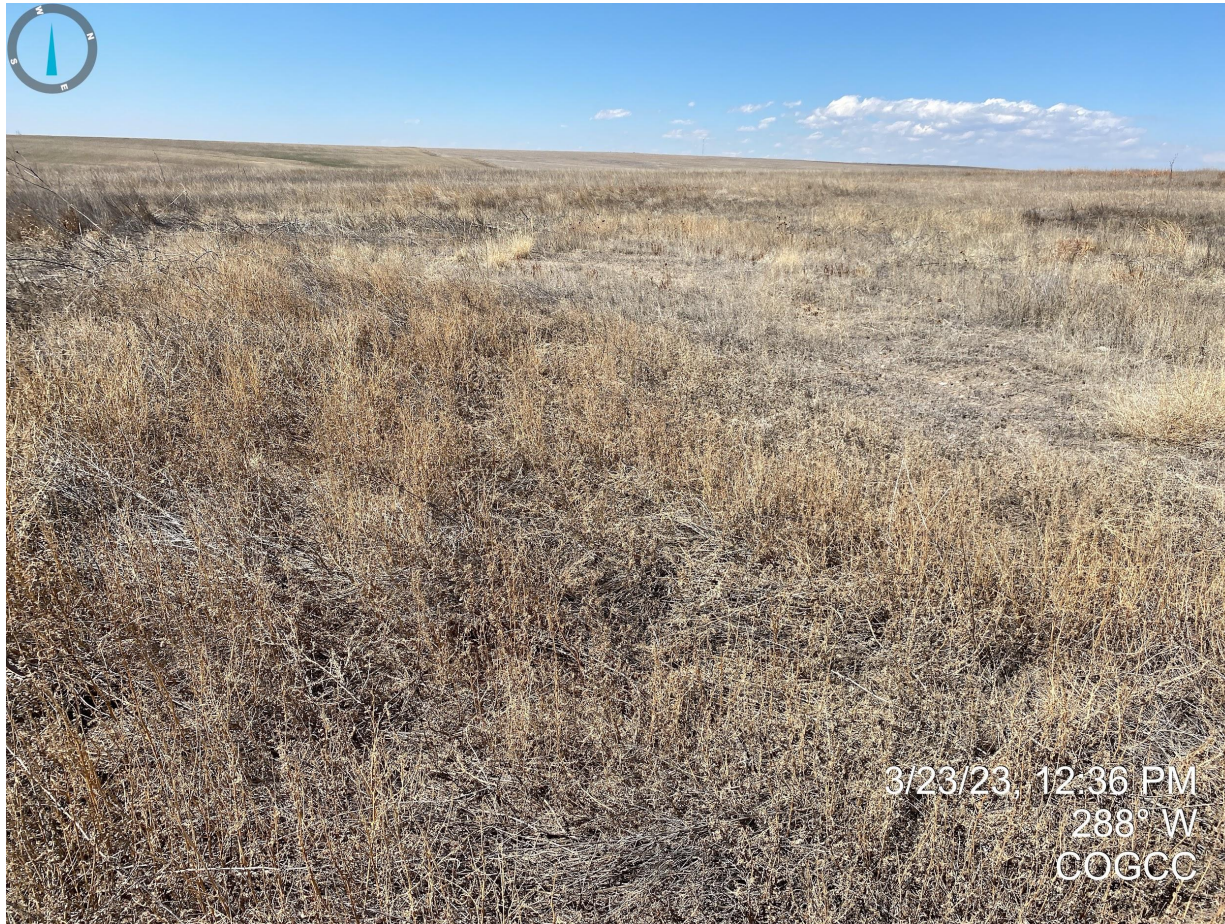
Photo 7. Facing west near the PA well; see comments in Photo 5.

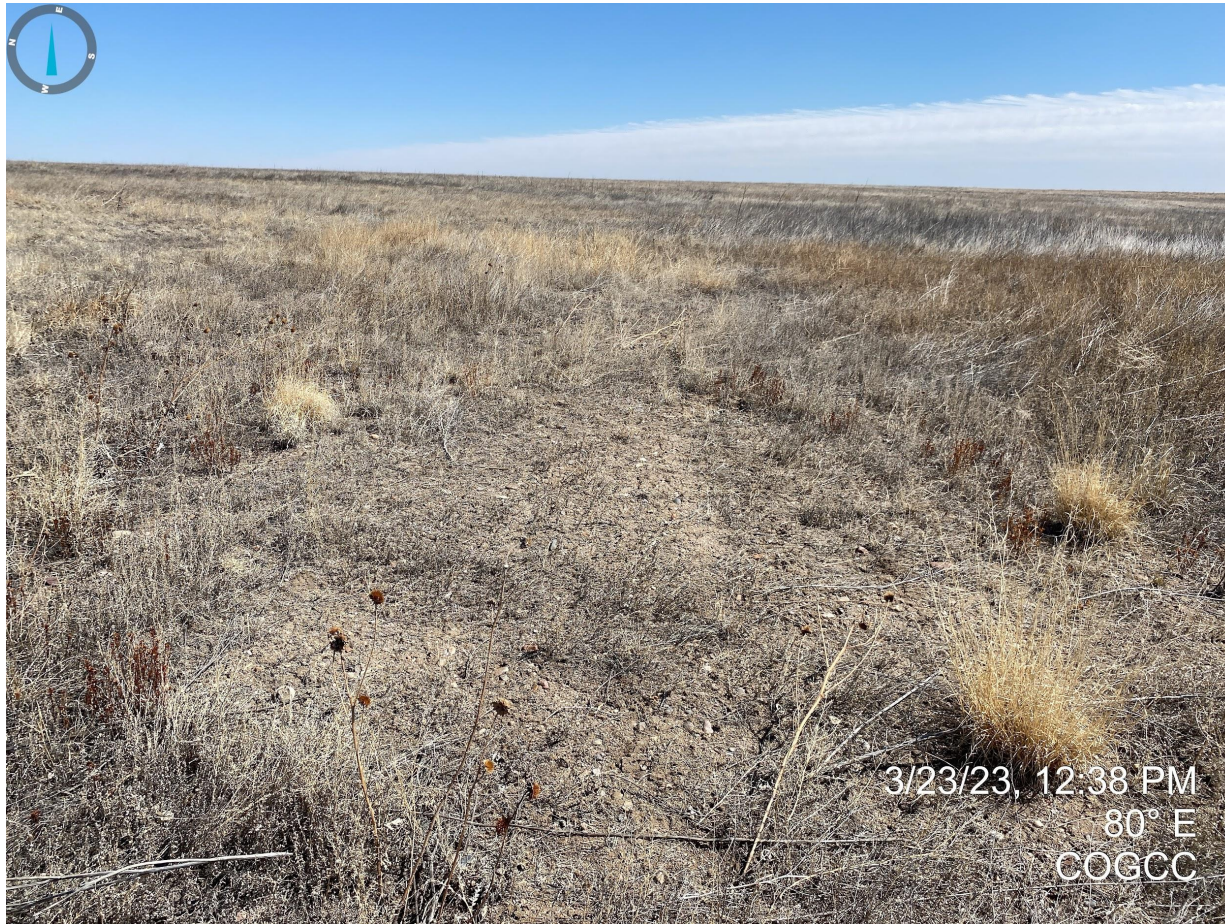
Photo 8. Facing east near the former pump jack location. Gravel and road base remain on location.

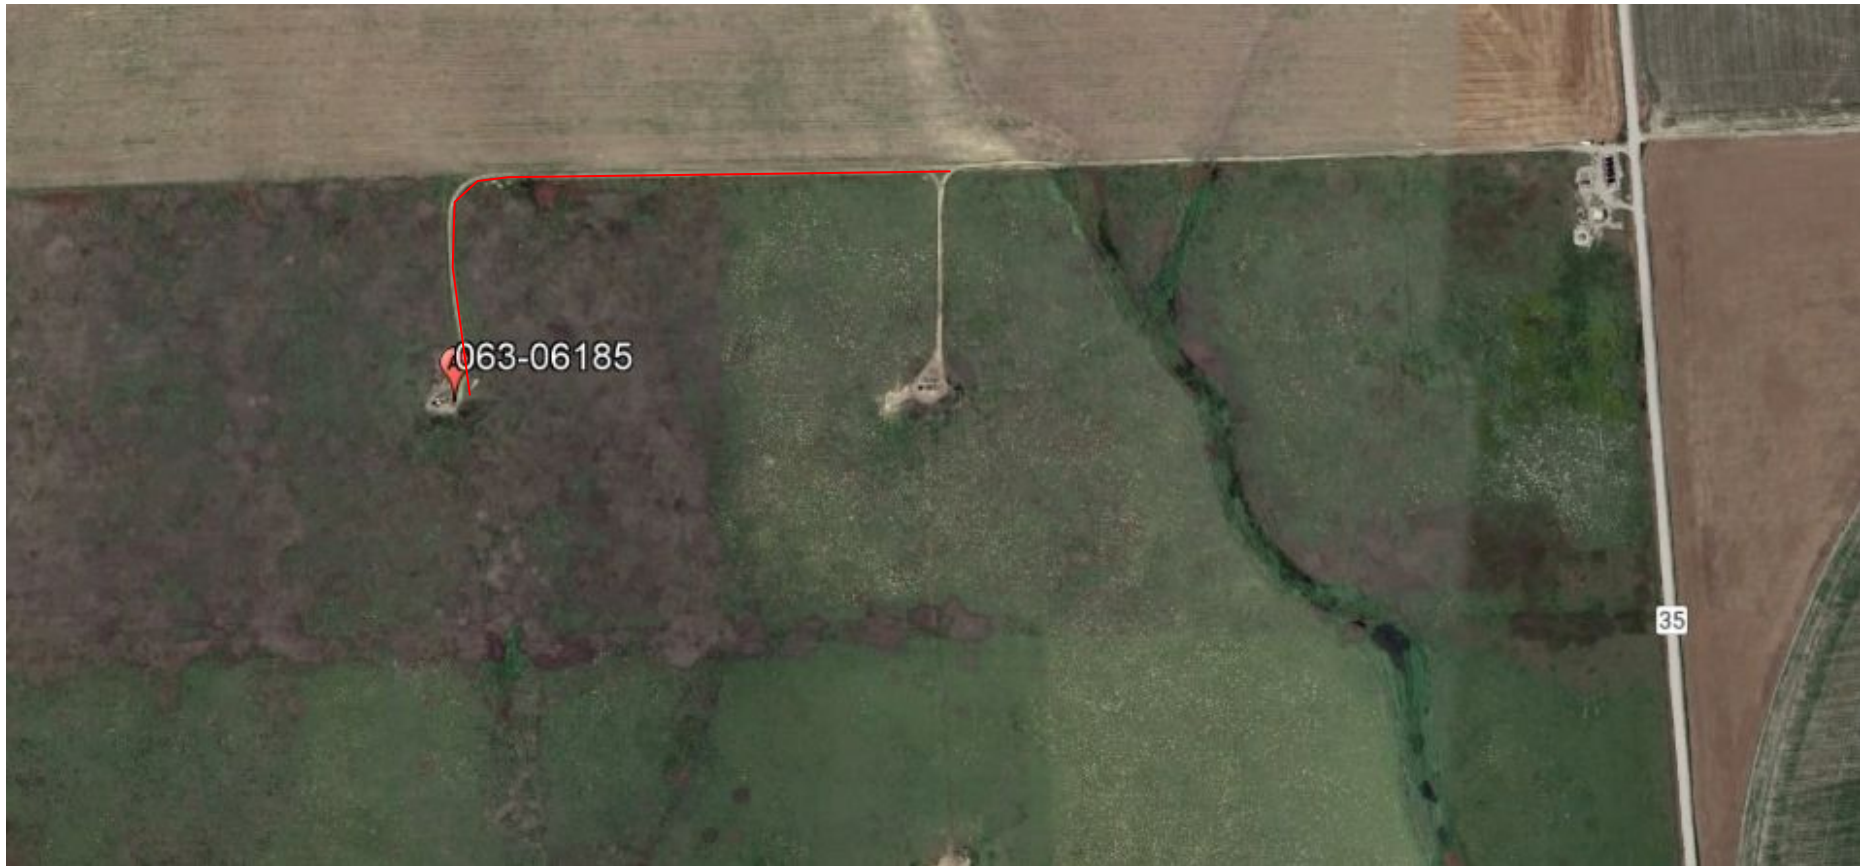
Photo 9. Google Earth aerial imagery illustrating the access road that will need to be reclaimed (highlighted in red) for this well/location. The other access roads will be addressed under a separate inspection.
