Inspection Photos

Loc: 333348

Operator: OXY USA INC

Inspection Date: 4/10/2023

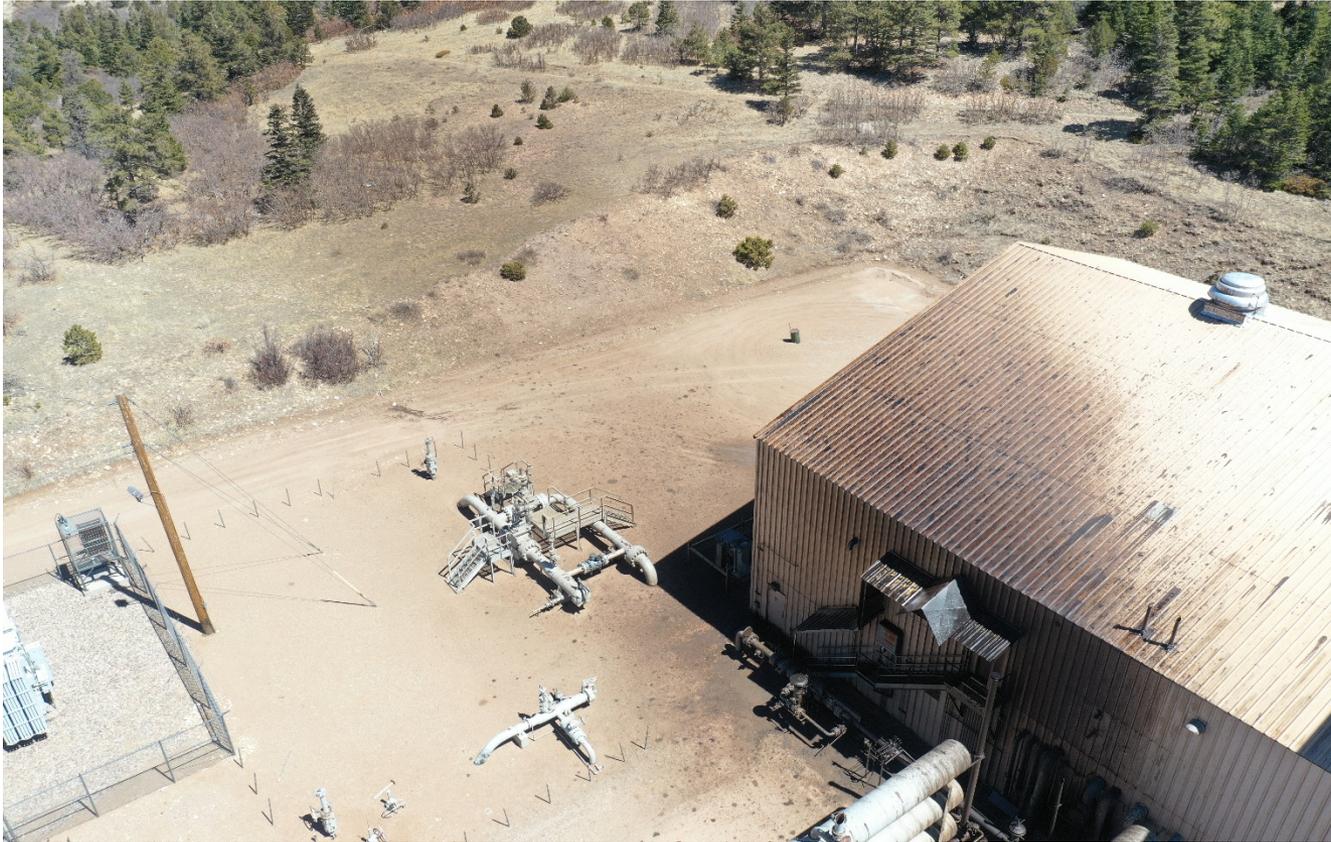
Photo 1. Drone aerial photo facing northeast at the Drill site 3 compressor. There was a leak that has blackened the facility and areas of the ground and sprayed out to the northeast off the location.

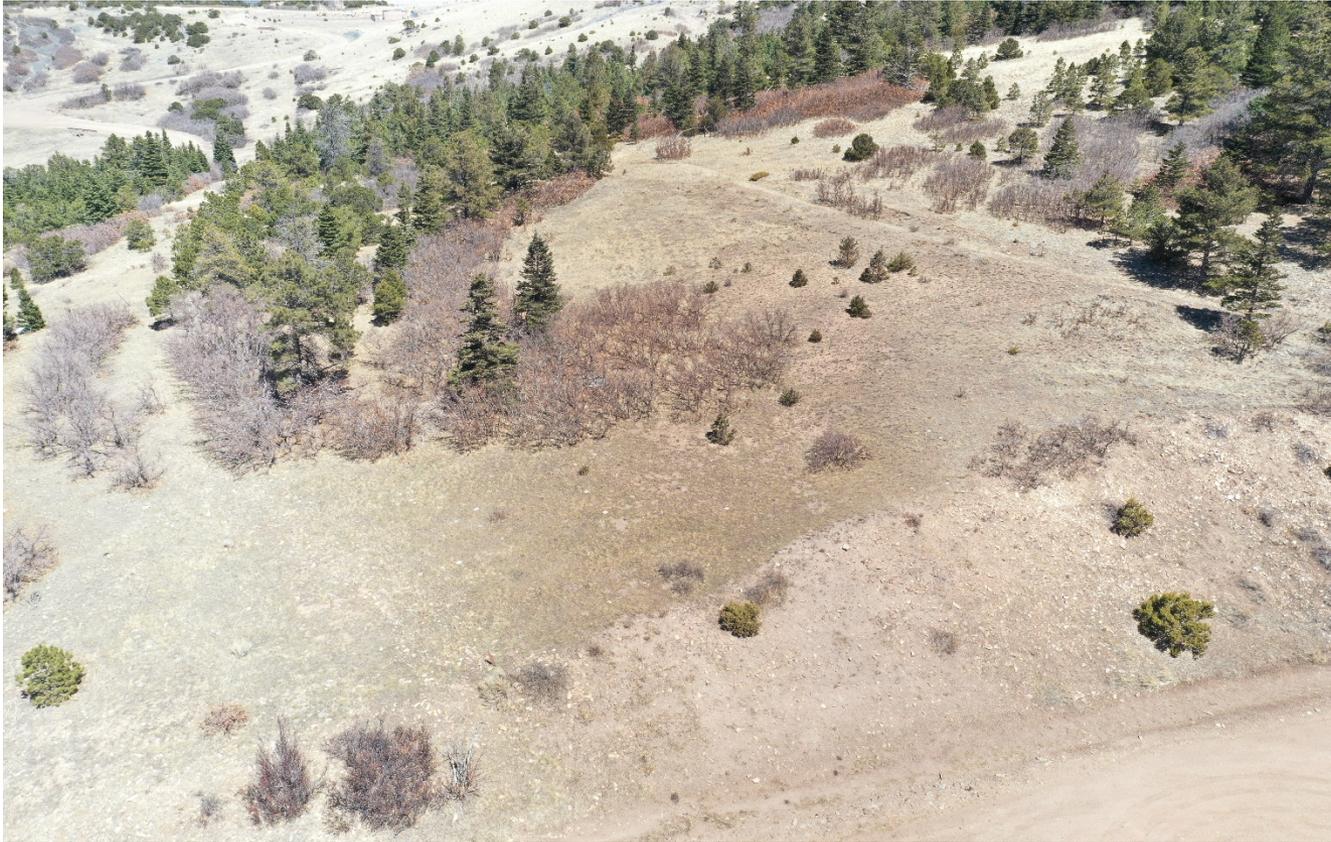
Photo 2. The area northeast off the location has been blackened from the spill that occurred at the compressor facility.

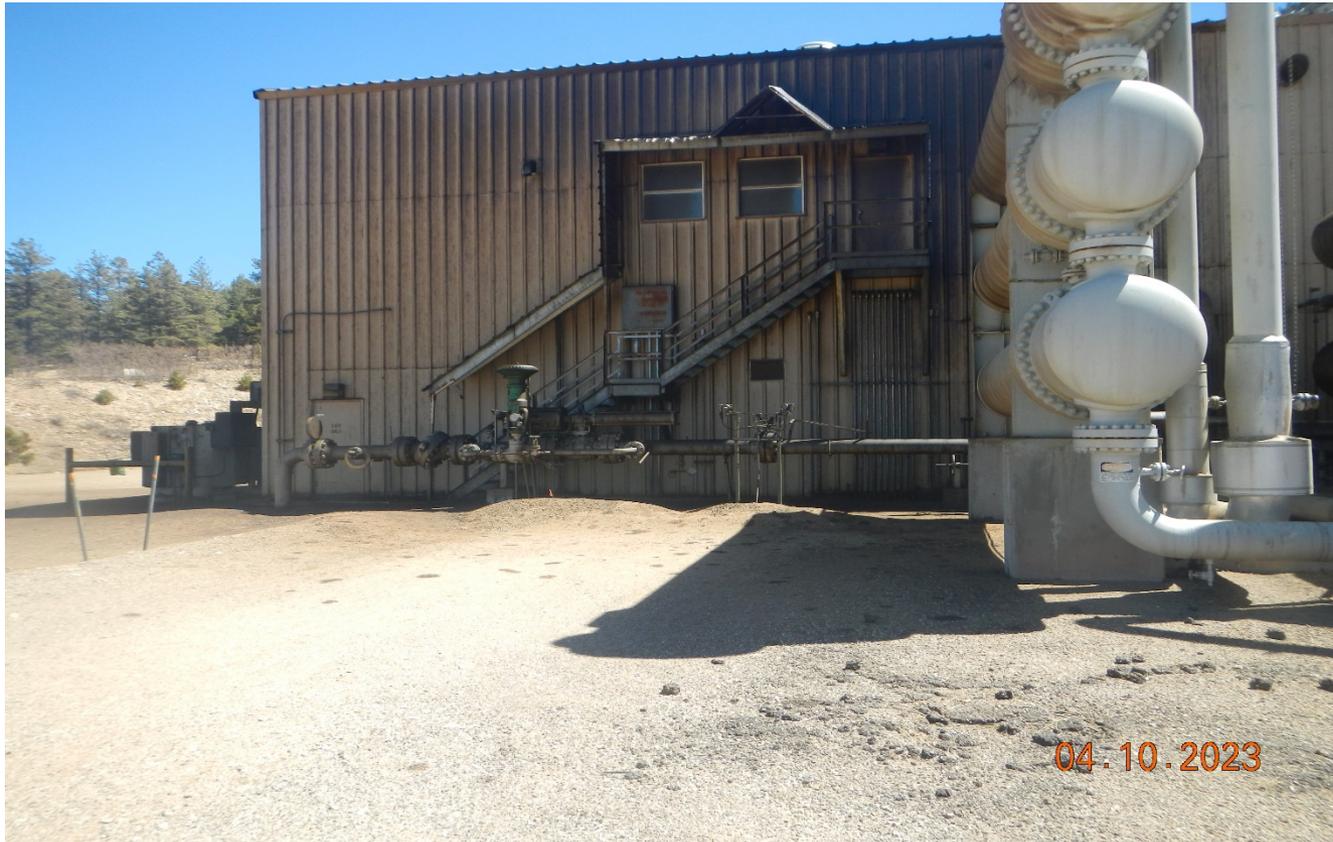
Photo 3. Facing east at the Drill site 3 compressor. There was a leak that has blackened the facility and areas of the ground that needs to be cleaned up.

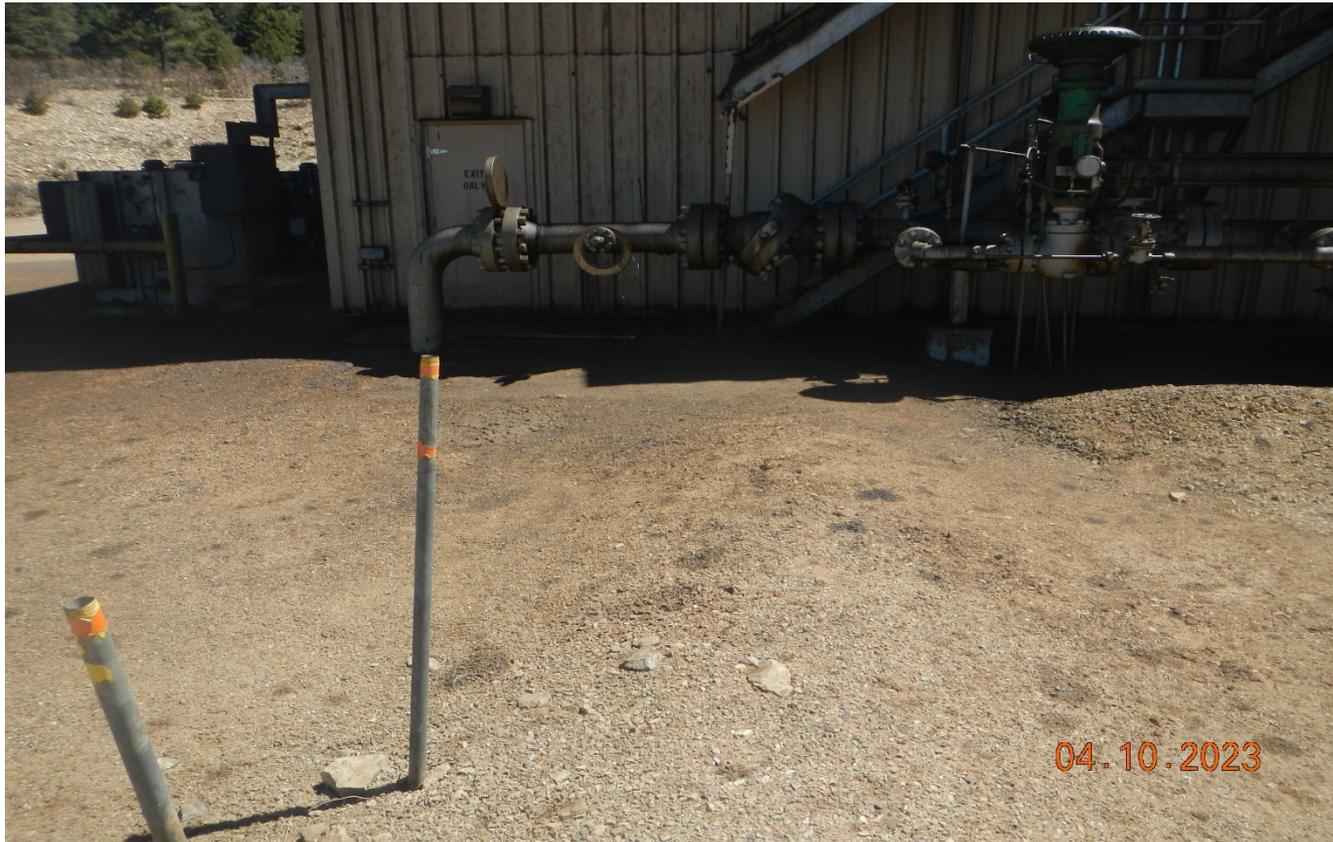
Photo 4. The is stained soils along the east side of the compressor.

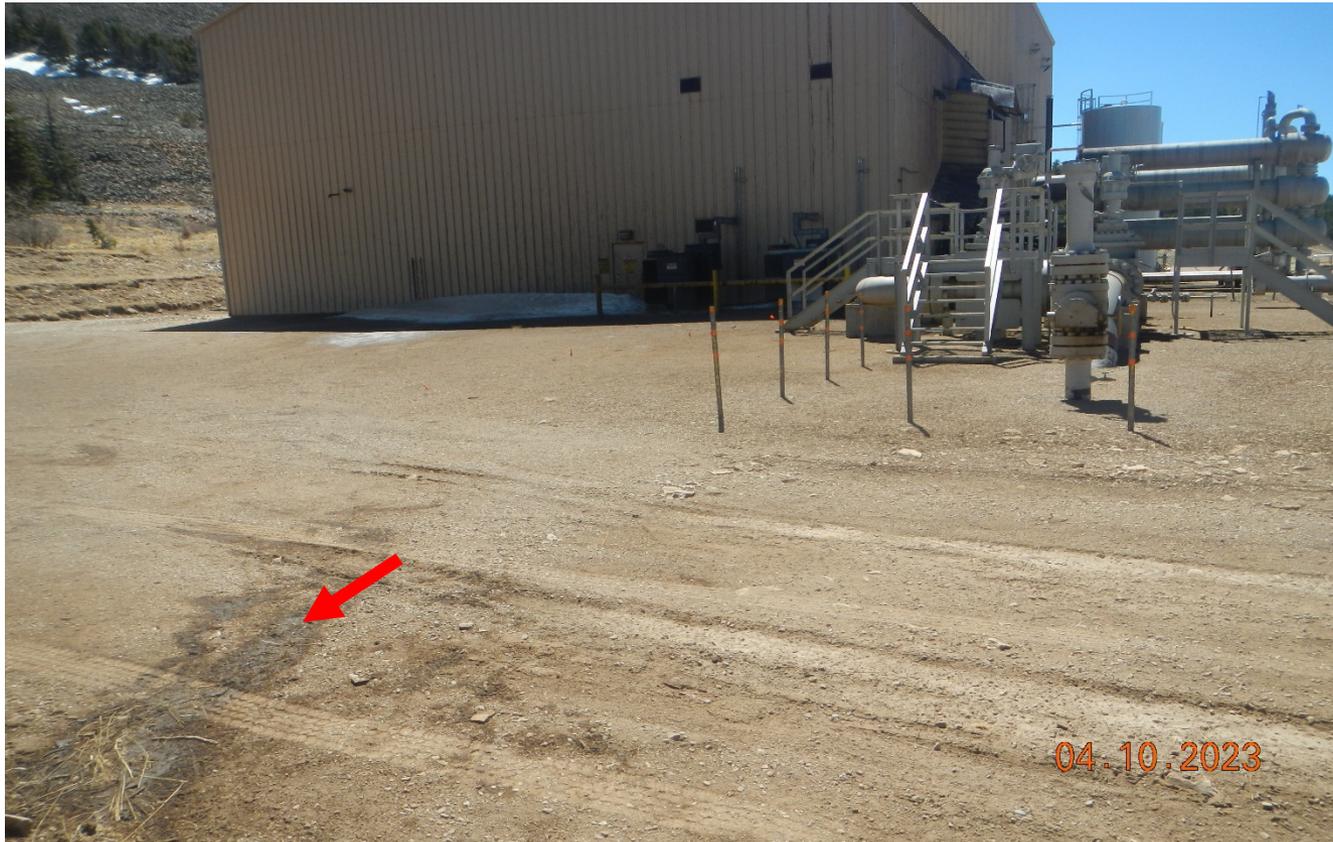
Photo 5. Facing southeast at the north side of the Drill site 3 compressor. There is oil stained soils that have sprayed out north of the compressor.

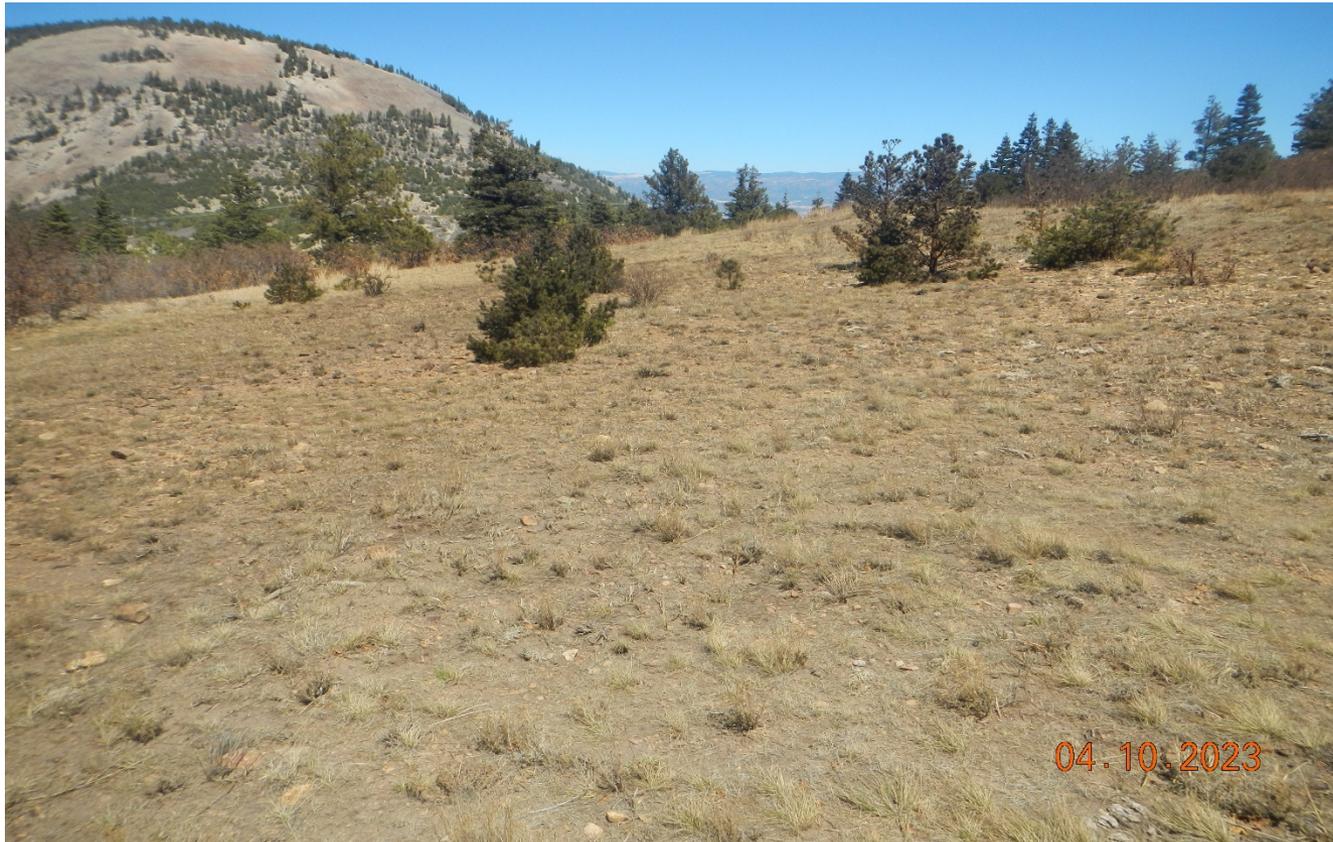
Photo 6. Facing northeast off the location. The vegetation and ground has been blacked from the spill at the compressor.

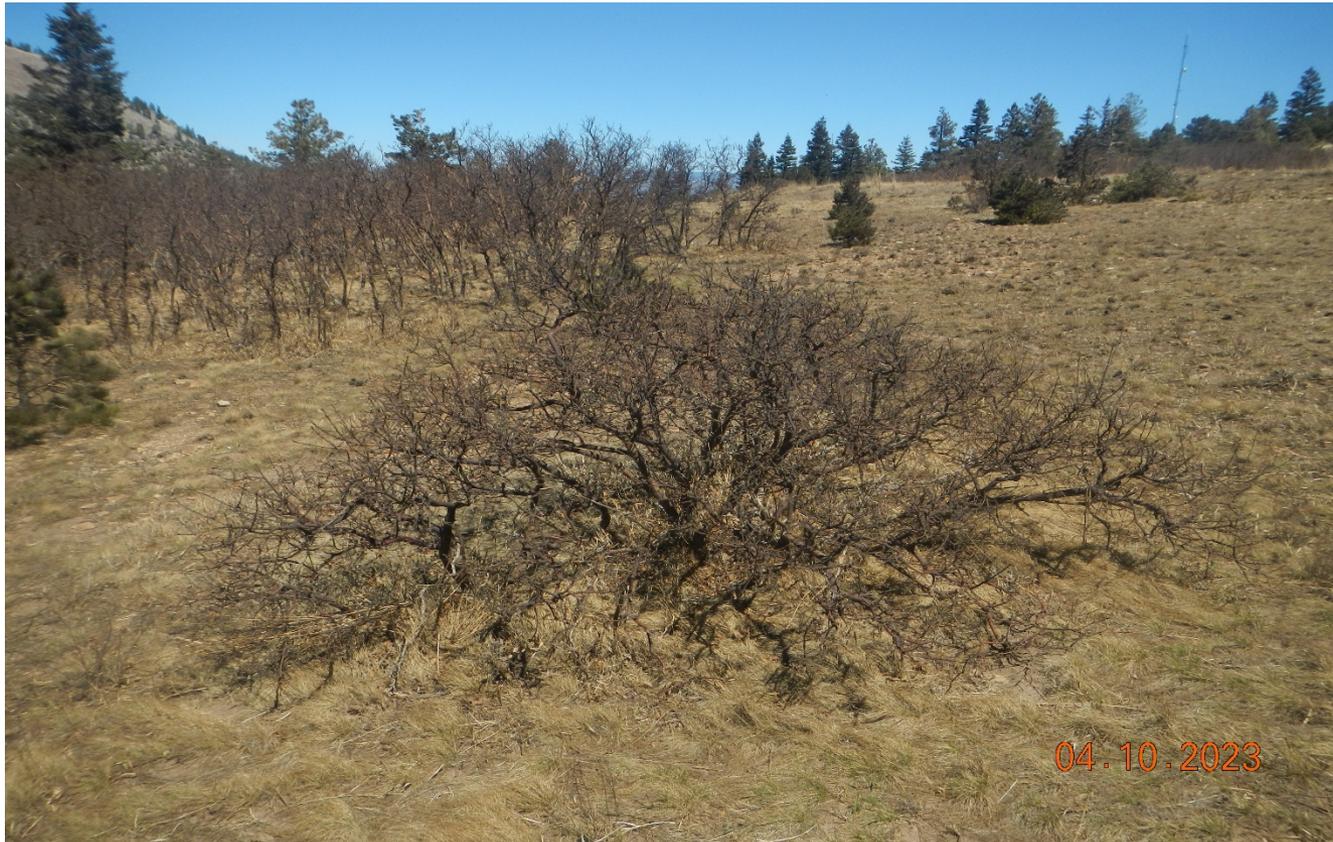
Photo 7. Facing northeast off the location. The vegetation and ground has been blacked from the spill at the compressor.

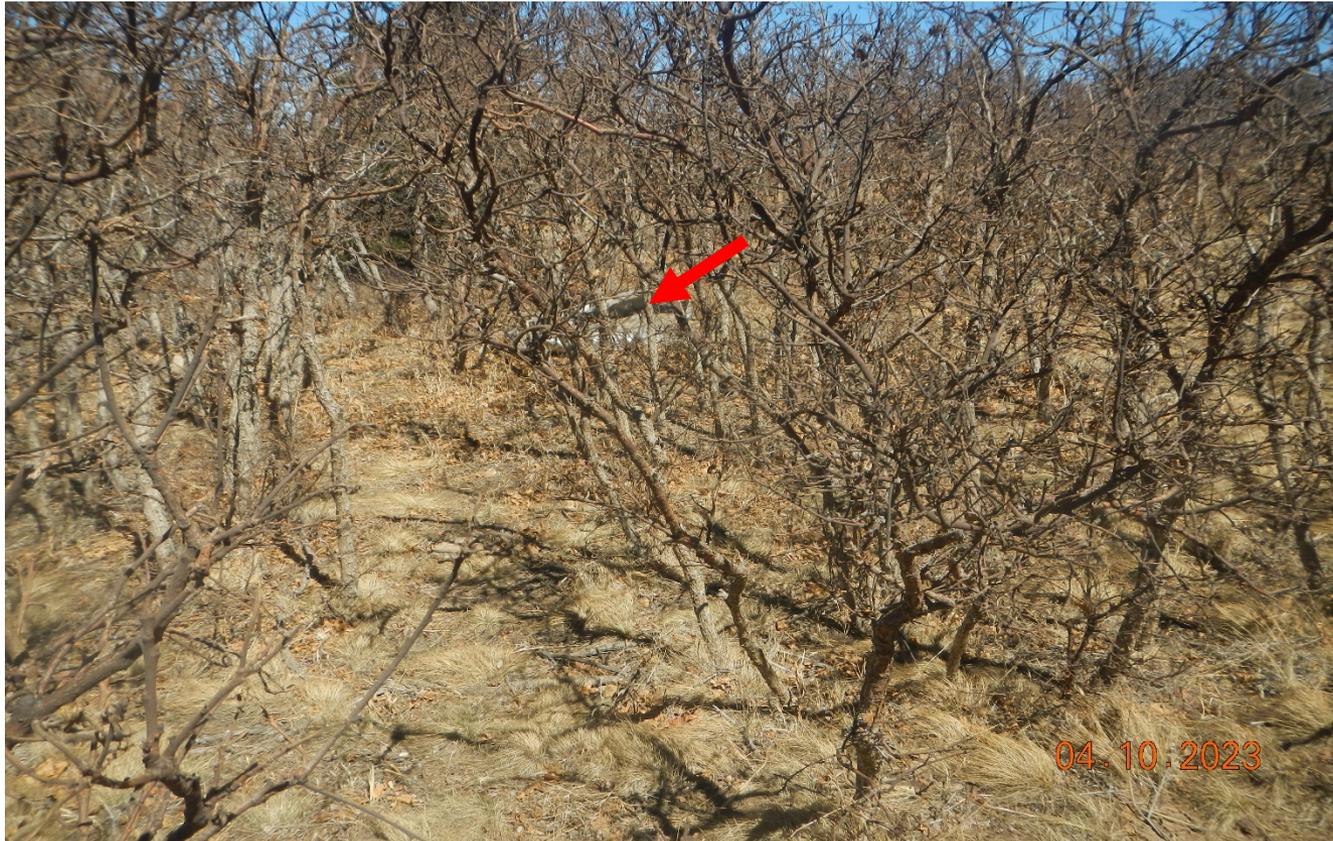
Photo 8. There was some trash/debris found north of the location that needs to be cleaned up. The vegetation in this area is also blackened from the spill.
