Final Reclamation Inspection

Operator: BONANZA CREEK ENERGY OPERATING COMPANY LLC - #8960

Location ID: 331413

Inspection Photos
Location Name: DOW #32-28
Location ID: 331413

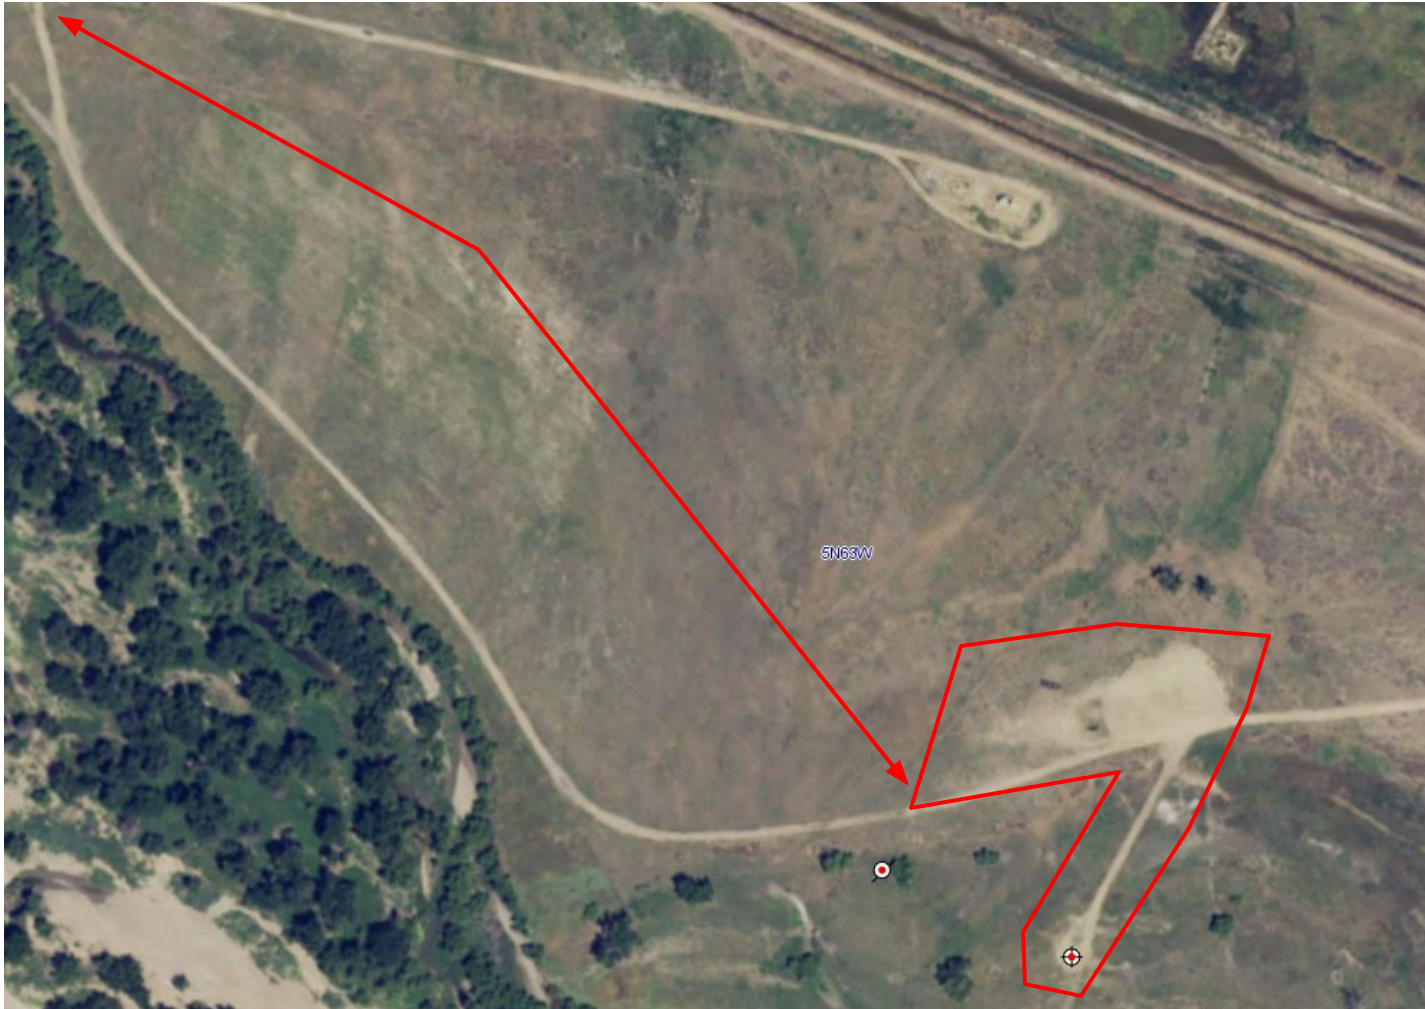
Photo 1. COGCC GISOnline aerial imagery from 2015. This inspection covers the well location, access roads and tank battery.

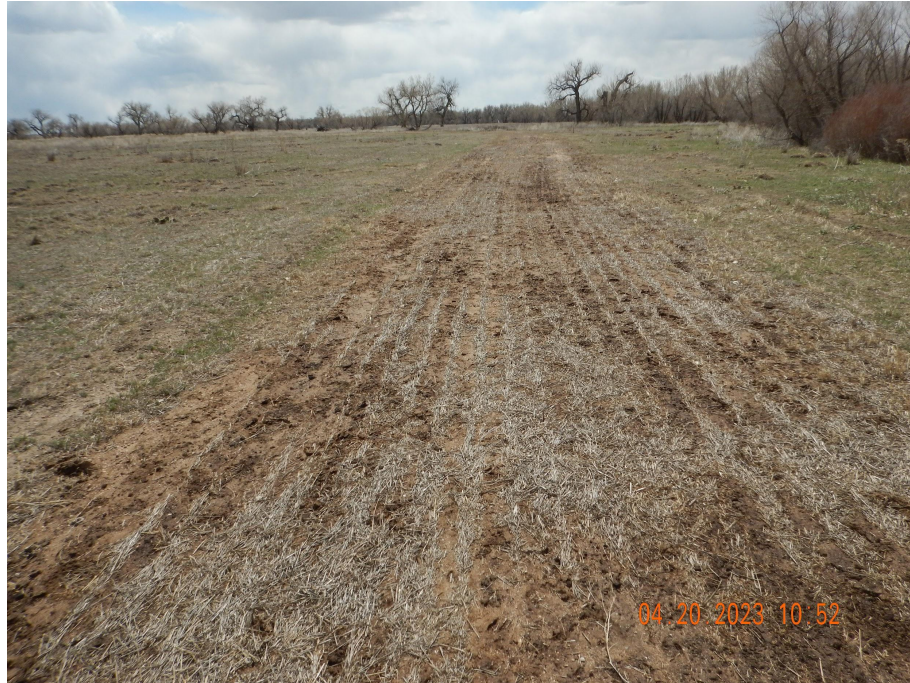
Photo 2. Photo taken from a portion of the main access road, facing Southeast. Photo illustrates the access road is bare with no perennial vegetation that is not reflective of reference areas.

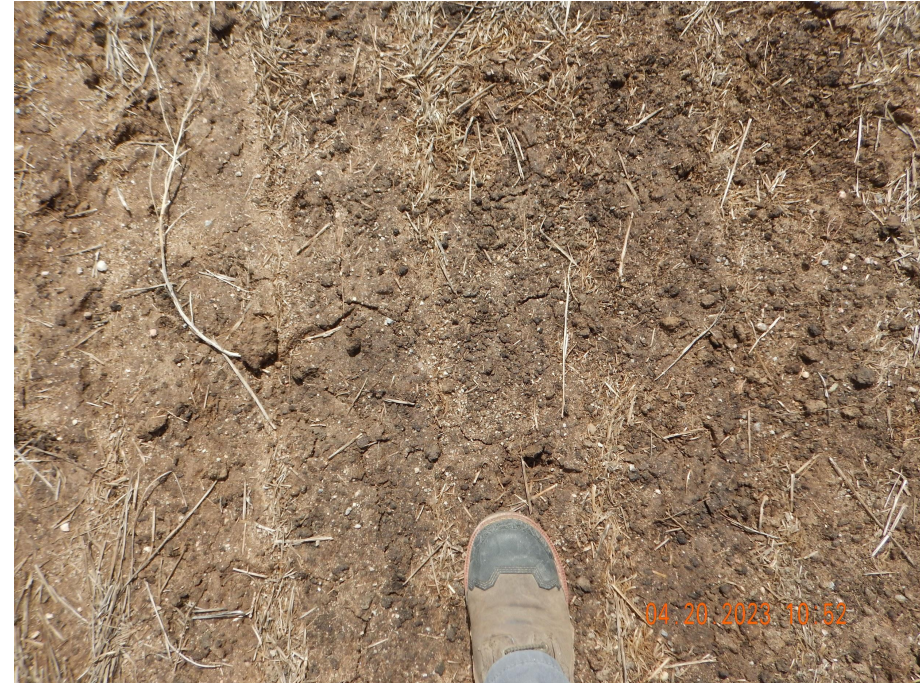
Photo 3. Close up photo taken from a portion of the main access road, illustrating the lack of any vegetation.

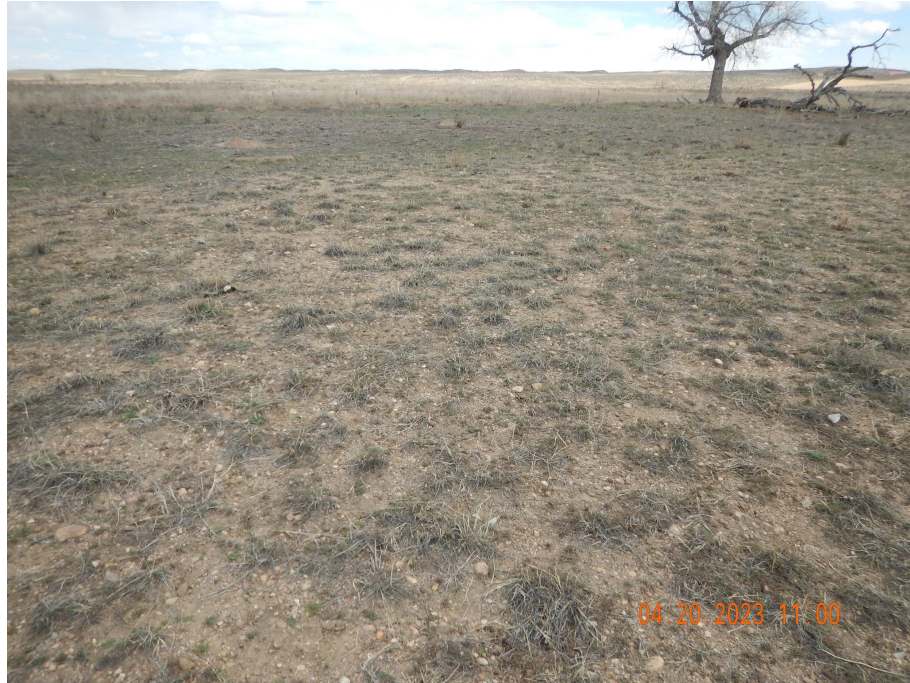
Photo 4. Photo taken from the offsite tank battery location, facing North. Photo illustrates the location consists mostly of weeds with little perennial vegetation that is not reflective of reference areas.

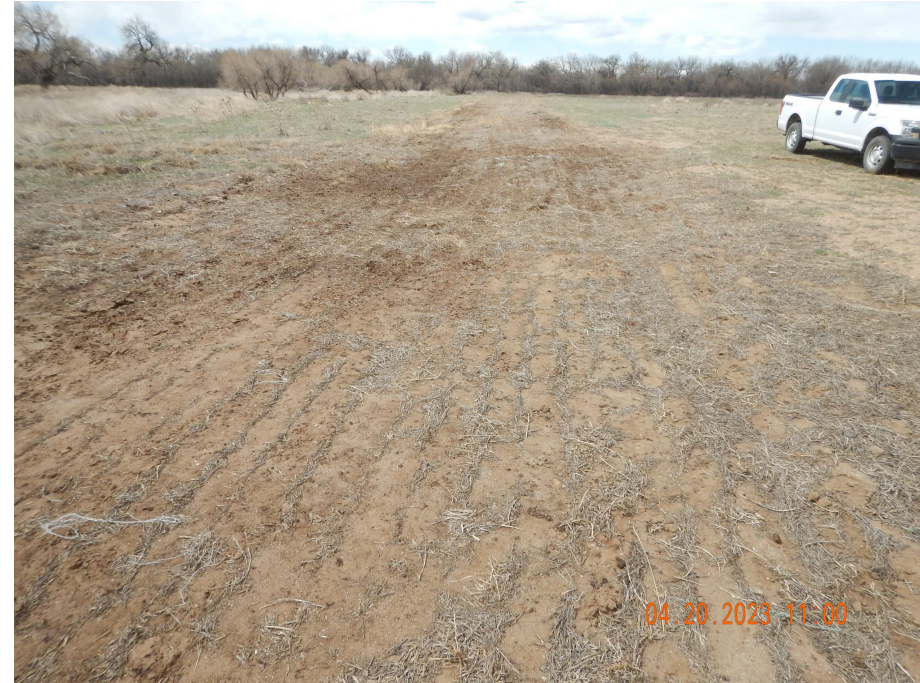
Photo 5. Photo taken from the offsite tank battery location, facing West. Photo illustrates more of the failed access road.

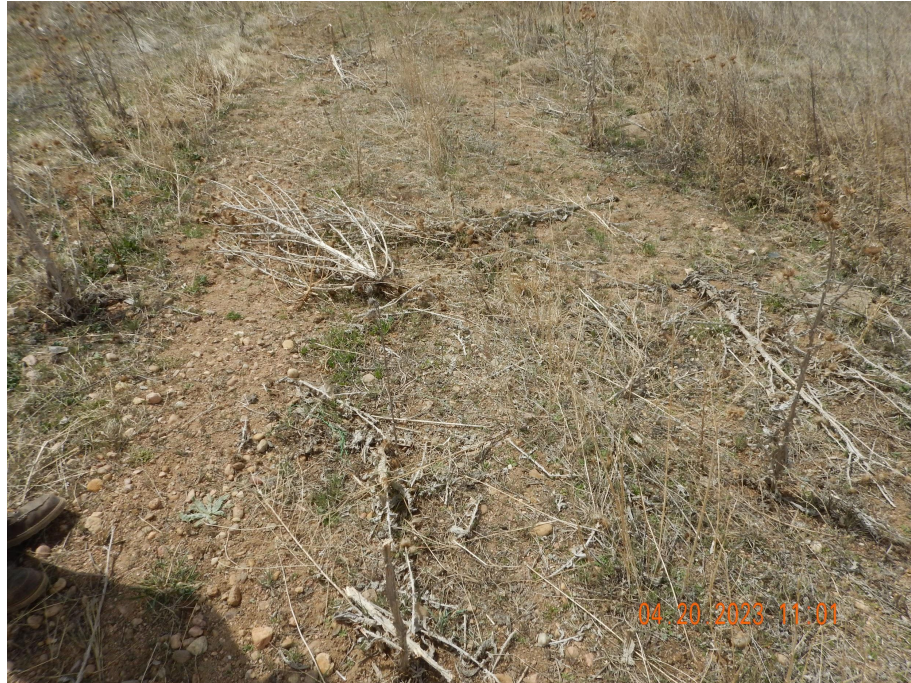
Photo 6. Photo taken from a portion of the well location access road, facing South. Photo illustrates the location consists mostly of weeds with little perennial vegetation that is not reflective of reference areas. It also appears to not all the gravel was removed.

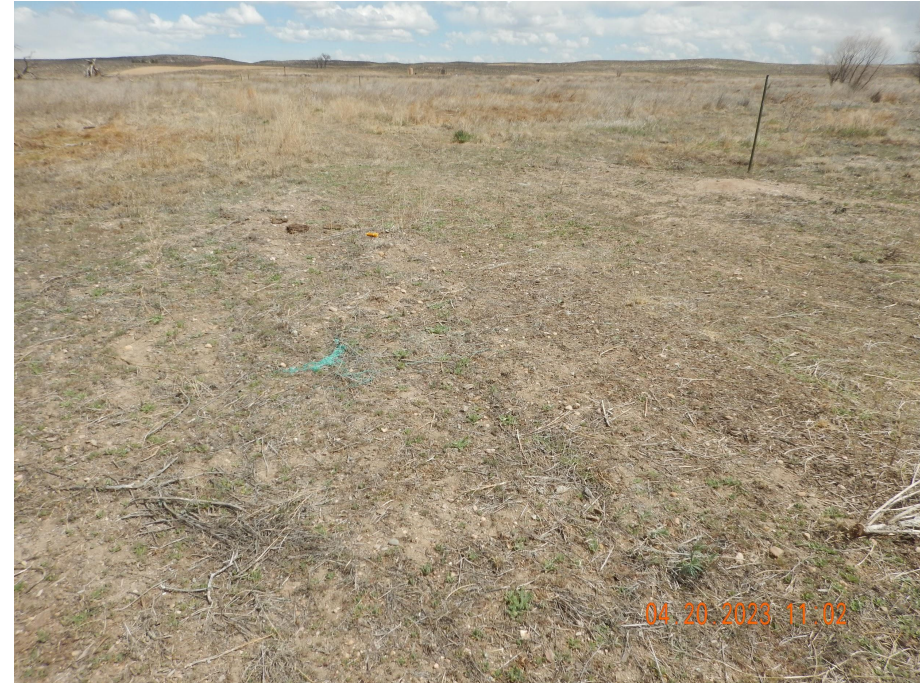
Photo 7. Photo taken from the well location, facing North. See comments under Photo 6.
