Final Reclamation Inspection

Operator: BONANZA CREEK ENERGY OPERATING COMPANY LLC - #8960

Location ID: 305671

Inspection Photos
Location Name: LAURA #8-28
Location ID: 305671

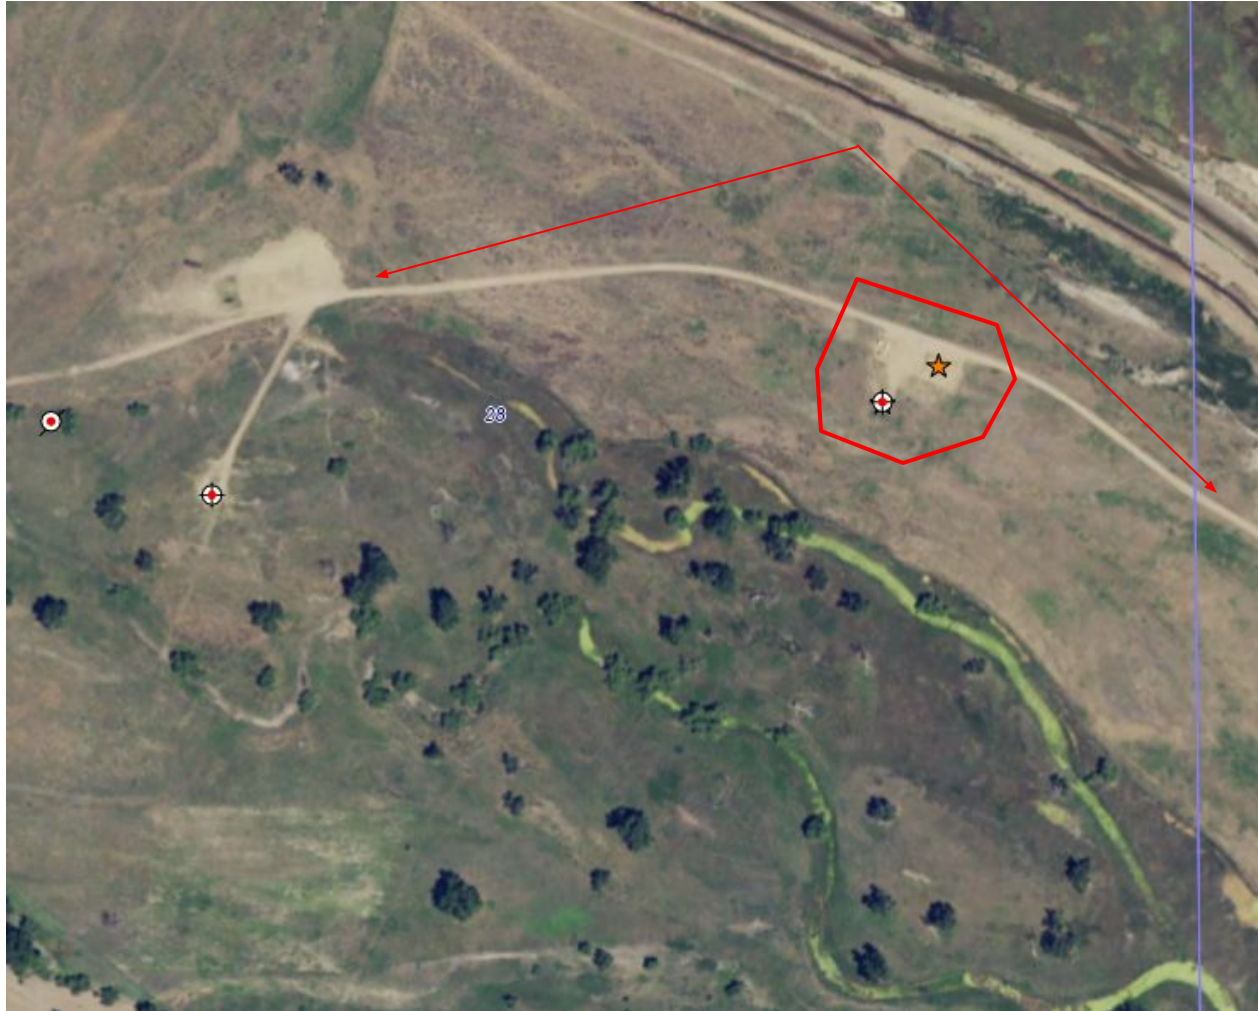
Photo 1. COGCC GISOnline aerial imagery from 2015. This inspection covers the well location/tank battery and access roads.

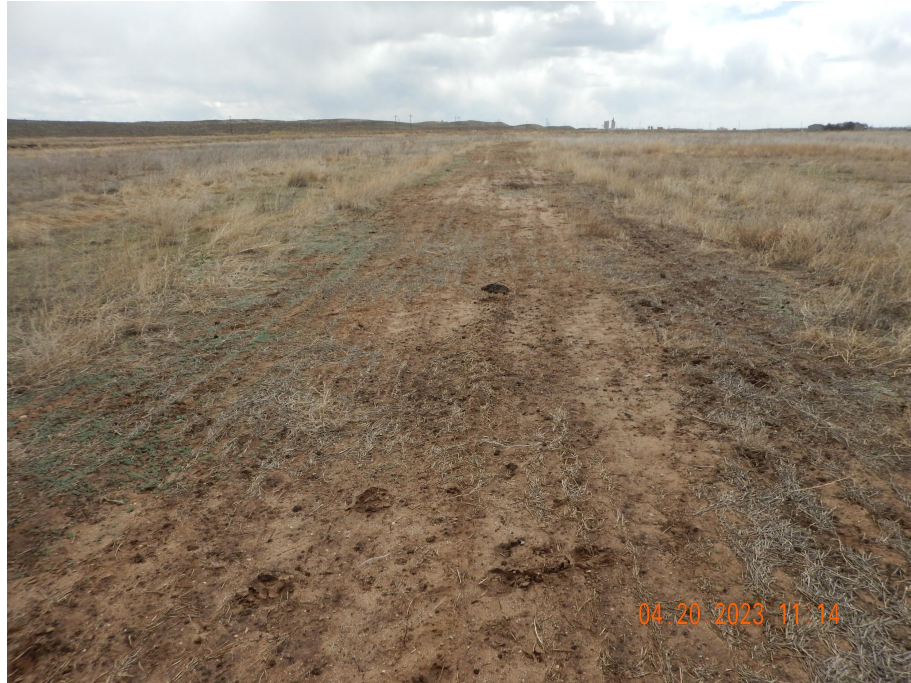
Photo 2. Photo taken from a portion of the main access road, facing West. Photo illustrates the access road is bare with no perennial vegetation that is not reflective of reference areas.

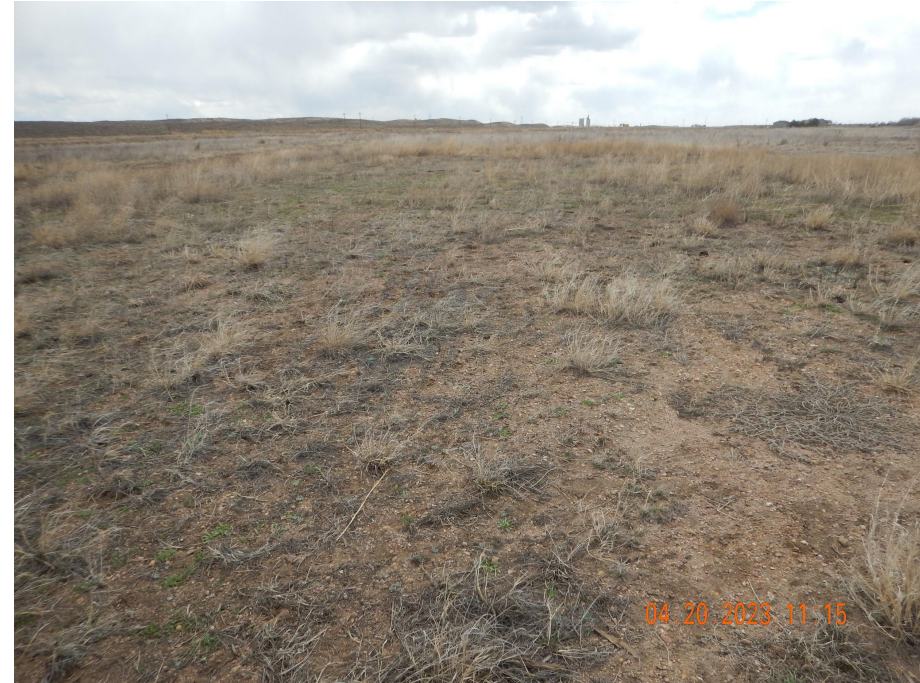
Photo 3. Photo taken from the well/tank battery location, facing West. Photo illustrates the location consists mostly of weeds with little perennial vegetation that is not reflective of reference areas.

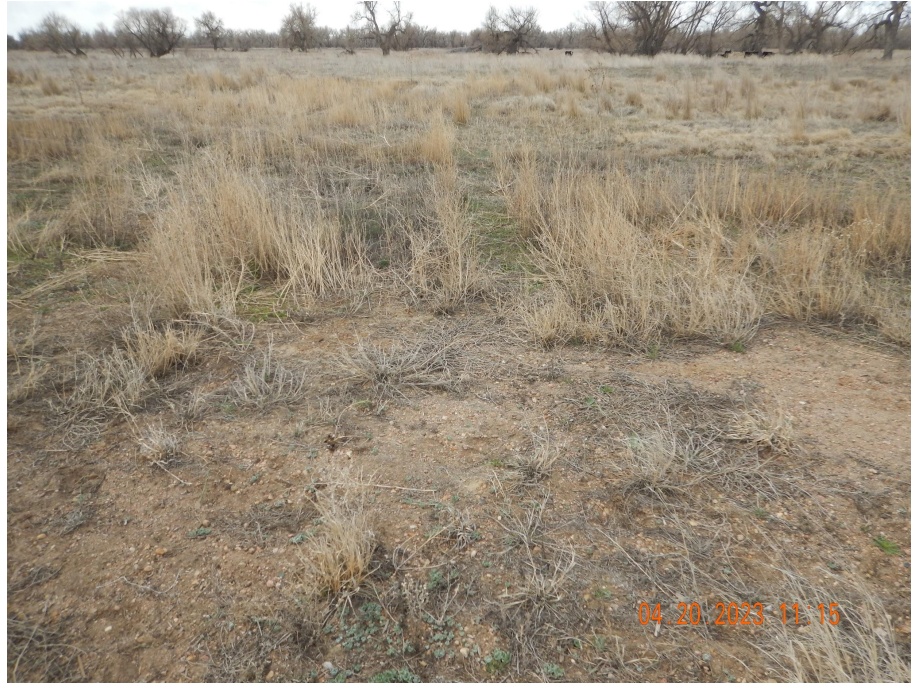
Photo 4. Photo taken from the well/tank battery location, facing South. See comments under Photo 3.

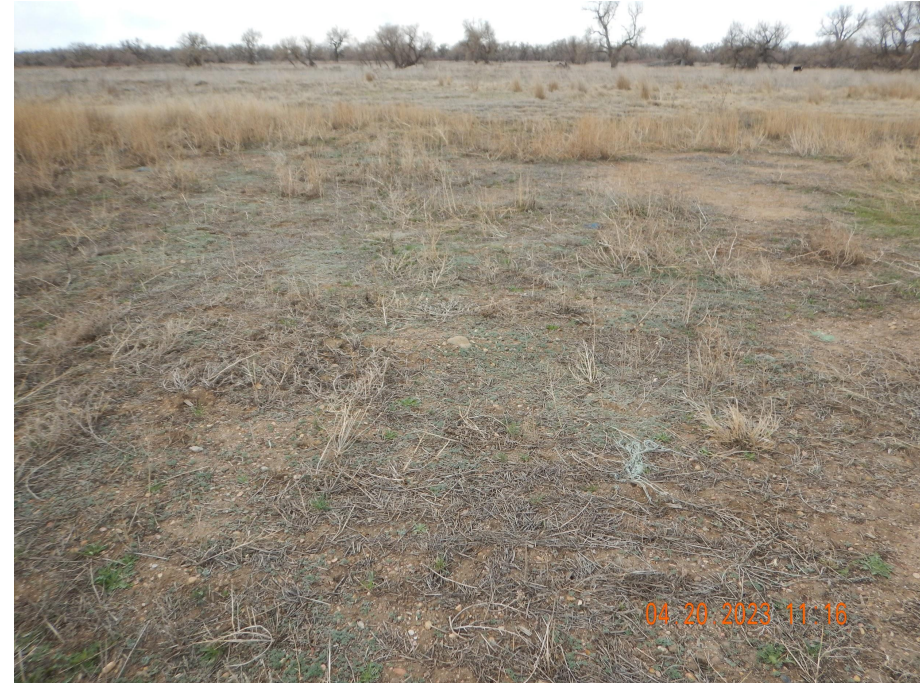
Photo 5. Photo taken from the well/tank battery location, facing East. See comments under Photo 3.
