Interim Reclamation and Stormwater Inspection

Operator: IMPETRO RESOURCES LLC - 10690

Location ID: 317362

Inspection Photos
Location Name: Christianson-63S50W
Location ID: 317362

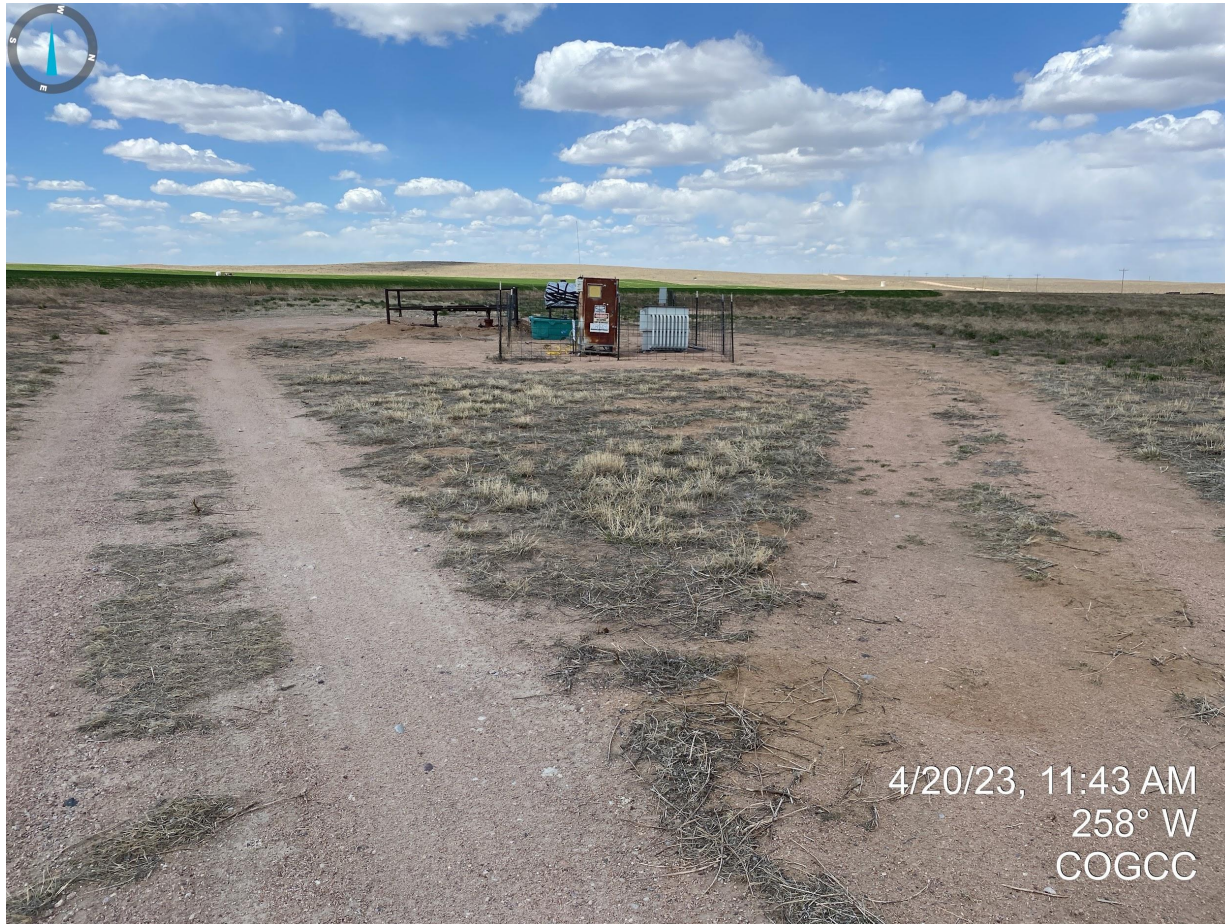
Photo 1. Interim areas appear to be reflective of reference areas at the time of this inspection. Production areas also appear to be stabilized with no evidence of stormwater/erosion issues.

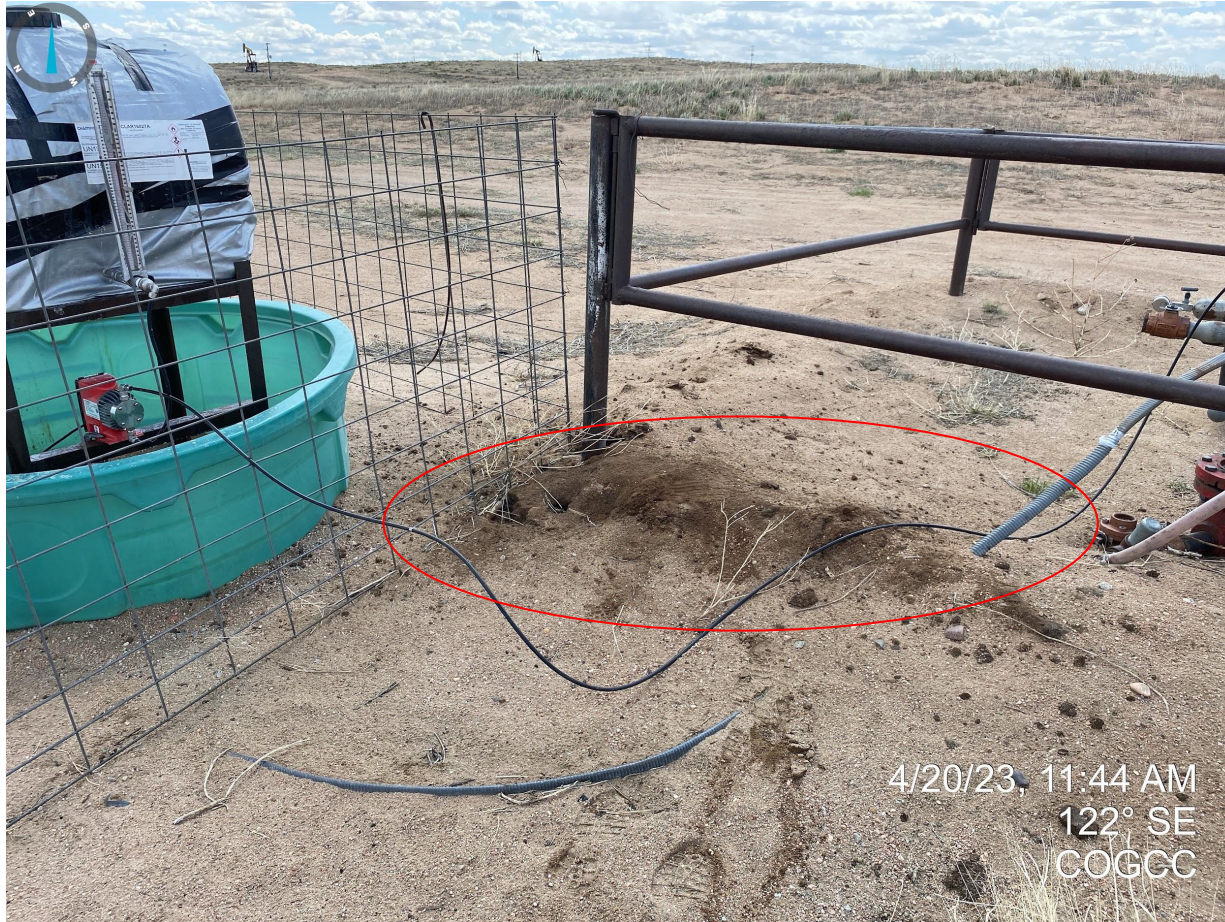
Photo 2. Stained soil near wellhead had chemical odor and will need to be properly disposed of per Rule 905.e.

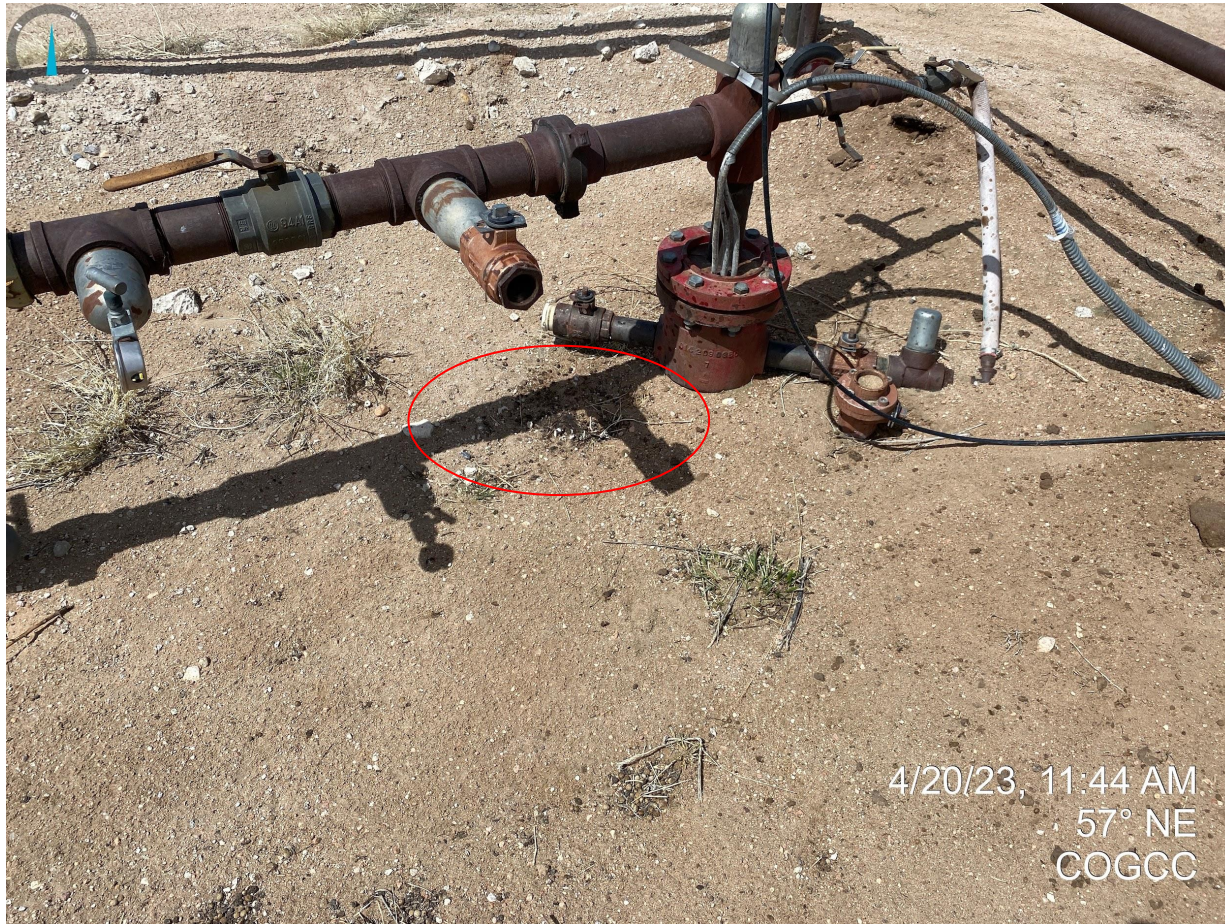
Photo 3. Stained soil at wellhead will need to be properly cleaned up per Rule 905.e.

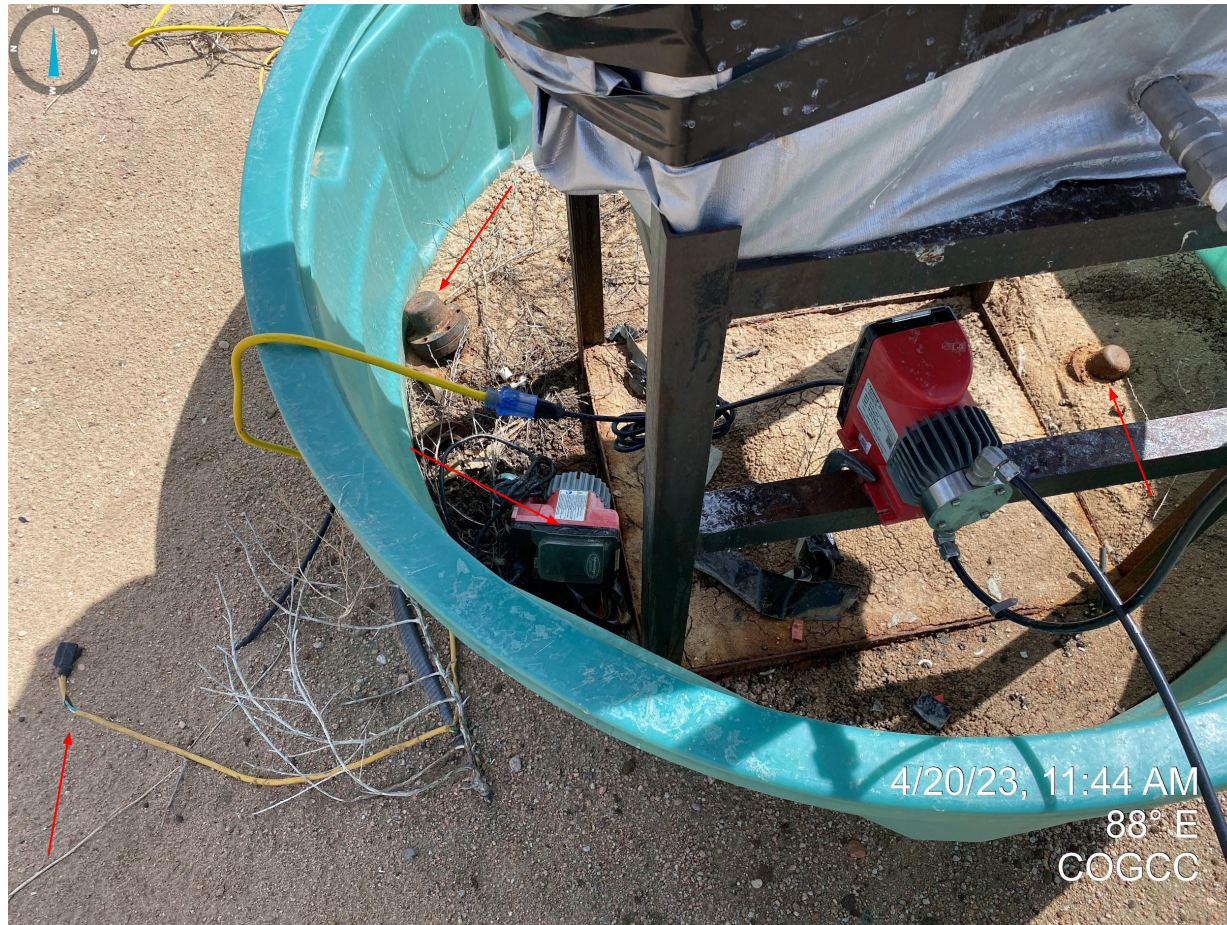
Photo 4. Close-up of day tank near wellhead. Photo illustrates unused equipment and no wildlife netting installed around secondary containment.
