Interim Reclamation and Stormwater Inspection

Operator: IMPETRO RESOURCES LLC - 10690

Location ID: 317363

Inspection Photos
Location Name: Christianson SWD-63S50W
Location ID: 317363

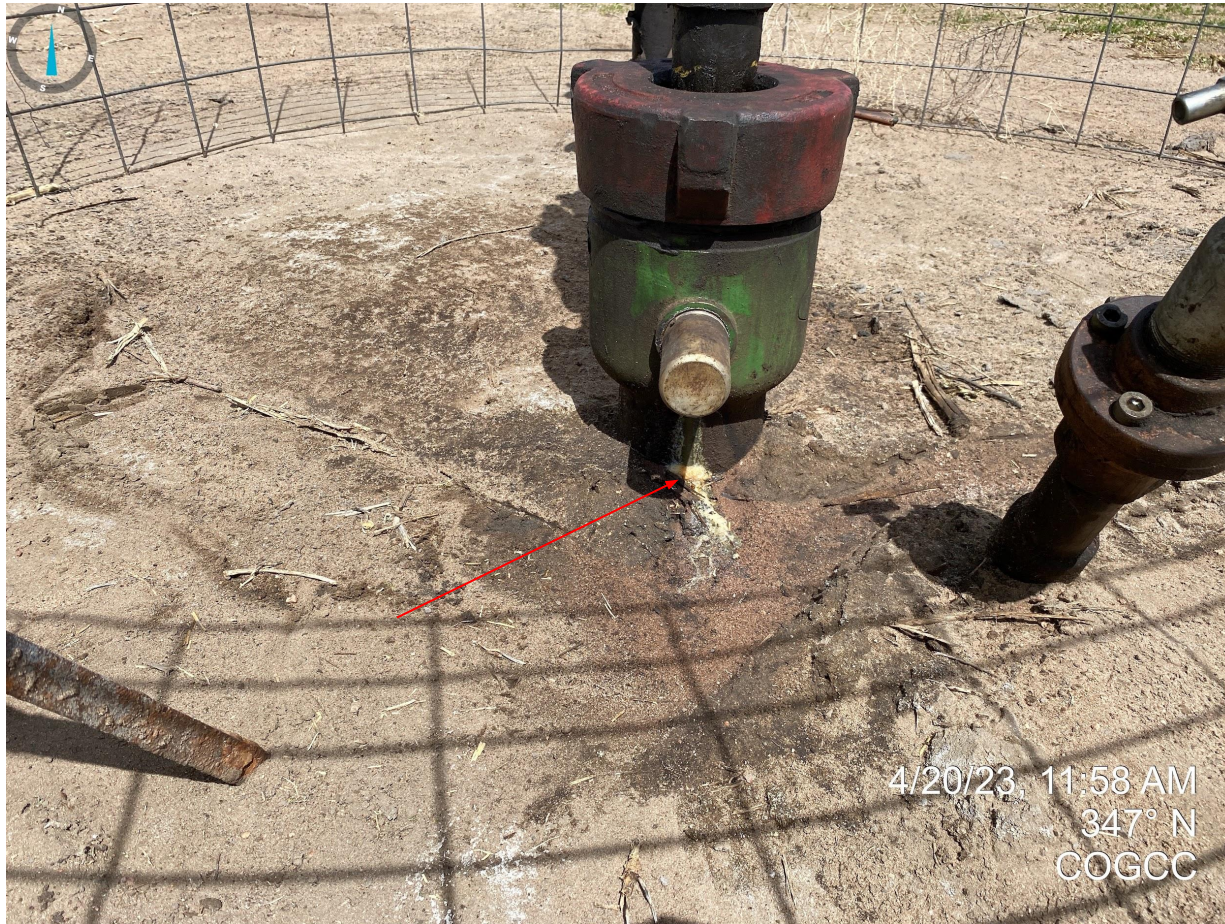
Photo 1. Stained soil will need to be properly cleaned up and disposed of per Rule 905.e. Additionally, unknown substance originating from wellhead will need to be properly disposed of and mechanical conditions will need to be inspected/maintained per Rule 608.e.

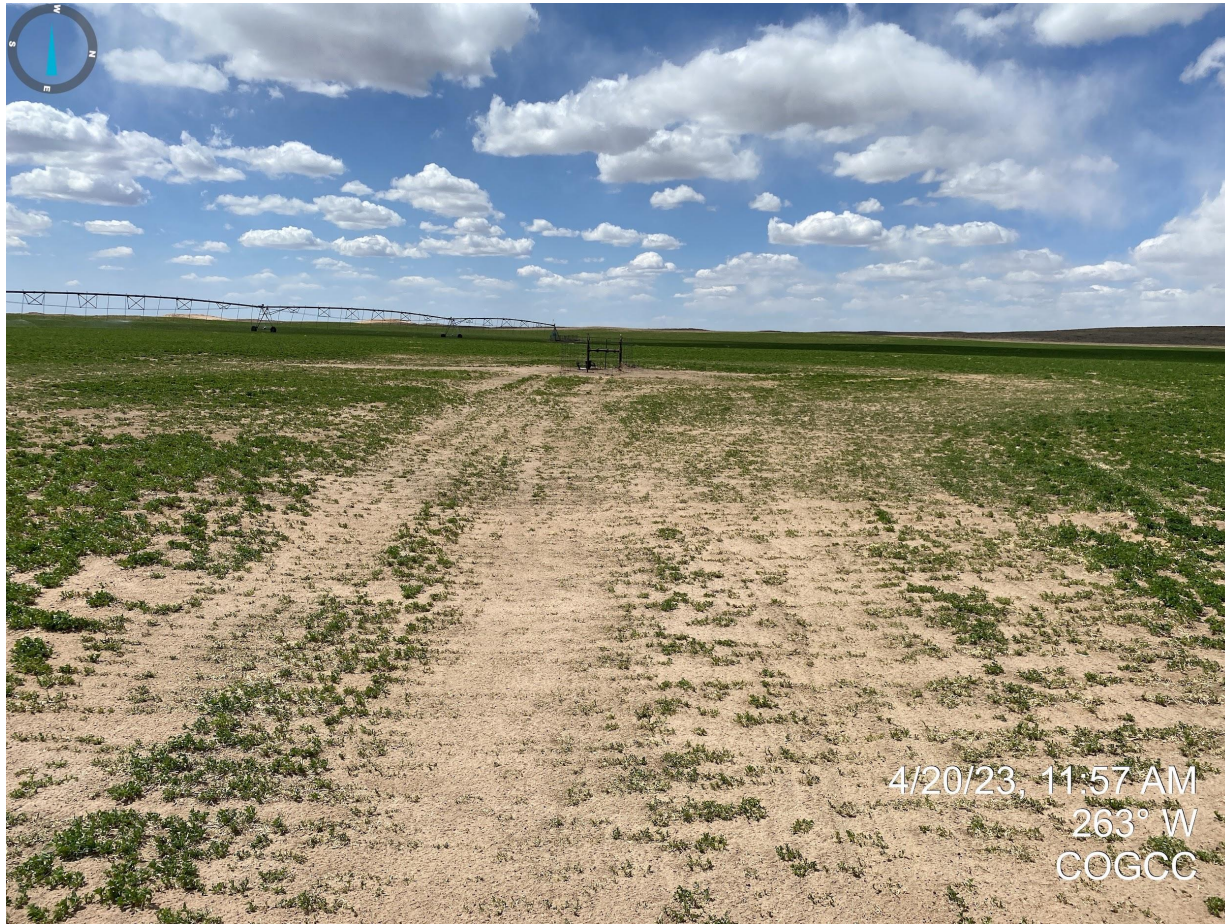
Photo 2. Overview of interim areas that are not progressing towards reclamation standards (e.g poor growth and vehicle tracks evident). Operator shall make attempts to limit excessive vehicle tracks.

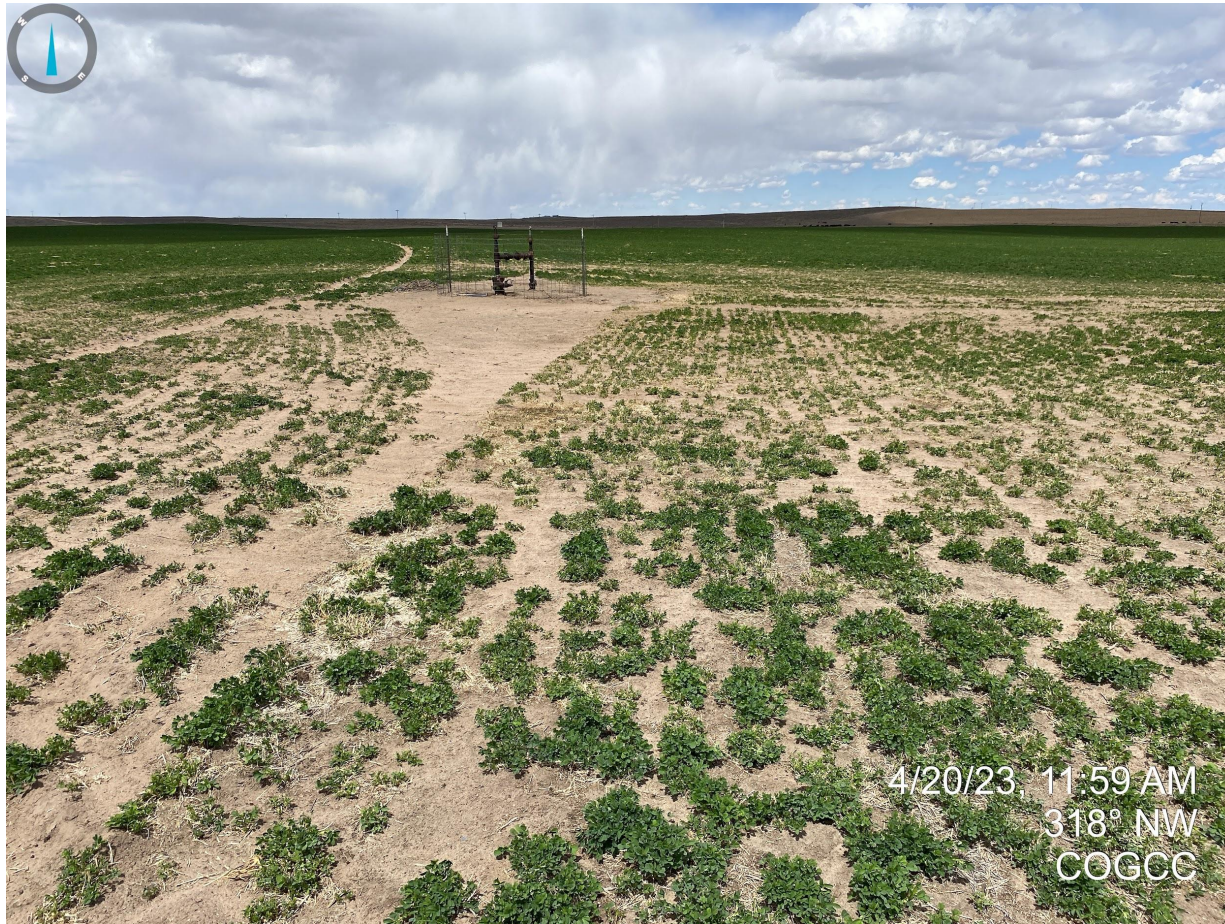
Photo 3. Facing northwest; see comments in Photo 2.

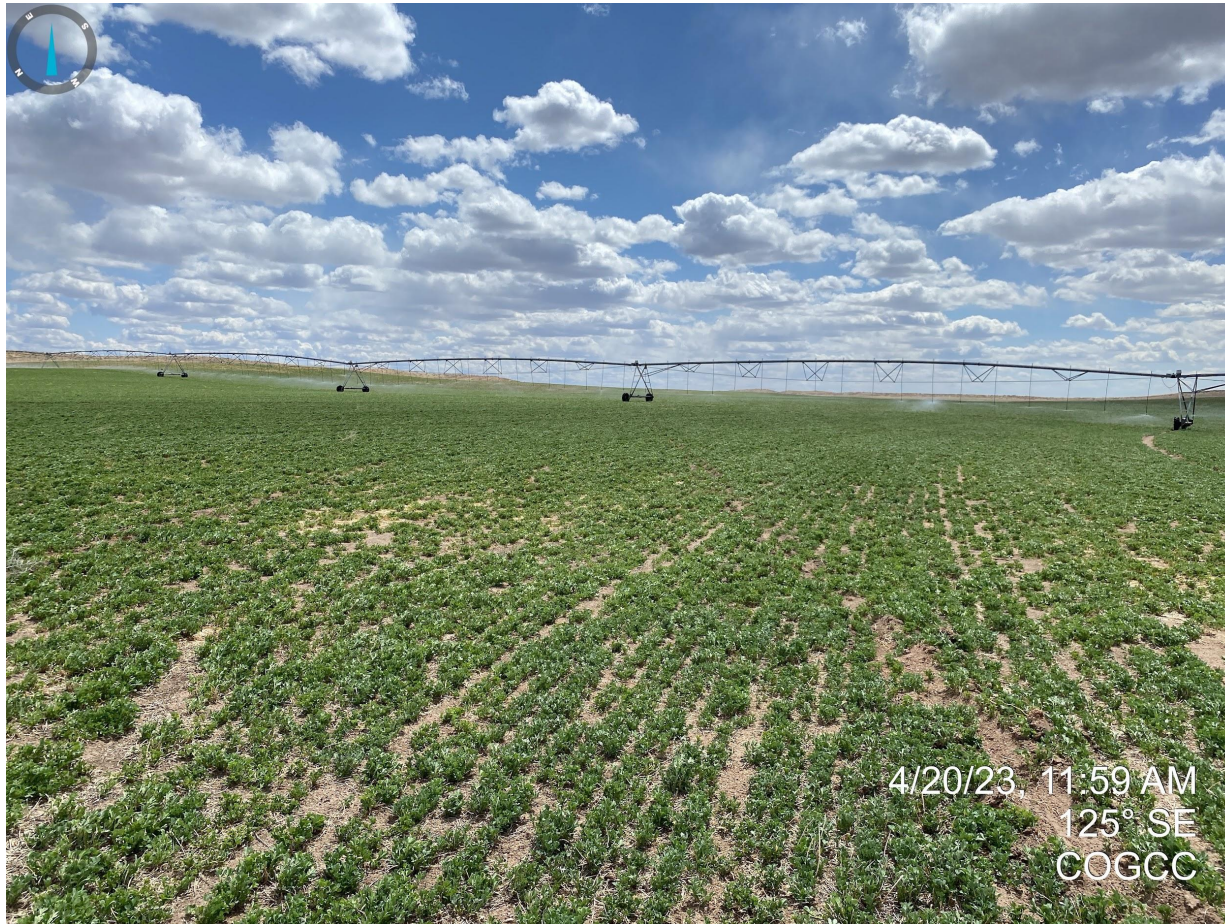
Photo 4. Reference area photo taken south of well.
