Attachment B

SITE NAME: Totems 44-24 Tank Battery							DATE: 10/21/2022	REM. PROJECT #: 24688	WEATHER: Sunny, 70's	
SITE DIRECTIONS: CR 6 & CR13 W 0.2 N into							CLIENT: PDC			
LEGALS AND LAT/LONG: (40.0295530, -104.9493141)							TASMAN PERSONNEL: AO			
SOIL TYPES: Lean Clay - CL							SURFACE GRADIENT: Northwest			
SOIL SAMPLING							FACILITY INFRASTRUCTURE			
Date/Time	Soil Sample ID	PID (ppm)	Visual	Olfactory	Photo?	Grab or Lab Sample?	EQUIPMENT		Quantity	
							Above Ground Storage Tank (AST)		1	
10/21/2022 13:12	SEP01-FL@4'	0.2	No Staining	No Odor	Yes	Lab	Buried or Partially Buried Vessel		1	
							Separator		1	
10/21/2022 12:23	MH01@0-6"	0.0	No Staining	No Odor	Yes	Grab	Emission Control Device (ECD)			
10/21/2022 12:25	AST01@0-6"	0.0	No Staining	No Odor	Yes	Lab	Dump Line		1	
							Wellhead			
							Flowline			
							Other: Meterhouse		1	
							Soil Loads Removed			
							IMPACTED SOIL IDENTIFIED?

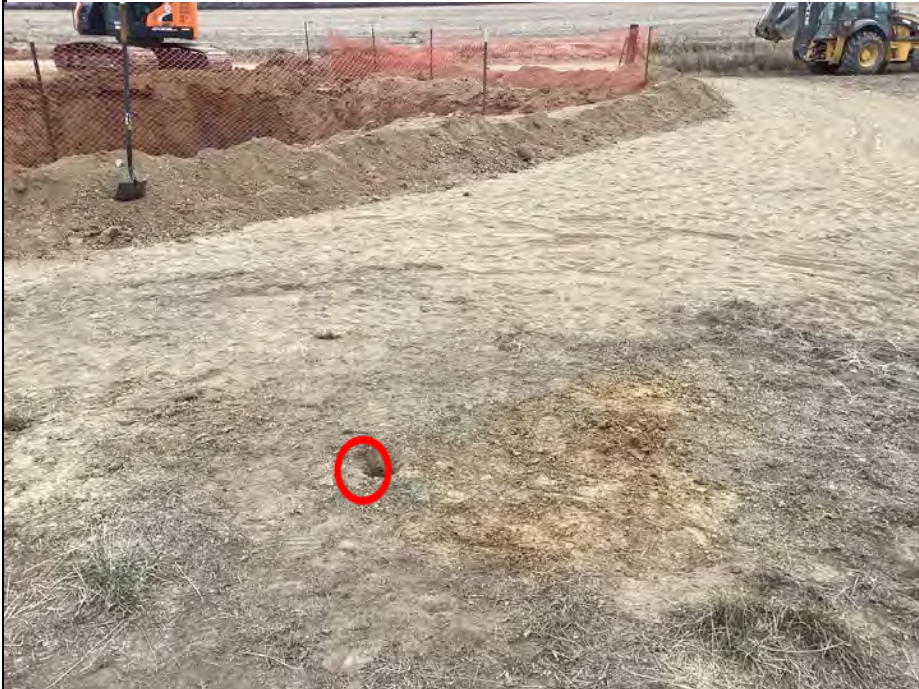
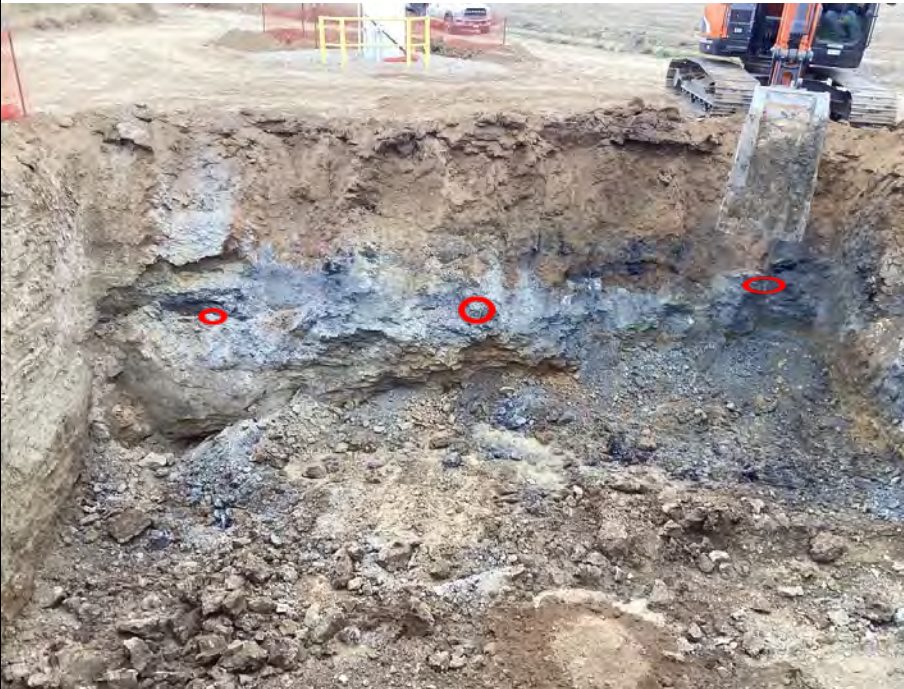
Equipment ID:		Equipment Type:		Equipment ID:		Equipment Type:			
Material:		Volume:		Material:		Volume:		Contents:	
Notes/Conditions: BKG02					Notes/Conditions: Left to Right GS33, GS34, GS35

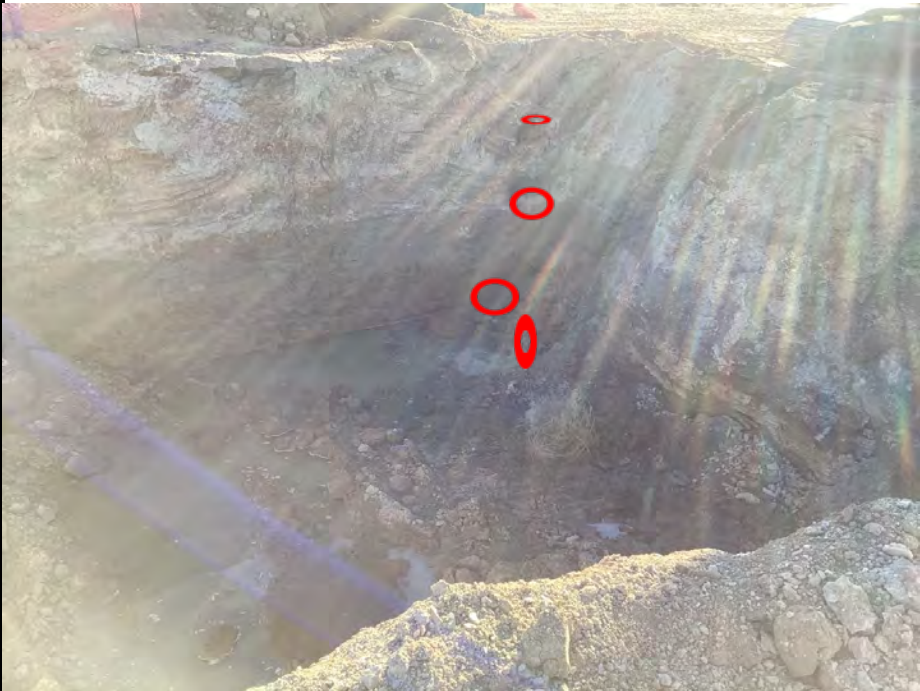
Equipment ID:		Equipment Type:	
						Material:	Volume:	Contents:	
						Notes/Conditions: Top:SS21 Middle:SS22 Bottom:SS23 Bottom-Right:SS24			
Equipment ID:		Equipment Type:							
Material:	Volume:	Contents:							
Notes/Conditions:

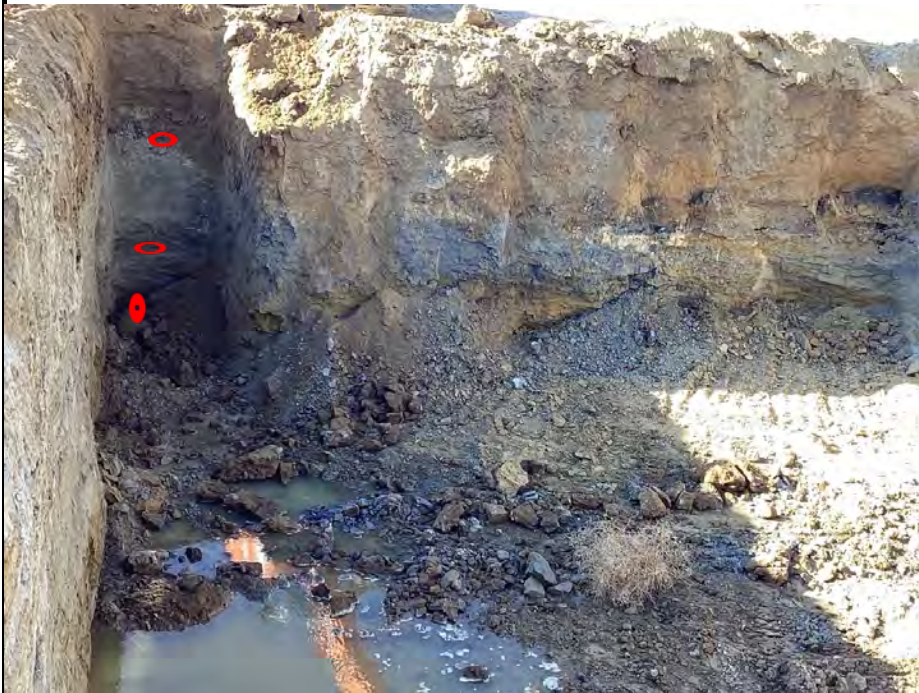
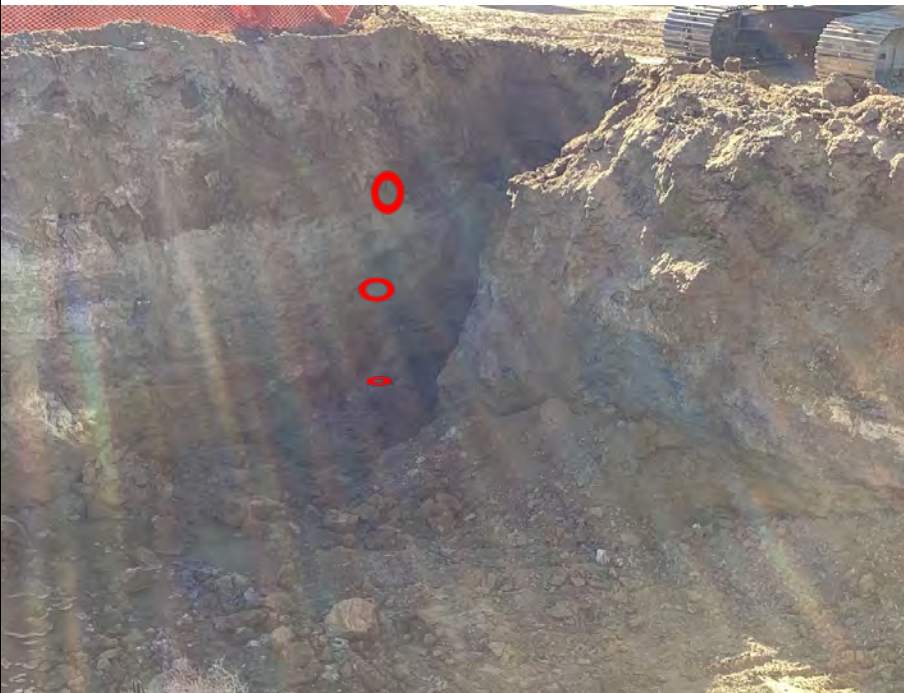
Equipment ID:		Equipment Type:		Equipment ID:		Equipment Type:			
Material:		Volume:		Material:		Volume:		Contents:	
Notes/Conditions: Top SS26, Middle SS27, Bottom SS28					Notes/Conditions: Top SS29, Middle SS30, Bottom SS31

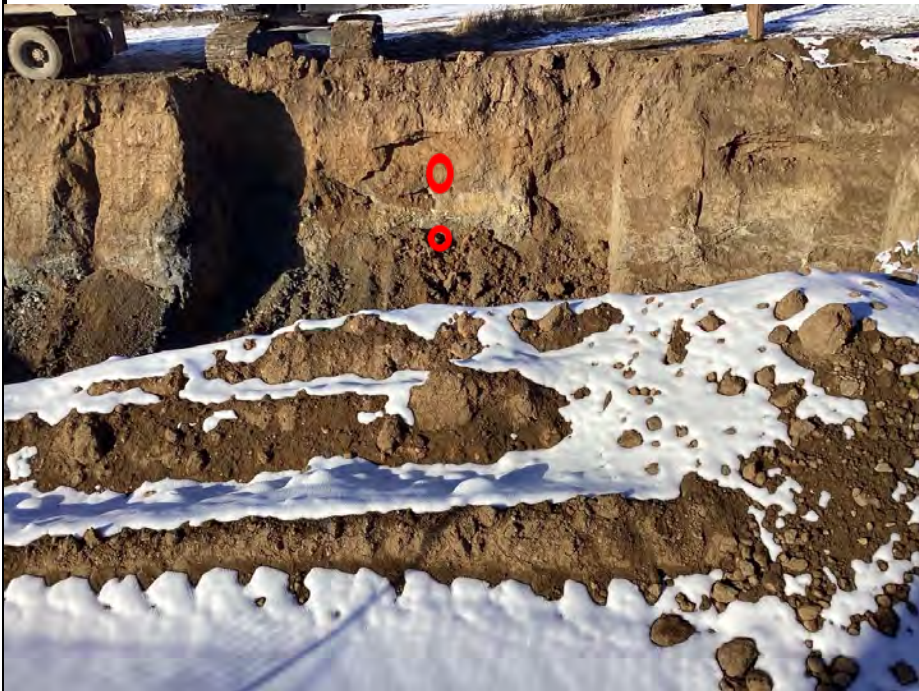
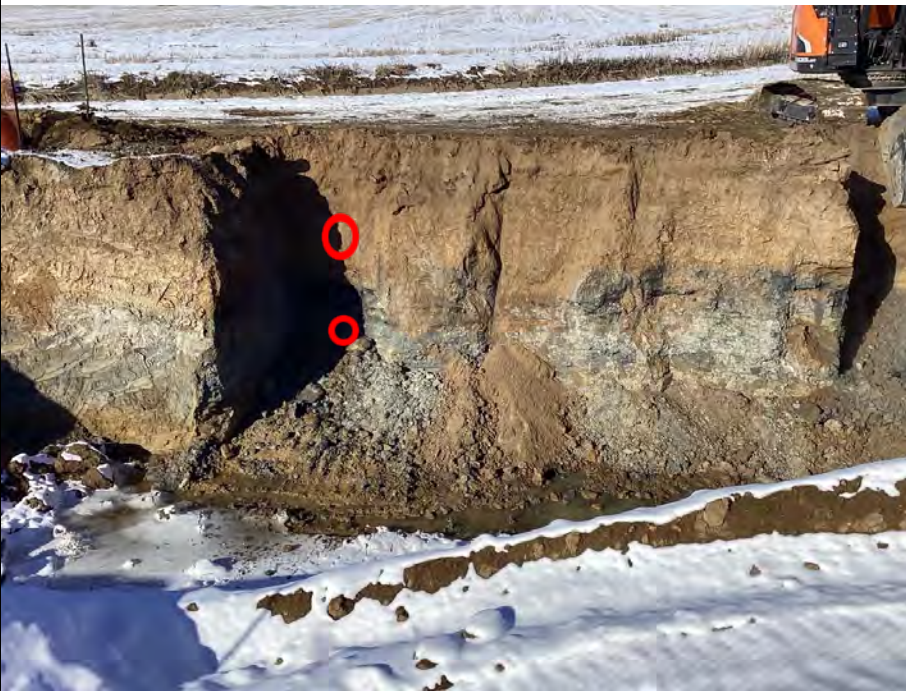
Equipment ID:		Equipment Type:		Equipment ID:		Equipment Type:			
Material:		Volume:		Material:		Volume:		Contents:	
Notes/Conditions: Top:GS42, Bottom:GS43					Notes/Conditions: Top:GS44, Bottom:GS45

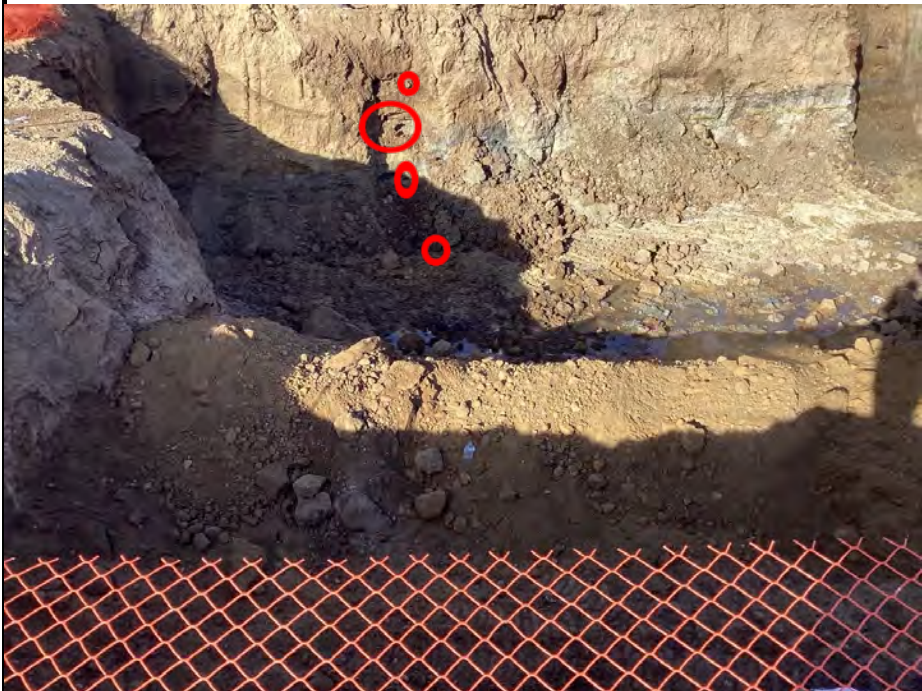
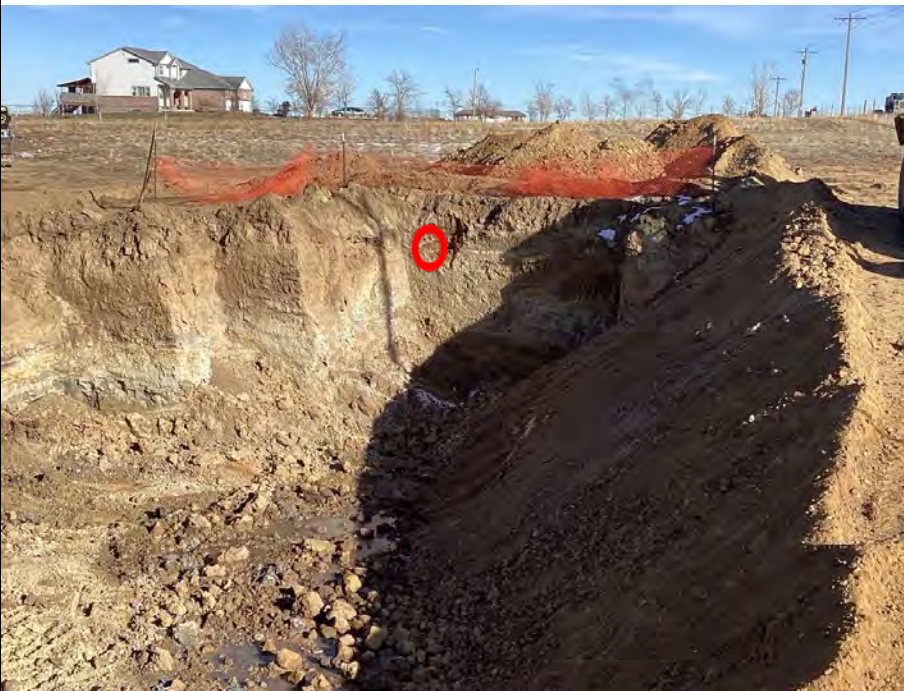
Equipment ID:		Equipment Type:		Equipment ID:		Equipment Type:	
Material:	Volume:	Contents:		Material:	Volume:	Contents:	
Notes/Conditions: Top to Bottom: SS50 SS51 SS52 SS53				Notes/Conditions: SS54

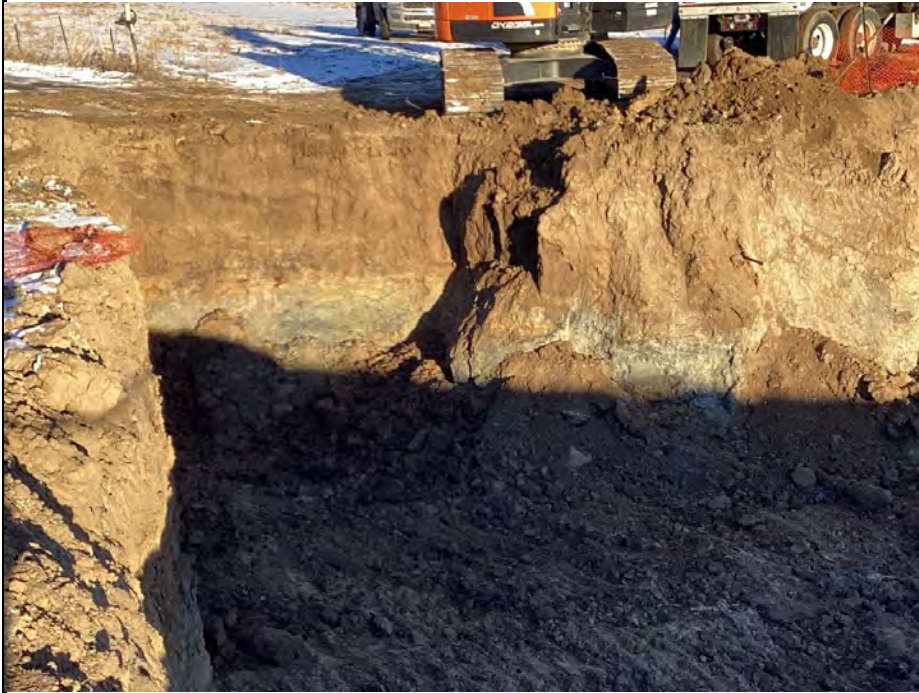
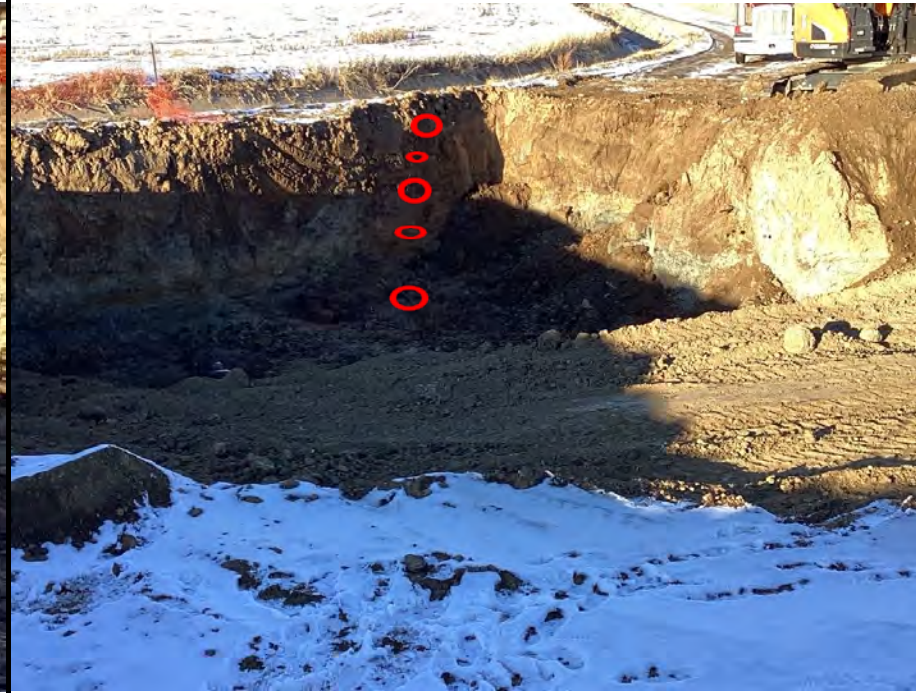
Equipment ID:		Equipment Type:		Equipment ID:		Equipment Type:			
Material:		Volume:		Material:		Volume:		Contents:	
Notes/Conditions: North Wall Facing East					Notes/Conditions: Top to Bottom: SS65, SS66, SS67, SS68, SS69

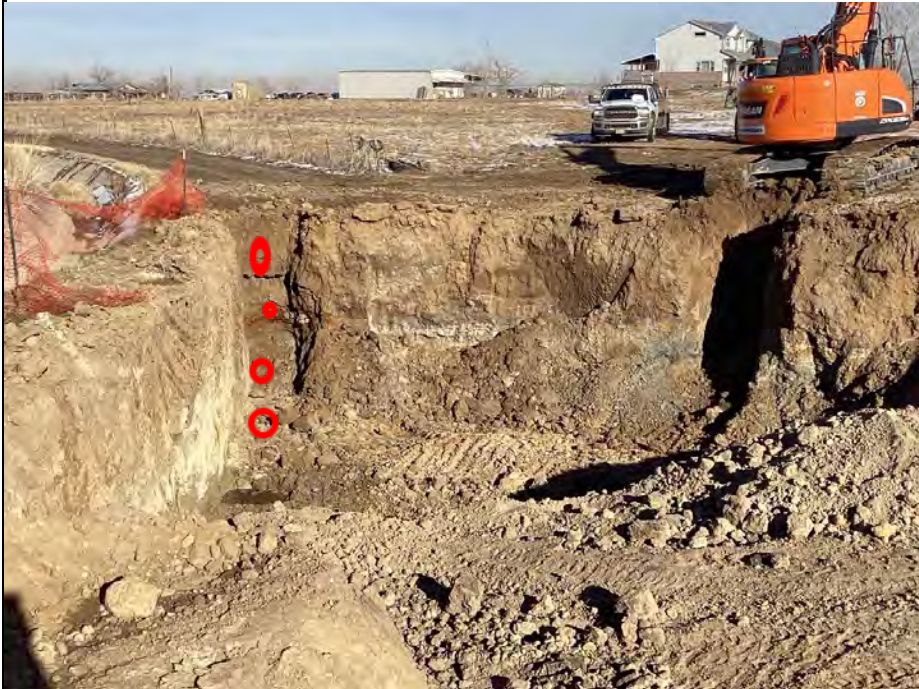
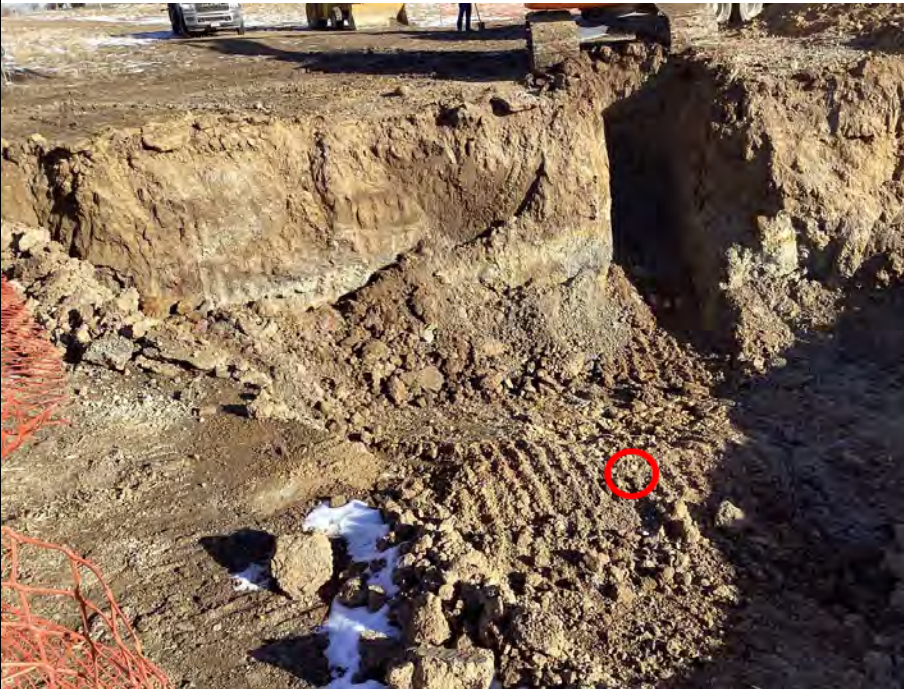
Equipment ID:		Equipment Type:		Equipment ID:		Equipment Type:	
Material:	Volume:	Contents:		Material:	Volume:	Contents:	
Notes/Conditions: Top to Bottom: SS72 SS73 SS74, SS71				Notes/Conditions: SS70
