Inspection Photos

Operator: GENESIS GAS & OIL COLORADO LLC
- 10384

Location Number: 414116
Rio Blanco County, CO

Aaron Trujillo
NW Reclamation Specialist
COGCC

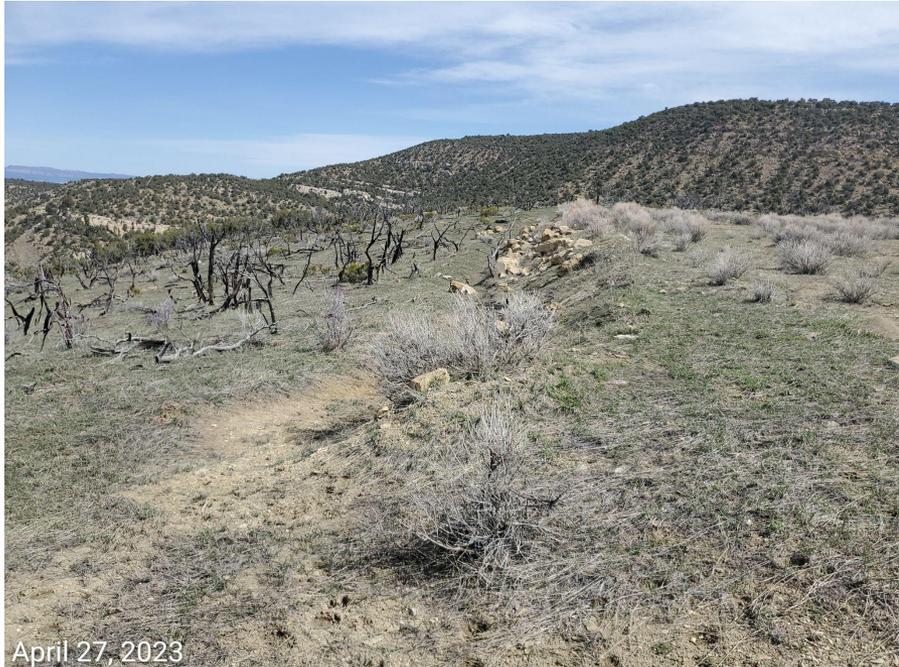
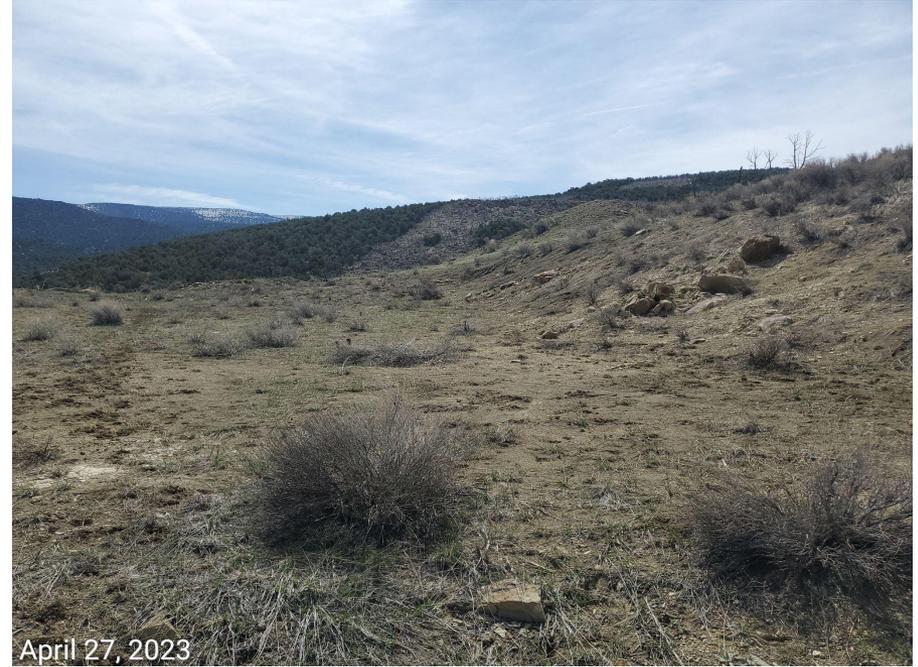
Photo 1: Photos taken from the southwest end of the Location, facing north and east. Photos show final reclamation including, but not limited to, compaction alleviation, recontouring/regrading and reclaiming has not been conducted on the Location. Photo left shows fill slopes. Photo right shows cut slopes.

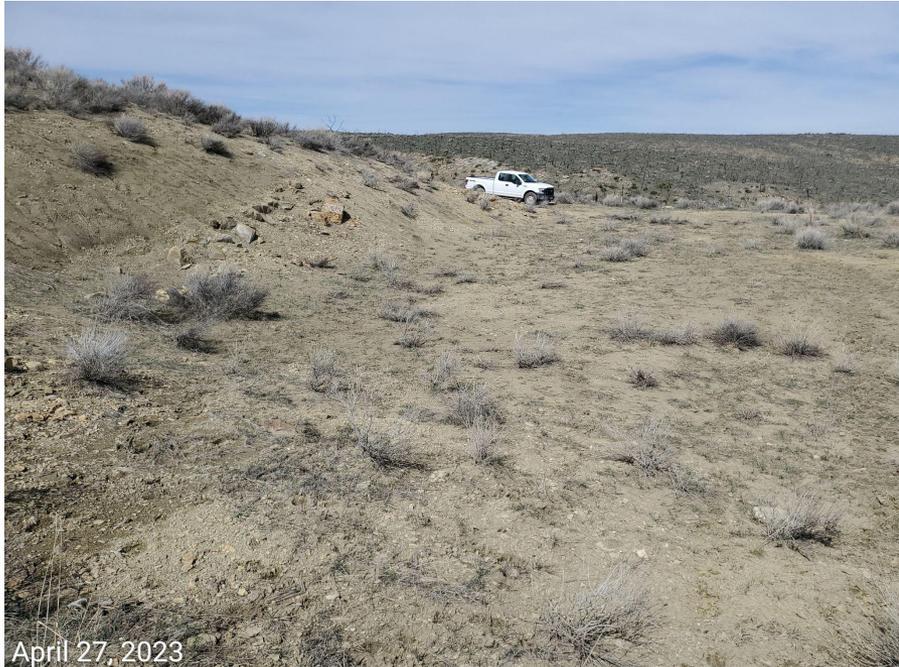
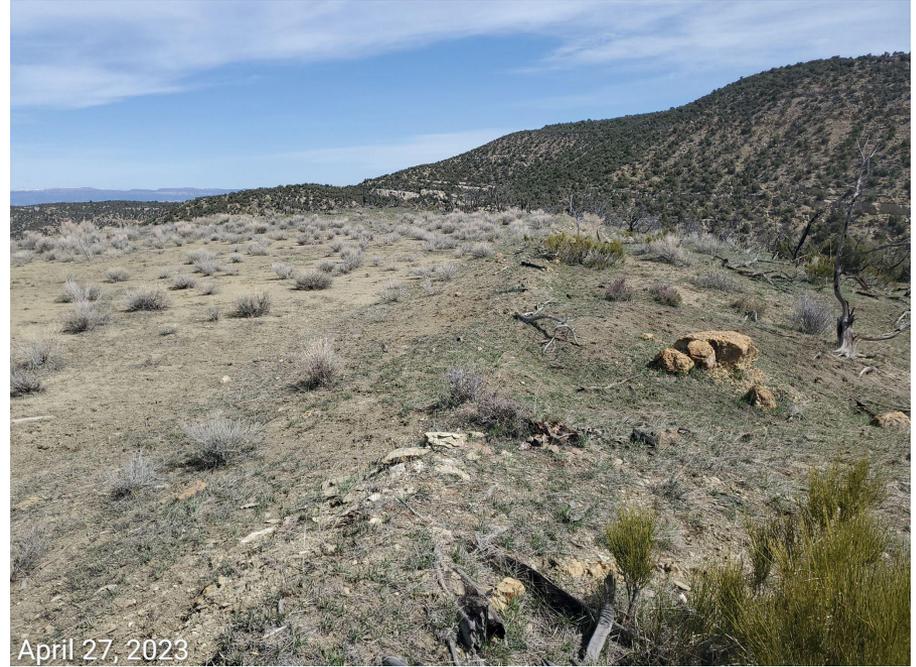
Photo 2: Photos taken from the southeast end of the Location, facing west and north. Photos show final reclamation including, but not limited to, compaction alleviation, recontouring/regrading and reclaiming has not been conducted on the Location. Photo left shows fill cut slopes. Photo right shows fill slopes.

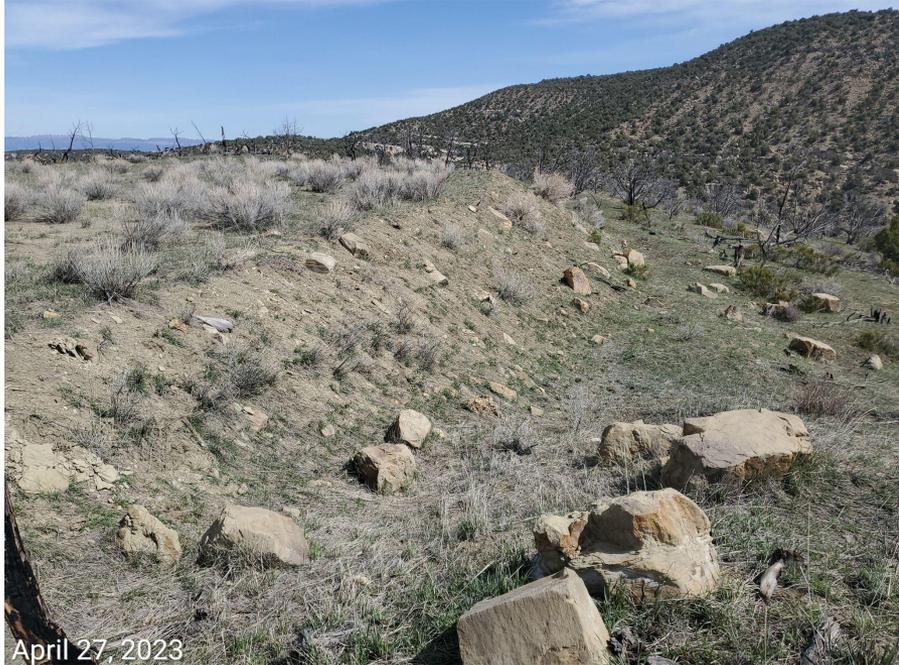
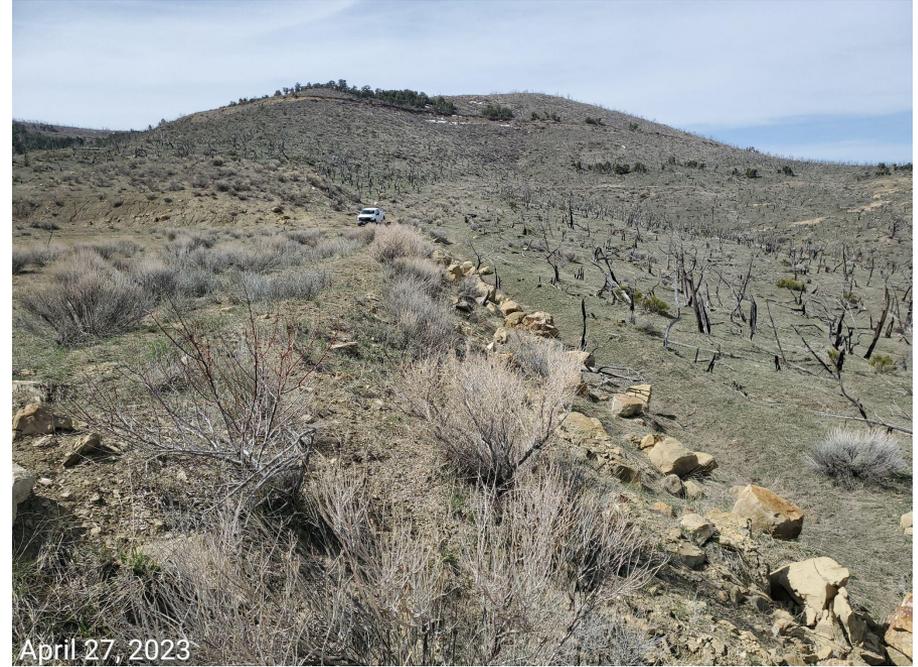
Photo 3: Photos example showing fill slopes of the Location. Photo left taken from the east end of the Location; photo right taken from the west end. Final reclamation including, but not limited to, compaction alleviation, recontouring/regrading and reclaiming has not been conducted on the Location.

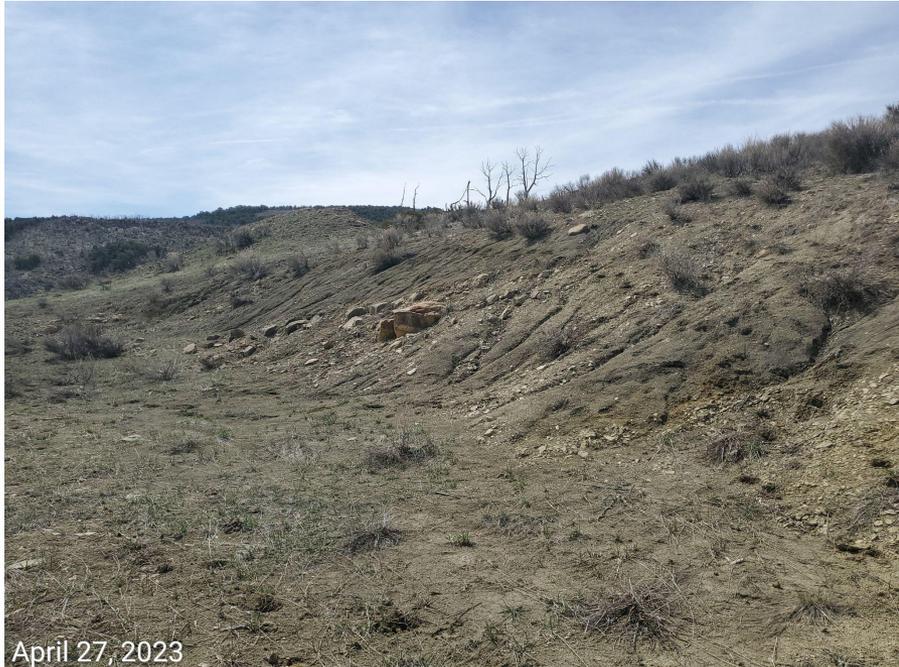
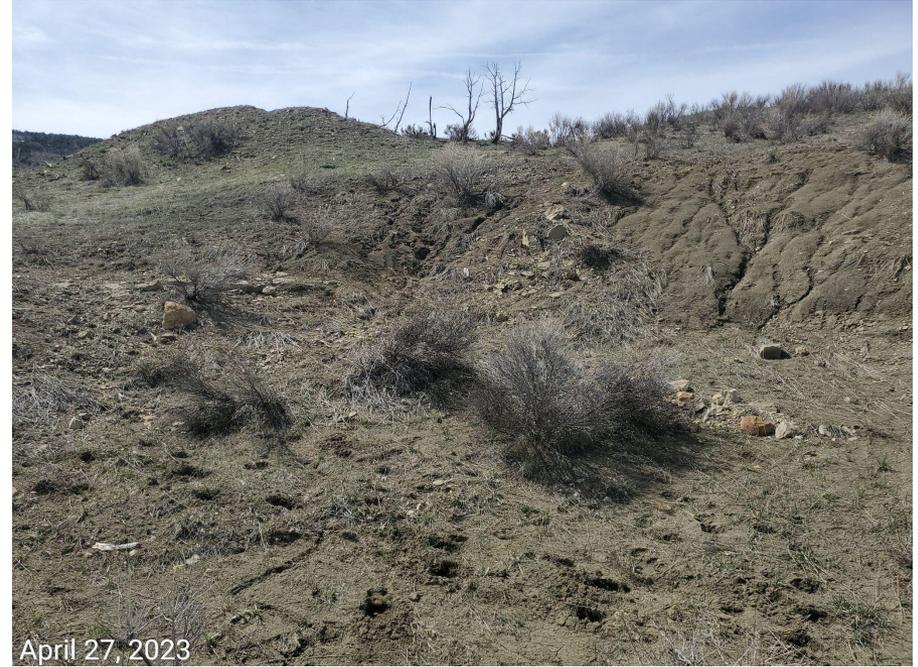
Photo 4: Photo taken from the cut slopes of the Location. Stormwater and erosion control BMPs to control stormwater runoff in a manner that minimizes erosion, transport of sediment offsite, and site degradation are missing or insufficient; photos show erosion degradation at the cut slopes of the Location. Slopes lack stabilization.

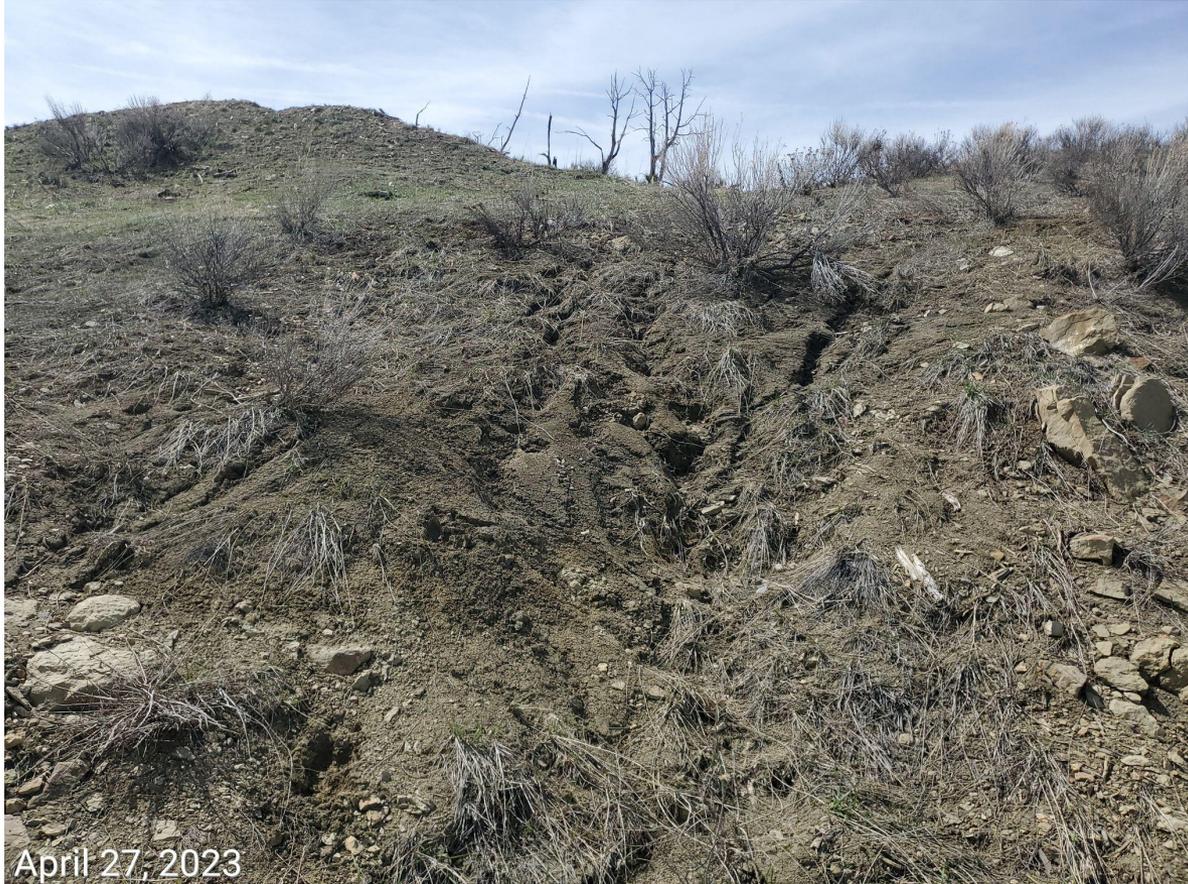
Photo 5: See comments under photo 4. Erosion degradation at the cut slopes of the Location; slopes lack stabilization.

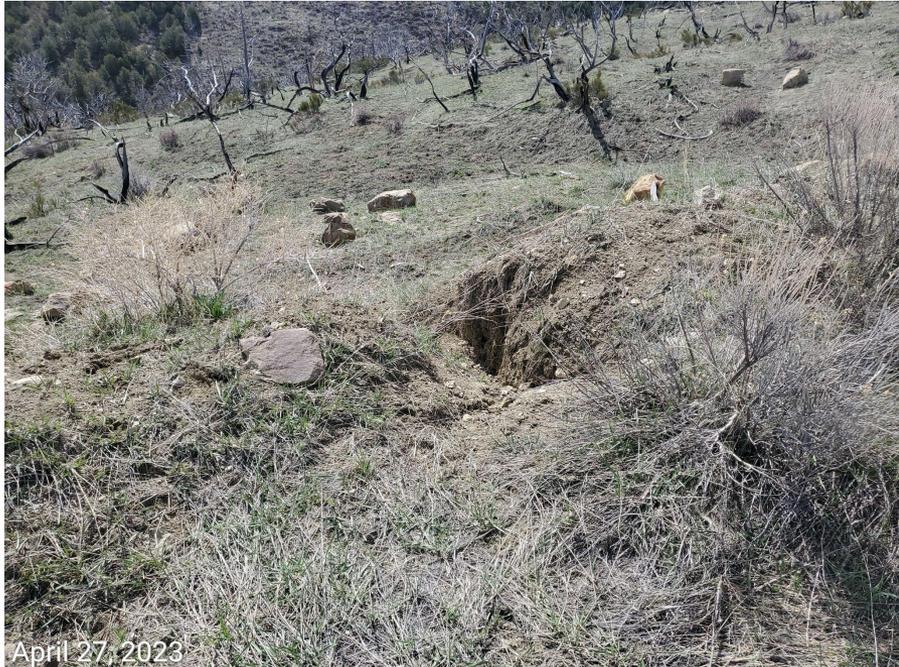
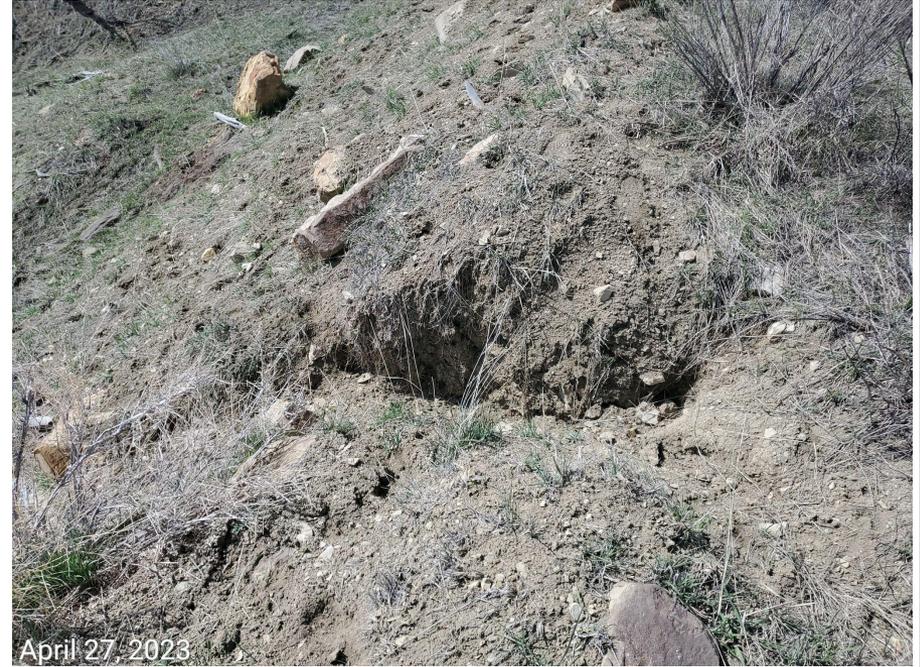
Photo 6: Photo taken from the fill slopes on the east end of the Location. Stormwater and erosion control BMPs to control stormwater runoff in a manner that minimizes erosion, transport of sediment offsite, and site degradation are missing or insufficient; photo shows stormwater runoff from the Location has resulted in gully erosion and off-site sediment transport.

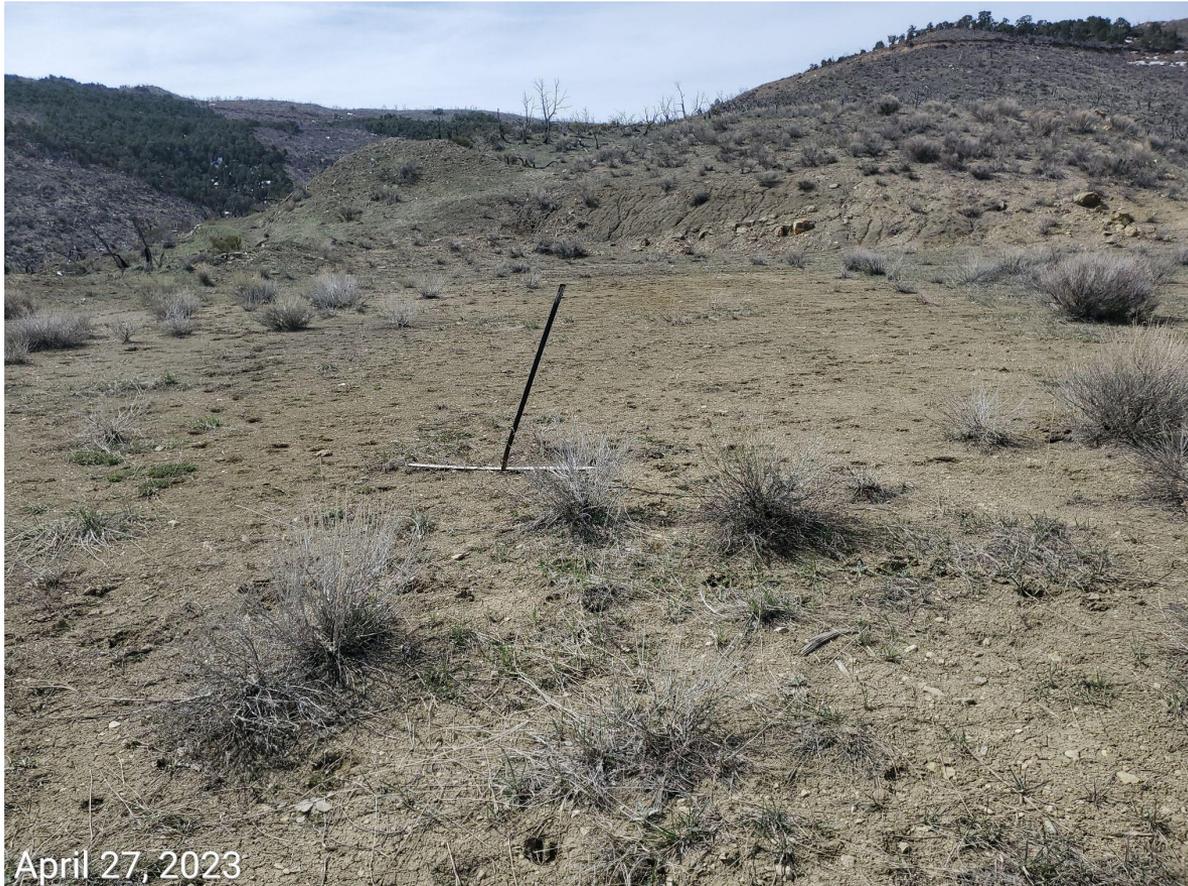
Photo 7: Well marker. Well has not been drilled. All Form 2 and Federal “permits to drill” on file for the Location have expired.

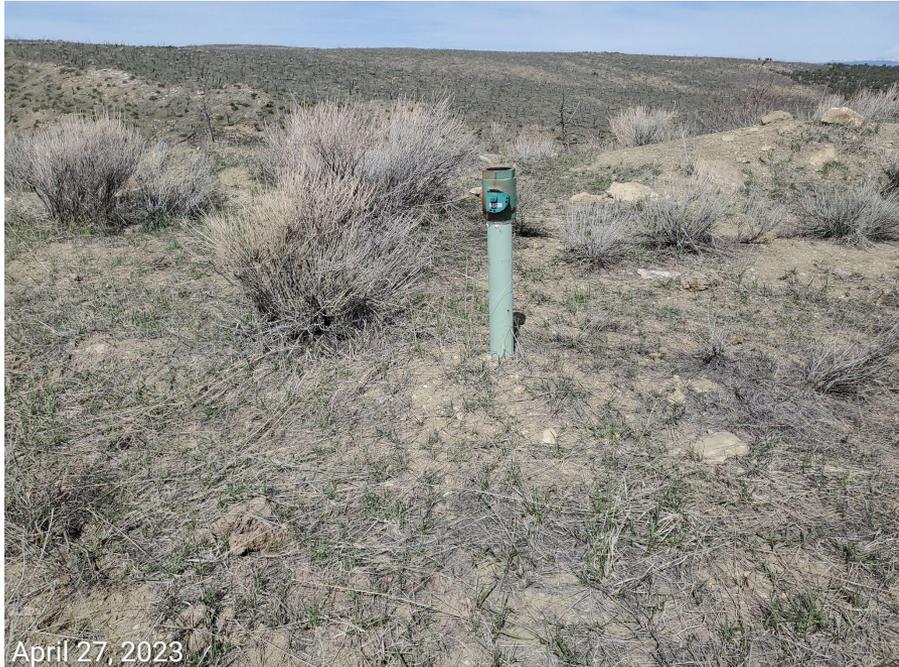
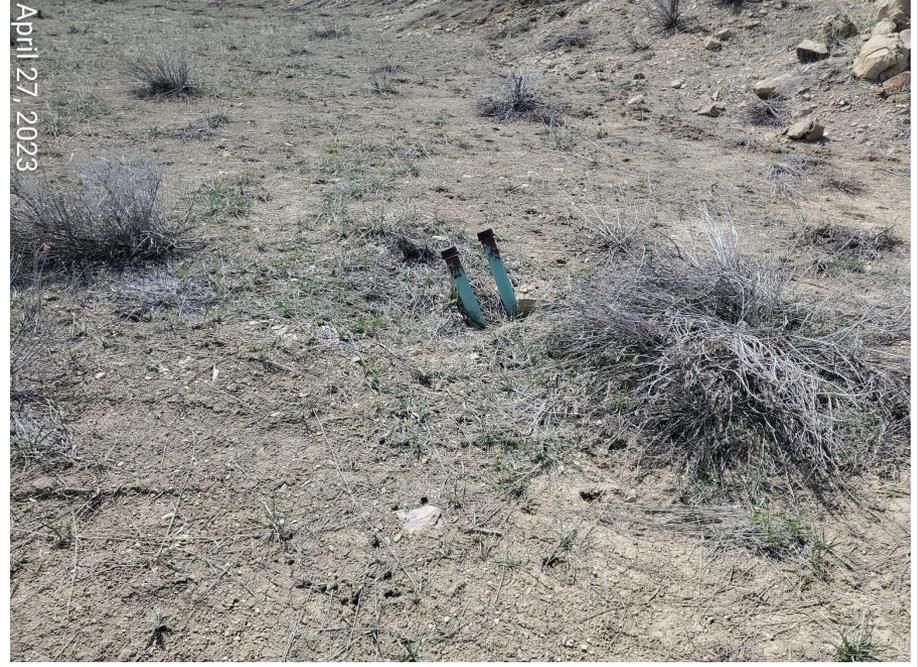
Photo 8: Photos examples showing surface equipment remaining on the Location.

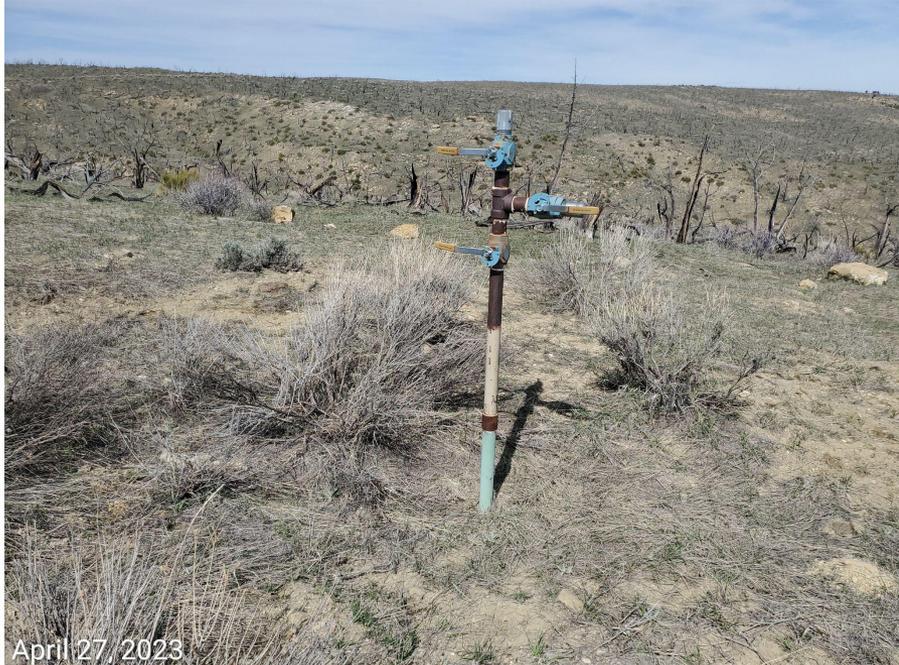
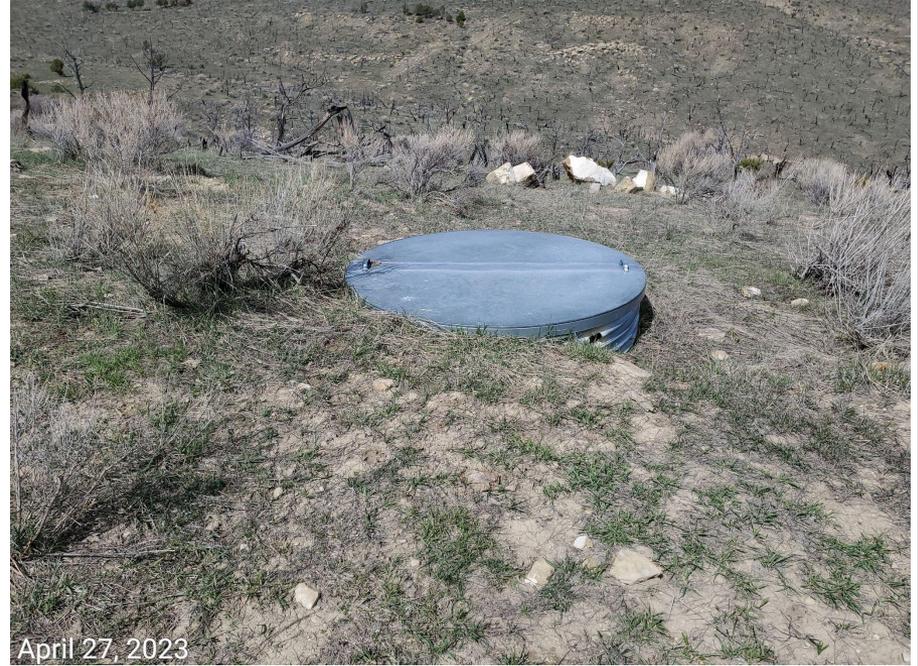
Photo 9: Photos examples showing surface equipment remaining on the Location and access road.

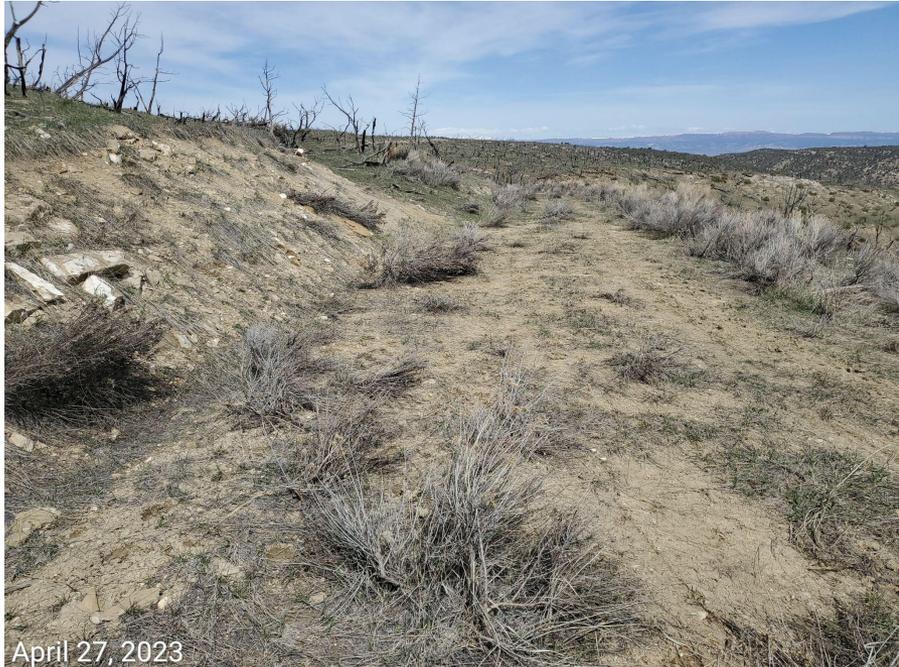
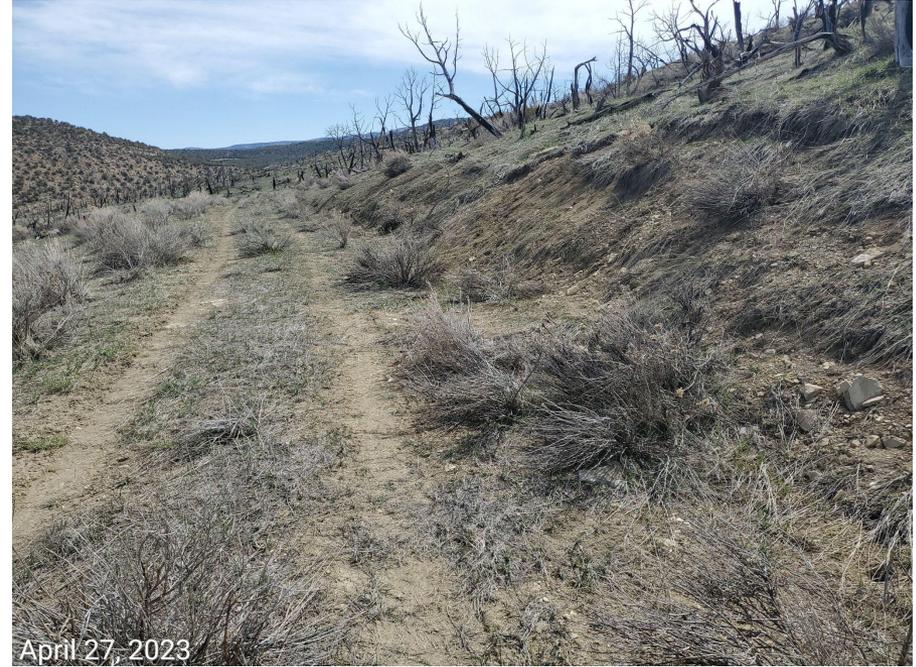
Photo 10: Photos taken from the access road. Photos examples showing final reclamation including, but not limited to, compaction alleviation, recontouring/regrading and reclaiming has not been conducted on the access road. Slopes lack stabilization.

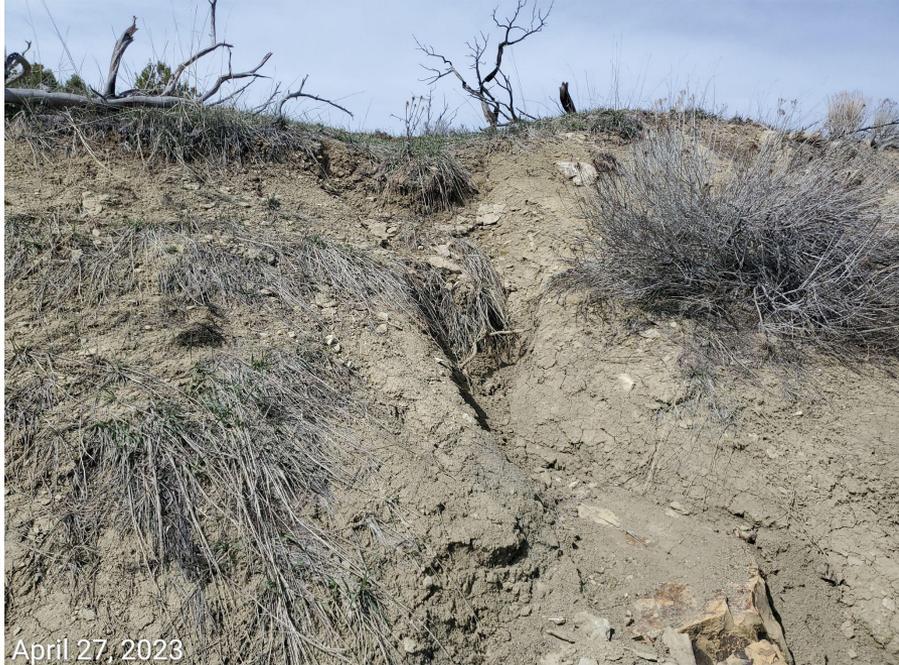
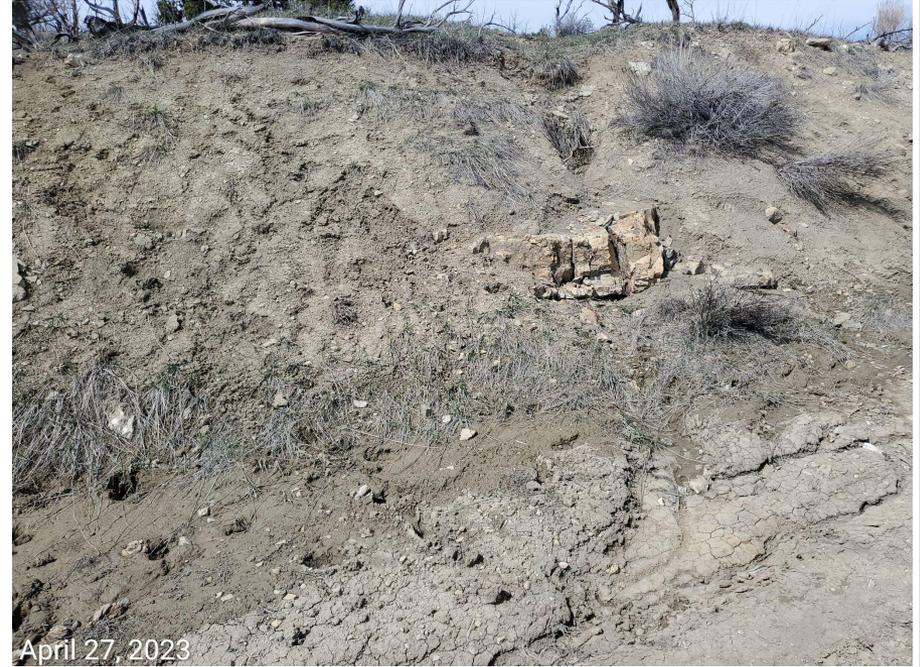
Photo 11: See comments under photo 10. Photo shows erosion degradation observed along cutslopes of the access road; slopes lack stabilization.

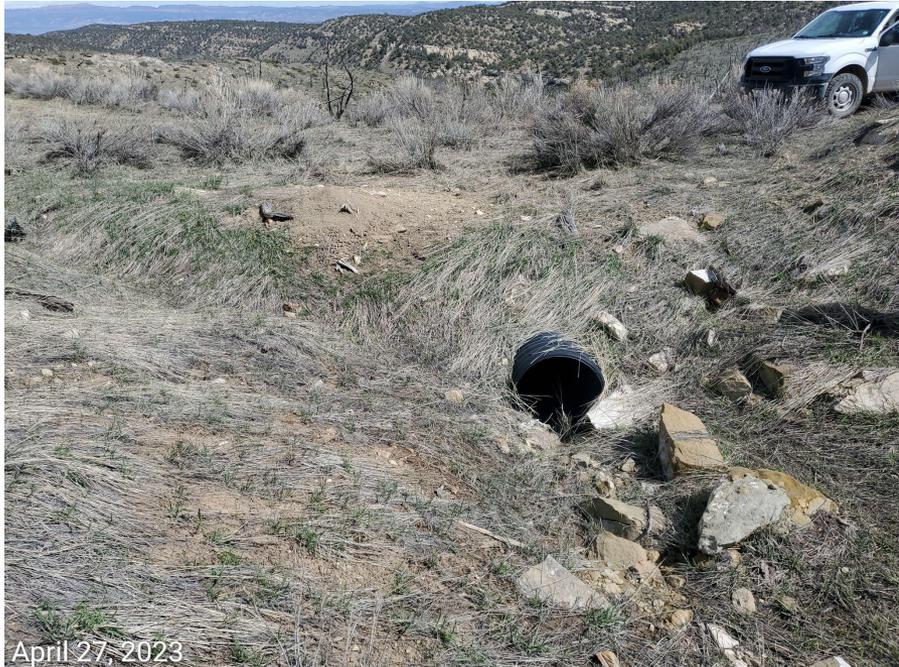
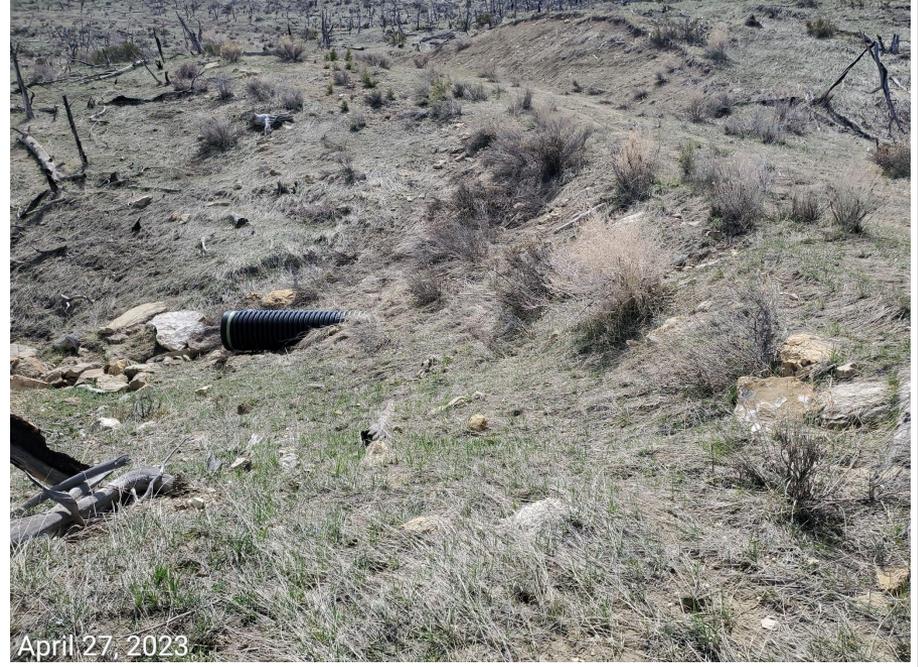
Photo 12: See comments under photo 10. Photos also examples of many culverts observed remaining along the access road.

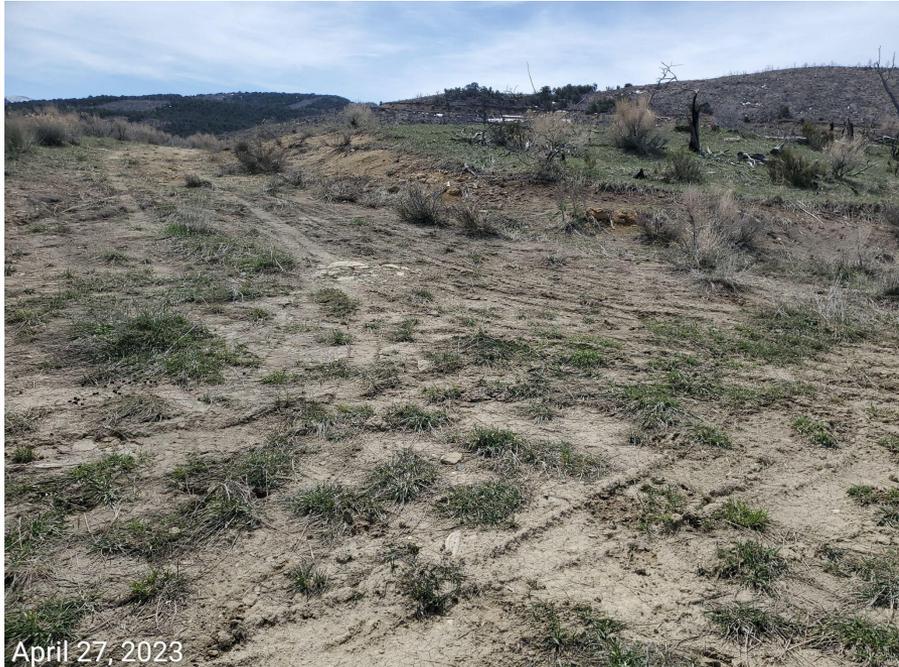
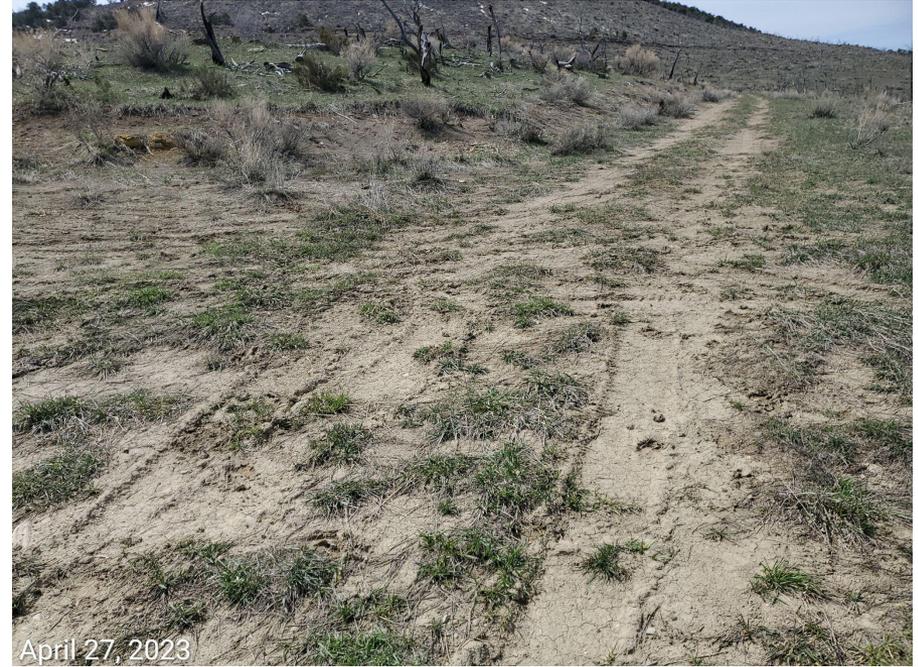
Photo 6: Photo left shows access road leading to the Location. Photo right shows main access road that continues to additional Genesis Locations within Fletcher Gulch. Access road intersects with Co Rd 122 at $40.076157^{\circ}/-108.637129^{\circ}$
