# Inspection Photos

Operator: GENESIS GAS & OIL COLORADO LLC  
- 10384

Location Number: 414168  
Rio Blanco County, CO

Aaron Trujillo  
NW Reclamation Specialist  
COGCC

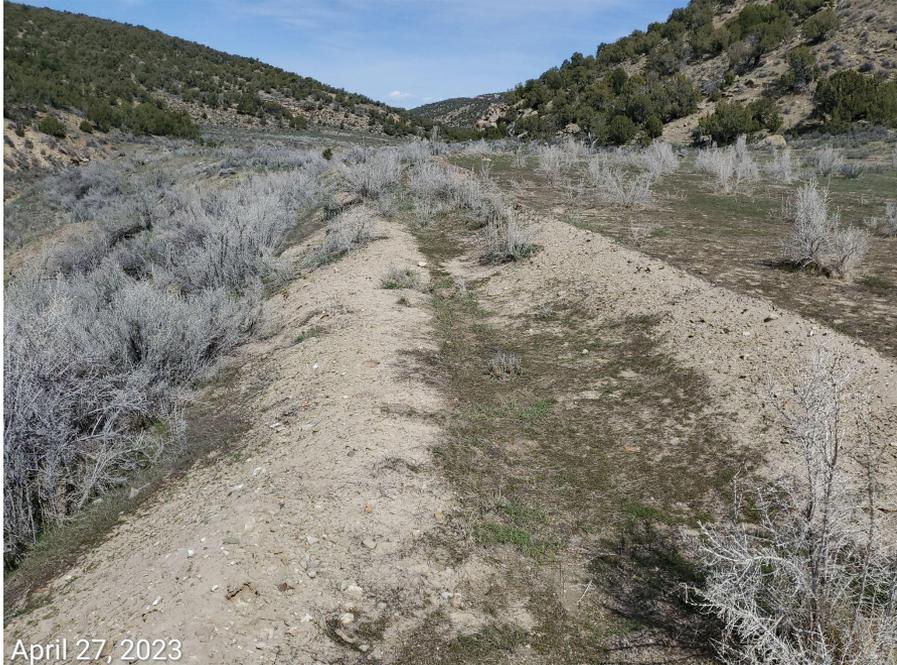
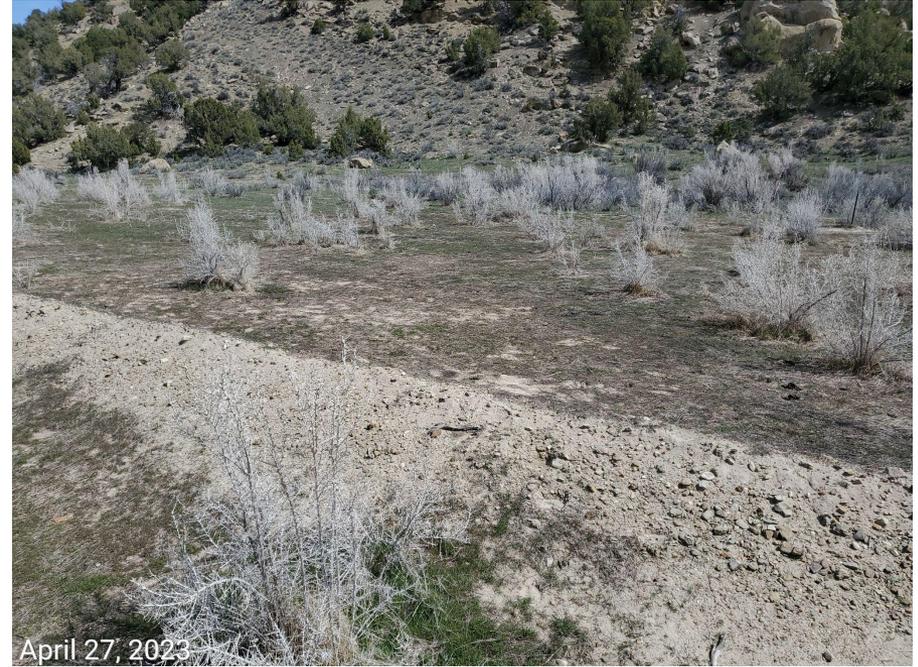
**Photo 1:** Photos 1-2 taken from the southwest end of the Location. Photos provide an overview of the Location from northwest, north, east to southeast. Photos show final reclamation including, but not limited to, compaction alleviation, recontouring/regrading and reclaiming has not been conducted on the Location.

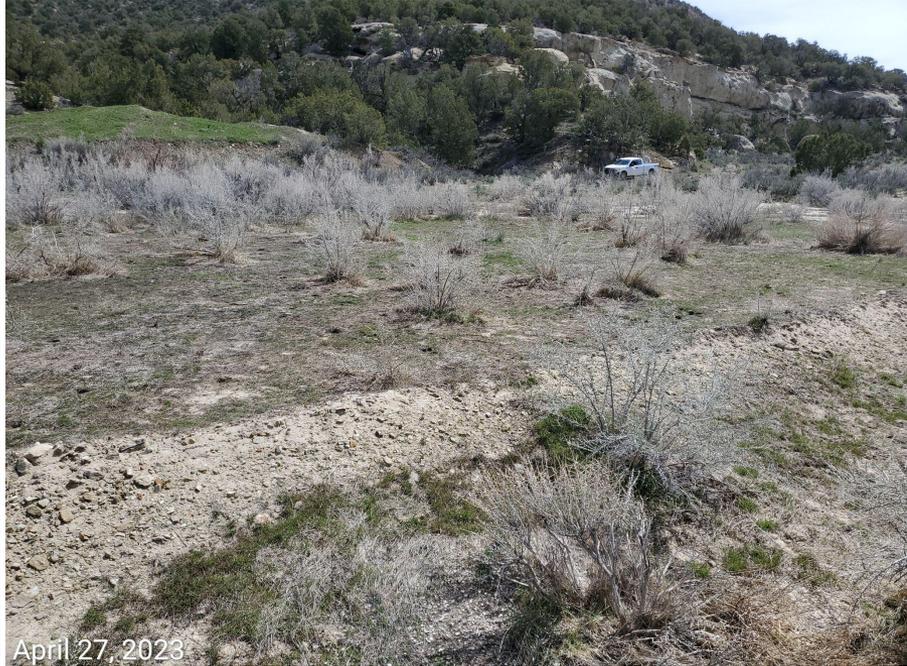
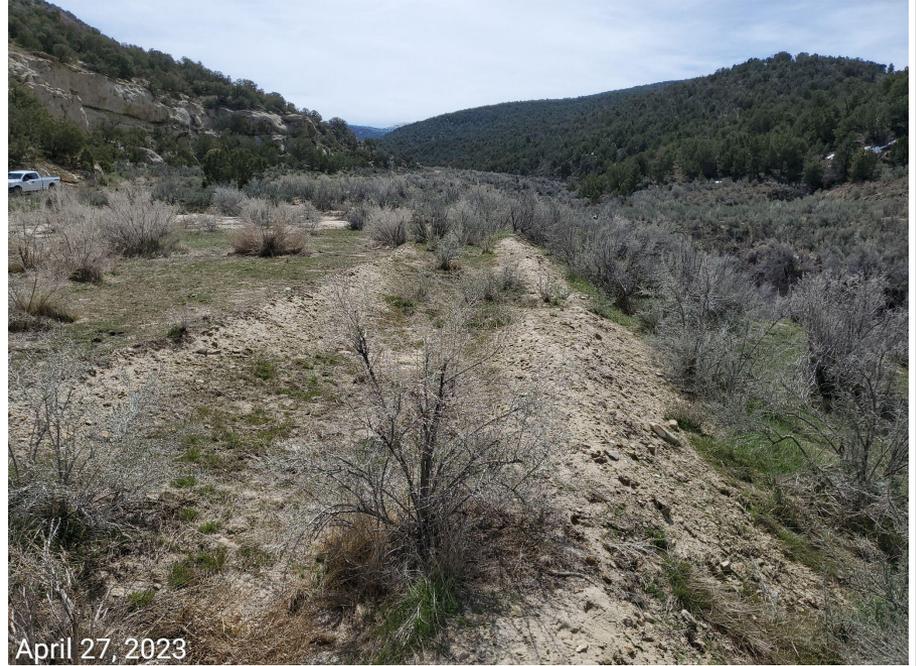
**Photo 2:** See comments under photo 1.

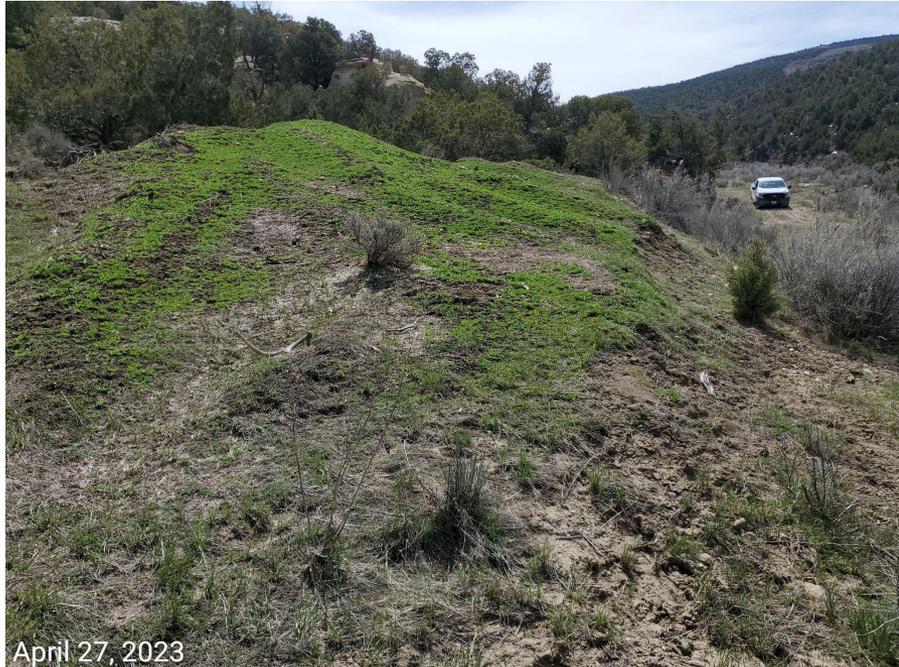
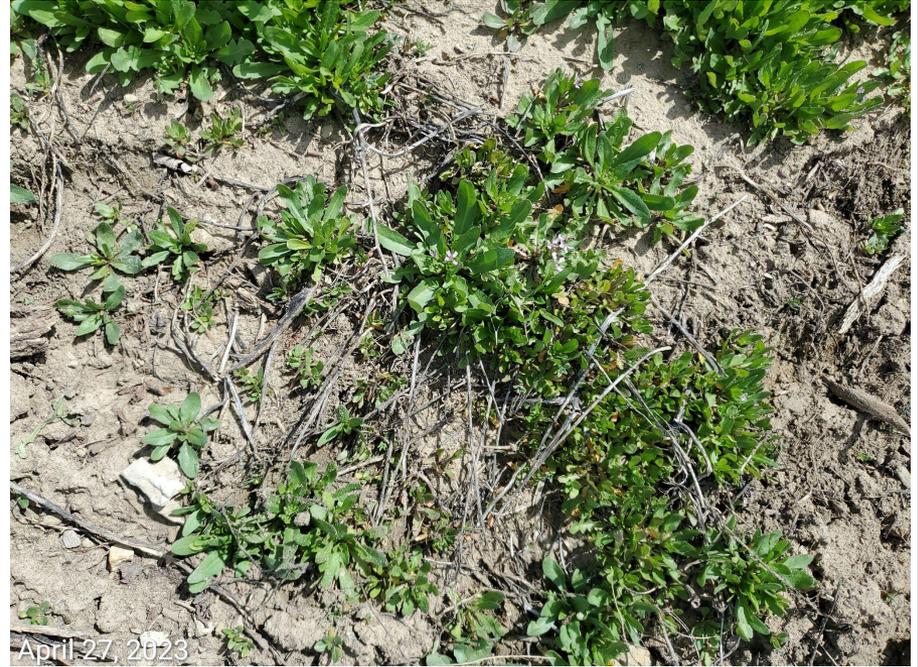
**Photo 3:** Photos taken from the cut slope/soil stockpile on the northeast end of the Location. Vegetation observed on the soil stockpile predominantly Undesirable Plant Species (Purple Mustard).

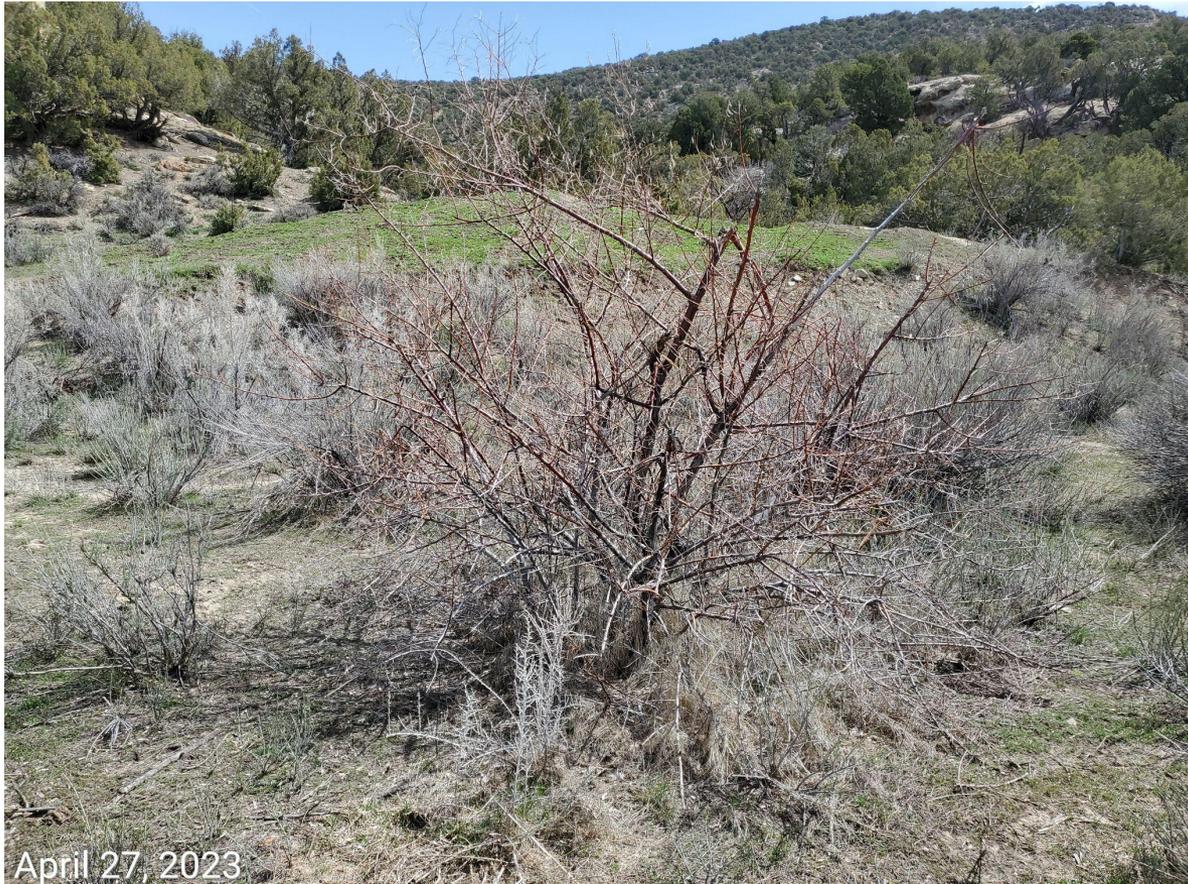
**Photo 4:** Undesirable Plant Species (Russian Olive) observed on Location.

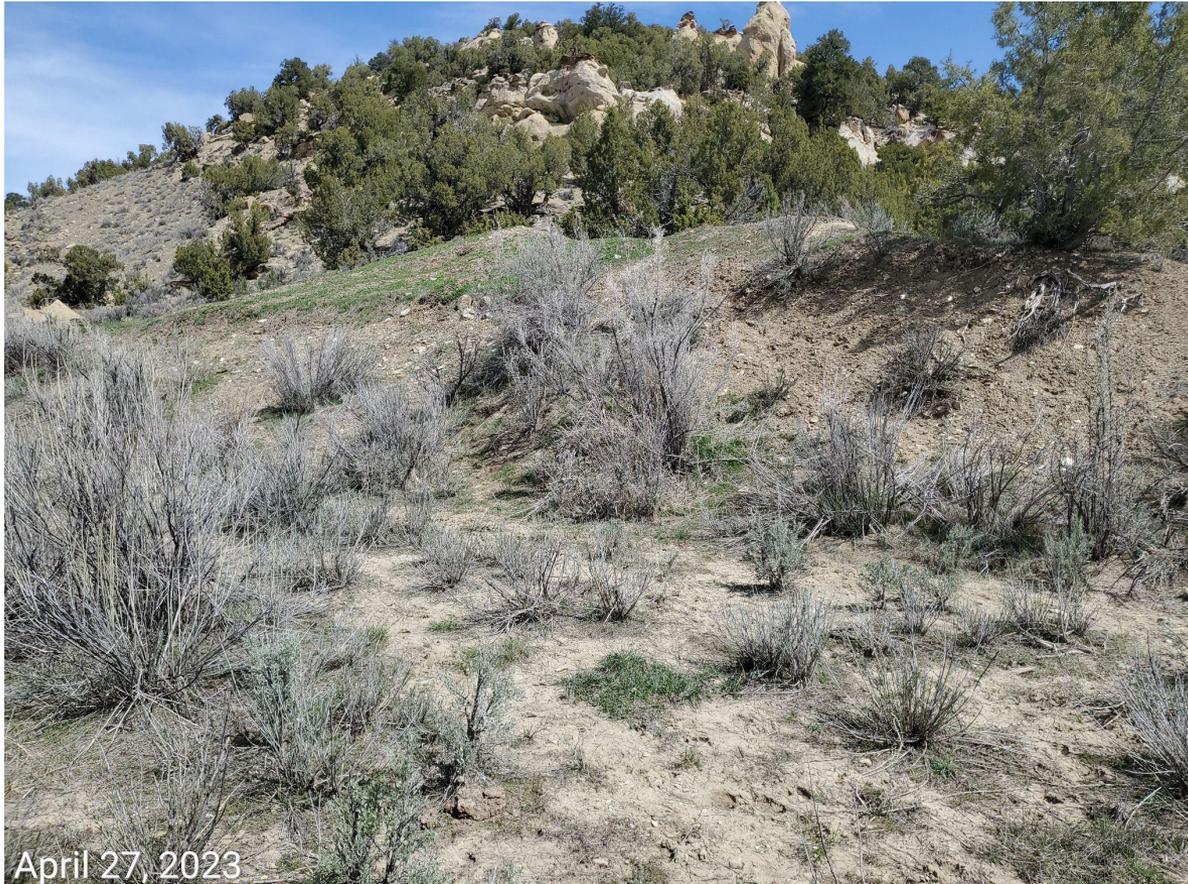
**Photo 5:** Cut slopes and soil stockpile on the northeast end of the Location.

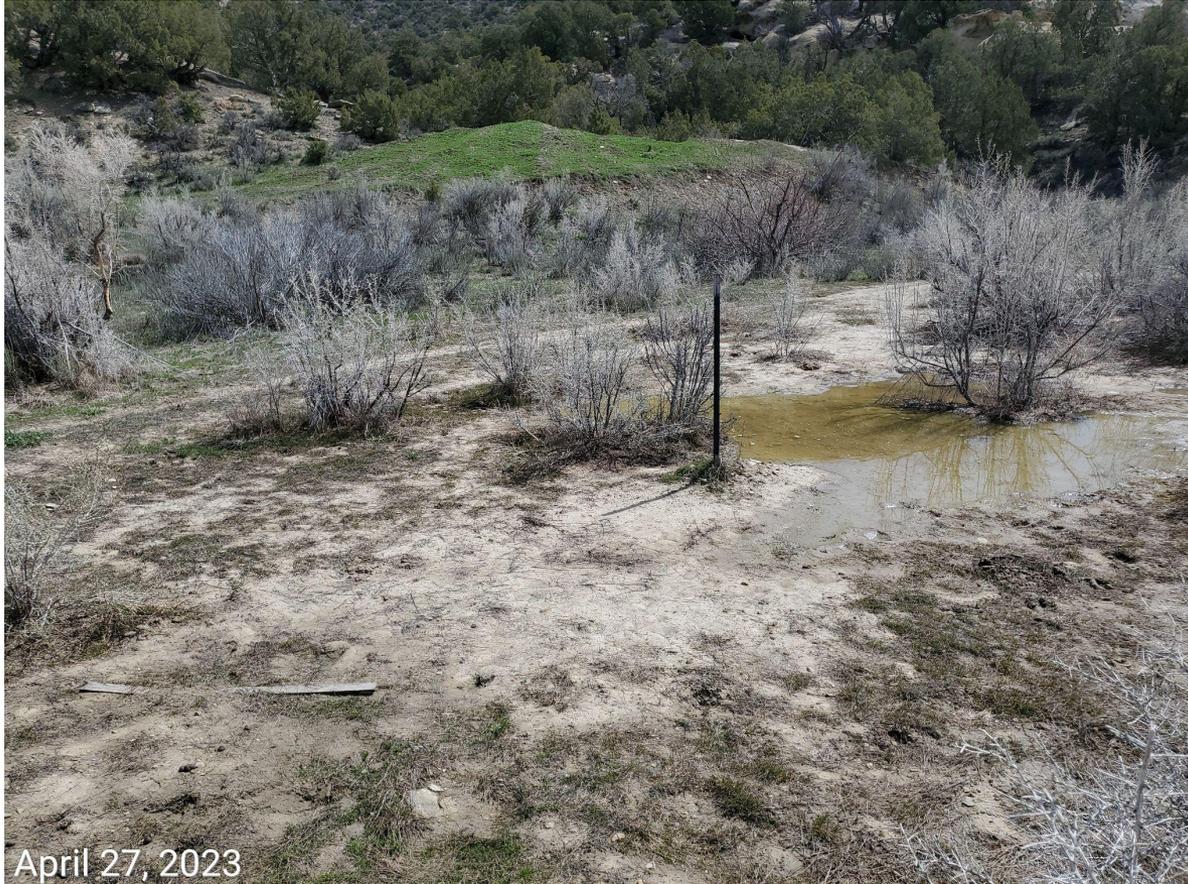
**Photo 6:** Well marker. Well has not been drilled. All Form 2 and Federal “permits to drill” on file for the Location have expired.

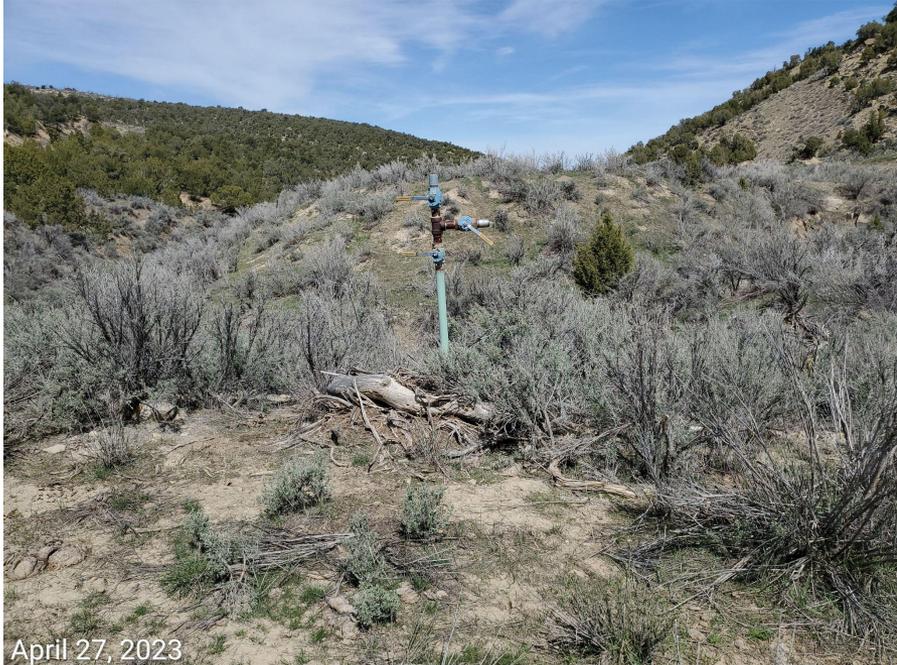
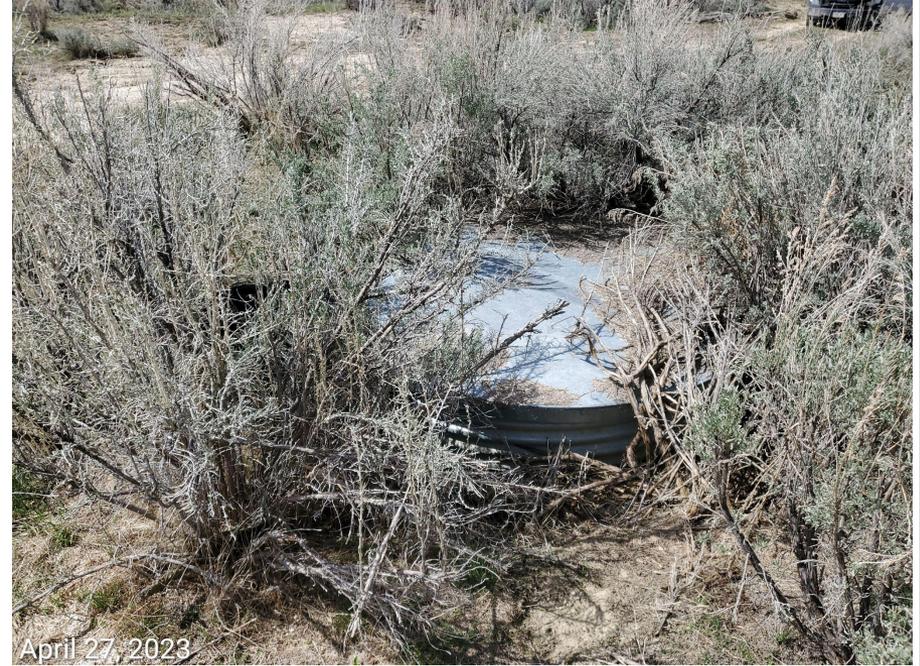
**Photo 7:** Photos examples showing surface equipment remaining on the Location and access road.

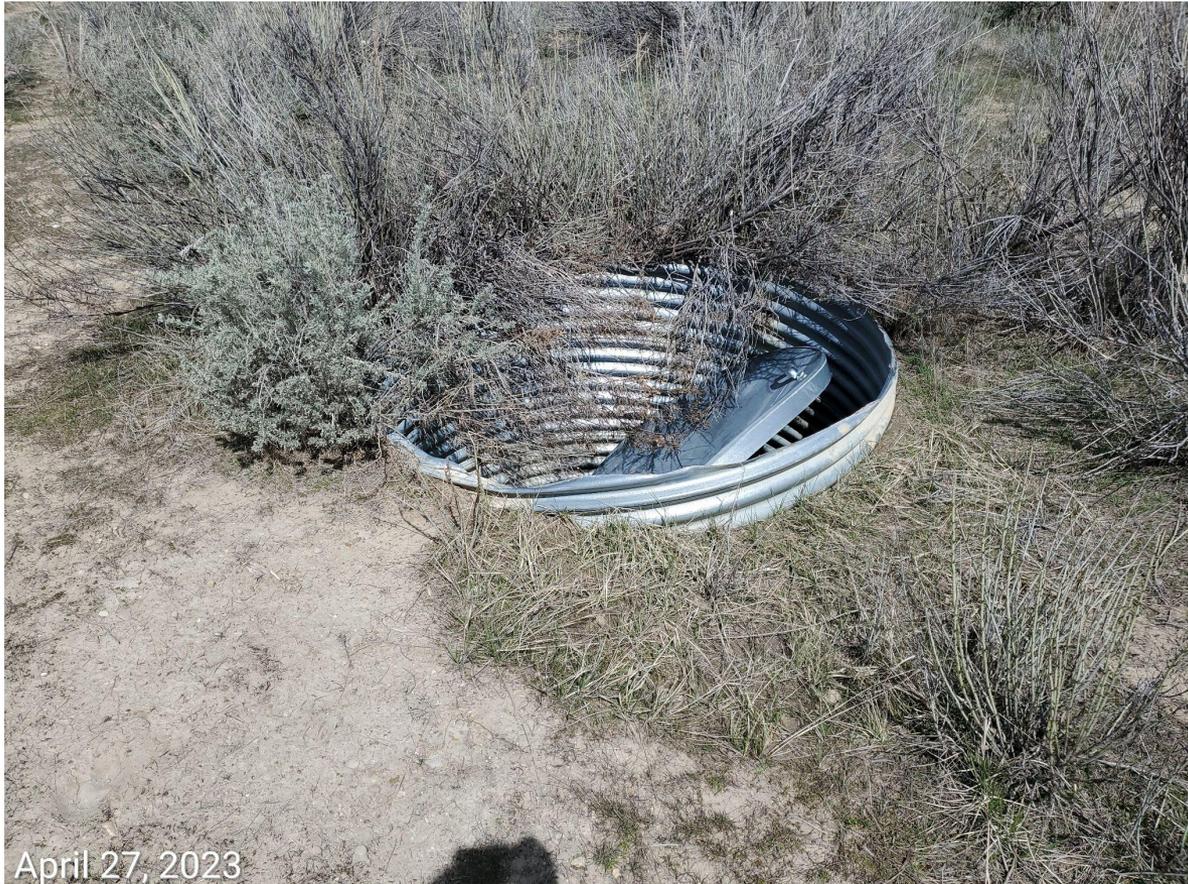
**Photo 8:** Photo taken from the south end of the Location. Photo shows cellar is not properly covered to prevent wildlife access.

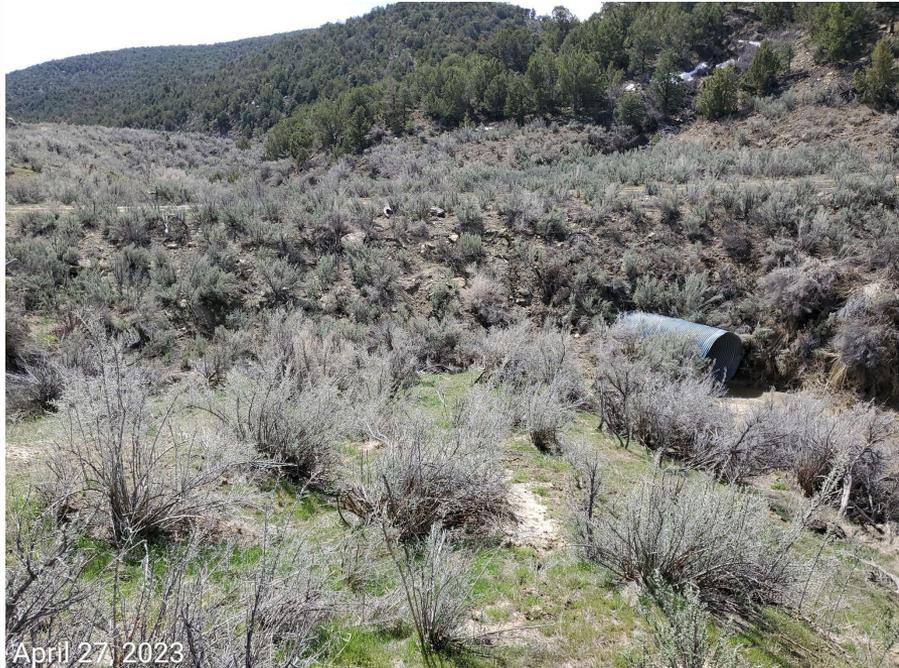
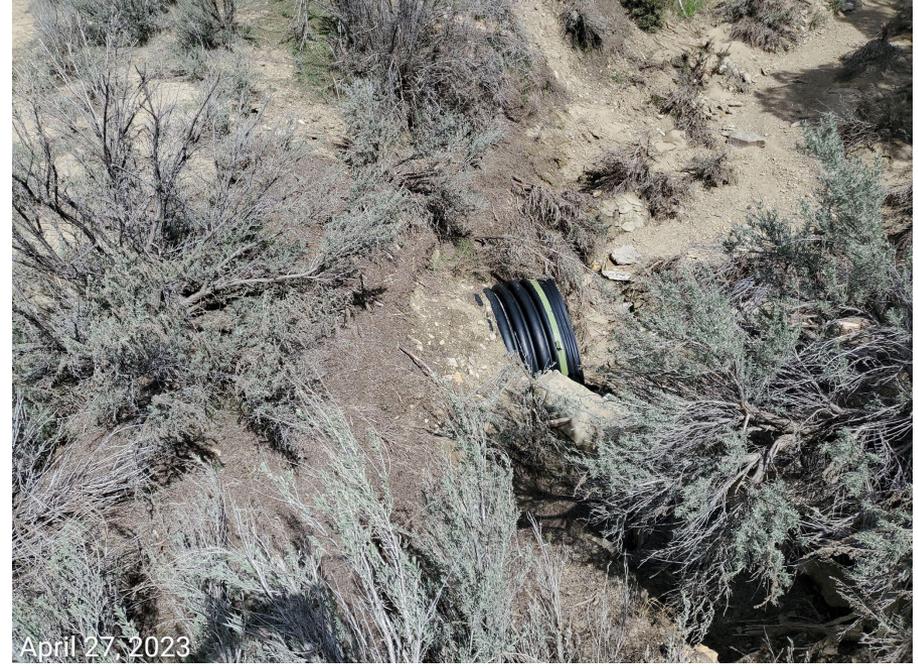
**Photo 9:** Photos taken from the access road. Photos examples showing final reclamation including, but not limited to, compaction alleviation, recontouring/regrading and reclaiming has not been conducted on the access road. Photos also examples of culverts observed remaining along the access road.

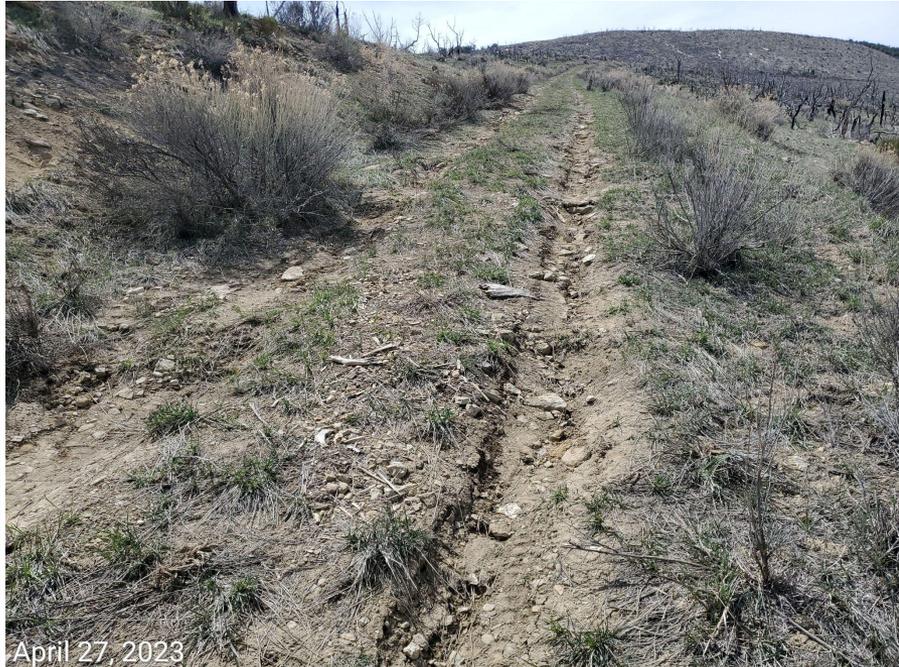
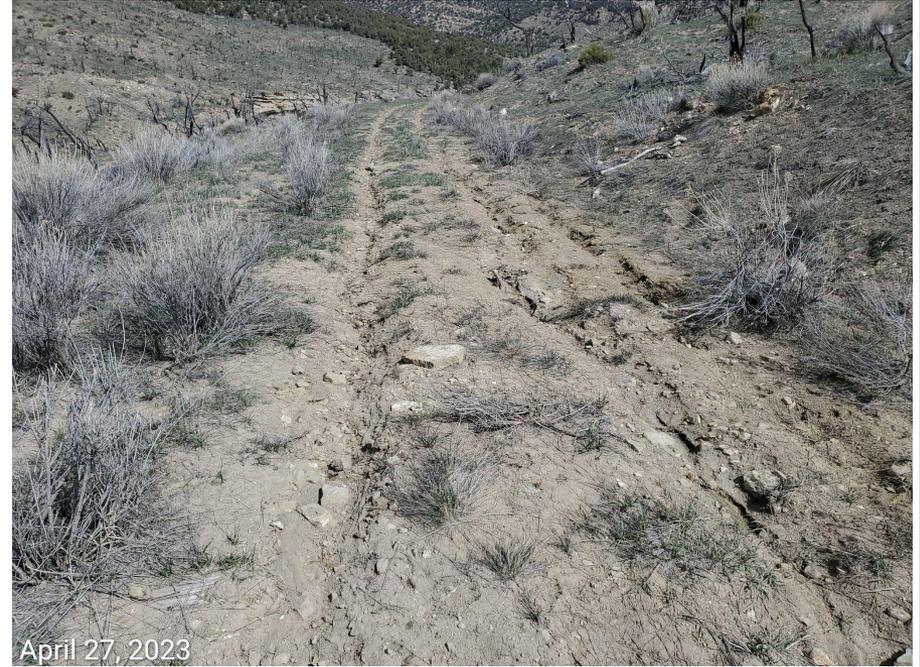
**Photo 10:** Photos 10-12 taken from the access road. Photos examples showing final reclamation including, but not limited to, compaction alleviation, recontouring/regrading and reclaiming has not been conducted on the entire access road. Photos also show erosion degradation at access road due to inadequate stormwater management. Access road intersects with Co Rd 122 at  $40.076157^{\circ}/-108.637129^{\circ}$ .

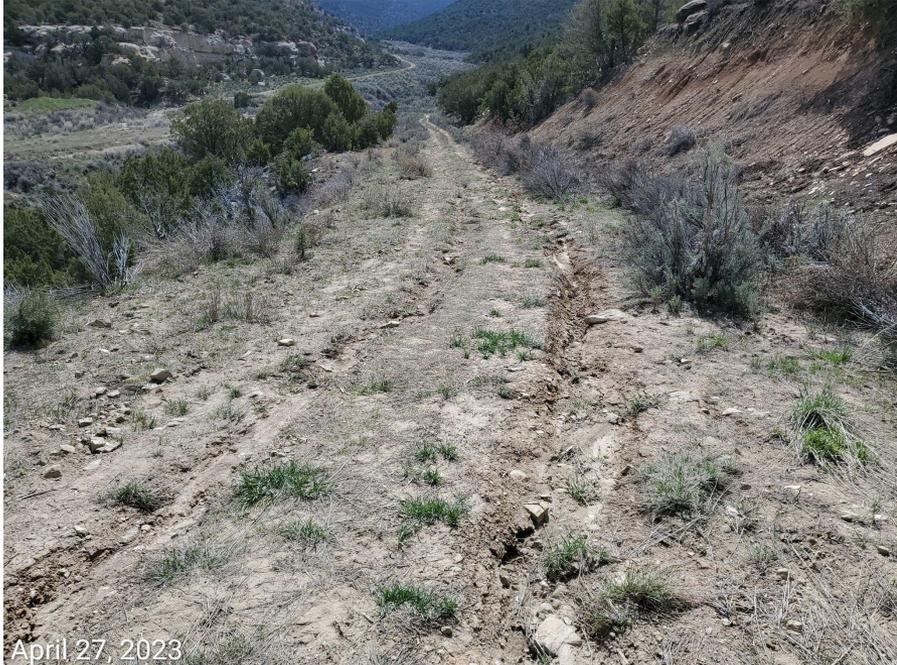
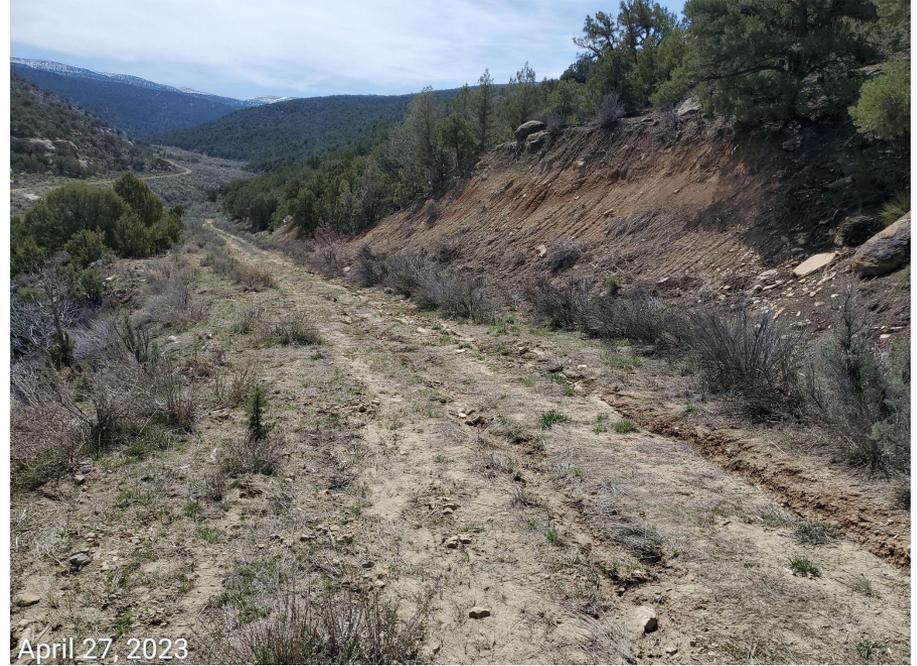
**Photo 11:** See comments under photo 10. Photo shows erosion degradation observed along cutslopes of the access road; slopes lack stabilization.

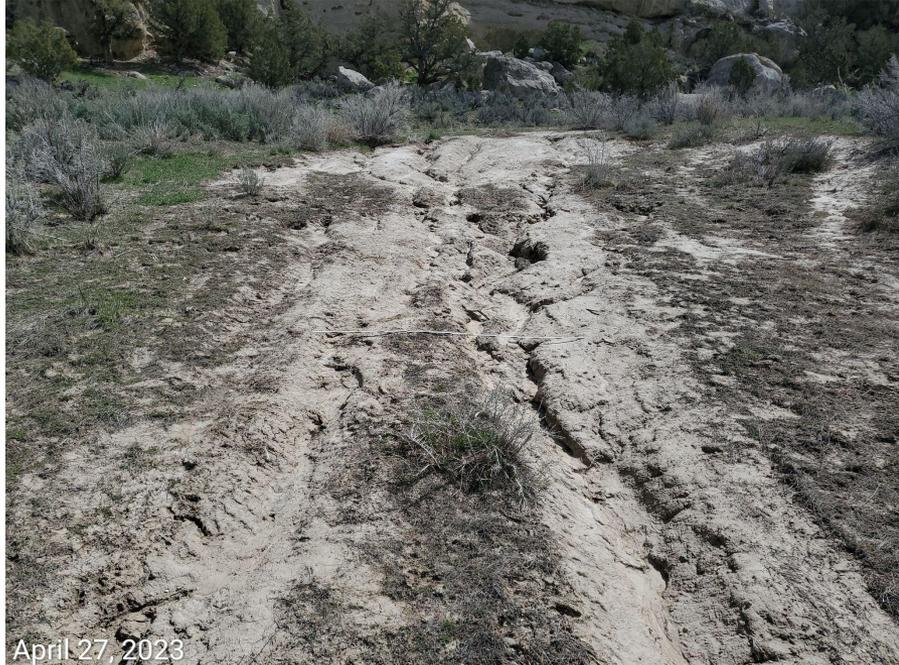
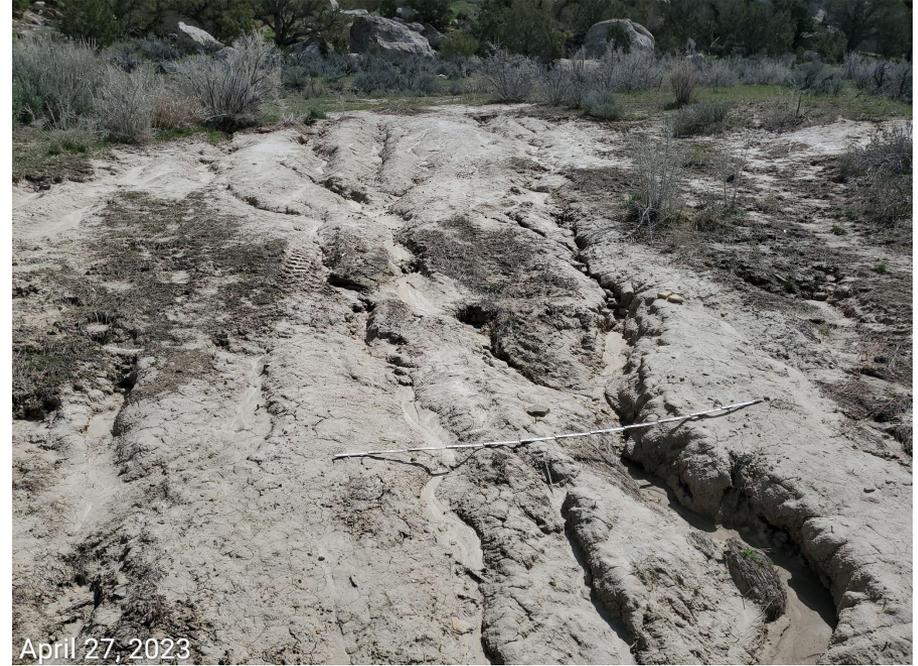
**Photo 12:** See comments under photo 10. 6 foot measuring stick for reference.

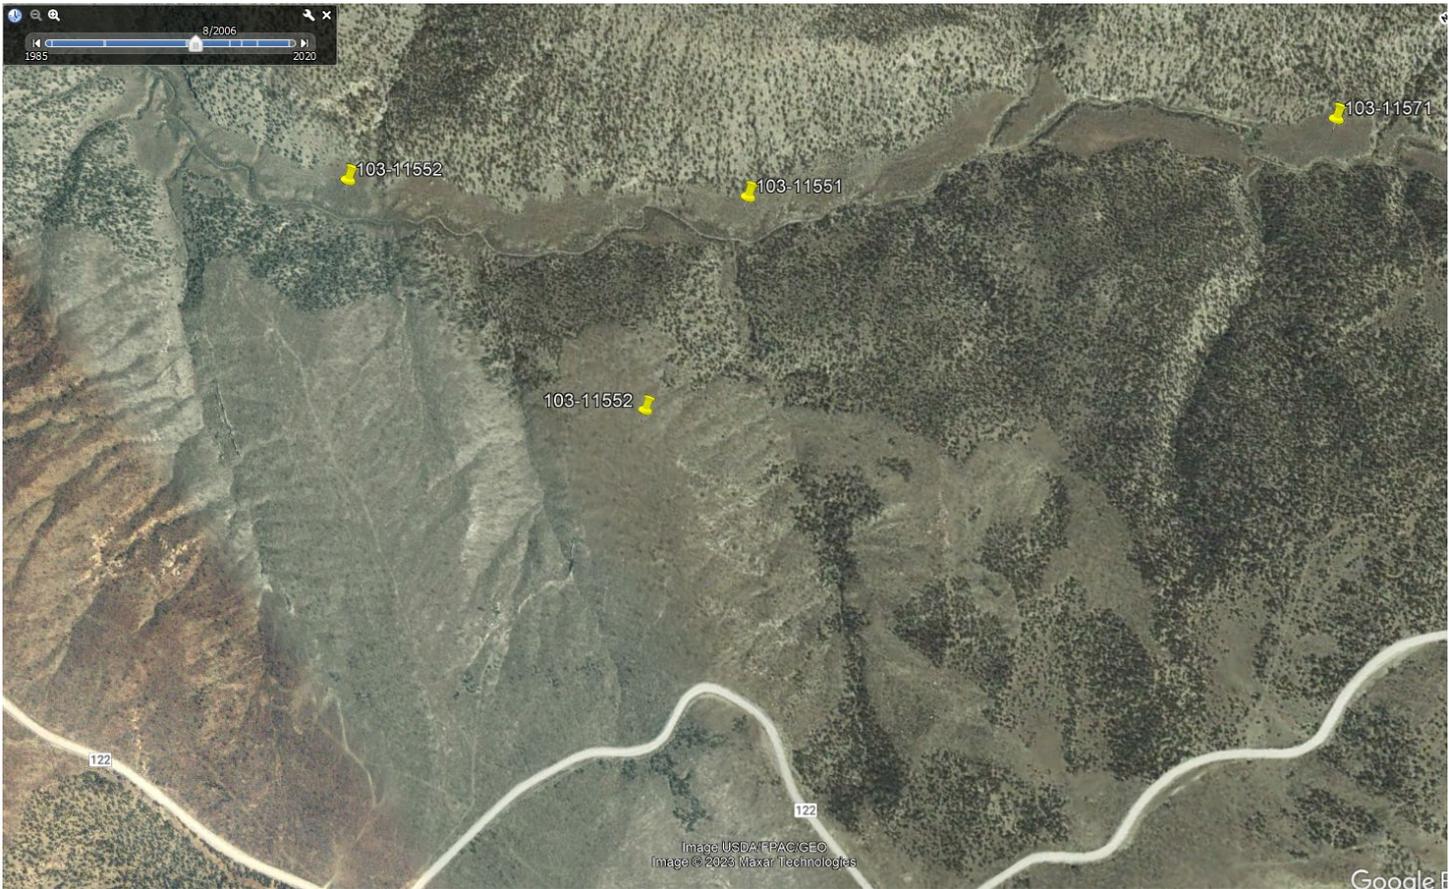
**Photo 13:** 2006 Google Earth aerial imagery showing the 4 expired Genesis Locations within the Fletcher Gulch Drainage, prior to construction of the Locations and access road—access roads did not exist prior to O&G disturbance.

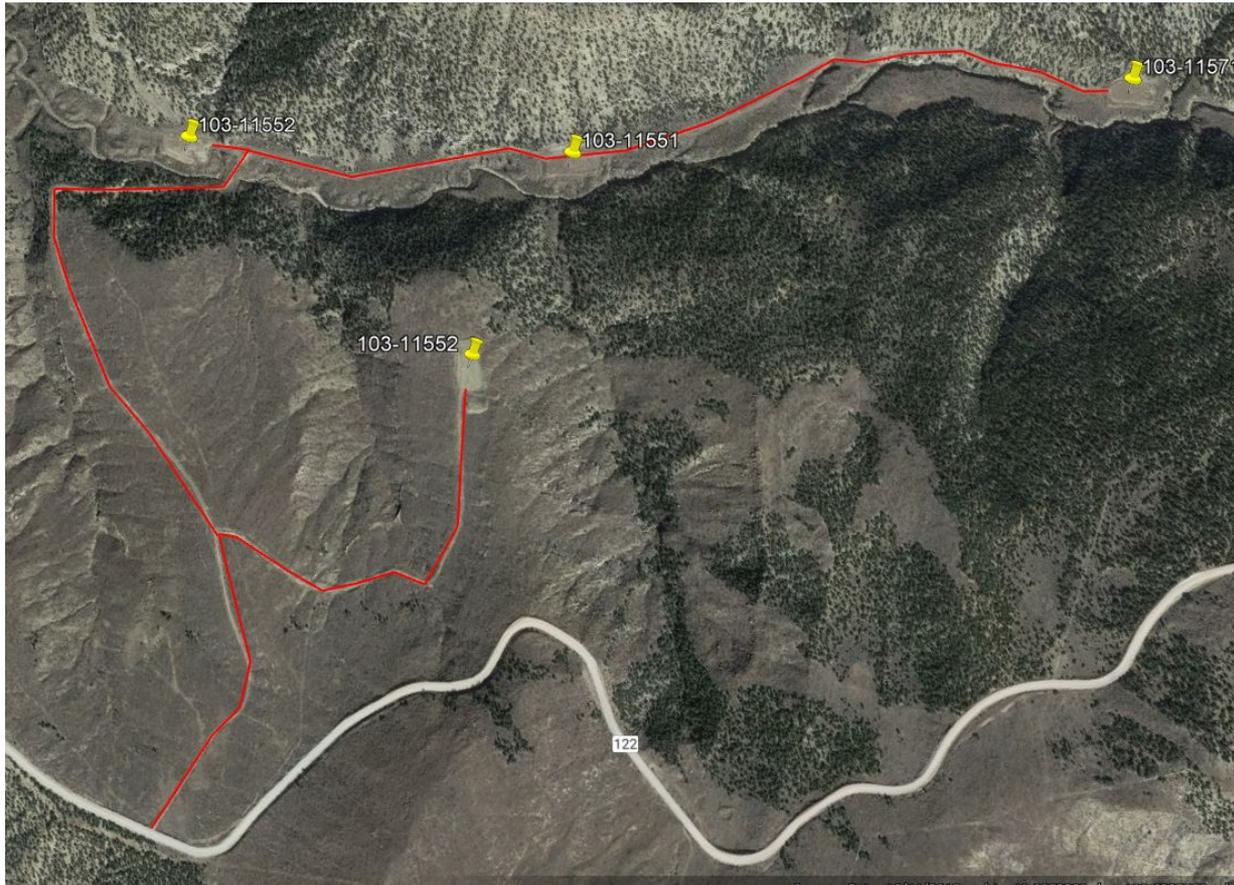
**Photo 14:** Google Earth aerial imagery showing the 4 expired Genesis Locations constructed within the Fletcher Gulch Drainage, and the access road(s) leading to the Locations (accessed via Co. Rd 122). Locations/Access roads subject to 1004 Reclamation.
