Inspection Photos

Operator: GENESIS GAS & OIL COLORADO LLC
- 10384

Location Number: 413918
Rio Blanco County, CO

Aaron Trujillo
NW Reclamation Specialist
COGCC

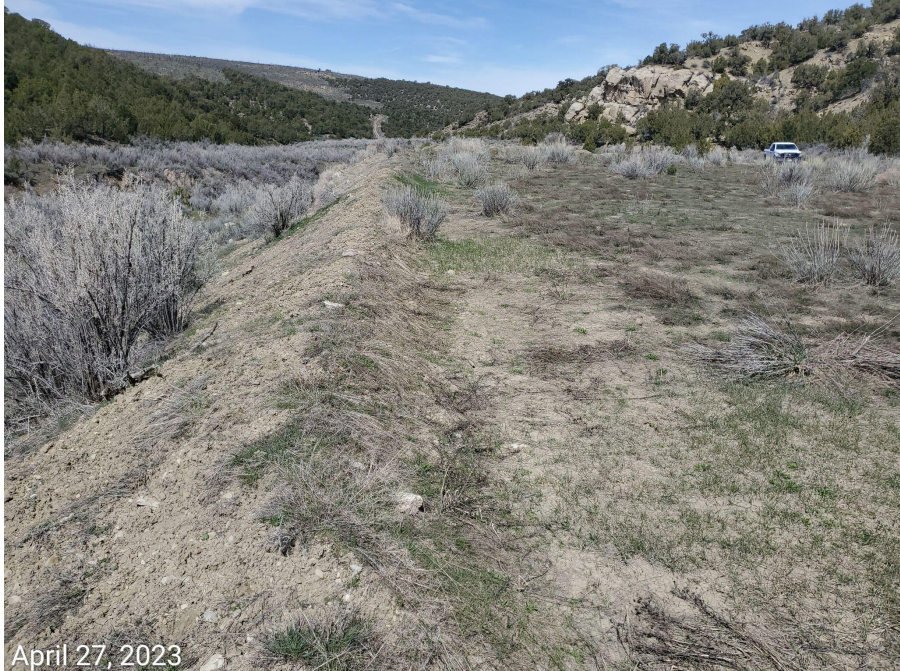
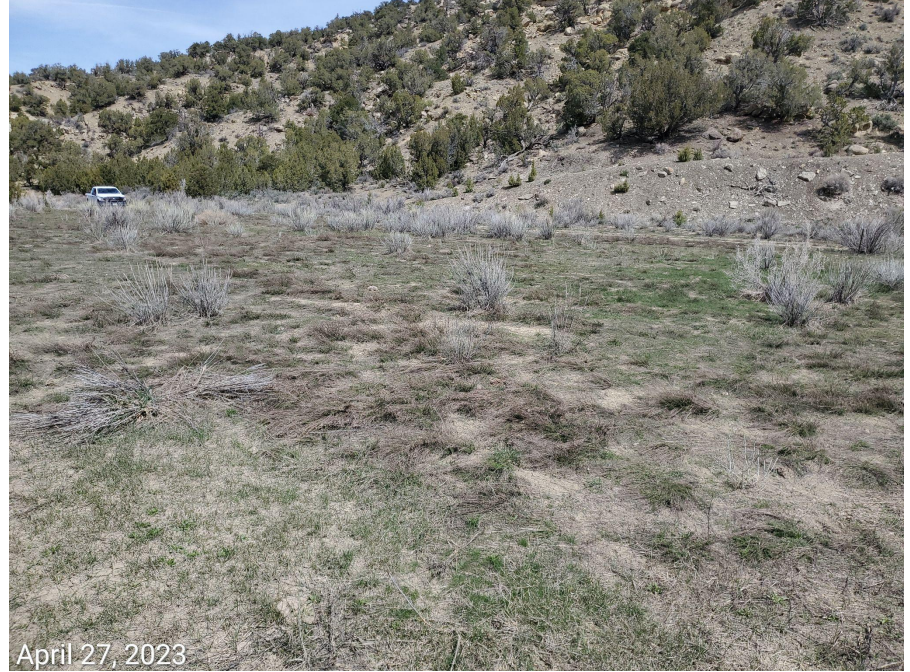
Photo 1: Photos 1-2 taken from the south end of the Location. Photos provide an overview of the Location from west, northwest, northeast to east. Photos show final reclamation including, but not limited to, compaction alleviation, recontouring/regrading and reclaiming has not been conducted on the Location.

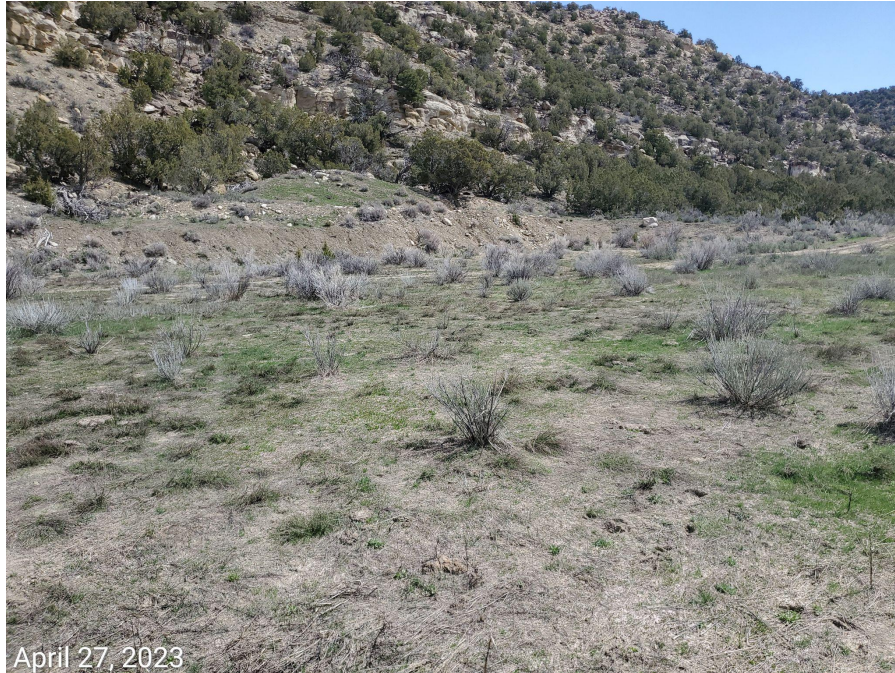
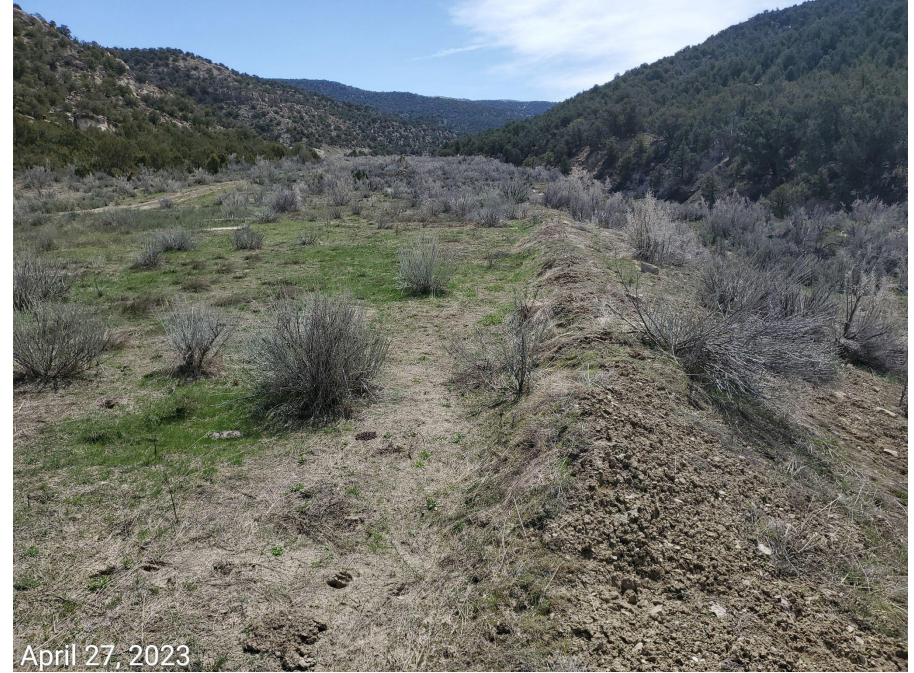
Photo 2: See comments under photo 1.

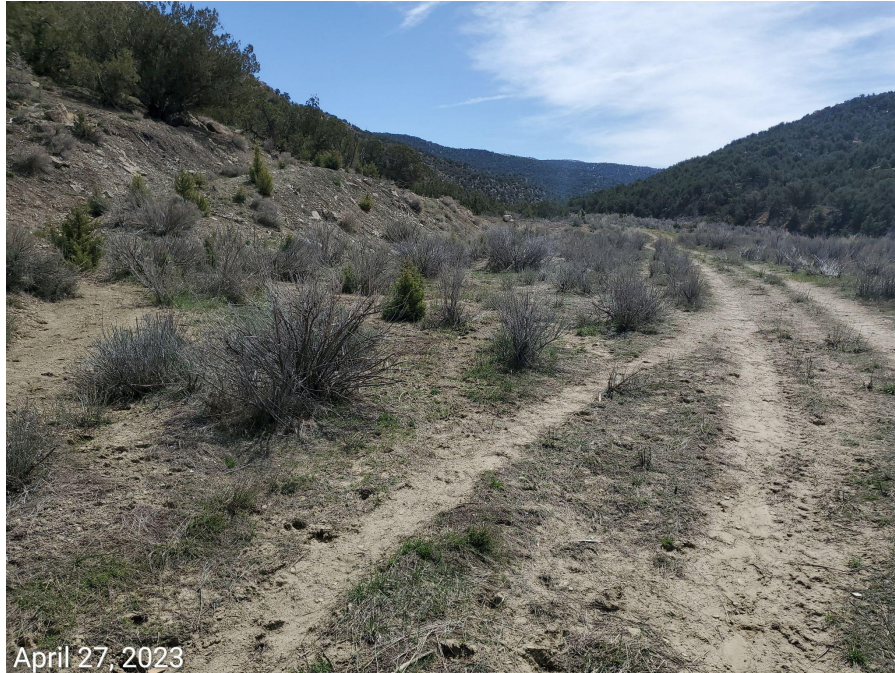
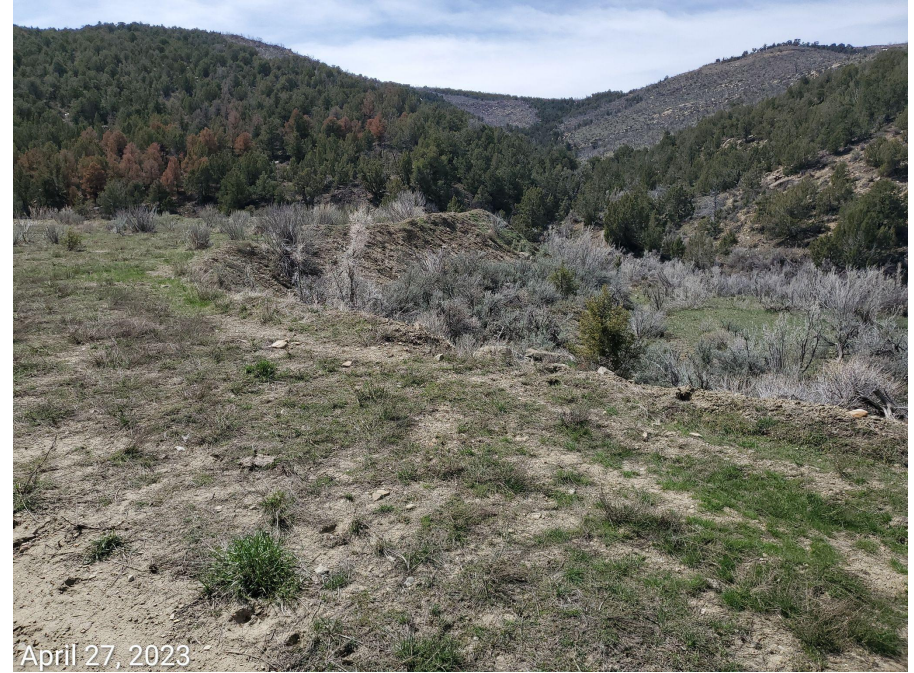
Photo 3: Photos taken from the Location entrance, facing east and south. Photos show remaining cut/fill slopes.

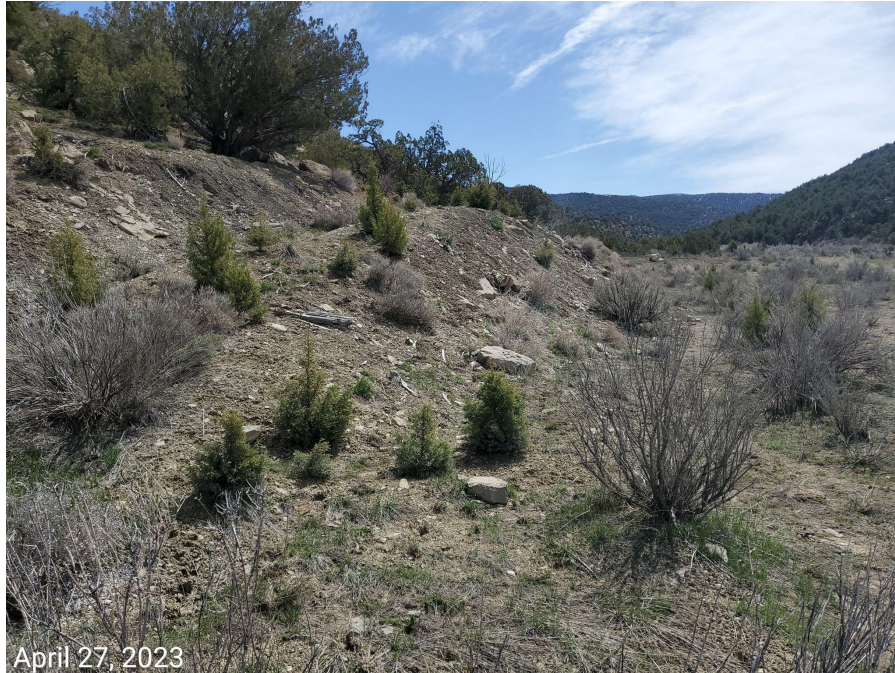
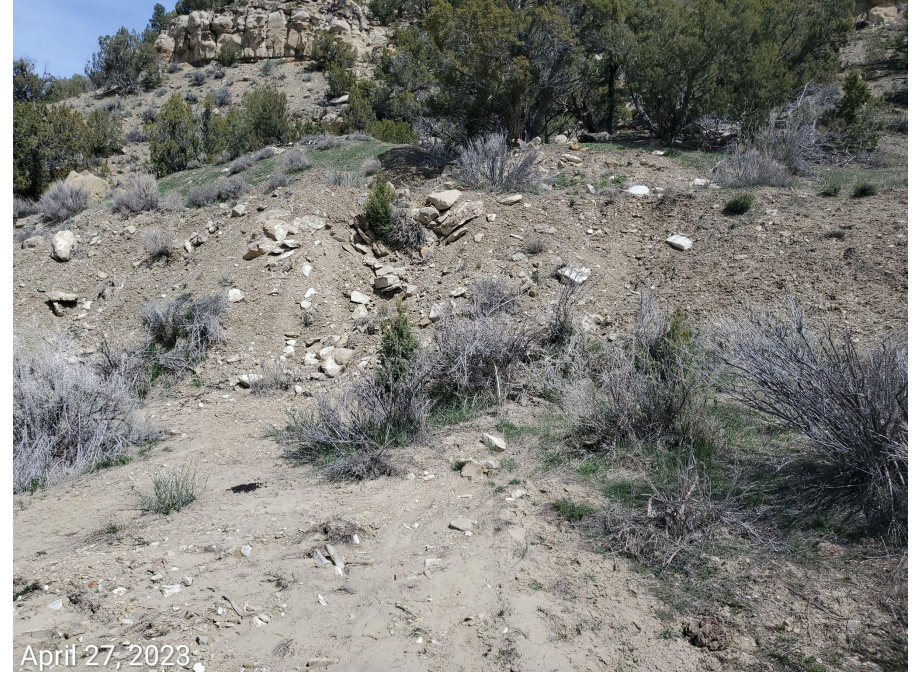
Photo 4: Photos taken from the cut slopes on the north end of the Location. Photos examples showing cut slopes lack stabilization. BMPs to minimize erosion, degradation and sediment transport missing or insufficient.

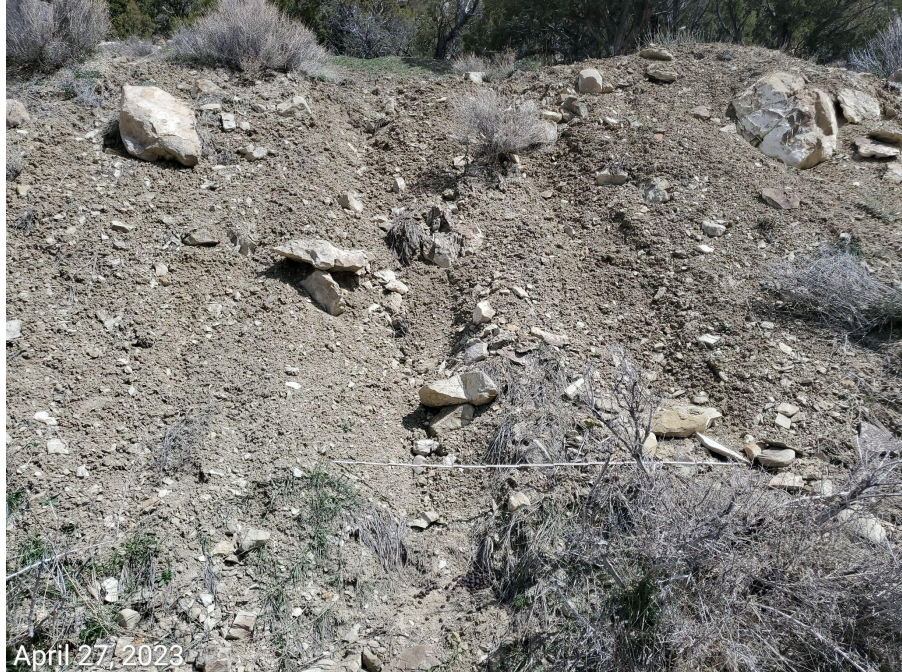
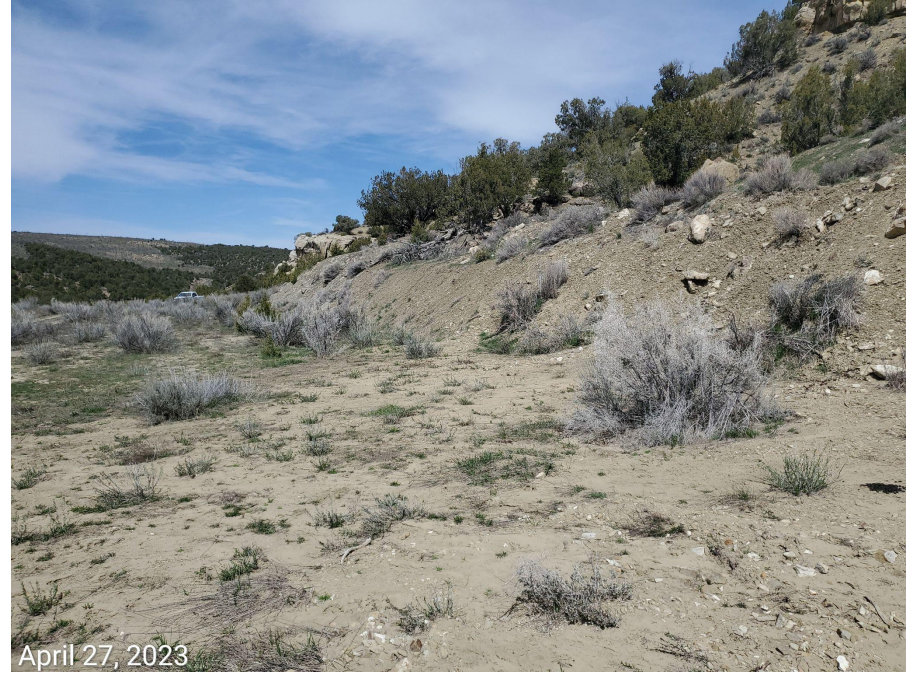
Photo 5: Photos taken from the cut slopes on the north end of the Location. Photos examples showing cut slopes lack stabilization. BMPs to minimize erosion, degradation and sediment transport missing or insufficient. 6 foot measuring stick in photo left for reference. Lighter brown soils observed on flat areas of the Location is sediment deposition due to unstabilized cut slopes.

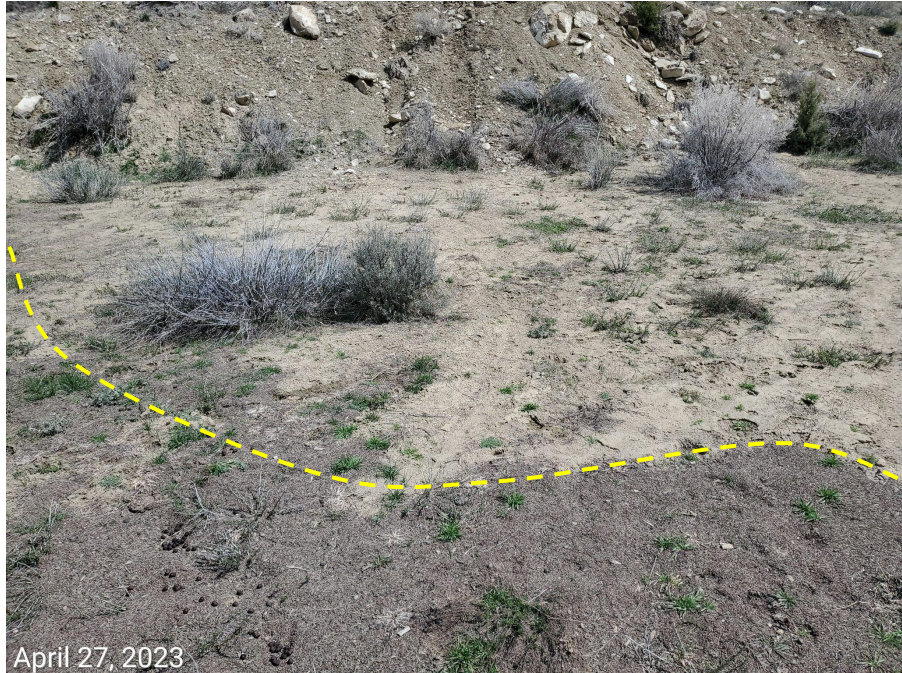
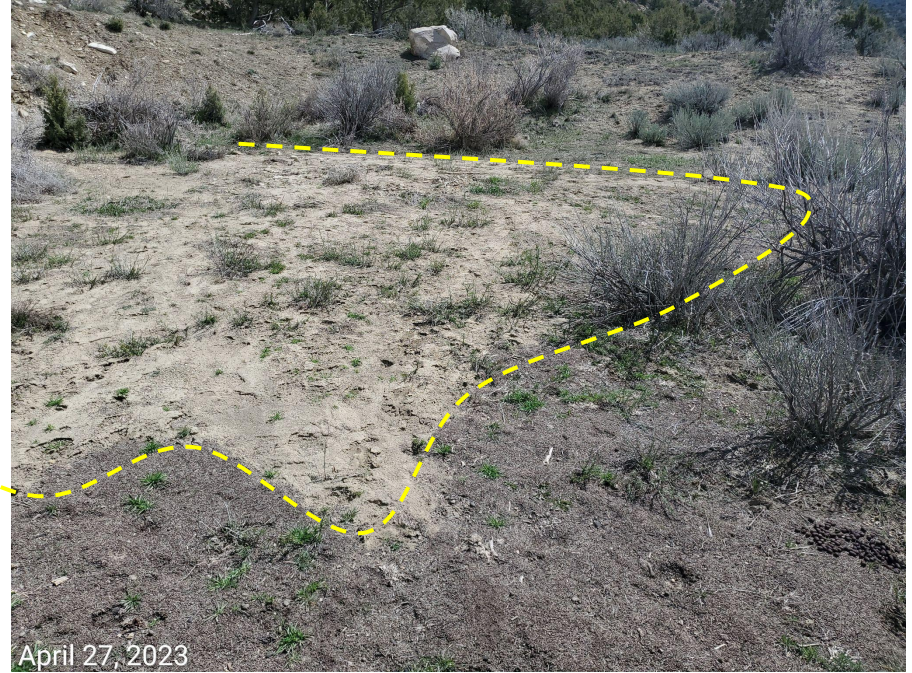
Photo 6: Sediment deposition due to unstabilized cut slopes. Darker materials on soil surface observed below the dotted line is vegetative debris carried by stormwater and deposited onto the pad surface.

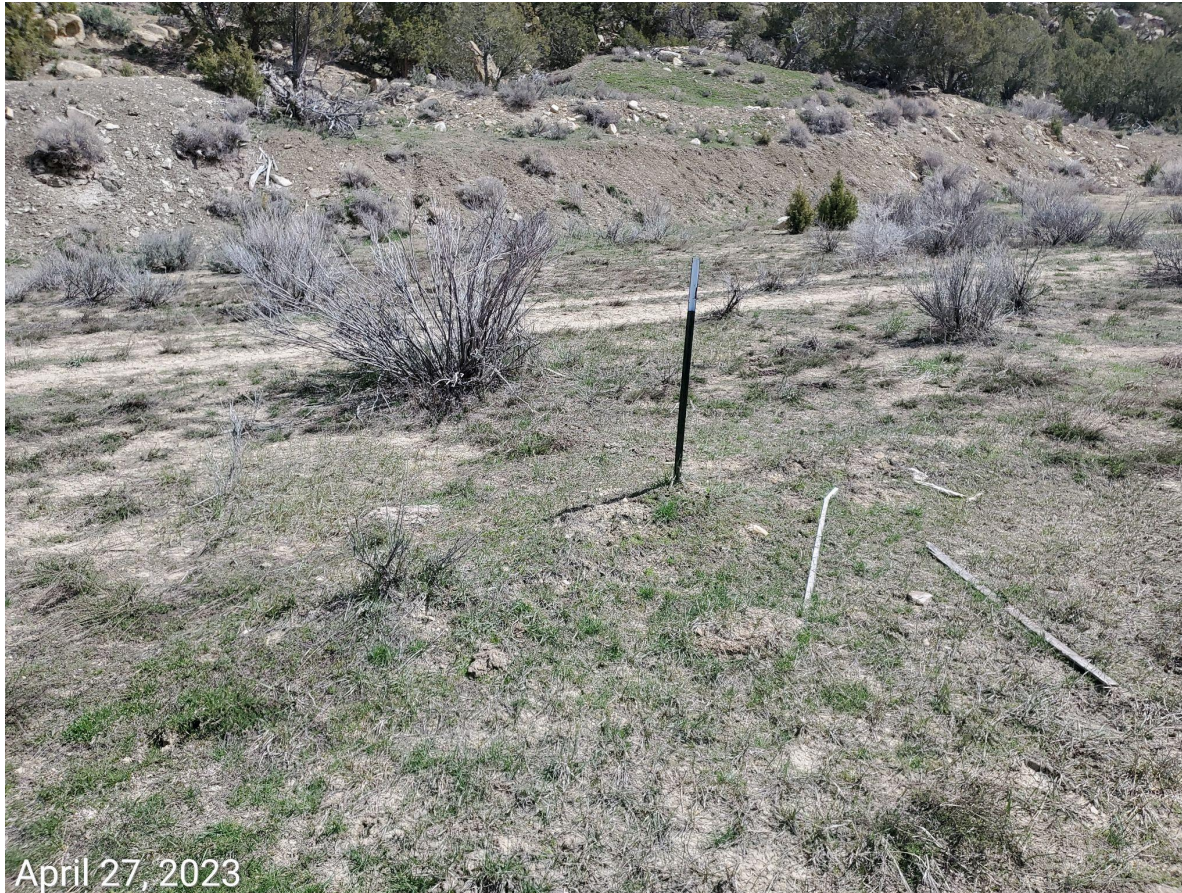
Photo 7: Well marker. Well has not been drilled. All Form 2 and Federal “permits to drill” on file for the Location have expired.

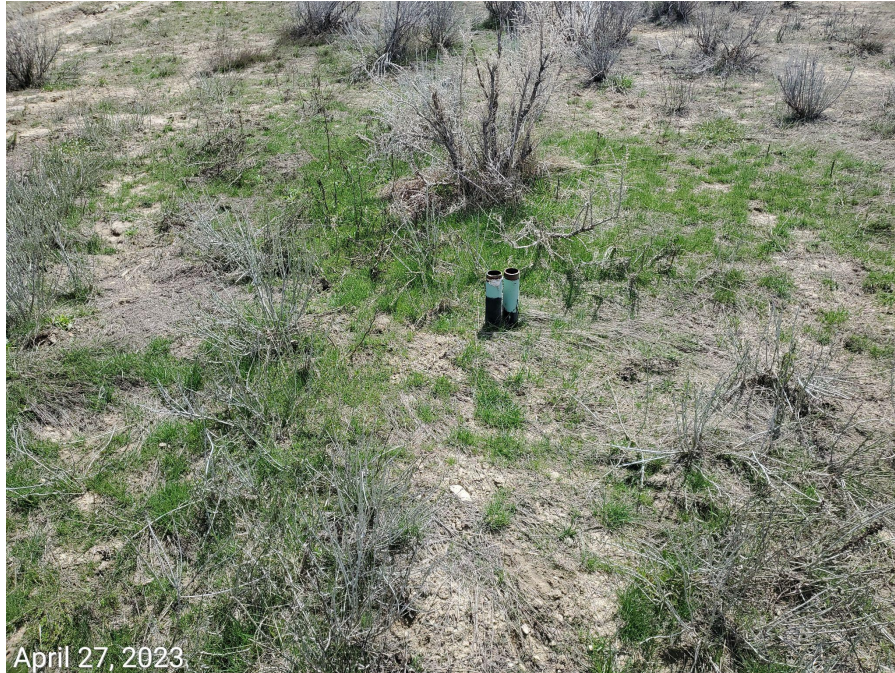
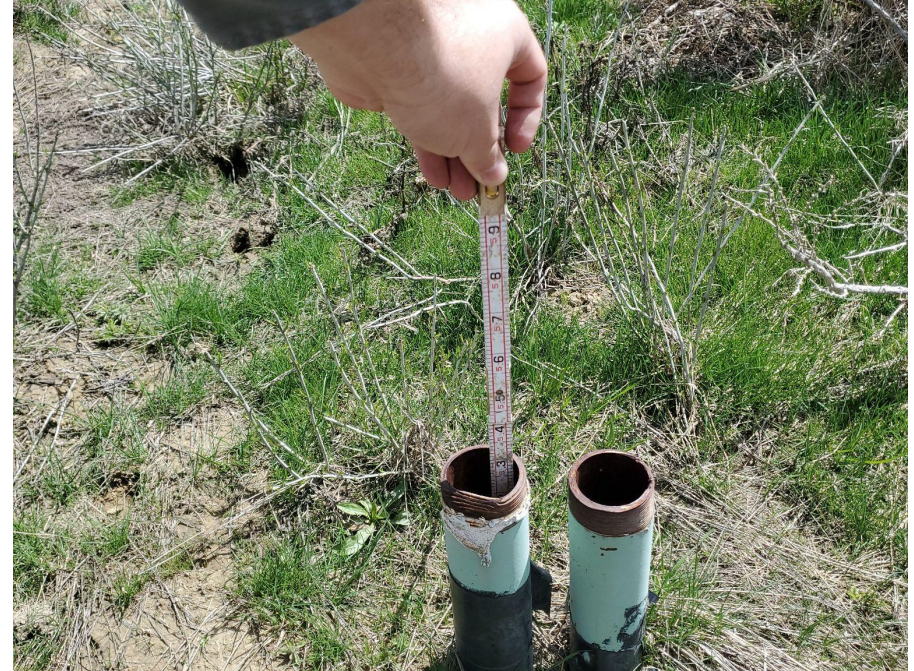
Photo 8: Photos show pipe riser equipment remaining on the Location. Risers have not been properly capped. 6 foot measuring stick for reference.

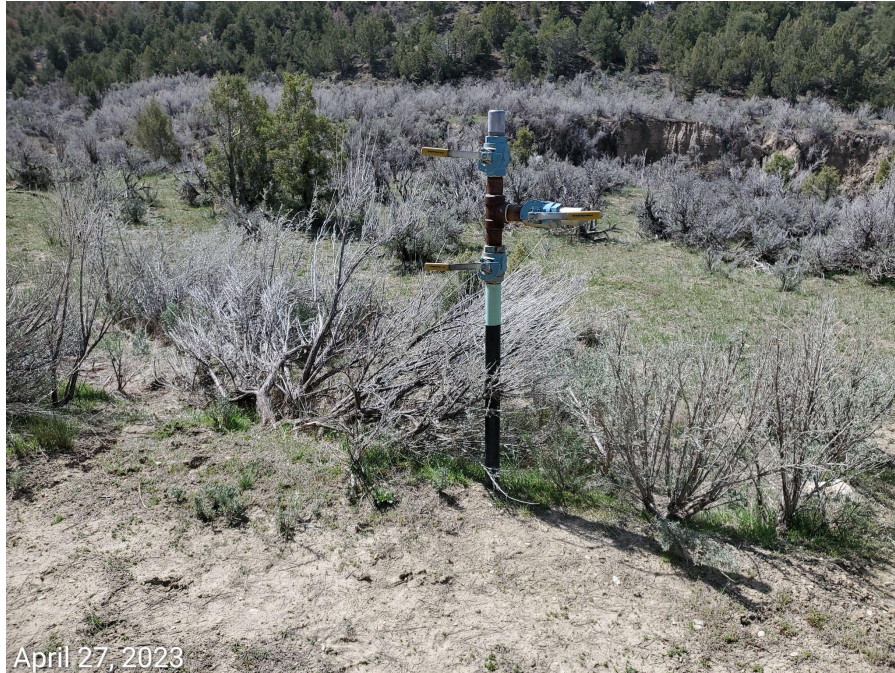
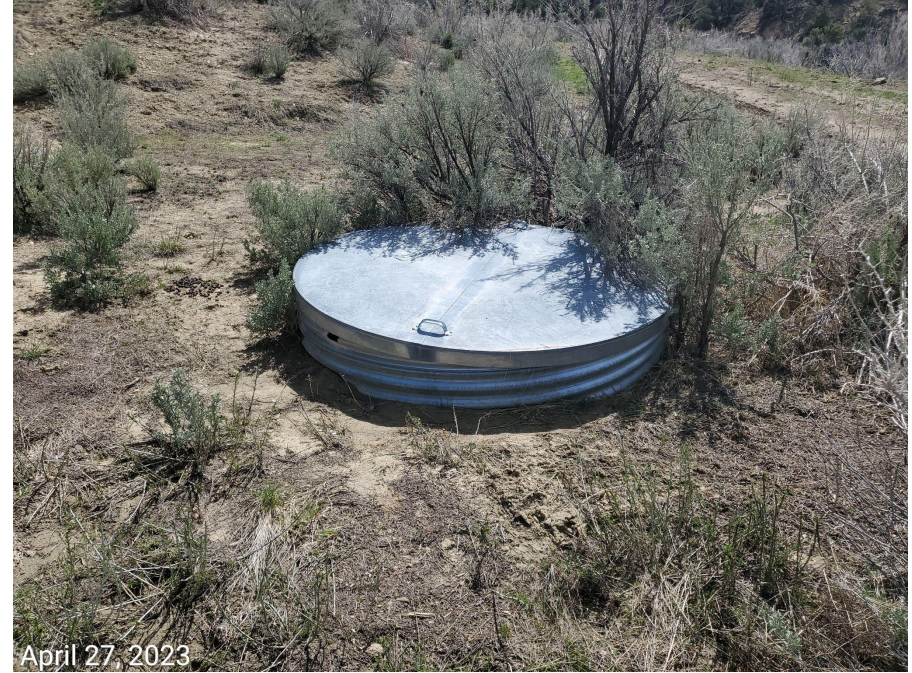
Photo 9: Photos examples showing surface equipment remaining on the Location and access road.

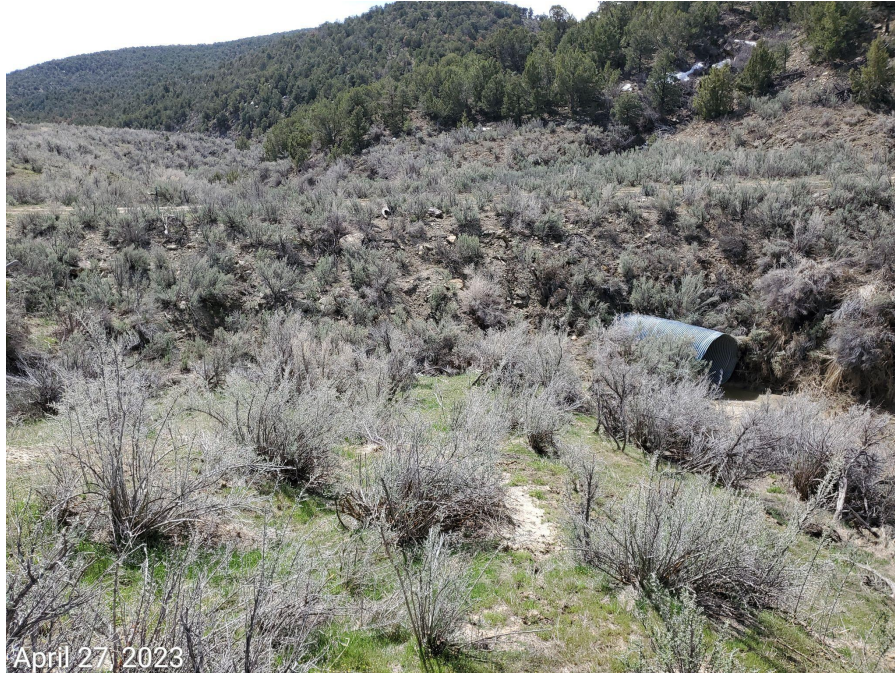
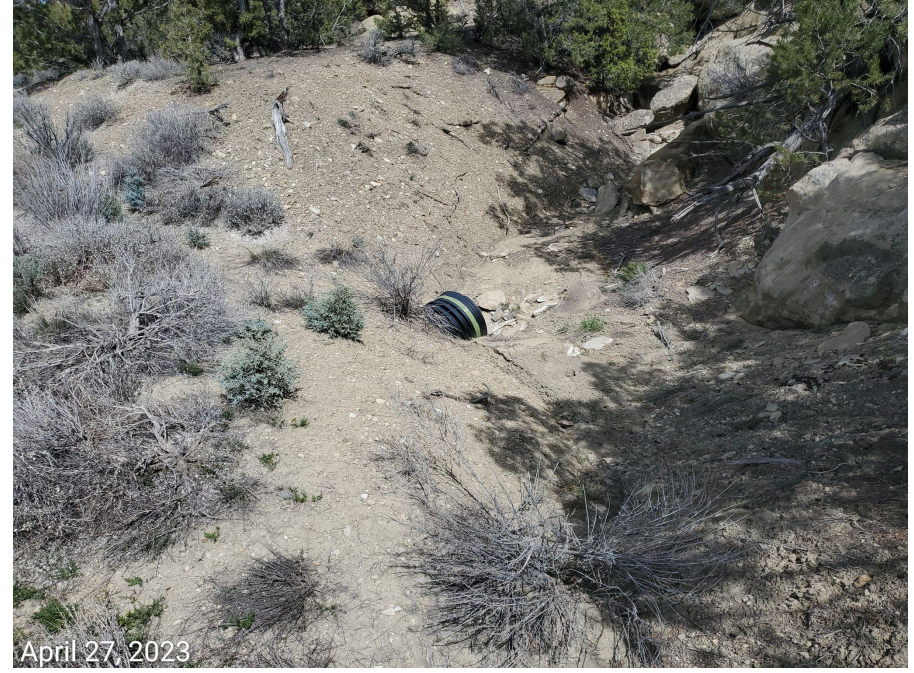
Photo 10: Photos taken from the access road. Photos examples showing final reclamation including, but not limited to, compaction alleviation, recontouring/regrading and reclaiming has not been conducted on the access road. Photos also examples of culverts observed remaining along the access road.

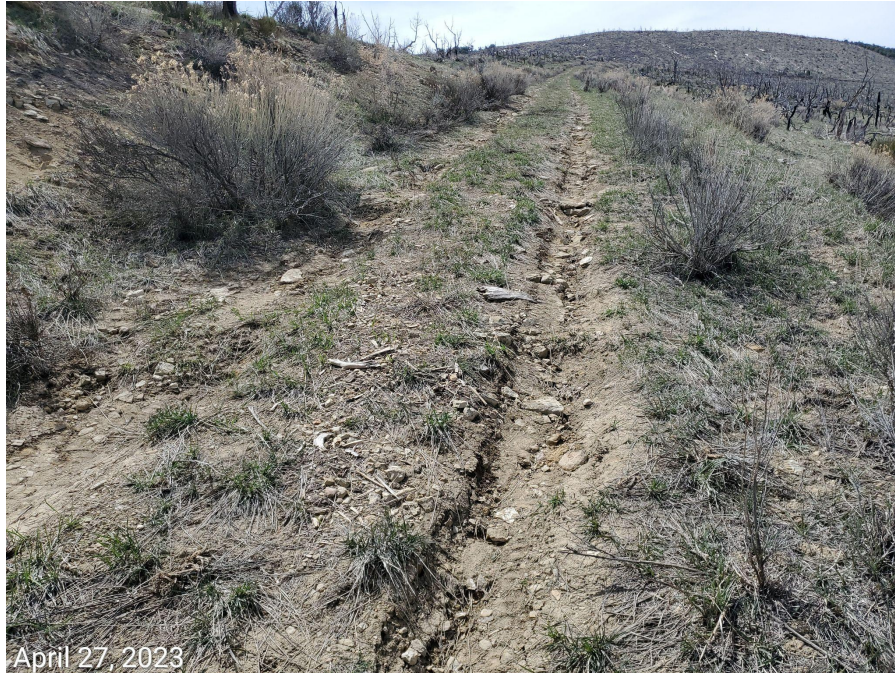
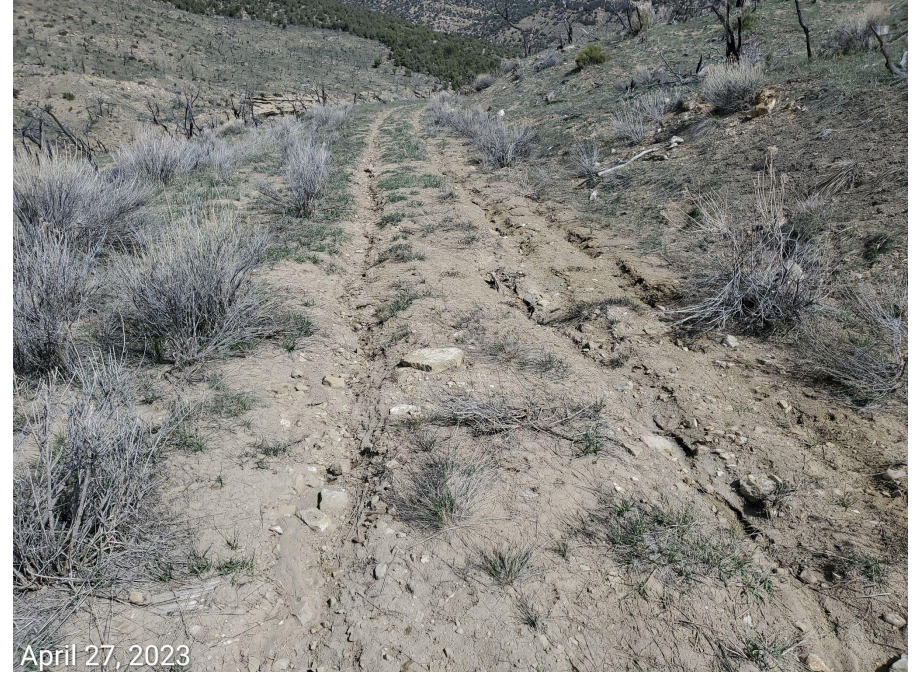
Photo 11: Photos 11-14 taken from the access road. Photos examples showing final reclamation including, but not limited to, compaction alleviation, recontouring/regrading and reclaiming has not been conducted on the entire access road. Photos also show erosion degradation at access road due to inadequate stormwater management. Access road intersects with Co Rd 122 at 40.076157°/-108.637129°.

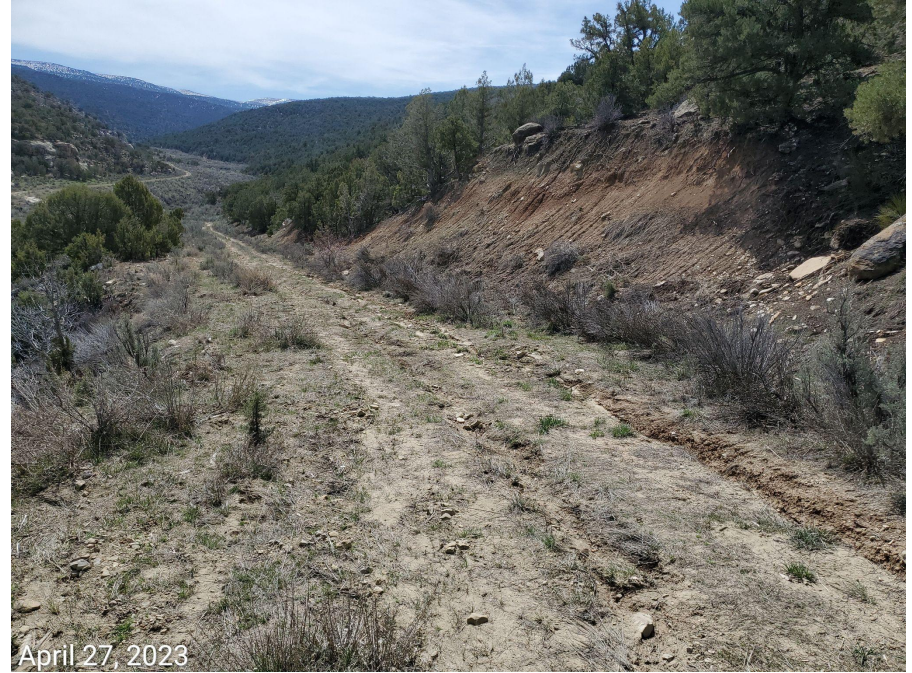
Photo 12: See comments under photo 11. Photo shows erosion degradation observed along cutslopes of the access road; slopes lack stabilization.

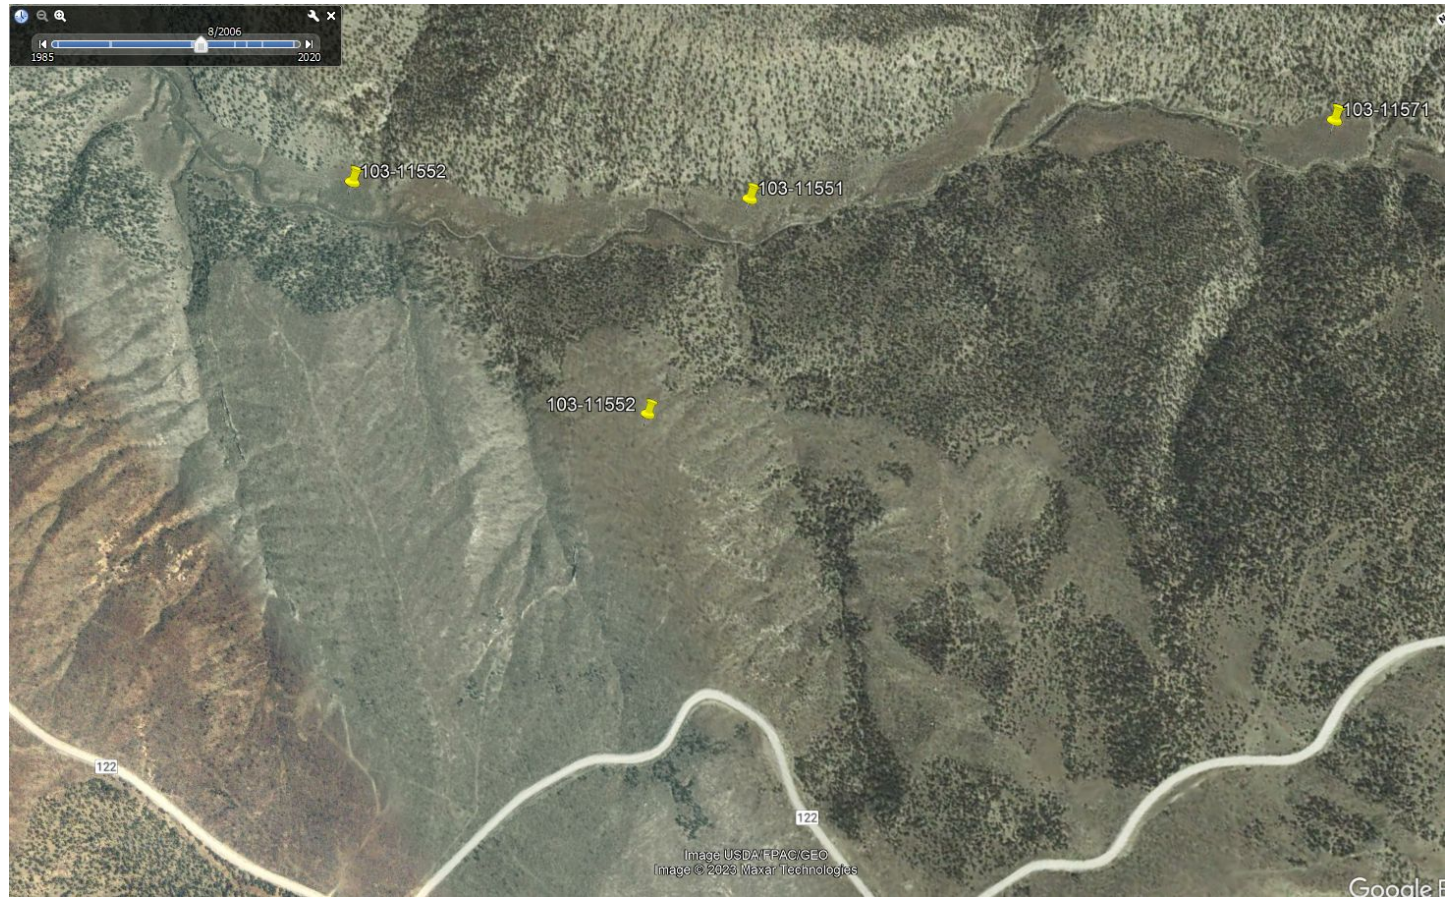
Photo 15: 2006 Google Earth aerial imagery showing the 4 expired Genesis Locations within the Fletcher Gulch Drainage, prior to construction of the Locations and access road—access roads did not exist prior to O&G disturbance.
