Inspection Photos

4/27/2023

Operator: GENESIS GAS & OIL COLORADO LLC
- 10384

Location Number: 413496
Rio Blanco County, CO

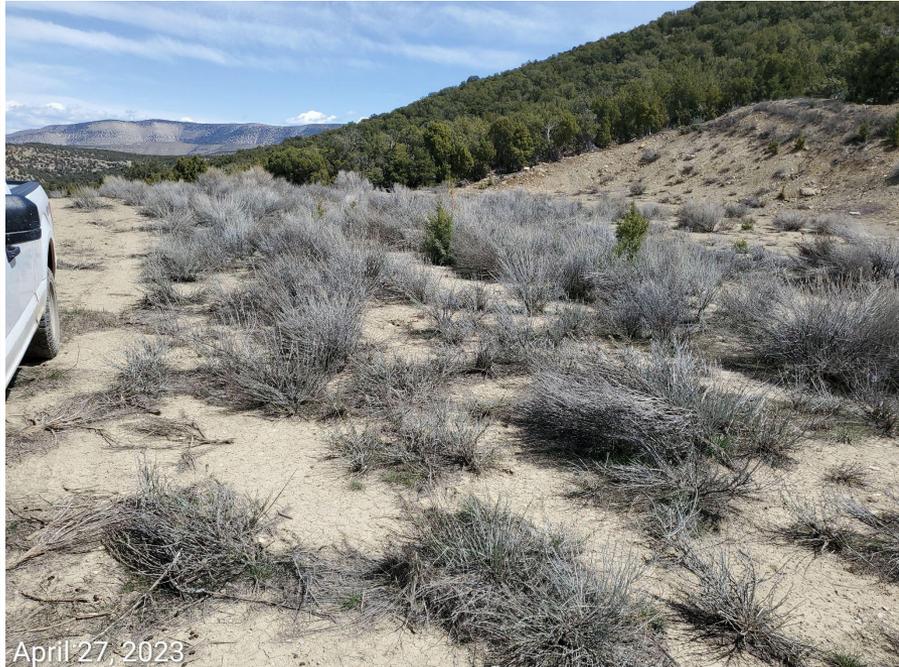
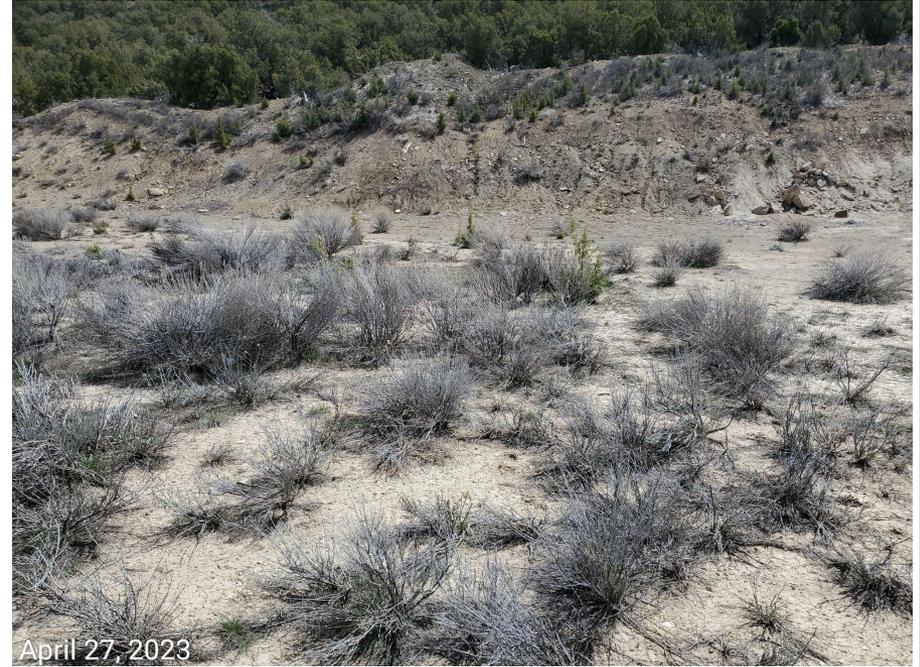
Photo 1: Photos 1-2 taken from the northwest end of the Location. Photos provide an overview of the Location from northeast, southeast, south to southwest. Photos show final reclamation including, but not limited to, compaction alleviation, recontouring/regrading and reclaiming has not been conducted on the Location.

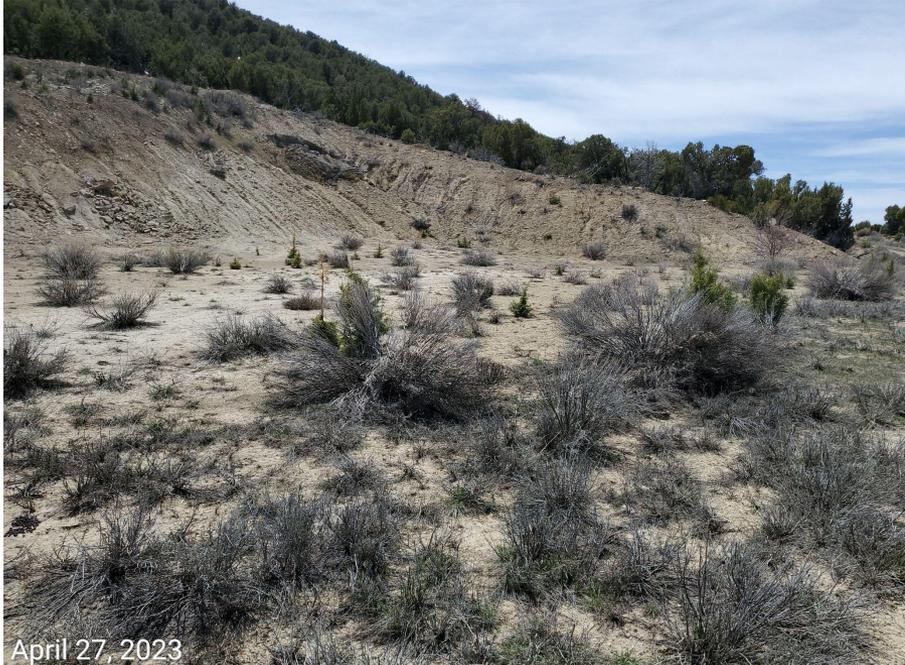
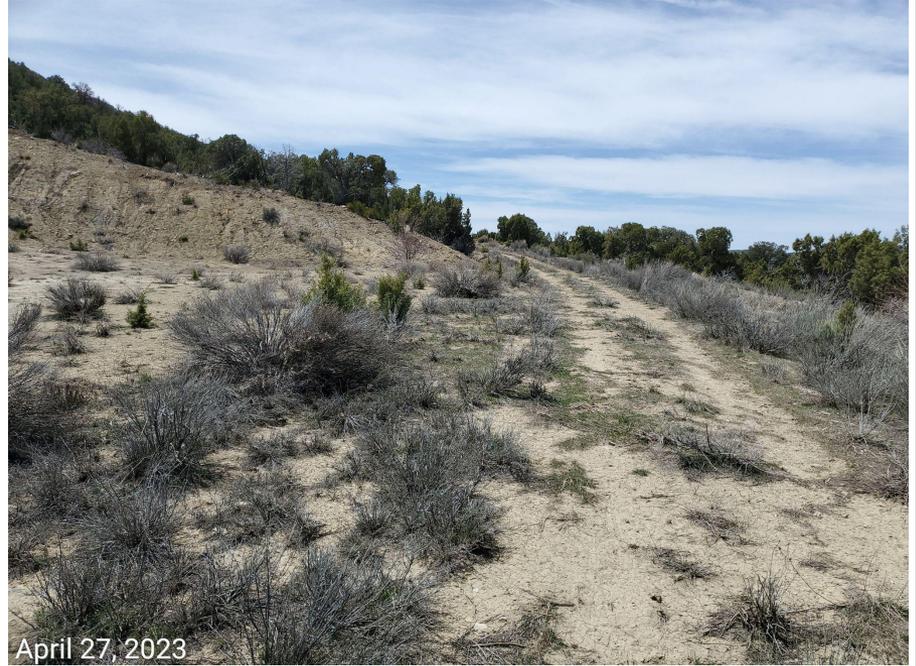
Photo 2: See comments under photo 1.

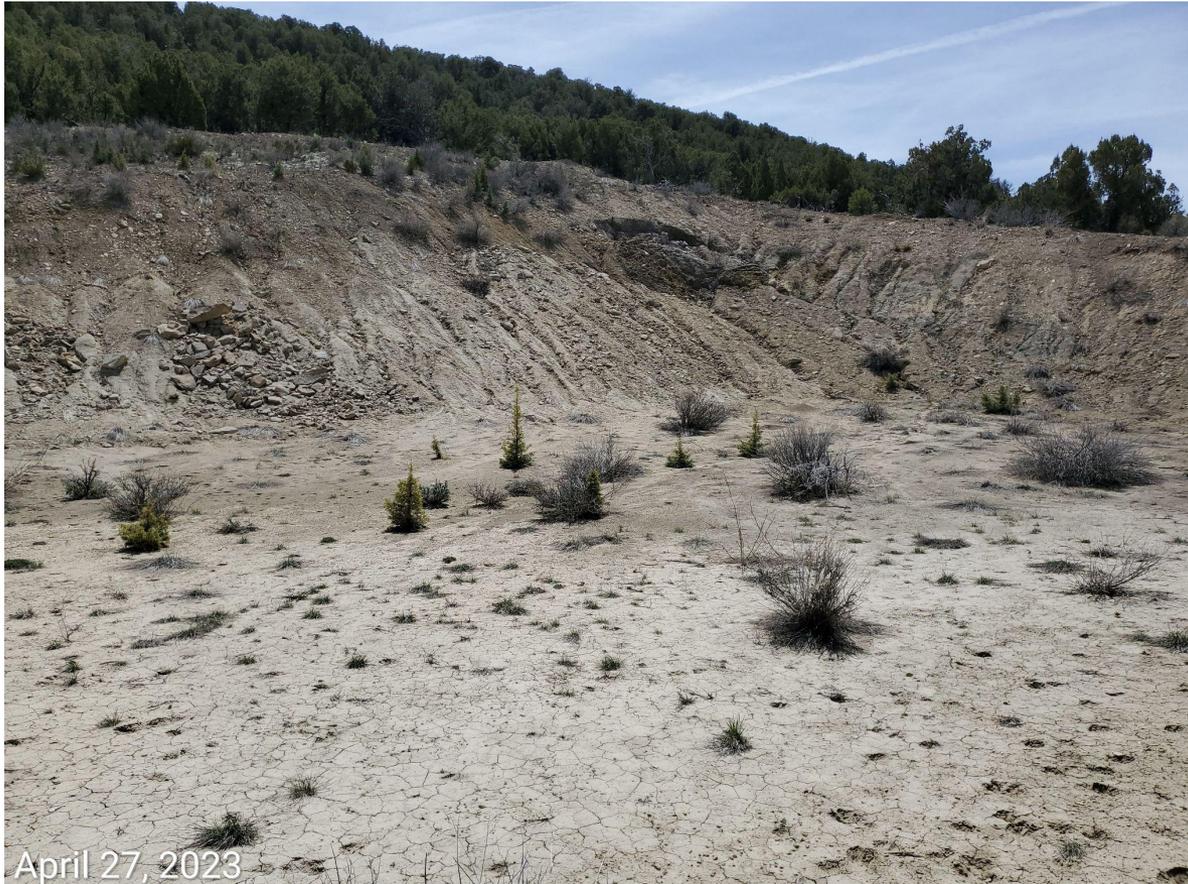
Photo 3: Photo taken from the Location, facing south. Photo shows stormwater and erosion control BMPs on the Location, including the cut slopes, remain missing or insufficient. Erosion degradation and mass soil movement has persisted.

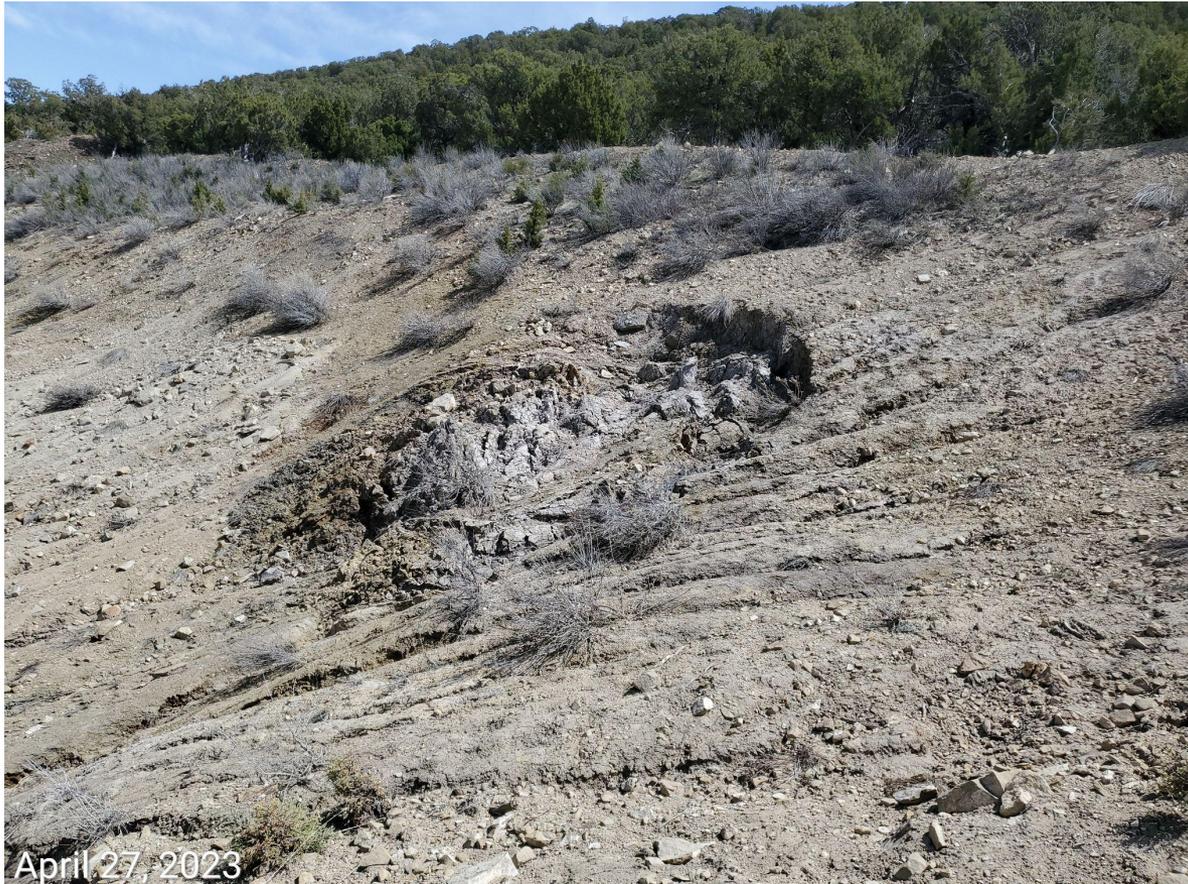
Photo 4: See comments under photo 3.

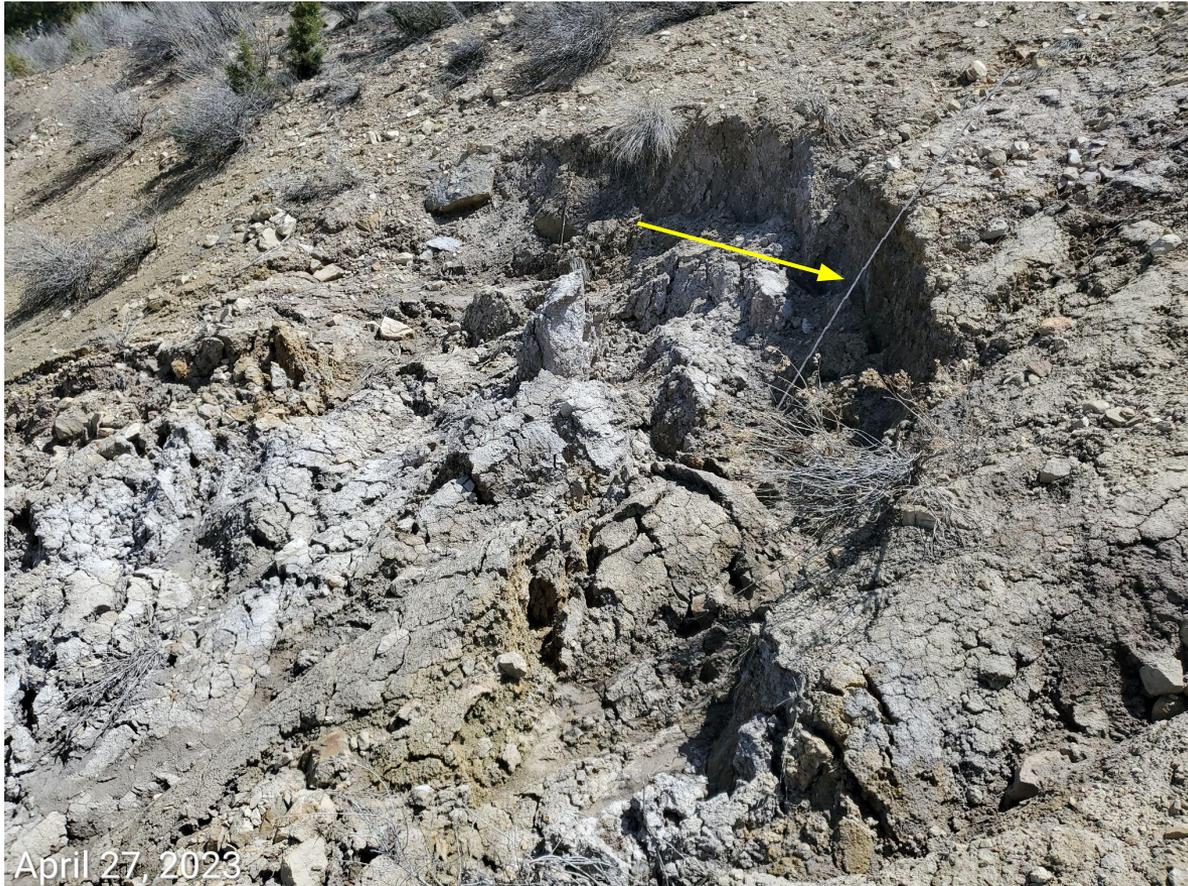
Photo 5: See comments under photo 3. 6 foot measuring stick (arrow) used for reference.

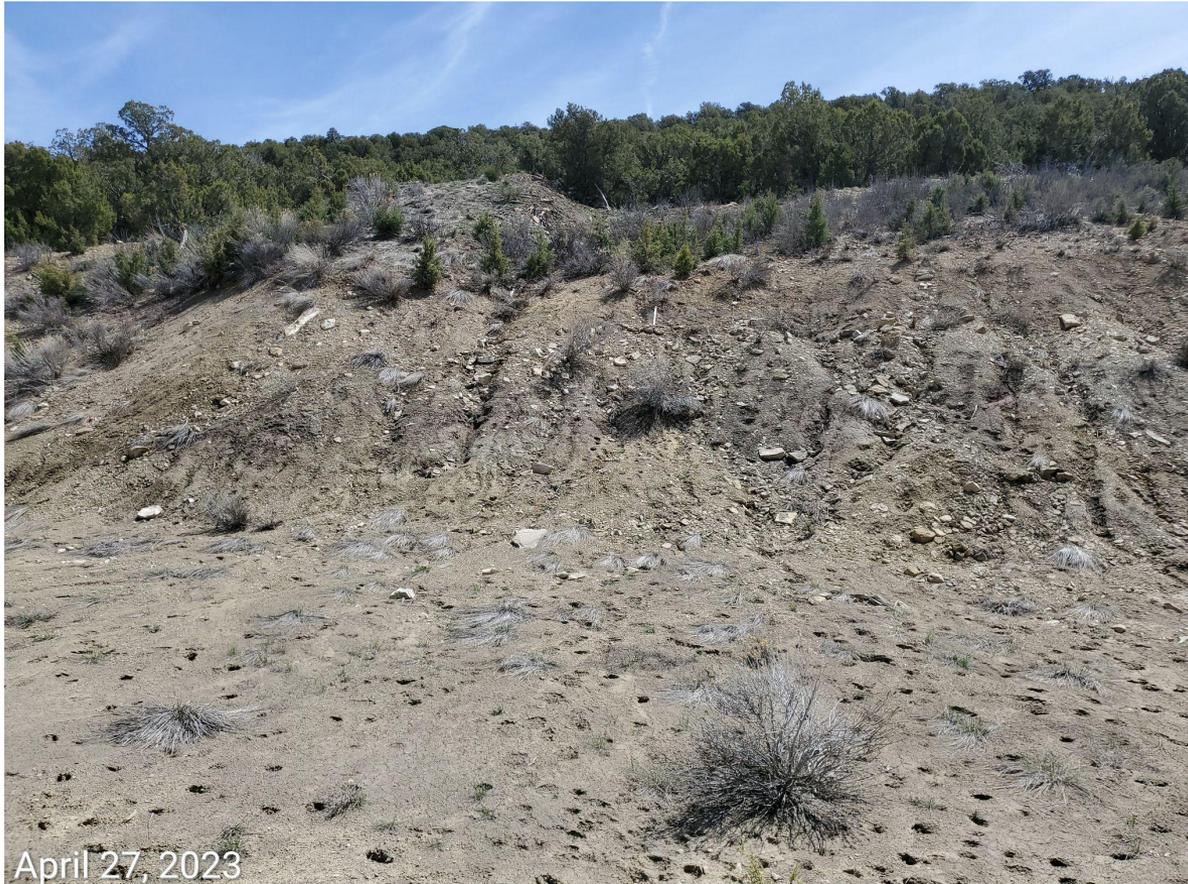
Photo 6: See comments under photo 3.

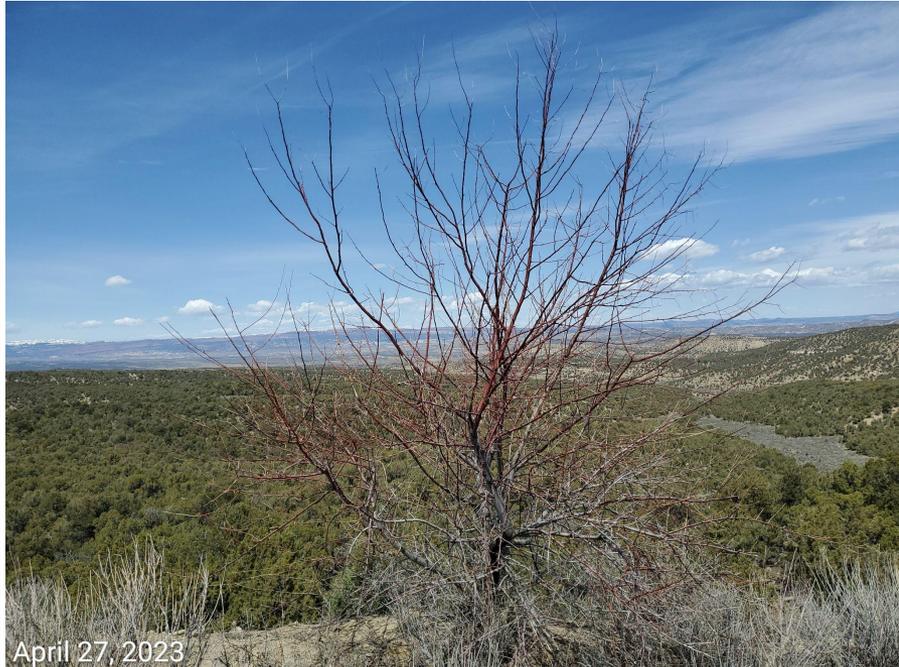
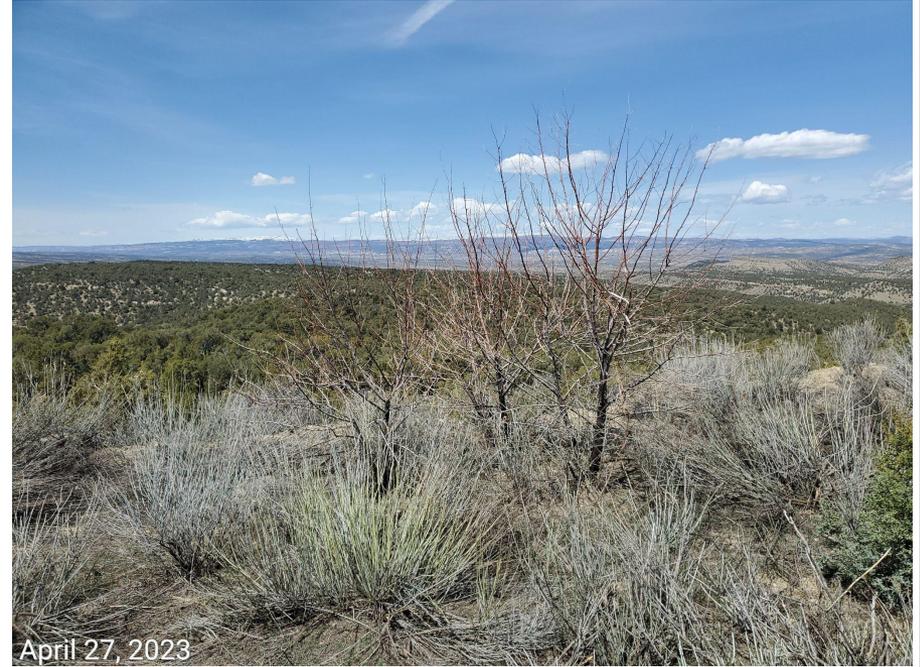
Photo 7: Photos taken from the north end of the Location. Photo provides examples of multiple Russian Olive plants observed established on the Location, and access road. Plant is an Undesirable Plant Species; pursuant to Rule 606.c, Operator shall keep Locations free of all Undesirable Plant Species

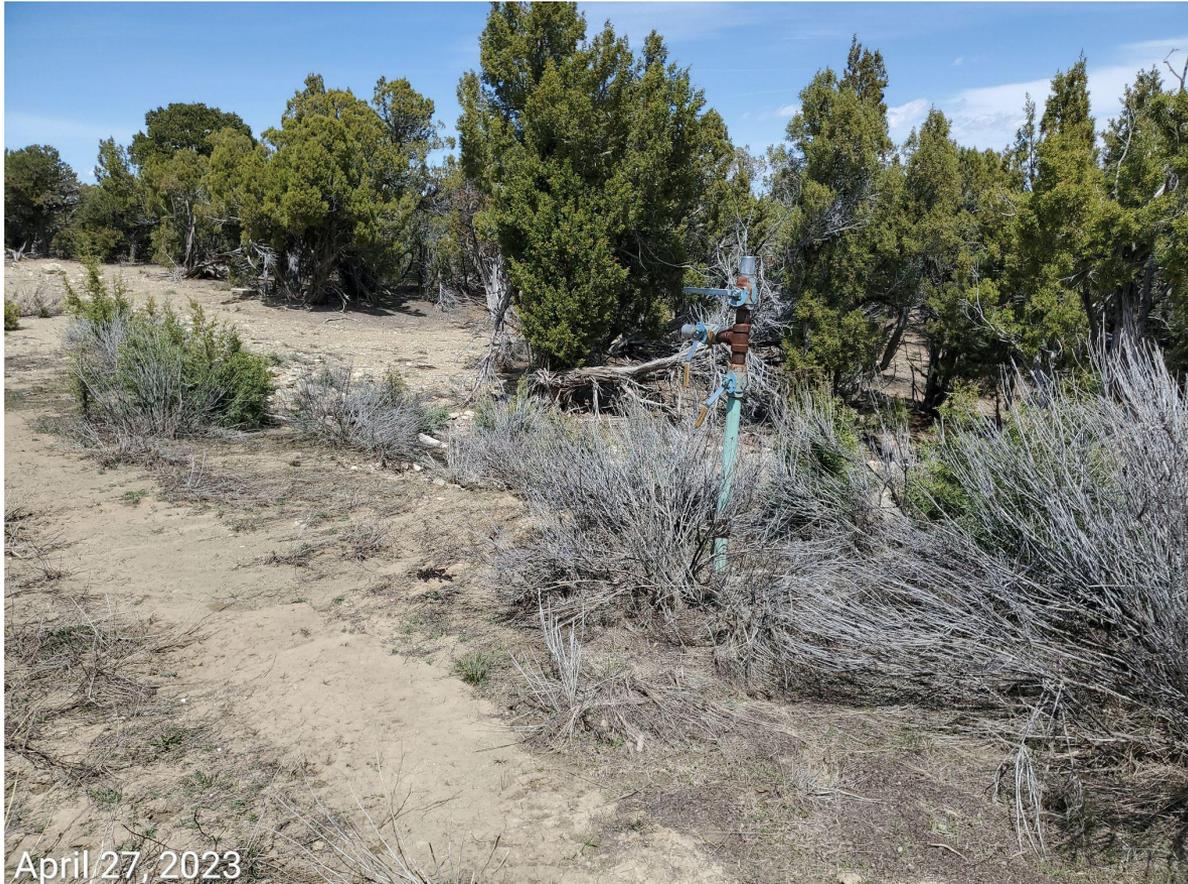
Photo 8: Example of surface equipment remaining along access road.

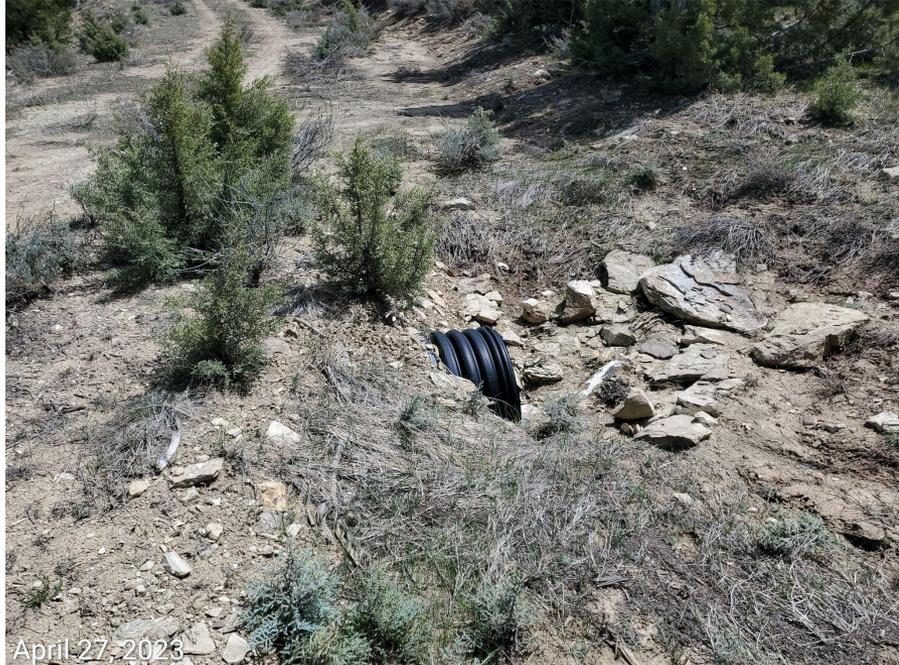
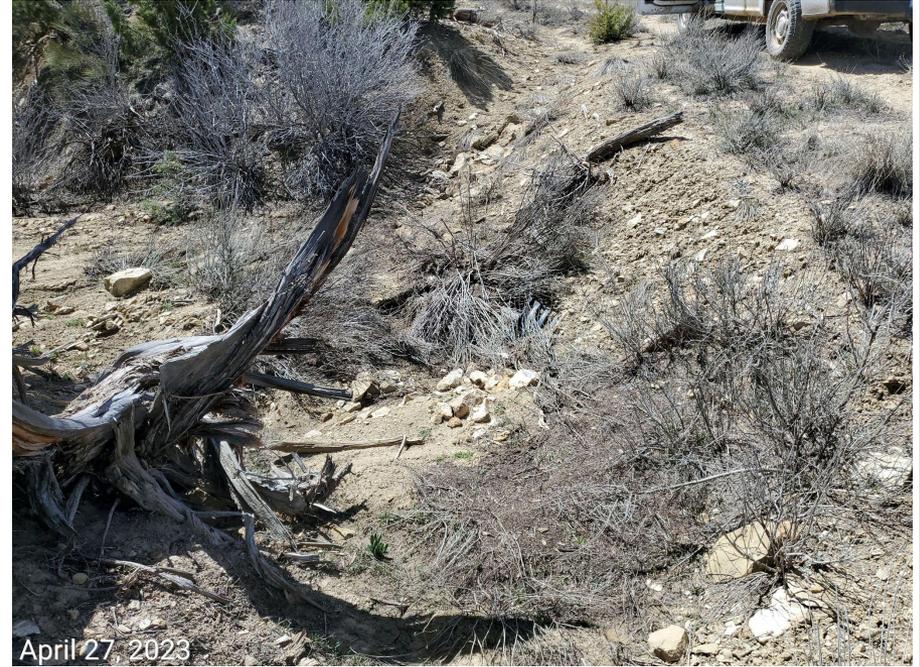
Photo 9: Photos taken from the access road. Photos examples showing final reclamation including, but not limited to, compaction alleviation, recontouring/regrading and reclaiming has not been conducted on the access road. Photos also examples of culverts observed remaining along the access road.

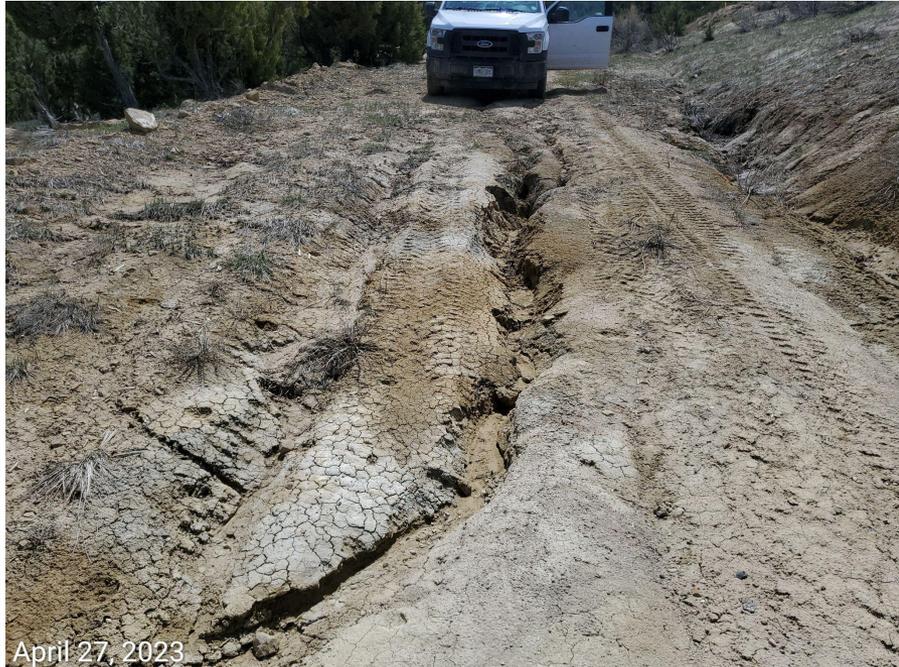
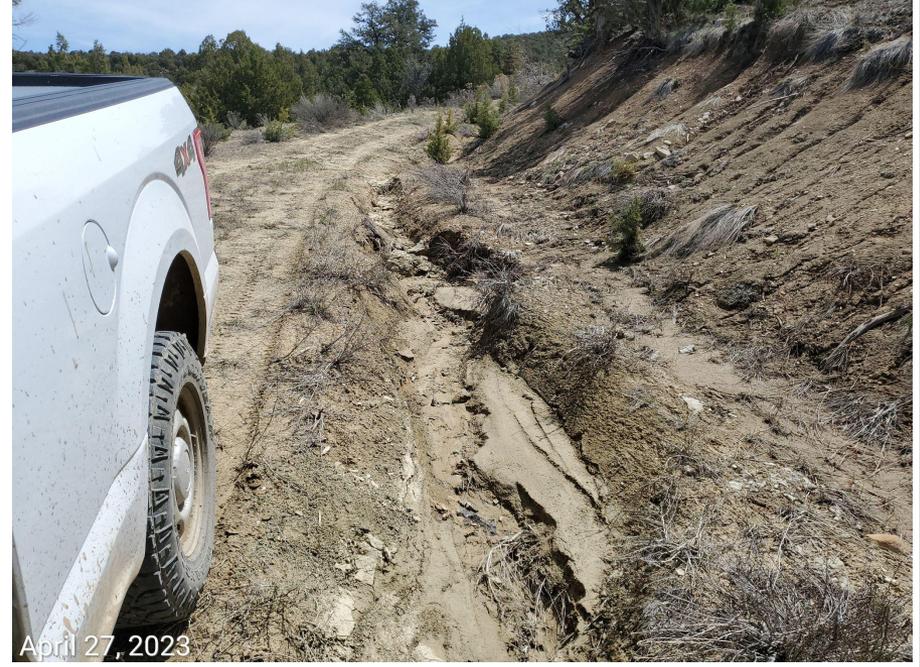
Photo 10: Photos 10-12 taken from the access road. Photos examples showing final reclamation including, but not limited to, compaction alleviation, recontouring/regrading and reclaiming has not been conducted on the entire access road. Photos also show erosion degradation at access road due to inadequate stormwater management and slope stabilization.

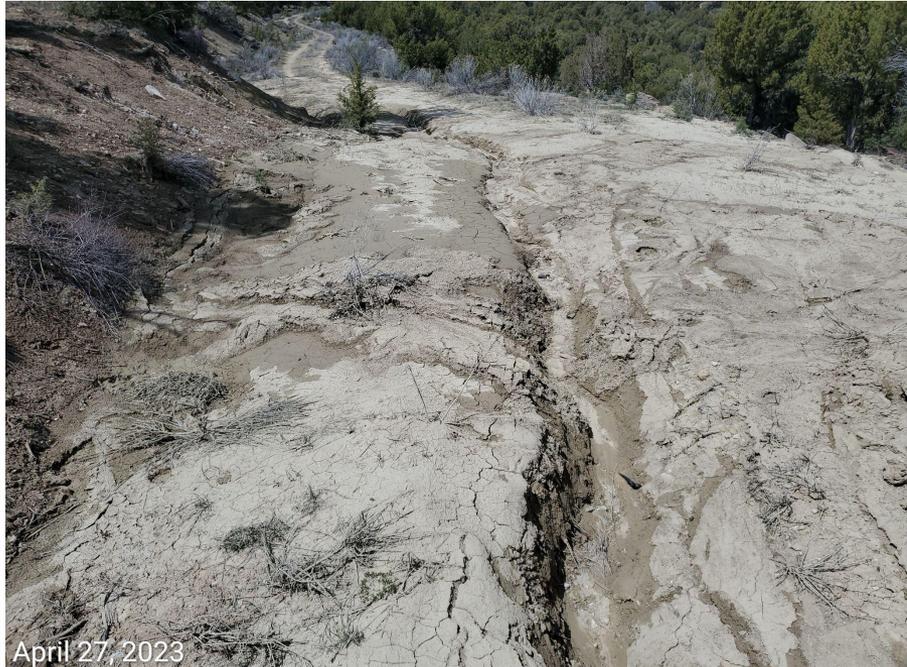
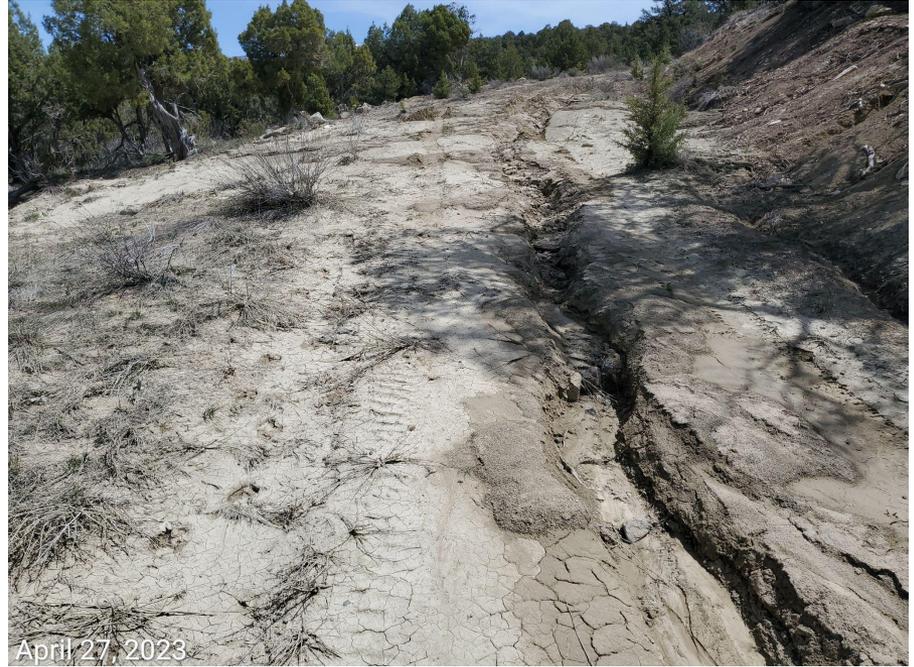
Photo 11: See comments under photo 10.

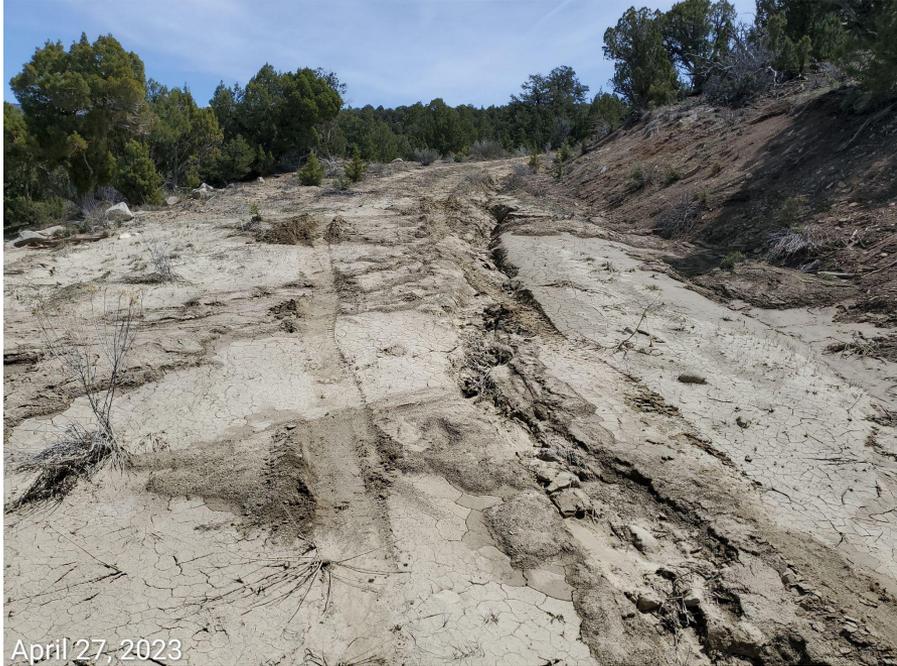
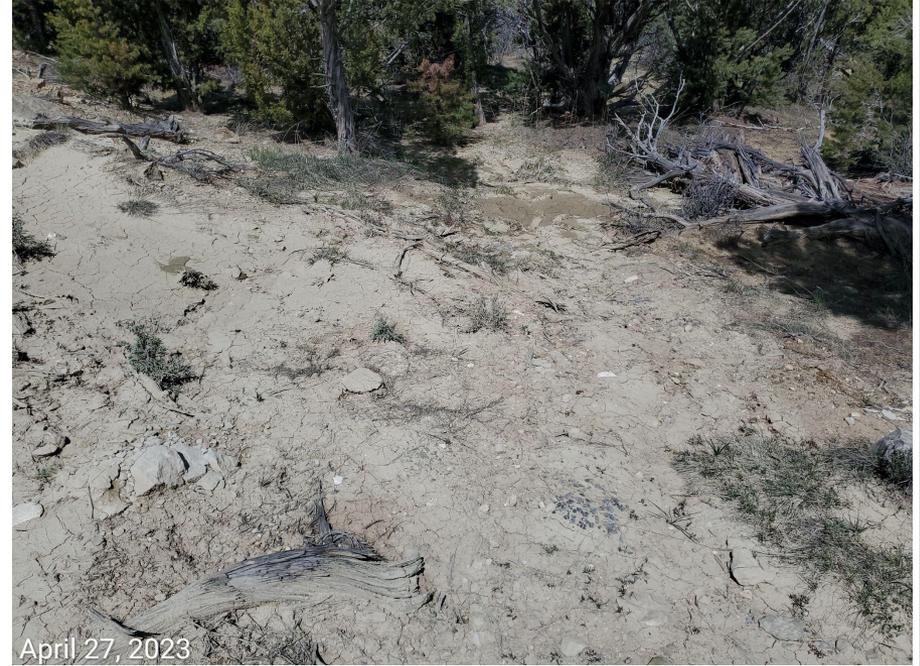
Photo 12: See comments under photo 10. Photo right shows sediment discharge/deposition from the access road.

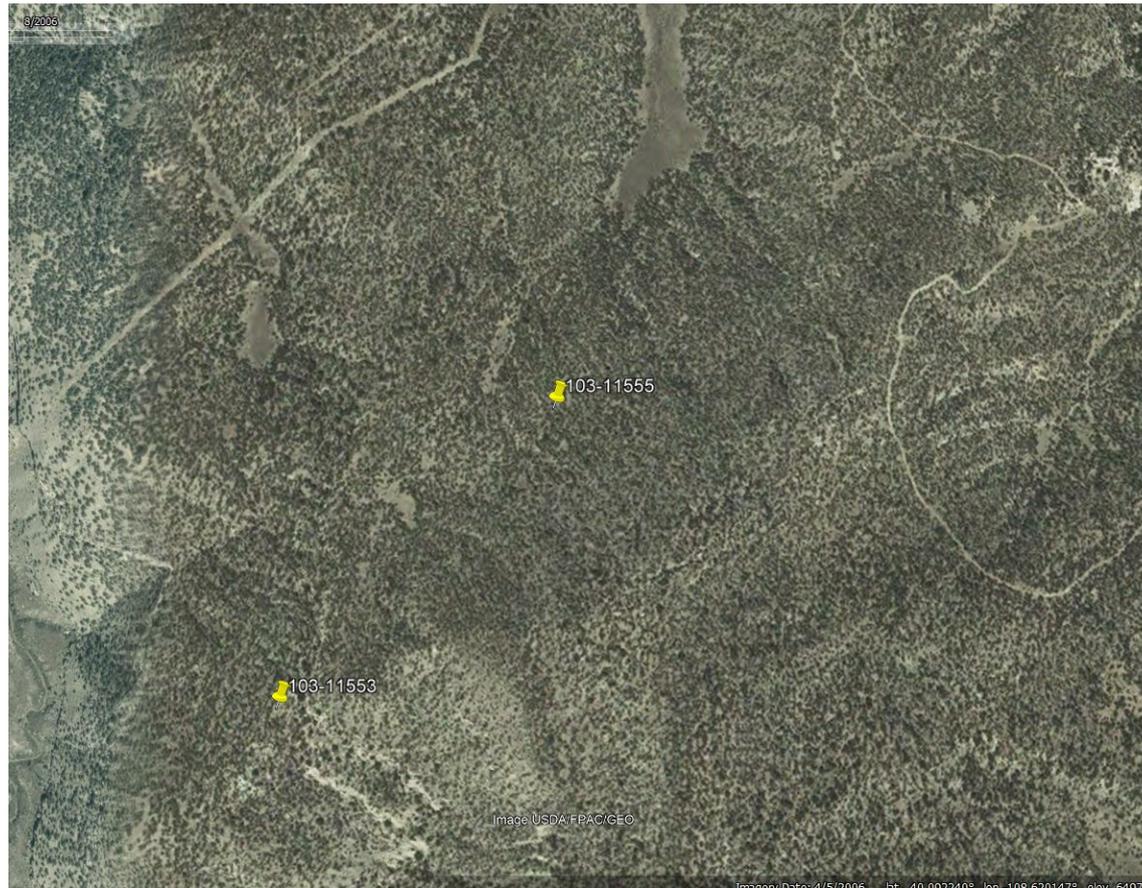
Photo 13: 2006 Google Earth aerial imagery showing the expired Genesis FGSU #4-12 and FGSU #33-42 Locations, prior to construction of the Locations and access road.

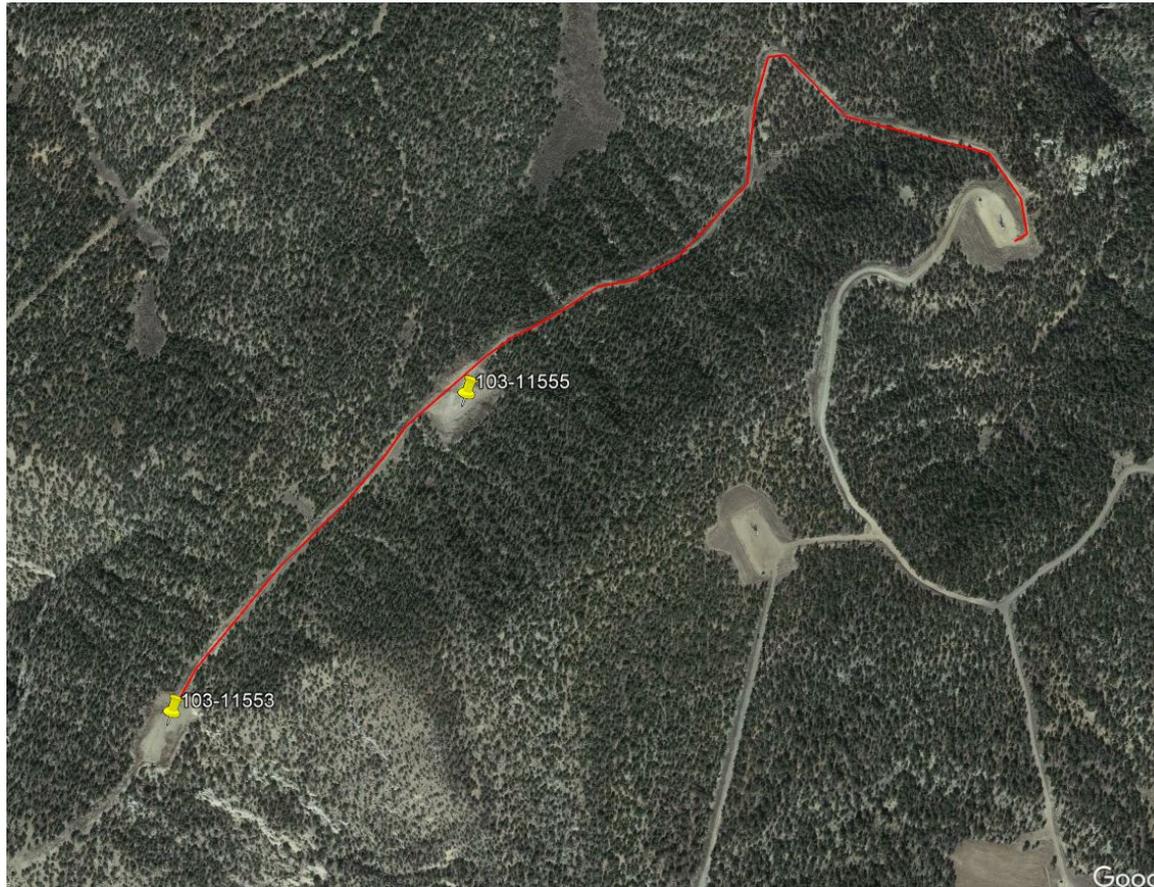
Photo 14: Google Earth aerial imagery showing the expired Genesis FGSU #4-12 and FGSU #33-42 Locations constructed within the Fletcher Gulch Drainage, and the access road leading to the Locations. Locations/Access roads subject to 1004 Reclamation.
