Final Reclamation Inspection

Operator: PDC ENERGY INC - 69175

Location ID: 305495

Inspection Photos
Location Name: CORNISH #22-3
Location ID: 305495

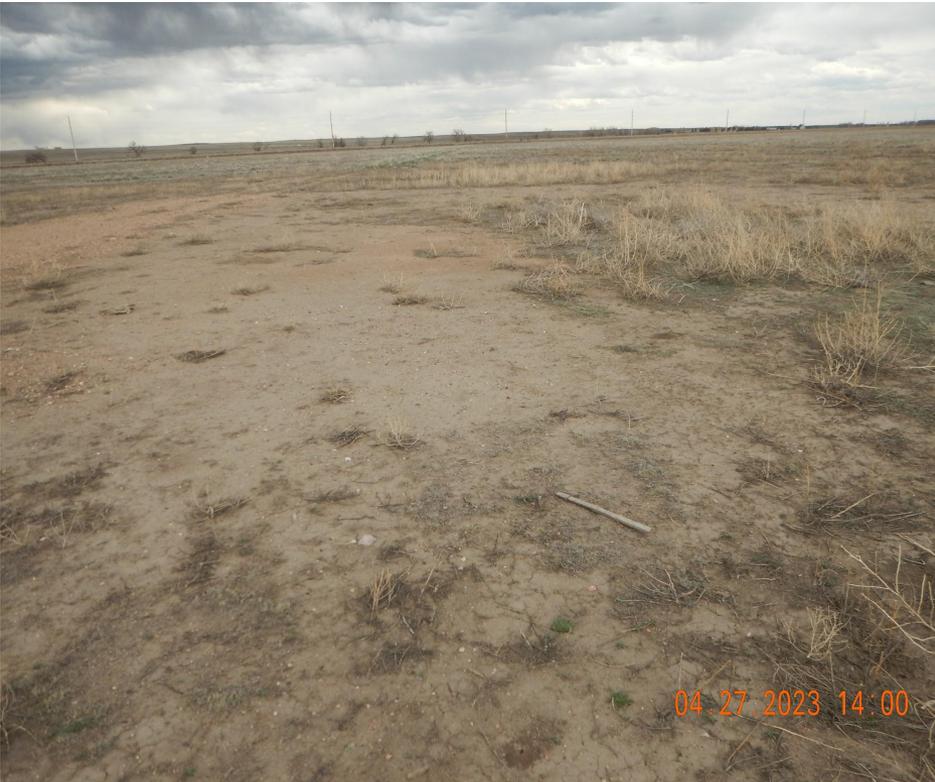
Photo 1. Photo taken from the well location, facing South. Photo illustrates the well location is mostly bare ground and weedy, annual vegetation.

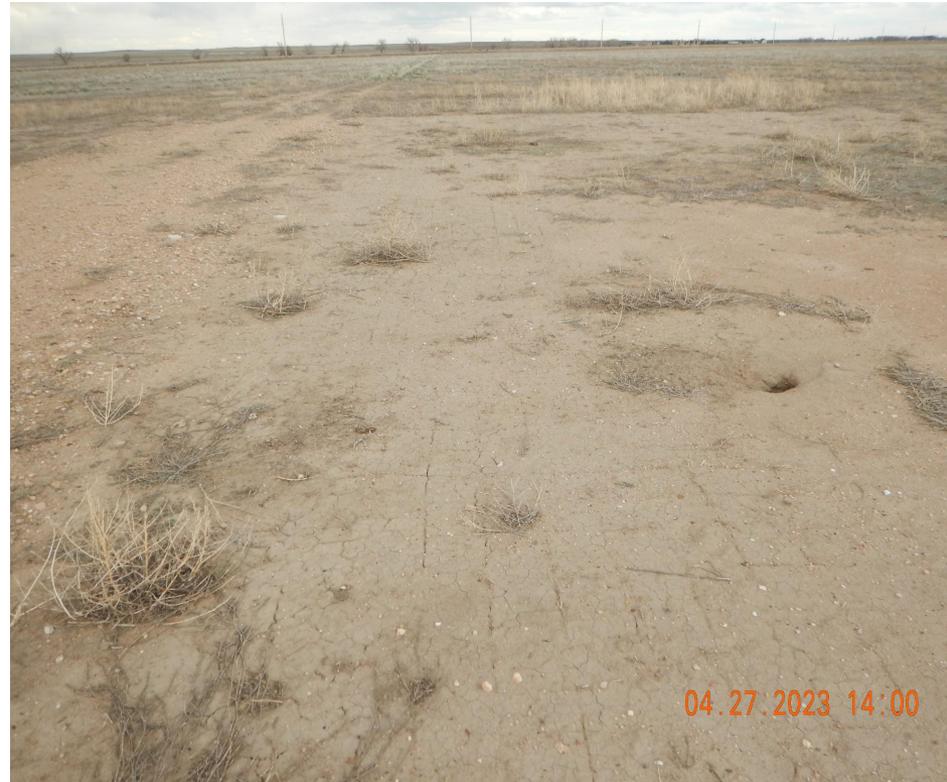
Photo 2. Photo taken from the well location, facing South. Photo is illustrating the well location was seeded with the evidence of drill rows but no germination.

Note- well location access road remains due to TA'ed wells from another Operator (Noble).

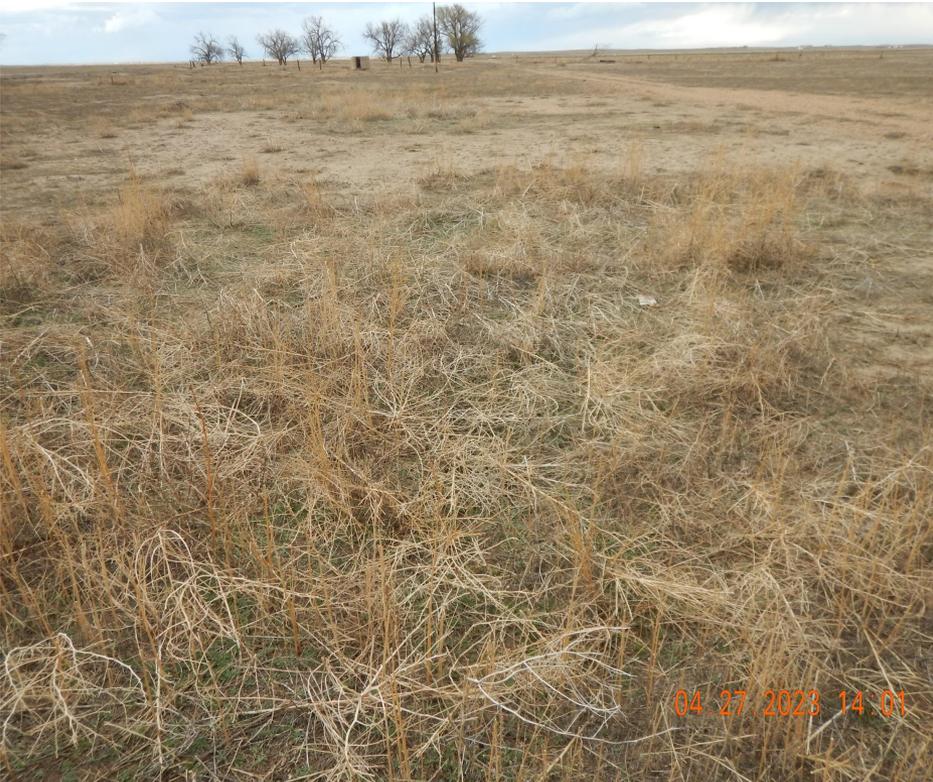
Photo 3. Photo taken from the well location, facing North. See comments under Photo 1.

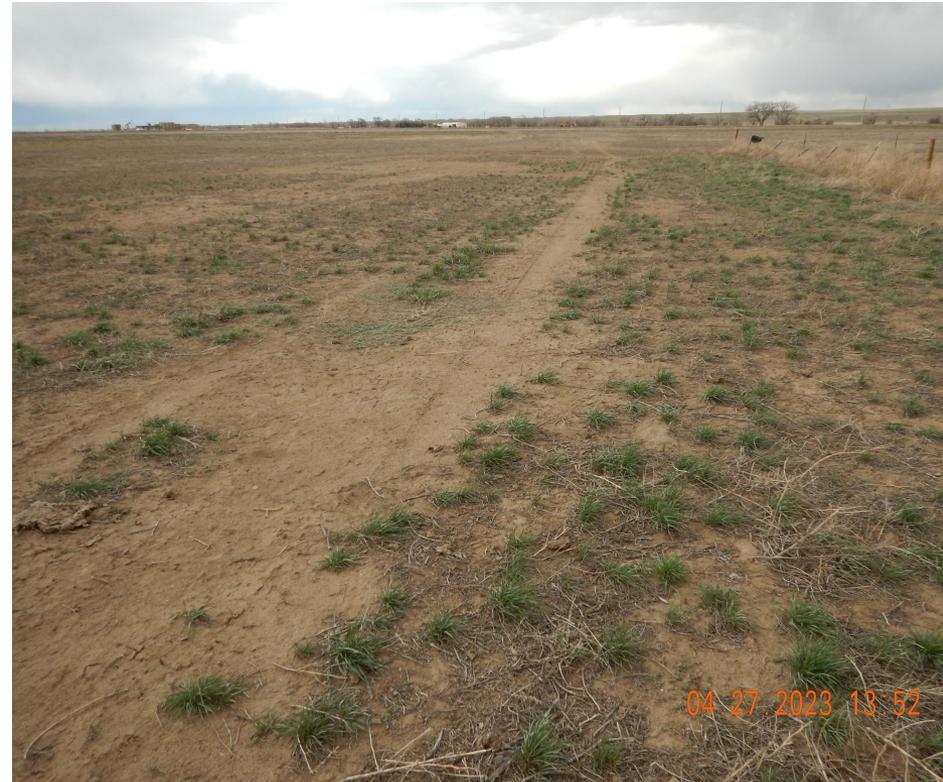
Photo 4. Photo taken from the associated offsite tank battery, facing East. Photo illustrates the establishment of desirable species (Crested wheatgrass) but there are bare patches which are not reflective of reference areas.

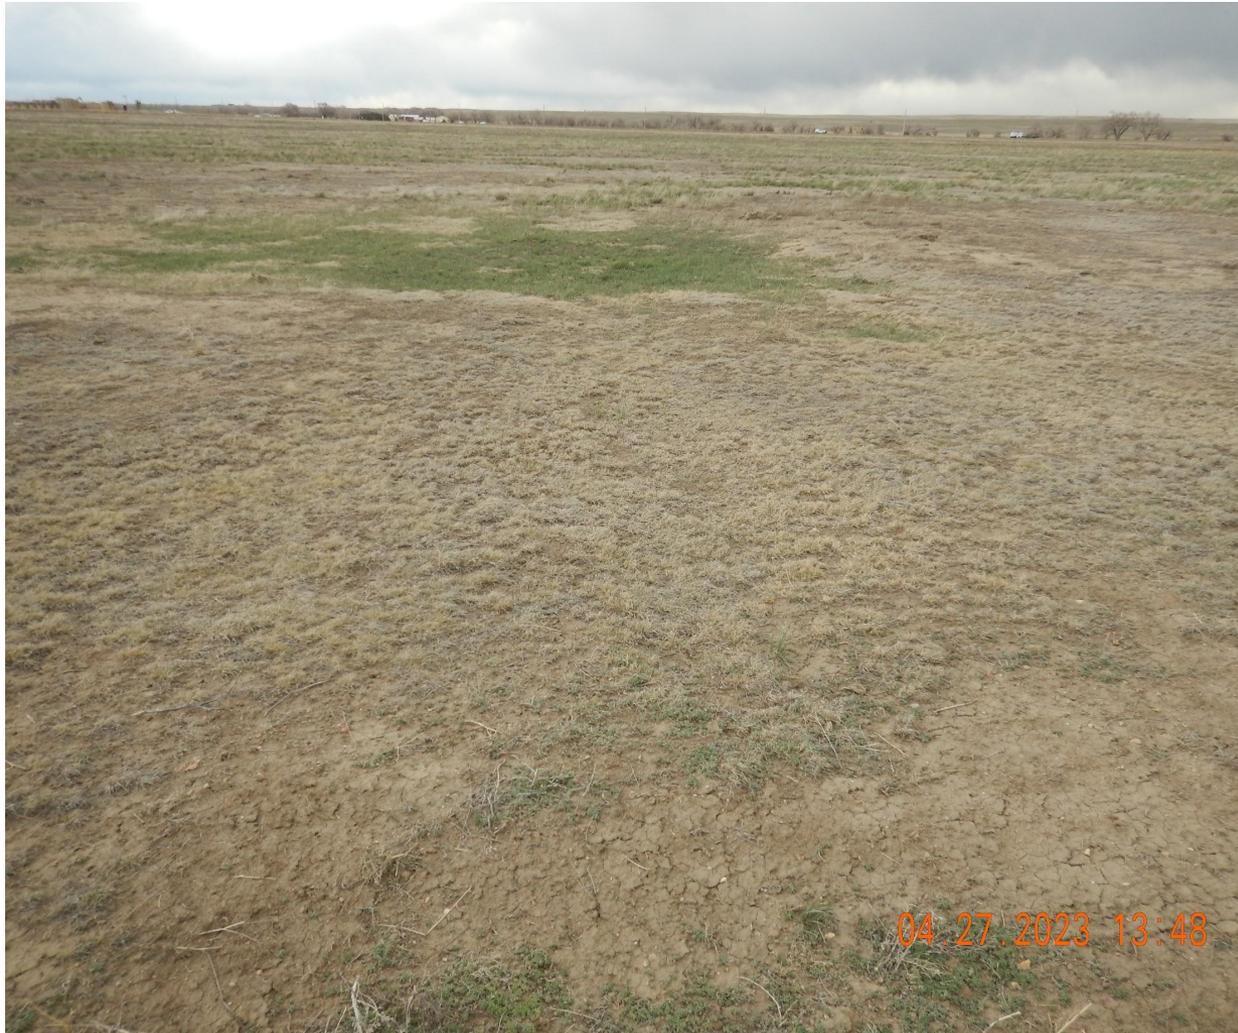
Photo 5. Reference photo taken north of the well location, facing East.
