# Interim Reclamation and Stormwater Inspection

Operator: FUNDARE RESOURCES OPERATING  
COMPANY LLC - 10773

Location ID: 442134

Inspection Photos  
Location Name: Razor 30J Pad  
Location ID: 442134

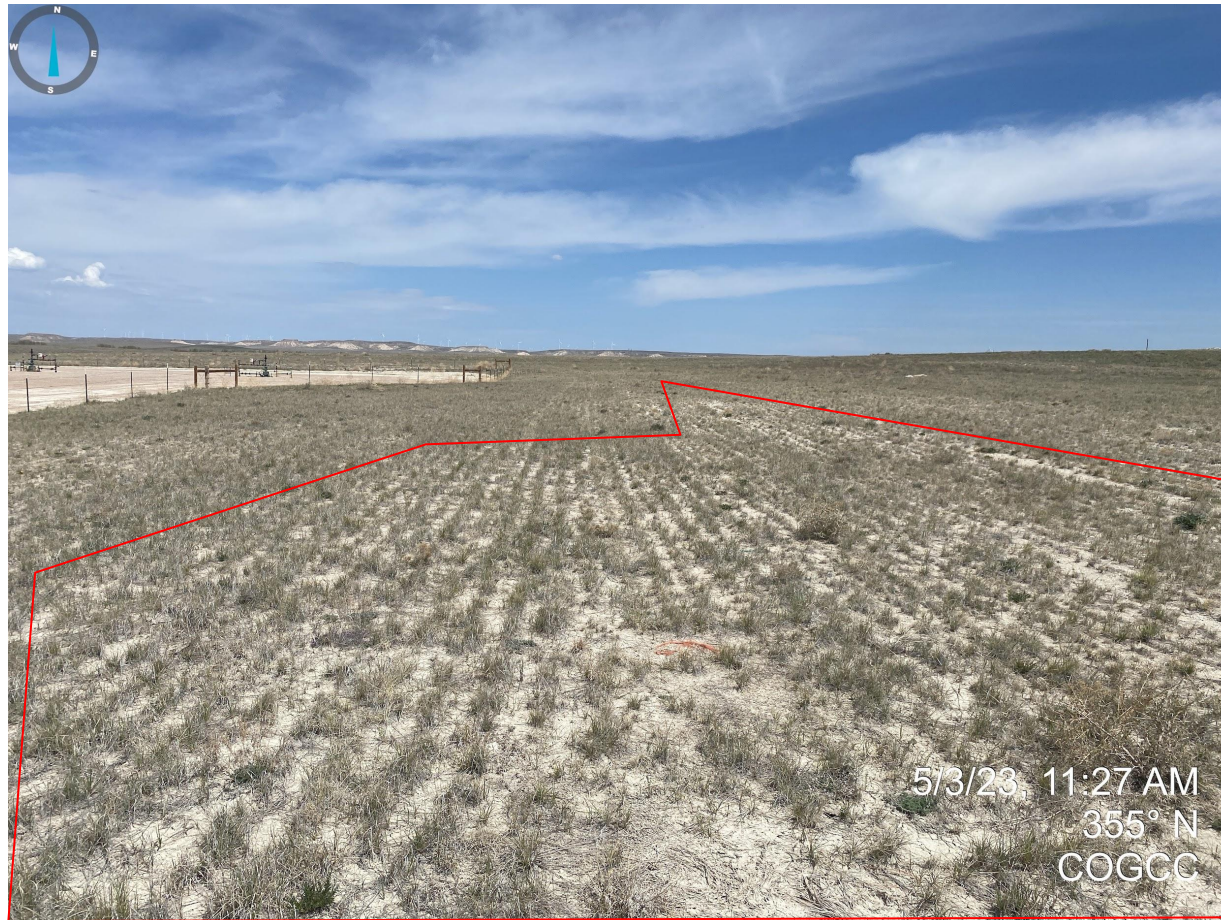
**Photo 1.** Taken from the eastern portion of the reclaimed area. Photo illustrates that desirable perennial plant species are evident throughout the interim areas. However, portions of the reclaimed areas don't appear to be progressing towards Rule 1003 standards with evidence of non-uniform vegetation cover resulting in areas of bare soil, highlighted in red.

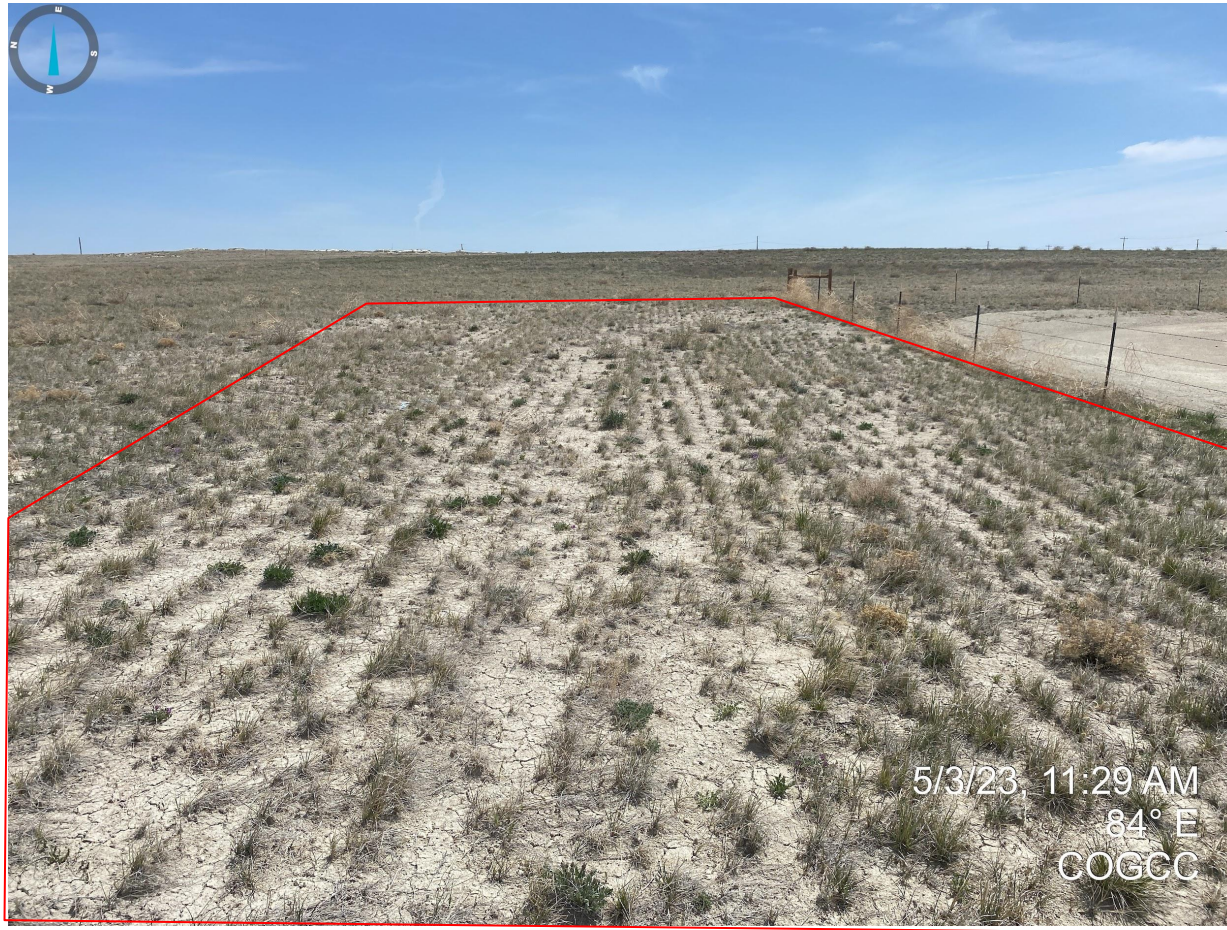
**Photo 2.** Taken from the northern portion of the reclaimed areas; see comments in Photo 1.

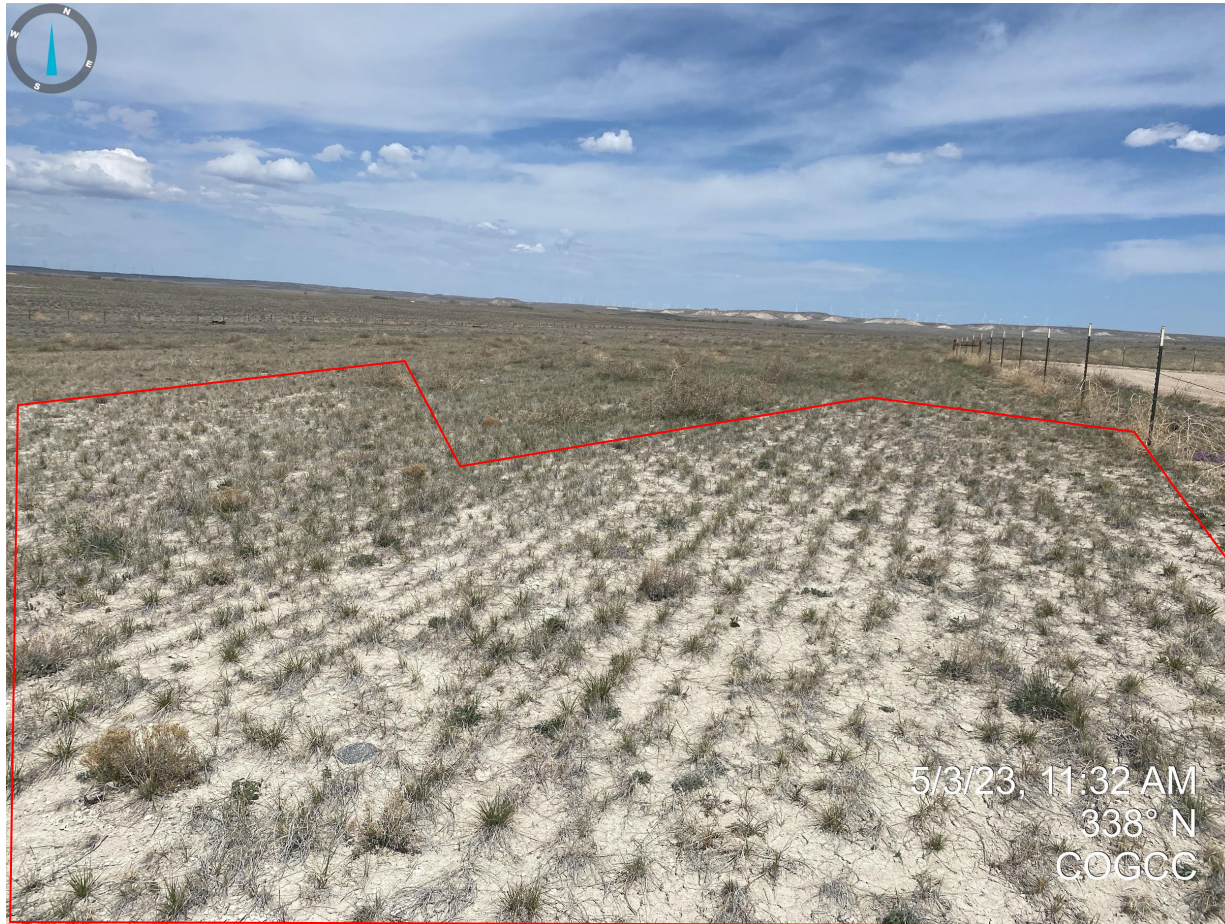
**Photo 3.** Taken from the western portion of the reclaimed areas; see comments in Photo 1.

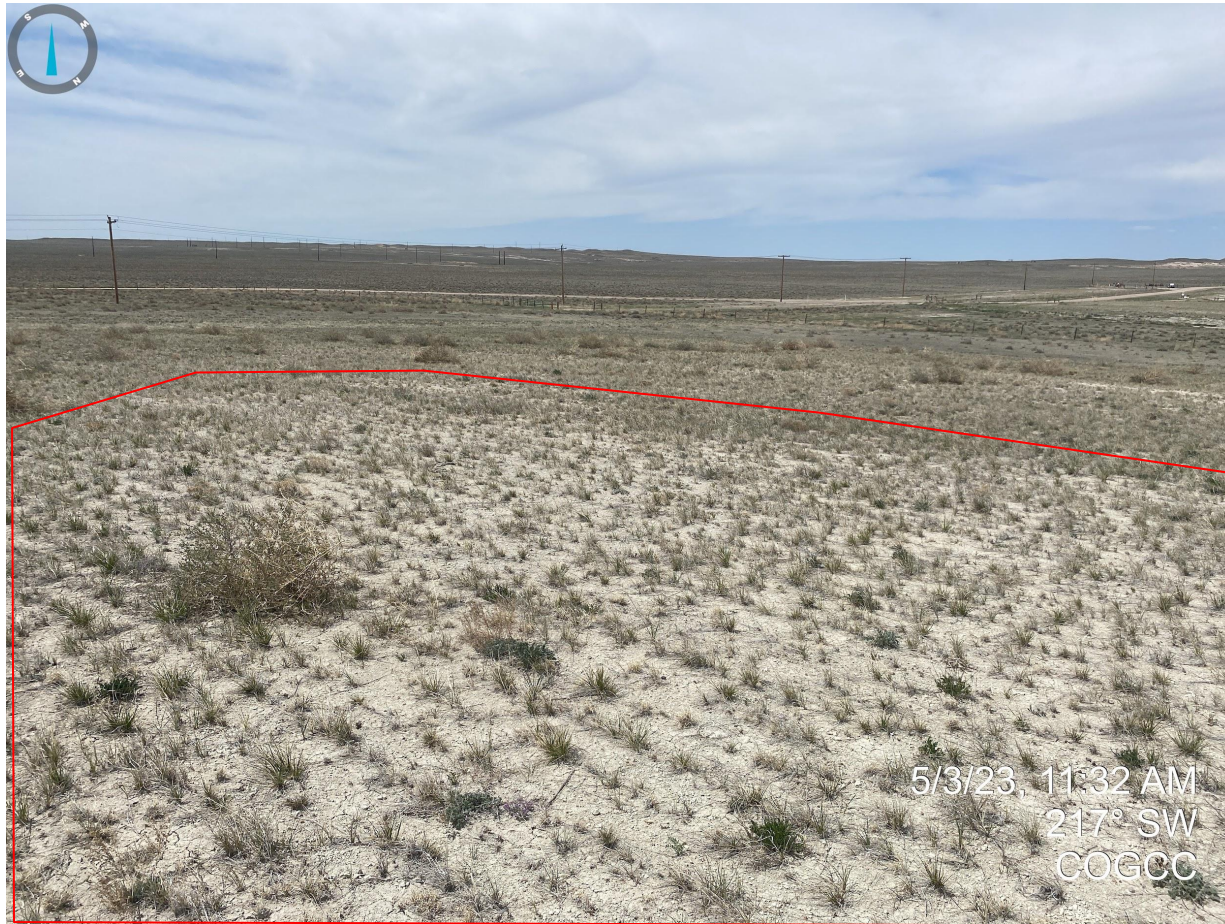
**Photo 4.** Taken from the southern portion of the reclaimed areas; see comments in Photo 1.

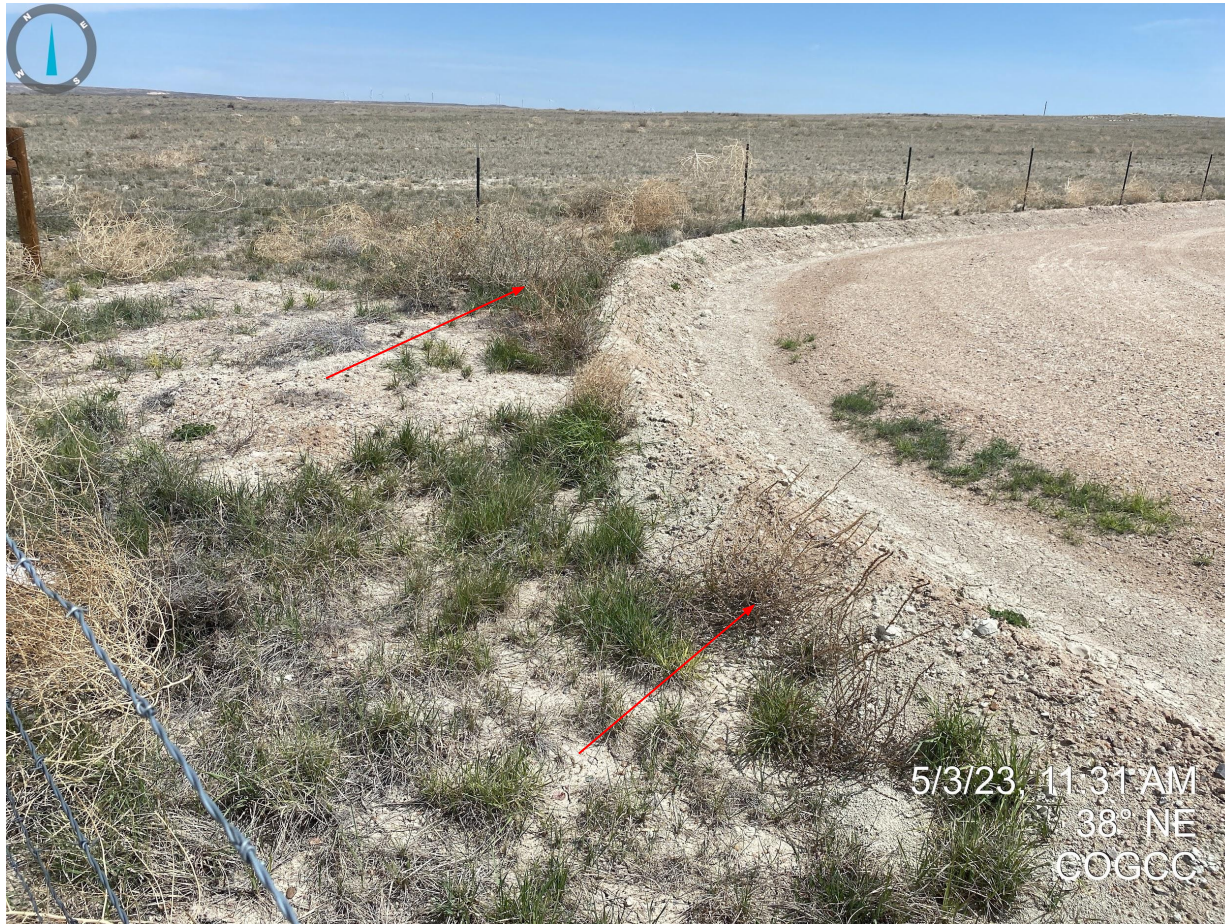
**Photo 5.** Example of russian thistle observed within the production area. Undesirable plant species will need to be properly managed for during the next local growing season.

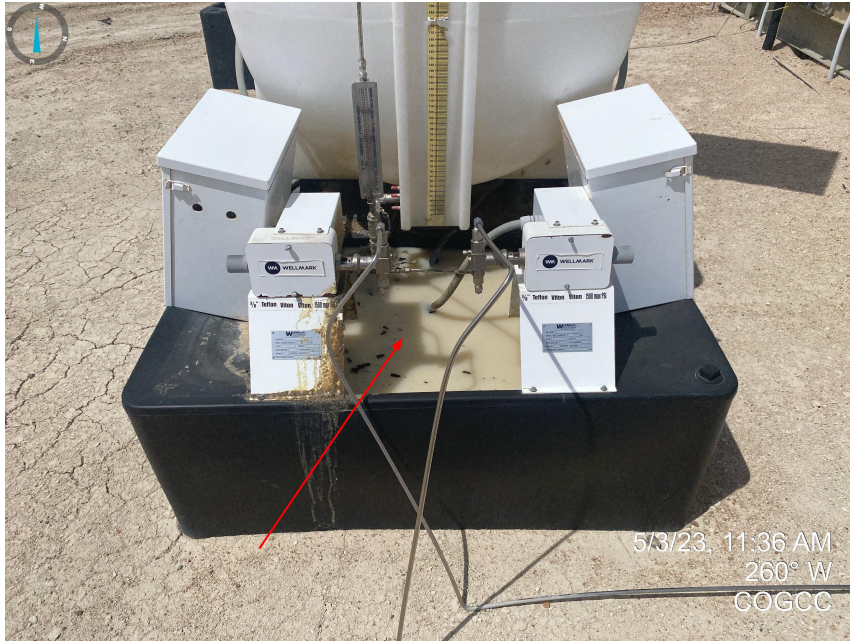
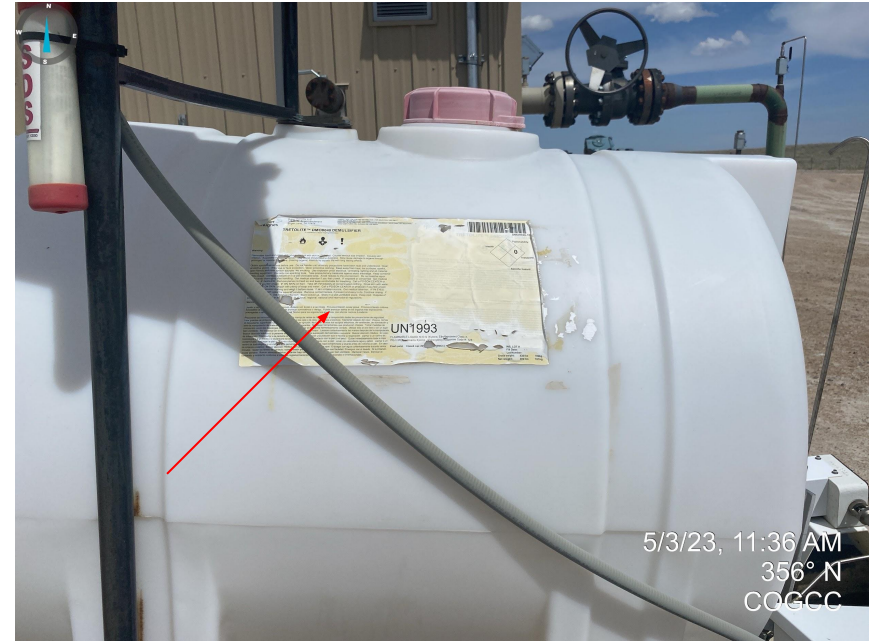
**Photos 6 & 7.** Unknown fluid observed pooling on top of the secondary containment will need to be properly cleaned up/disposed of. Also pictured, tank label that is peeling, faded, and cracked; label/placard will need to be replaced.
