# Inspection Photos

ID: 150396

Operator: CHEMCO INC

Inspection Date: 5/15/2023

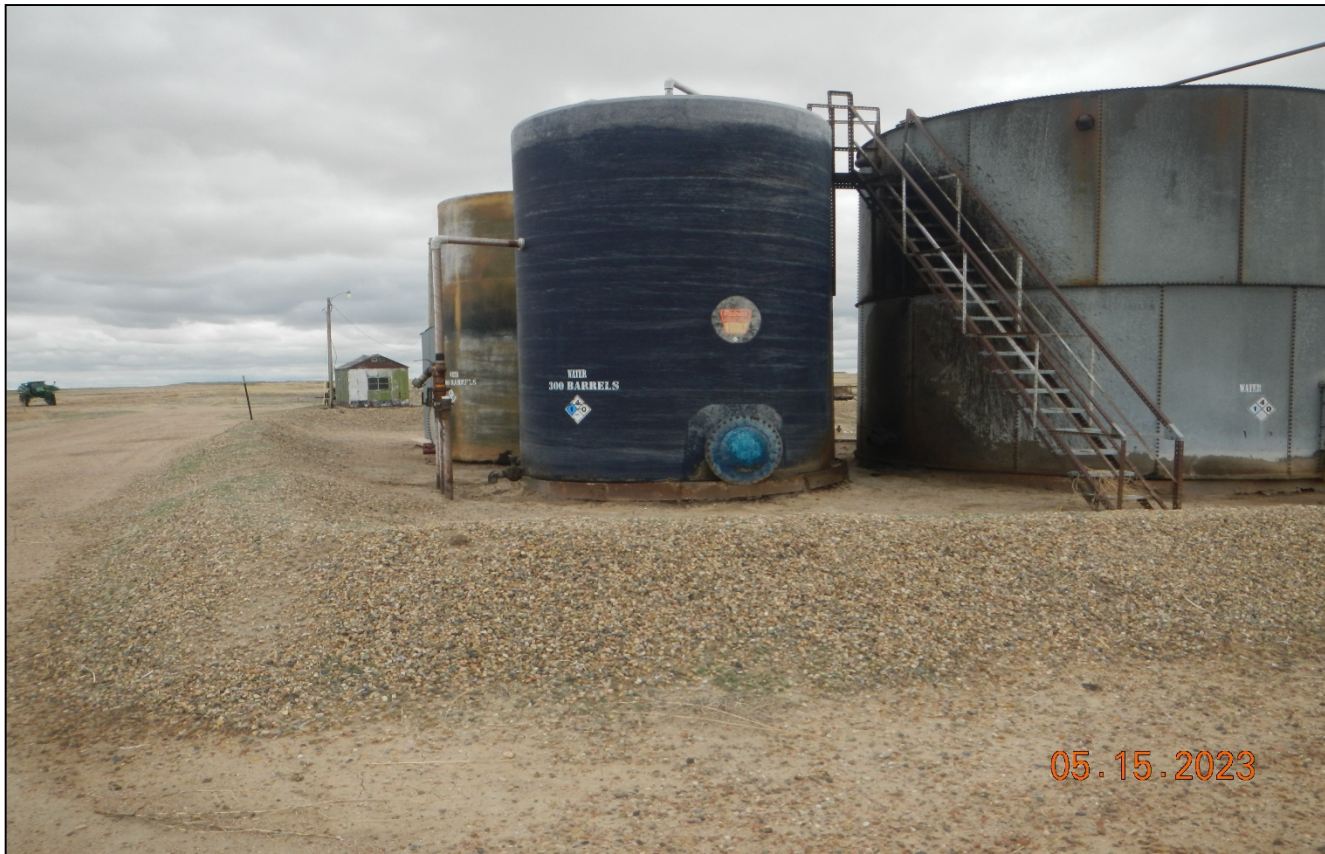
**Photo 1.** Facing southeast toward the tank battery. Stained soils appear to be cleaned up at the west side of the tanks.

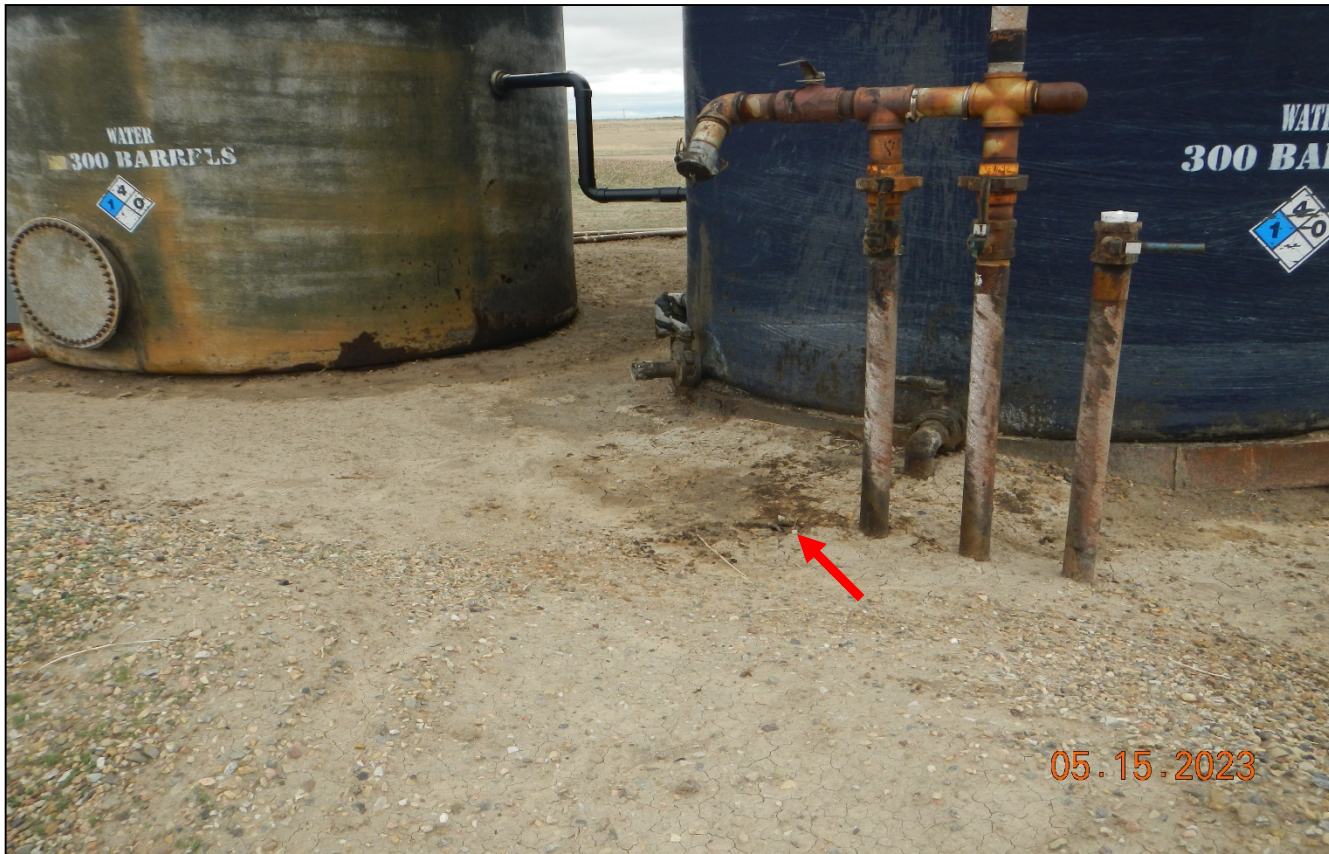
**Photo 2.** There is still oil stained soil around the tank from a spill contained inside the bermed area.

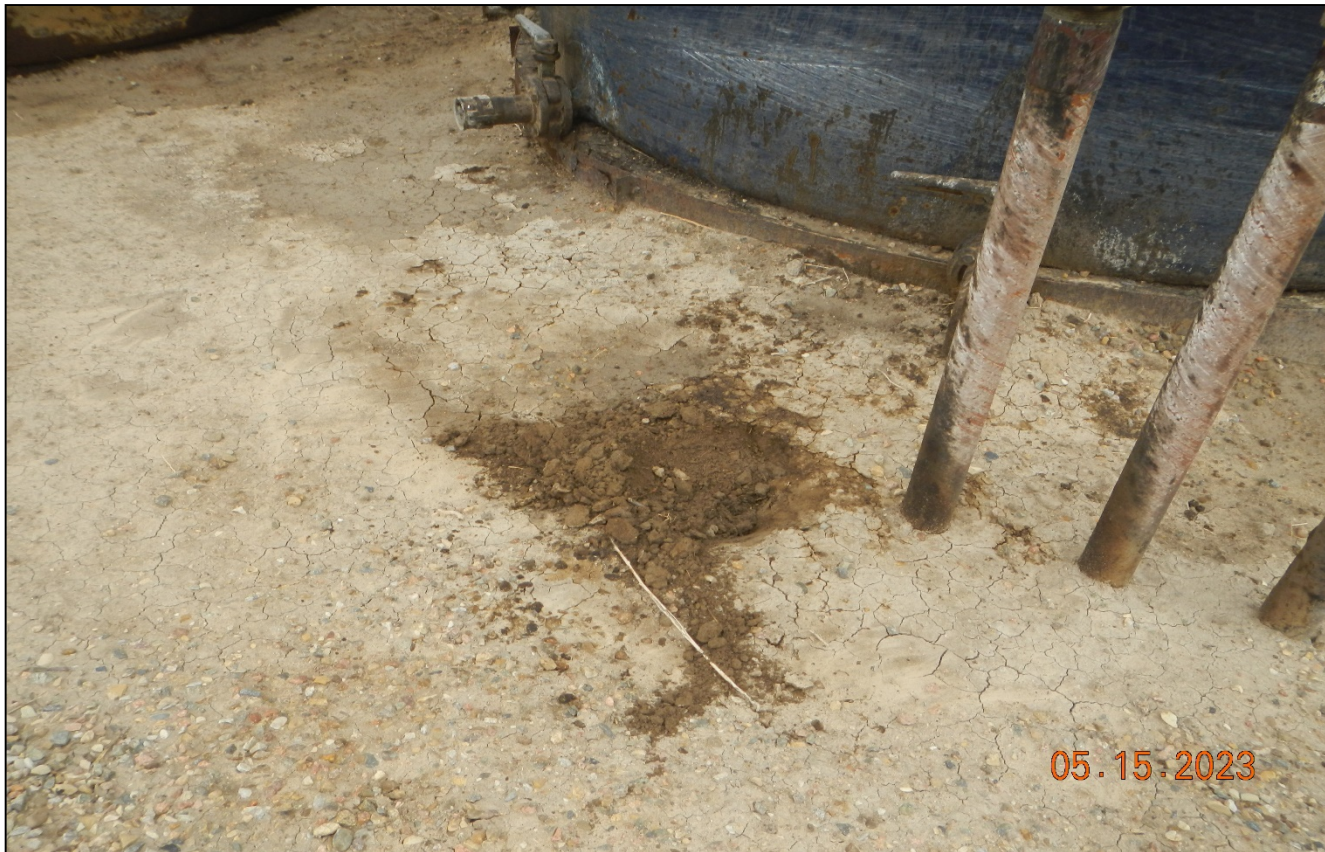
**Photo 3.** There is still oil stained soil around the tank from a spill contained inside the bermed area.

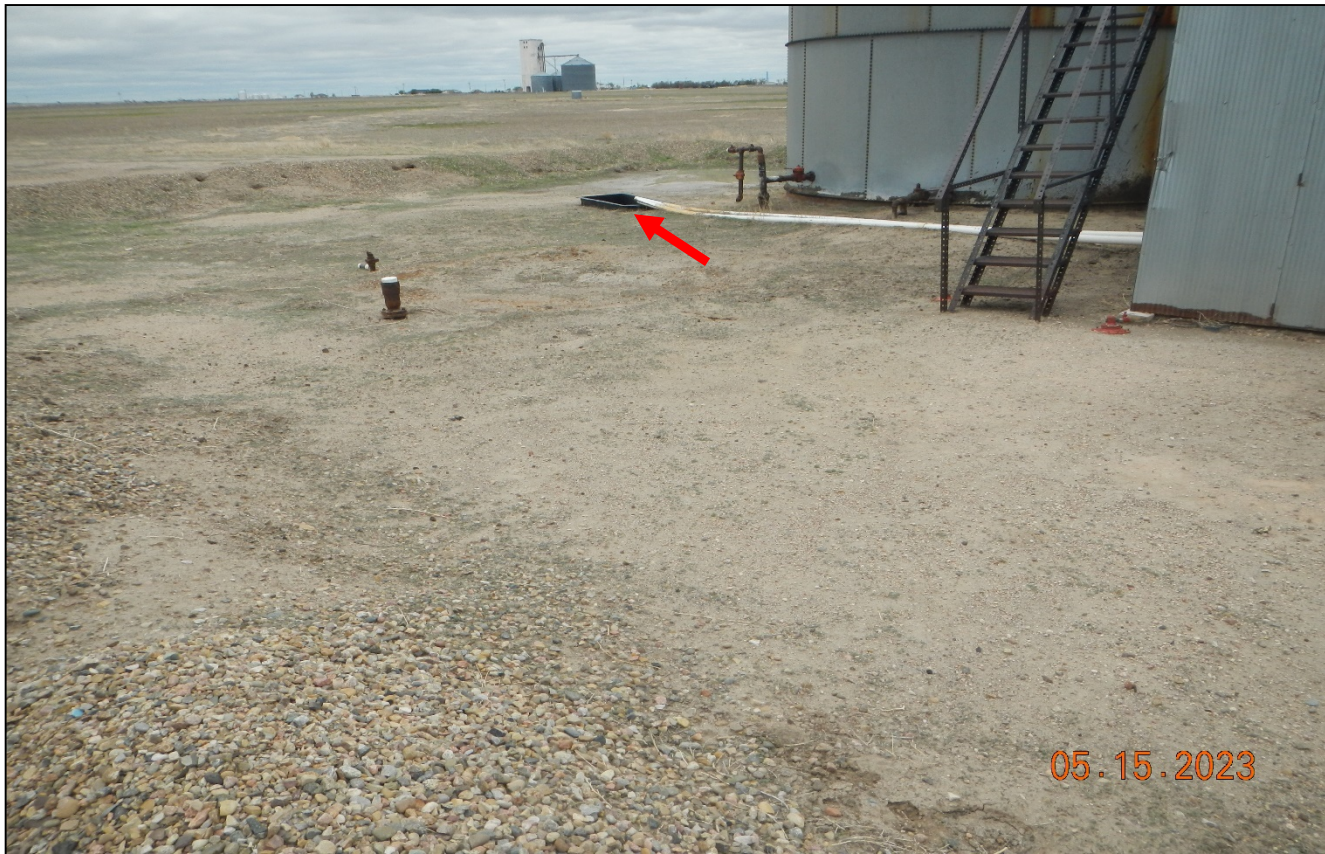
**Photo 4.** The container at red arrow has been replaced to the pipe outlet.

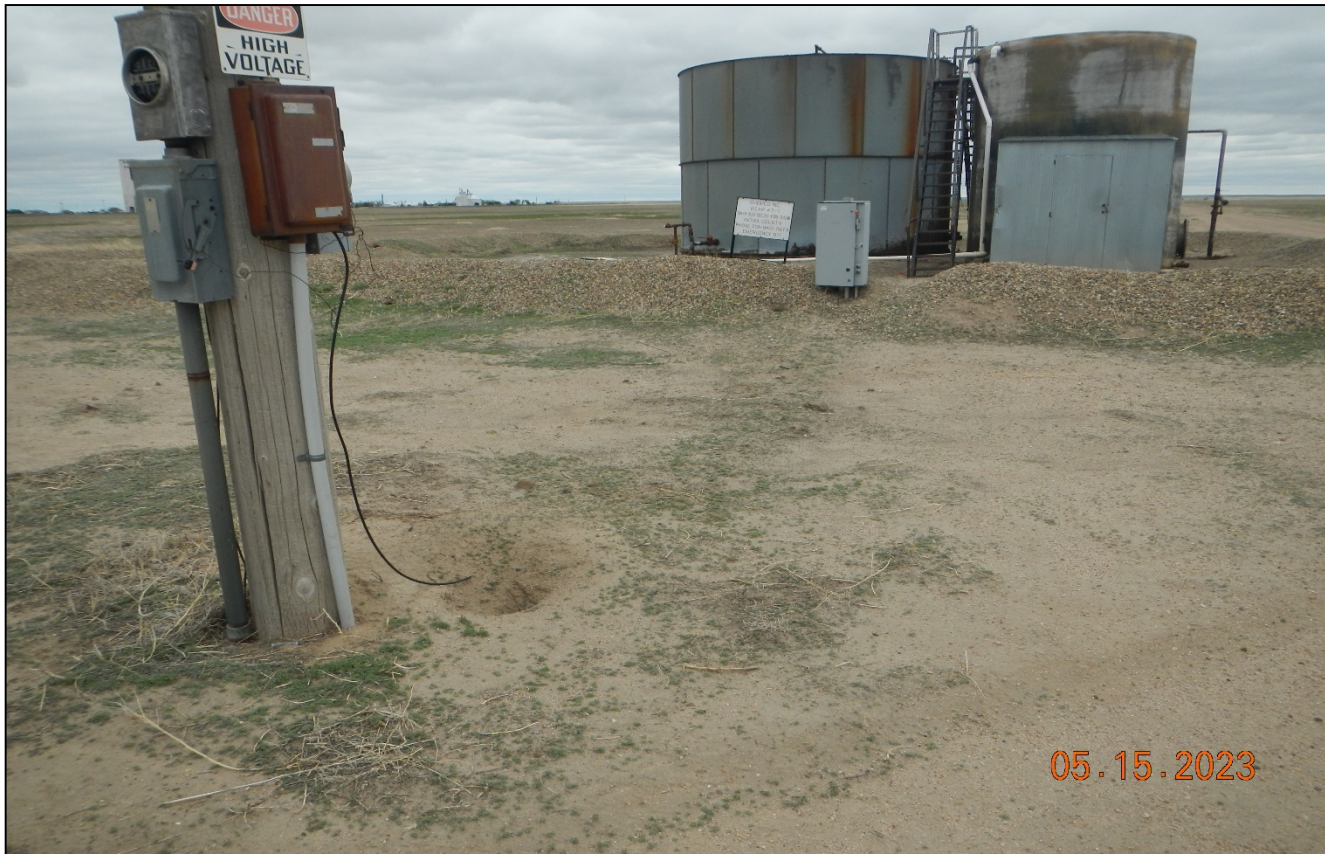
**Photo 5.** The electric line appears to have been buried to the tank battery. The line still hang by the pole and should be better protected with pipe, ect.

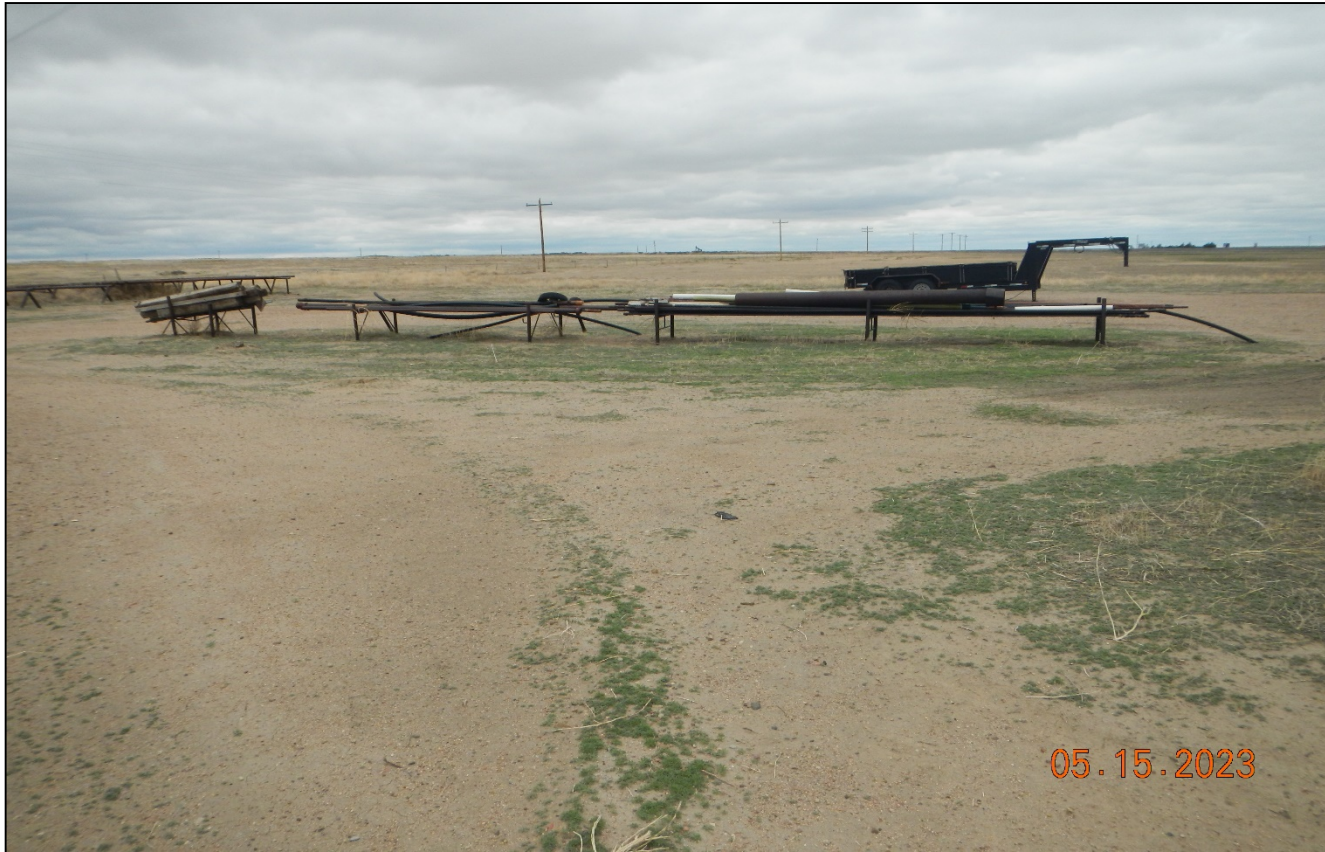
**Photo 6.** There is still storage of pipe and equipment at the location. All equipment and supplies not necessary for use on this Oil and Gas Location is prohibited per Rule 606 and 1003.a.

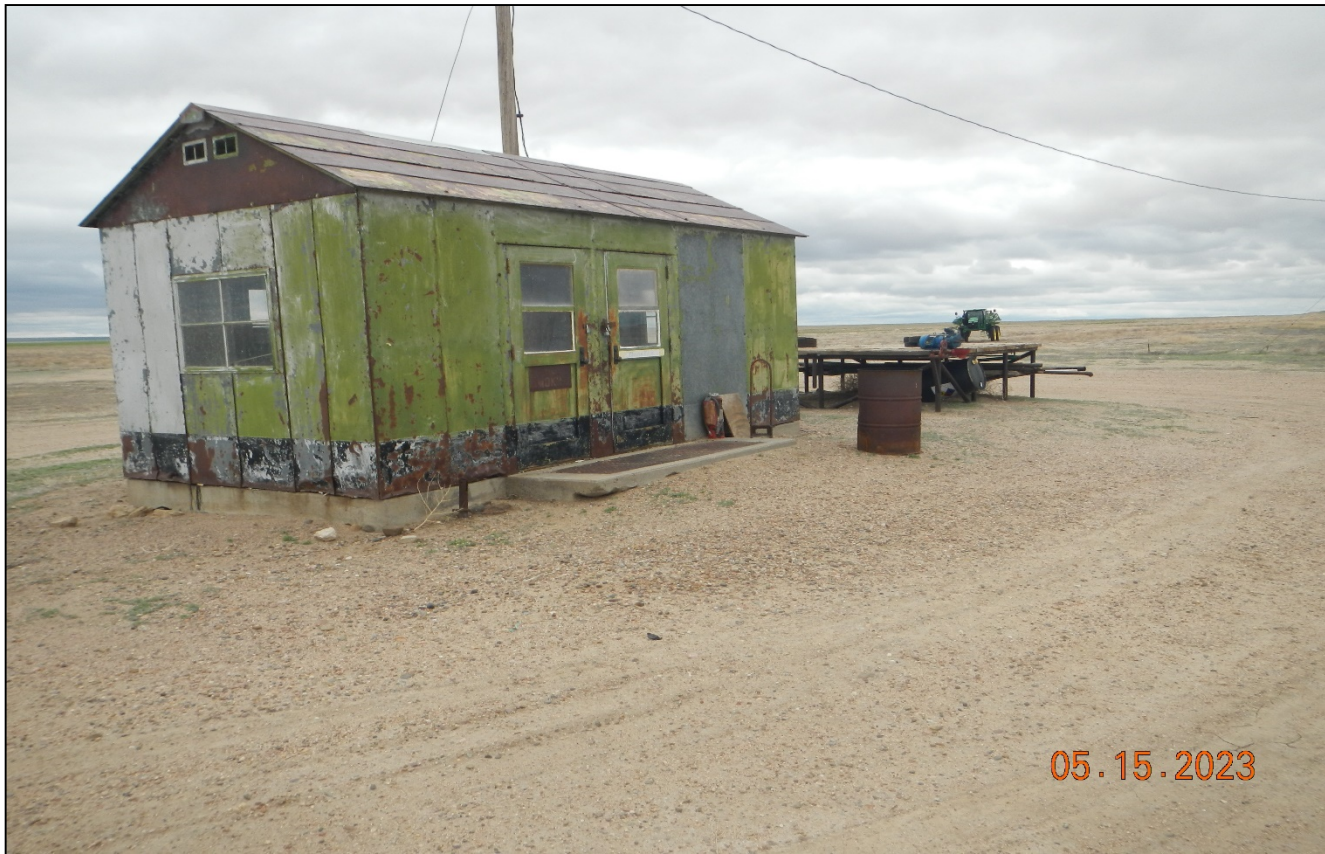
**Photo 7.** Facing northeast toward the storage shed which can remain.

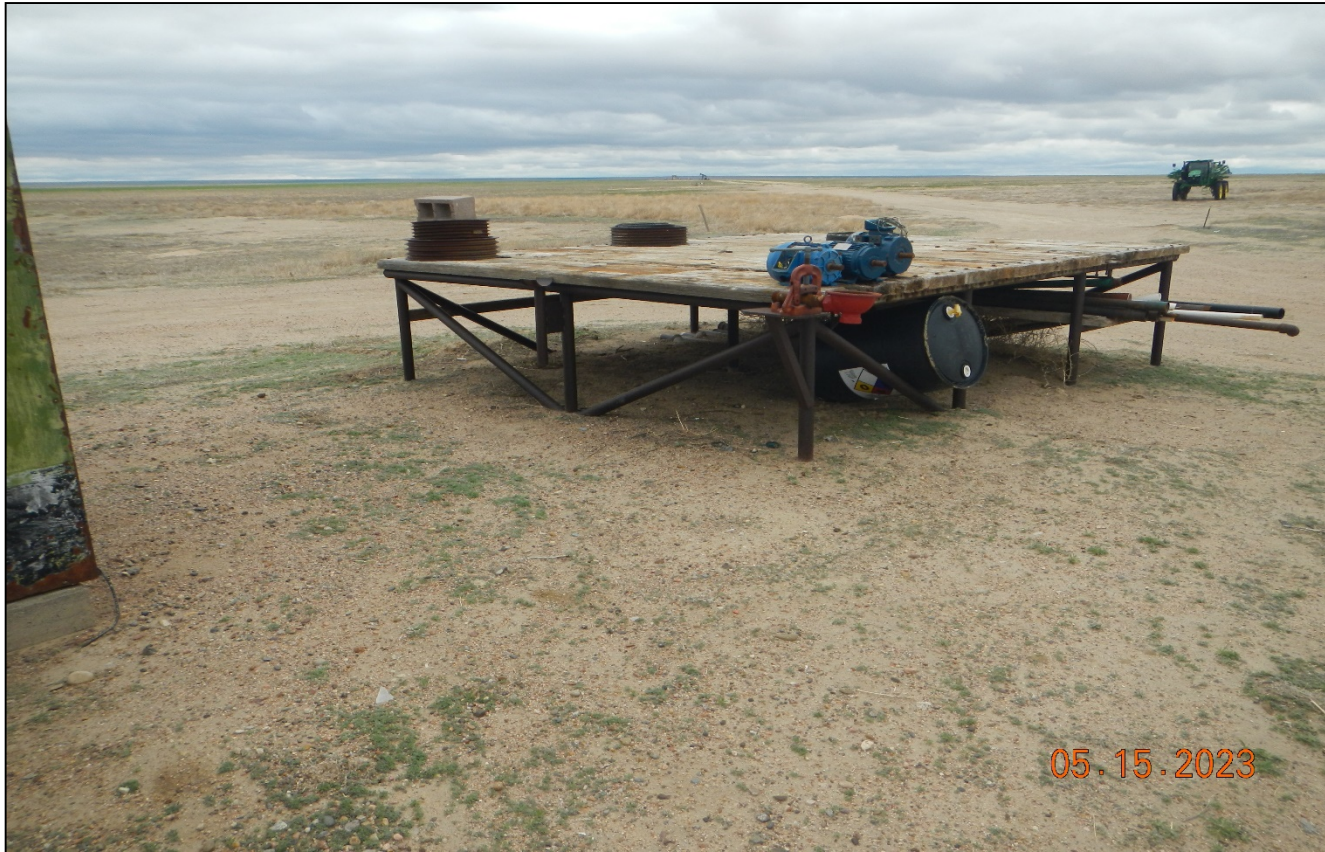
**Photo 8.** Most of the unused supplies stored in this area has been removed. The remainder including the work table should also be removed.

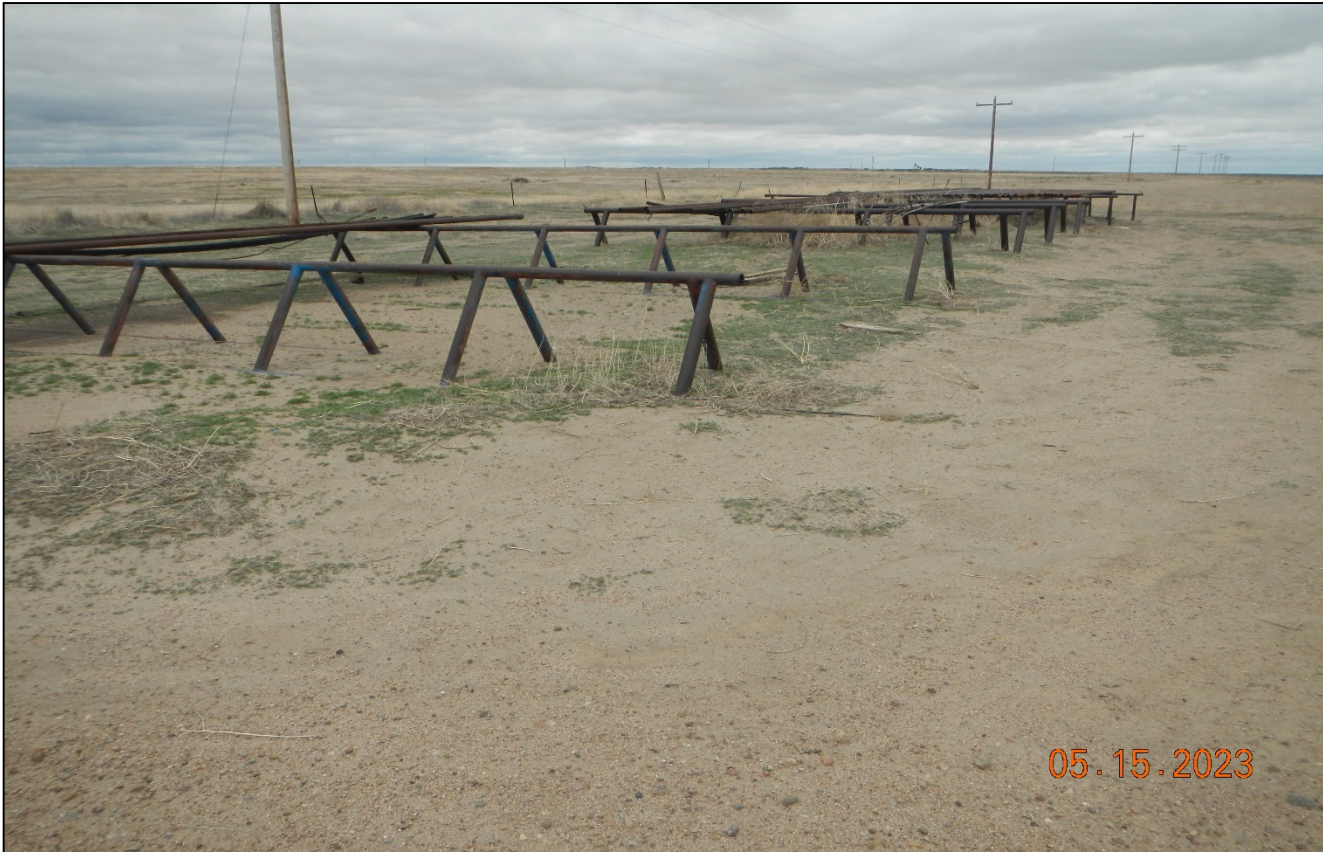
**Photo 9.** There is drilling pipe stored at the east side of the location that also needs to be removed. All supplies not necessary for use on the location is prohibited.

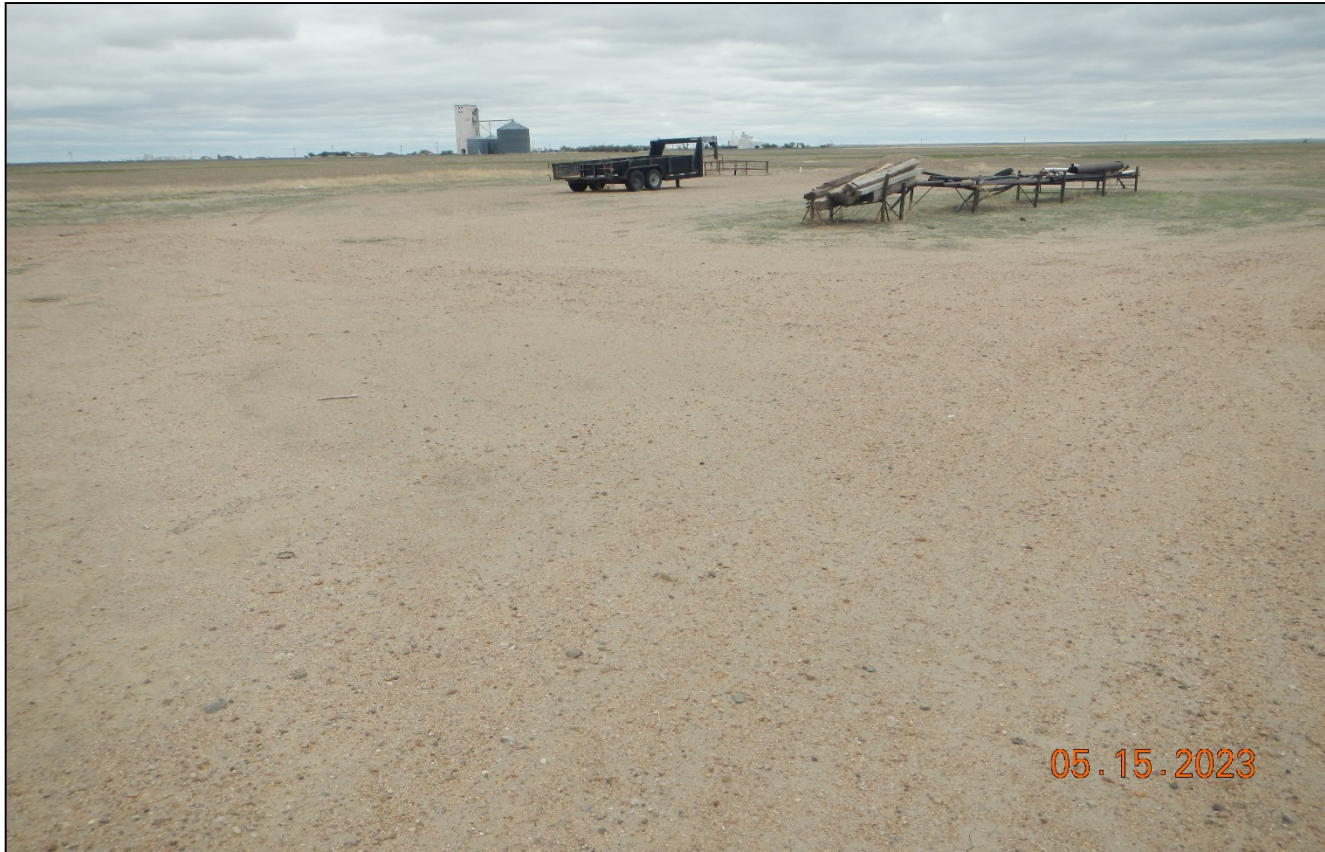
**Photo 10.** Facing southwest at the tank battery location. All unused equipment not necessary for use on the location is prohibited and must be removed. All areas not necessary for operations need to be reclaimed per Rule 1003.

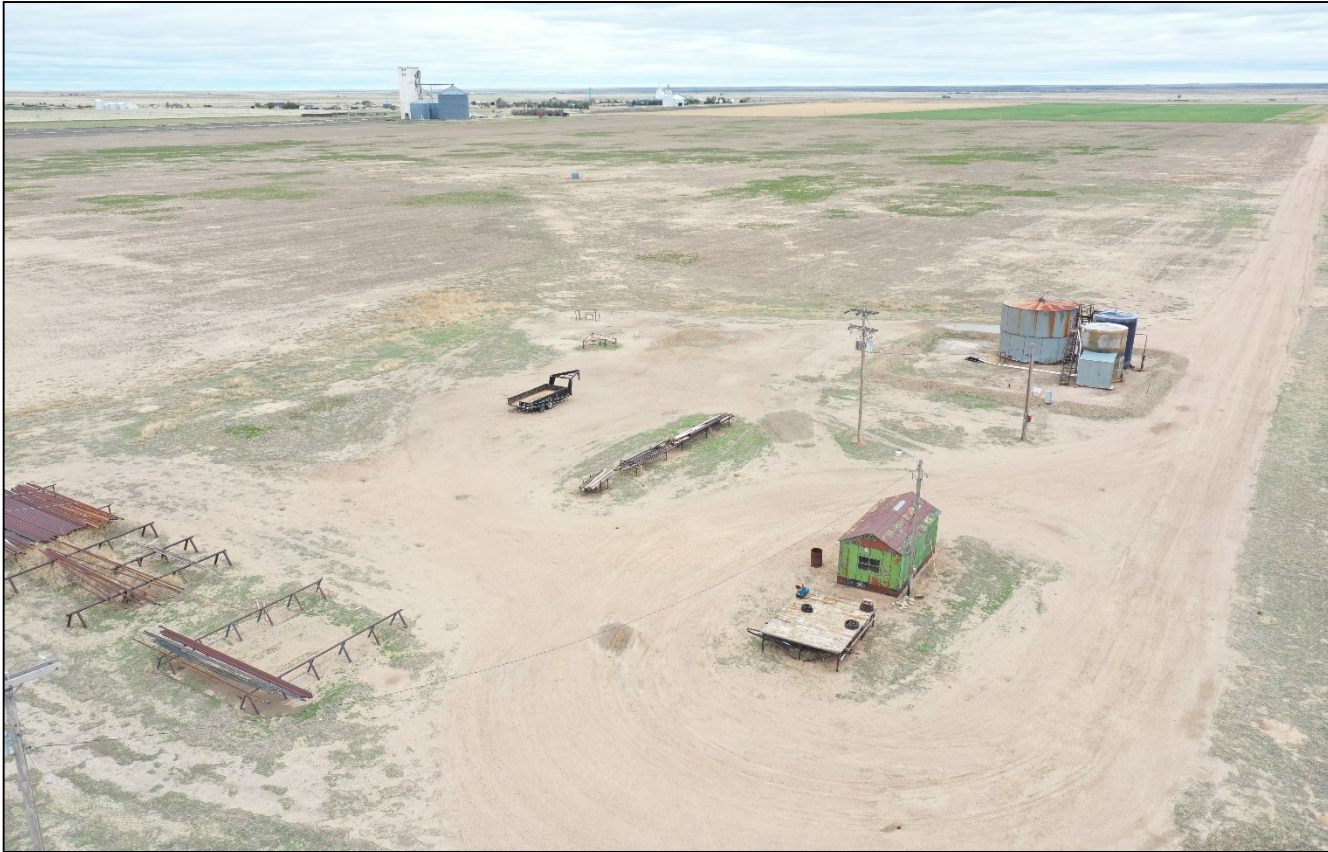
**Photo 11.** Drone aerial imagery facing southwest toward the tank battery location. The location needs to be reduced in size through interim reclamation to be put back into cropland use. All unused equipment not necessary for use on the location is prohibited and must be removed.
